2014 ENGINEER'S INSPECTION A/B POND COMPLEX DIKE COLSTRIP, MONTANA

PPL MONTANA, LLC
Colstrip, Montana

SEPTEMBER 2014

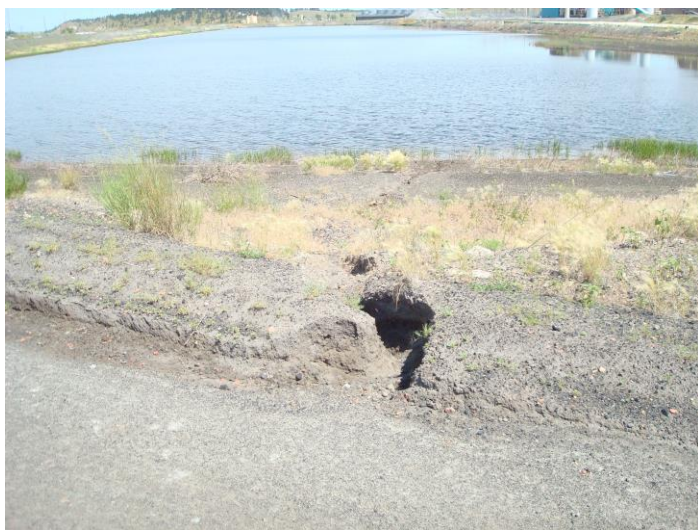
The crest of the Pond AB Dike is approximately 20 feet wide. The horizontal alignment of the crest appears to be good with no surface cracking, areas of unusual movement or cave in. There are no ruts, puddles or low areas. There are two areas where surface runoff breached the small berms on the shoulders of the crest and caused some erosion on the side slopes. These areas should be repaired and the surface drainage of the crest should be evaluated for modifications to control drainage without causing erosion. The crest is used as a road and was bare of vegetation. See Photos 1, 6, 7, 8 and 9.

Photo 1. Pond AB Dike, July 15, 2014.
Crest, south dike, erosion on inboard shoulder.

1. Backfill rodent holes and monitor to determine if rodents are active. If rodents are present, reinstate a rodent control program.
2. Reseed recently disturbed areas where a pipeline was installed to establish vegetation.
3. Repair eroded areas in the crest shoulder berms and the downstream and upstream slopes. Prepare a drainage plan to prevent further erosion damage.

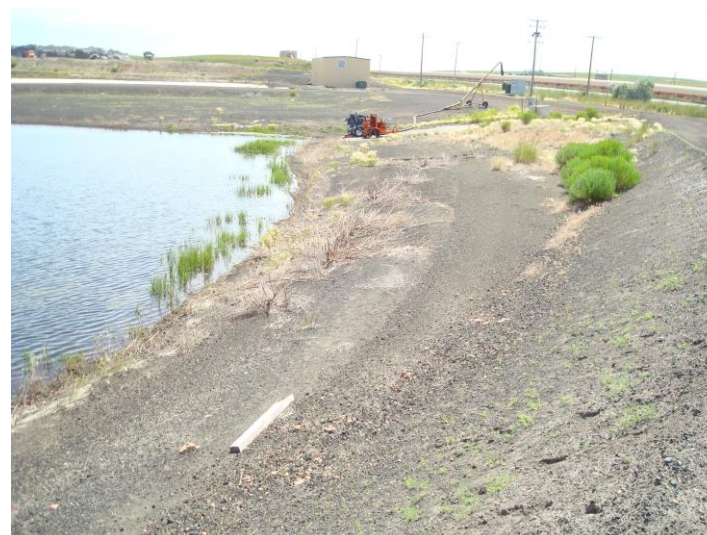
There is no slope protection on the southwest pond upstream slope, but little or no wave erosion has occurred (Photos 4 and 5). The northwest pond is lined with a reinforced polypropylene liner (Photos 38 and 39). Erosion rills exist in places where surface runoff broke through the crest shoulder berms. The erosion damage requires repair.

Photo 4. Pond AB Dike, July 15, 2014.
Upstream slope, south dike

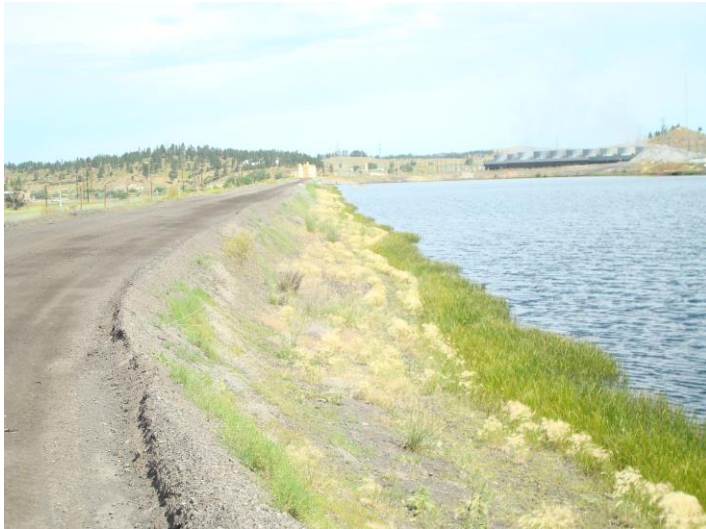
Photo 5. Pond AB Dike, July 15, 2014.
Upstream slope, west dike taken from south side.

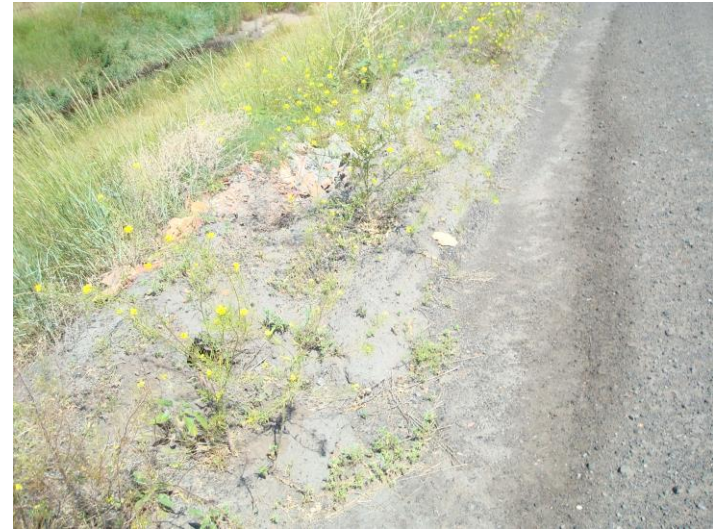
Photo 6. Pond AB Dike, July 15, 2014.
Erosion on downstream shoulder of crest, west dike.

Status: Eroded areas still are on the crest shoulders. We recommend a drainage plan to prevent further erosion damage.

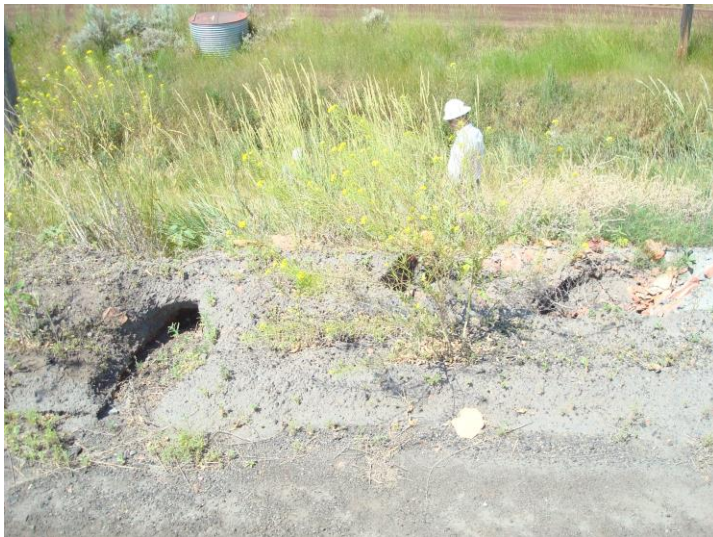
Photo 7. Pond AB Dike, July 15, 2014.
Erosion on downstream shoulder of crest, west dike.

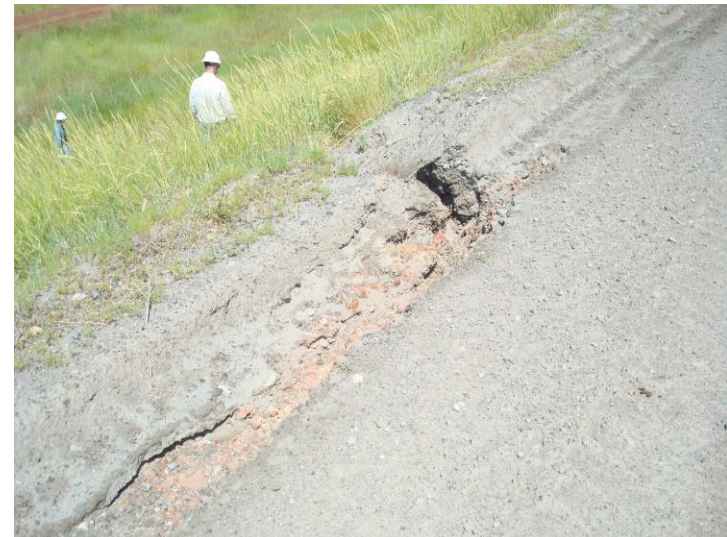
Photo 8. Pond AB Dike, July 15, 2014.
Erosion on downstream shoulder of crest, west dike.

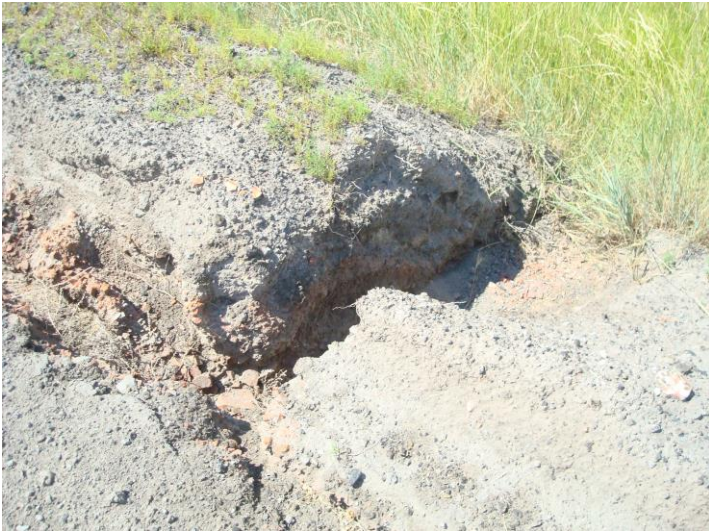
Photo 9. Pond AB Dike, July 15, 2014.
Erosion on downstream shoulder of crest, west dike.

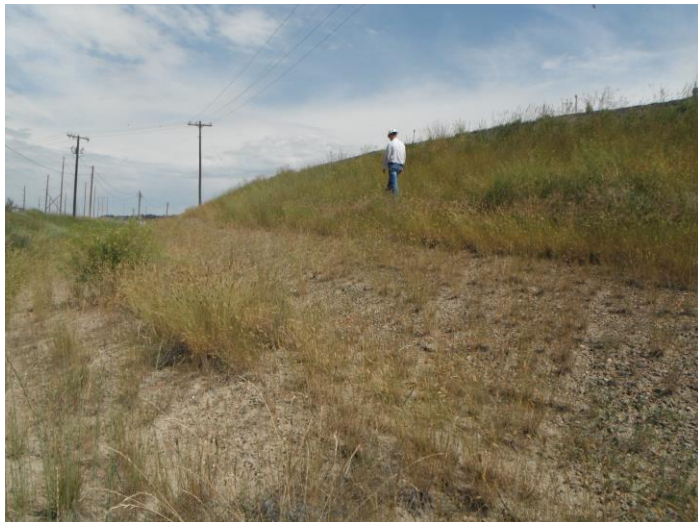
Photo 11. Pond AB Dike, July 15, 2014.
Downstream slope, southwest corner, repair fill material.

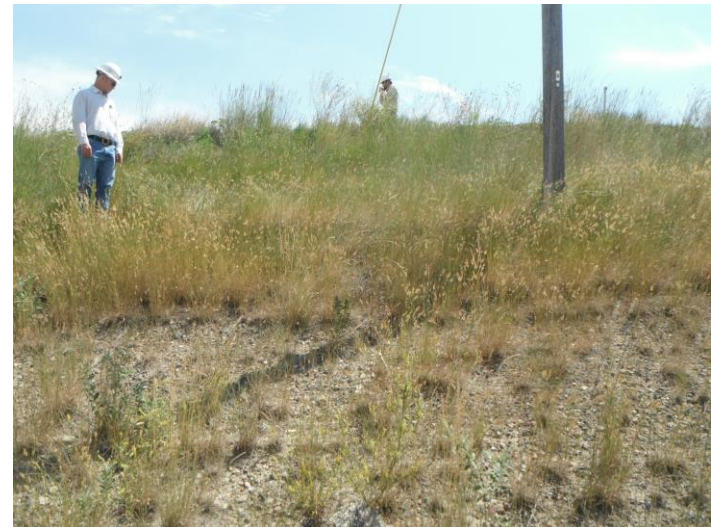
Photo 12. Pond AB Dike, July 15, 2014.
Downstream slope, south side of west dike, rodent holes by person.

Status: A rodent control program was started in 2009. Several rodent holes were found on the 2014 inspection. We recommend backfilling the holes and monitoring. If rodents return, reinstate a control program.

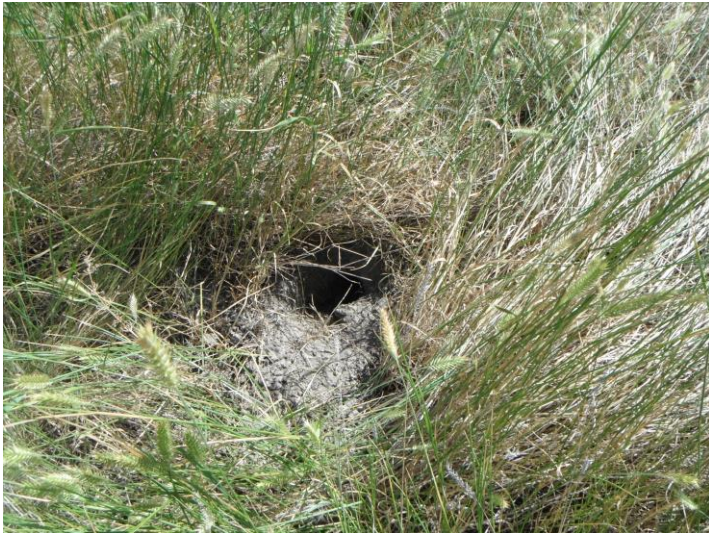
Several rodent holes are on the downstream slope (Photo 13). We recommend backfilling the holes and monitoring the area to determine if rodents return. If rodents are present, the rodent control program should be reinstated. For the most part, grass cover along the slope is well established with the exception of some areas of pipe installations where vegetation is not yet established (Photo 24). These areas may need to be reseeded. The downstream slope is over-steepened on the northwest corner of the dike where backfill from a recent pipeline installation did not match the existing embankment slope (Photo 30).

Photo 13. Pond AB Dike, July 15, 2014.
Downstream slope, south side of west dike, rodent hole.

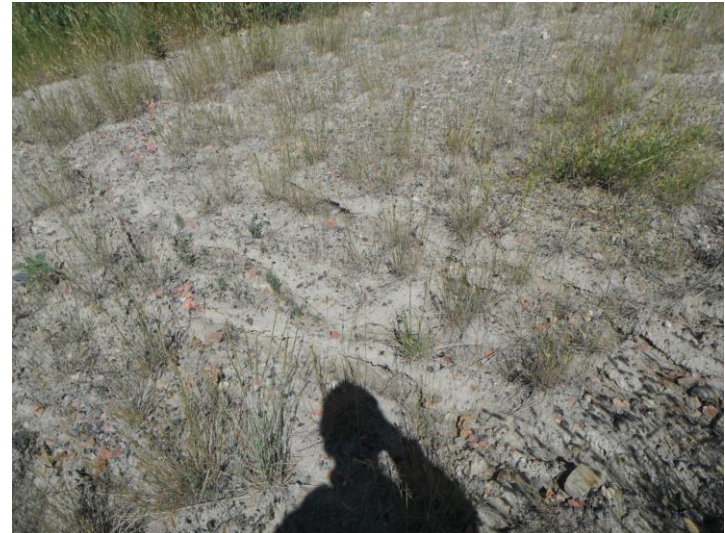
The downstream slope did not exhibit signs of sliding, sloughing, or unusual movement. There are two areas where surface runoff from the crest eroded the slope (Photo 14). These areas require repair. There are several small woody bushes that need removing (Photo 34). Neither wet areas nor seepage are present on the surface of the slope. The contact between the embankment and south abutment is in good condition.

Photo 14. Pond AB Dike, July 15, 2014.
Downstream slope, south side of west dike, erosion rills near toe.

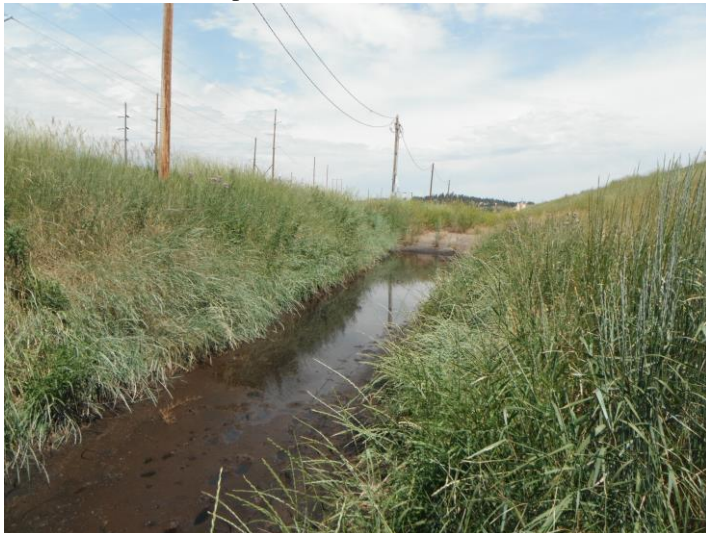
The downstream area of the A/B Pond Dike does not have abutment or foundation seepage showing on the surface. There is no evidence of sliding or sloughing. There is standing water in one part of the downstream area, which appears to be from surface runoff (Photo 15). The area should be monitored to determine if the water remains or evaporates. The depression where water collects should be modified to allow it to drain. This area is used as

Photo 15. Pond AB Dike, July 15, 2014.
Downstream slope, south side of west dike, seepage or runoff ponded.

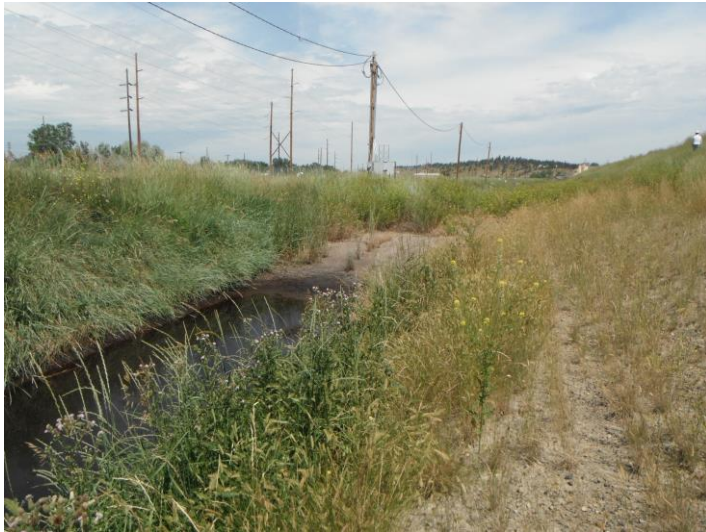
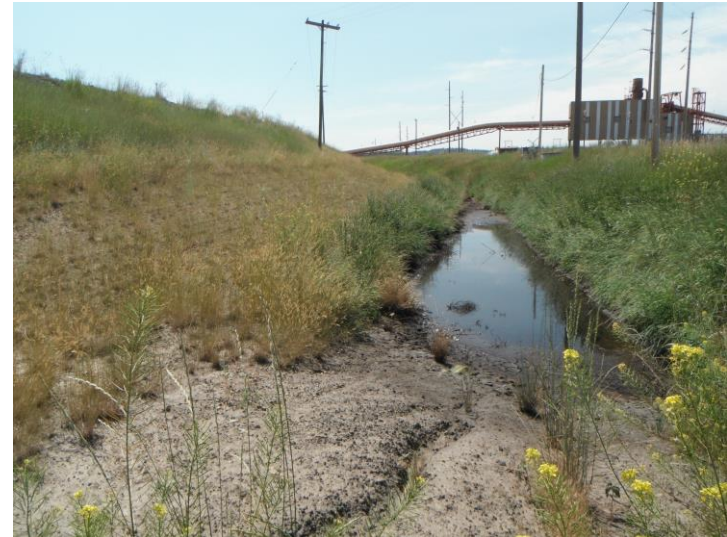
Photo 17. Pond AB Dike, July 15, 2014.
Downstream slope, south side of west embankment, seepage/runoff ponding.

Photo 18. Pond AB Dike, July 15, 2014.
Downstream slope, south side of west embankment, seepage/runoff ponding.

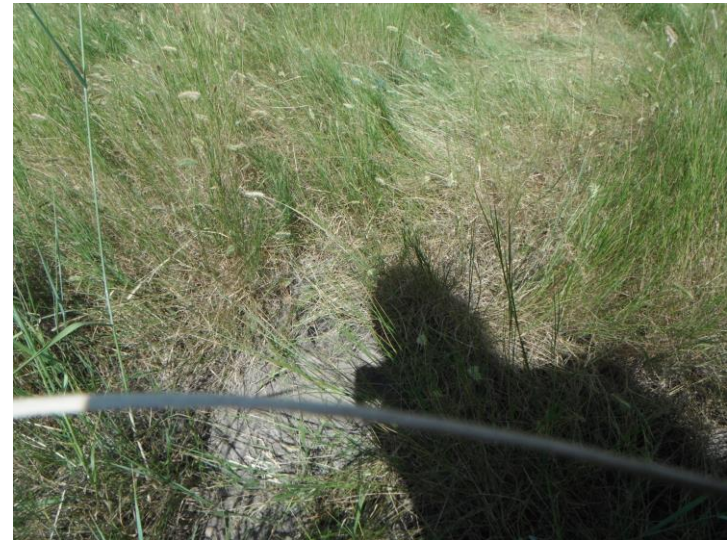
Photo 20. Pond AB Dike, July 15, 2014.
Rodent hole, downstream toe, middle of west dike.

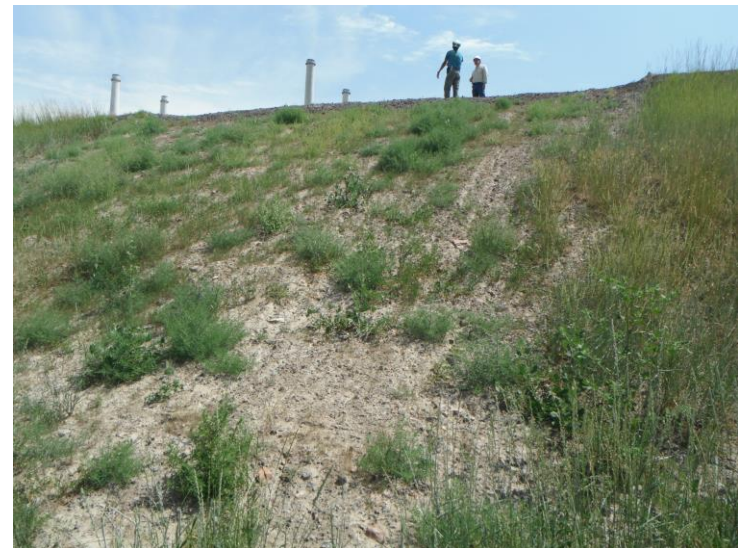
Photo 24. Pond AB Dike, July 15, 2014.
Downstream slope, repair area after pipe installation.

Status: Disturbed areas observed in 2009 appear to be in good condition. Other recently disturbed areas found during the 2014 inspection require more seeding to establish vegetation.

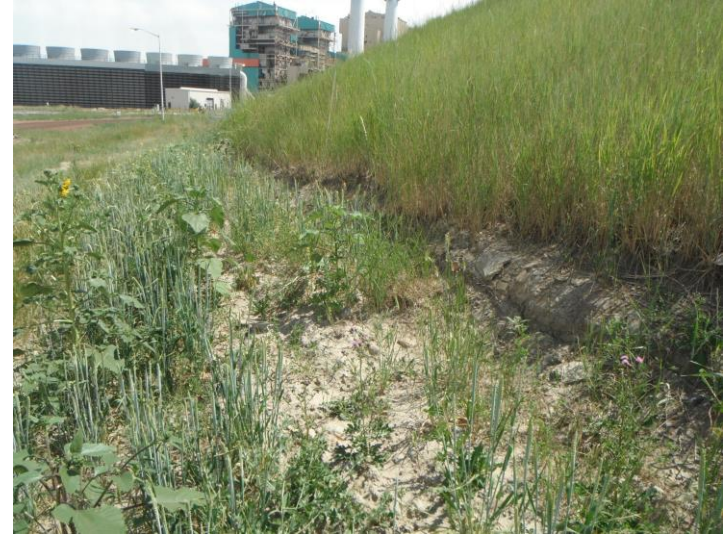
Photo 30. Pond AB Dike, July 15, 2014.
Downstream slope, northwest corner, pipe installation at toe.

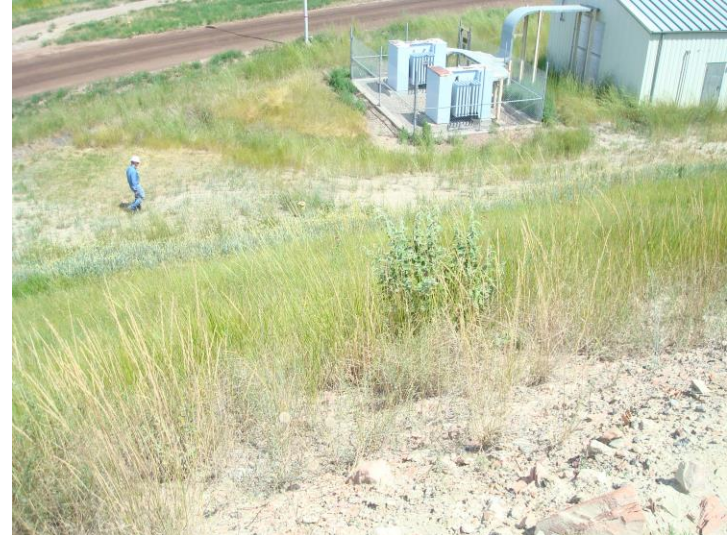
Photo 34. Pond AB Dike, July 15, 2014.
Downstream slope, northwest corner, woody vegetation near crest.

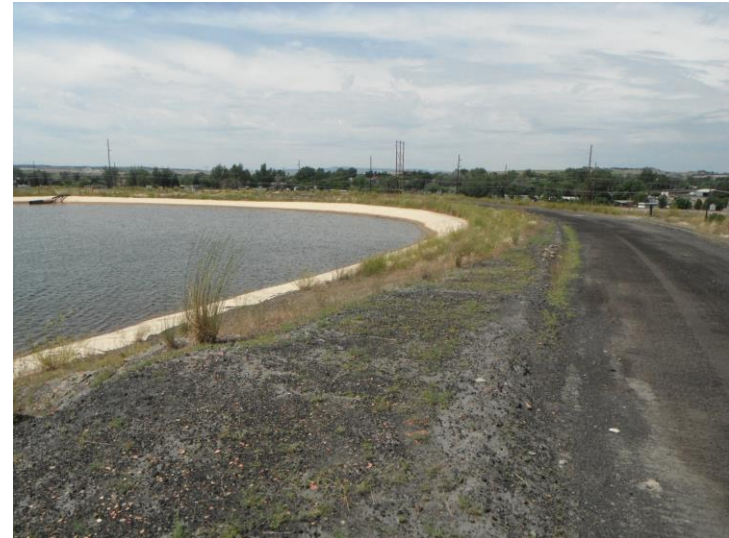
Photo 38. Pond AB Dike, July 15, 2014.
Crest and pond, northwest corner.

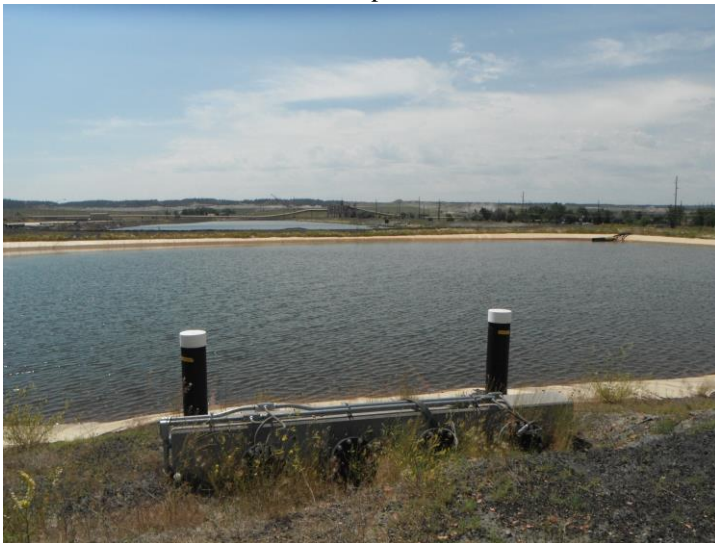
Photo 39. Pond AB Dike, July 15, 2014.
Pond, northwest corner.

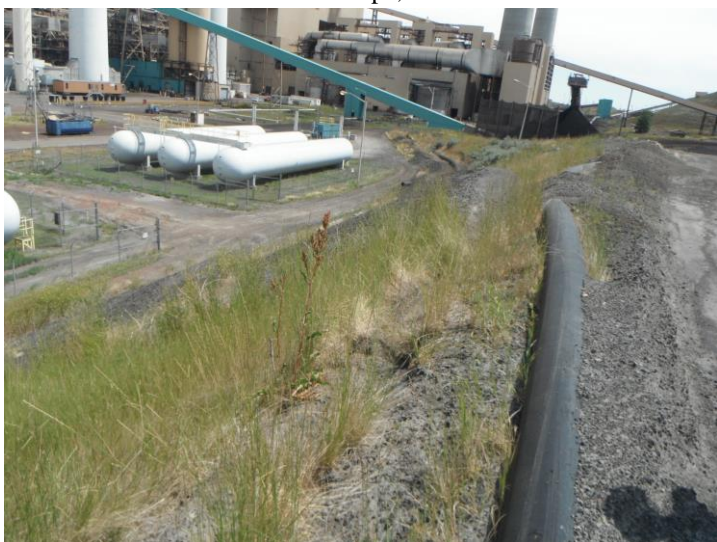
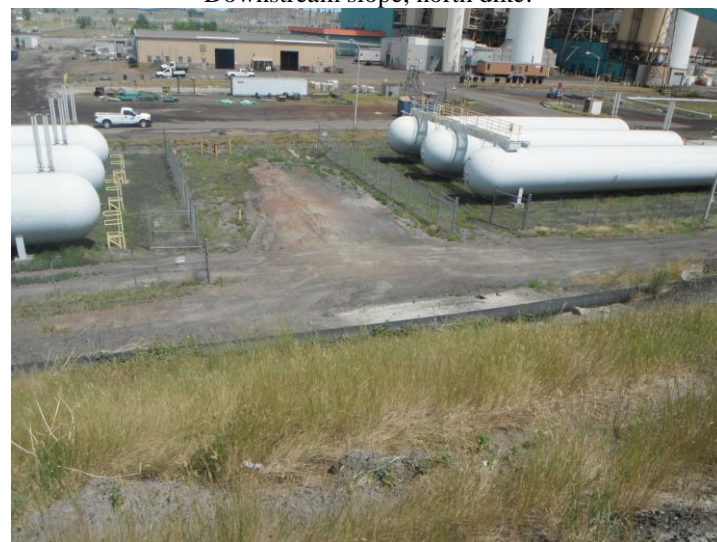
Photo 43. Pond AB Dike, July 15, 2014.
Old seepage area, repaired, north dike.

Photo 44. Pond AB Dike, July 15, 2014.
Old seepage area, repaired, north dike.
