# 2014 PERIODIC ENGINEER'S INSPECTION CASTLE ROCK RESERVOIR MAIN AND SADDLE DAMS COLSTRIP, MONTANA

**PPL MONTANA, LLC**  
Colstrip, Montana

**Hydrometrics, Inc.**  
Consulting Scientists and Engineers

SEPTEMBER 2014

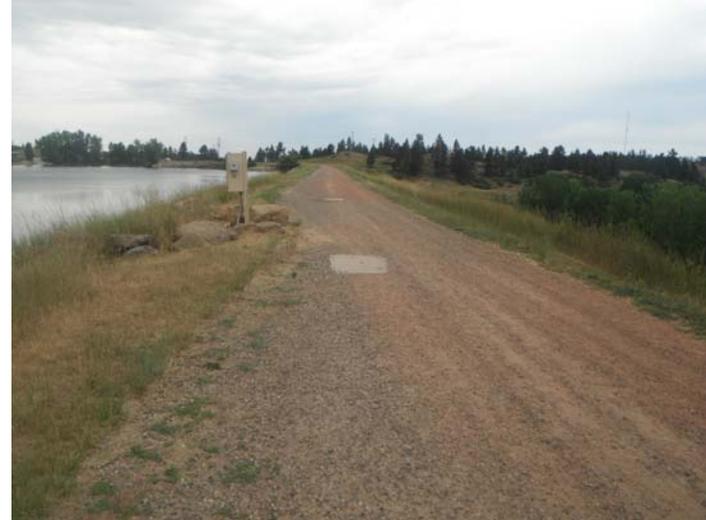
The crest of the Main Dam was in good condition (Photo 2). An elevation survey along the crest was not conducted during this inspection. Surveys conducted in 1988 and 1993 indicated no unusual settlement of the crest. The vegetation along the shoulders of the road was in good condition. The horizontal alignment of the crest appears to be good with no surface cracking, low areas, or animal burrows. The tire rut identified in 2009 appears to have been repaired.

Photo 2. Castle Rock Surge Pond Main Dam, July 15, 2014.  
Crest and upstream slope from right abutment.

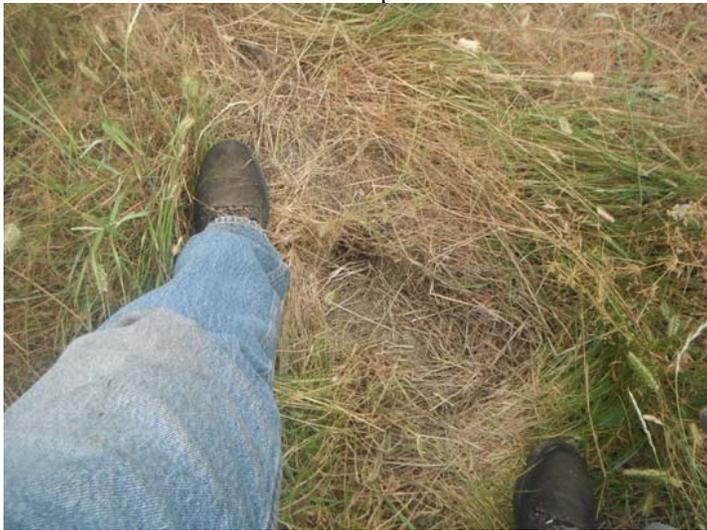
Photo 11. Castle Rock Surge Pond Main Dam, July 15, 2014.  
Rodent hole, mid-dam on downstream slope.

Status: PPL Montana has reported to have engaged the services of a rodent control firm on all embankments in the past. Several rodent holes were found during the 2014 inspection but it was not known if they were active. It is recommended to have the rodent control program renewed plus it is recommended that all rodent holes are backfilled in order to identify if rodents return in the future.

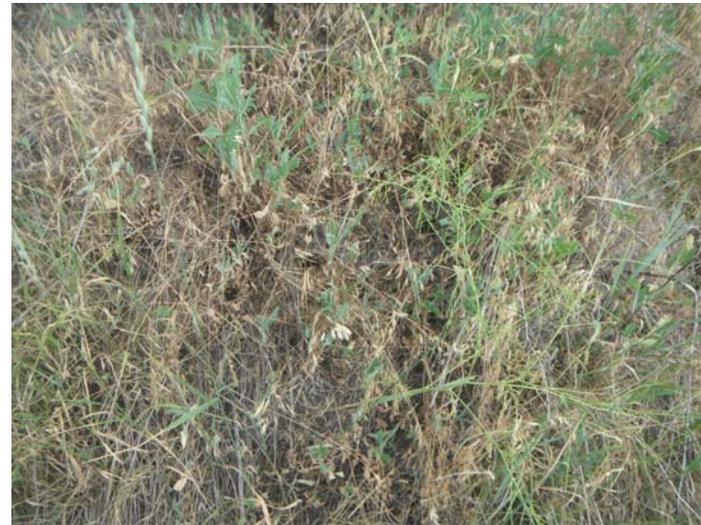
Photo 12. Castle Rock Surge Pond Main Dam, July 15, 2014.  
Rodent holes and dried grass and weeds near mid-dam on downstream slope.

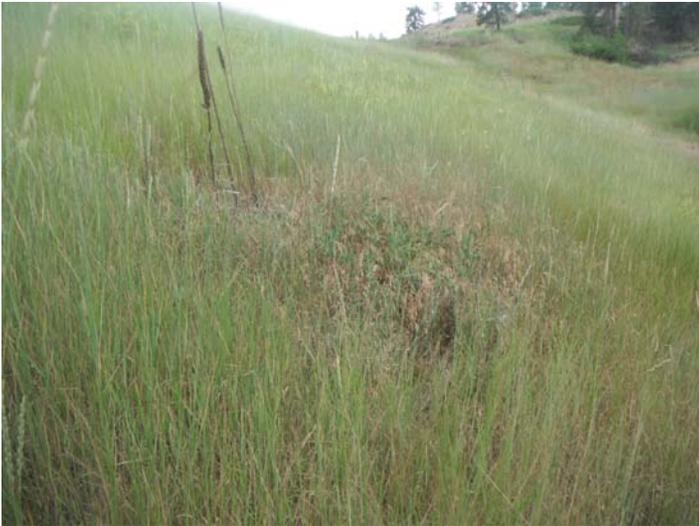
Photo 13. Castle Rock Surge Pond Main Dam, July 15, 2014.  
Rodent holes and dried grass and weeds near mid-dam on downstream slope.

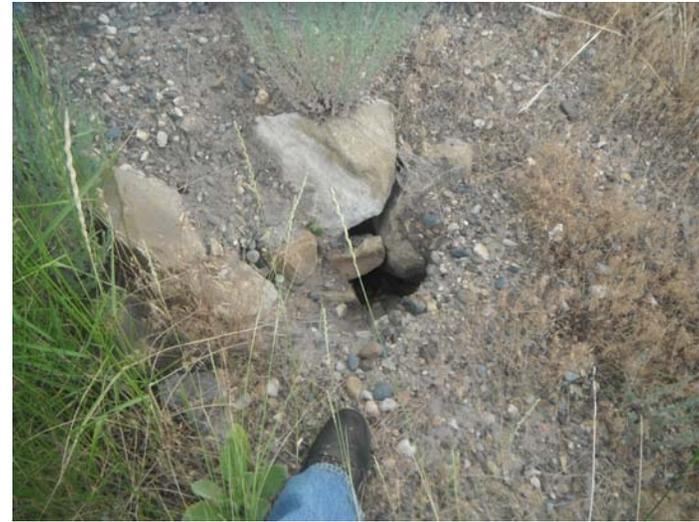
The downstream slope was in good condition with minor items identified that require attention. No signs of slope instability, wet areas, or seepage were observed. There was no erosion or unusual movement (Photos 5 and 9). The vegetative cover was good except for some scattered sagebrush growing near the crest. Some weeds were identified that should be controlled, and the weeds typically were present near identified rodent holes (Photos 12 and 13). It is not known if the rodent holes were active. We recommend backfilling rodent holes and monitoring to identify if rodents are present. PPL Montana reported that a rodent control program was enacted several years ago. A similar program will have to be used if rodents are still active. A large rodent or fox hole was found in the left downstream groin that needs to be backfilled and treated similar to the other rodent holes (Photo 14).

Photo 14. Castle Rock Surge Pond Main Dam, July 15, 2014.  
Large rodent/fox hole in left downstream groin area.

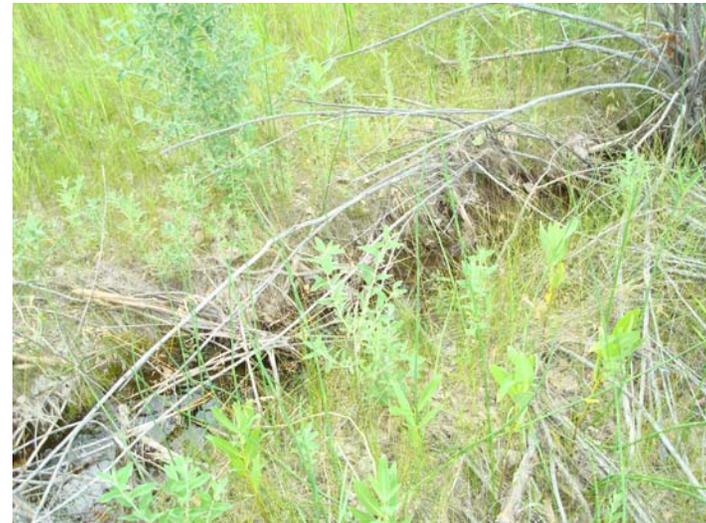
Photo 16. Castle Rock Surge Pond Main Dam, July 15, 2014.  
Seepage channel, toe of main dam.

The downstream area of the Main Dam showed no signs of surface seepage except in the toe drain of the dam and in the interception trench near the Pumping Plant Building (Photos 17 through 22). Installation of a weir or other type of flow measuring device is recommended in the drainage channel in the center toe area (see Figure 2-3 for potential weir location). Once a measuring device is installed, flow in the trench should be monitored monthly, accompanied by corresponding reservoir water surface elevations.

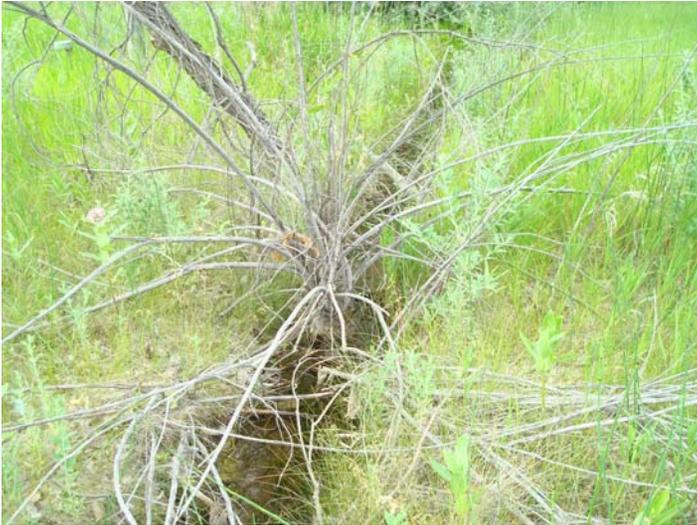
Photo 17. Castle Rock Surge Pond Main Dam, July 15, 2014.  
Seepage channel, toe of main dam.

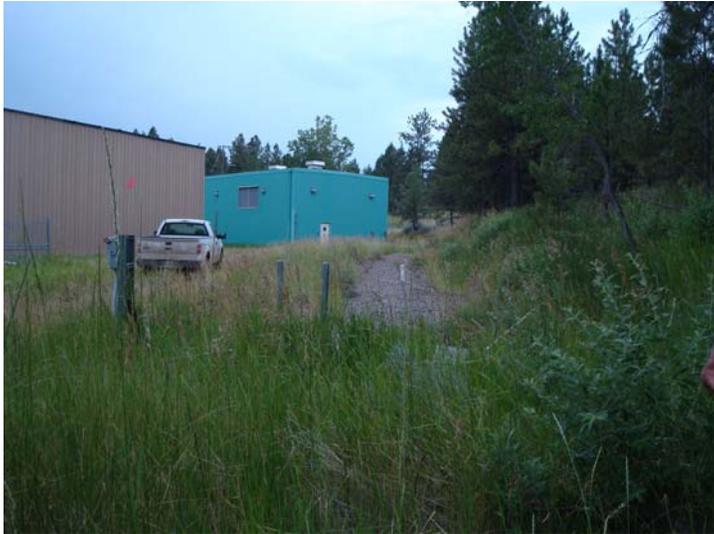
the dam phreatic surface may indicate piping or stability problems in the dam. As discussed above, the installation of a drainage channel flow measuring device is recommended. A new drain comprised of slotted pipe within a gravel bed was installed since 2005 in the channel below the right abutment next to the Pumping Plant Building and across the access road to the east of the Pumping Plant to collect seepage. Flow is collected in a sump and then pumped to the toe drainage channel (Photos 21 and 22). Seepage flow is not measured at this point.

Photo 21. Castle Rock Surge Pond Main Dam, July 15, 2014.  
Seepage interception trench with drain gravel and perforated pipe.

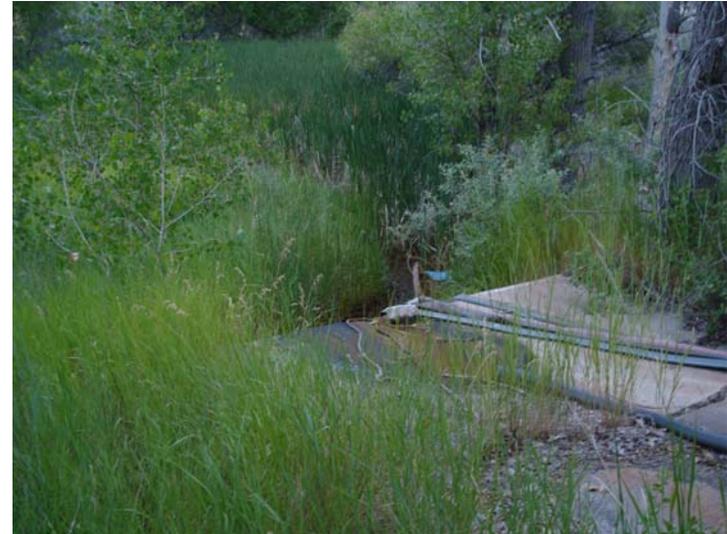
Photo 22. Castle Rock Surge Pond Main Dam, July 15, 2014.  
Seepage flow pipes discharging from collection vault to drainage ditch.

- b. Install surface flow measurement devices to monitor the flow from the Main Dam's internal drain and from the interception ditch adjacent to the Pumping Plant Building. A recommended location for a measuring device is shown on Figure 2-2.

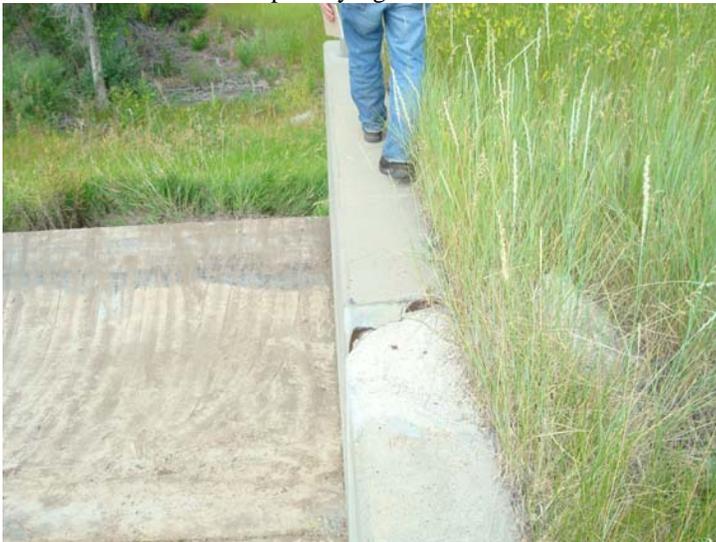
The spillway channel floor appears to be in good condition (Photos 28 and 33). There was no indication of displacement or unusual movement within the channel. The sidewalls appear to be in good condition except for spalling at the top of the right wall at a joint on the lower part of the spillway that needs repair (Photo 31). Some filler material is missing in the floor-wall joint on the left side near the flip bucket, which requires repair (Photo 35). The discharge area was in good condition with established vegetation.

Photo 31. Castle Rock Surge Pond Main Dam, July 15, 2014.  
Spalling on top of spillway right wall.

- f. Repair concrete spalling on right spillway wall and joint filler in the left wall-floor joint near the flip bucket.
- g. Have an engineer inspect the outlet pipe access tunnel and the intake tower.

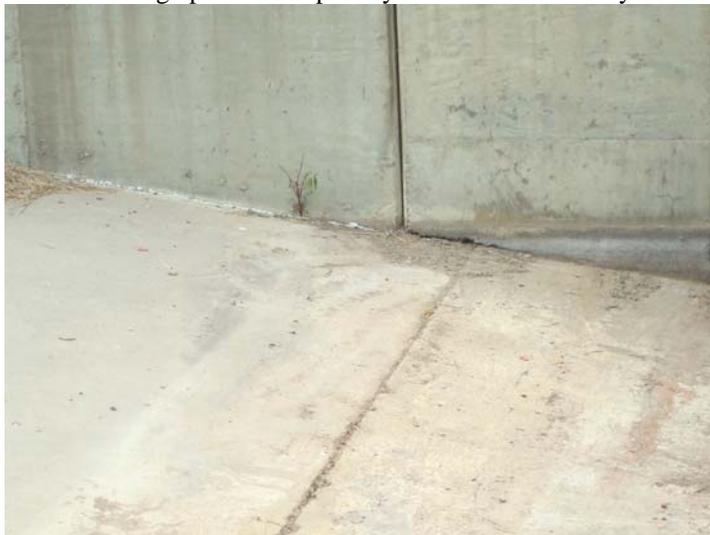
Photo 35. Castle Rock Surge Pond Main Dam, July 15, 2014.  
Missing joint filler along wall-floor joint, left spillway wall.

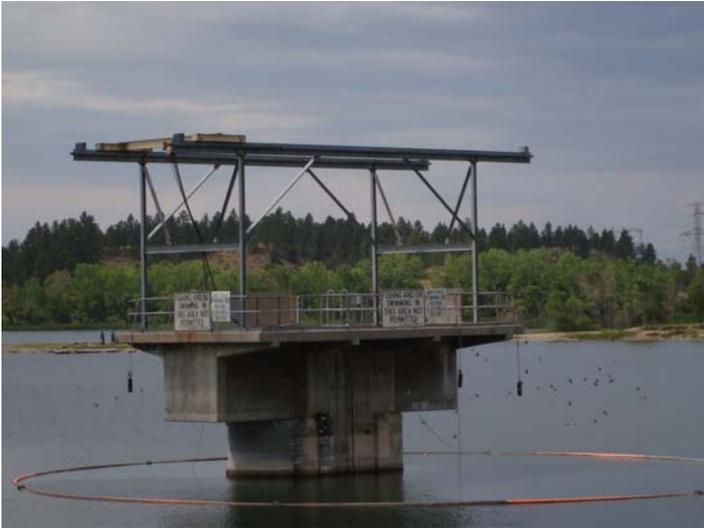
inlet structure for the outlet works. The outlet works and inlet structure were not inspected during this site visit and have not been inspected for the last several periodic inspections. While the guidelines for embankment dam outlet inspections vary according to purpose, size and site conditions, we recommend inspecting the outlet tunnel and intake tower of the Main Dam at or before the next periodic inspection. Inspection guidelines are available from FEMA (2005). Photo 37 shows the intake tower.

Photo 37. Castle Rock Surge Pond Main Dam, July 15, 2014.  
Intake tower.

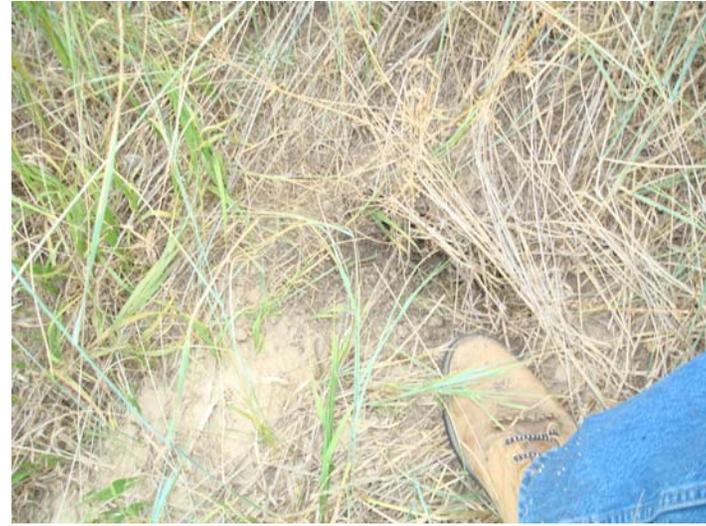
The downstream slope showed no evidence of slides, sloughs, scarps, erosion, or unusual movement. Several rodent burrows were found; treatment should be the same as for the Main Dam. No seepage or wet areas were observed. The contact between the embankment and abutment was good and vegetation control was good.

Photo 42. Castle Rock Surge Pond Saddle Dam, July 15, 2014.  
Rodent hole, downstream slope.

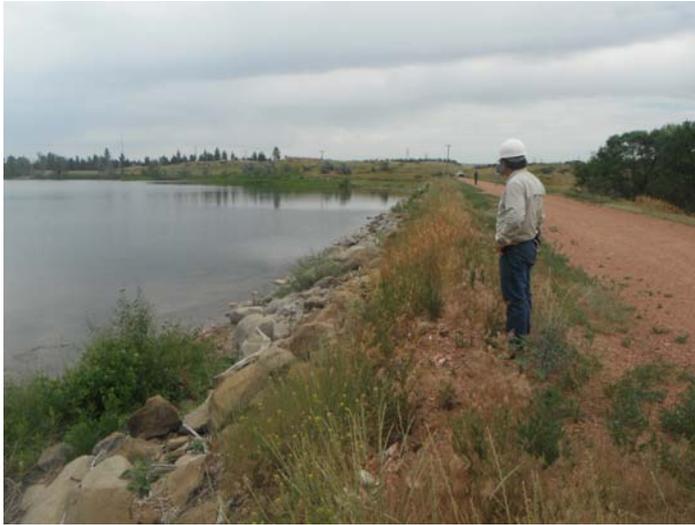
The upstream slope of Saddle Dam was in good condition. The slope is protected with generally well-distributed rock. No erosion, sinkholes or animal burrows were observed. The contact between the embankment and abutment was in good condition. Trees near the abutments have been removed but some young willows and cottonwood trees are starting to grow in between riprap on the upstream slope and the abutment areas that needs to be cut down (Photos 45 and 46).

Photo 45. Castle Rock Surge Pond Saddle Dam, July 15, 2014.  
Crest and upstream slope from right abutment.

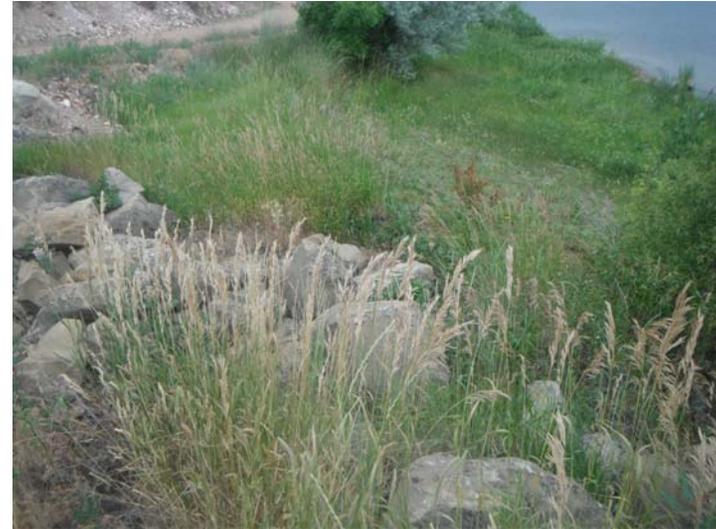
Photo 46. Castle Rock Surge Pond Saddle Dam, July 15, 2014.  
Right upstream groin area.
