## - TECHNICAL MEMORANDUM -

DATE: 9 September 2013

TO: Mike Holzwarth, Steve Christian, Gordon Criswell – PPL Montana, LLC

SUBJECT: **ADDENDUM -- SOUTH FORK COW CREEK DIVERSION SEDIMENT REMOVAL**

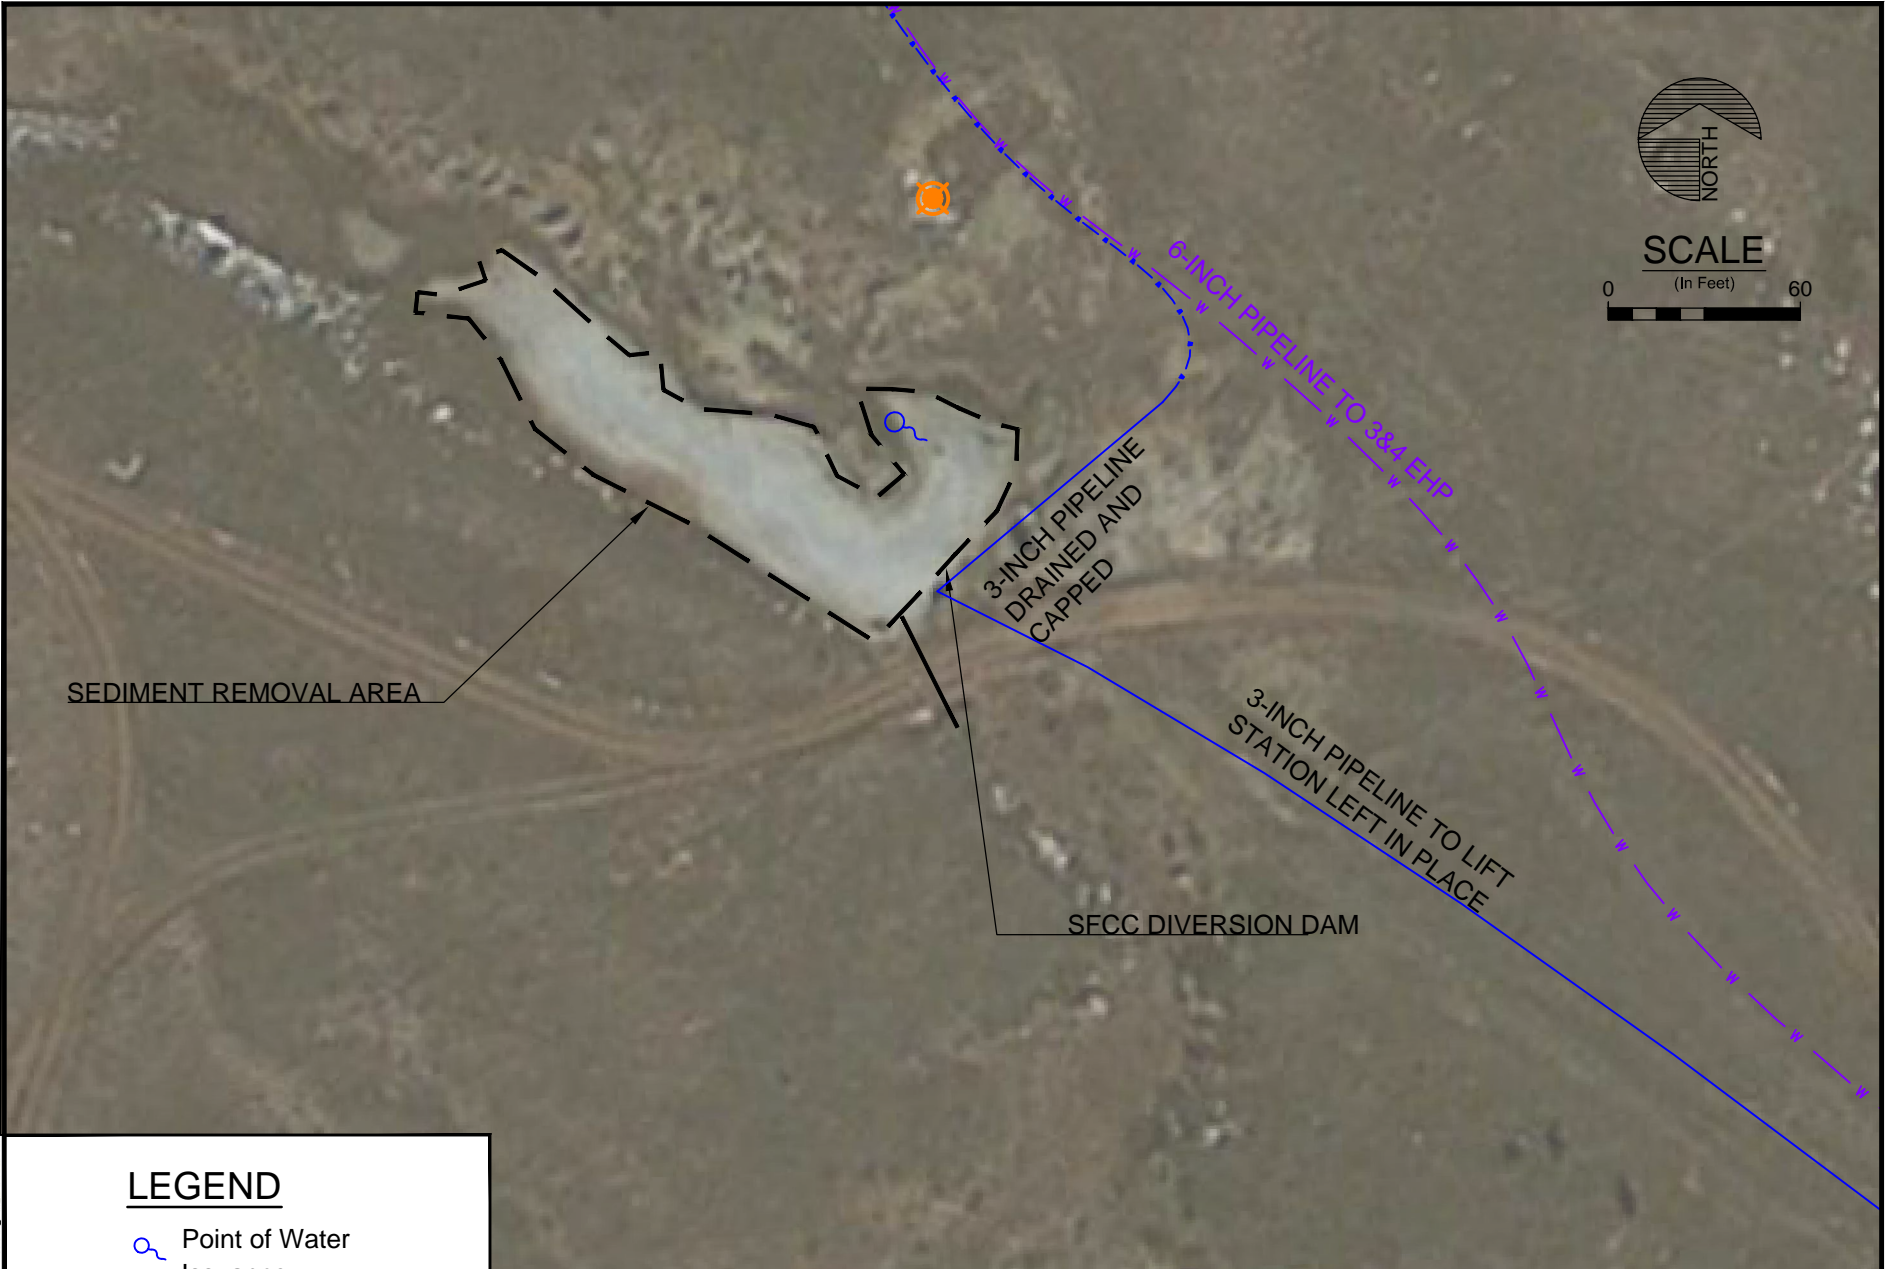
FIGURE  
**1**

Personnel from PPL Montana LLC's Colstrip-SES Environmental Department tracked the source of the impacted water to a leaky unused pipeline upgradient of the SFCC Diversion Dam. Specifically, the leak originated at a valve housed below ground in a vault constructed of corrugated metal pipe (CMP). The discontinued pipeline was connected to the active pipeline that distributes captured groundwater from SFCC to the 3&4 EHP. The leaks were repaired and

the valves and CMP vault were removed. The location of the pipeline and removed valve vault are shown in relation to the SFCC Diversion Dam and point of issuance of the impacted water in Figure 1.

**LOCATION OF LEAKY PIPELINE AND  
POINT OF WATER ISSUANCE**

No further issuance of water to the ground surface above the SFCC Diversion has been observed since the repair of the leaky valves took place. Note also that surface water was not allowed to pass beyond the SFCC Diversion Dam from the date of discovery of the surface water issuance until it was verified that the issuance was stopped. The culvert at the site was plugged throughout the spring; and impounded water was removed to the 3&4 EHP. Most of the water removed was either snowmelt or storm water runoff.
