2014 PERIODIC ENGINEER'S INSPECTION UNITS 1 & 2 STAGE II EVAPORATION POND (STEP) MAIN DAM COLSTRIP, MONTANA

PPL MONTANA, LLC
Colstrip, Montana

SEPTEMBER 2014

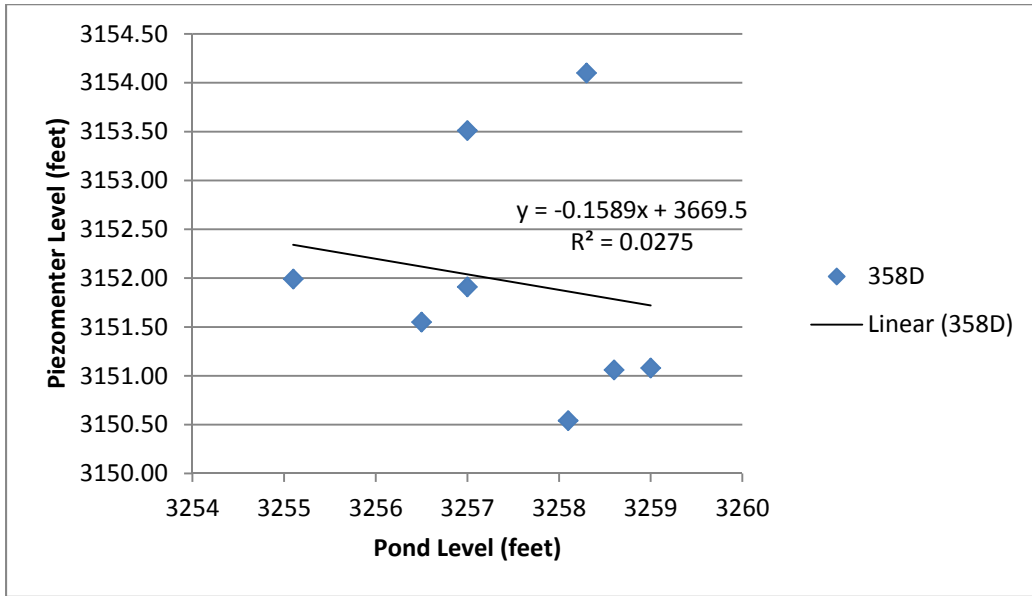
FIGURE 4-2. PIEZOMETER 358D LEVELS VS POND LEVELS

generally viewed as favorable because it suggests that the piezometers are not hydraulically connected to the pond and are not being influenced significantly by leakage or preferential seepage paths.

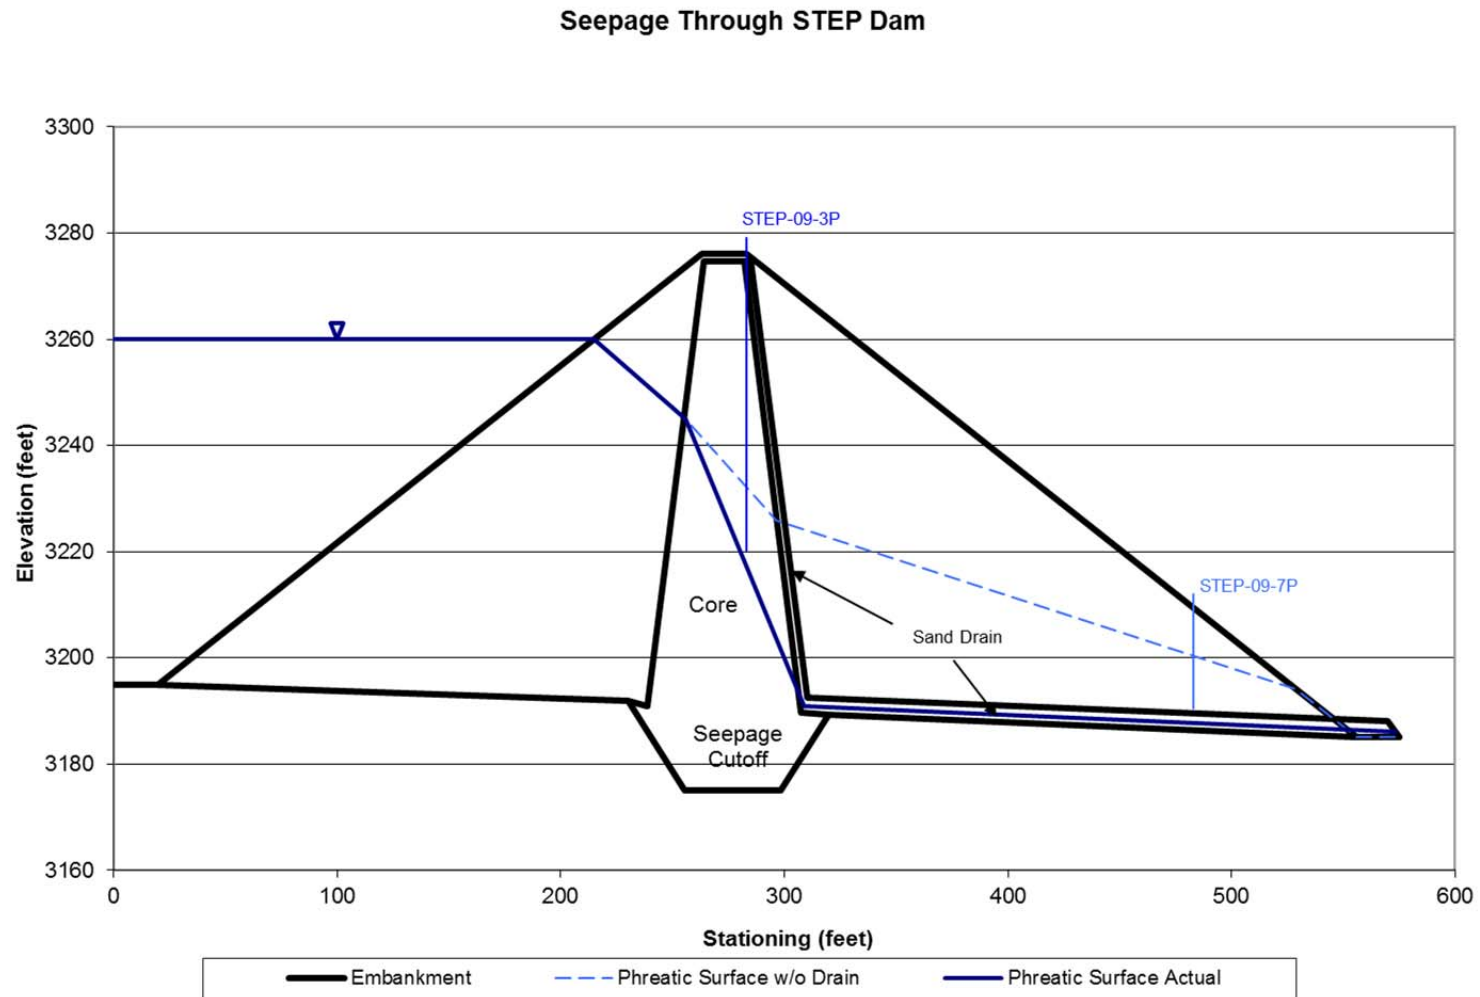
FIGURE 4-5. CROSS SECTION OF UNITS 1 & 2 PONDS MAIN DAM AND PHREATIC SURFACE

filter in the embankment, and the seepage cutoff in the foundation. Since the piezometers for the most part have not recorded water levels, it is possible that the phreatic surface dips below the internal drain and deep into the foundation of the dam. This would suggest that the foundation is quite permeable and that the seepage cutoff is effective. Without the seepage control measures mentioned above, this permeable foundation could lead to problems over time. Figure 4-5 also shows what the phreatic surface might look like if the embankment had no liner or internal drain and was on an impermeable foundation. All piezometer and monitoring well data indicate seepage is not a dam safety problem in the Units 1 & 2 STEP Main Dam and it appears the measures to control seepage appear to be working well.

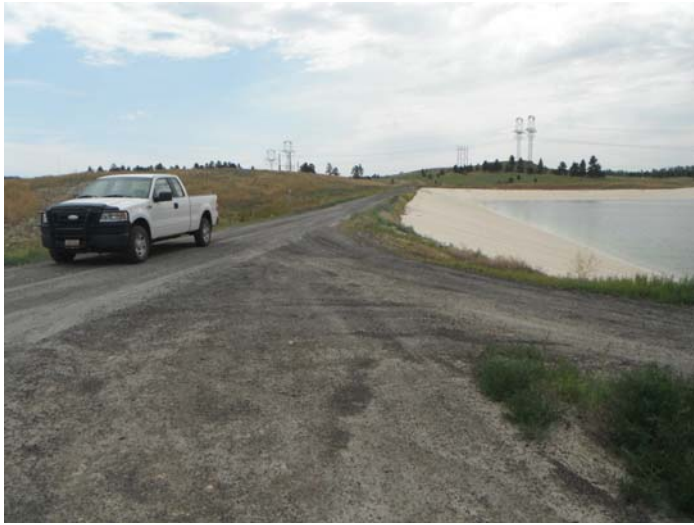
Photo 1. Units 1 & 2 STEP Main Dam, July 15, 2014.
New Cell D liner and fill on downstream side of dam.

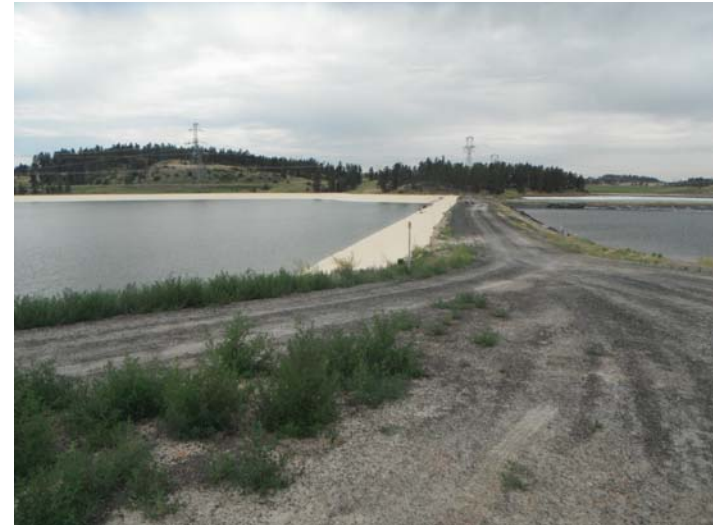
Photo 2. Units 1 & 2 STEP Main Dam, July 15, 2014.
New Cell D liner on north side.

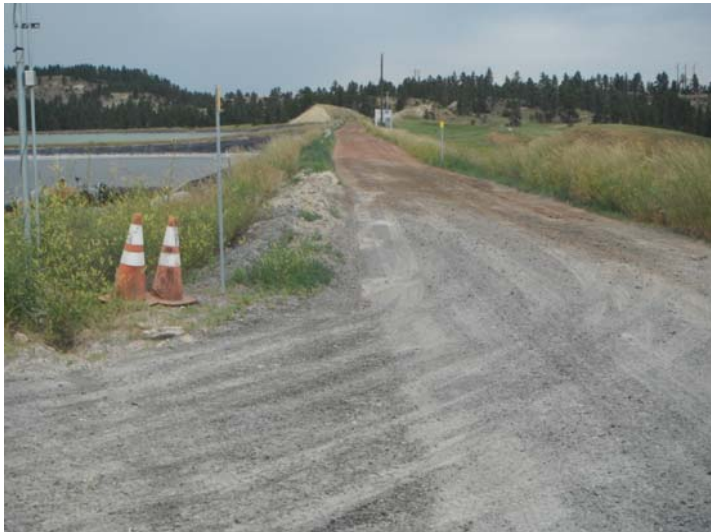
The crest of the Main Dam is in good condition (Photo 3). The horizontal alignment of the crest appears to be good with no surface cracking. No change in the vertical profile is apparent since it was last surveyed in 1993 (Maxim Technologies, 1993). There are slight low areas near the right abutment with apparent dried puddles in tire ruts that should be filled. Vegetation along the shoulders of the road is in good condition; otherwise the surface is bare and is used as an access road. The Main Dam crest is approximately 8 feet higher than the divider dikes in the evaporation pond.

Photo 3. Units 1 & 2 STEP Main Dam, July 15, 2014.
Crest from right abutment.

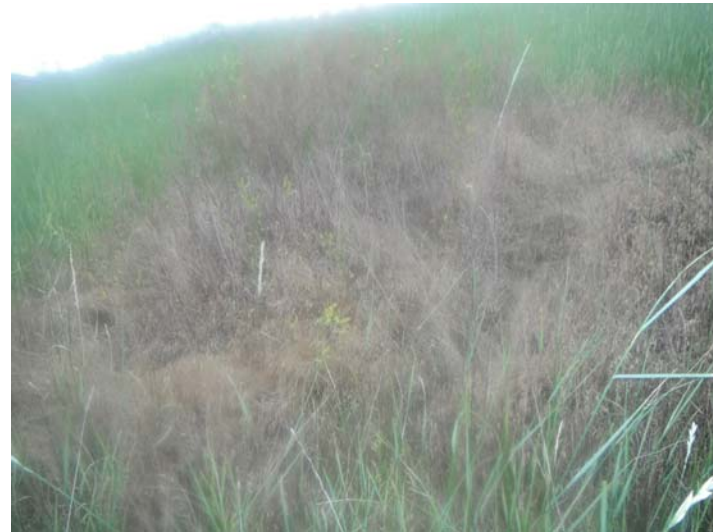
The downstream slope does not exhibit signs of sliding, sloughing, erosion, or unusual movement. The vegetative cover is good except for patches of weeds that seem to correspond with rodent holes, and some sagebrush located near the crest at mid-dam (Photos 4 and 24). The contact between the embankment and abutment is in good condition except for some small erosion rills where the embankment meets fill placed during the excavation of Cell D on the right side of the slope. In the right toe groin, areas noted in past inspections as having erosion from surface runoff have been repaired and vegetation has established, leaving the area in good condition.

Photo 4. Units 1 & 2 STEP Main Dam, July 15, 2014.
Downstream slope, dry, weedy patch typical around rodent holes.

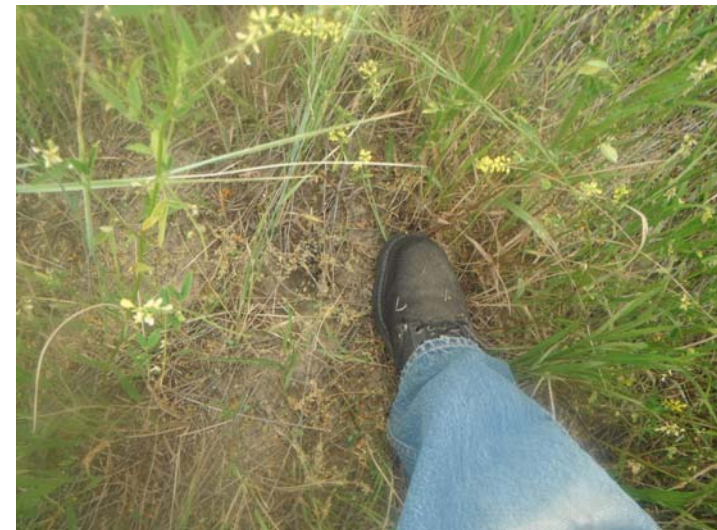
Numerous rodent holes are on the downstream slope (Photos 8, 9, 24, 26 and 27). The holes should be backfilled and monitored for signs of rodents. If rodents are active, it is recommended that a rodent control program be reinstated, similar to what was done in 2009.

Photo 8. Units 1 & 2 STEP Main Dam, July 15, 2014.
Rodent hole, downstream slope.

Status: Rodent holes were still present on the Main Dam but it is unknown if rodents are present. Recommend that rodent holes be backfilled and monitored to determine if rodents return. If rodents are present, reinstate the rodent control program that was initiated in 2009.

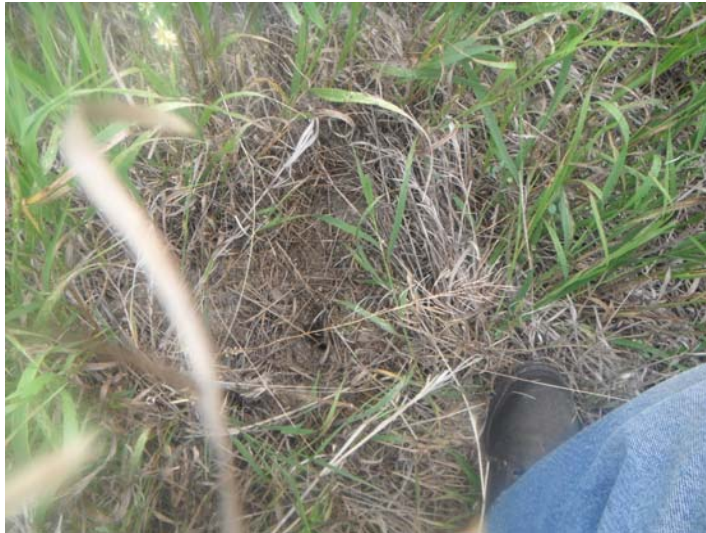
Photo 9. Units 1 & 2 STEP Main Dam, July 15, 2014.
Rodent hole, downstream slope.

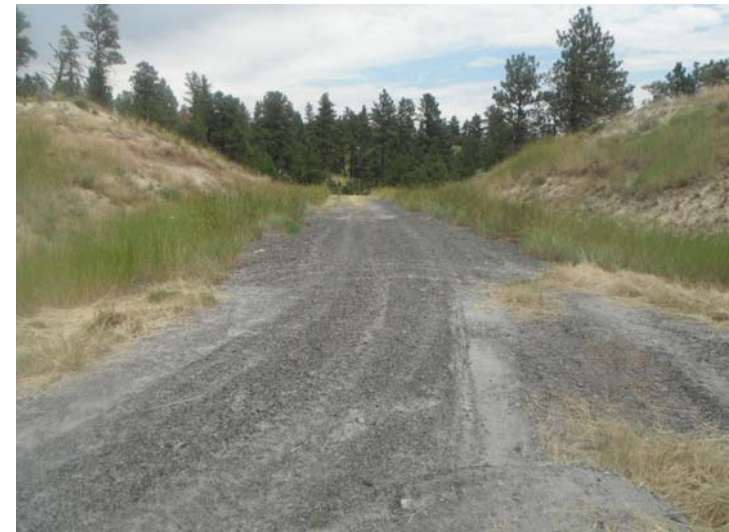
The spillway is an uncontrolled, unlined excavation through baked shale and weakly cemented bedrock. It is located about 200 feet north of the left abutment (Photo 12). A typical cross section of the spillway is shown on Figure 2-2. It has a bottom width of 36 feet and side slopes of 2:1, horizontal to vertical. The spillway would not be used unless Divider Dike C (see Figure 2-1) is overtopped or failed and enough water is stored in Area C (Figure 2-1) to flow into the spillway. Photo 13 is a view from the spillway crest back to Divider Dike C, looking across Area C.

There is no indication of displacement or unusual movement within the spillway channel. Erosion observed in 2009 on the spillway side slopes has been repaired and vegetation is established. The area should be monitored to determine if further erosion is taking place that requires attention. It is recommended to limit vehicle use in this area, especially during the wet season. The access road from the north side of the Main Dam forms the crest of the spillway. The downstream end of the spillway is steep (Photo 14) and the grade break between the spillway crest and the downstream area should be monitored for erosion and repaired if necessary.

Photo 12. Units 1 & 2 STEP Main Dam, July 15, 2014.
Spillway, looking downstream.

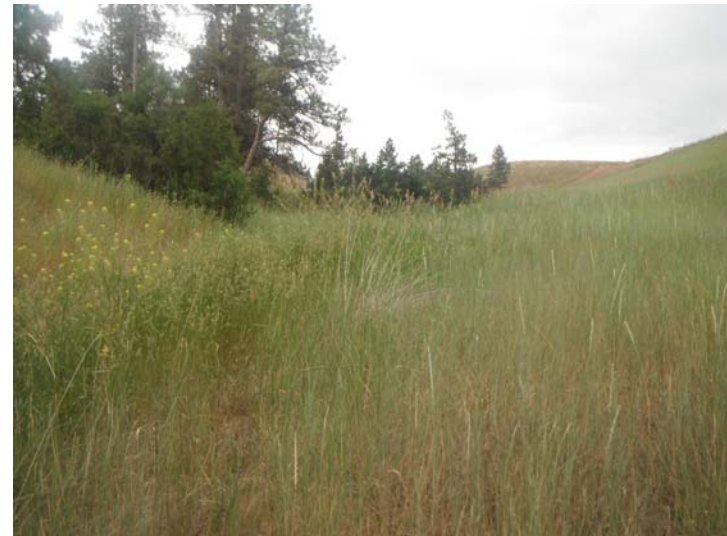
Status: Erosion in the toe area has been repaired and vegetation has established. The area should be monitored for erosion.

Photo 16. Units 1 & 2 STEP Main Dam, July 15, 2014.
Downstream toe, right groin area, erosion repaired.

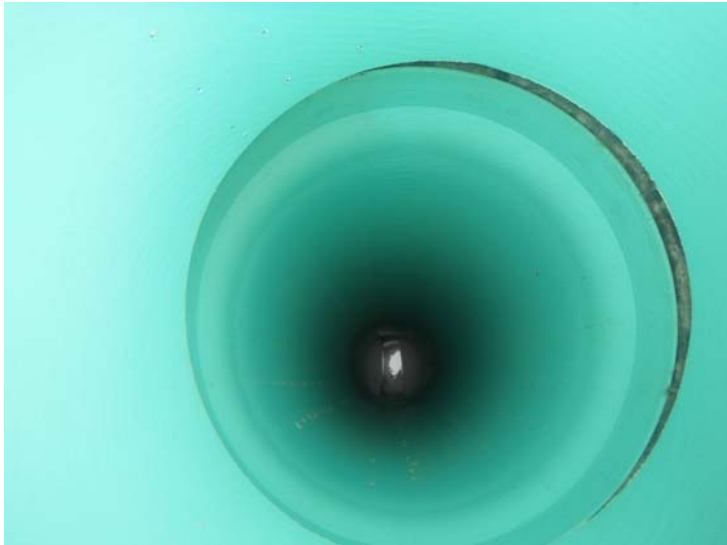
Photo 17. Units 1 & 2 STEP Main Dam, July 15, 2014.
Toe drain access hole, downstream toe.

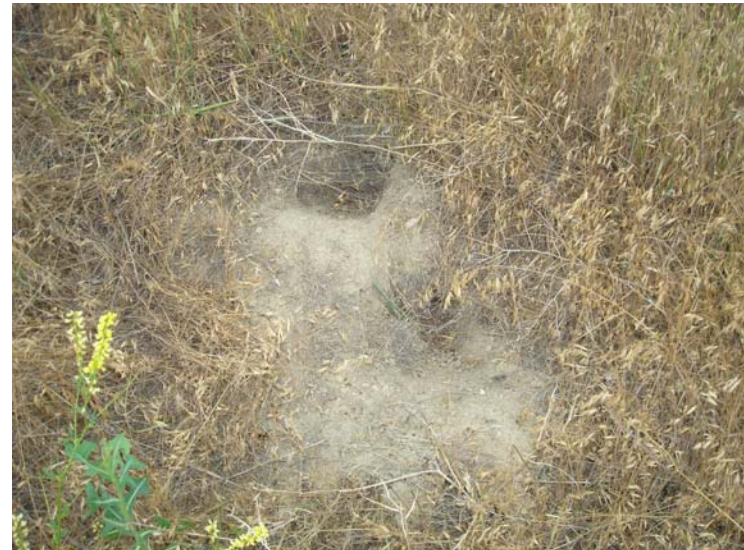
Photo 24. Units 1 & 2 STEP Main Dam, July 15, 2014.
Rodent hole, dead grass on downstream slope.

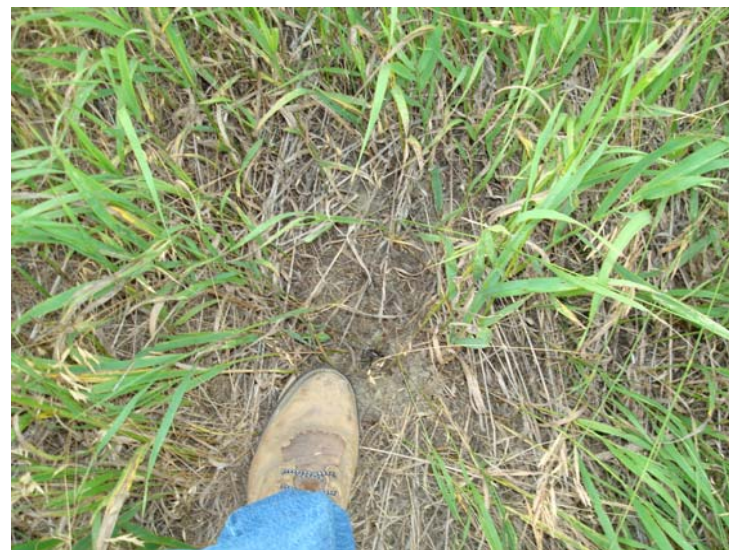
Photo 26. Units 1 & 2 STEP Main Dam, July 15, 2014.
Rodent hole, downstream slope.

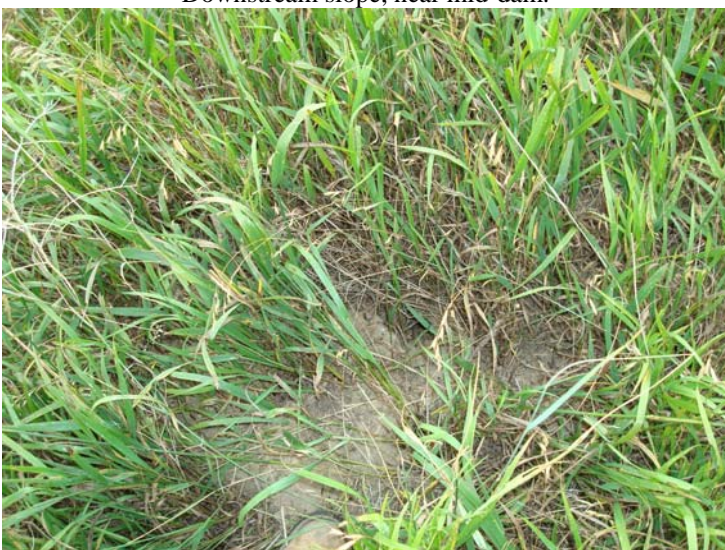
Photo 27. Units 1 & 2 STEP Main Dam, July 15, 2014.
Rodent hole, downstream slope.
