FINAL CONSTRUCTION COMPLETION REPORT FOR THE GARDNER EMERGENCY 2011

Richland County, Montana

March 6, 2014

Montana Department of Environmental Quality
Abandoned Mine Lands Program
P. O. Box 200901
Helena, Montana 59620

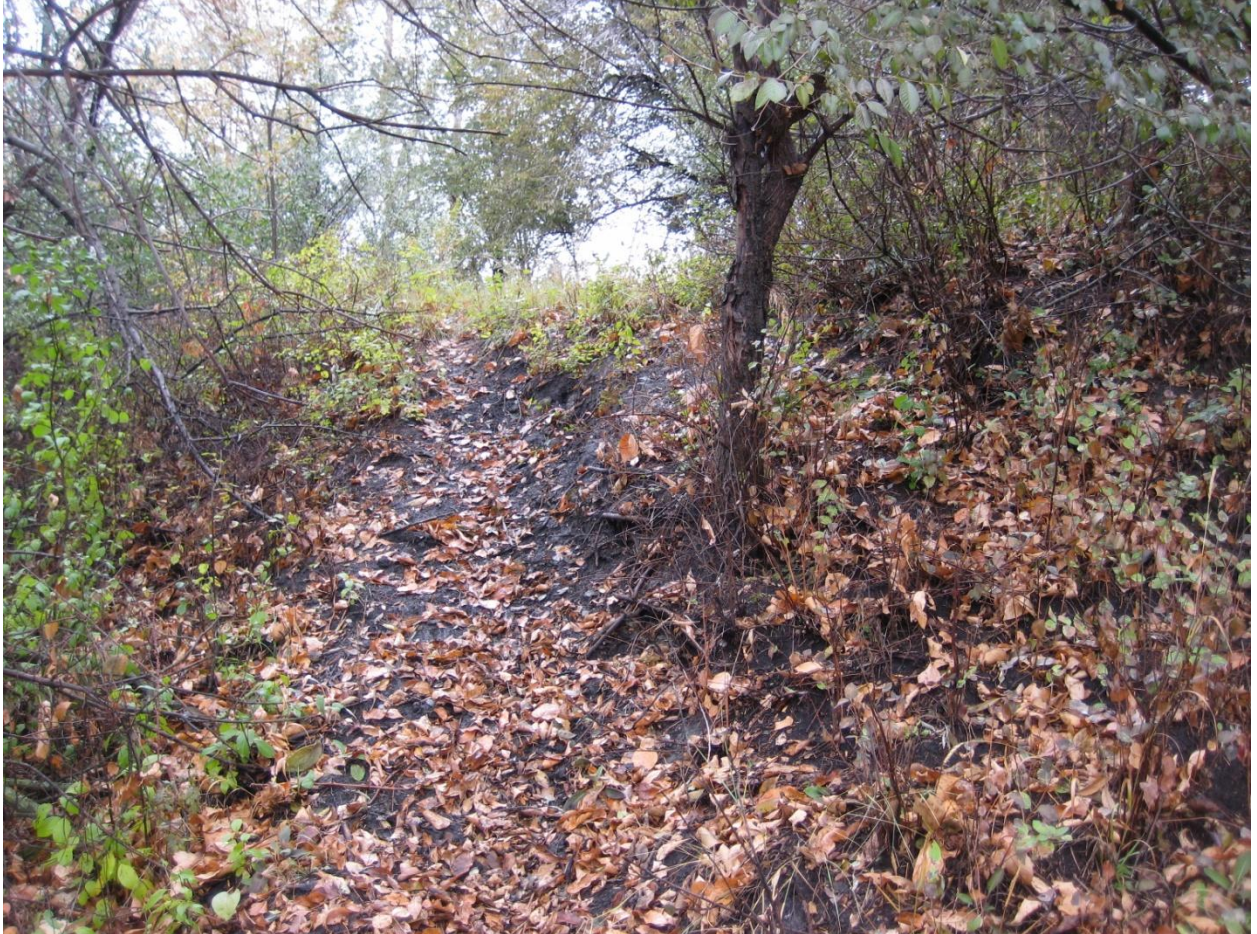
Vegetated Slack Pile near Gardner Residence

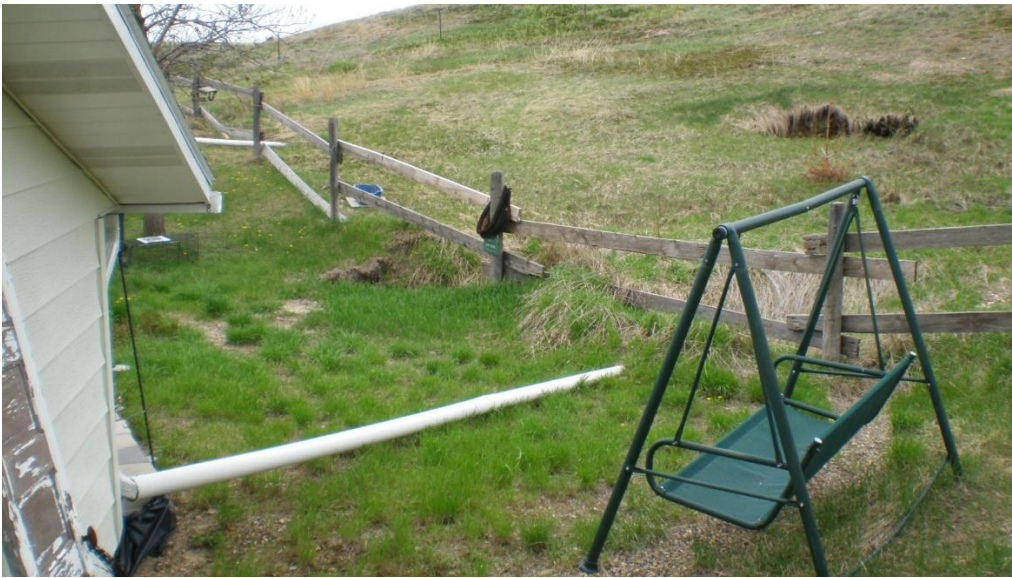
Subsidence holes 1 2 and 3

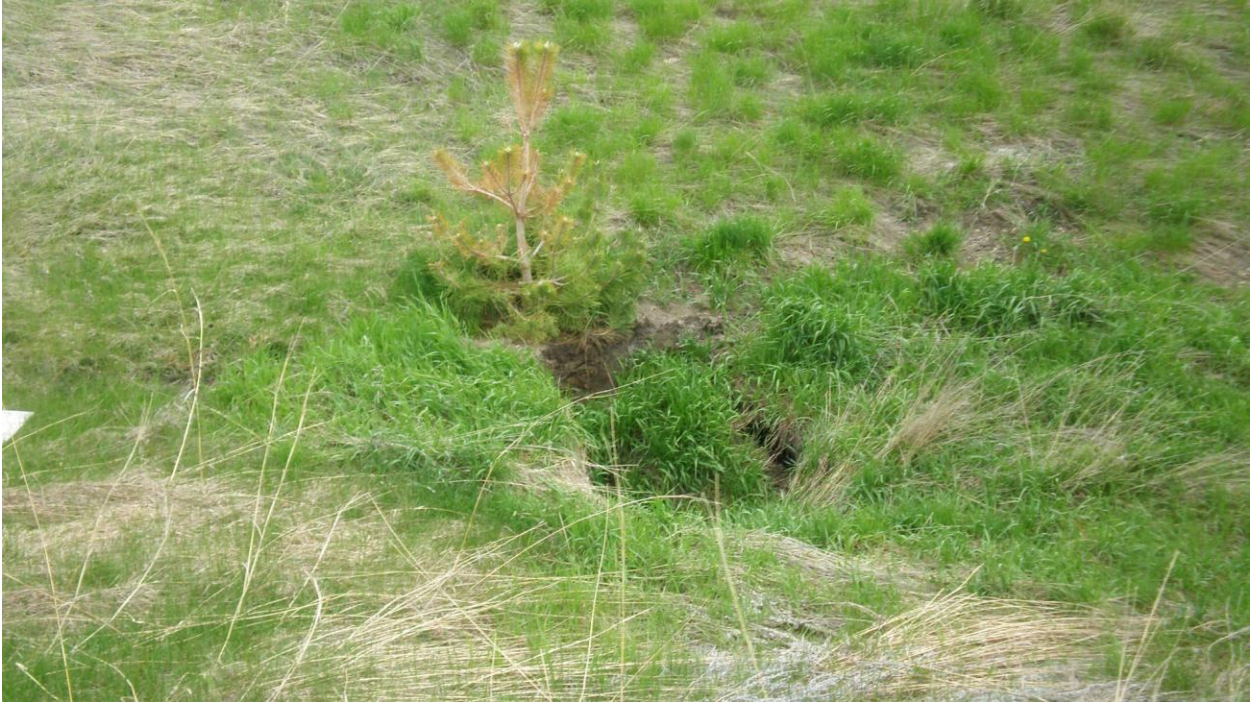
Subsidence hole 3

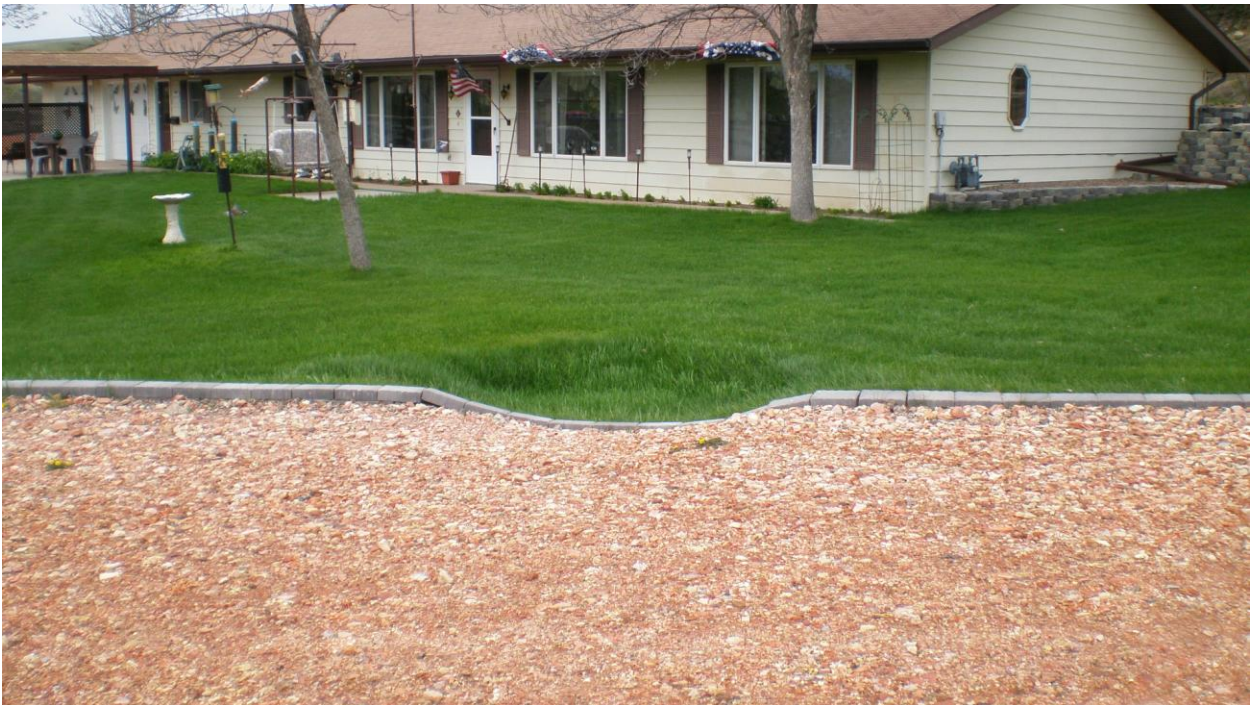
Subsidence hole 4

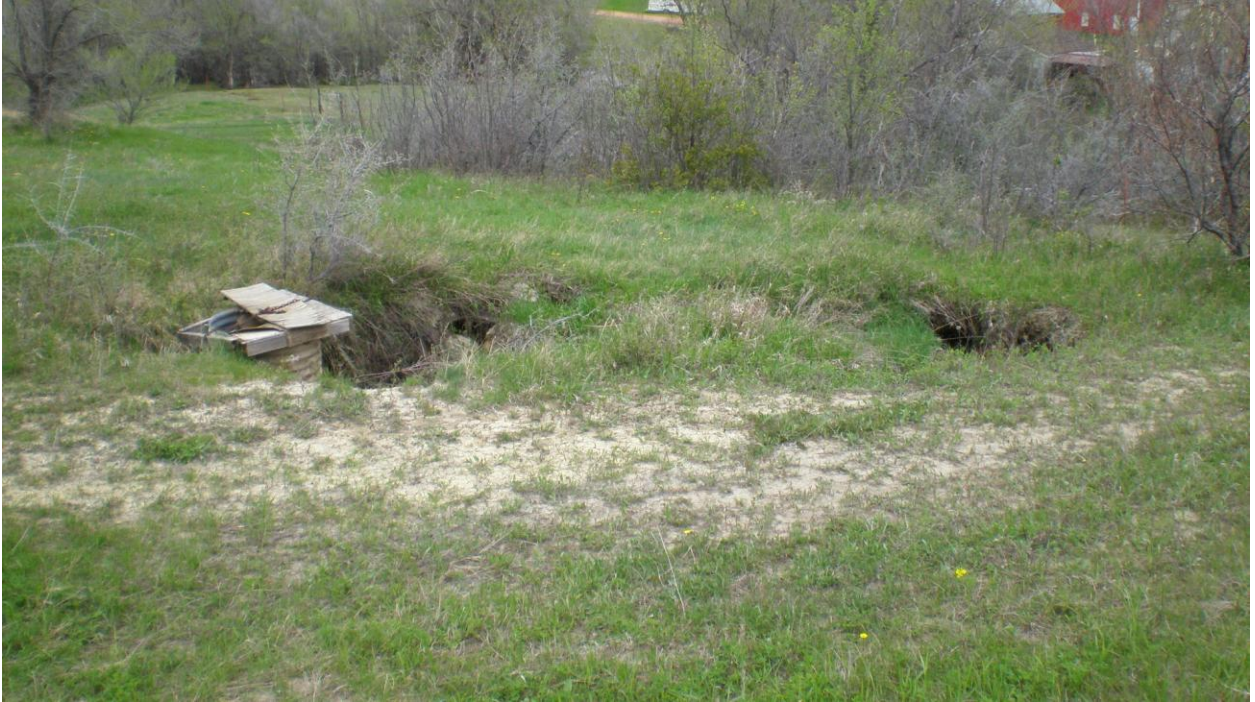
Daniels Well Collapsed into subsidence features

Water well at Sharon Daniels property was collapsed due to a subsidence event that occurred directly around the well casing. Well casing collapsed during mine subsidence event causing the loss of water supply. Mining at the site occurred entirely in the period prior to August 4, 1977. Mine collapse problems at the Garner Emergency site have been addressed by Montana AML on multiple occasions during the period 1986 – 2011. Previous subsidence has occurred around and under occupied dwellings. The loss of the Daniels well was due to a subsidence event that occurred at the location of the well. See photo included with priority documentation.

Well drilling is estimated to cost \$7000 including drilled casing, pump, electrical supply, pitless adaptor and supply line from the new well to the residence.

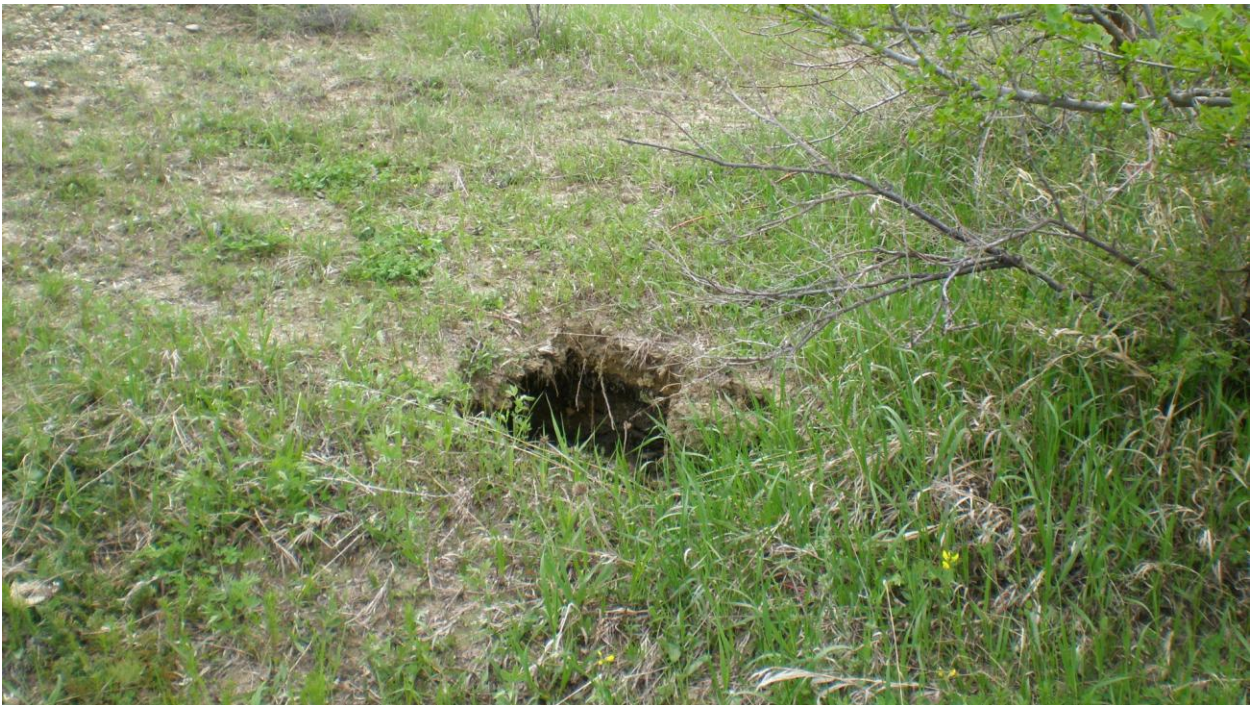
Additional Subsidence on Daniels property
