# Research Reports

## Mine tailings reclamation project improves water quality in Yellowstone's Soda Butte Creek

By Tom Henderson, Andrew Ray, Pete Penoyer, Ann Rodman, Mary Levandowski, Alysa Yoder, Shane Matolyak, Mary Beth Marks, and Autumn Coleman

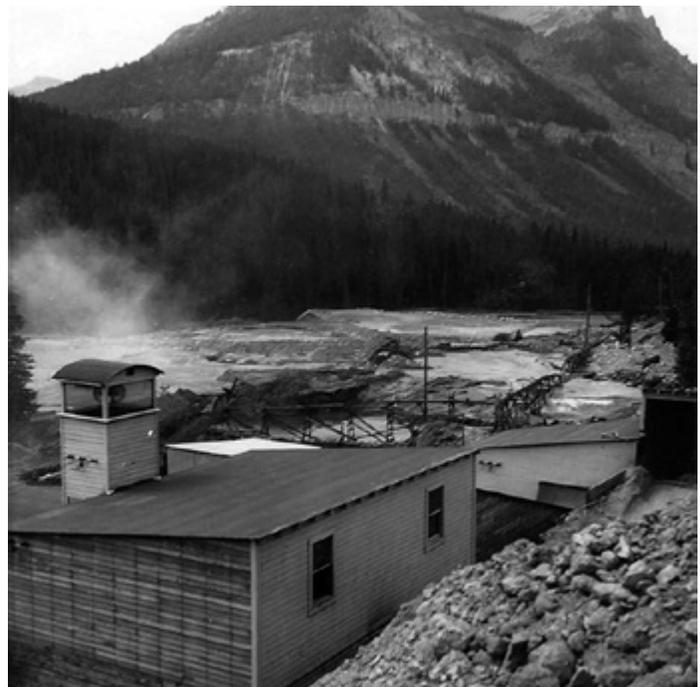
**Figure 1.** McLaren Gold Mine Mill near Cooke City, Montana, in 1946. The tailings impoundment extends outward from the mill and is likely encroaching on Soda Butte Creek.

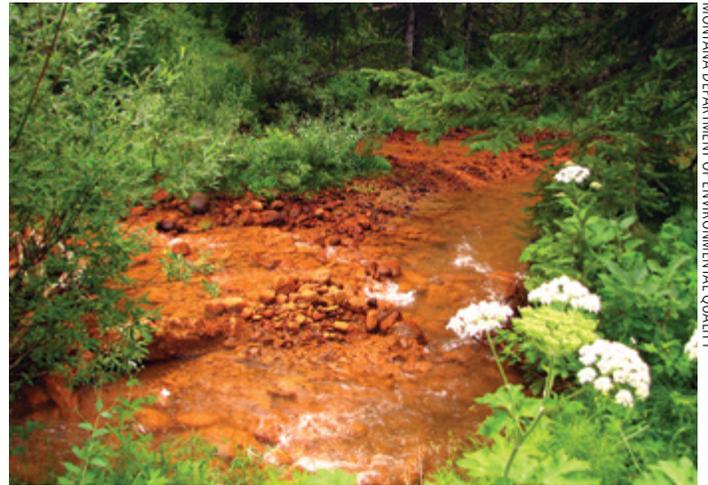
**Figure 3.** Oxidized iron sediments were the norm in Soda Butte Creek downstream of the McLaren Mill and Tailings site in 2009, prior to reclamation.

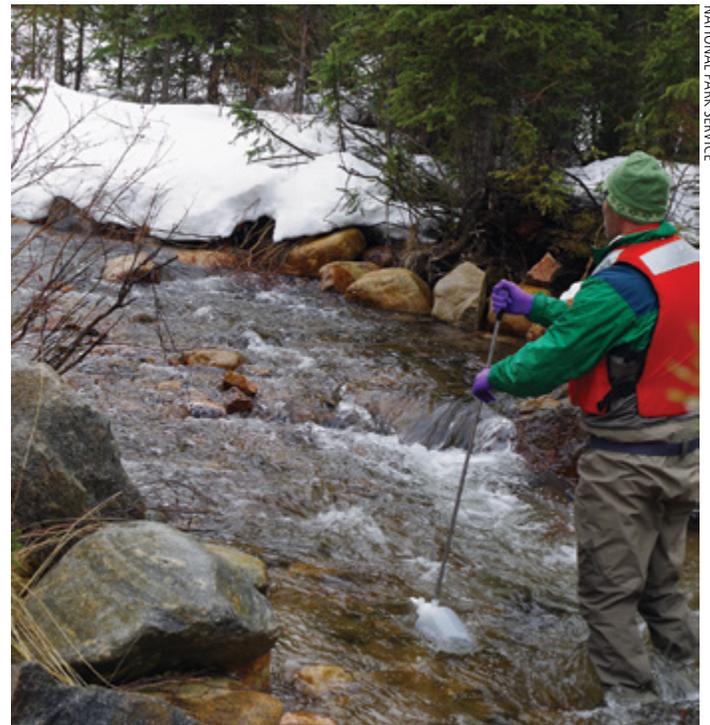
**Figure 4.** Water sampling in Soda Butte Creek downstream of the McLaren Mill and Tailings site in November 2015 following reclamation.

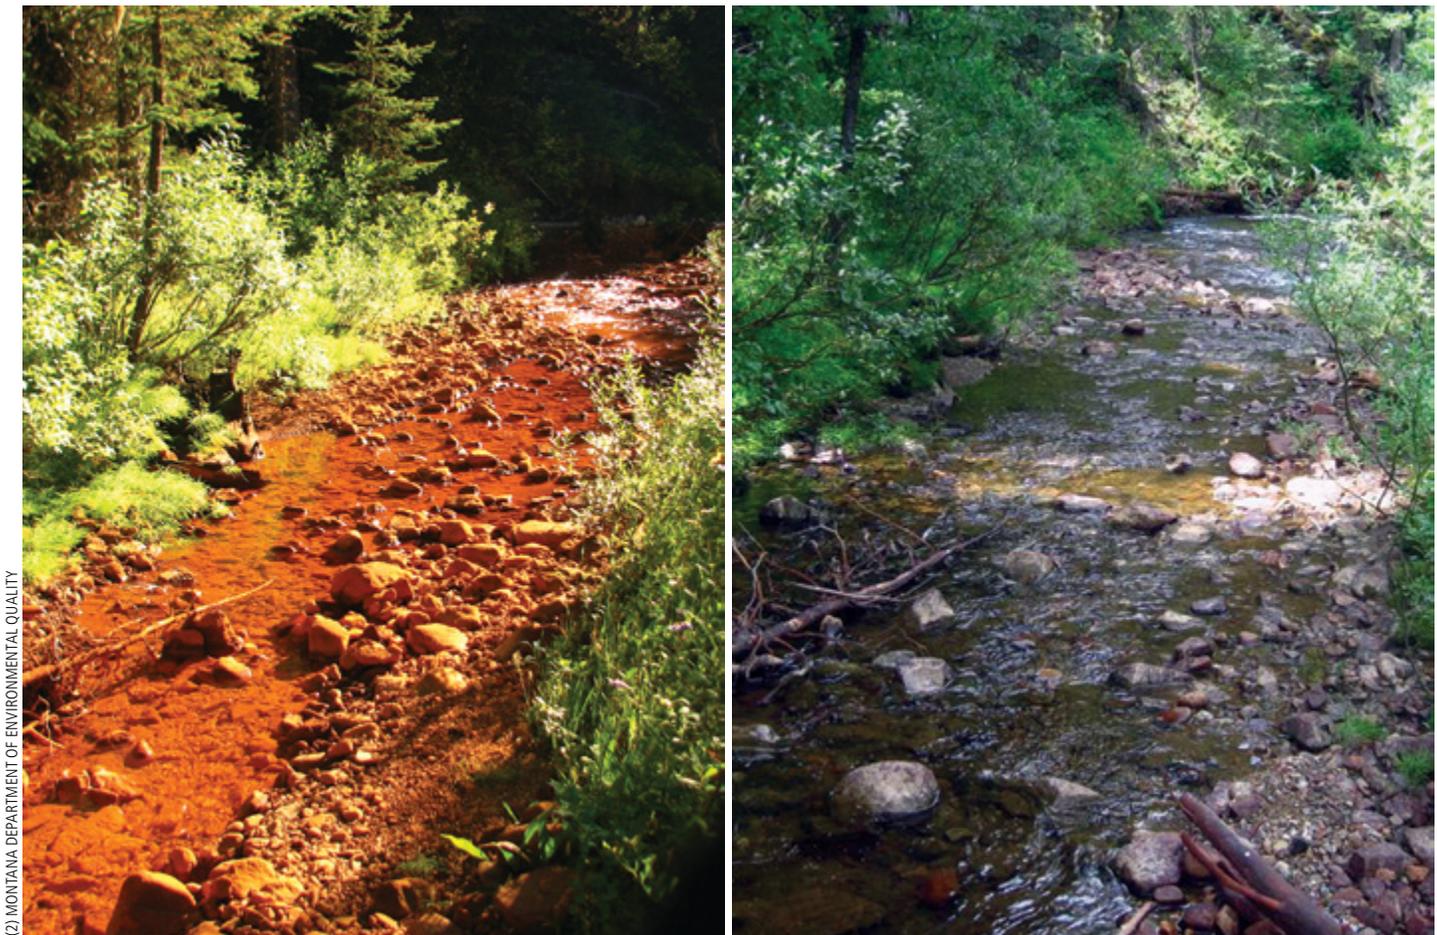
**Figure 10.** Soda Butte Creek downstream of the McLaren tailings impoundment in 2009 shows contamination by orange-colored iron (left) that is not evident in 2013 (right) following cleanup.

Taken as a whole, the investigation reveals significant improvements in the Soda Butte Creek water below the McLaren site (see fig. 10). Current water quality exceedances at the Yellowstone National Park boundary appear to be limited to iron. Iron in Soda Butte Creek is readily traced to two tributaries neither of which has any identified mine-land disturbances. At least one of these tributaries (the unnamed tributary) has no evidence of significant anthropogenic activity such as from roads or trails. As a result, water quality conditions in Soda Butte Creek now appear to be dominated by non-anthropogenic sources of metals.

Given the ongoing contamination of Soda Butte Creek from the tailings impoundment at the McLaren site and the risk of a catastrophic tailings release, Montana DEQ's preferred reclamation alternative was the complete removal of the tailings impoundment from the Soda Butte Creek channel and floodplain (MTDEQ 2002a). The tailings impoundment covered an area of approximately 10 acres (4 ha) and included approximately one-half million tons of mine tailings and approximately one million gallons of contaminated groundwater. Groundwater discharging from the impoundment contaminated the underlying aquifer, which contained groundwater under confined pressures (MTDEQ 2009).

In order to meet the objective of complete removal of the impoundment, project design and construction work included a significant groundwater pumping and treatment effort. Dewatering the tailings was achieved by capturing uncontaminated groundwater around the perimeter of the tailings impoundment and from the aquifer below the impoundment. The pumped water was sent to a water treatment plant to treat the water to achieve Montana water quality standards. More than 110 million gallons (0.4 million m<sup>3</sup>) of contaminated
