**HYMER MINE SHAFT  
SUBSIDENCE INVESTIGATION  
512 ADAMS AVE. SOUTH  
RED LODGE, MONTANA**

**FINAL REPORT**

October 27, 2012

**MONTANA DEPARTMENT OF ENVIRONMENTAL QUALITY  
CONTRACT 407040, TASK ORDER 17  
HYMER MINE SHAFT SUBSIDENCE INVESTIGATION FINAL REPORT**

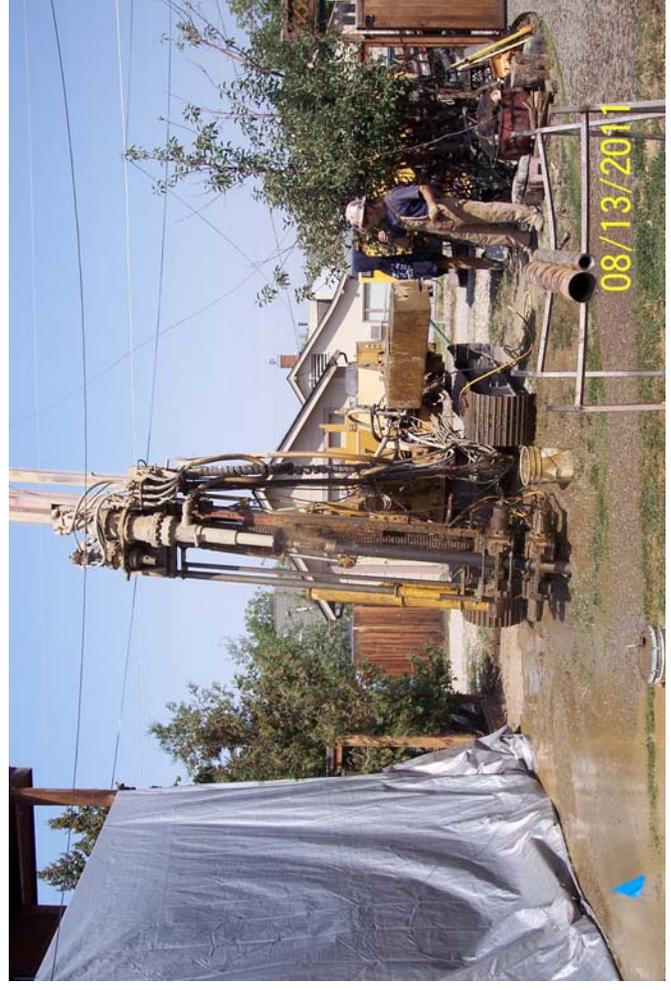
004-Hit Water Table In H-1

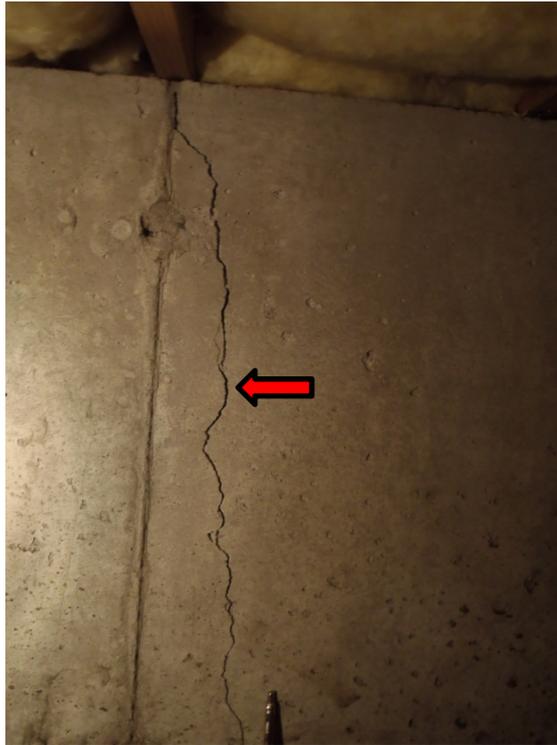
DESCRIPTION: Crack No 1: Observe crack width is larger at top than at bottom, looking south.

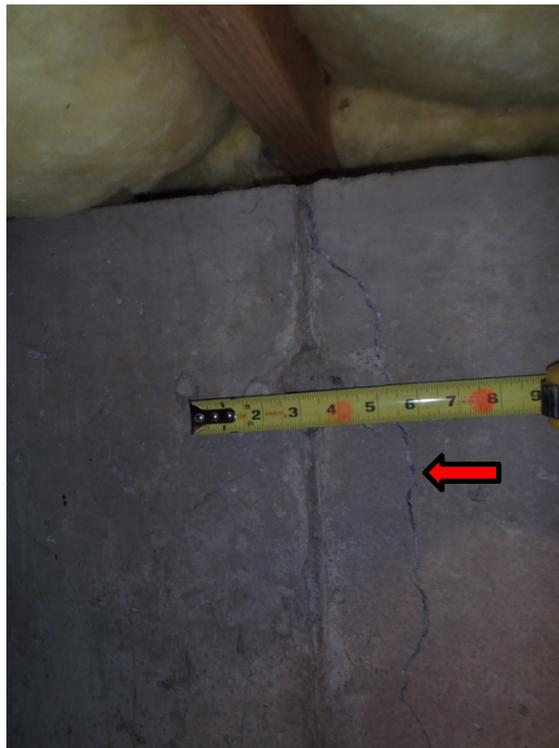
DESCRIPTION: Crack No 1: Close-up of top of upper portion of crack, looking south.

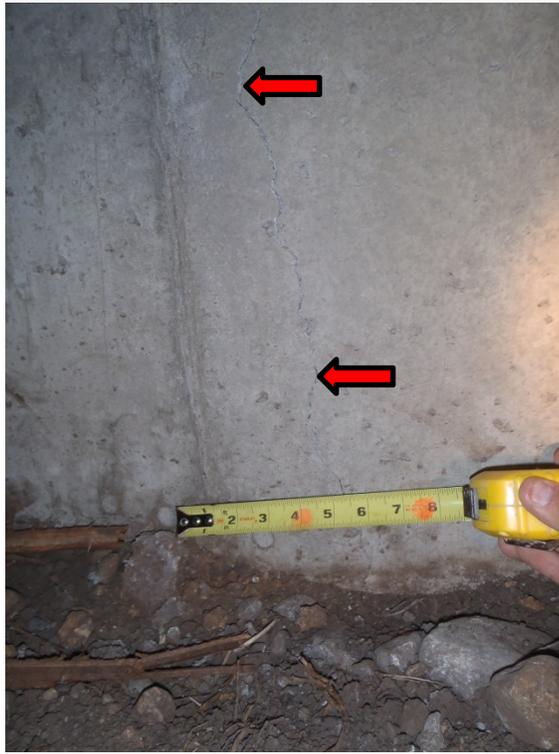
DESCRIPTION: Crack No 1: Close-up of bottom portion of crack, looking south.

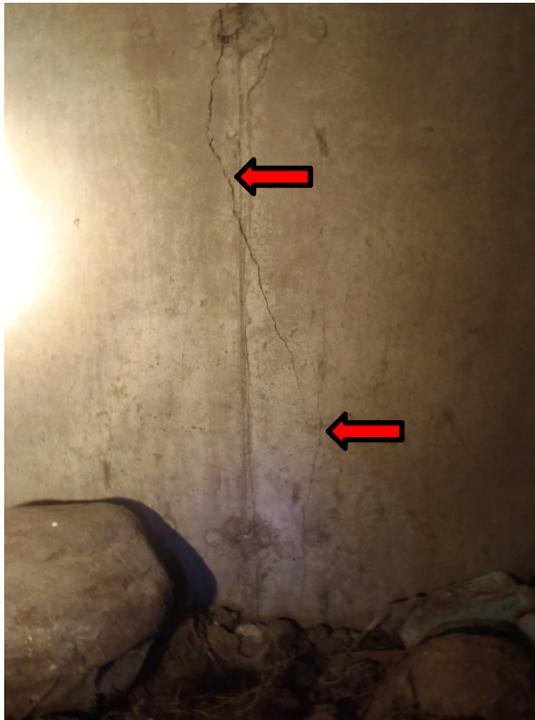
DESCRIPTION: Crack No 2. Observe the crack is wider at the top than the bottom, looking south.

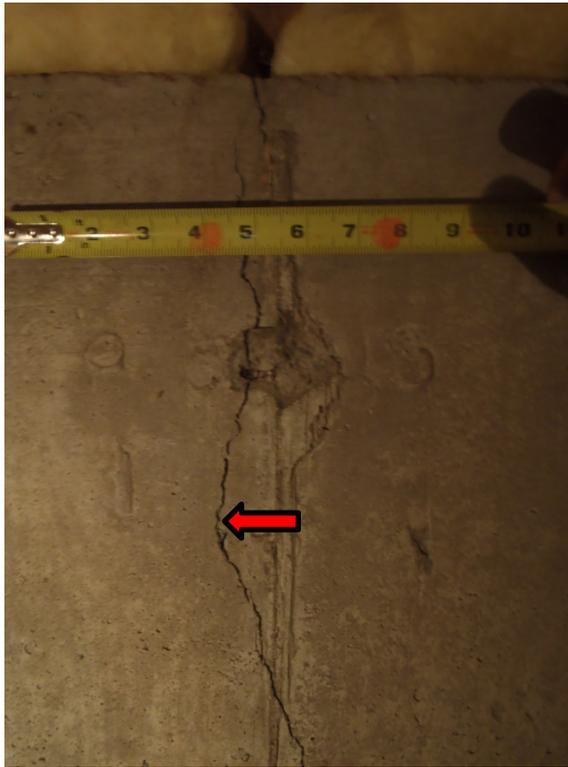
DESCRIPTION: Crack No 2. Close up view of top of the crack, looking south.

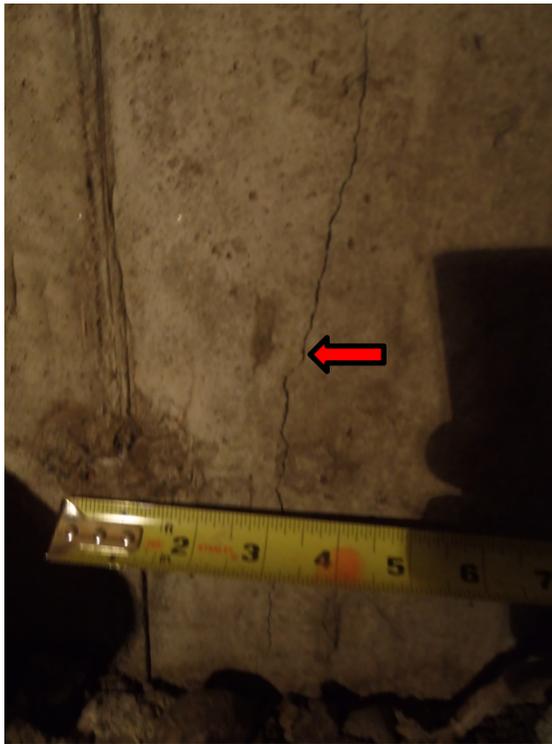
DESCRIPTION: Crack No 2. Close up view of bottom of crack, looking south.

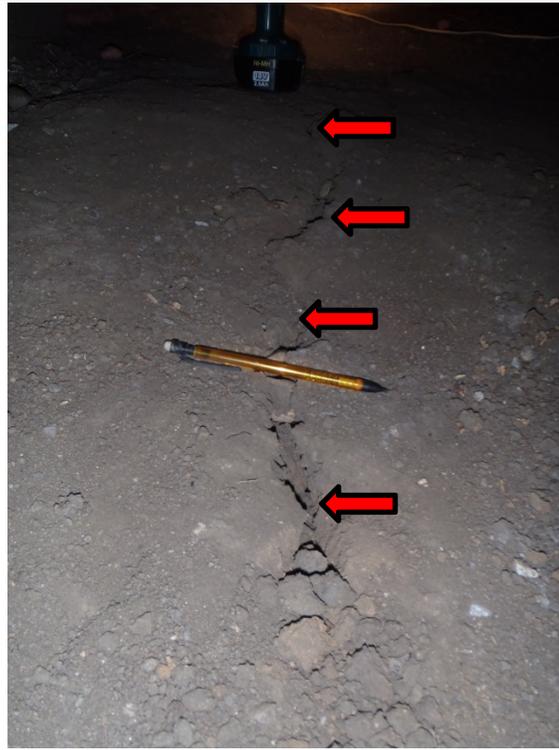
DESCRIPTION: Ground Crack: Crack is approximately 1 inch in width at the widest point, looking North.

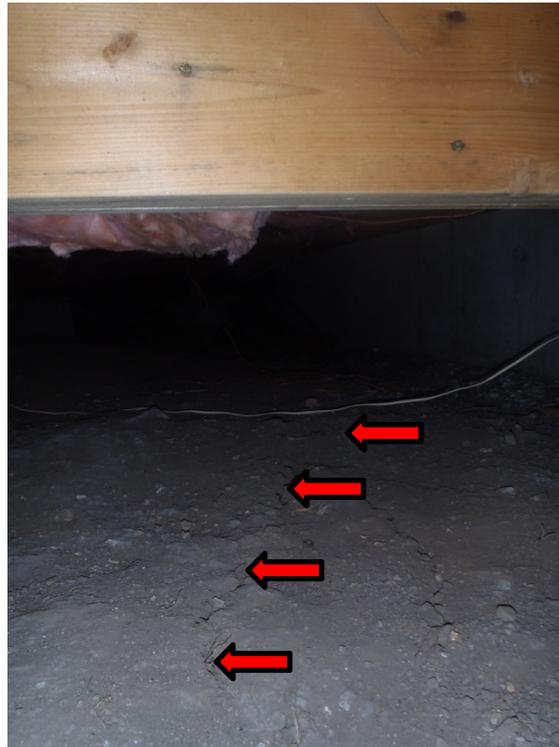
15. The inspection of the crawl space and stem walls of the structure found two cracks in the southern stem wall and a crack in the dirt floor of the crawl space. These features indicate that the subsidence cone associated with mine shaft extends under the southeast corner of the structure.

DESCRIPTION: Ground Crack: Looking north at trace of ground crack. Crack location is highlighted in photo.
