September 8, 2017

Re: Response by the Engineer of Record to Comments Submitted by Atlantic Richfield Company

Concordance Summary: Atlantic Richfield Company (ARCO) Comments/Recommendations, Yankee Doodle Tailings Impoundment

Annotated Version of the Final Report Yankee Doodle Tailings Impoundment, Butte, Montana; Davidson, Morgenstern, Hippley; May 3, 2017

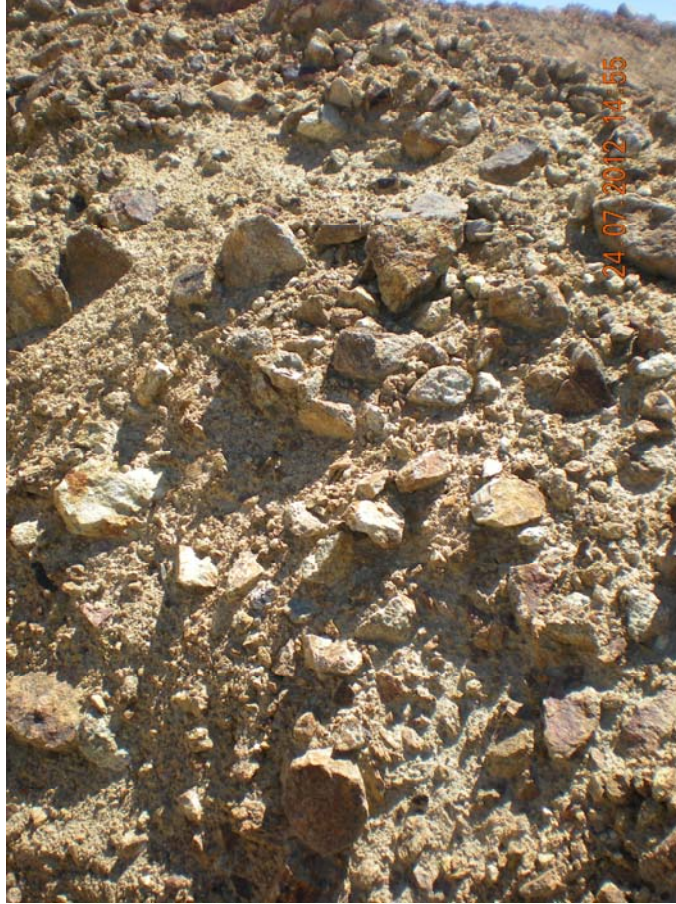
3-1

Photo 1. Matrix dominated rockfill observed in 2012.

Unfortunately there are no borehole permeability tests in the rockfill, but piezometric measurements suggest some perched conditions and a strong downward gradient.

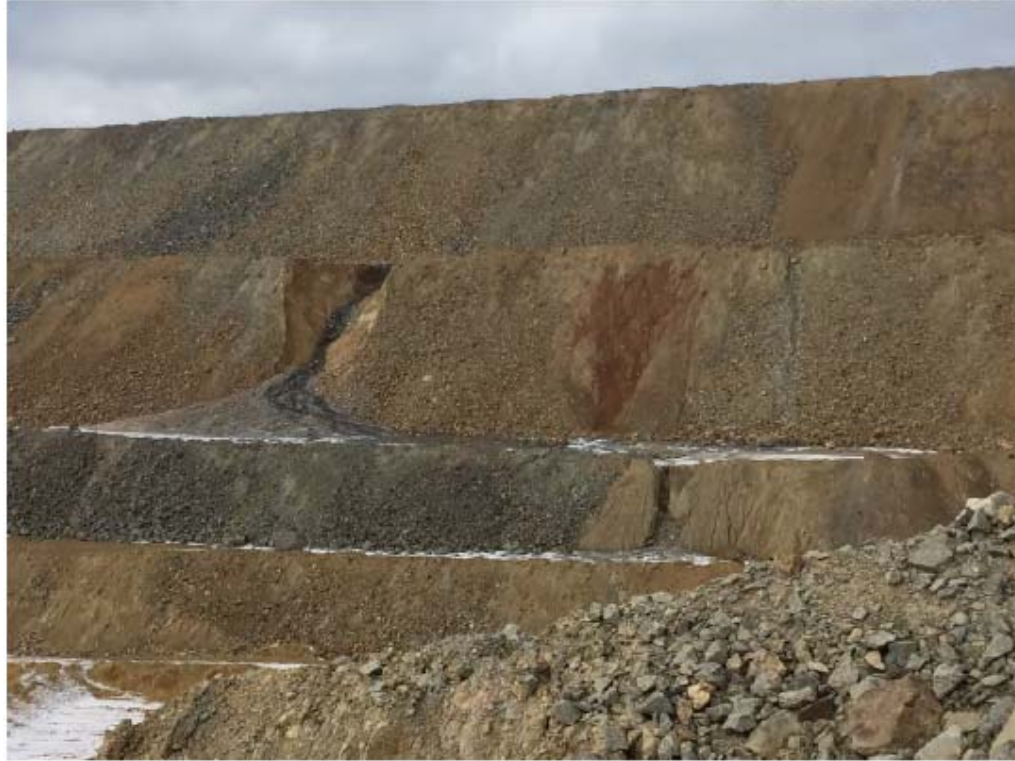
7-10

Photo 2. Seepage incident on North-South Embankment reported in 2016 KP EOR report.

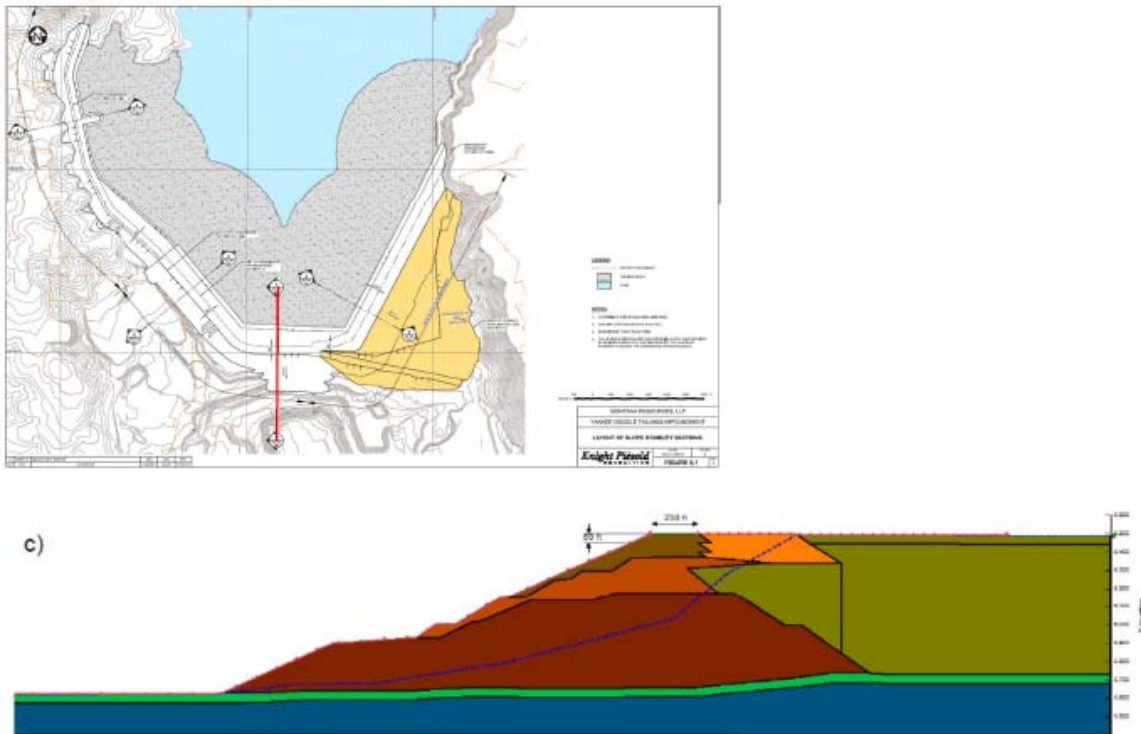
It is our view that the undrained strength, the degree of strain weakening associated with both static and dynamic loading, and the extent of saturated conditions are not known to us with sufficient precision to support a reduction in required factor of safety from 1.5 as a basis for design. We await additional input from MR and their consultant as to their assessment of conditions.

Figure 1. Study Section 8+00W originally from Knight Piésold for proposed, raised conditions and used for our analyses.

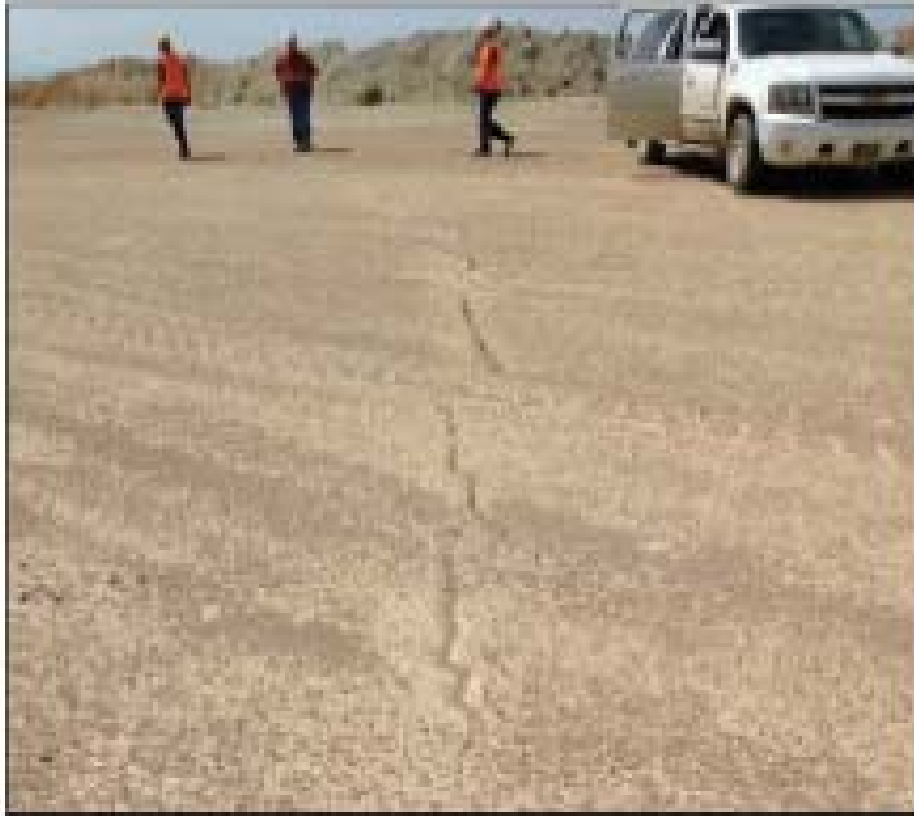
Photos 5 and 6 in the 2015 AIR display longitudinal cracking on the surface of the North-South Embankment, which have been interpreted to be the result of differential settlement and hence of limited consequence. We agree that this may well be the case. However, the pattern of cracking, particularly in Photo 6, looks like a system of Riedel shears, that would be symptomatic of differential lateral deformation. This photo is duplicated below in Photo 3. Additional surface cracking along the North-South Embankment is shown in Photo 8 of the 2016 AIR and duplicated below in Photo 4. 8-5

Photo 3. Cracking typical of a Riedel shear system.

We recommend that the cracking pattern be presented in plan and assessed as to whether any lateral displacements are likely, and if so, if they are of consequence.

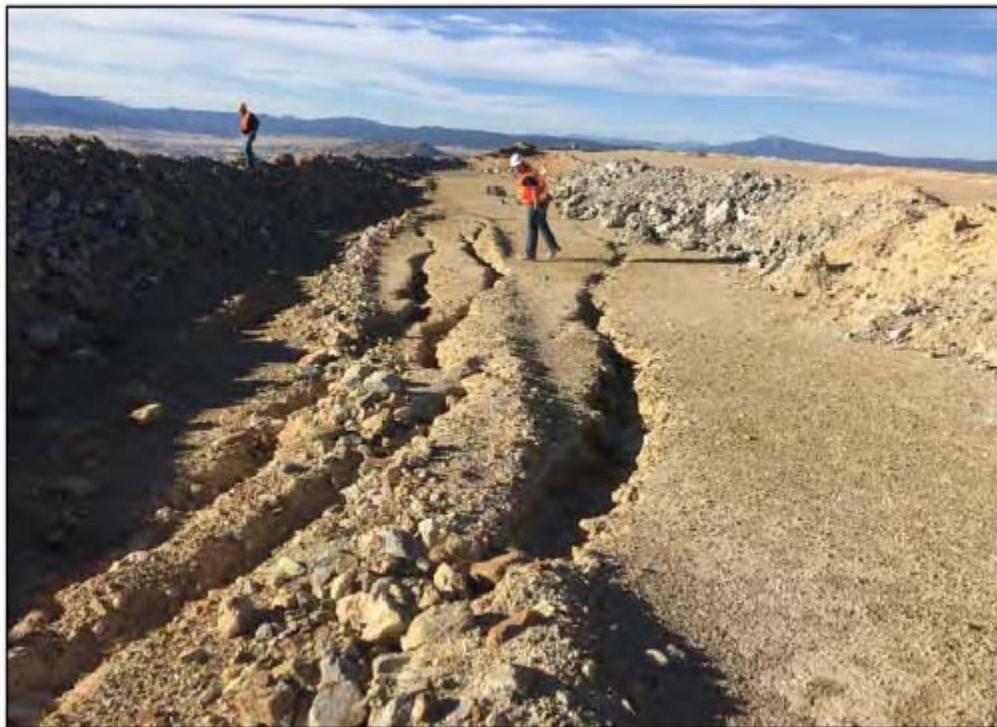
Photo 4. Cracking reported in the 2016 AIR report on the North-South Embankment.

8-7	Recommendation	<i>Recommend that the cracking pattern be presented in plan and assessed as to whether any lateral displacements are likely, and if so, if they are of consequence.</i>	Concur.
