**ATTACHMENT 1 – ANALYSIS OF BASE PARAMETER DATA AND EROSION
INVENTORY DATA FOR SEDIMENT TMDL DEVELOPMENT WITHIN THE
BOULDER-ELKHORN TPA**

Prepared for:

Montana Department of Environmental Quality
Water Quality Planning Bureau
P.O. Box 200901
Helena, MT 59620-0901

Water & Environmental Technologies, PC
480 East Park Street, #200
Butte, MT 59701

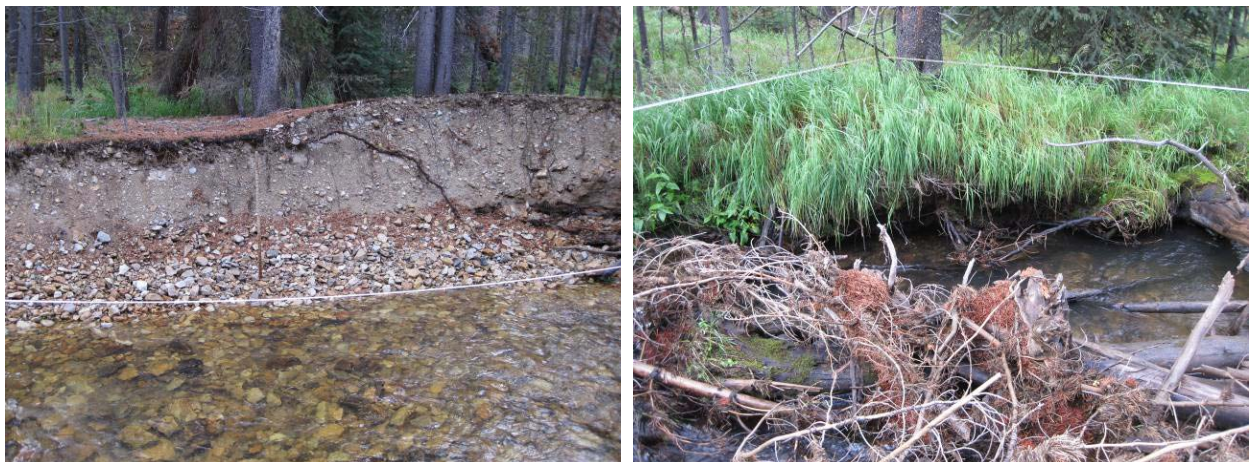
Figure 4-1. Typical eroding streambank conditions in Basin Creek Reach 08-02.

Only three eroding banks were identified in this reach, including two actively eroding banks and one slowly eroding bank. Banks are typically armored with cobbles and large gravel. The stream channel is overwidened through this reach. Typical eroding streambank conditions are depicted for this reach in **Figure 4-1** and sediment loading results are provided in **Table 4-5**.

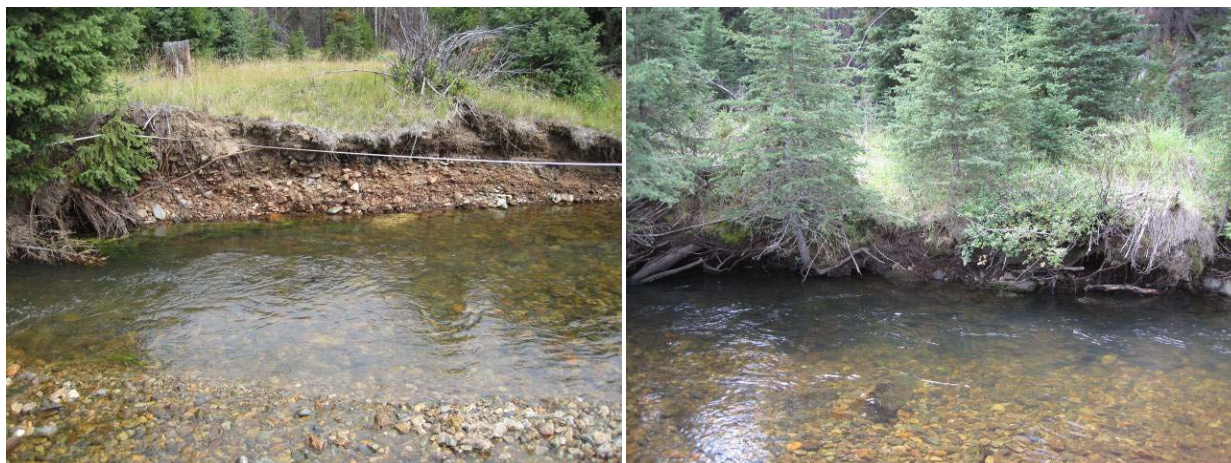
Figure 4-2. Typical eroding streambank conditions in Basin Creek Reach 15-02.

This reach had seven eroding banks, including four actively eroding and three slowly eroding. Actively eroding banks were typically associated with meander bends that direct flow into the bank and have limited stabilizing vegetation, possibly as a result of prior logging activity. Slowly eroding banks were accompanied by dense mature vegetation on the banks, including established willow and fir trees. Typical eroding streambank conditions are depicted in **Figure 4-2** and sediment loading results are provided in **Table 4-5**.

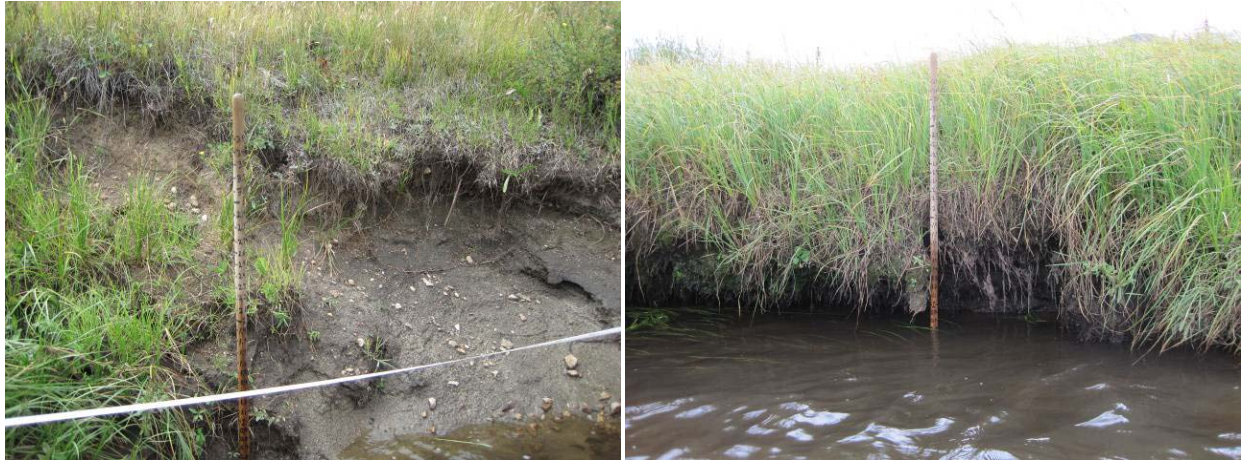
Figure 4-3. Typical eroding streambank conditions in Bison Creek Reach 04-02.

overhanging but well vegetated. Typical eroding streambank conditions are depicted for this reach in **Figure 4-3** and sediment loading results are provided in **Table 4-6**.

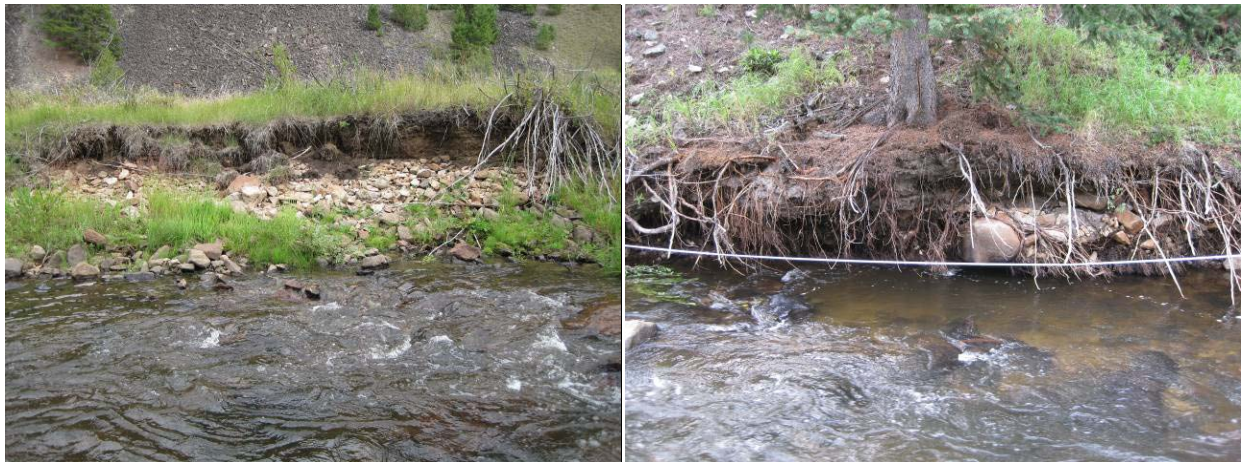
Figure 4-4. Typical eroding streambank conditions in Bison Creek Reach 11-01.

This reach had one slowly eroding bank and seven actively eroding banks. Actively eroding banks are typically tall and located on meander bends with little stabilizing vegetation and large cobble substrate armoring the toe. Slowly eroding banks are overhanging but bound by roots of mature vegetation. Typical eroding streambank conditions are depicted for this reach in **Figure 4-4** and sediment loading results are provided in **Table 4-6**.

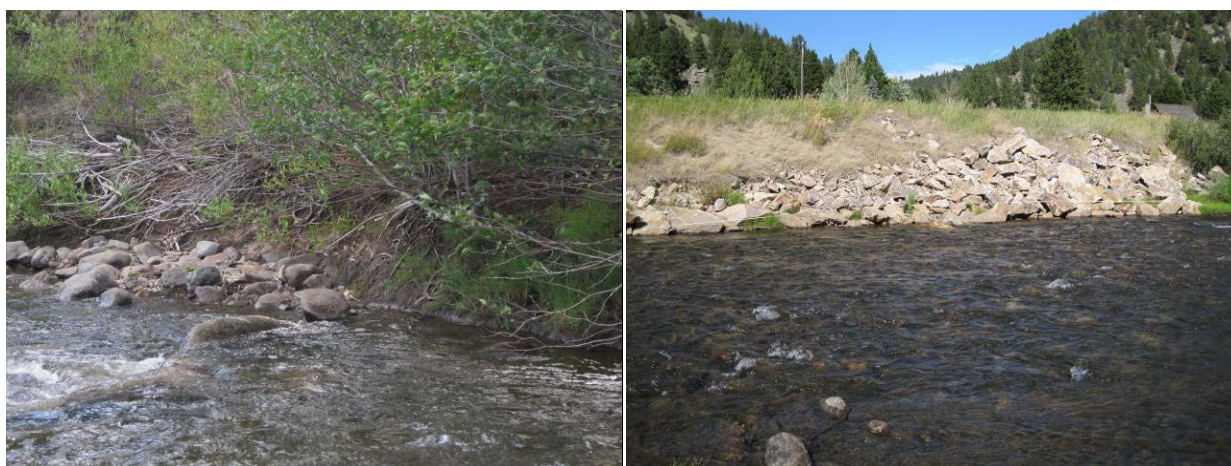
Figure 4-5. Typical eroding streambank conditions in Boulder River Reach 12-04.

This reach has only two slowly eroding banks, mainly because the channel is armored with rip-rap and large cobbles to protect the neighboring roads. One eroding bank occurs where the stream hits an area of road fill, and the other contains hard packed clay and is bound by mature alders and rushes. Typical eroding streambank conditions are depicted for this reach in **Figure 4-5** and sediment loading results are provided in **Table 4-7**. The left photo shows an example of a slowly eroding bank within this reach, and the right photo shows an example of the rip-rap stabilization within this reach.

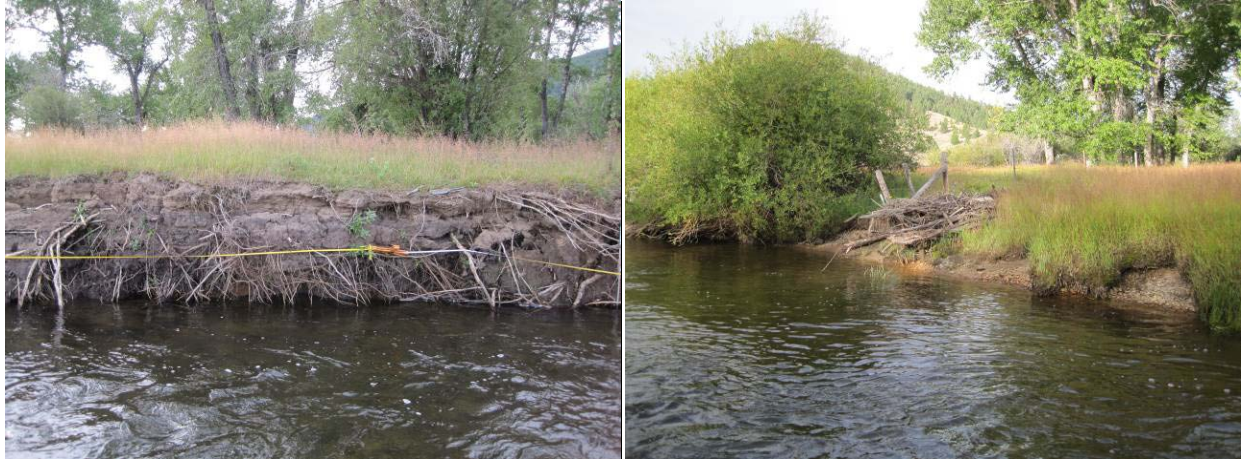
Figure 4-6. Typical eroding streambank conditions in Boulder River Reach 13-04.

sometimes with poorly placed rip-rap material that has slumped into the stream channel. Slowly eroding banks were low angled and had some vegetative cover. Typical eroding streambank conditions are depicted for this reach in **Figure 4-6** and sediment loading results are provided in **Table 4-7**.

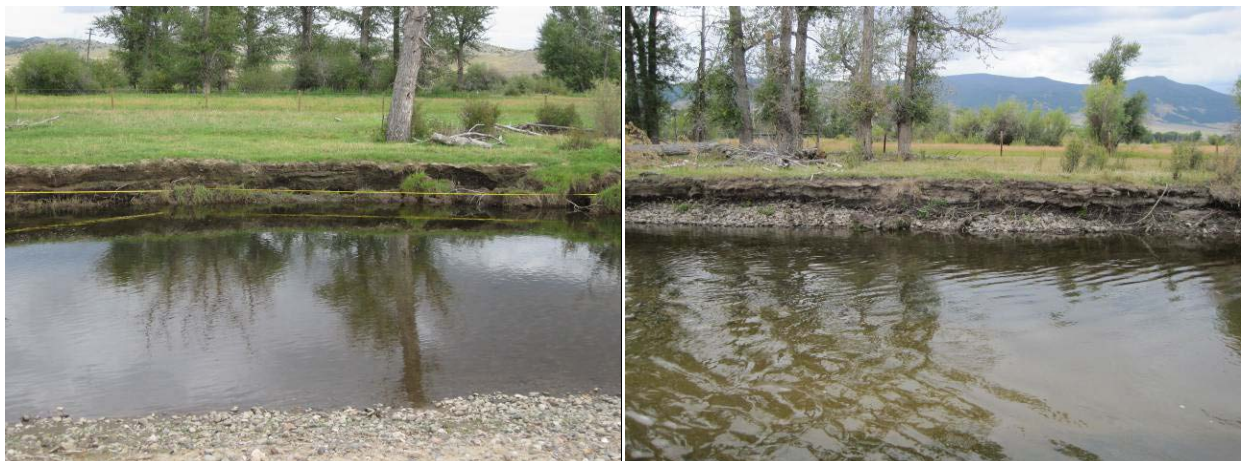
Figure 4-7. Typical eroding streambank conditions in Boulder River Reach 13-10.

Reach BLDR 13-10 has thirteen actively eroding banks that typically occur along outside meander bends. Eroding banks are near vertical and have either a silty/clayey substrate that is slumping into the stream channel, or they have a cobble layer near the toe that provides some armoring against erosion. Typical eroding streambank conditions are depicted for this reach in **Figure 4-7** and sediment loading results are provided in **Table 4-7**.

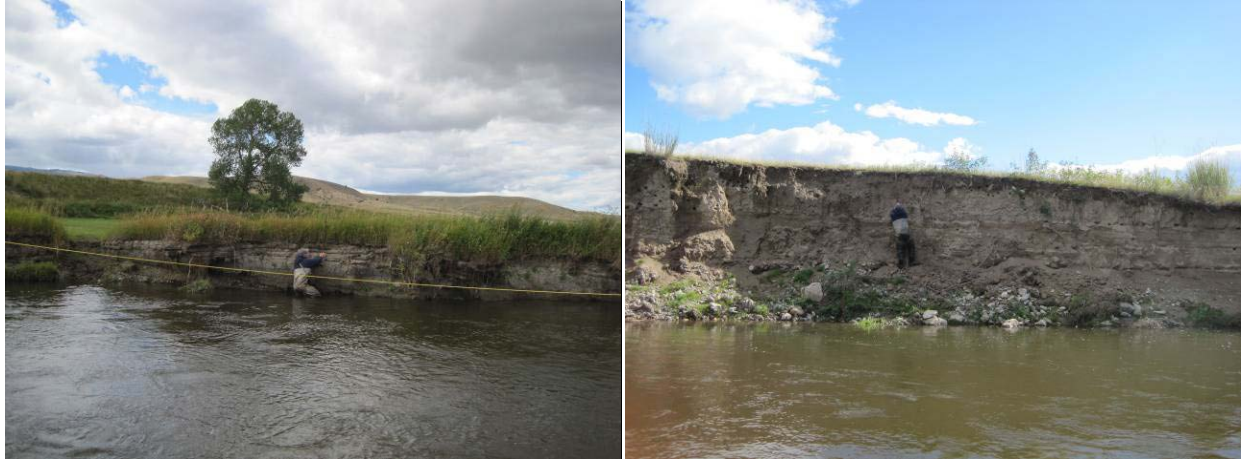
Figure 4-8. Typical eroding streambank conditions in Boulder River Reach 13-23.

(14.5'). One slowly eroding bank was identified, which had substantial willow growth that helps stabilize the bank. This reach had the highest loading rate of all sampled reaches. Typical eroding streambank conditions are depicted for this reach in **Figure 4-8** and sediment loading results are provided in **Table 4-7**.

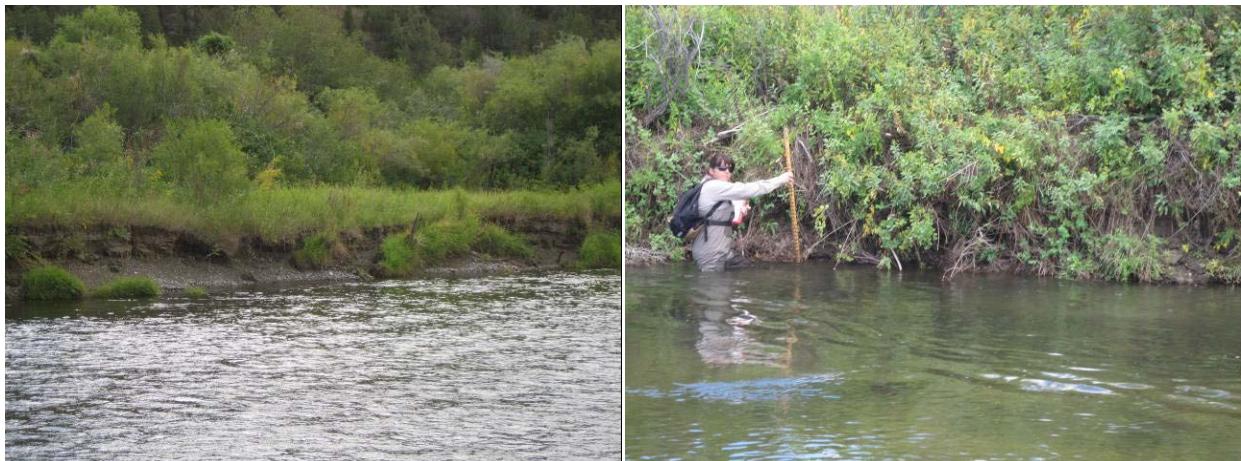
Figure 4-9. Typical eroding streambank conditions in Boulder River Reach 13-33.

This reach has twelve actively eroding banks and three slowly eroding banks. Actively eroding banks were typically slumping banks that occur on outside meander bends with little surface protection. One tall (11') actively eroding bank occurs where the stream closely parallels the road. The slowly eroding banks occur on straight sections where vegetation is established and root density is higher. Typical eroding streambank conditions are depicted for this reach in **Figure 4-9** and sediment loading results are provided in **Table 4-7**.

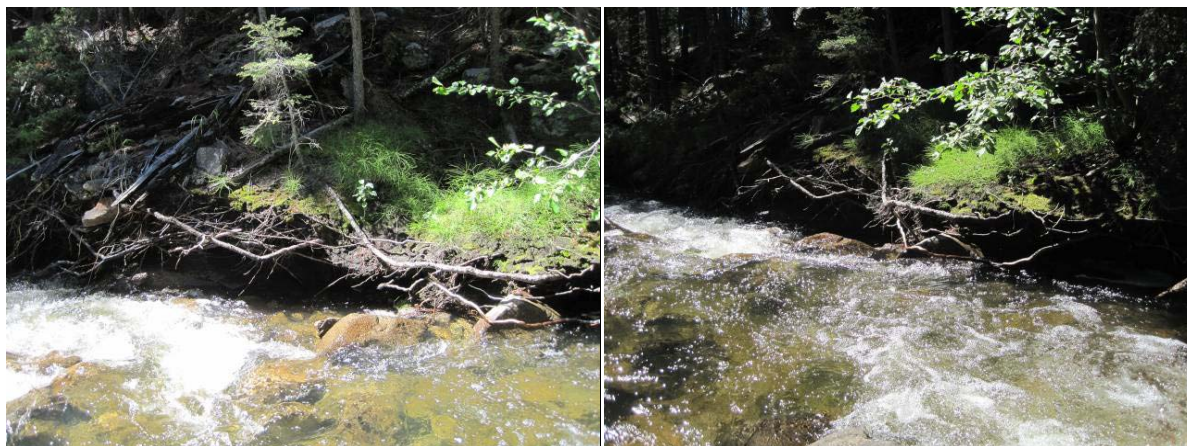
Figure 4-10. Typical eroding streambank conditions in Cataract Creek Reach 18-01.

Only one eroding streambank was identified in this reach, which was a slowly eroding undercut bank. Most banks in this high gradient reach are composed of hard packed clay and are armored with binding root masses and overgrown moss. Typical eroding streambank conditions are depicted in **Figure 4-10** and sediment loading results are provided in **Table 4-8**.

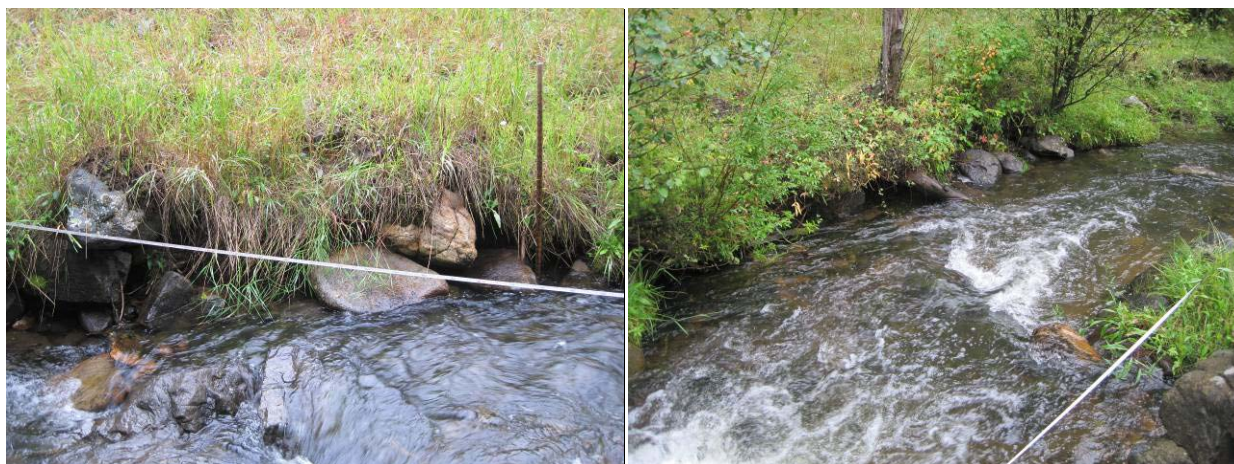
Figure 4-11. Typical eroding streambank conditions in Elkhorn Creek Reach 23-01.

Seven slowly eroding banks were identified in reach ELKH 23-01. Eroding banks were typically short in length, well vegetated, and occur at knick points coming from boulders, LWD, or tight stream meanders. In several places, the erosion is influenced by reduction of vegetation and bank trampling from hoof shear. Typical eroding streambank conditions are depicted in **Figure 4-11** and sediment loading results are provided in **Table 4-9**.

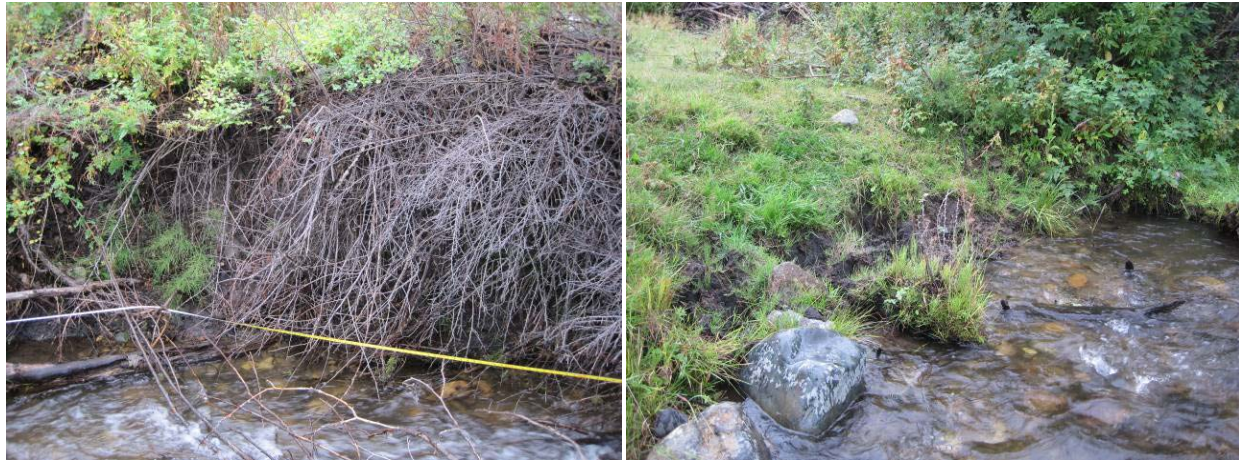
Figure 4-12. Typical eroding streambank conditions in Elkhorn Creek Reach 28-01.

This reach had thirteen actively eroding banks with three primary bank types. Eroding banks included tall, steep banks that are partially protected by dead woody vegetation, low angle banks at stream crossings that are trampled by cattle, and a few slumping vegetated banks on outside meander bends. Typical eroding streambank conditions are depicted in **Figure 4-12** and sediment loading results are provided in **Table 4-9**.

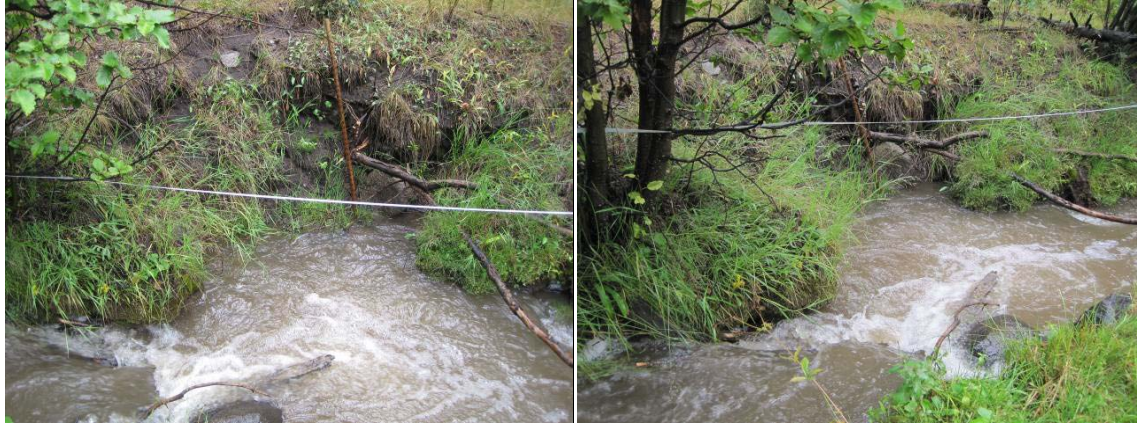
Figure 4-13. Typical eroding streambank conditions in High Ore Creek Reach 09-01.

Only one eroding streambank was identified in this reach, which is a tall, poorly vegetated bank where LWD directs stream flow into the bank. Banks are quite stable despite limited riparian vegetation, possibly because floodplain has been significantly flattened and few tall banks exist. Typical eroding streambank conditions are shown in **Figure 4-13** and sediment loading results are provided in **Table 4-10**.

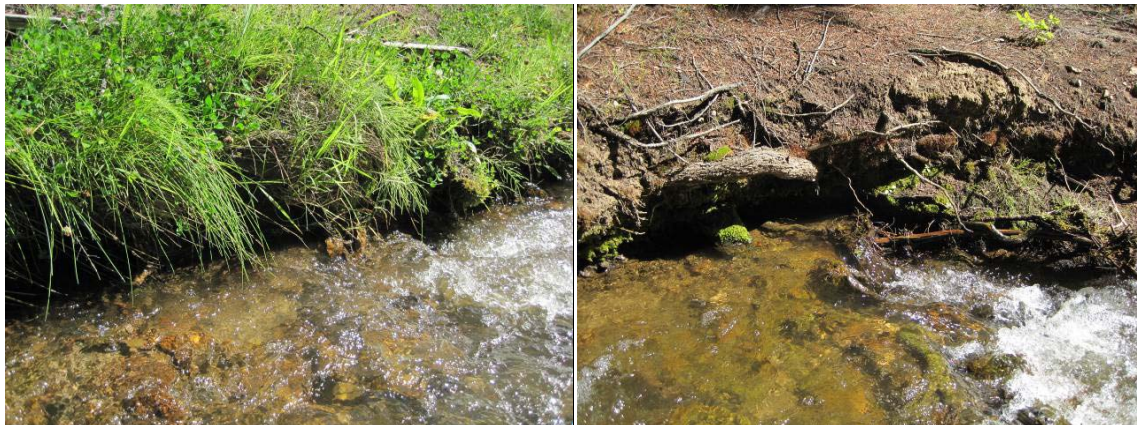
Figure 4-14. Typical eroding streambank conditions in High Ore Creek Reach 15-01.

This reach has six slowly eroding banks and one actively eroding bank. Slowly eroding banks are short, overhanging banks with good riparian vegetation. The actively eroding bank is taller with exposed soil, but bound by roots. Typical eroding streambank conditions are shown in **Figure 4-14** and sediment loading results are provided in **Table 4-10**.

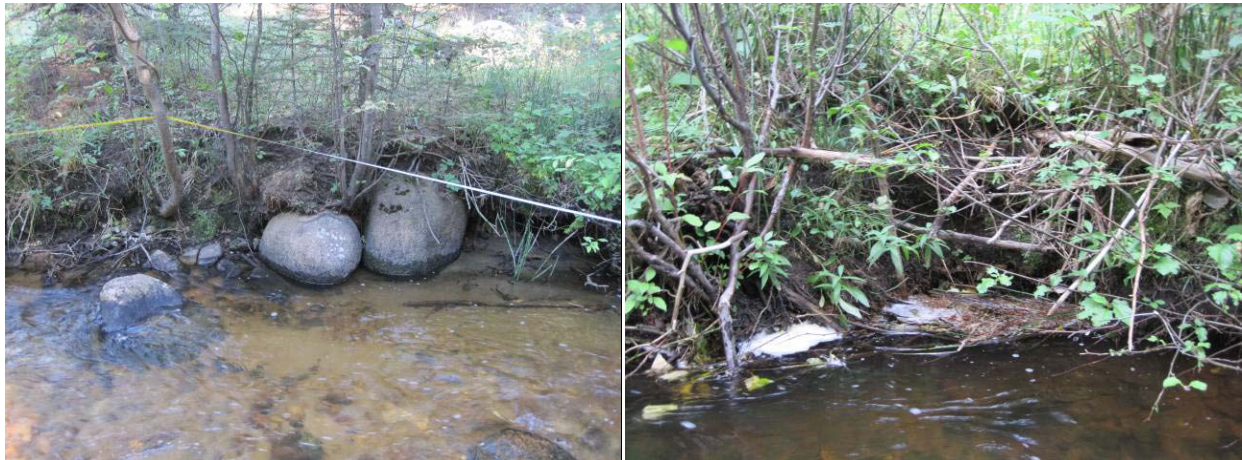
Figure 4-15. Typical eroding streambank conditions in Little Boulder River Reach 32-01.

This site has eleven slowly eroding banks that are typically near vertical with woody vegetation and a dense root mass that helps stabilize the banks. Undercut banks are not uncommon, especially in areas where stream is altered by large boulders or stabilized by mature coniferous trees. Typical eroding streambank conditions are depicted in **Figure 4-15** and sediment loading results are provided in **Table 4-11**.

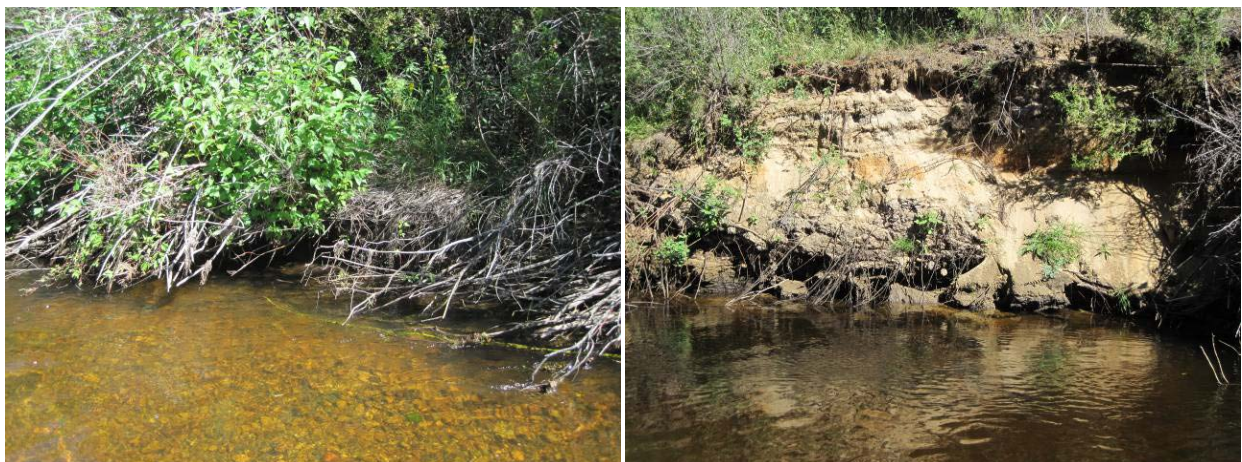
Figure 4-16. Typical eroding streambank conditions in Little Boulder River Reach 37-01.

This reach has ten eroding streambanks, including two actively eroding and eight slowly eroding. Slowly eroding banks are typically found on outside bends, but have significant surface protection from dead and living willows. One actively eroding bank occurs where the stream abuts a tall sandy terrace. Typical eroding streambank conditions are depicted in **Figure 4-16** and sediment loading results are provided in **Table 4-11**.

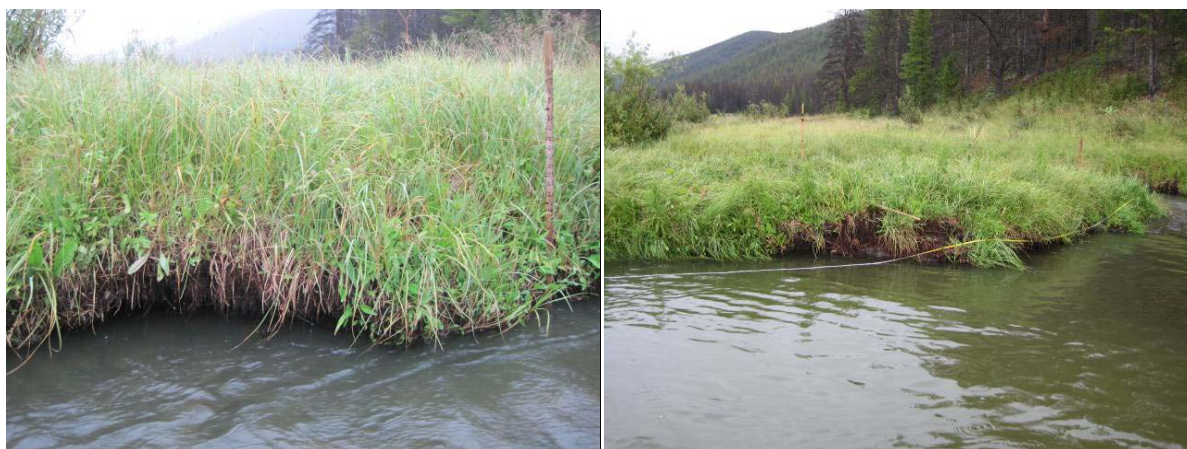
Figure 4-17. Typical eroding streambank conditions in Lowland Creek Reach 08-01.

Fourteen slowly eroding streambanks were identified in this reach. Banks are typically well vegetated with sedges and grasses, but are often undercut and slumping into the stream channel on outside meander bends. Typical eroding streambank conditions are depicted in **Figure 4-17** and sediment loading results are provided in **Table 4-12**.

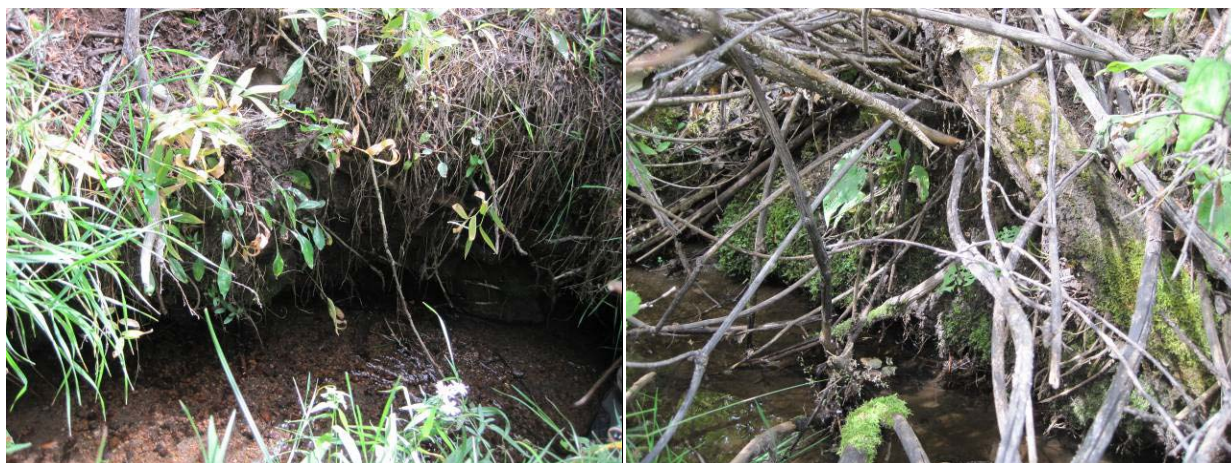
Figure 4-18. Typical eroding streambank conditions in McCarty Creek Reach 22-01.

This reach has eleven slowly eroding banks and seven actively eroding banks. Slowly eroding banks are typically near vertical or undercut with stabilizing vegetation. Actively eroding banks occur where woody vegetation has died, or on tight meander bends. Erosion appears partially due to the severe downcutting observed in this reach. Typical eroding streambank conditions are depicted in **Figure 4-18** and sediment loading results are provided in **Table 4-13**.

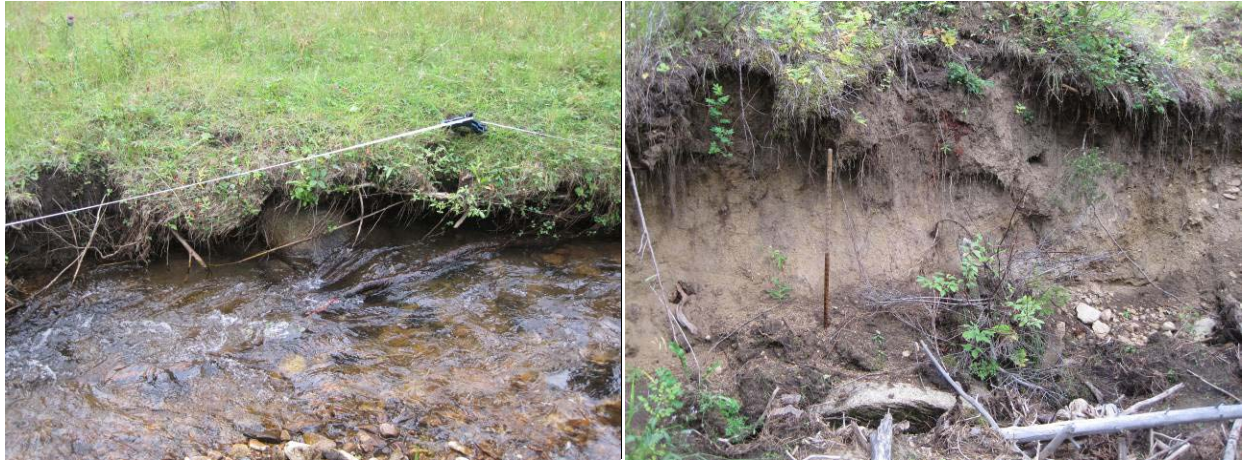
Figure 4-19. Typical eroding streambank conditions in Muskrat Creek Reach 18-01-02.

slowly eroding conditions found within this reach and the right photos shows the mass wasting site that is presently separated from the main channel.

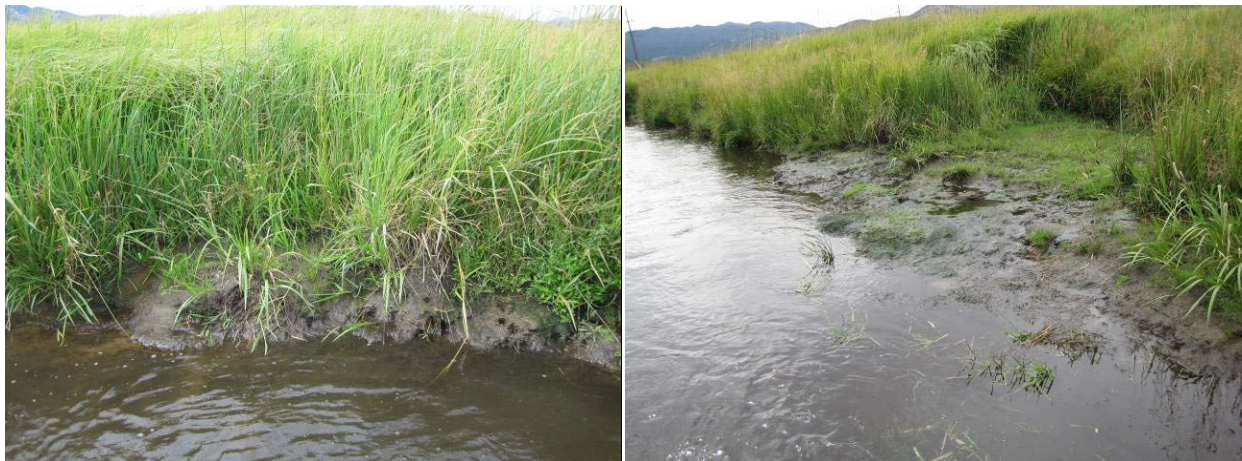
Figure 4-20. Typical eroding streambank conditions in Muskrat Creek Reach 22-08.

This site has numerous slowly eroding banks that are generally well vegetated with low NBS due to the straight channel. Some eroding banks are associated with seeps that occur from irrigation recharge. Typical eroding streambank conditions are depicted in **Figure 4-20** and sediment loading results are provided in **Table 4-14**.

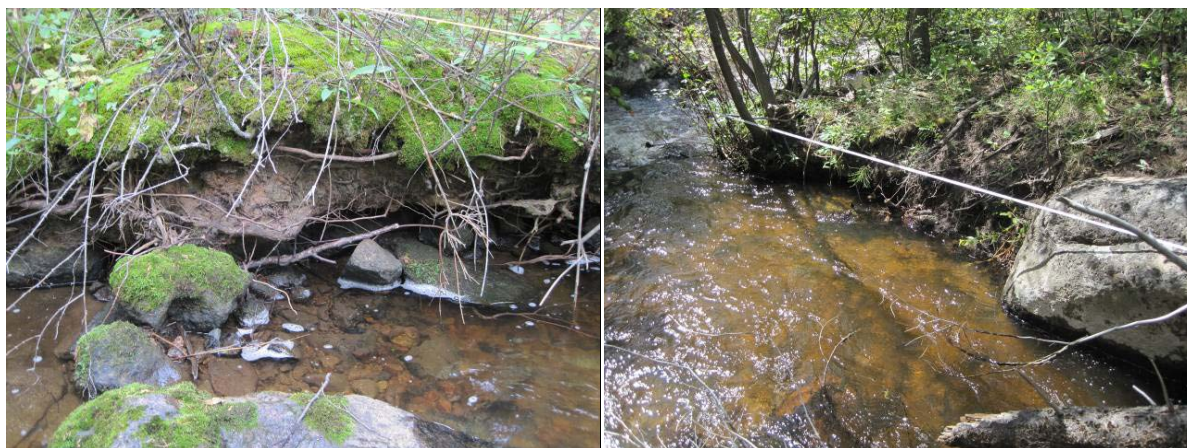
Figure 4-21. Typical eroding streambank conditions in North Fork Little Boulder 42-01.

This reach has eleven actively eroding streambanks that are generally associated with LWD or boulders that direct streamflow into the bank. Eroding banks are generally short and near vertical or overhanging. Typical eroding streambank conditions are depicted in **Figure 4-21** and sediment loading results are provided in **Table 4-15**.

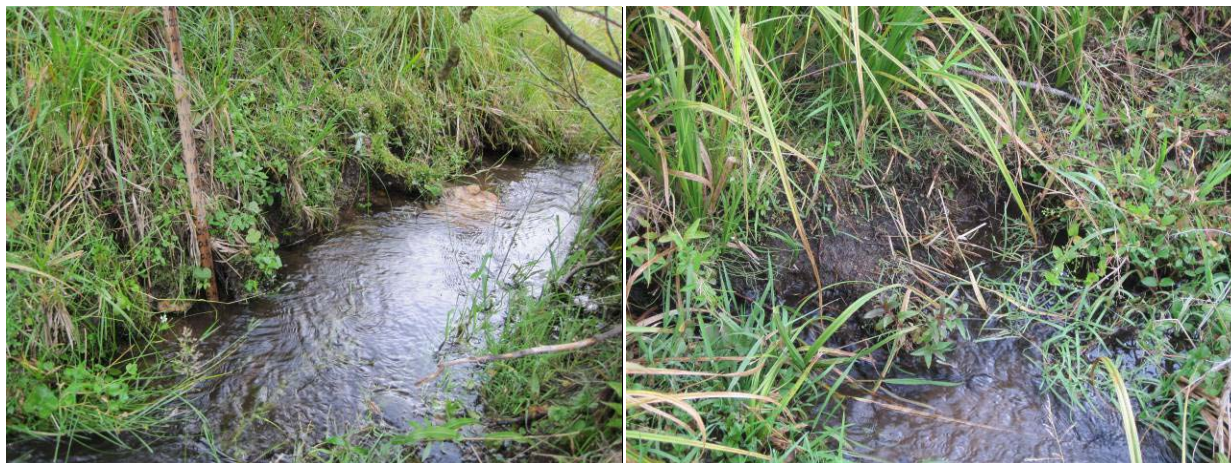
Figure 4-22. Typical eroding streambank conditions in Nursery Creek Reach 07-01.

This reach has seven slowly eroding streambanks that are generally associated with seeps, LWD, or cattle trampling. Lush wetland vegetation stabilizes the banks throughout most of the reach. Typical eroding streambank conditions are depicted in **Figure 4-22** and sediment loading results are provided in **Table 4-16**.

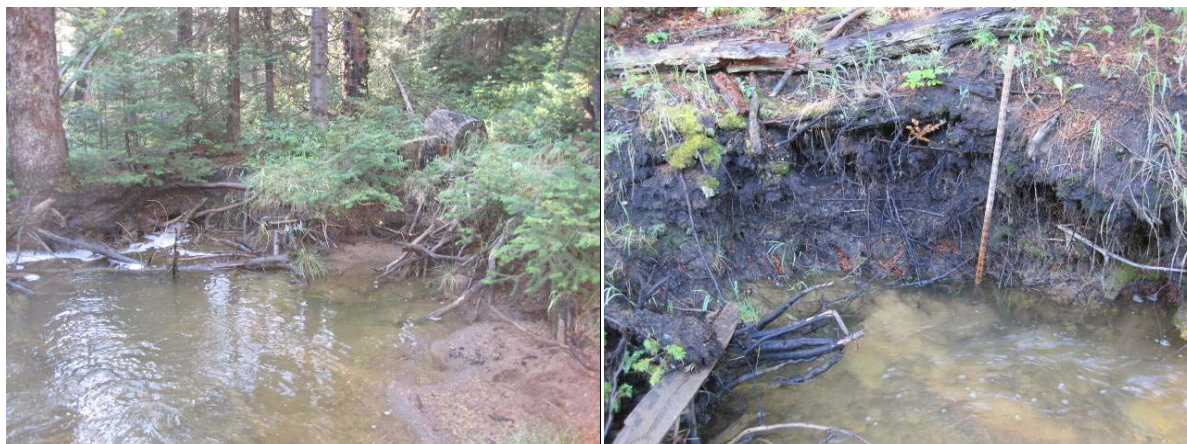
Figure 4-23. Typical eroding streambank conditions in Uncle Sam Gulch Reach 10-01.
