Montana Department of  
Environmental Quality

**Helena Solvent Site  
Vapor Intrusion Investigation Data Report**

June 2010

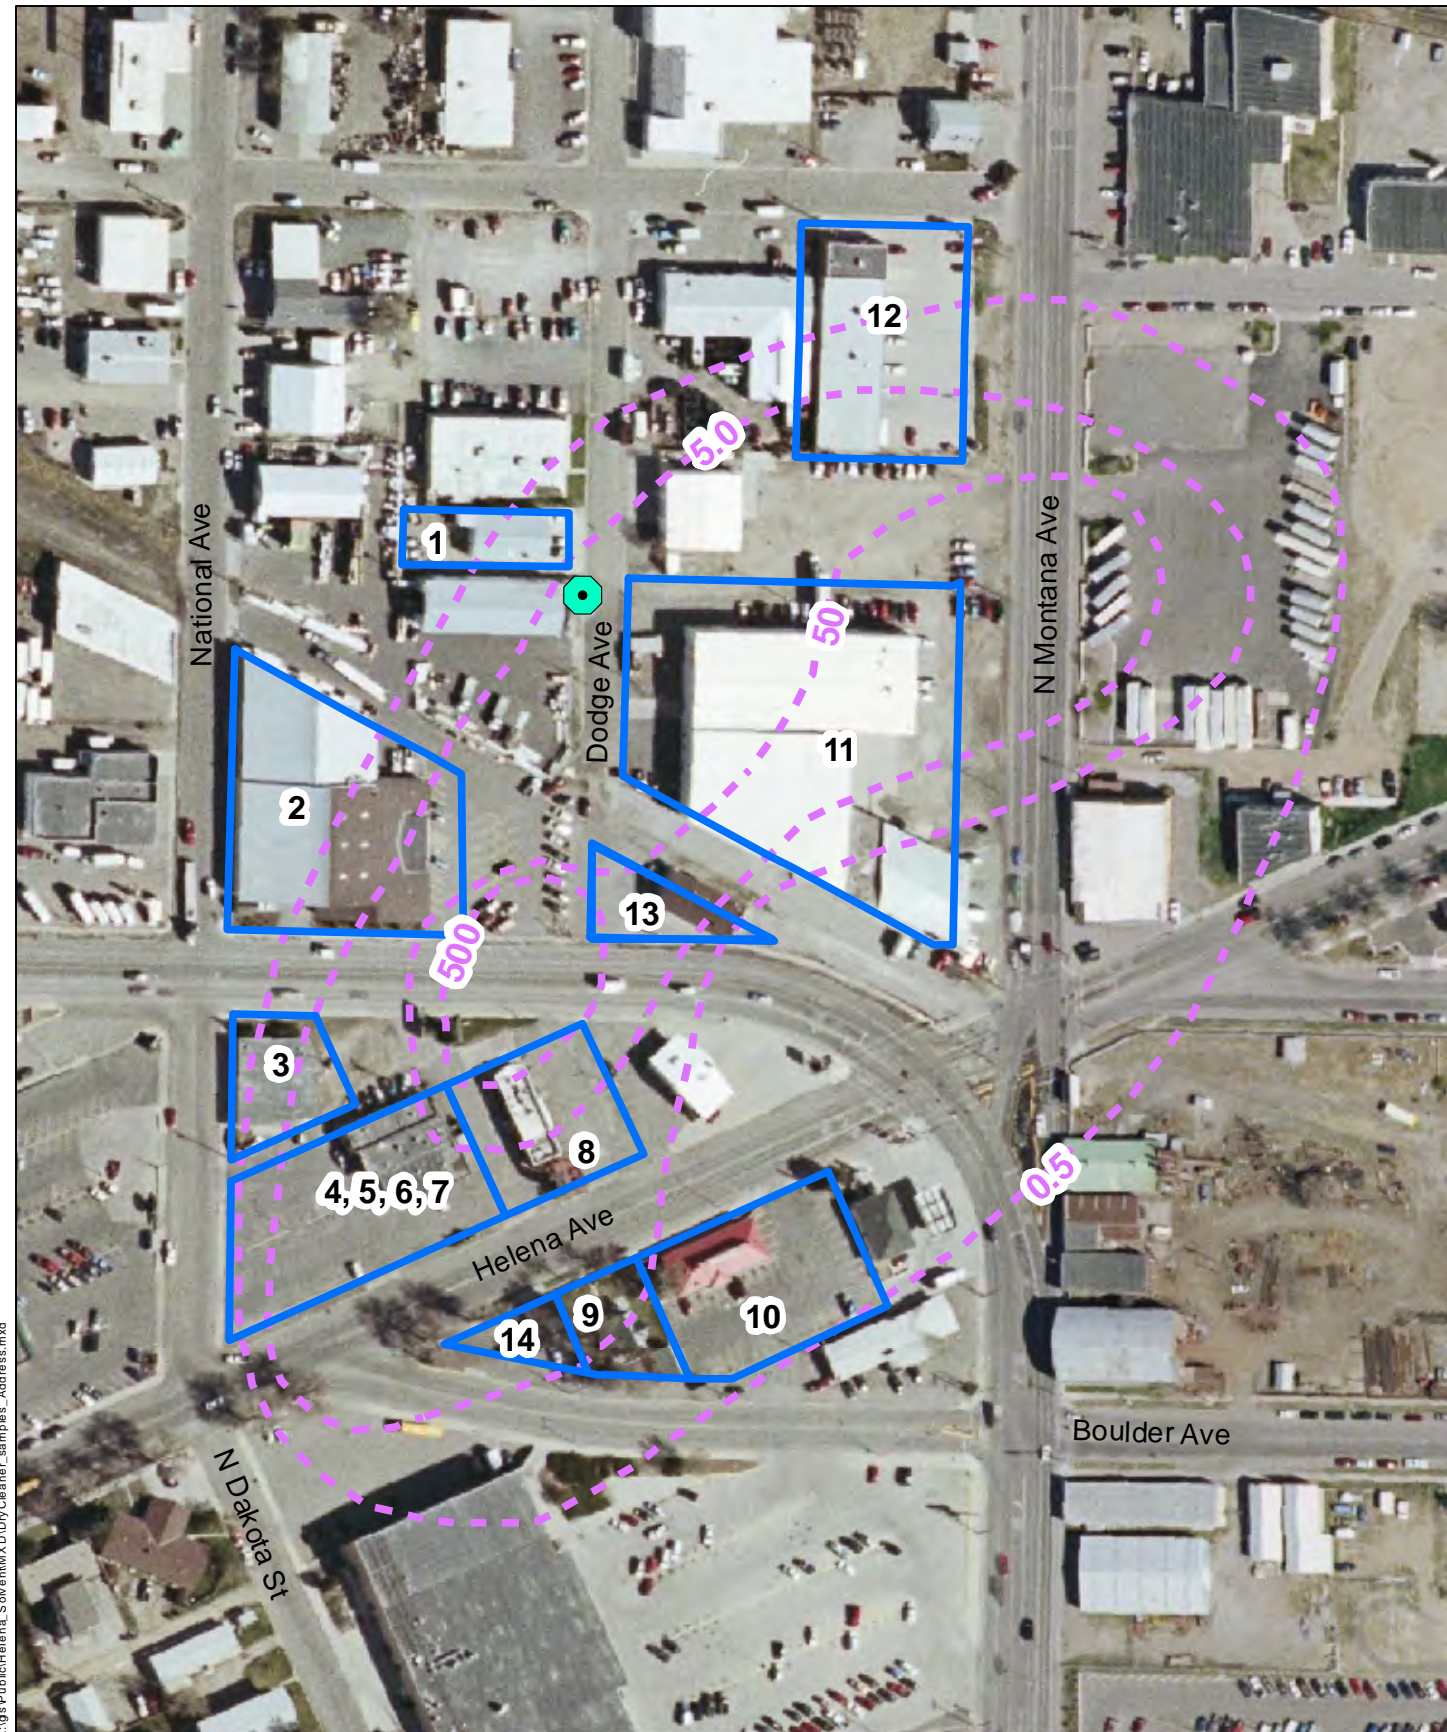
**Figure 1**  
**Helena Solvent Site**  
**Vapor Intrusion**  
**Site Map**

PCE was detected in all of the ambient air samples at concentrations ranging from 0.57 to 3.2  $\mu\text{g}/\text{m}^3$ . While no screening levels exist for PCE in ambient air, it is worth noting that these PCE concentrations all exceeded residential indoor air screening levels, and two of the five samples exceeded industrial indoor air screening levels. It is possible that PCE in outdoor air could be contributing to PCE in the indoor air in several of the buildings that were sampled. However, at least one indoor air sample in each of the following structures was lower than the ambient air levels of PCE on the day the sample was collected: ProBuild, Pierce Builders, and Flooring America. It is not known where the PCE in the ambient air is originating. Known PCE sources that could be contributing to PCE in ambient air include the HSS groundwater PCE plume and PCE inside Mr. Wise Cleaners. The wind tended to come from the southwest during the sampling event (see the discussion of weather data, below), therefore the ambient air samples may have been located downwind of Mr. Wise Cleaners rather than upwind or crosswind (see Appendix G- Figure 1).

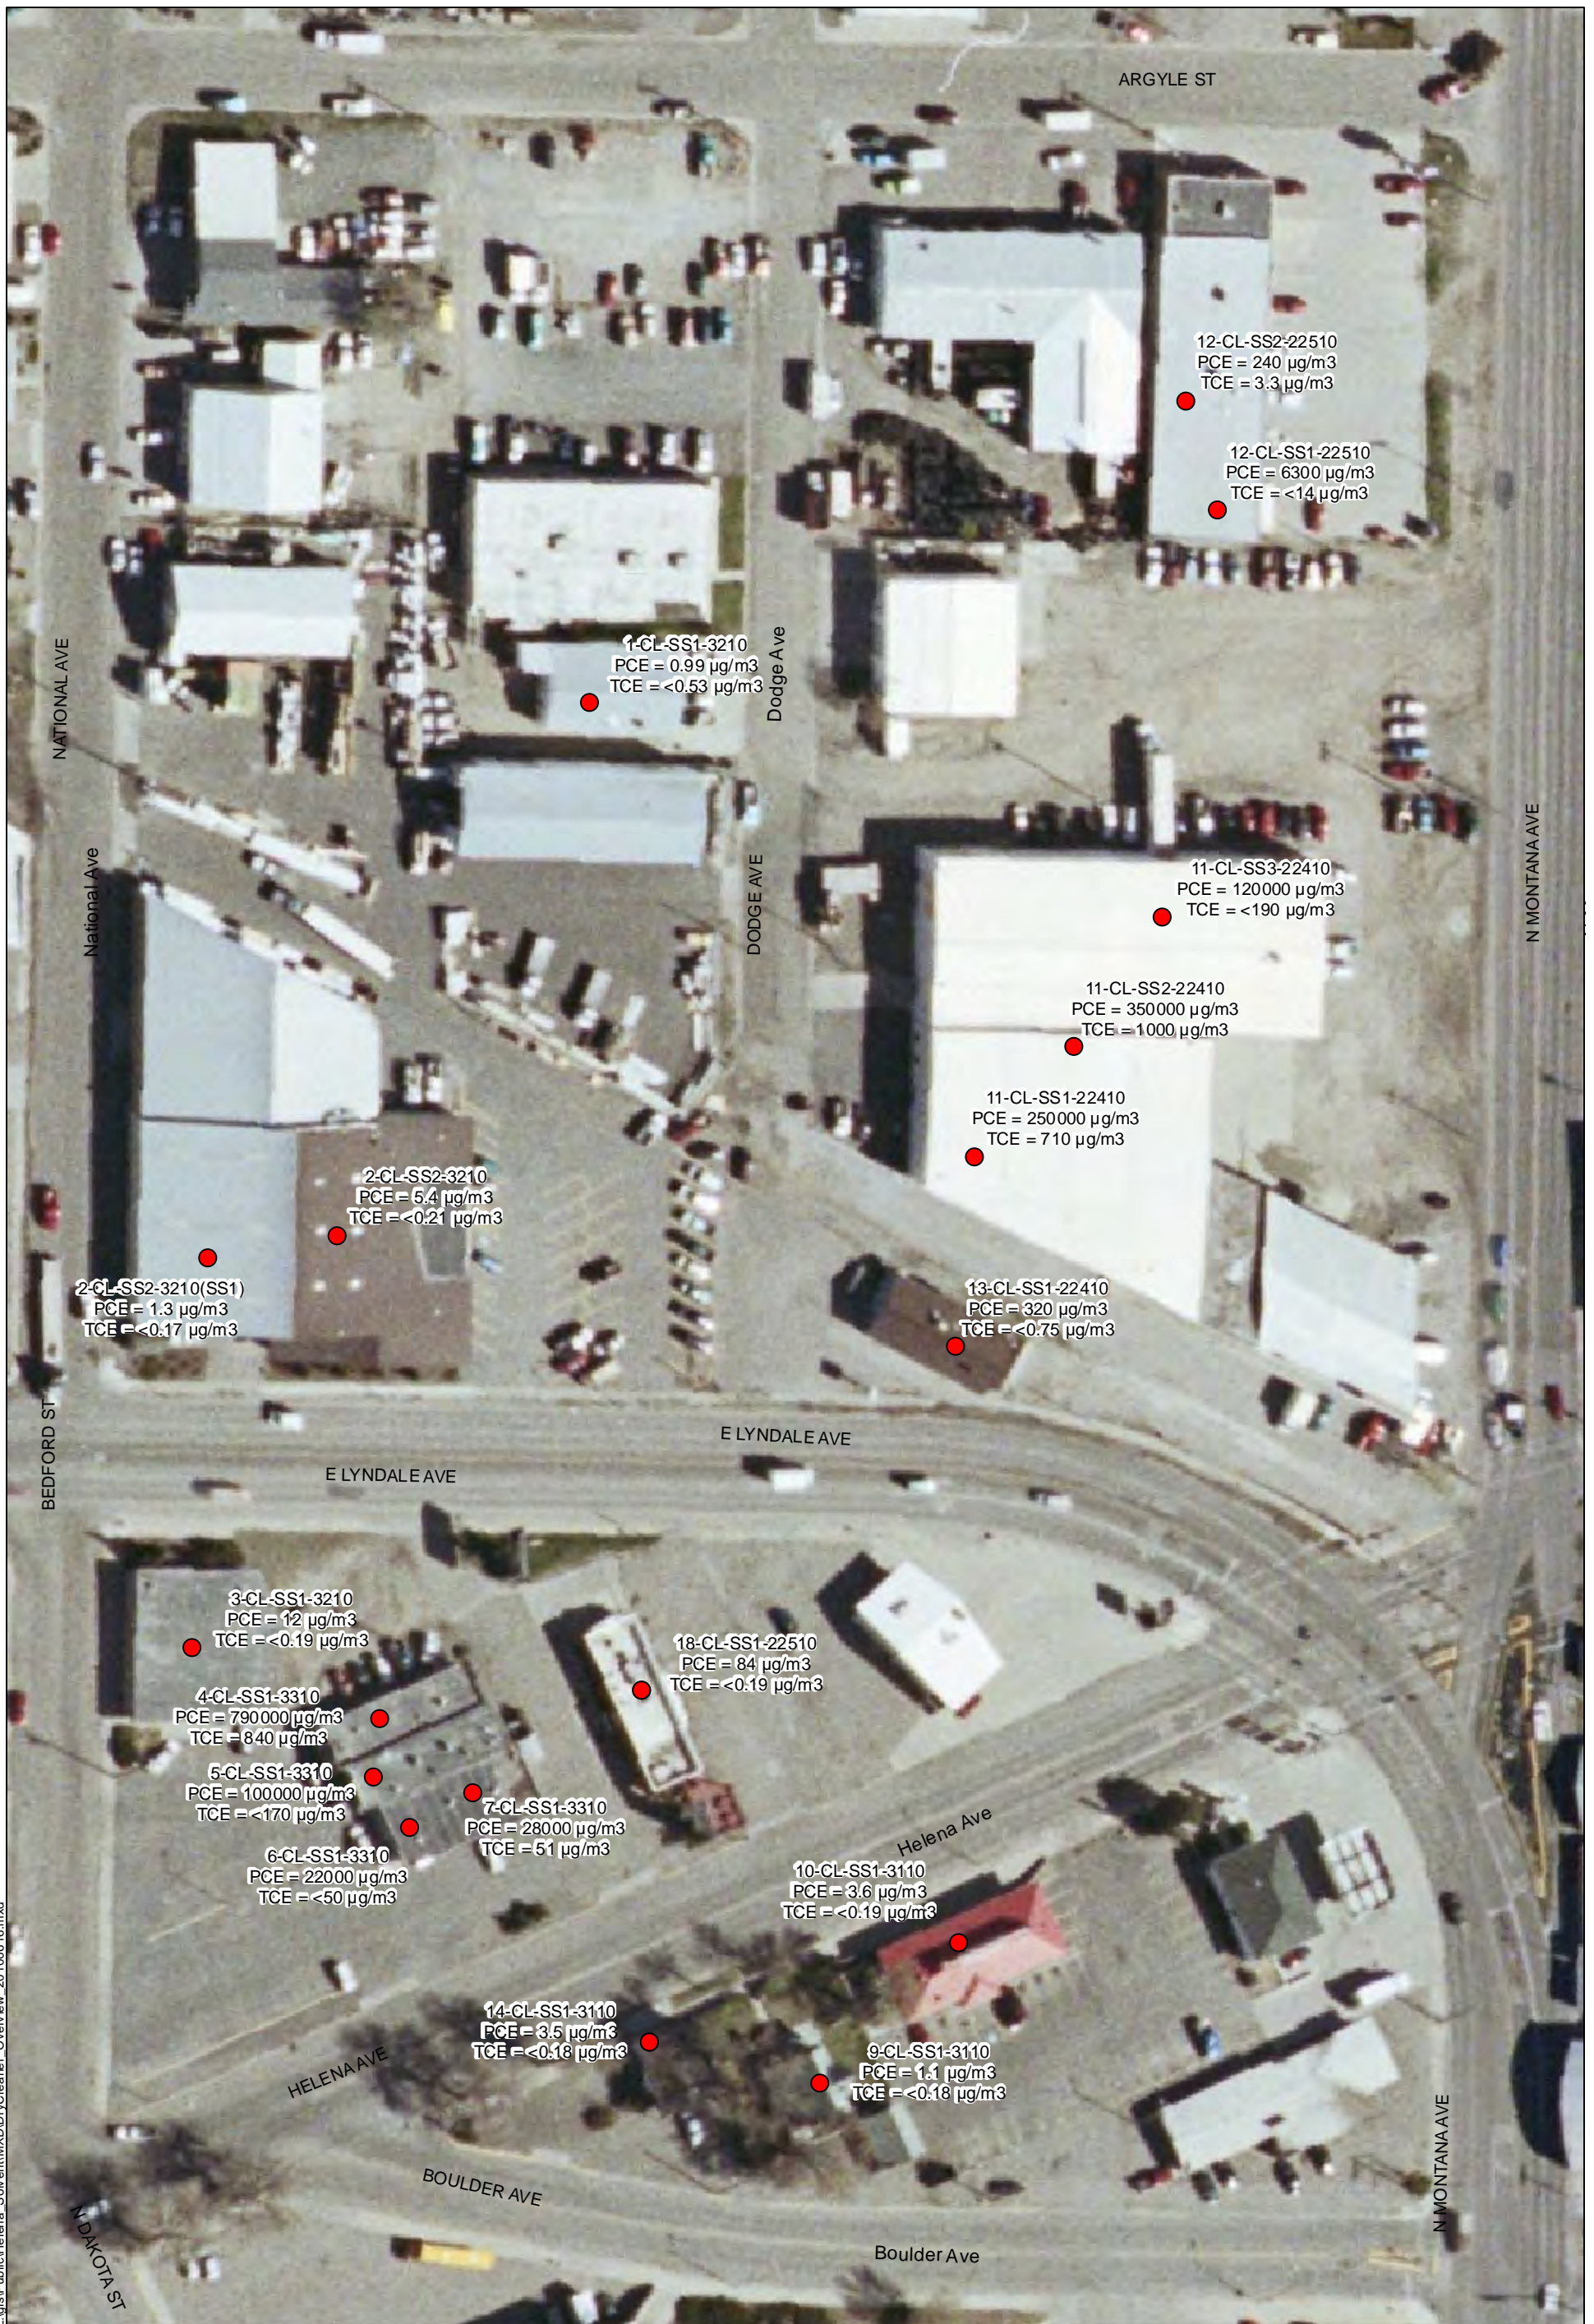
**Figure 2**  
**Helena Solvent Site**  
**Vapor Intrusion**  
**Subslab Sample Locations**  
**and PCE/TCE Results**

All laboratory data can be found in Appendix A on the attached compact disc (CD) along with Table A-1 that summarizes the results and compares the results to the applicable screening levels. Table A-1 also summarizes the results of the ambient air samples. Figure 2, in Appendix G, shows the approximate locations of subslab locations and results of these samples.

Significant concentrations of PCE were found in the indoor air in the offices located in the Hustad LLC Building, which is the building that houses Mr. Wise Cleaners. The highest PCE concentration was at Canine Capital (3400  $\mu\text{g}/\text{m}^3$ ), while Bloomer's Floral (410  $\mu\text{g}/\text{m}^3$ ) and the vacant Hustad Center office (260  $\mu\text{g}/\text{m}^3$ ) also had elevated PCE concentrations. These concentrations exceed the commercial and residential indoor air Regional Screening Levels of 2.1 and 0.41  $\mu\text{g}/\text{m}^3$ , respectively. Indoor air samples were not collected from Mr. Wise Cleaners because it is an active drycleaner that currently uses PCE in its operations, and indoor air concentrations were expected to be elevated. Elevated subslab concentrations (28,000 - 790,000  $\mu\text{g}/\text{m}^3$ ) were present beneath this building. The highest subslab PCE concentration was found beneath Mr. Wise Cleaners. The elevated concentrations of PCE in the subslab air likely indicate the presence of a source of PCE in the soils, as well as the groundwater, beneath this building.

TCE was detected in the subslab air beneath Mr. Wise and the vacant office at 840 and 51  $\mu\text{g}/\text{m}^3$ , respectively. Vinyl chloride was not detected in any of the subslab air samples, however, the detection limits were elevated due to the presence of high concentrations of PCE and possibly TCE.

Elevated subslab results for PCE were found under the Mergenthaler slab in all three subslab samples (120,000, 250,000, and 350,000 µg/m<sup>3</sup>). Indoor air PCE in the Mergenthaler office was 68 µg/m<sup>3</sup>, and in the warehouse was 32 µg/m<sup>3</sup>, which are both higher than the industrial and residential indoor air screening levels of 2.1 and 0.41 µg/m<sup>3</sup>, respectively. The DEQ is requiring mitigation of indoor air in Mergenthaler's, and will require investigation and cleanup of PCE in the subsurface in this area.

Given the high subslab and indoor air PCE concentrations in this building, the DEQ is requiring mitigation of indoor air in all offices in this building. Further, the DEQ is requiring investigation and cleanup of any source area near or under the building, as well as additional investigation and remediation at the HSS.
