**FINAL CONSTRUCTION COMPLETION REPORT FOR THE GARDNER EMERGENCY 2009**

**Richland County, Montana**

**January 10, 2011**

**Montana Department of Environmental Quality**

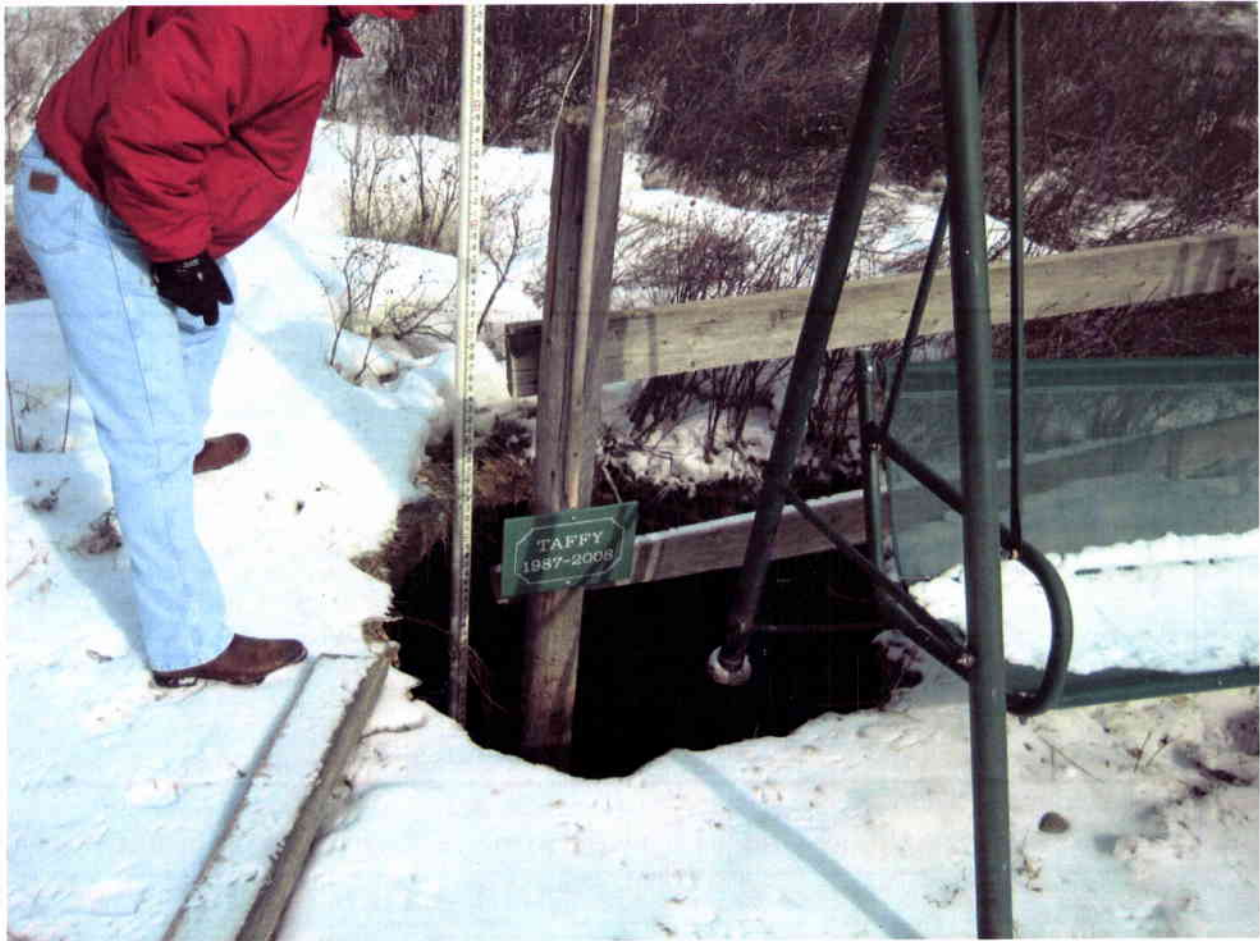
*Subsidence Feature 1*

Jerry Gardner contacted Jeffrey Fleishman in the Casper, Wyoming Office of Surface Mining on March 24, 2009. Bill Botsford and Steve Opp of the DEQ AML Section drove out to Fairview on March 25, 2009 and conducted a site visit to the residence on March 26, 2009. Two subsidence features were identified behind the Gardner residence. The subsidence collapse 20 feet from the Gardner residence's backdoor, began on the morning of March 24, 2009. A collapse further from the house had occurred the previous year and continued to get larger and deeper. The feature closest to the house measured 5' -5.5' in circumference and 6' deep. The subsidence feature furthest from the house measured 9.5' to 13.5' in circumference and 4' deep. Botsford and Opp put safety fencing up around both features.

Personnel from the DEQ AML section returned on April 21, 2009 with an operator and CAT 430D 4x4 backhoe of W. L. Neu Construction Inc. of Fairview, Montana to oversee the backfilling the subsidence features. The two subsidence features were over-excavated and the bottom of the features was compacted. An onsite borrow source recommended by Jerry Gardner was used for backfill. Additionally, an onsite stockpile of topsoil was used to top off the backfill in the subsidence features. Upon completing the reclamation of the subsidence features, the safety fences were removed. The reclamation cost was \$1405.00.

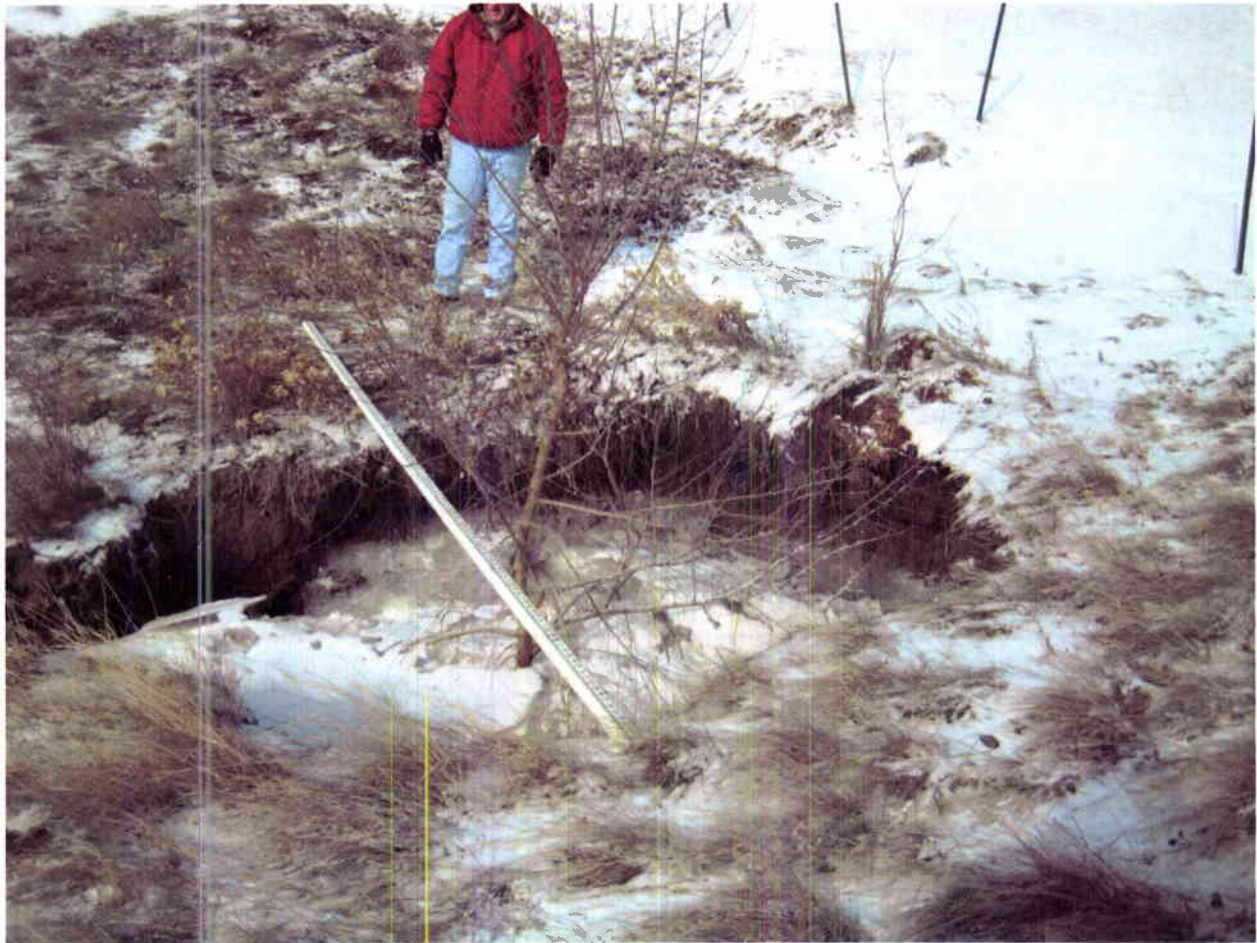
*Subsidence Feature 2*

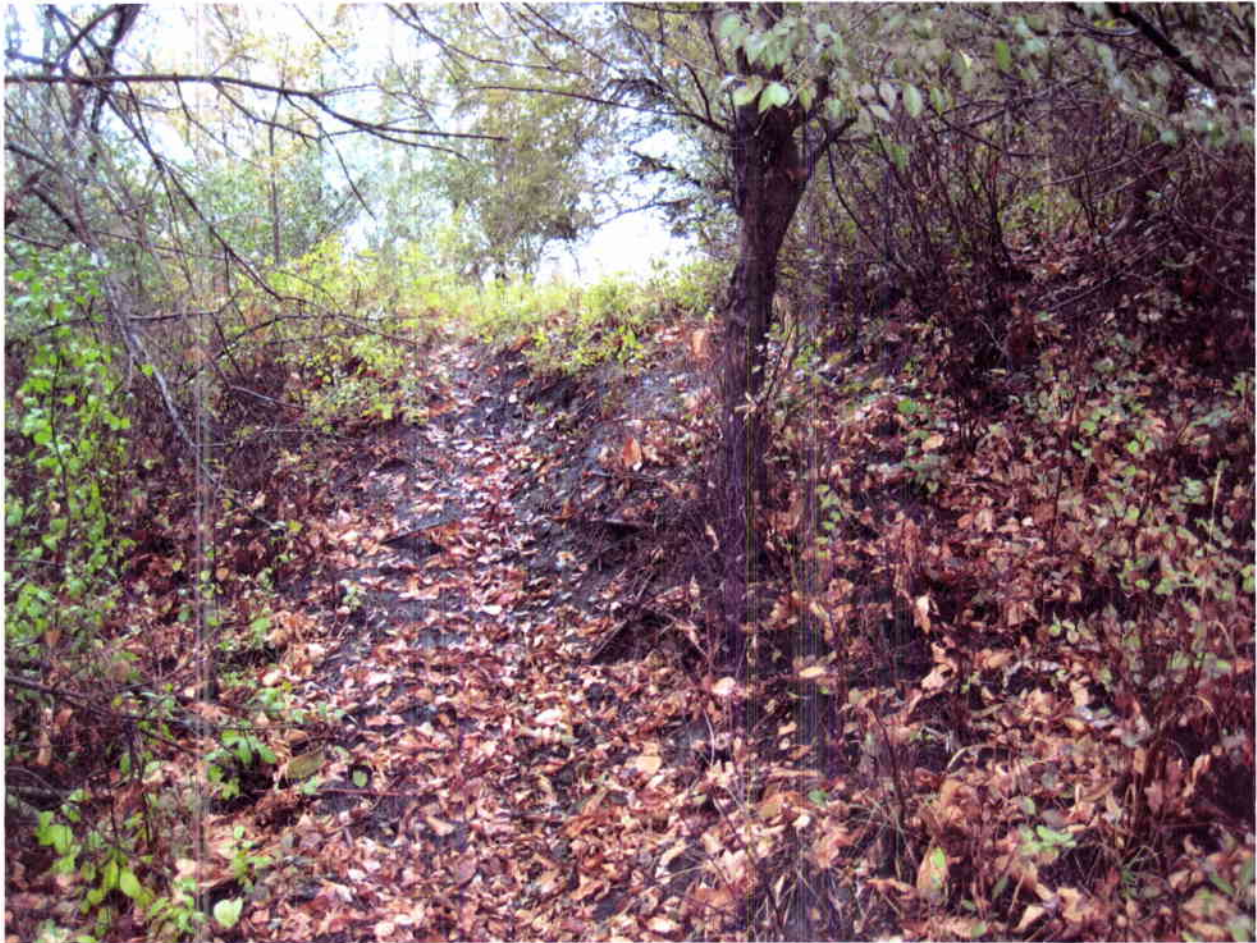
*Slack pile at collapsed Adit 2*

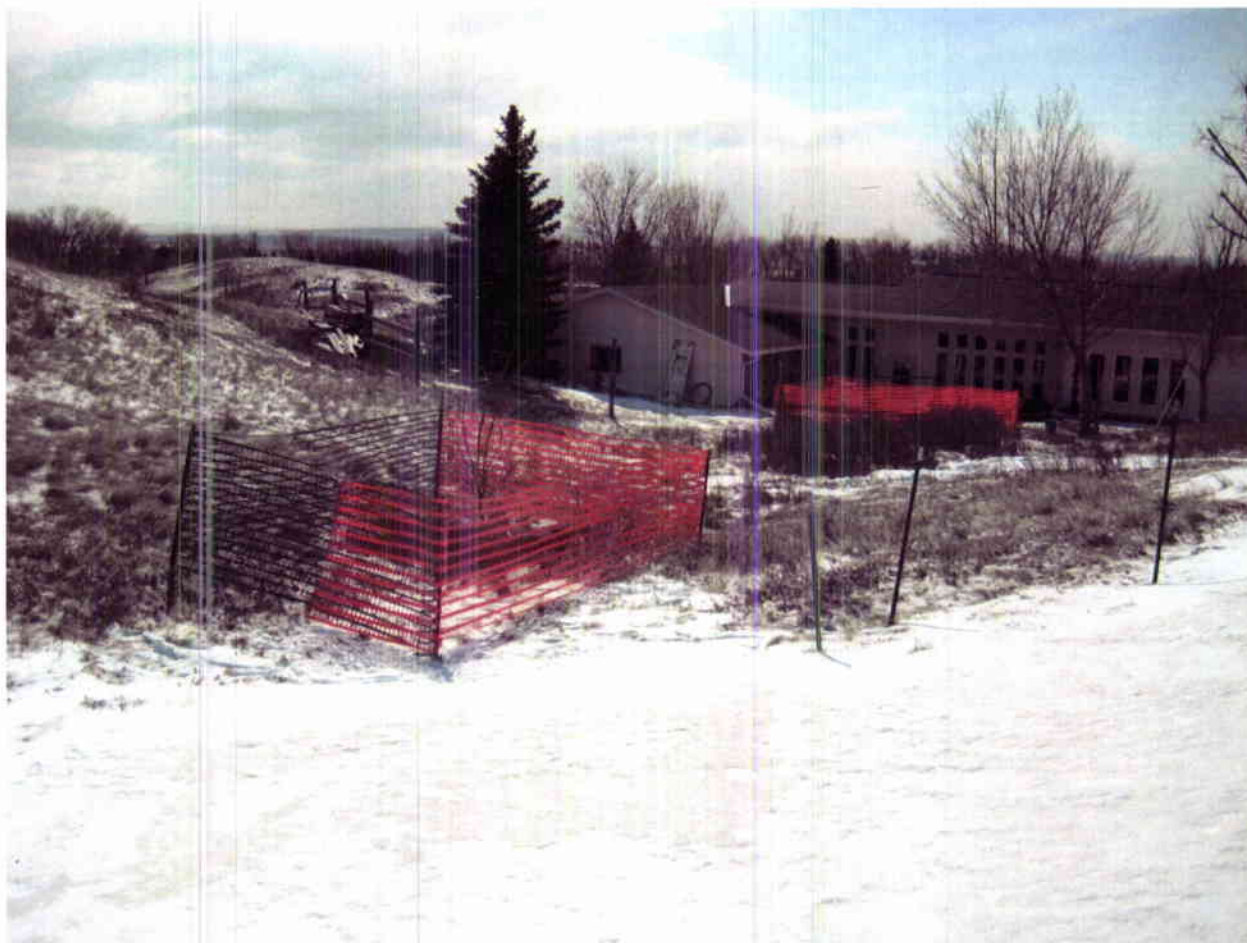
*Safety Fencing Surrounding Subsidence Features*

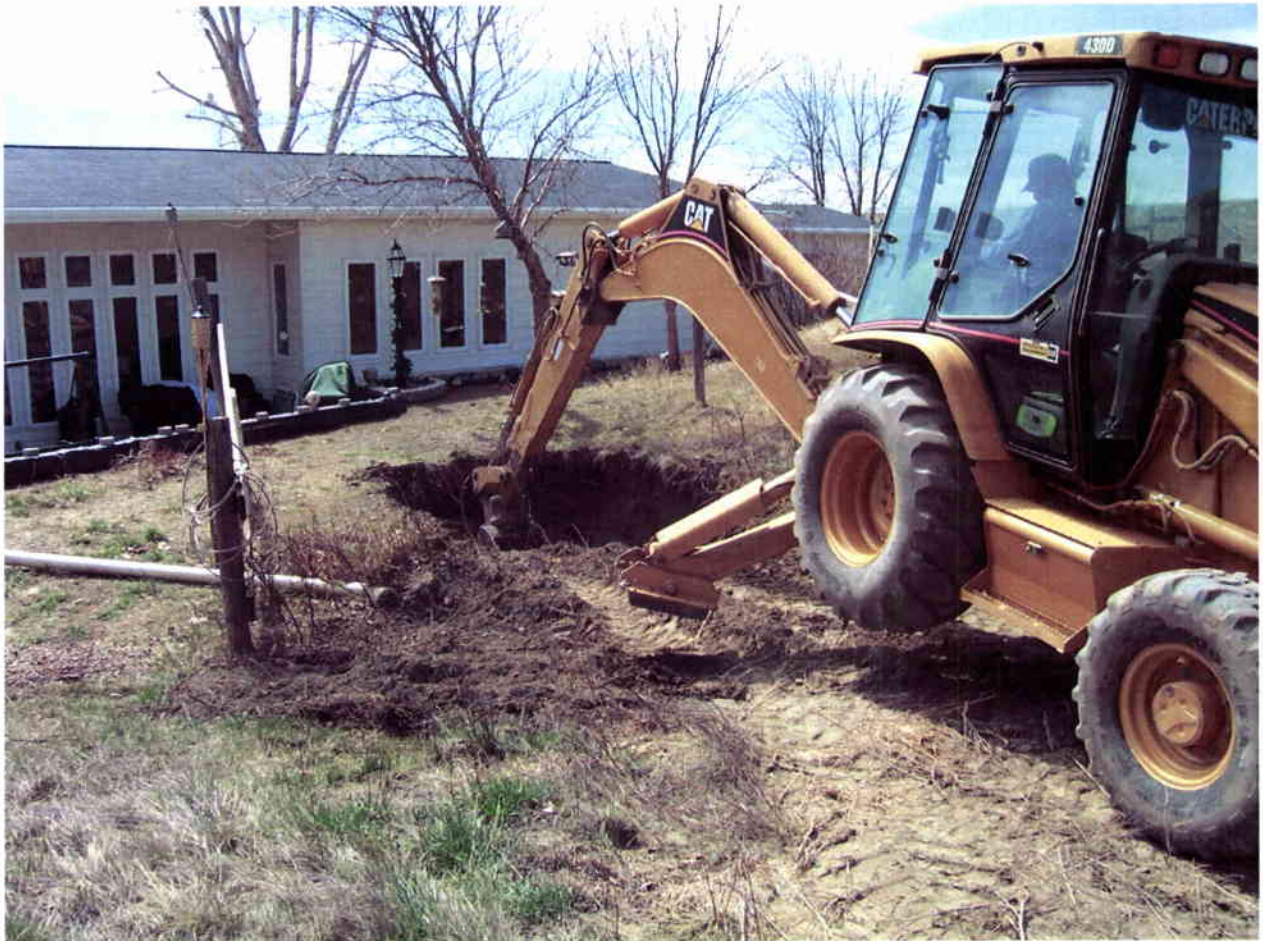
*Over-excavating and backfilling Subsidence Feature 1*

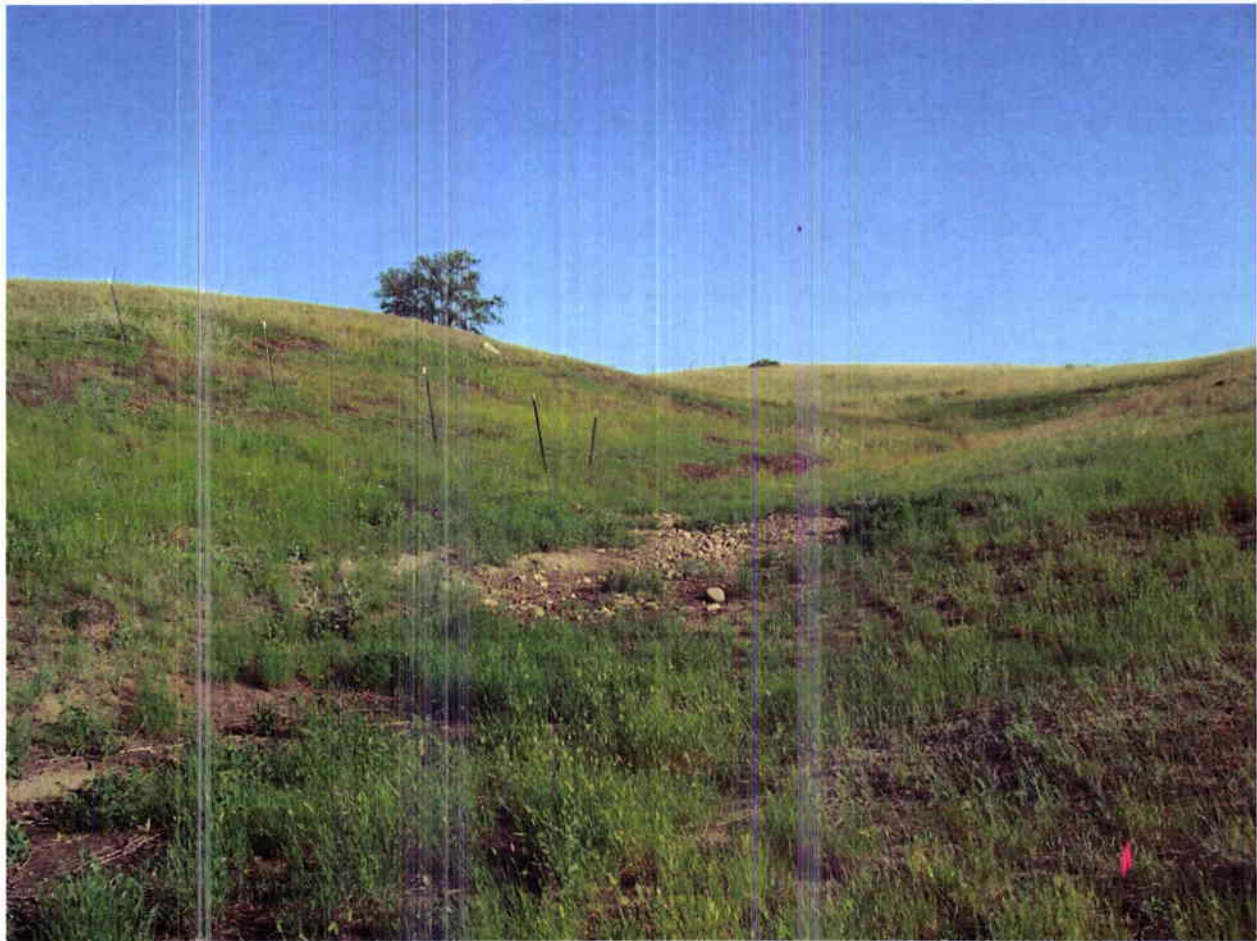
*Subsidence Feature 2 After Landscaping*

Once the subsidence features were backfilled, the DEQ AML subcontracted J&J Services of Fairview, Montana for landscaping work at a cost of \$2750.00.

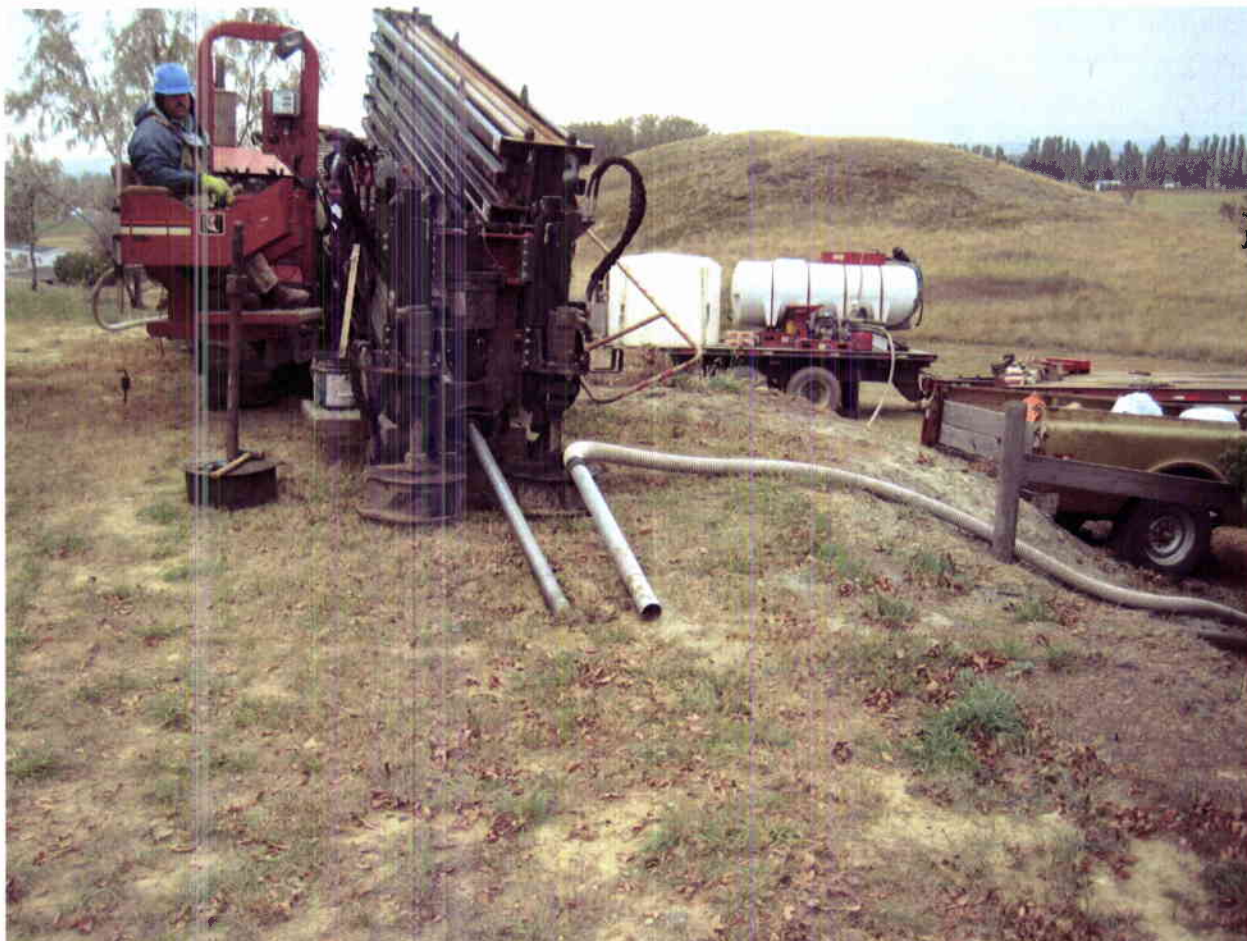
*Advancing HDD Hole Number 1*

horizontal/directional drilling (HDD) investigation followed by a grouting program. The DEQ AML Program developed an Invitation for Bid (IFB) and specifications for this phase of work. Agri Industries Inc. of Williston, North Dakota was the low bidder for the IFB and was awarded the contract. In the summer of 2009, Agri Industries with oversight by personnel from the DEQ AML Program, began an HDD investigation. Four horizontal/directional holes were advanced parallel and perpendicularly underneath the Gardner residence to identify mine voids (Figure 3). Two of the HDD holes (Number 2 and Number 4 on Figure 3) did not identify mine voids. HDD holes Number 1 and Number 3 intersected several mine voids underneath the house and in front of the garage. These holes were day-lighted and perforated HDPE pipe was pulled back through the borehole. The pipe was only perforated in areas of mine voids based on the drilling logs. An end cap was placed on the HDPE pipe at the daylight end. A coupling was installed on the drilling end of the HDPE pipe to connect to a grout pump. Grouting was attempted in HDD hole Number 1, but the pressures created by the grout pump blew the coupling connection several times. It was determined that reducing the viscosity of the grout mix would make the grout more flowable through the perforations, thereby decreasing pumping pressures. Additionally, Agri Industries fabricated a heavy-duty coupling that was successful used in pumping grout into HDD holes Number 1 and Number 3. Approximately 3 cubic yards of grout was injected into HDD hole Number 1 and approximately 15 cubic yards of grout was injected in HDD hole Number 3. The cost of the project was \$51,407.00.

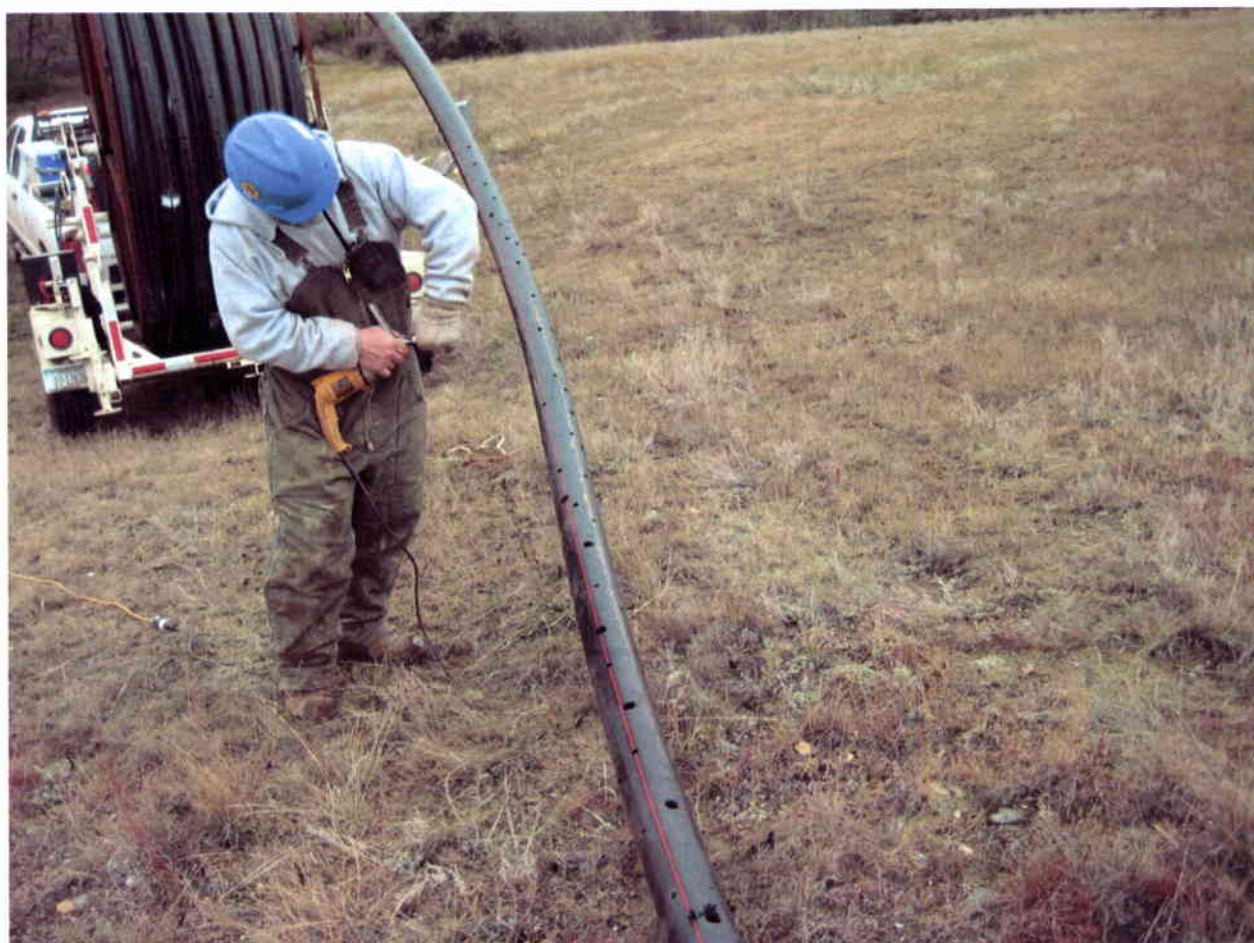
*Perforating HDPE pipe for grout injection*

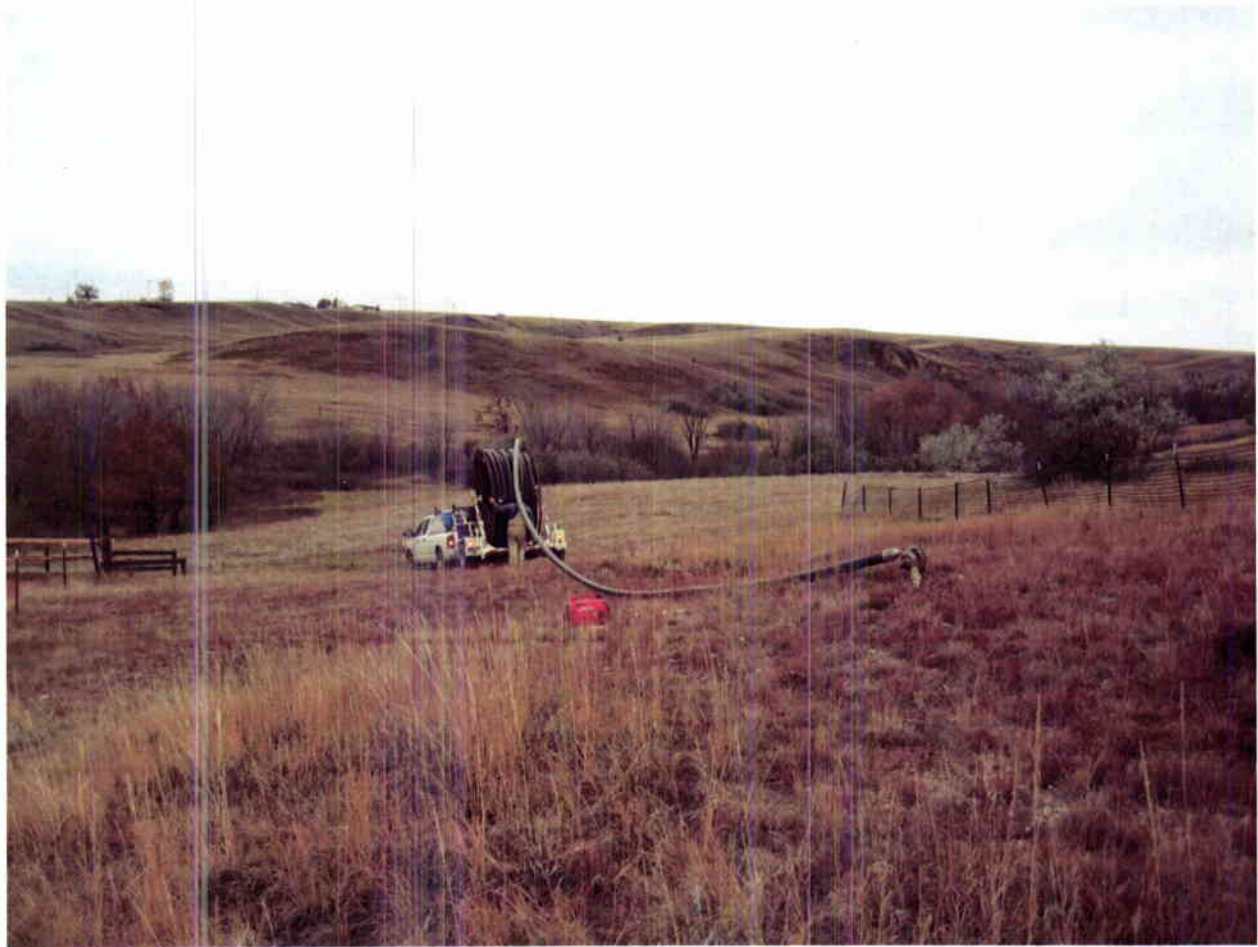
*Pulling HDPE Pipe Back Through Borehole*

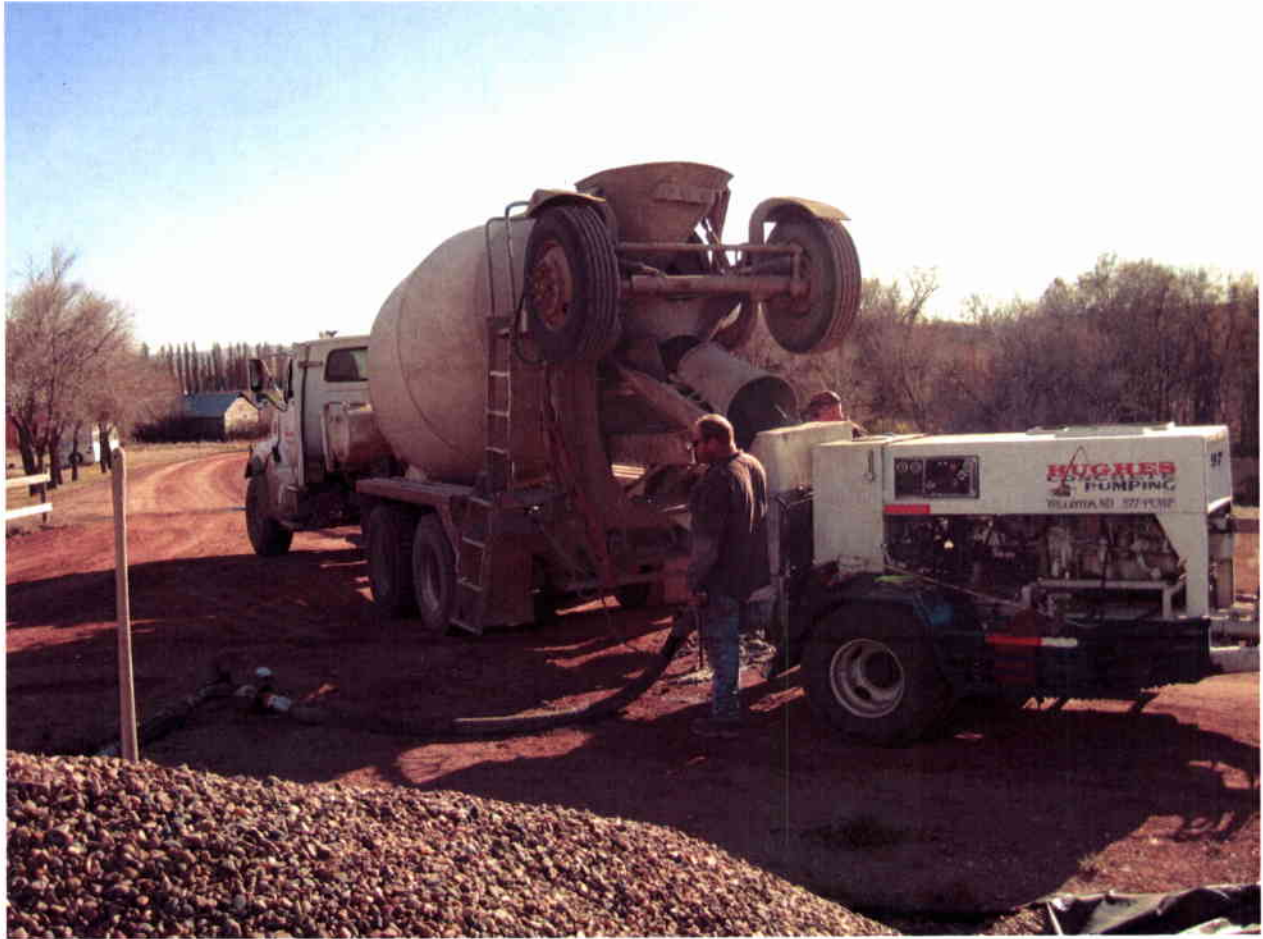
### *Injecting Grout*

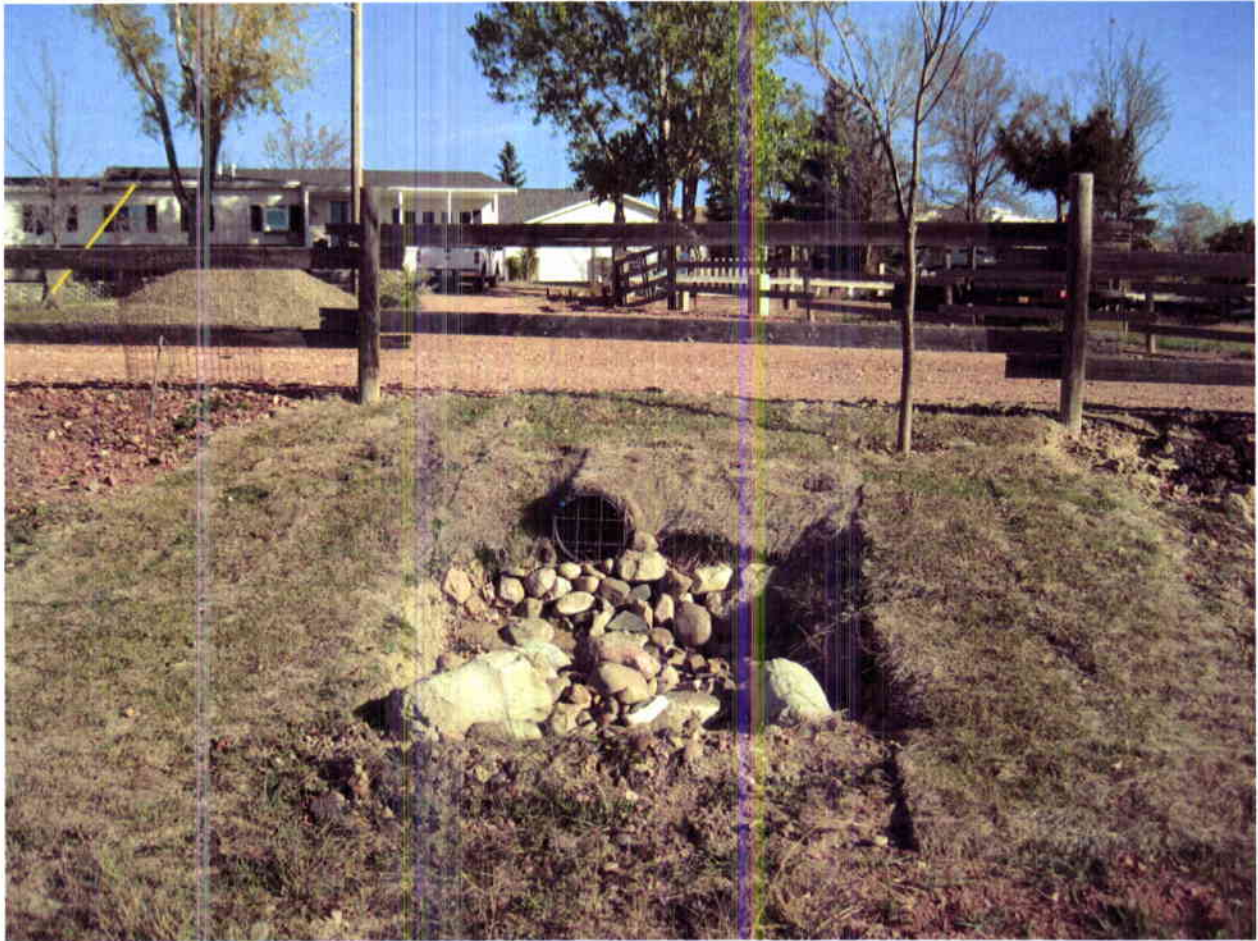
*New storm water drainage culvert after installation*

The final phase of work for the project included the installation of a storm water culvert in front of the Gardner residence. It was determined that the subsidence features near the residence predominately develop during rainy seasons. Therefore, the culvert was installed to divert storm water away from the residence in an attempt to prevent future subsidence features from developing near the residence. The work was completed in August 2010 by John Wyman of Williston North Dakota at a cost of \$3841.06.

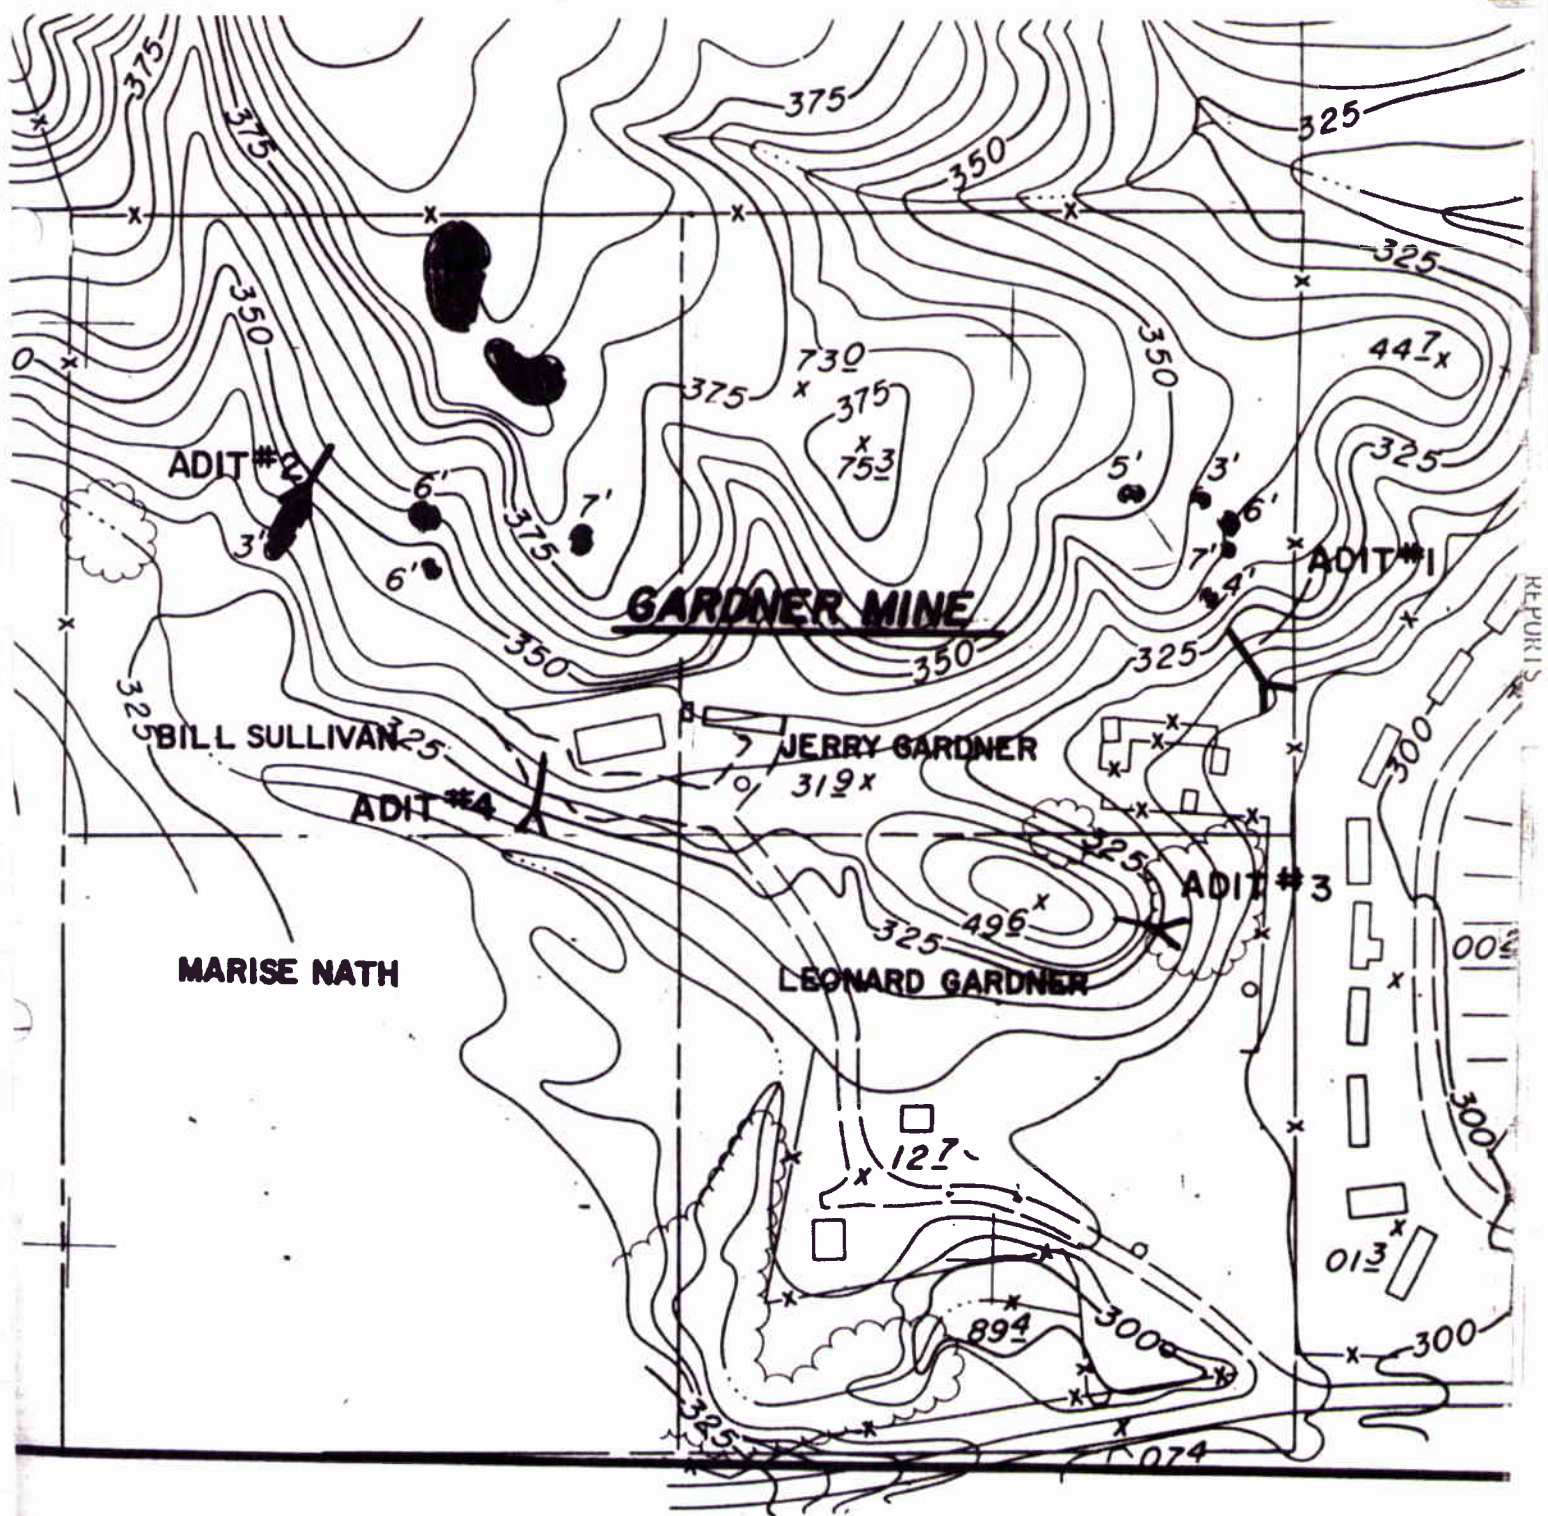
**Figure 2**  
**Collapsed Adit Location Map**

Grout  
barrier  
walls

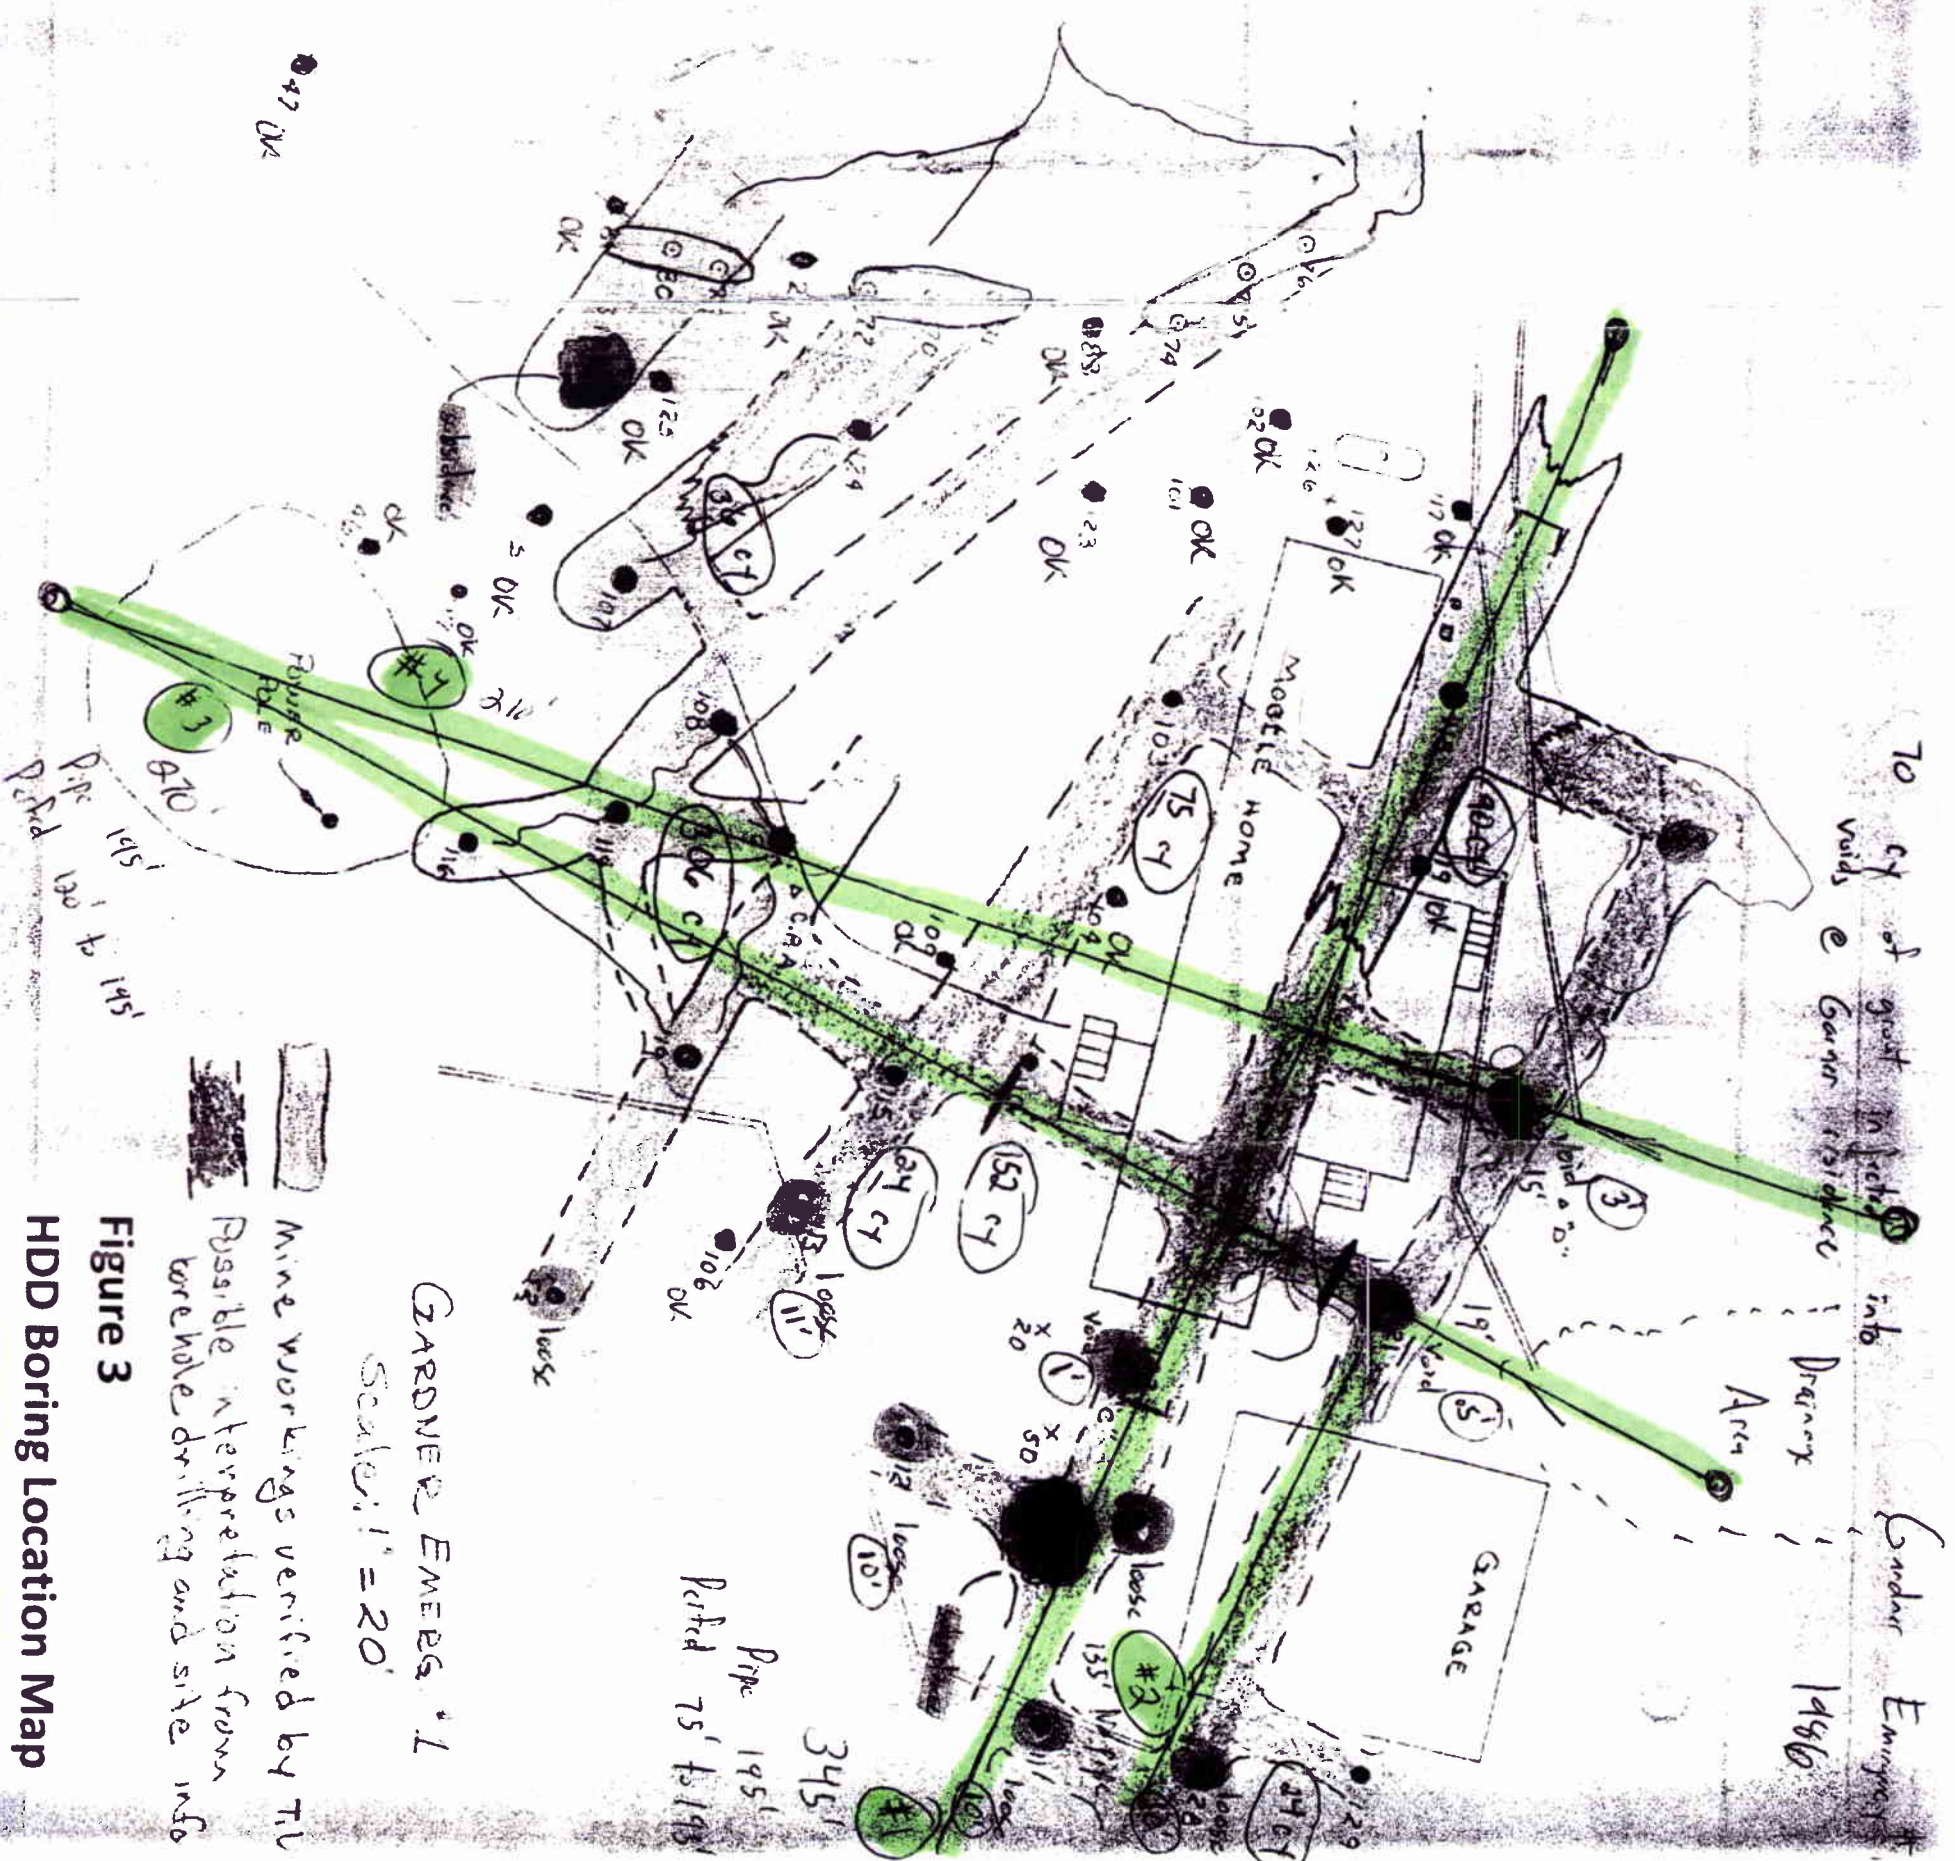
Figure 3

Verbally Jerry Gardner indicated that during pad construction for his home, a bulldozer dropped into a subsidence feature. He also indicated that to stabilize this feature, portions of the old Fairview School were backfilled into the void. This would explain the rubble zone identified during the horizontal/directional drilling.

- Mine workings verified by TL
- Possible interpretation from borehole drilling and site info
