McLaren Tailings Reclamation

Project Status

July 21, 2011

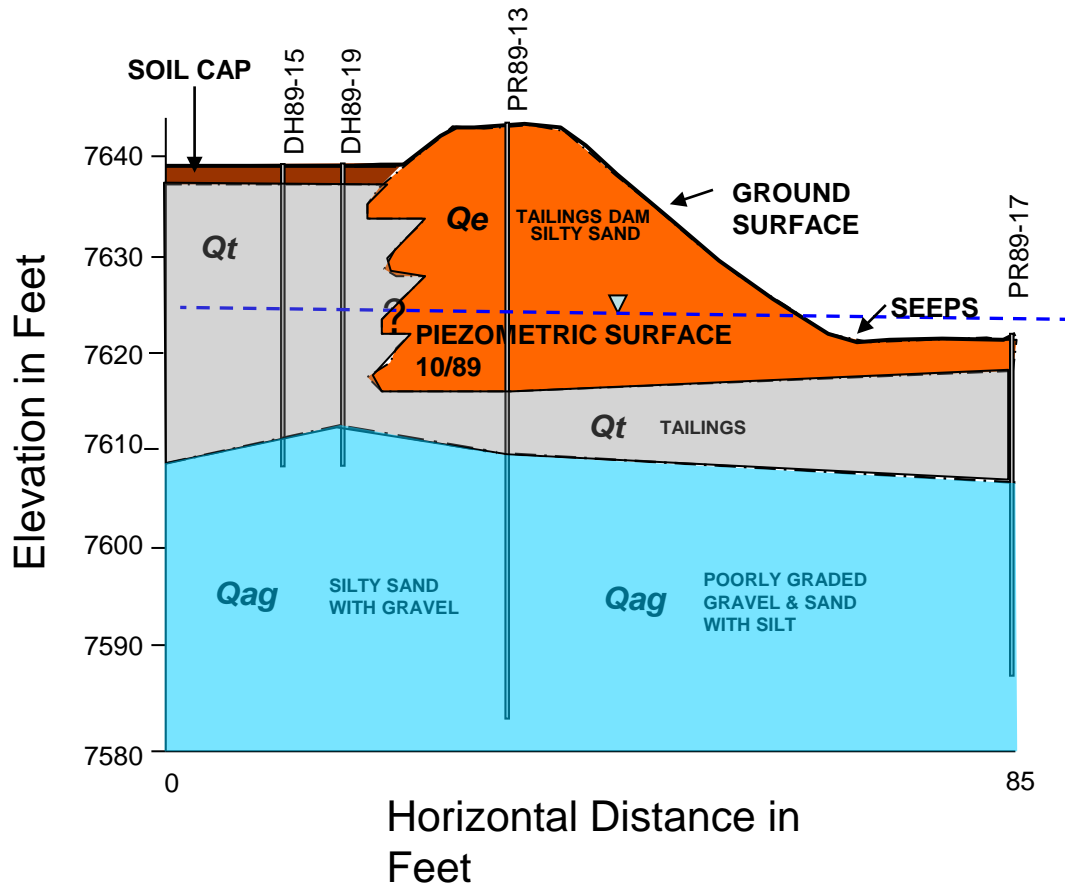
Tailings Dam Stability Cross-section View

Previous Assessment
Marginal static stability;
material under dam highly
susceptible to liquefaction.

Total flow from seeps
approx. 40 gpm from 5
seeps in September 2008

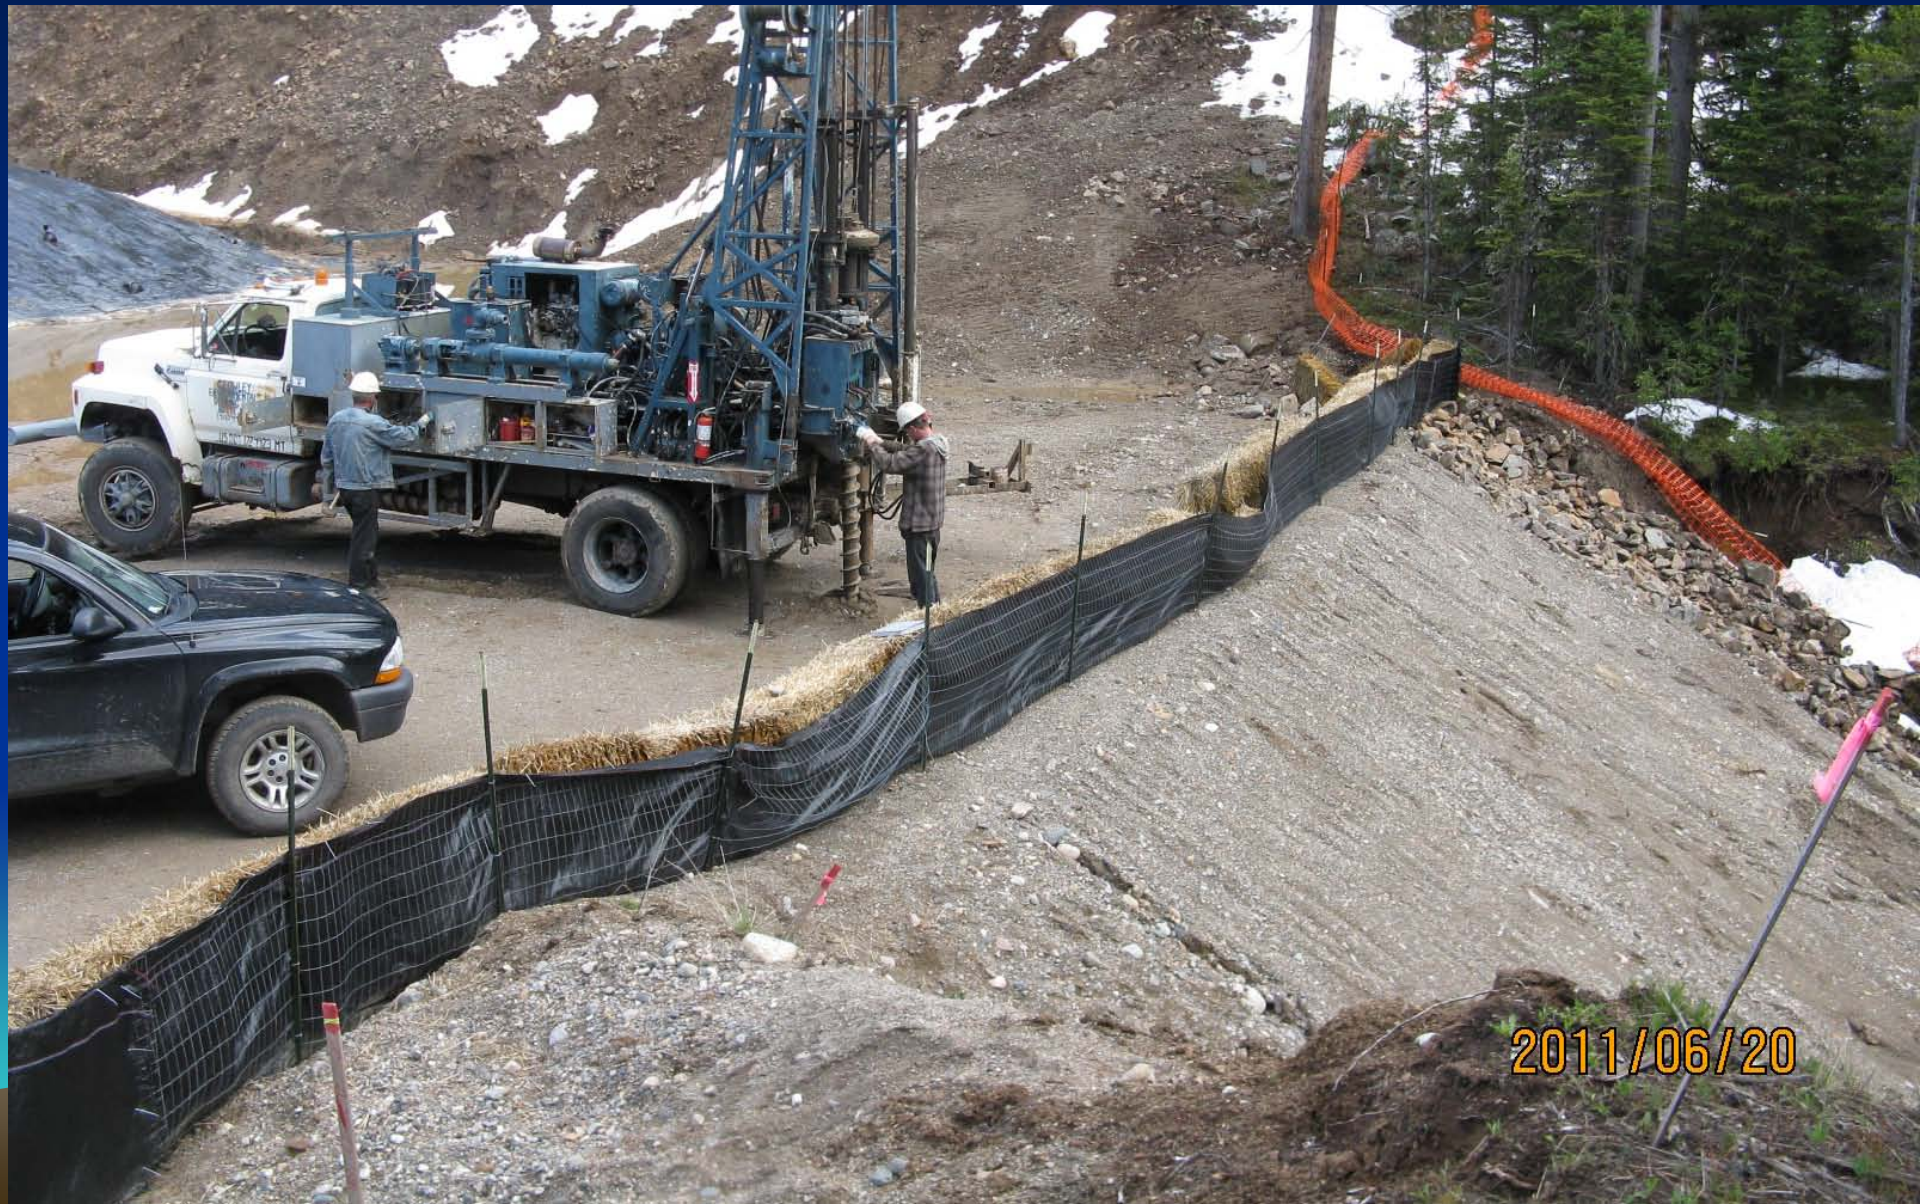
New Piezometer PZ-8

- New piezometers indicate adequate separation to groundwater under expanded repository
- Significant improvements in mixing lime into tailings have occurred in 2011
- Stabilization and compaction of tailings in repository have been successful
- Project currently on schedule / ahead of schedule
