MDEQ-AML  
McLaren Tailings  
photo 1/18

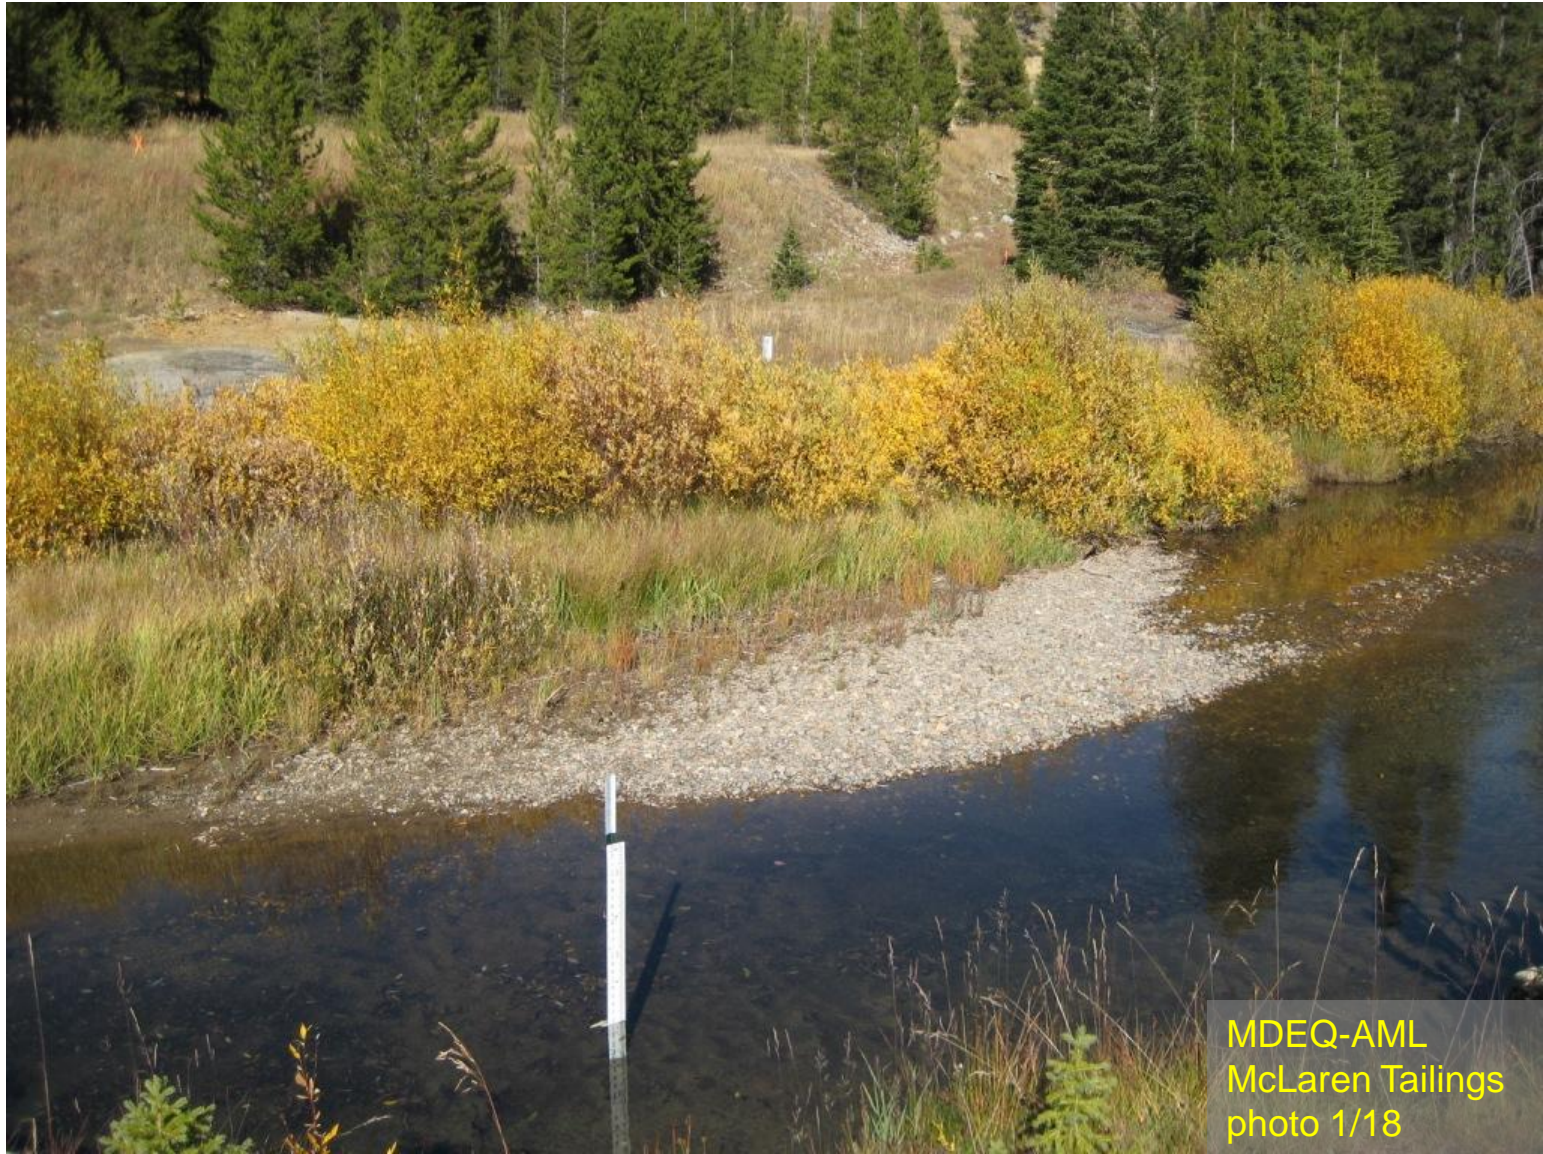
Soda Butte Creek upstream of McLaren Tailings  
September 30, 2008

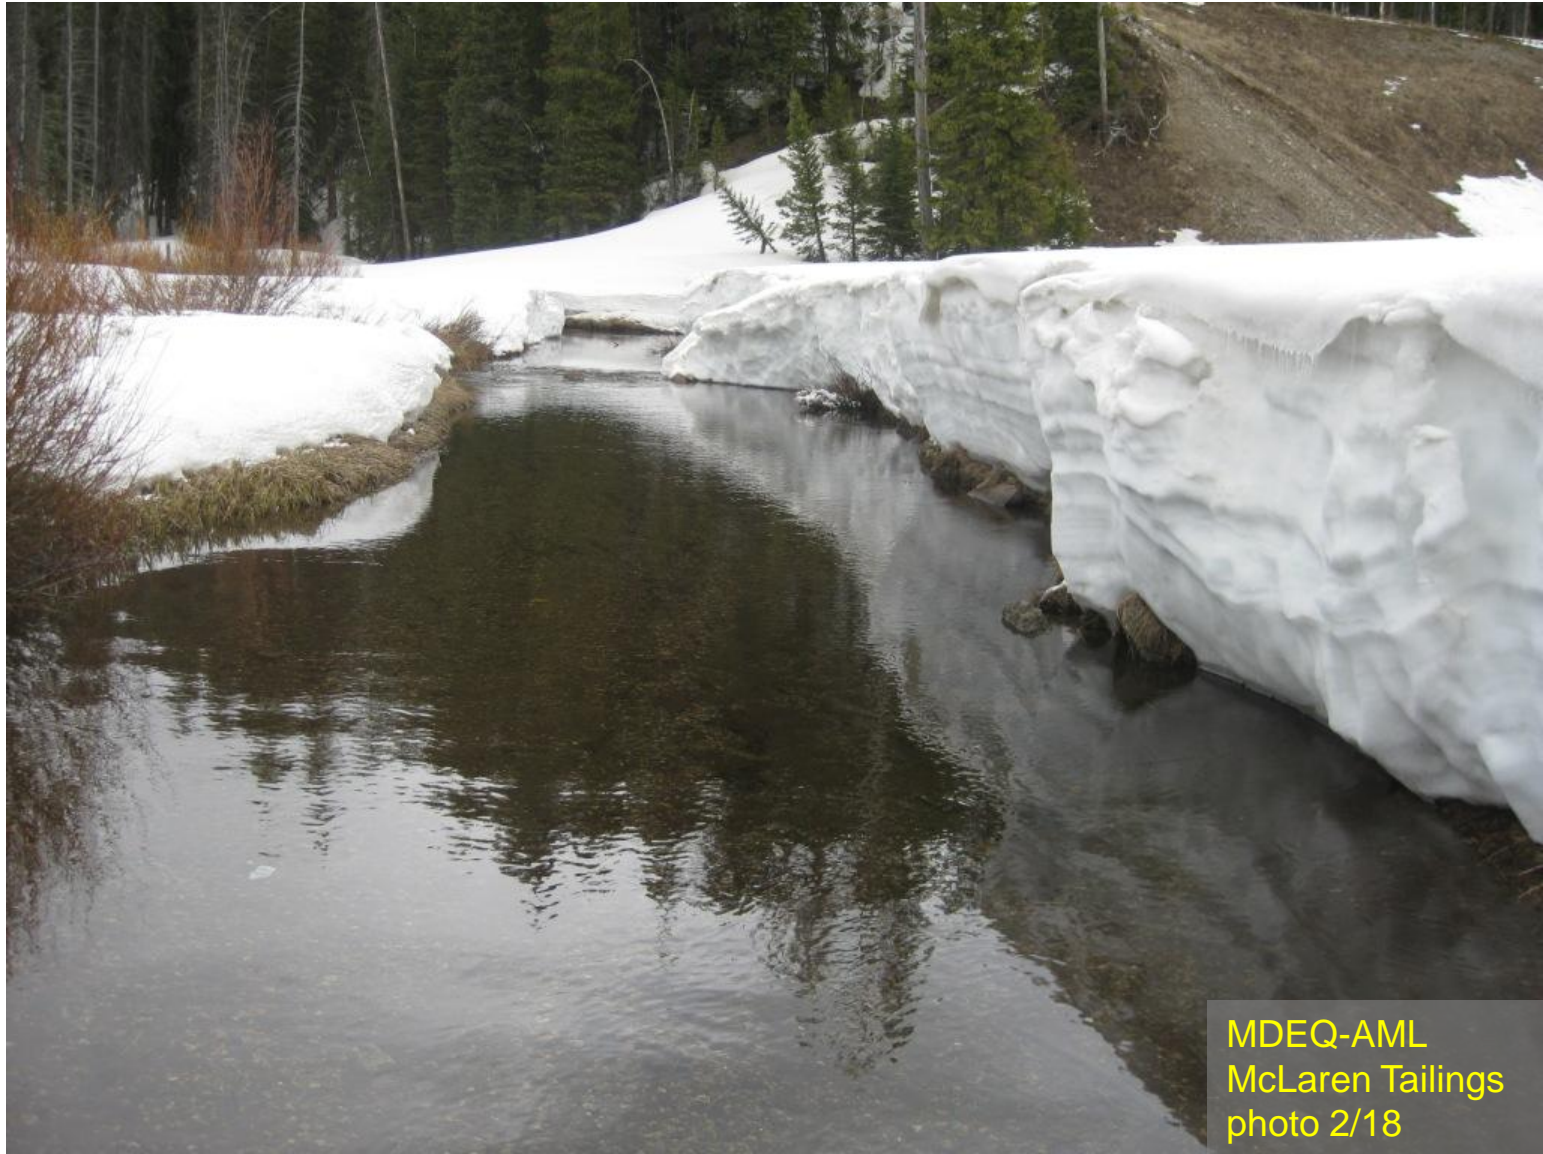
MDEQ-AML  
McLaren Tailings  
photo 2/18

Soda Butte Creek upstream of McLaren Tailings  
May 14, 2009

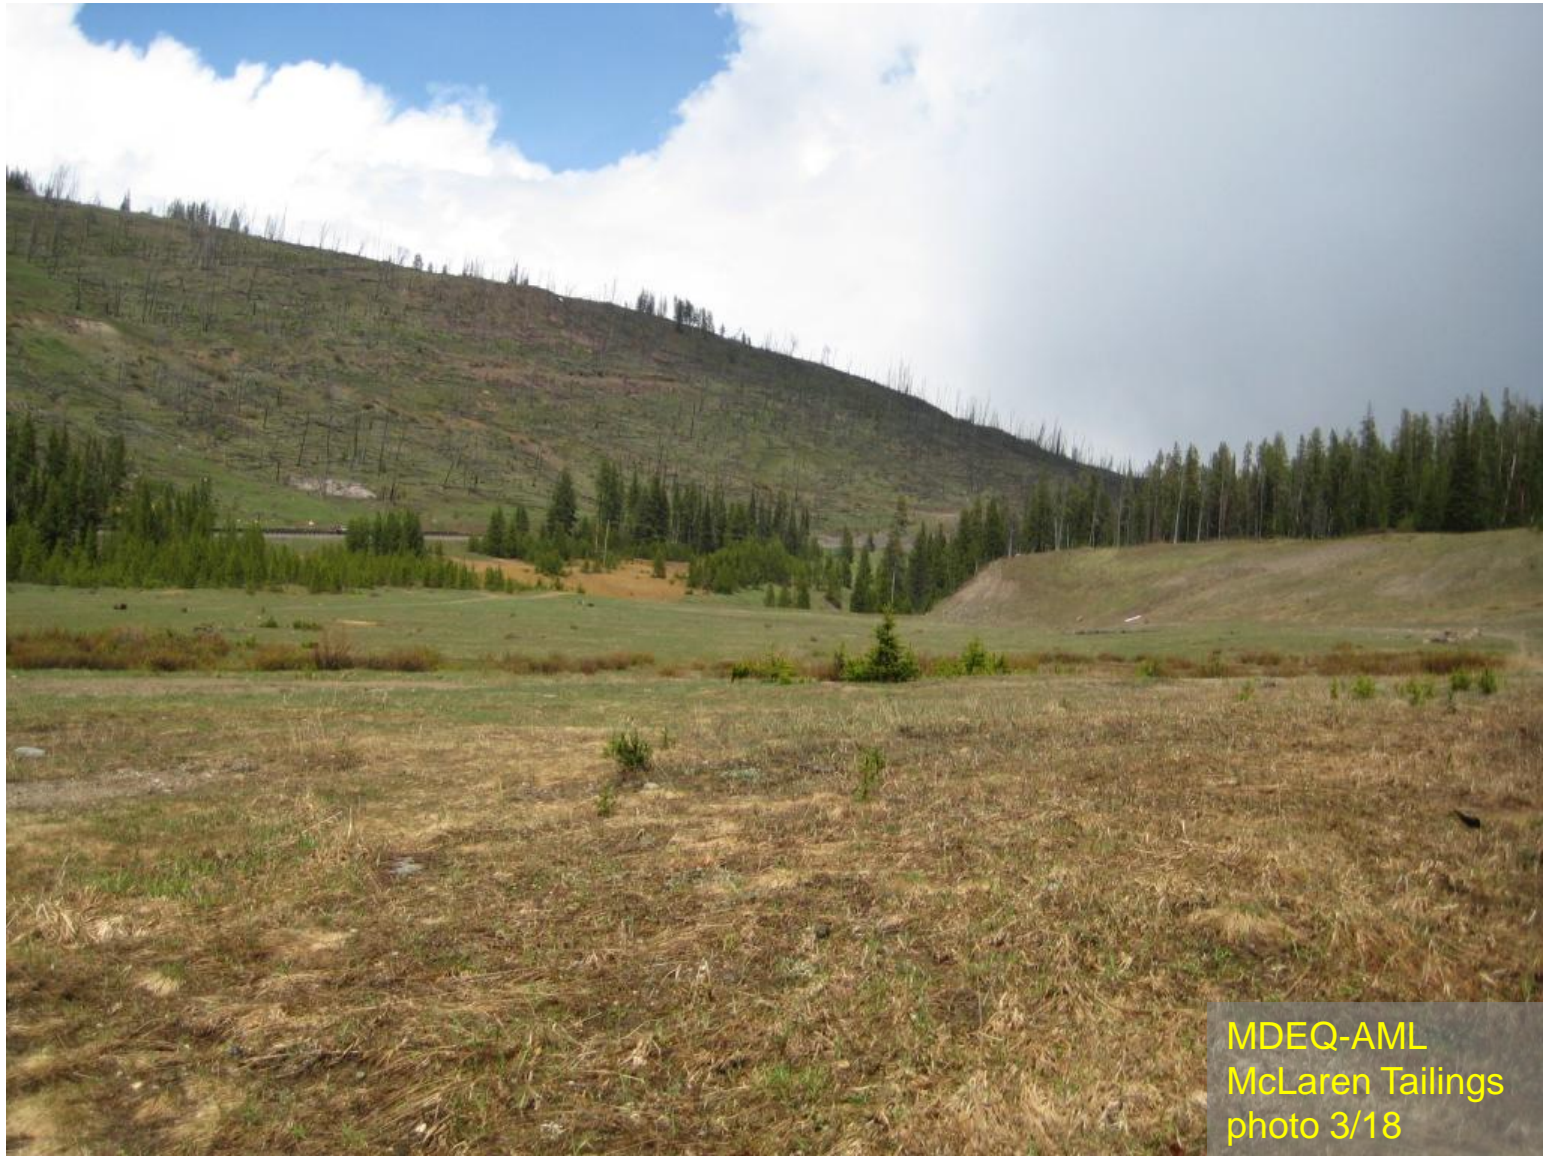
MDEQ-AML  
McLaren Tailings  
photo 3/18

Existing soil cap over tailings impoundment  
June 19, 2008

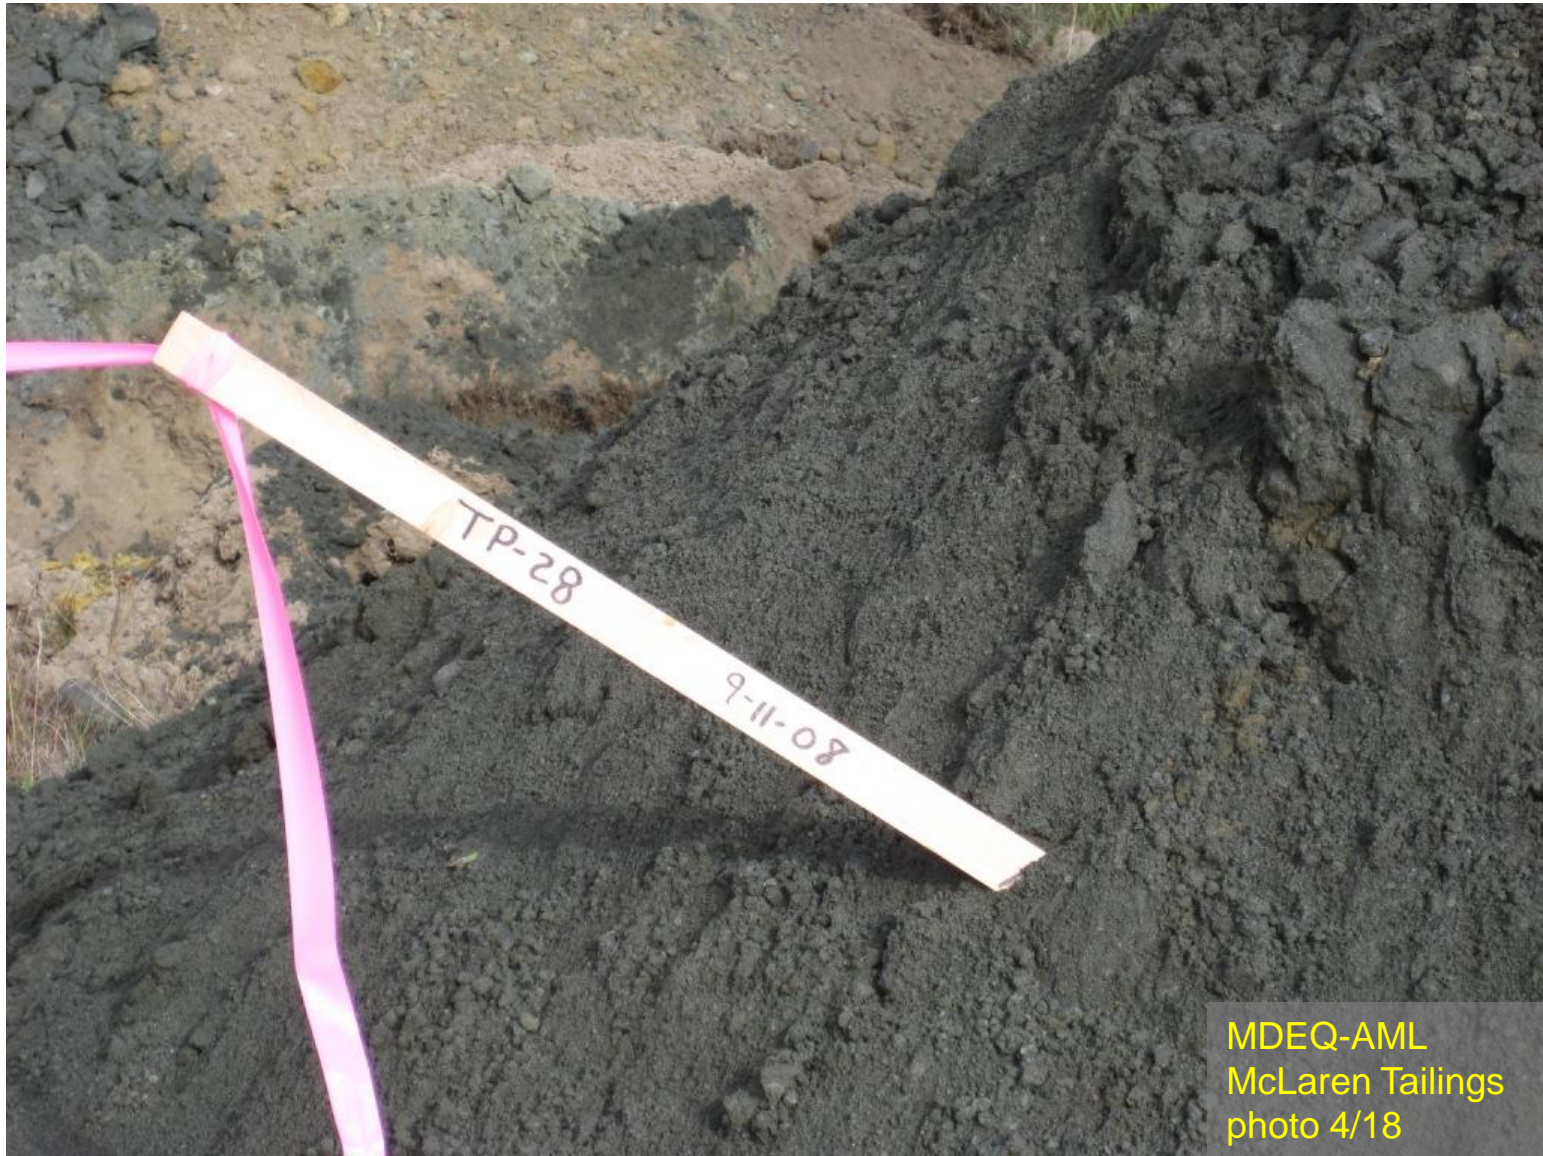
MDEQ-AML  
McLaren Tailings  
photo 4/18

Excavated tailings for characterization  
September 11, 2008

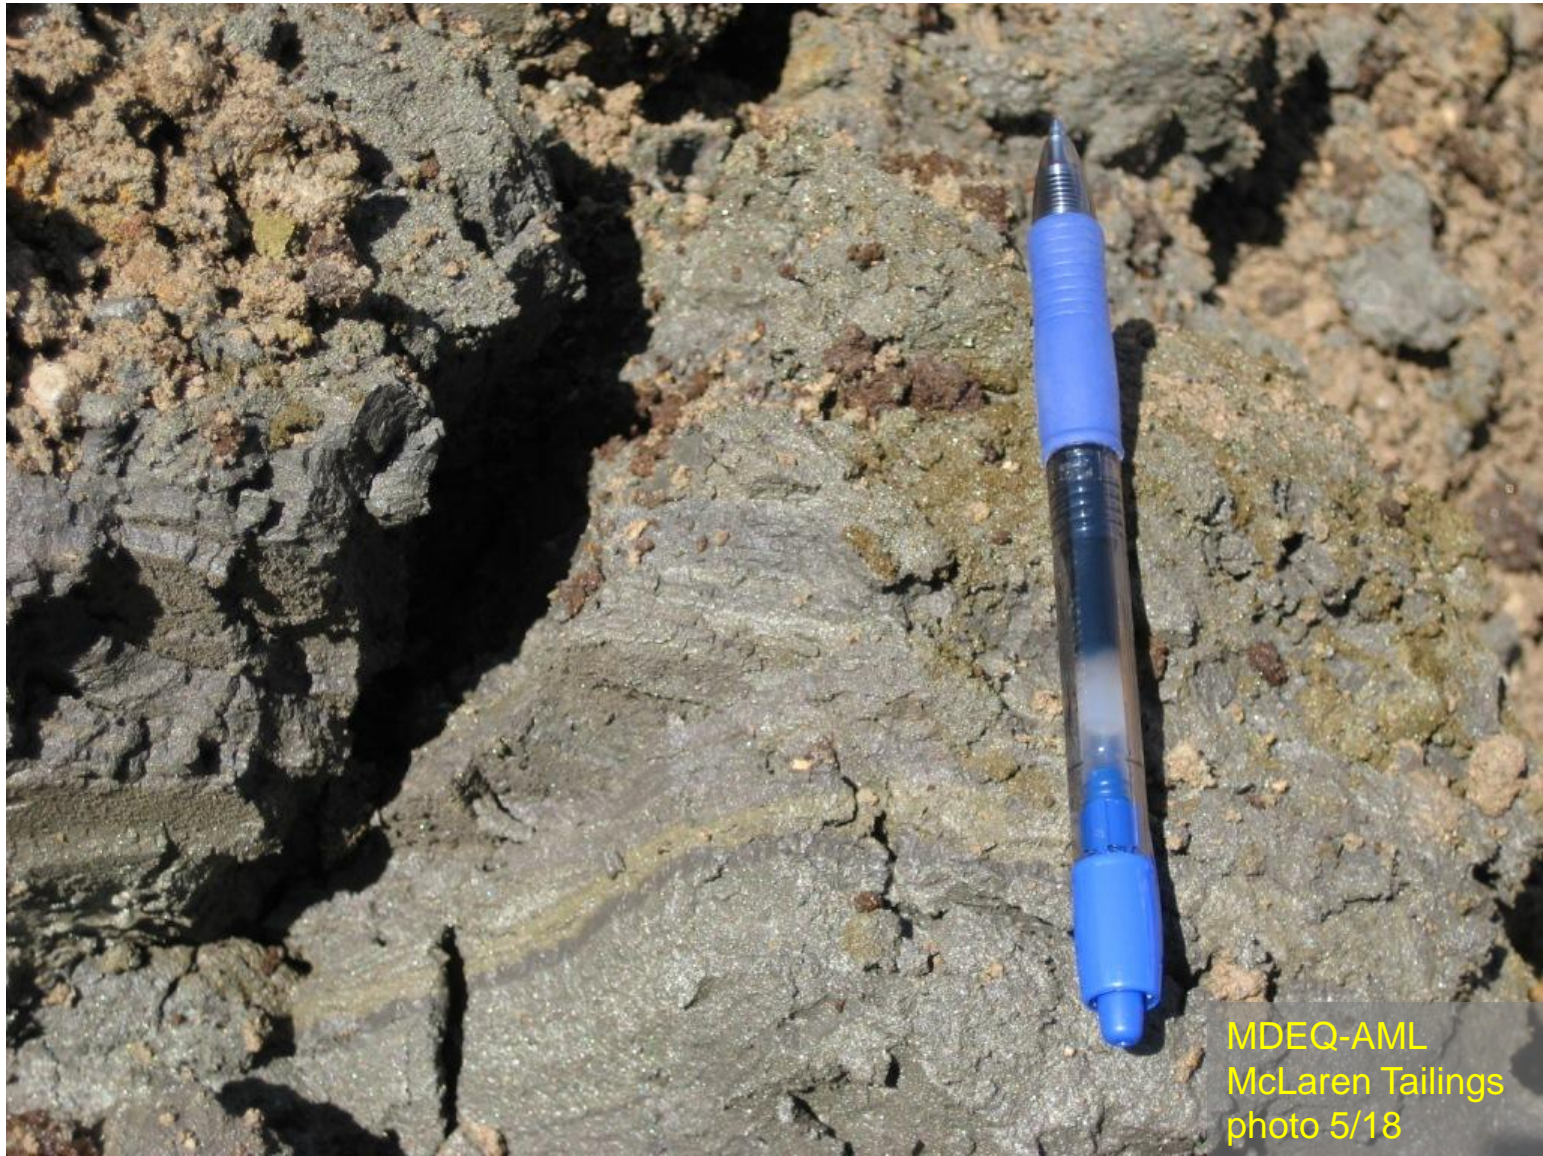
MDEQ-AML  
McLaren Tailings  
photo 5/18

Excavated tailings for characterization  
September 11, 2008

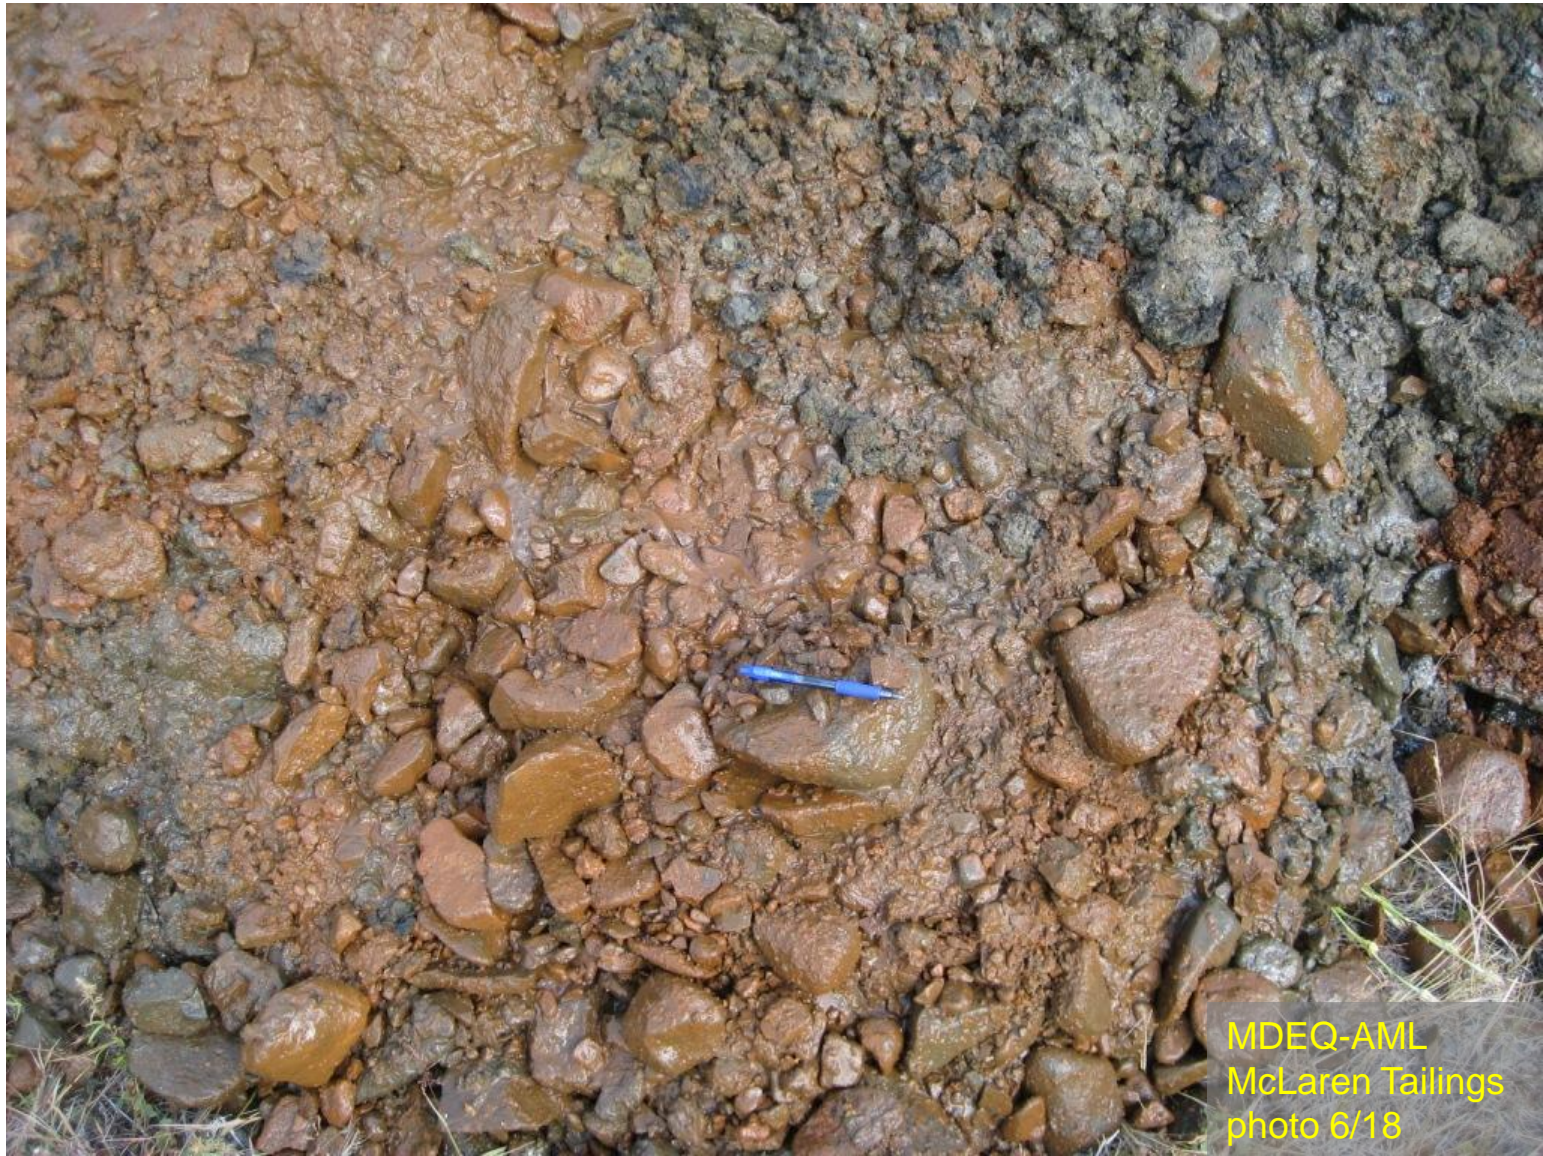
MDEQ-AML  
McLaren Tailings  
photo 6/18

Iron stained alluvial sediments underlying tailings  
September 11, 2008

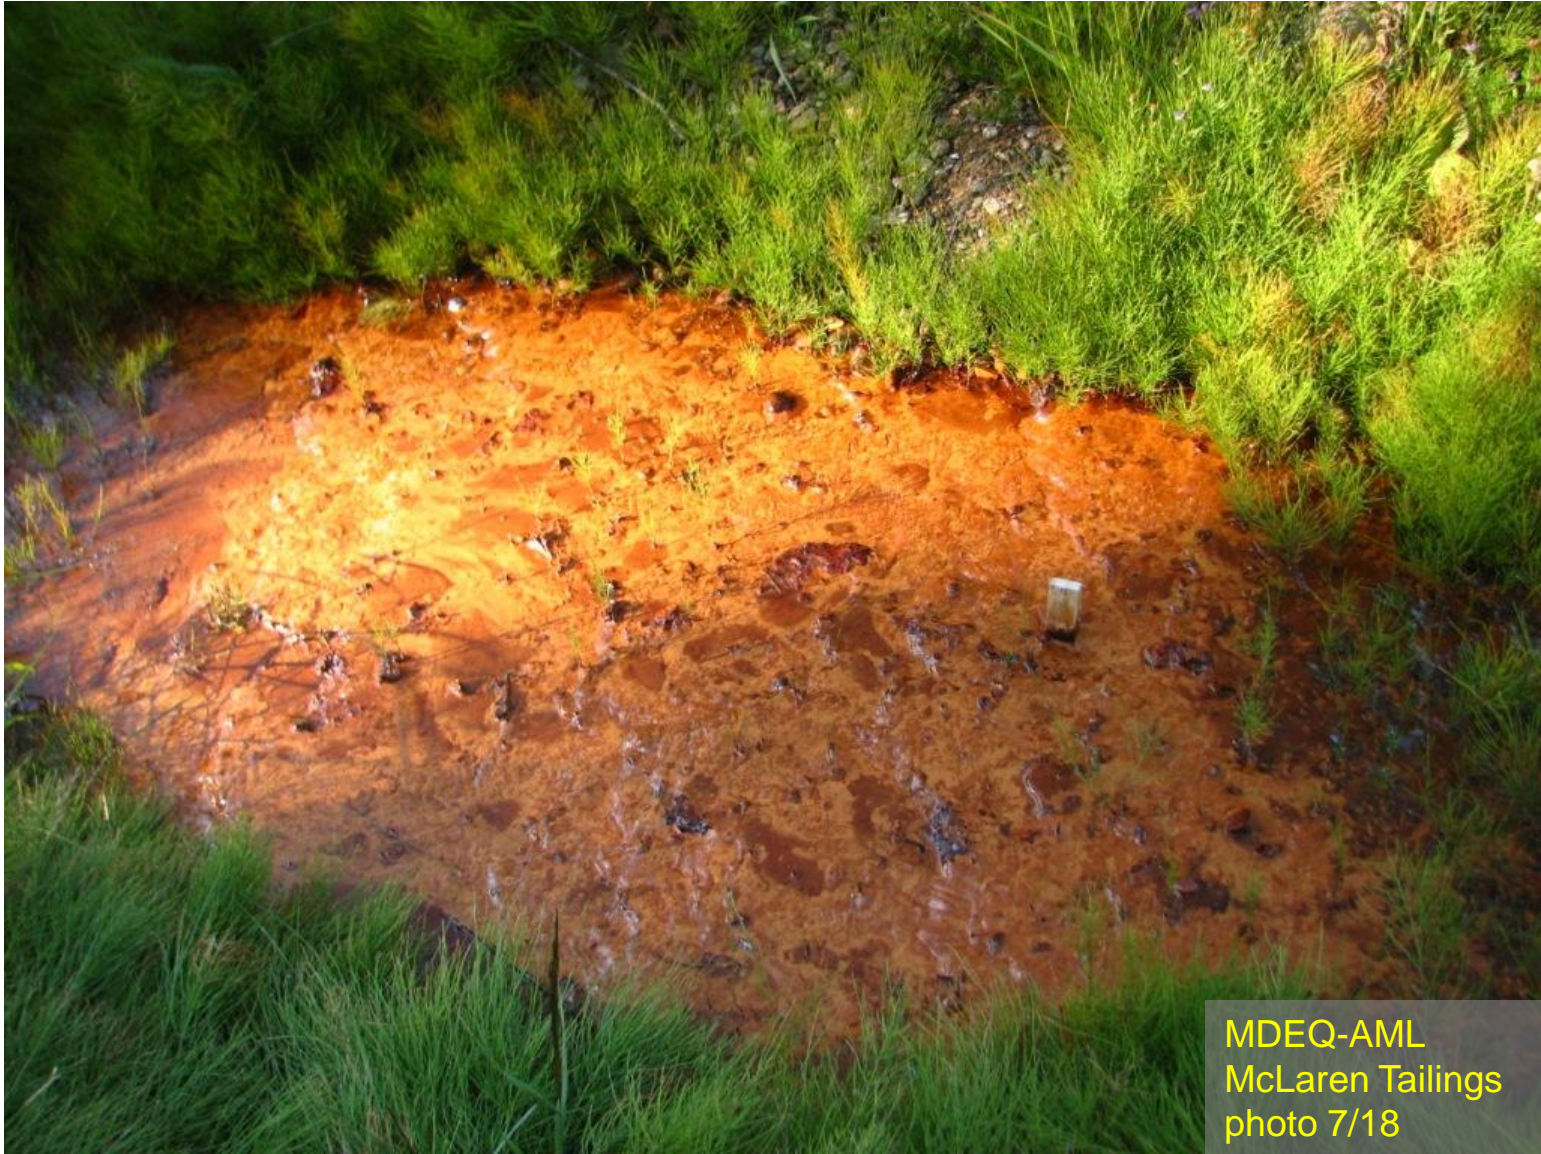
MDEQ-AML  
McLaren Tailings  
photo 7/18

Seep discharging below tailings dam  
September 8, 2008

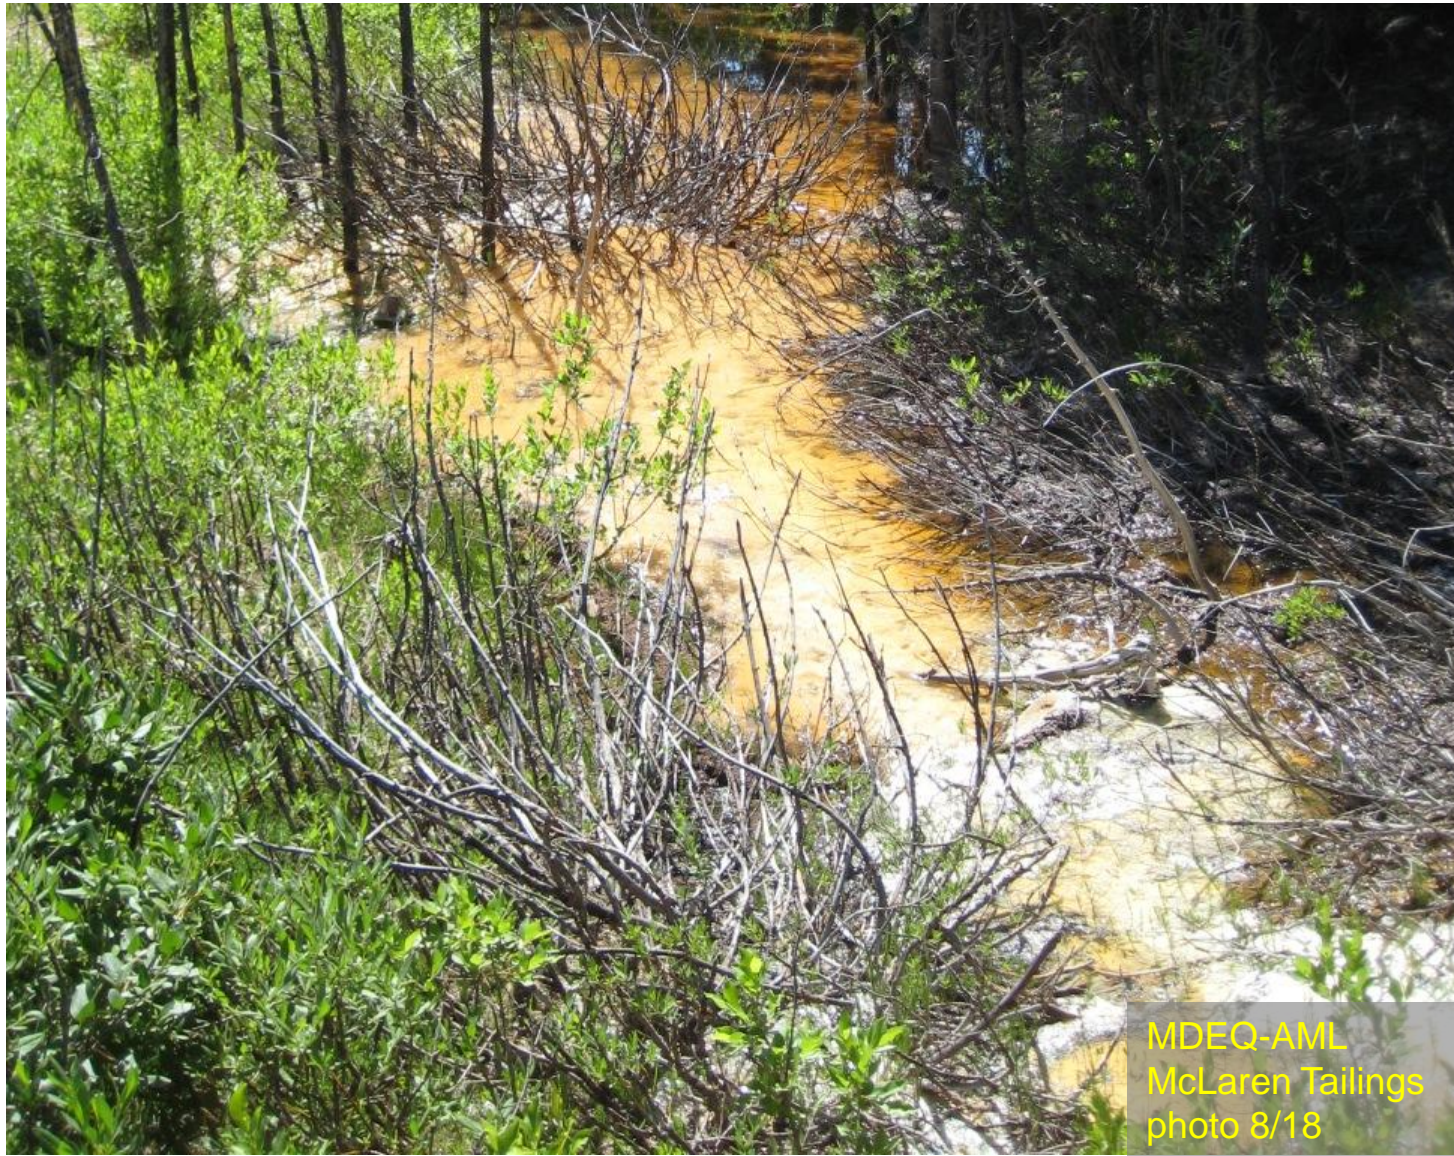
MDEQ-AML  
McLaren Tailings  
photo 8/18

Acid mine drainage discharging from north end of tailings dam  
July 10, 2008

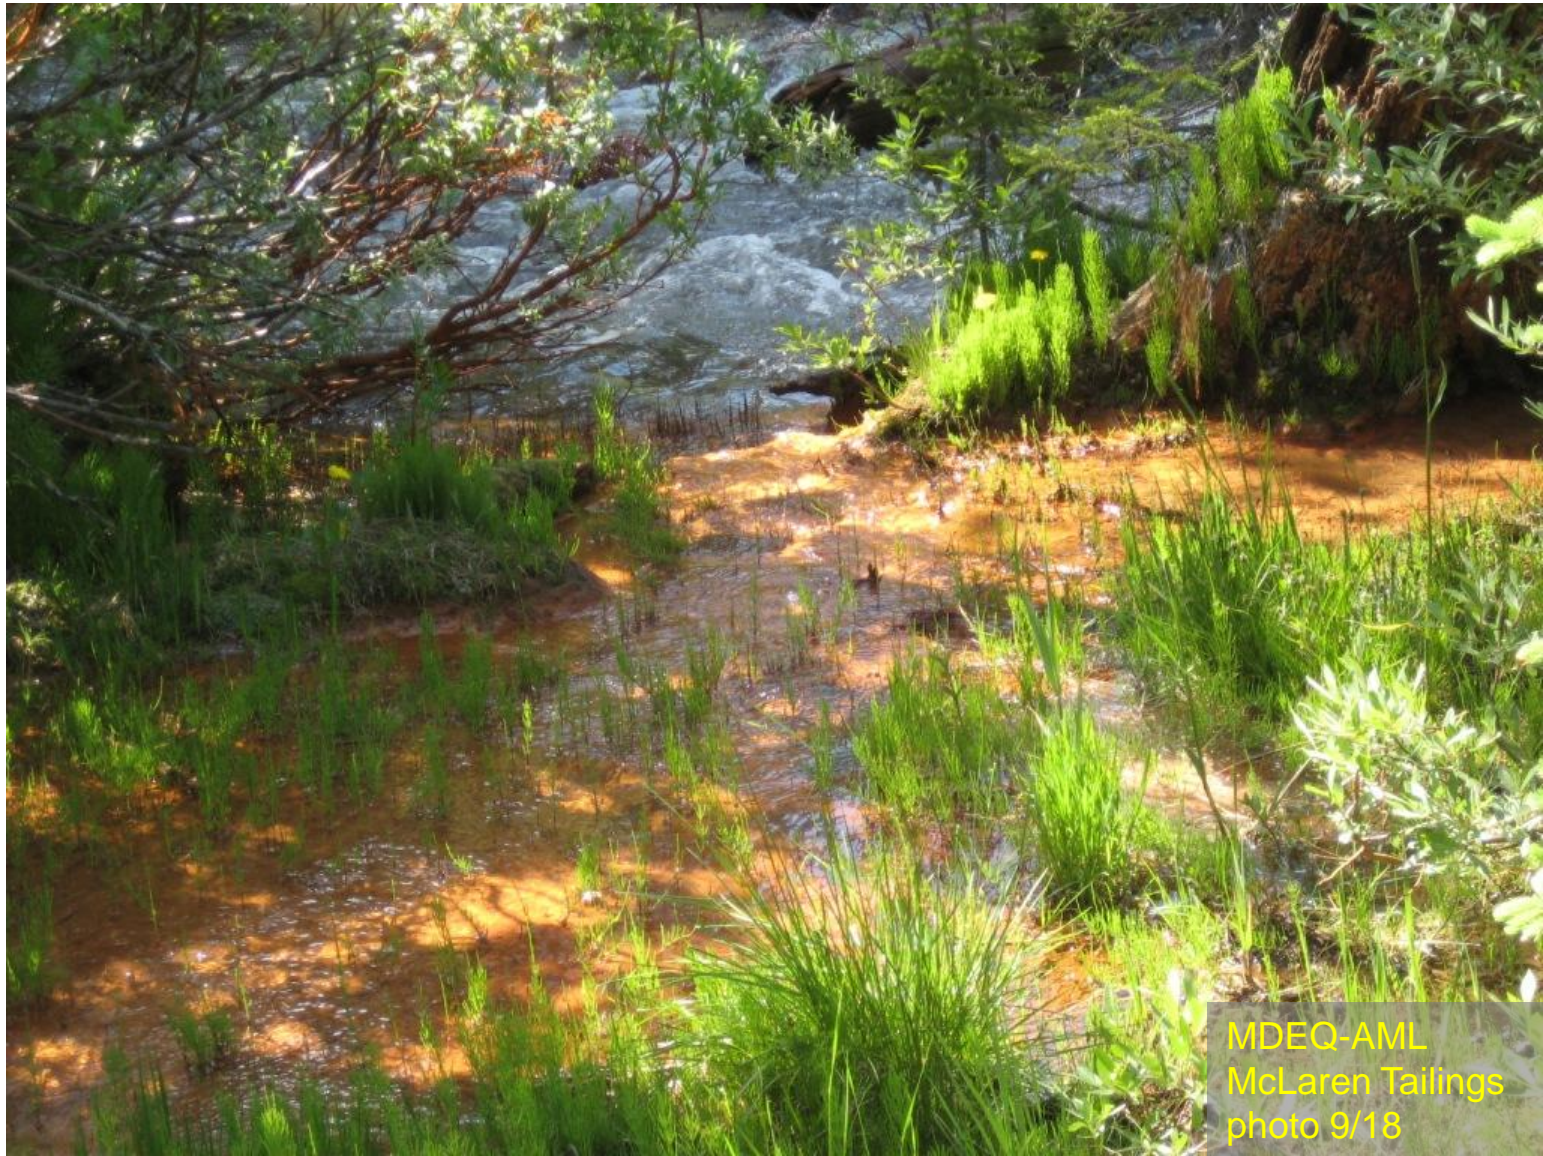
MDEQ-AML  
McLaren Tailings  
photo 9/18

Acid mine drainage discharging to Soda Butte Creek  
July 10, 2008

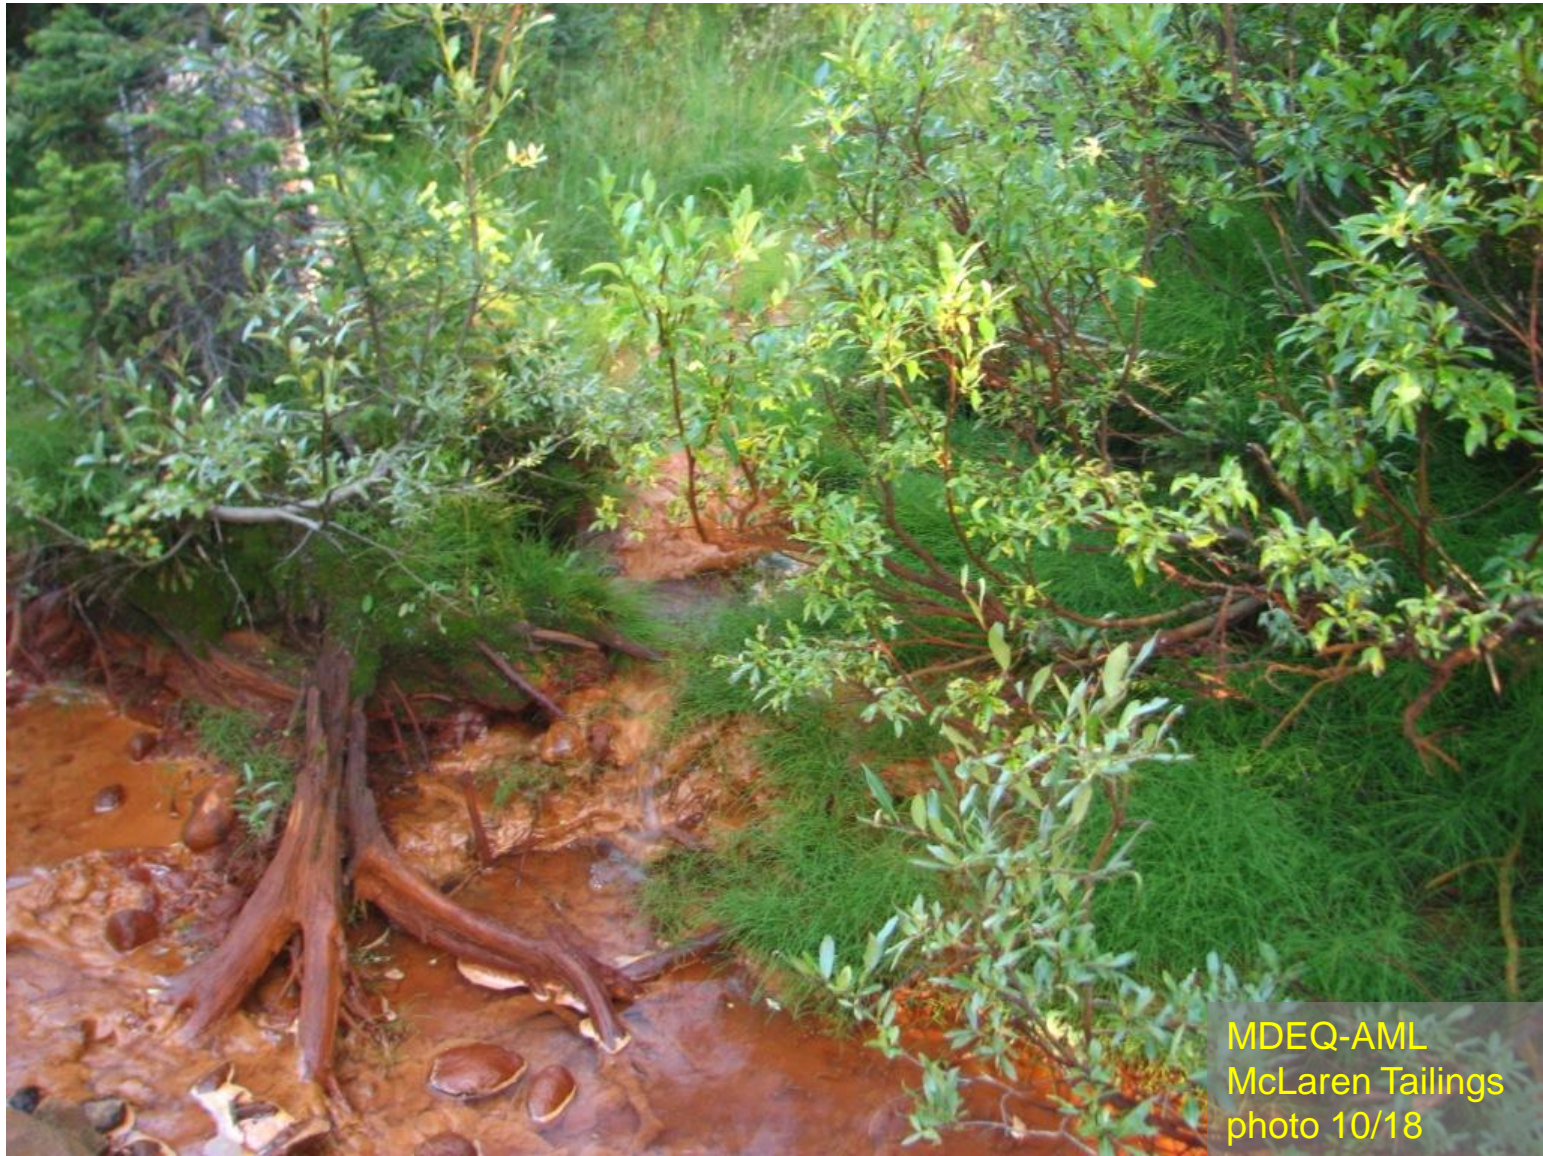
MDEQ-AML  
McLaren Tailings  
photo 10/18

Acid mine drainage discharging to Soda Butte Creek  
September 8, 2008

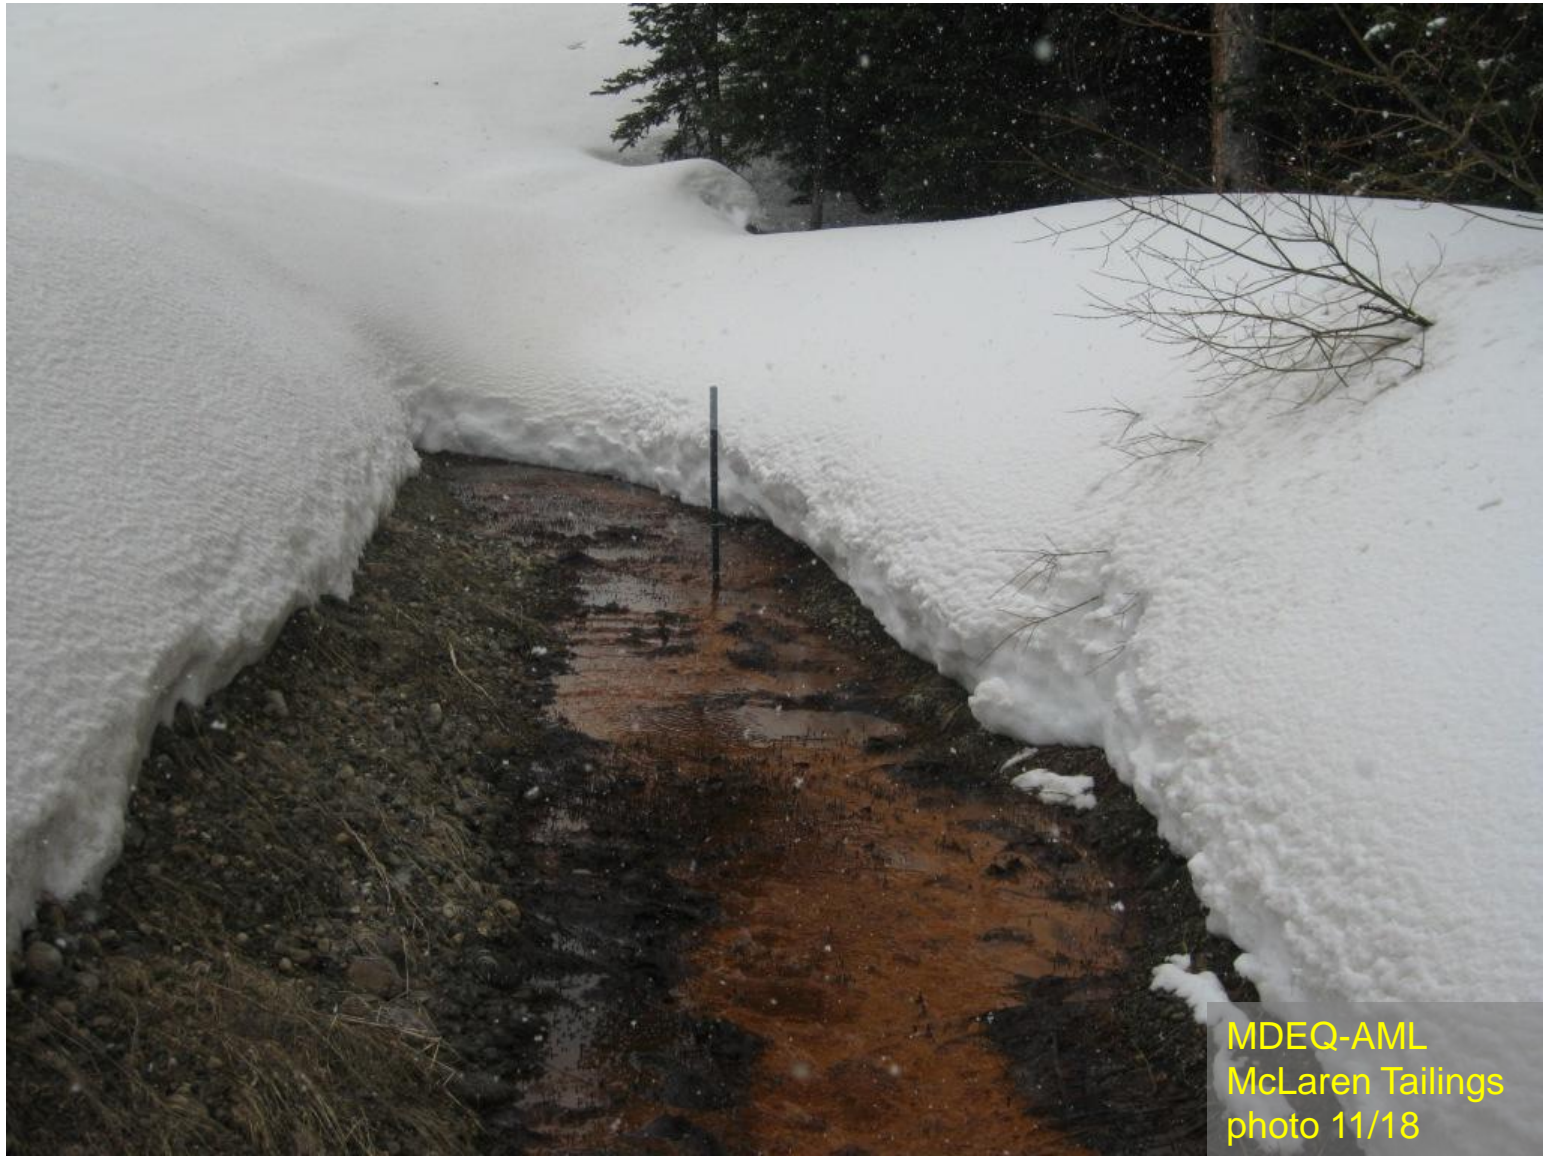
MDEQ-AML  
McLaren Tailings  
photo 11/18

Acid mine drainage discharging from south end of tailings dam  
May 14, 2009

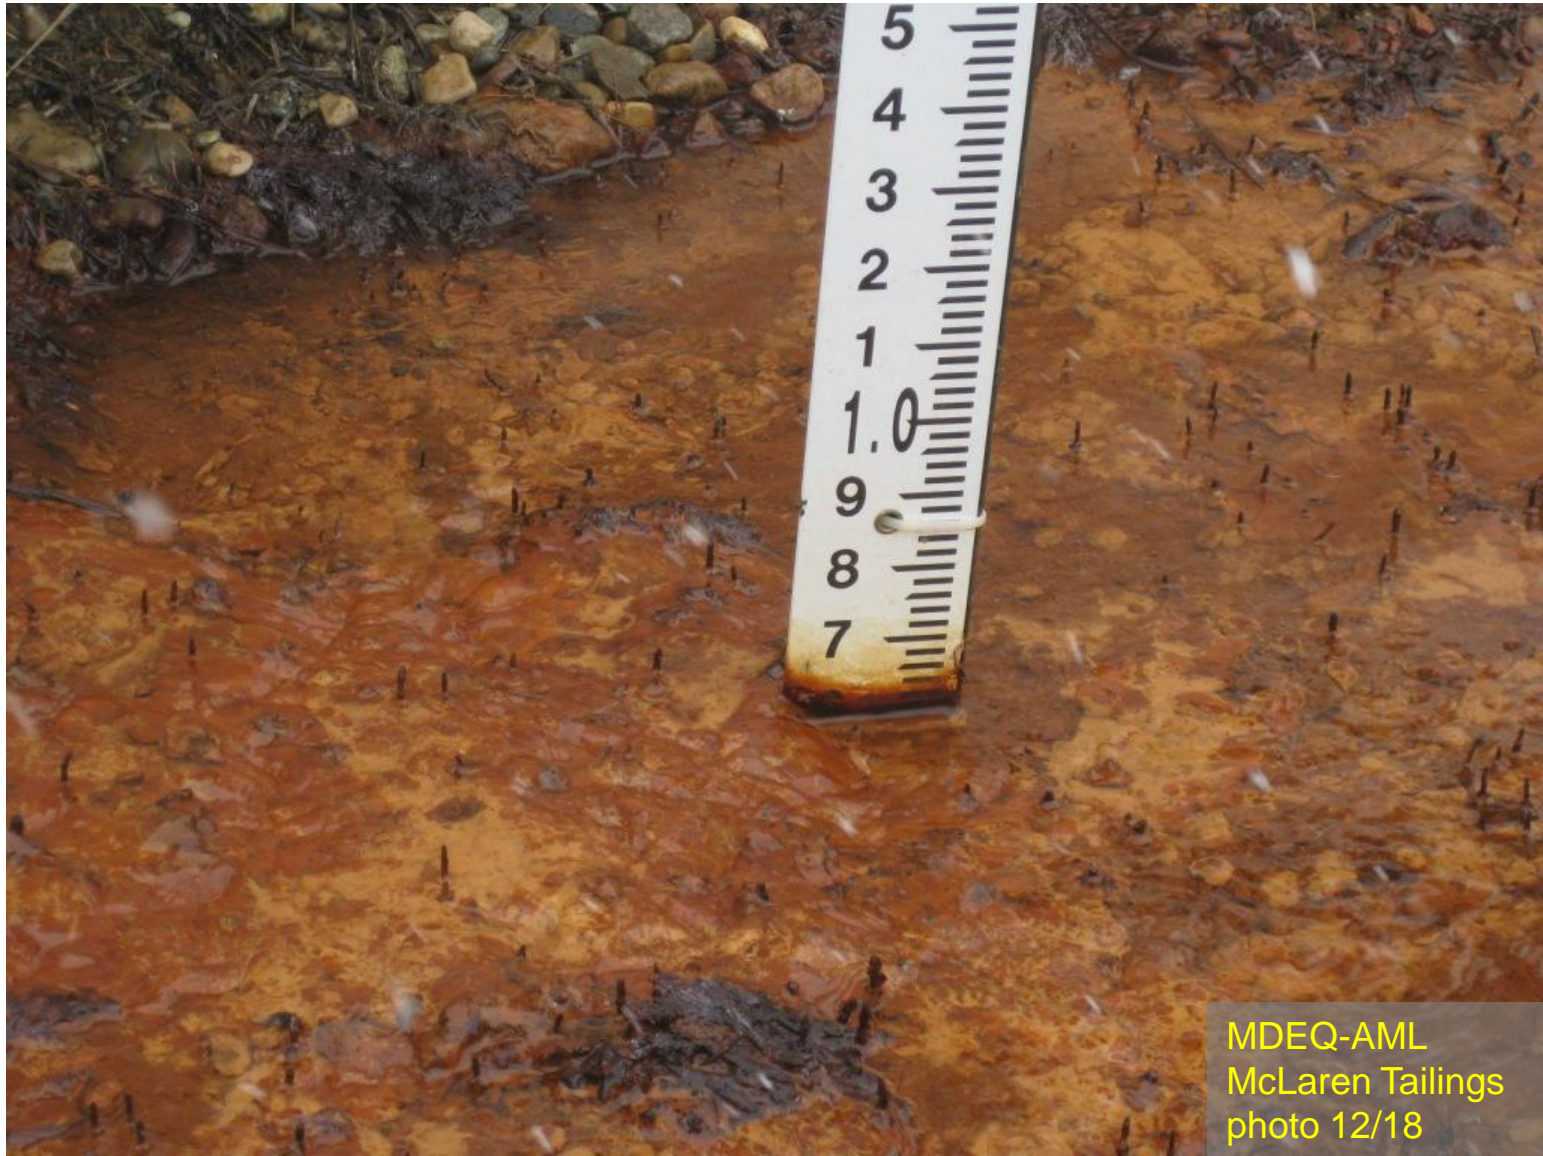
MDEQ-AML  
McLaren Tailings  
photo 12/18

Acid mine drainage discharging from south end of tailings dam  
May 14, 2009

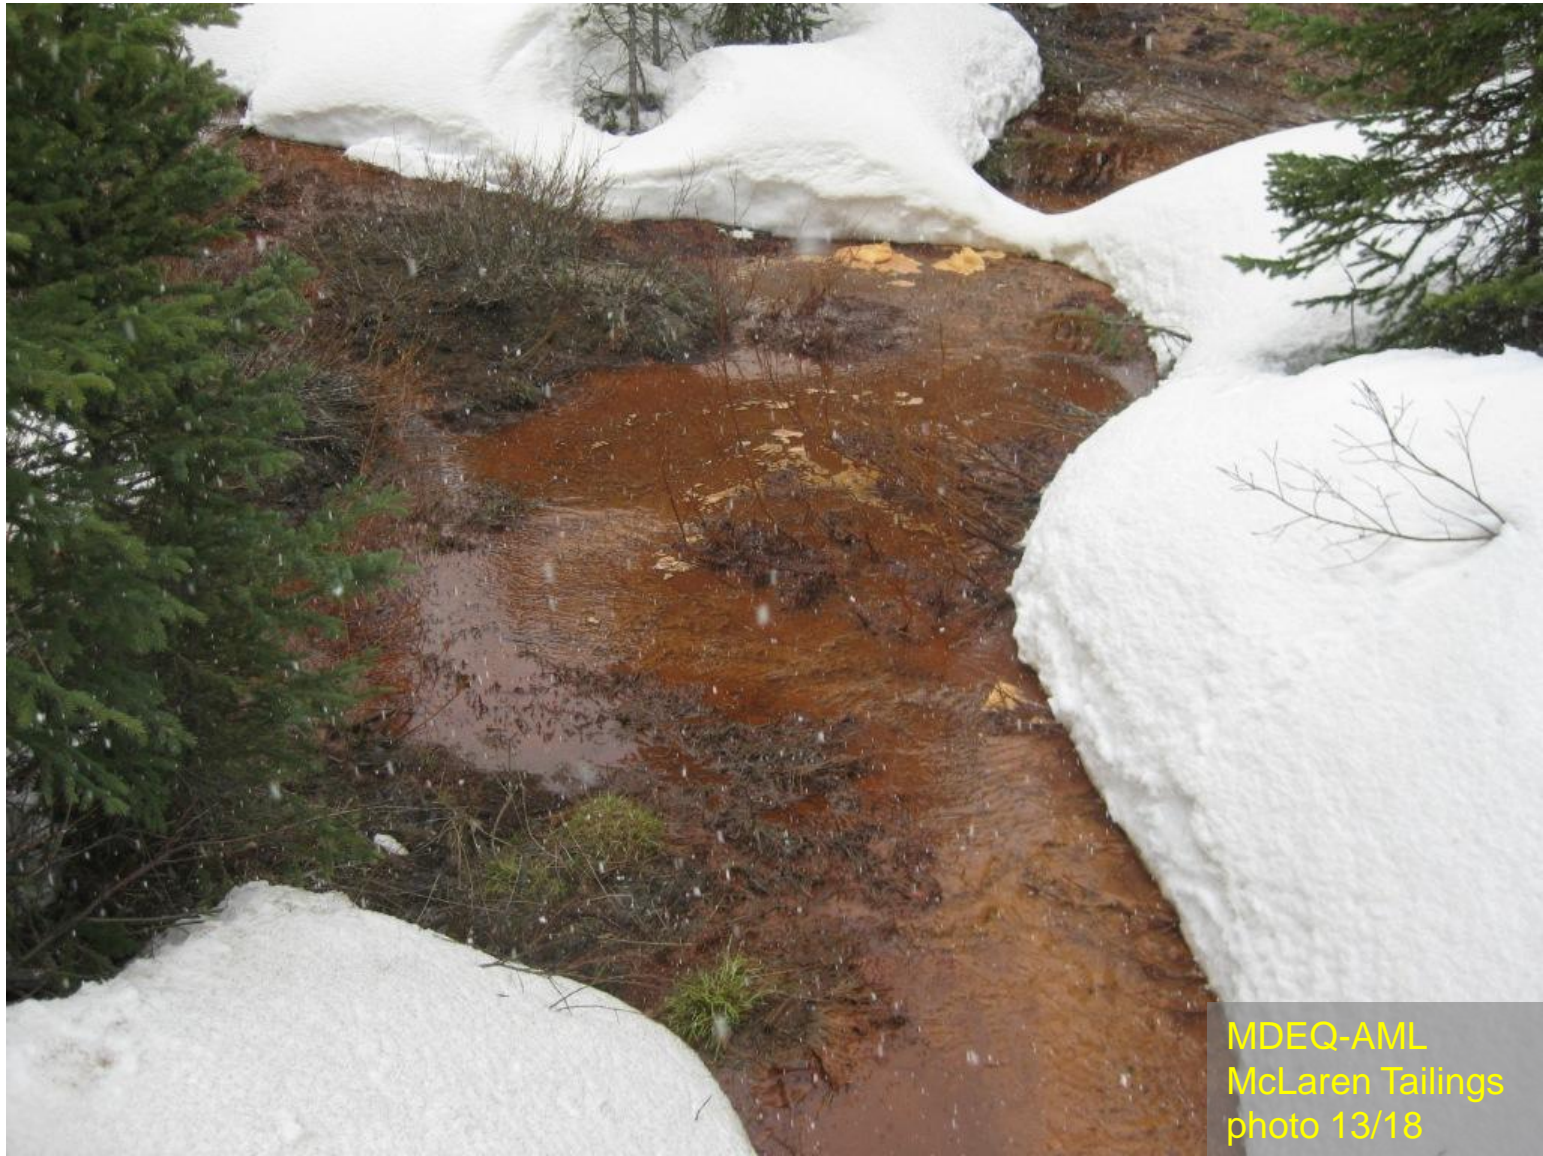
MDEQ-AML  
McLaren Tailings  
photo 13/18

Acid Mine Drainage discharging from McLaren Tailings  
May 14, 2009
