MDEQ-AML  
McLaren Tailings  
photo 1/18

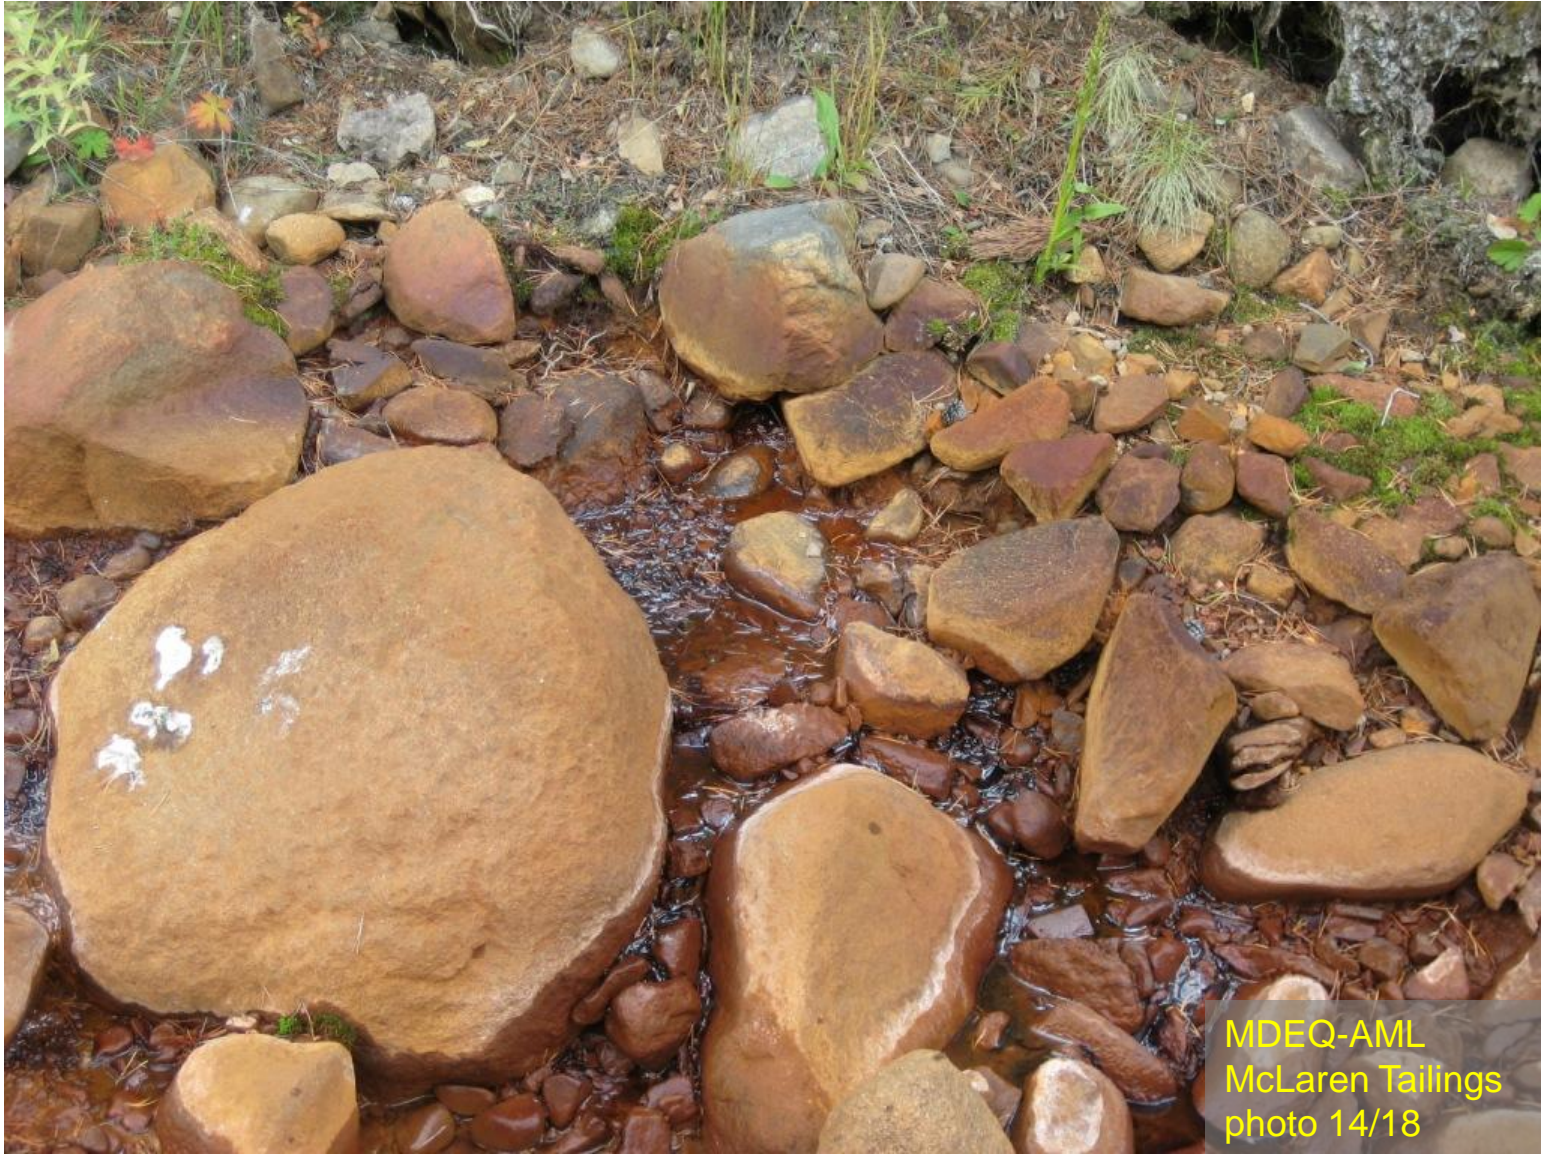
MDEQ-AML  
McLaren Tailings  
photo 14/18

Seep discharging to Soda Butte Creek  
September 18, 2008

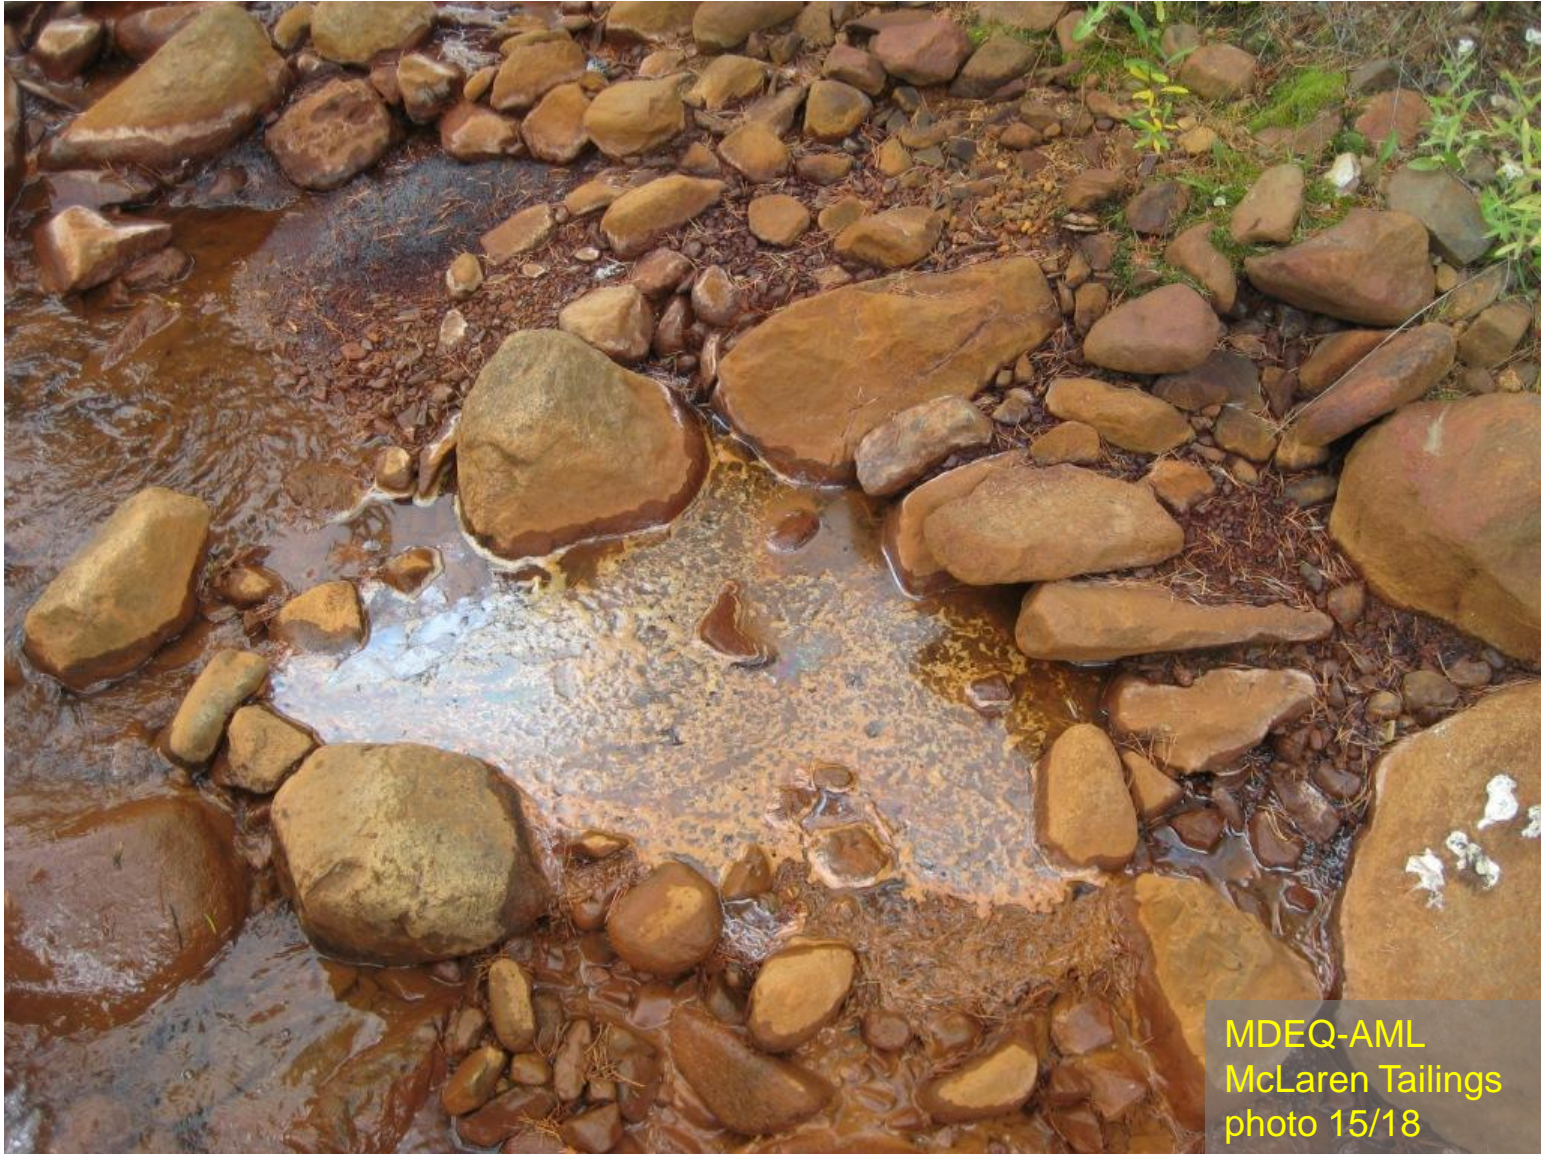
MDEQ-AML  
McLaren Tailings  
photo 15/18

Seep discharging to Soda Butte Creek  
September 18, 2008

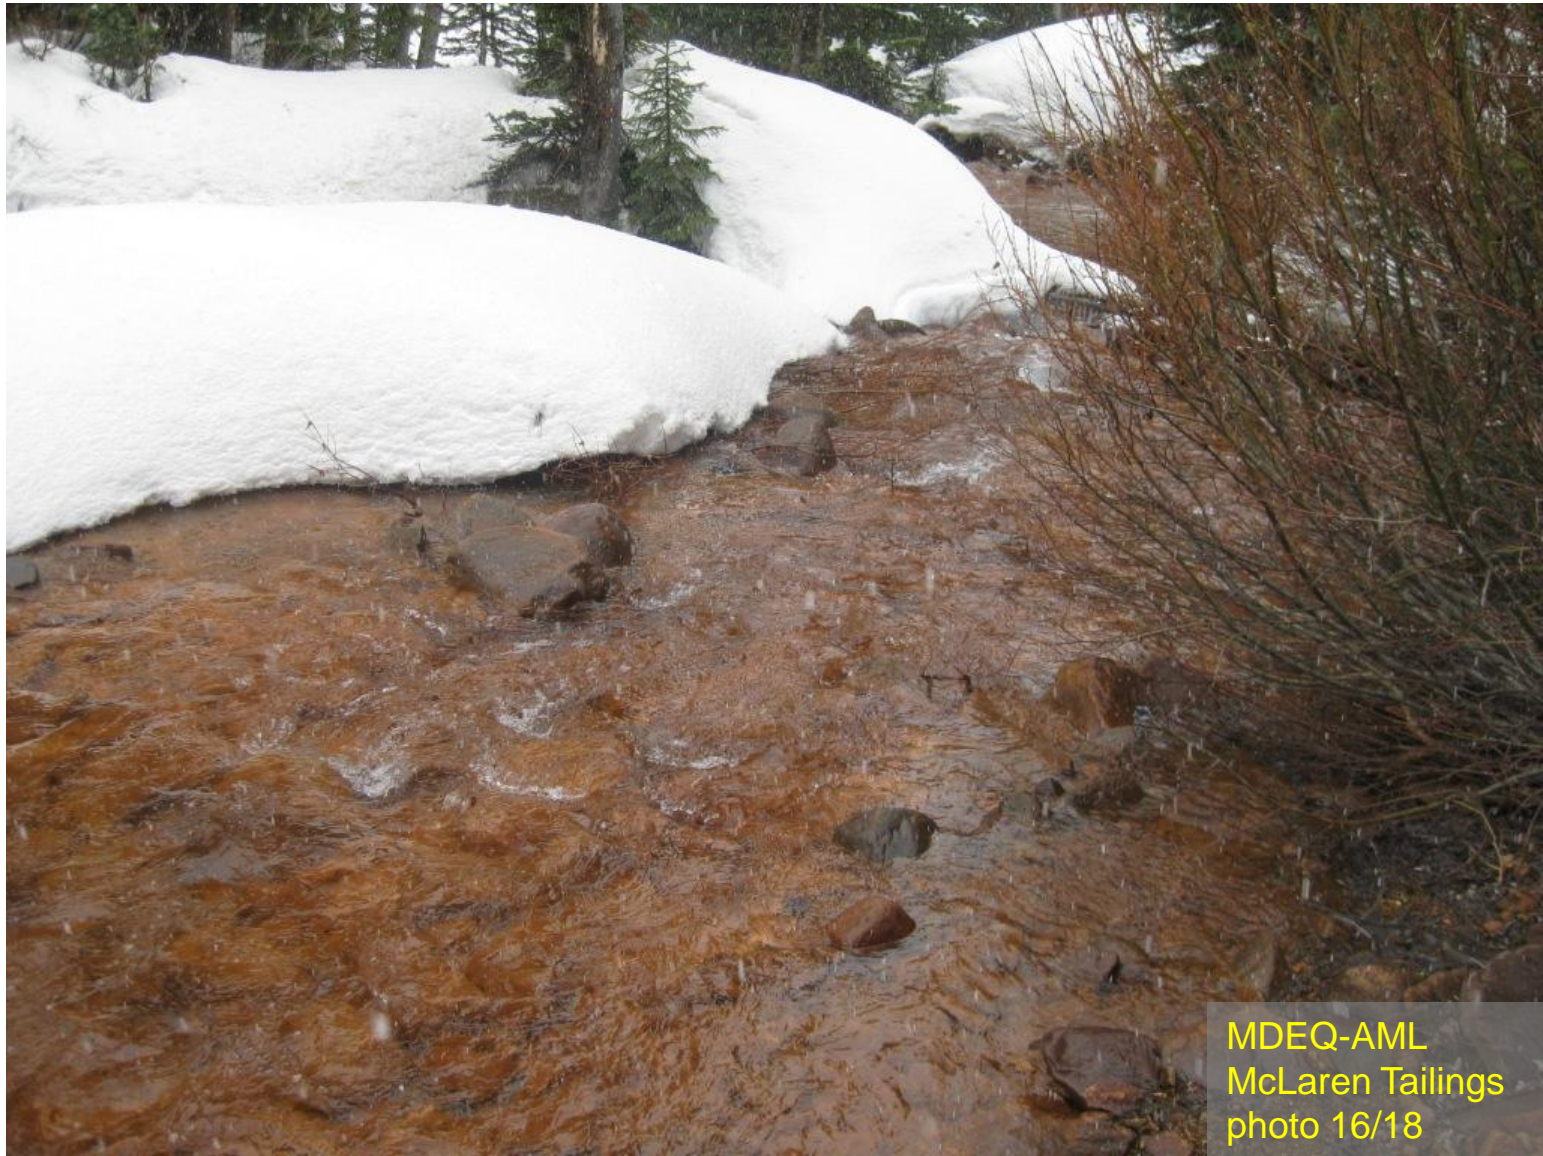
MDEQ-AML  
McLaren Tailings  
photo 16/18

Iron staining in Soda Butte Creek downstream of McLaren Tailings  
May 14, 2009

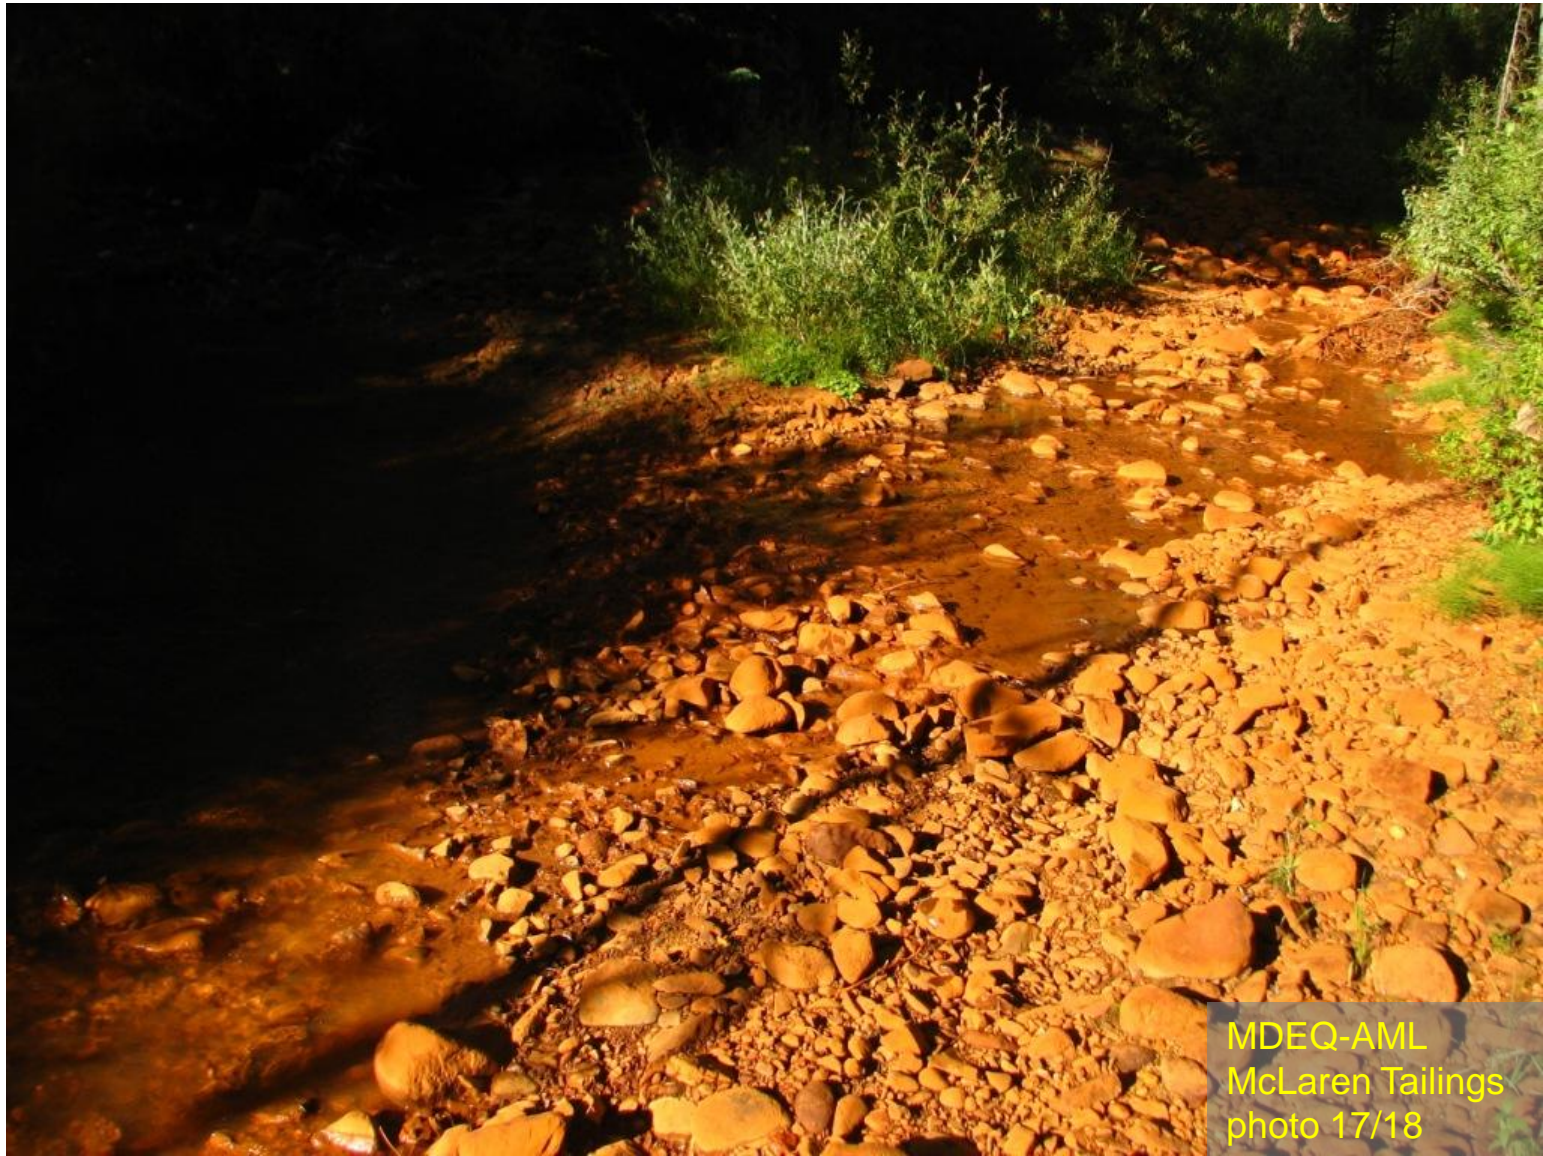
MDEQ-AML  
McLaren Tailings  
photo 17/18

Iron staining in Soda Butte Creek downstream of McLaren Tailings  
September 8, 2008

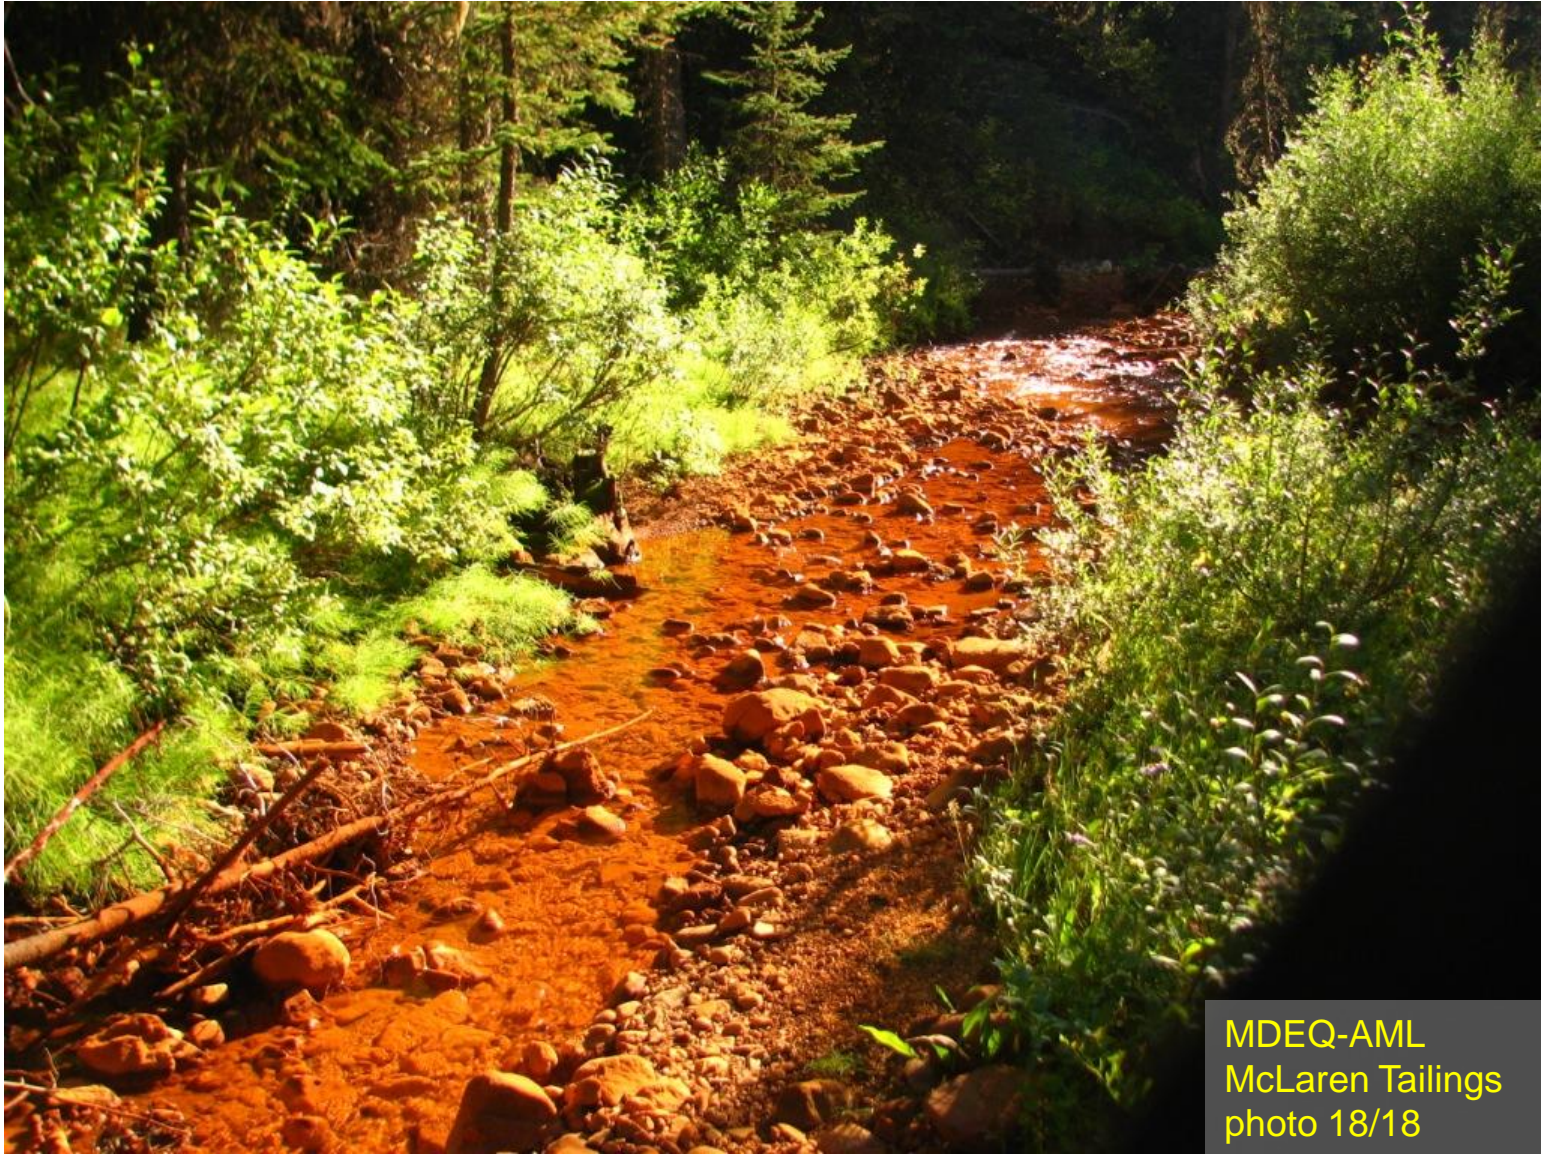
MDEQ-AML  
McLaren Tailings  
photo 18/18

Iron staining in Soda Butte Creek downstream of McLaren Tailings  
September 8, 2008
