Report of Subsidence Investigation – Phase 1  
501 Broadway Avenue South  
Red Lodge, Carbon County, MT

SUBJECT: Report of Subsidence Investigation – Phase 1  
501 Broadway Avenue South  
Red Lodge, Carbon County, MT

DATE: November 3, 2011  
\\bil-fs-7189\eng\31\20281\reports\501 broadway ave s\final report mdeq\_redlodge\_501broadwayaves.docx

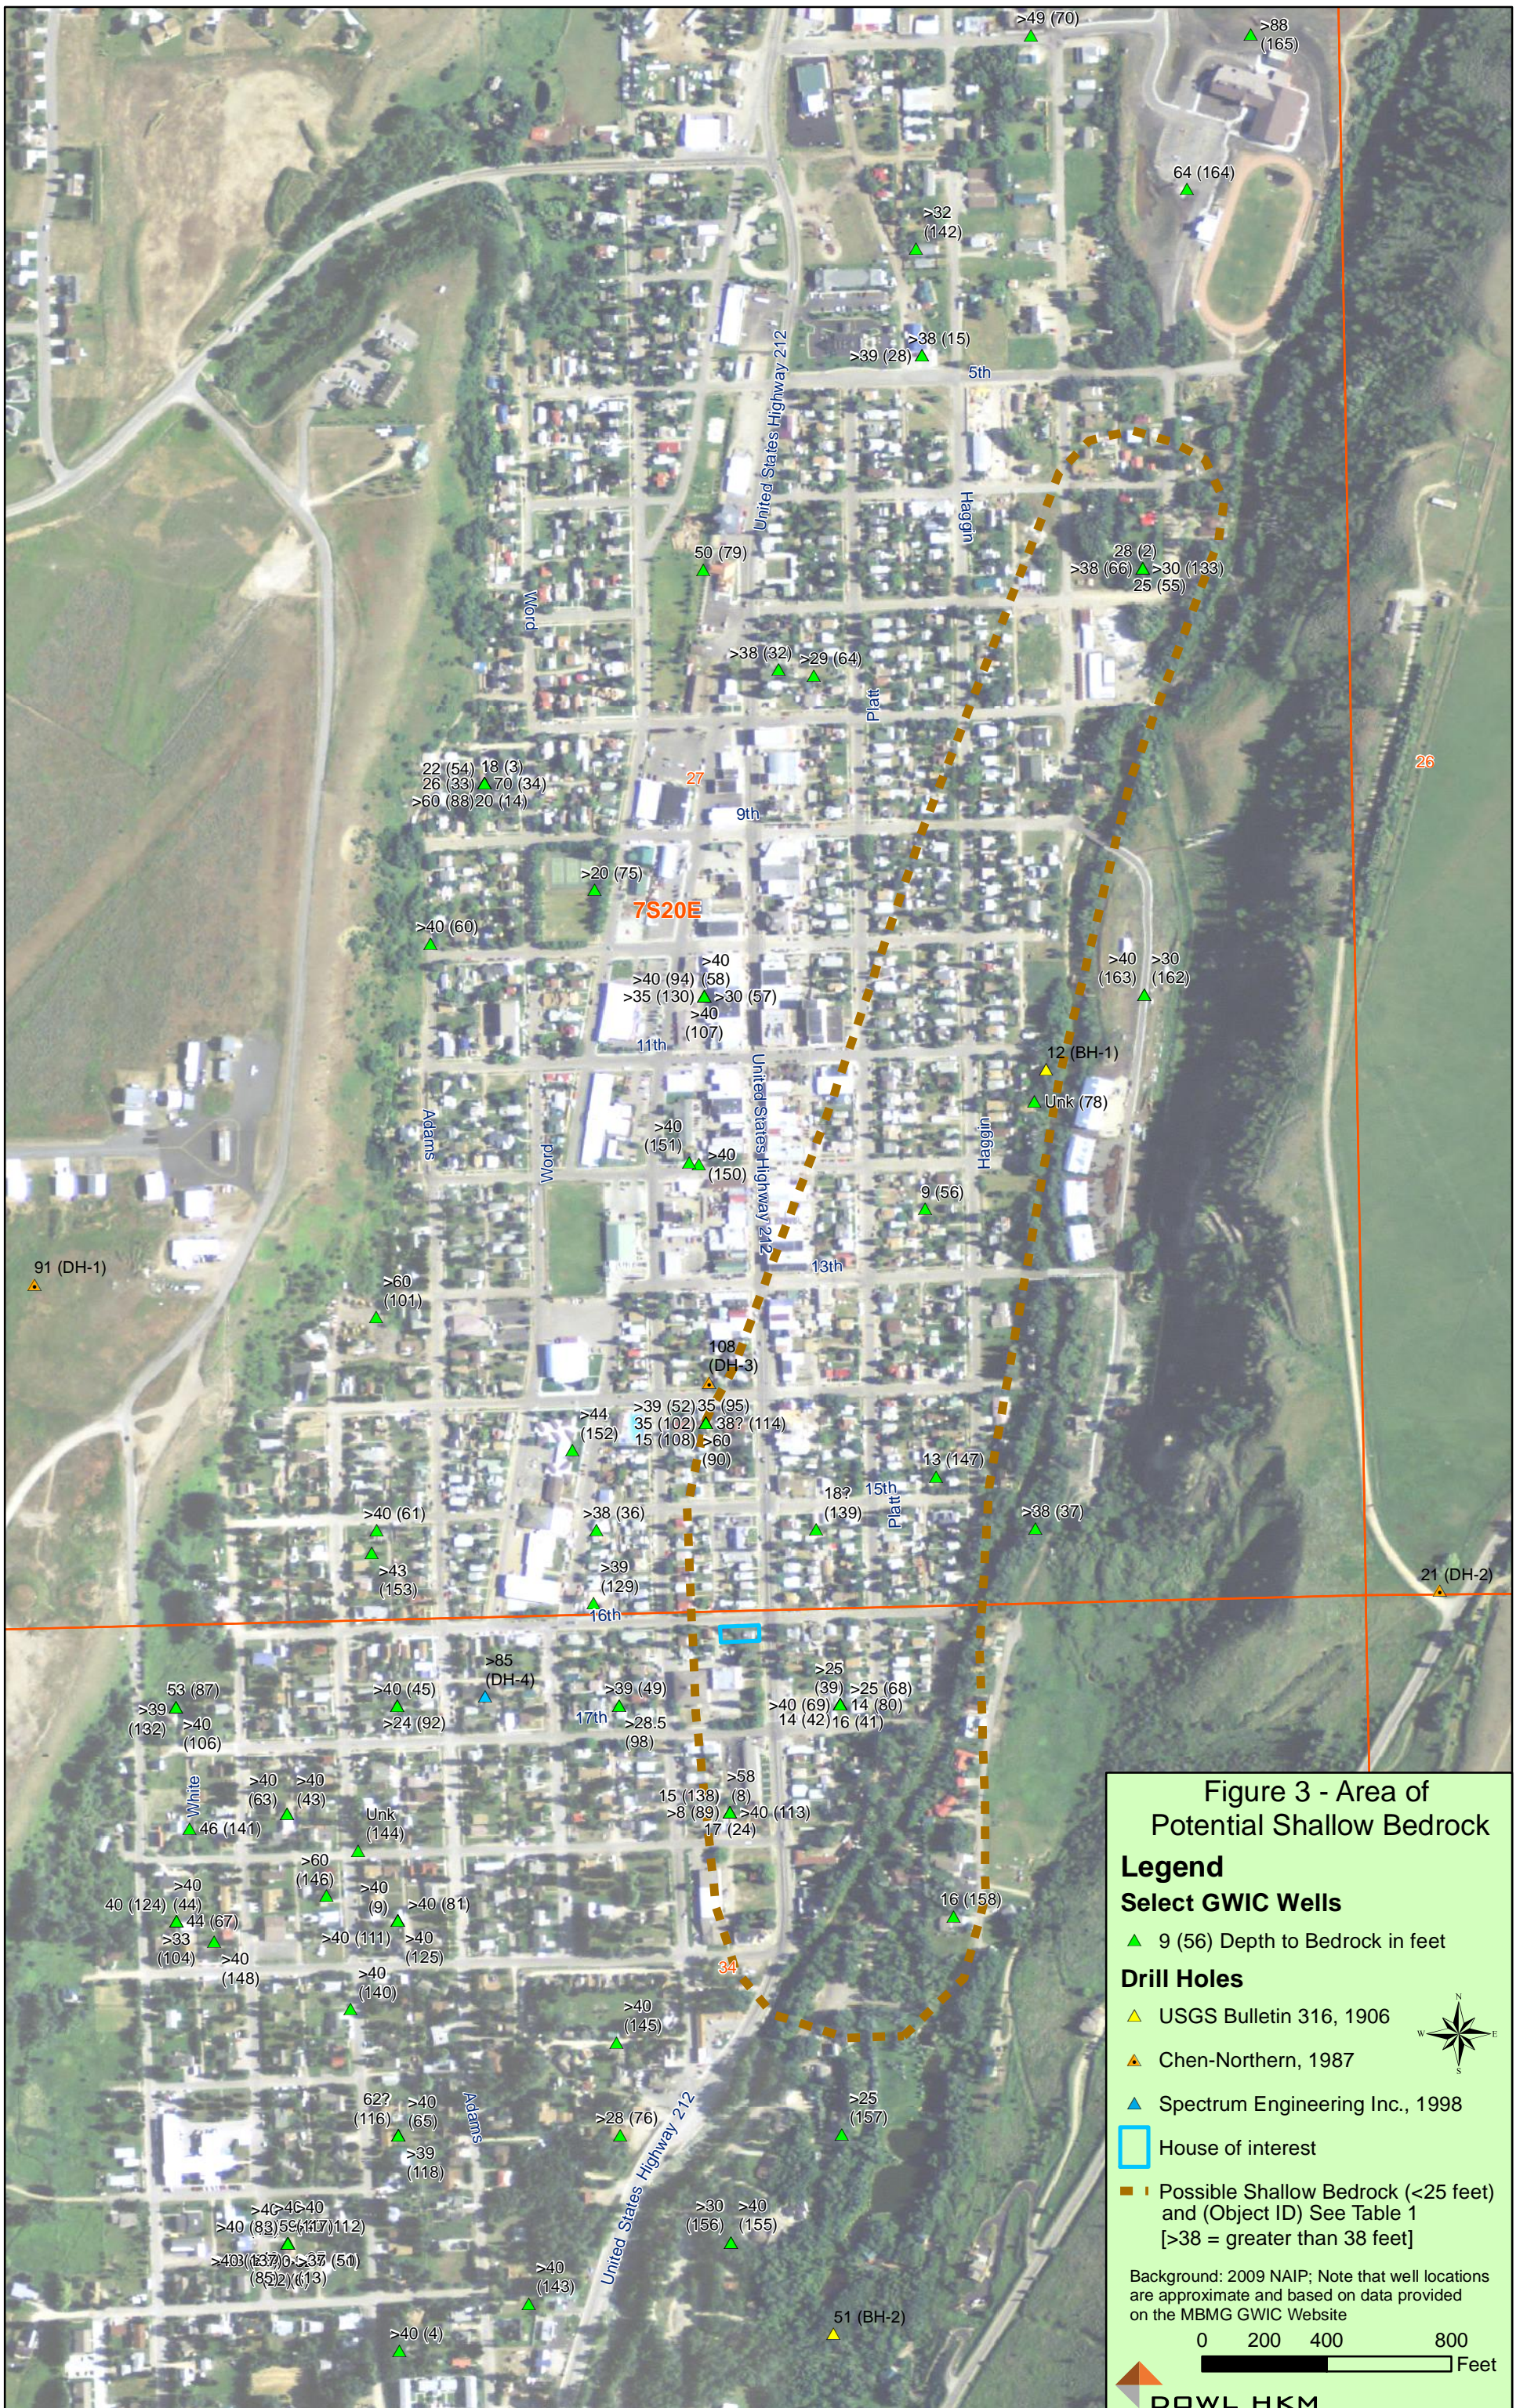
**Figure 4 - August 2011 Site Survey**

Most of the house foundation is visible but somewhat obscured by paint and stucco. However, overall the foundation appeared to be in relatively good condition with the exception of the area near the northeast corner of the house. Two cracks were observed on either side of the concrete steps at the contact with the foundation (front addition) of the house. These cracks were open and the crack on the north side appeared to be offset slightly down to the east (indicating some recent settlement of the concrete stairs). Another open crack was observed near the northeast corner of the house where the front addition and the main foundation of the house meet. The crack was observed in the stucco façade and may not penetrate the entire foundation wall. This open crack may indicate possible settlement of a portion of the foundation, although it may just be the stucco façade cracking in response to the settlement of the front stairs. Other hairline cracks were observed in the foundation (Figure 4 in Appendix A).

As was observed during the site visit, the survey shows that the low spots occur along the crack in the city sidewalk and concrete walkway (Figure 4a in Appendix A).

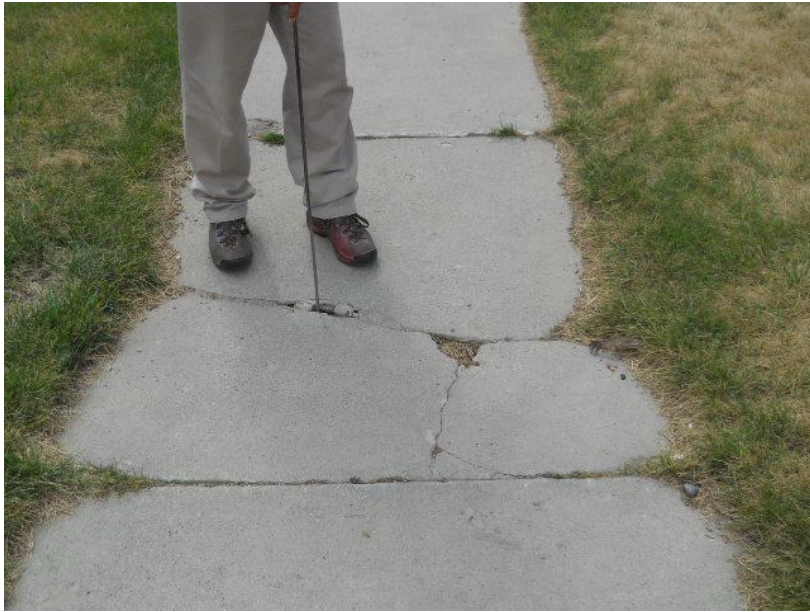
There is a concrete (city) sidewalk along the east side of the property. A concrete walkway was observed leading from the city sidewalk to the front steps. A low spot and significant crack in the city sidewalk was very apparent. DOWL HKM probed the crack in the city sidewalk and it appeared to be open to a depth of about 4 inches. An offset crack in the walkway just below the front steps was also observed. The settlement in the city sidewalk appears to have existed for a period of time as grass had grown into the low spot along the crack. However, fresh pieces of broken concrete in the city sidewalk and a fresh looking surface to the cracked concrete in the walkway possibly indicate recent movement.

8/25/2011 12:30:19 PM  
View South of Sidewalk  
501 Broadway Avenue South, Red Lodge, MT  
2011-08-25 12-30-19 - 0089.JPG

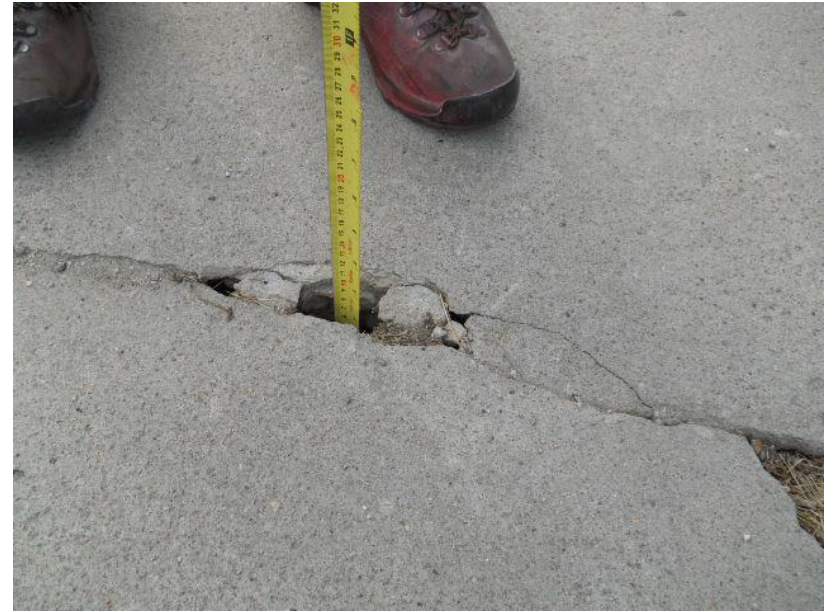
8/25/2011 12:30:32 PM  
View South of Sidewalk - Crack is Open to a Depth of 4 Inches  
501 Broadway Avenue South, Red Lodge, MT  
2011-08-25 12-30-32 - 0090.JPG

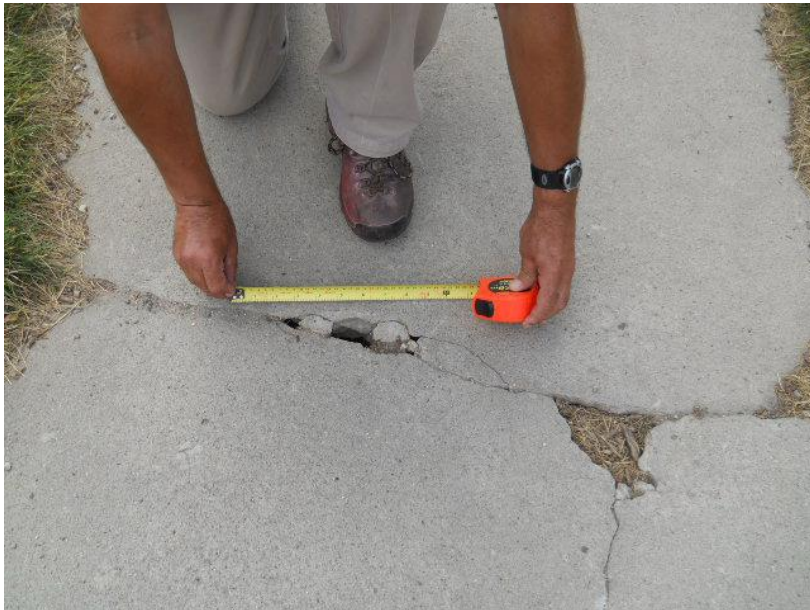
8/25/2011 12:30:49 PM  
View South of Sidewalk  
501 Broadway Avenue South, Red Lodge, MT  
2011-08-25 12-30-49 - 0091.JPG

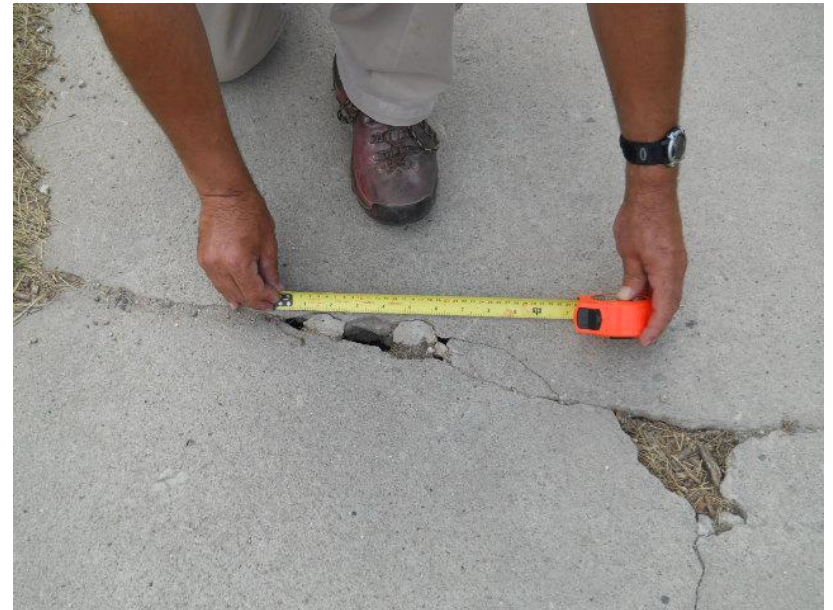
8/25/2011 12:30:55 PM  
View South of Sidewalk  
501 Broadway Avenue South, Red Lodge, MT  
2011-08-25 12-30-55 - 0092.JPG

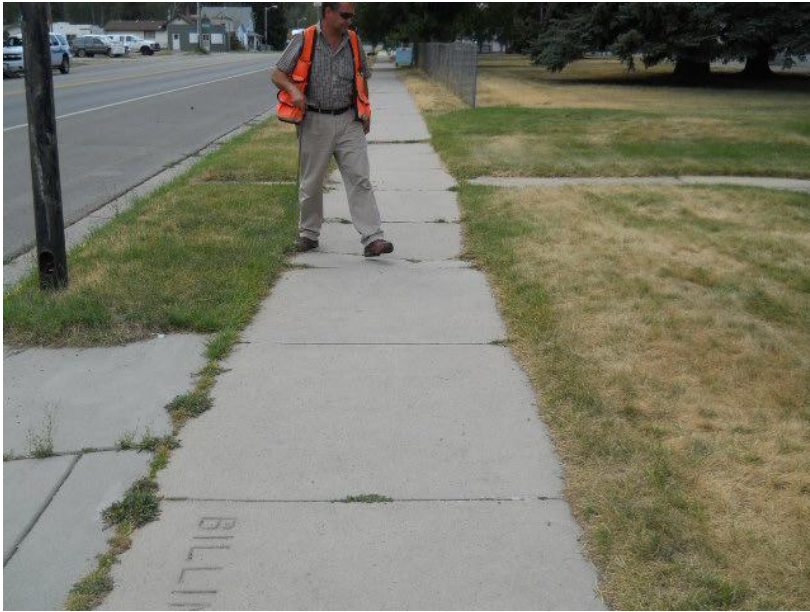
8/25/2011 12:31:03 PM  
View South of Sidewalk  
501 Broadway Avenue South, Red Lodge, MT  
2011-08-25 12-31-03 - 0093.JPG

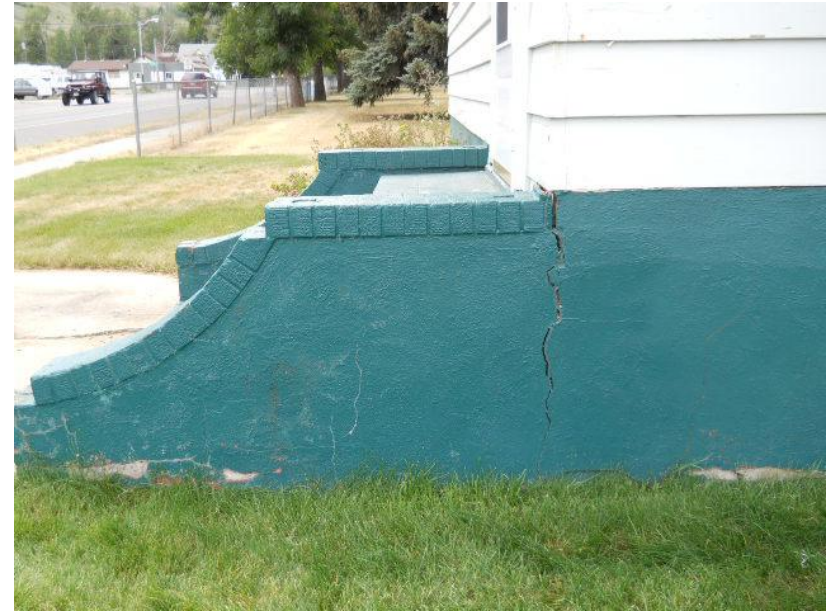
- It appears that recent settlement of the city sidewalk, concrete walkway and front stairs at the subject property has occurred relatively recently. There is also an open crack near the northeast corner of the foundation that may indicate possible settlement of a portion of the foundation, although it may just be the stucco façade cracking in response to the settlement of the front stairs.

8/25/2011 12:31:35 PM  
View South of Front Stairs - Note Open Crack Between the Stairs and Foundation  
501 Broadway Avenue South, Red Lodge, MT  
2011-08-25 12-31-35 - 0094.JPG

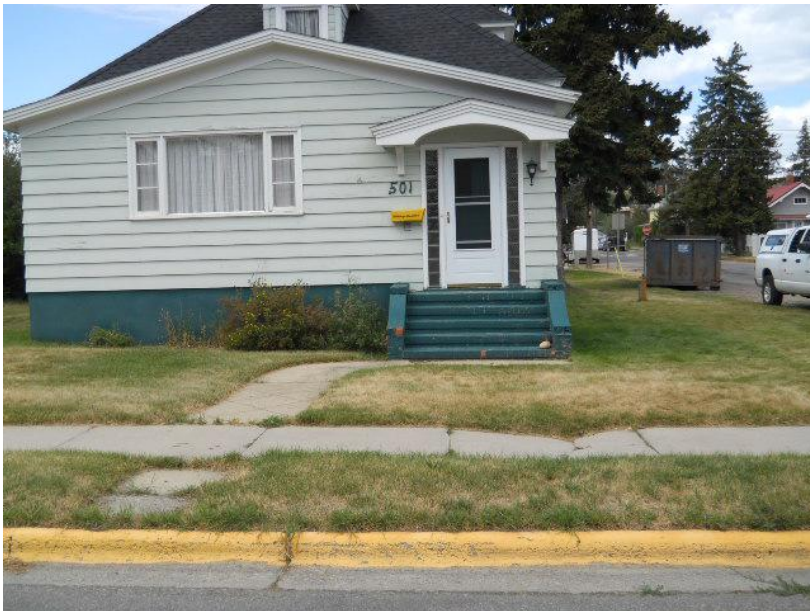
8/25/2011 12:32:00 PM  
View West of Front of House  
501 Broadway Avenue South, Red Lodge, MT  
2011-08-25 12-32-00 - 0095.JPG

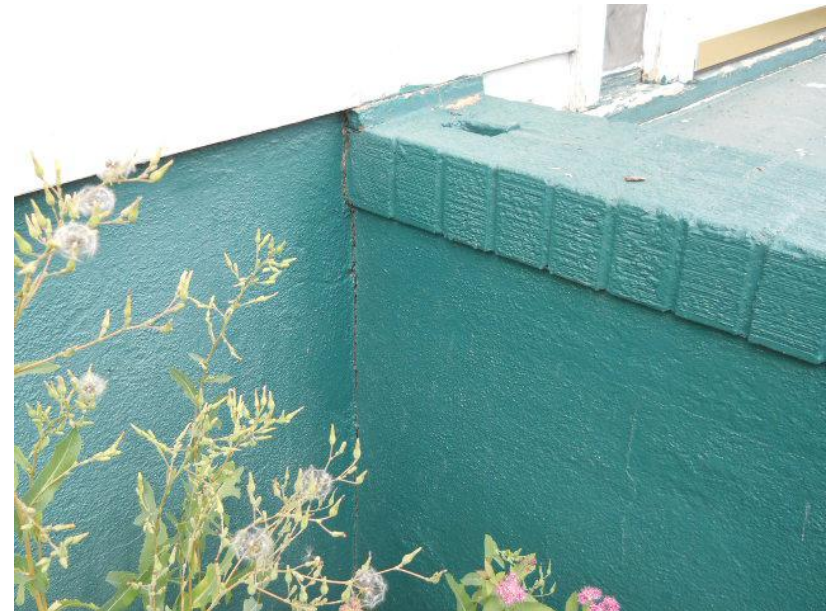
8/25/2011 12:32:24 PM  
View Northwest of South Side of Front Stairs - Note Open Crack Between the Stairs and Foundation  
501 Broadway Avenue South, Red Lodge, MT  
2011-08-25 12-32-24 - 0096.JPG

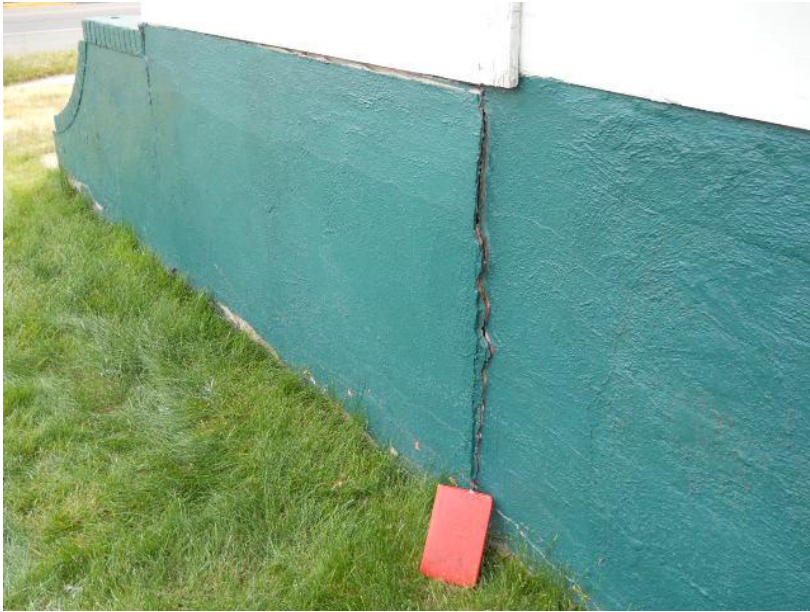
8/25/2011 12:33:32 PM

View Southeast of North Foundation and Open Crack 7 in Stucco Where the Front Addition and Main House Foundation Meet  
501 Broadway Avenue South, Red Lodge, MT

- Instrumentation could potentially be installed, such as crack monitors, to gauge whether there is any additional movement in the house foundation.
- The house is built upon a mixed concrete/concrete block foundation. Most of the house foundation is visible but somewhat obscured by paint and stucco. However, overall the foundation appeared to be in relatively good condition with the exception of the area near the northeast corner of the house. As previously mentioned, there are many reasons for the settlement of flatwork (sidewalk and walkways) and foundations. Differences in foundation construction techniques within one house foundation can sometimes magnify even minor settlement of the surface soil. If the water/utility lines are found to be in sound condition, DOWL HKM recommends a shallow foundation investigation near the northeast corner of the house to document the soil types present below the footings as well as footing types and depths.

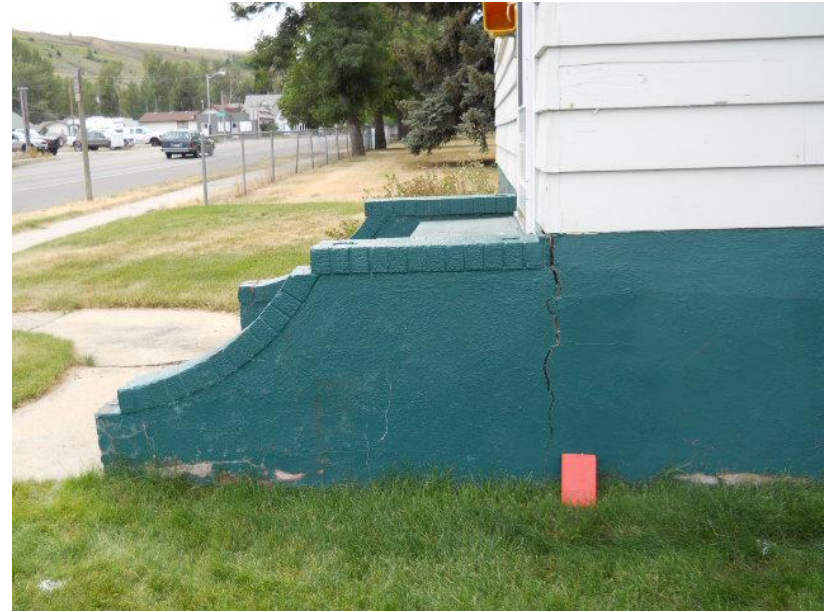
8/25/2011 12:33:47 PM

View South of Front Stairs - Note Open Crack Between the Stairs and Foundation  
501 Broadway Avenue South, Red Lodge, MT  
2011-08-25 12-33-47 - 0098.JPG

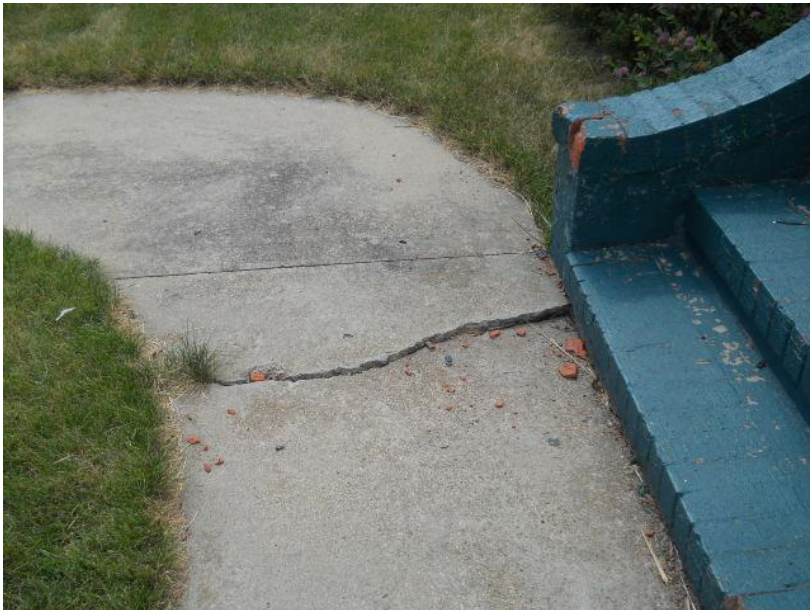
8/25/2011 12:57:16 PM

View South of Front Stairs and Crack in Walkway  
501 Broadway Avenue South, Red Lodge, MT  
2011-08-25 12-57-16 - 0099.JPG

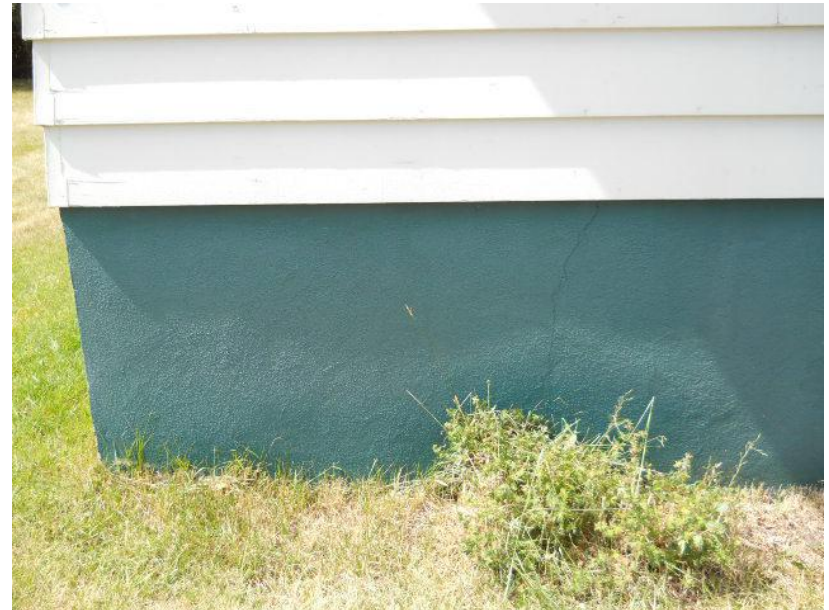
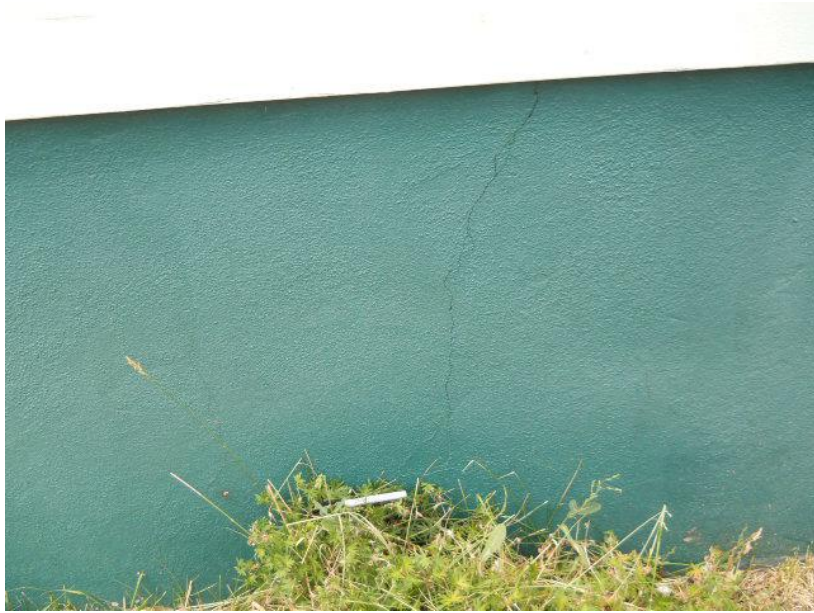
View West of East Foundation and Hairline Crack 1 near Southeast Corner of House  
501 Broadway Avenue South, Red Lodge, MT  
2011-08-25 12-57-55 - 0100.JPG

View West of East Foundation and Hairline Crack 1 near Southeast Corner of House  
501 Broadway Avenue South, Red Lodge, MT  
2011-08-25 12-58-39 - 0101.JPG

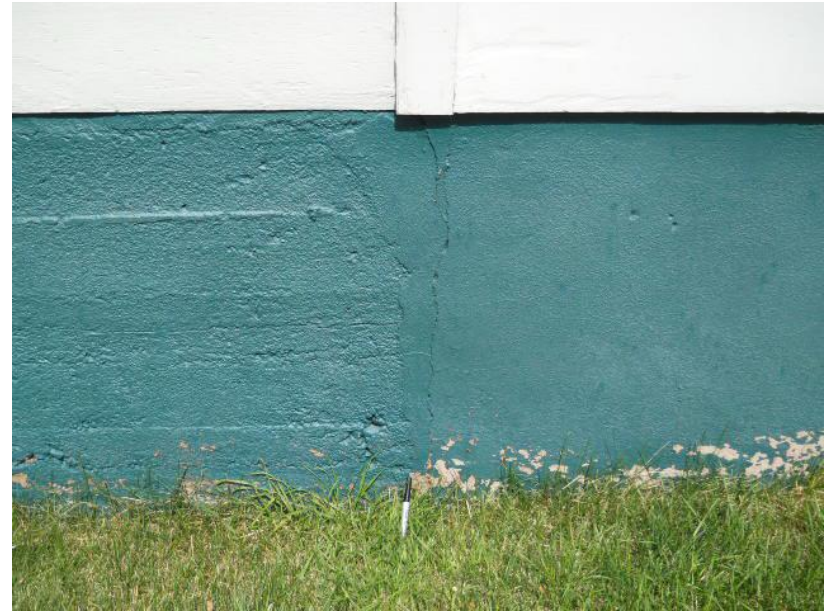
8/25/2011 12:59:16 PM

View North of South Foundation and Hairline Crack 2 at Front Addition  
501 Broadway Avenue South, Red Lodge, MT  
2011-08-25 12-59-16 - 0102.JPG

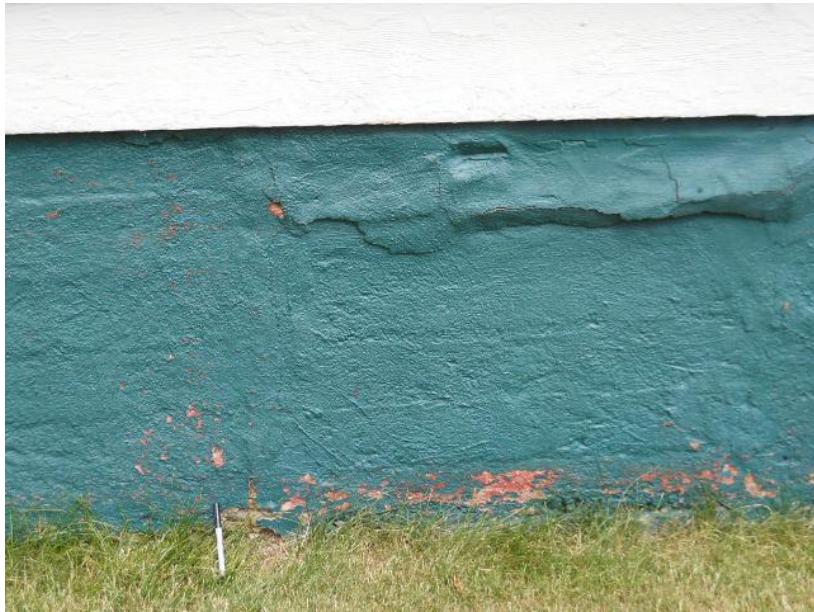
8/25/2011 1:00:21 PM

View North of South Foundation and Buckled Stucco and Hairline Crack 3  
501 Broadway Avenue South, Red Lodge, MT  
2011-08-25 13-00-21 - 0103.JPG

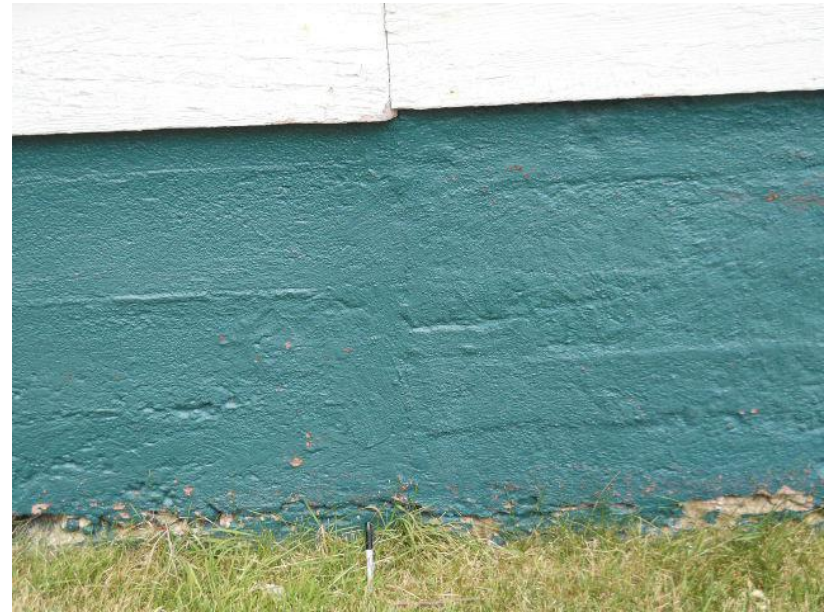
8/25/2011 1:00:30 PM

View North of South Foundation and Hairline Crack 4 at Back Addition  
501 Broadway Avenue South, Red Lodge, MT  
2011-08-25 13-00-30 - 0104.JPG

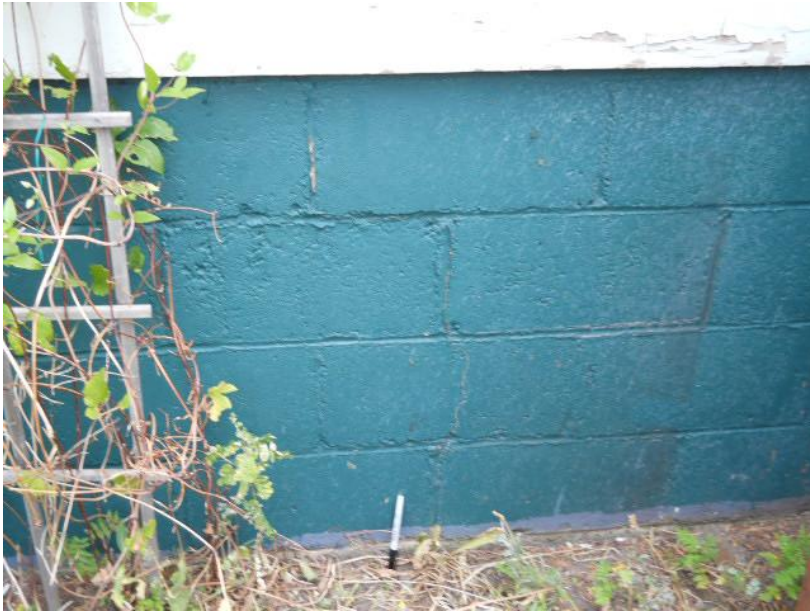
8/25/2011 1:01:16 PM  
View East of West Foundation and Crack 5 in CMU Block  
501 Broadway Avenue South, Red Lodge, MT  
2011-08-25 13-01-16 - 0105.JPG

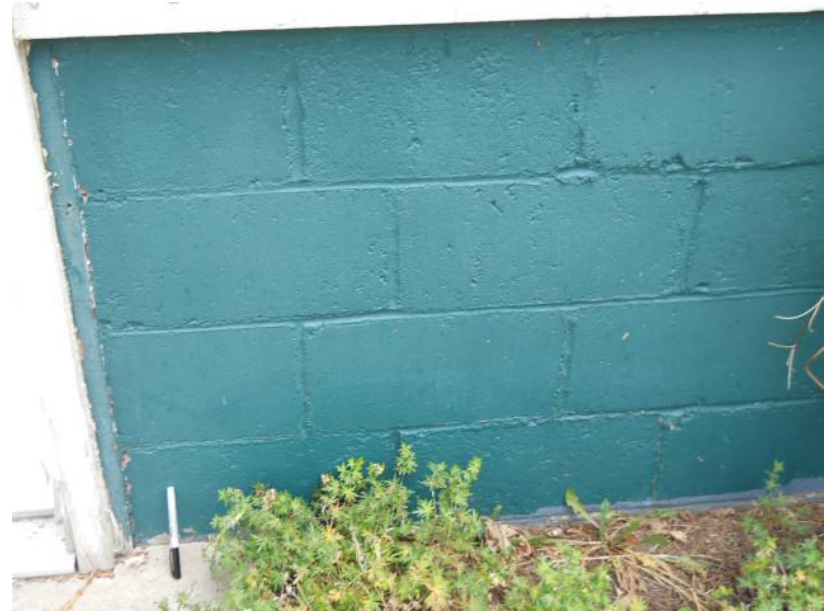
8/25/2011 1:01:41 PM  
View East of West Foundation and Paint Peeling or Possible Cracking in CMU Block  
501 Broadway Avenue South, Red Lodge, MT  
2011-08-25 13-01-41 - 0106.JPG

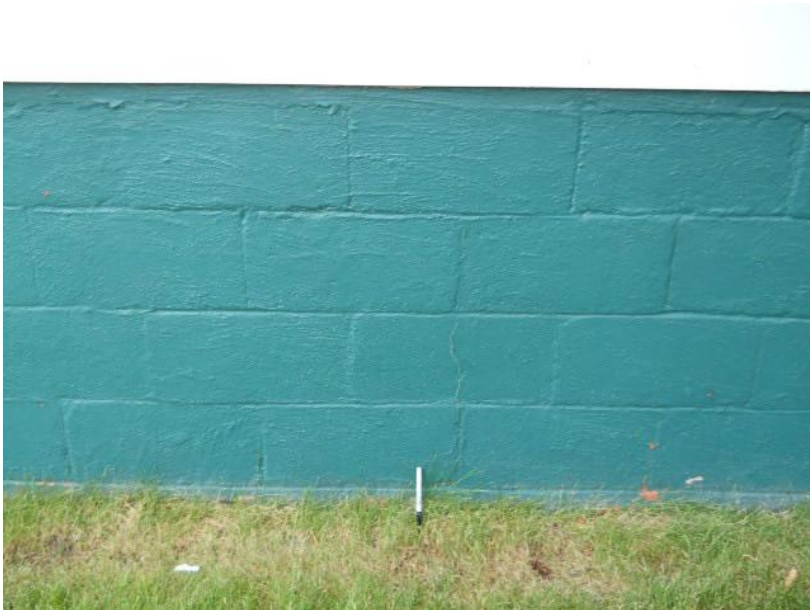
8/25/2011 1:02:54 PM  
View South of North Foundation and Paint Peeling or Possible Cracking in CMU Block  
501 Broadway Avenue South, Red Lodge, MT  
2011-08-25 13-02-54 - 0107.JPG

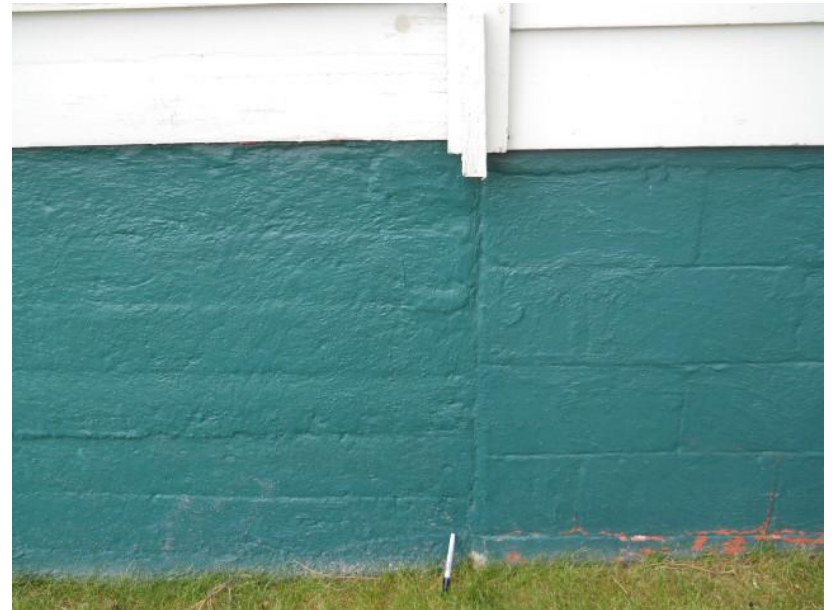
8/25/2011 1:03:05 PM  
View South of North Foundation and Hairline Crack 6 at Back Addition  
501 Broadway Avenue South, Red Lodge, MT  
2011-08-25 13-03-05 - 0108.JPG
