Subsidence Investigation – Phase 1 Summary
505 Platt Avenue South
Red Lodge, Carbon County, MT

SUBJECT: Subsidence Investigation – Phase 1 Summary
505 Platt Avenue South
Red Lodge, Carbon County, MT

DATE: November 3, 2011

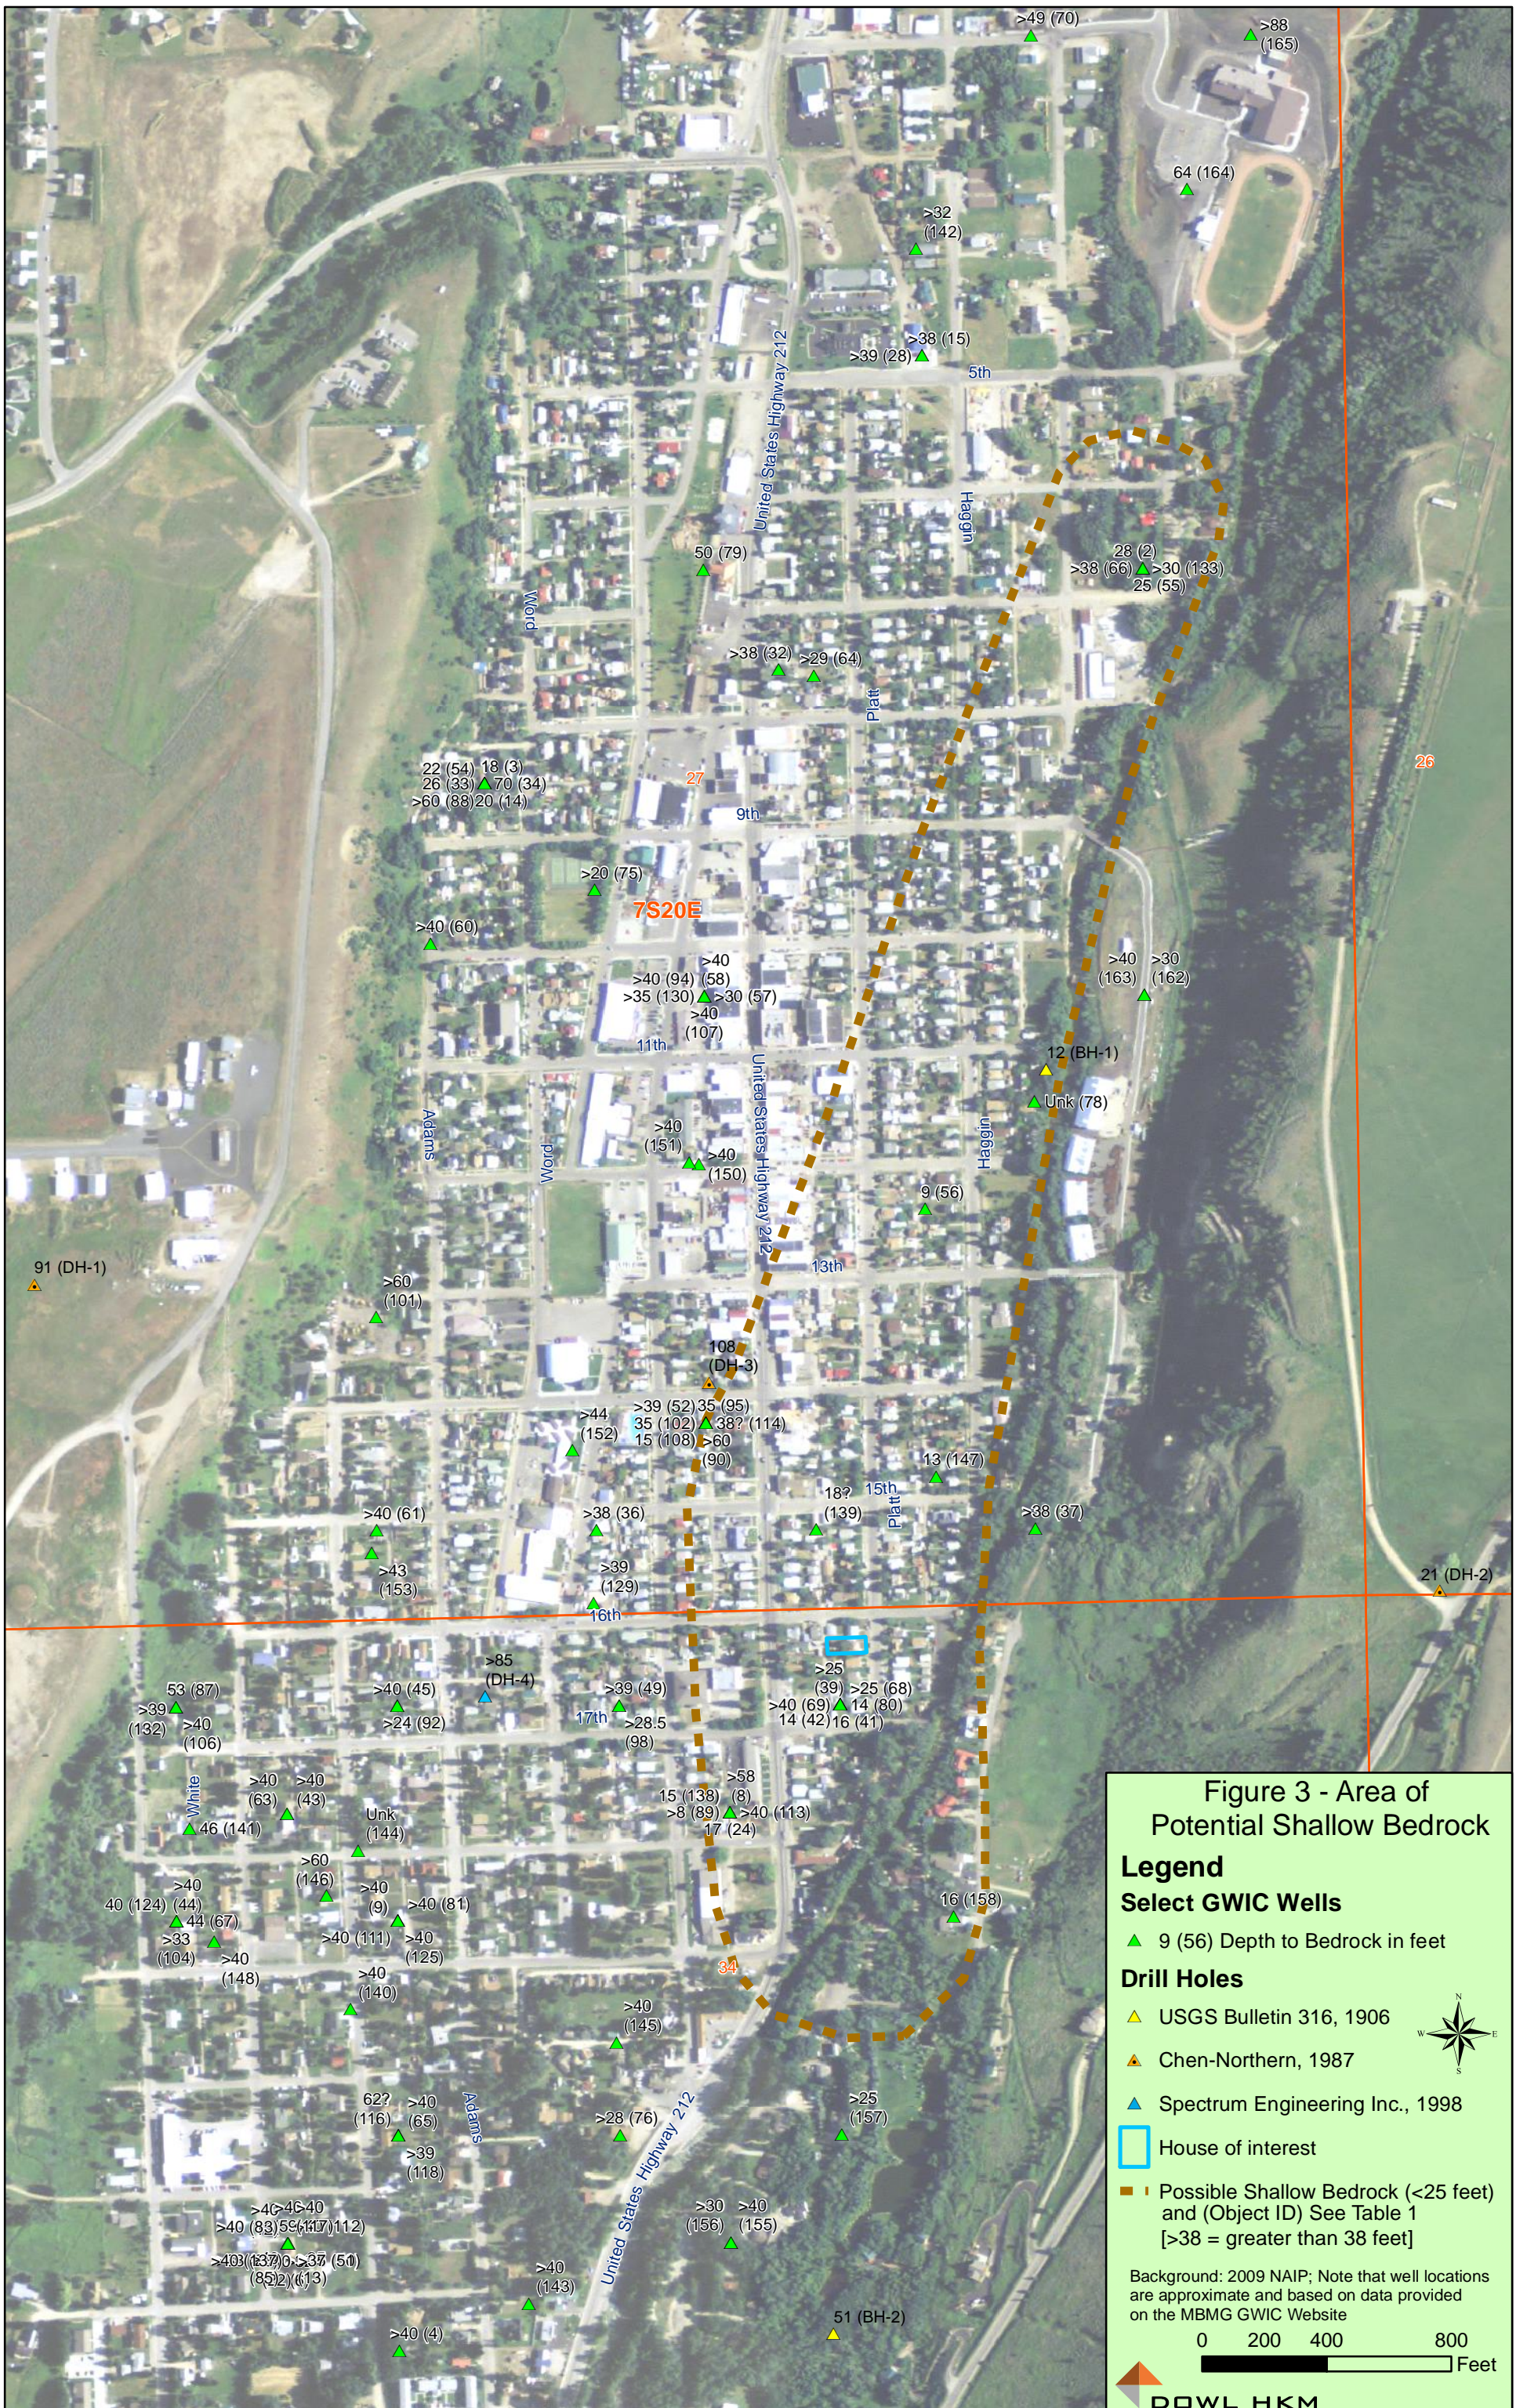
Figure 3 - Area of Potential Shallow Bedrock

Based on a review of published material and well logs, the thickness of the alluvium appears to vary from a few feet to over 100 feet in the valley bottom. As part of a preliminary study of the potential for subsidence in the Red Lodge and Bearcreek Areas, Chen-Northern (1987) advanced a drill hole (DH-3) to 450.5 feet approximately two to three blocks northwest of the subject property (Figure 3 in Appendix A). The base of the alluvium was encountered at a depth of 108 feet. At least 85 feet of alluvium was encountered in drill hole DH-4 advanced as part of the Spectrum (1998) investigation and grouting project. However, during well log research of the Montana Bureau of Mines and Geology (MBMG) Groundwater Information Center (GWIC) website several well logs along the central and east sides of town noted encountering relatively shallow (less than 25 feet) bedrock (Figure 3 in Appendix A).

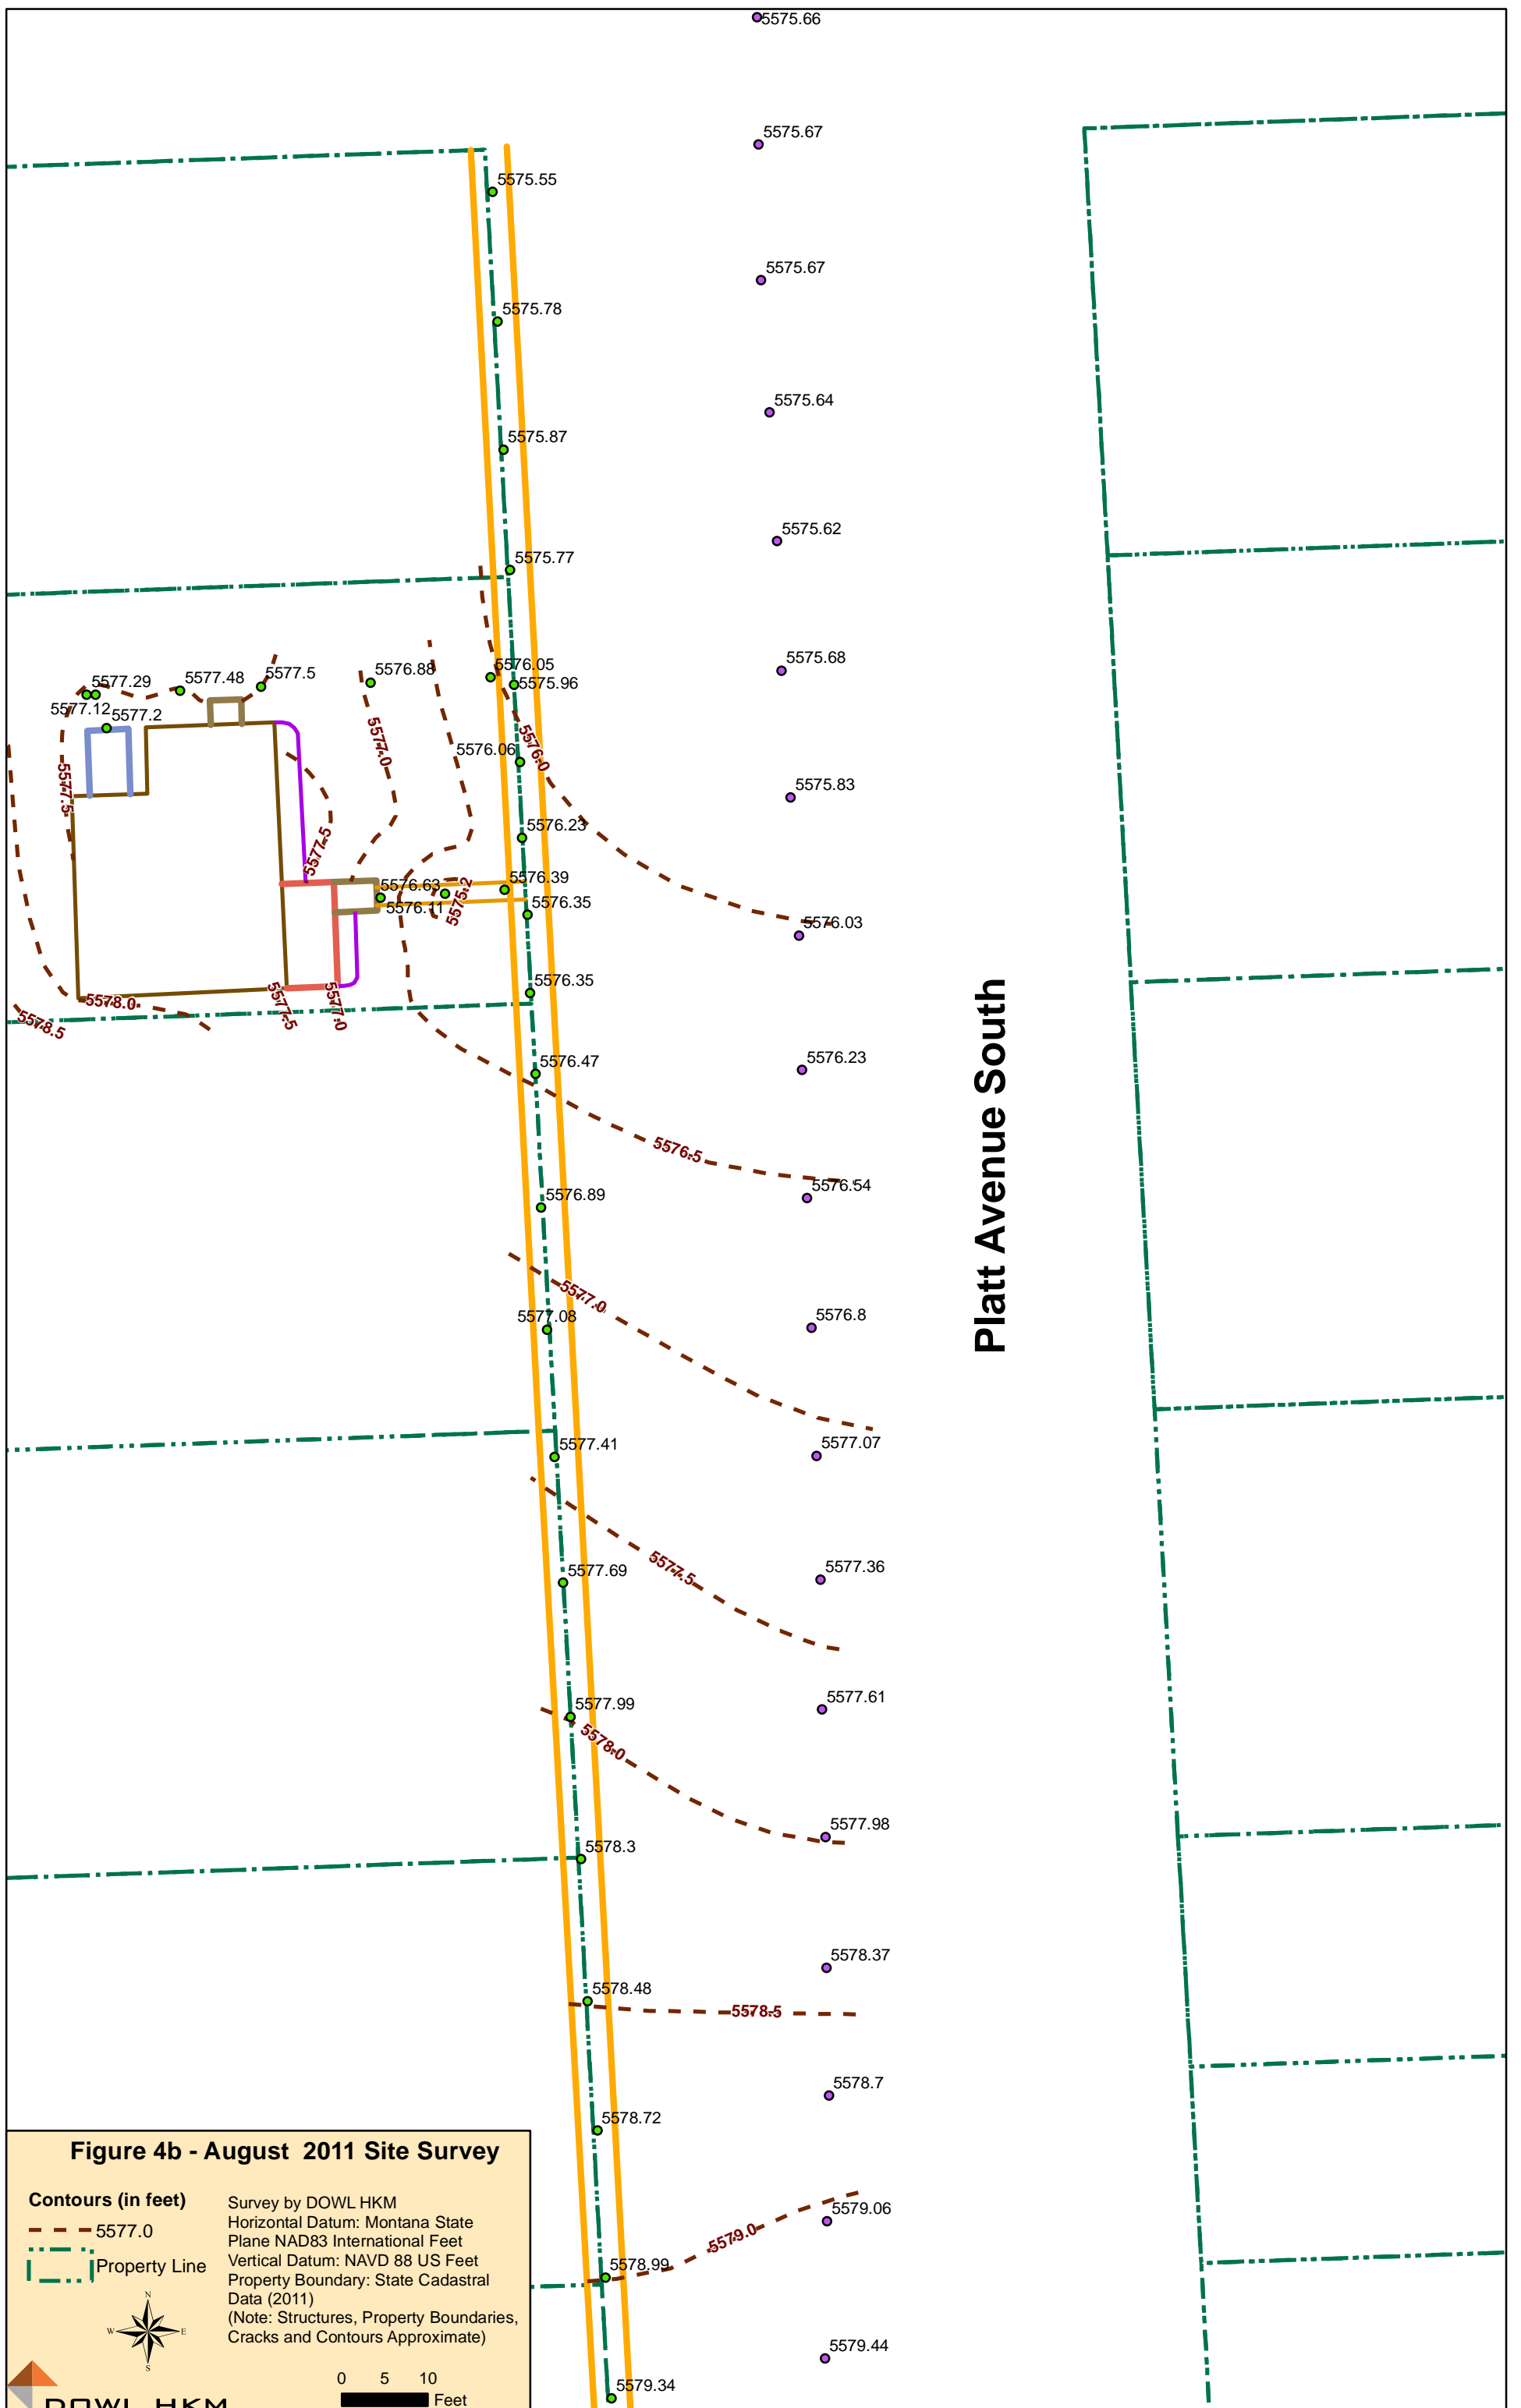
Figure 4b - August 2011 Site Survey

A survey transect was made of the city sidewalk and the block of Platt Ave. S. where the subject property resides (Figure 4b in Appendix A). The survey results indicate that there is a general and consistent grade down to the north of the city sidewalk and Platt Ave. S. However, there is a slightly lower spot in Platt Ave. S. just east of the north property line of 505 Platt Ave. S.

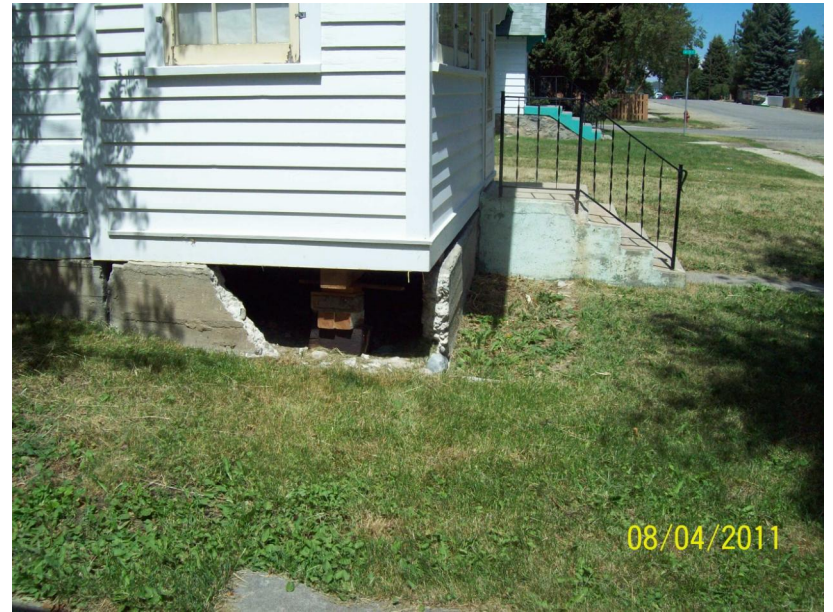
At the time of the April 25-26, 2011th site visit by DEQ-AML, the front porch had been jacked up and was resting on wood blocks. The footing below the front porch had been partially removed. The front porch appeared to be in the same condition during the August 4th site visit by DOWL HKM (see photos in Appendix B). Between August 4 and August 25, 2011 the footing below the front porch had been completely removed. Some soil had been excavated and concrete blocks had been placed at the southeast corner on what appeared to be alluvium consisting of coarse clasts (gravel, cobbles and boulders) in a sand matrix. Wood shims had been placed between the concrete block and the porch floor. A small gap (about 1 centimeter) was visible between the main part of the house and the foundation at the southeast corner, presumably related to the jacking-up of the front porch. The northeast corner of the porch was still resting on wood blocks. Although a portion of the porch foundation had been removed prior to any site visit by DOWL HKM, it appears that the porch foundation may have been a separate structure from the main house foundation.

View North of the Porch Foundation Partially Removed
505 Platt Avenue South, Red Lodge, MT
100_2694.JPG

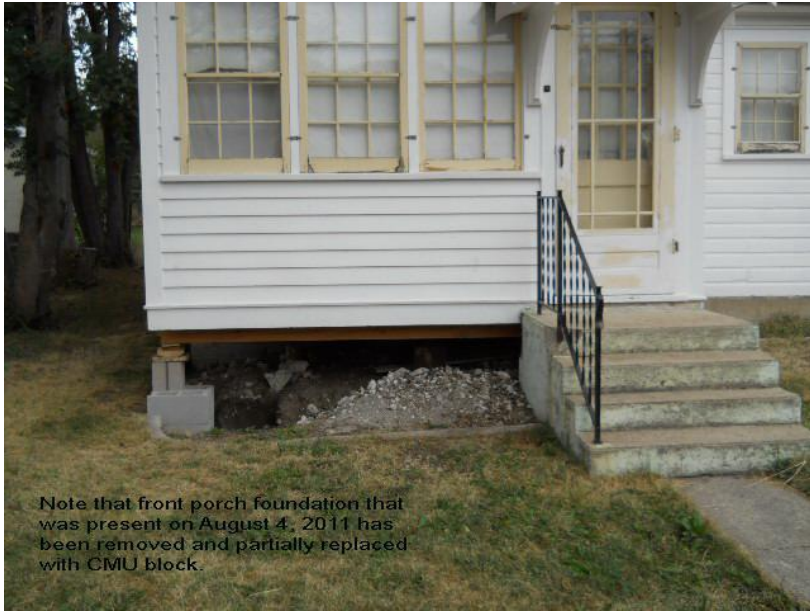
Note that front porch foundation that was present on August 4, 2011 has been removed and partially replaced with CMU block.

9/22/2011 4:18:44 PM
View West of east side of house
505 Platt Avenue South, Red Lodge, MT
2011-0072.JPG

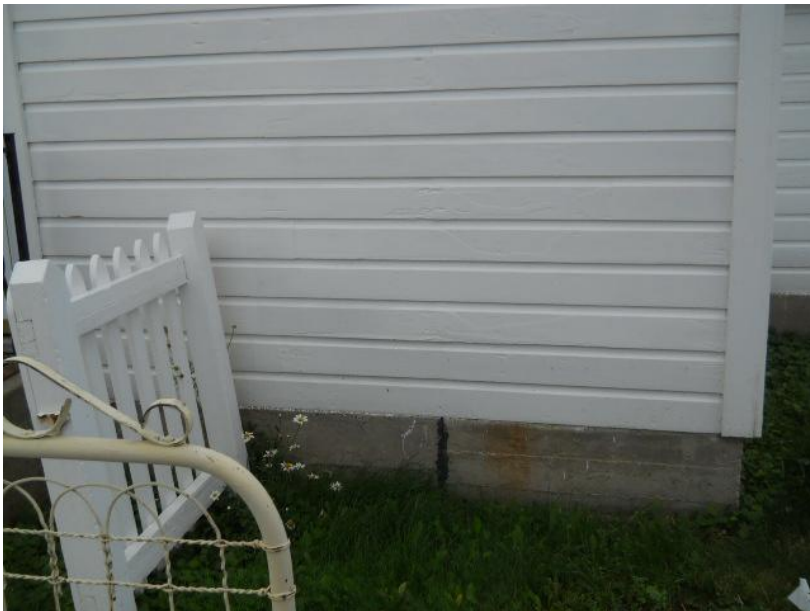
that had been repaired was observed along the north foundation wall and two hairline cracks were observed along the south and east foundation walls. No significant opening or offset (horizontal or lateral) of the cracks was observed, although the crack that had been filled was somewhat obscured. A crack was also observed between the concrete stairs on the north side of the house and the foundation. The cracks observed in the foundation wall and between the steps and the foundation are very common and typical in this type and age of construction.

8/25/2011 10:39:00 AM
View South of North Side of House. Note Patched Crack
505 Platt Avenue South, Red Lodge, MT
2011-0078.JPG

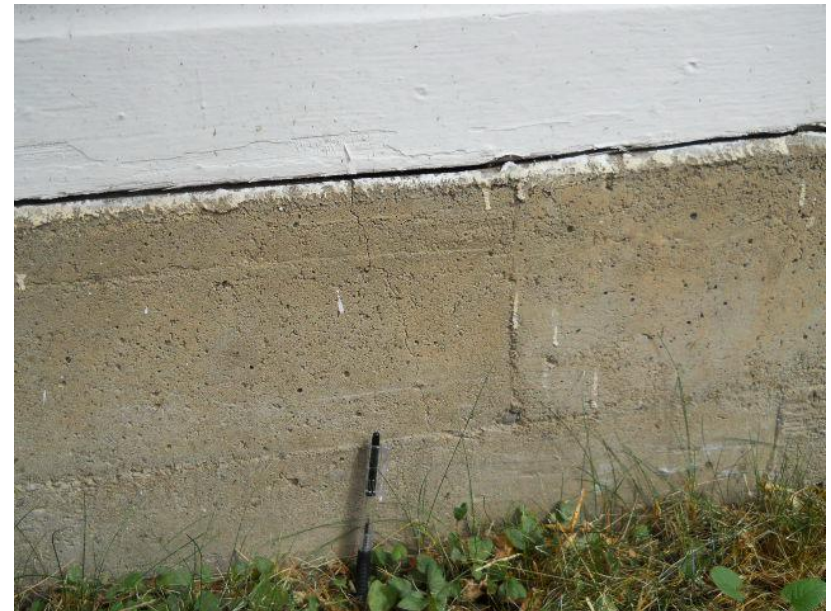
The concrete foundation of the main part of the house was well exposed and appeared to be in relatively good condition. Three cracks were observed and documented the foundation: one crack

8/25/2011 10:46:01 AM
View North of South Foundation Wall. Hairline Crack Visible (Crack 1)
505 Platt Avenue South, Red Lodge, MT
2011-0083.JPG

- Additional instrumentation could potentially be installed, such as crack monitors, to gauge whether there is any movement in the house foundation.
- An attempt should be made to locate any additional mine maps or mine related information, particularly the map of the No. 2 bed or any information referenced in the Chen-Northern (1987) report specific to the Red Lodge area mining.

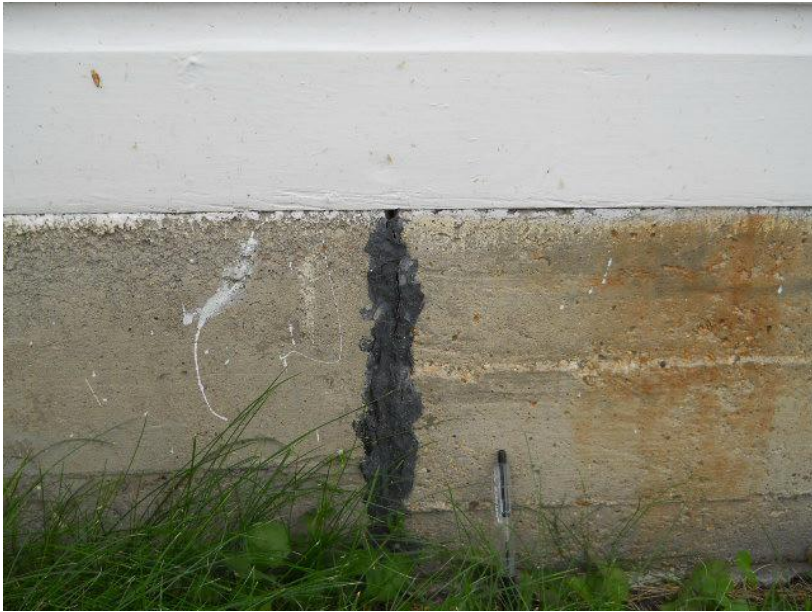
8/25/2011 10:46:45 AM
View South of North Foundation Wall. Repaired Crack Visible (Crack 2)
505 Platt Avenue South, Red Lodge, MT
2011-0084.JPG

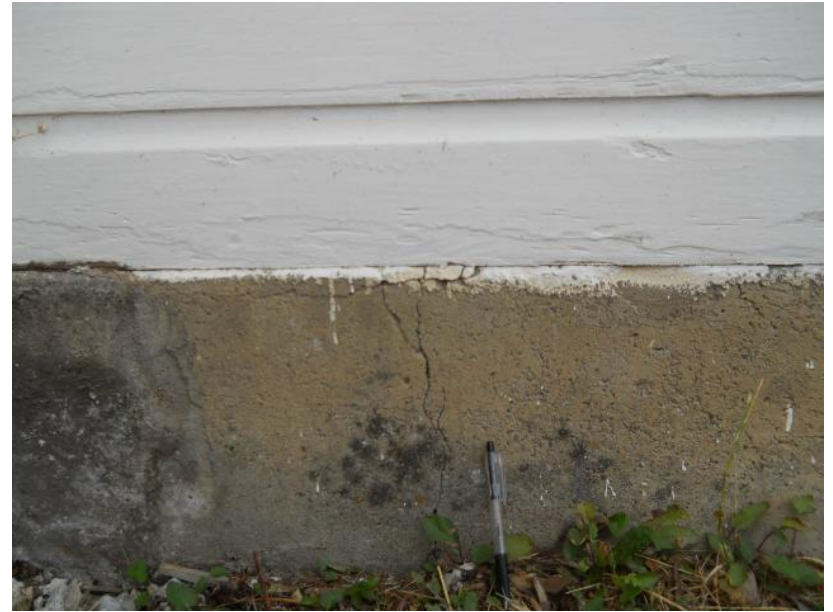
8/25/2011 10:47:07 AM
View West of East Foundation Wall. Hairline Crack Visible (Crack 3)
505 Platt Avenue South, Red Lodge, MT
2011-0085.JPG
