Subsidence Maintenance Investigation – Phase 1 Summary  
512 Adams Avenue South  
Red Lodge, Carbon County, MT

**SUBJECT:** Subsidence Maintenance Investigation – Phase 1 Summary  
512 Adams Avenue South  
Red Lodge, Carbon County, MT

**DATE:** November 3, 2011

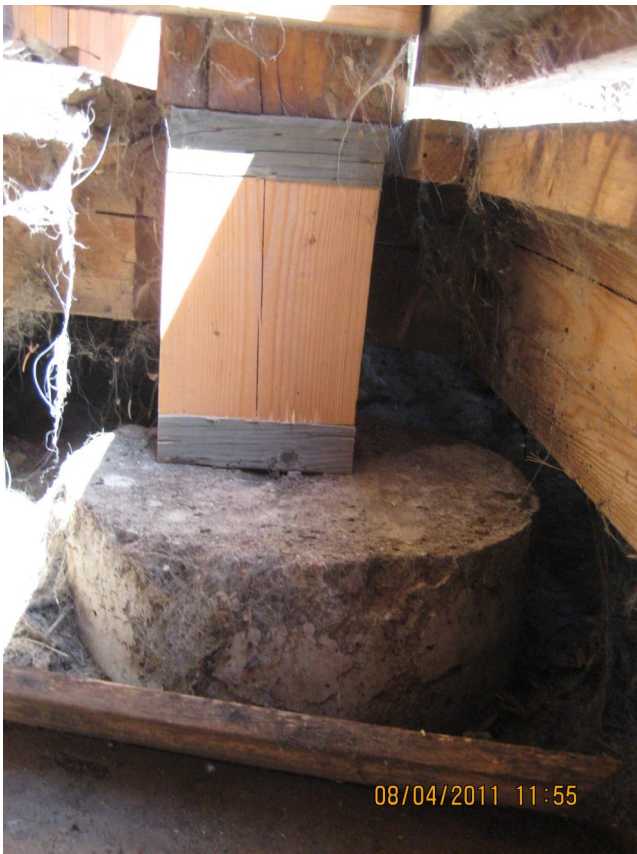
The shims below the wood posts holding up his roof are visible when the decking is removed and the shims below the fence are also visible. The cracks in the concrete sidewalk are visible and appear to be offset down to west which was consistent with the survey results.

View of concrete pier and wood shim below the back deck along east side of house. Photo by DEQ-AML  
512 Adams Avenue South, Red Lodge, MT  
512 Adams St.\_8-4-11 004.jpg

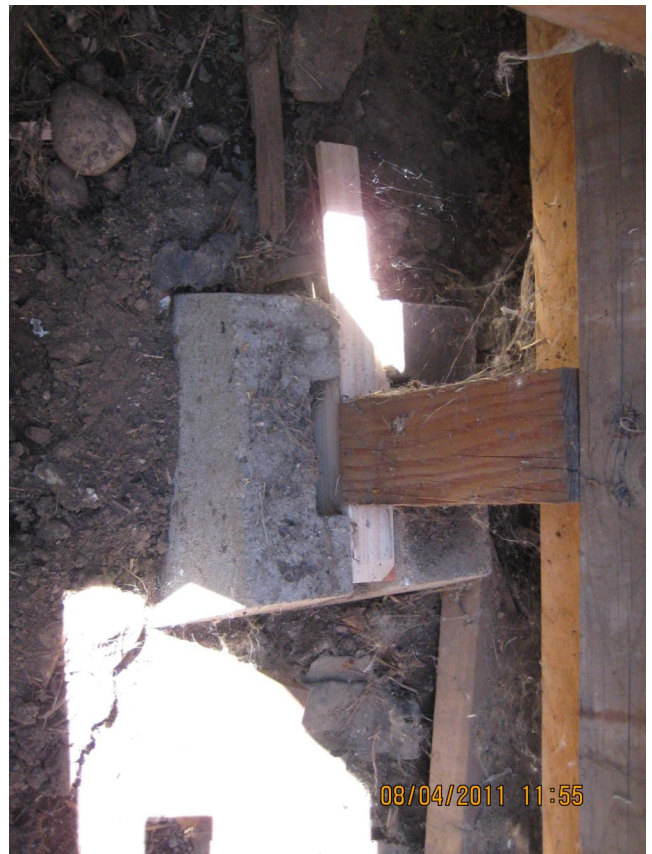
View of concrete block and wood shim below the back deck along east side of house. Photo by DEQ-AML  
512 Adams Avenue South, Red Lodge, MT  
512 Adams St.\_8-4-11 002.jpg

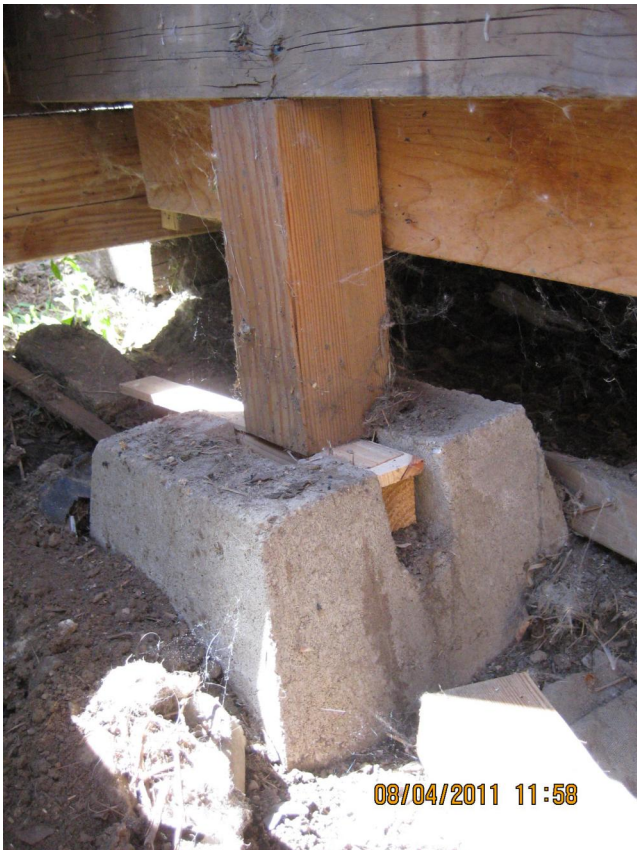
View of concrete block and wood shim below the back deck along east side of house. Photo by DEQ-AML  
512 Adams Avenue South, Red Lodge, MT  
512 Adams St.\_8-4-11 006.jpg

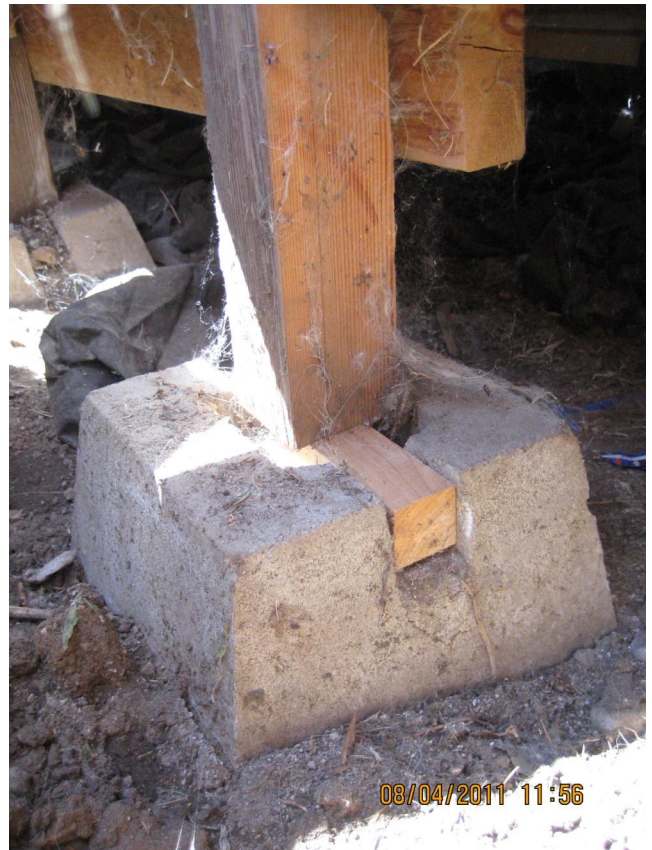
View of concrete block and wood shim below the back deck along east side of house. Photo by DEQ-AML  
512 Adams Avenue South, Red Lodge, MT  
512 Adams St.\_8-4-11 005.jpg

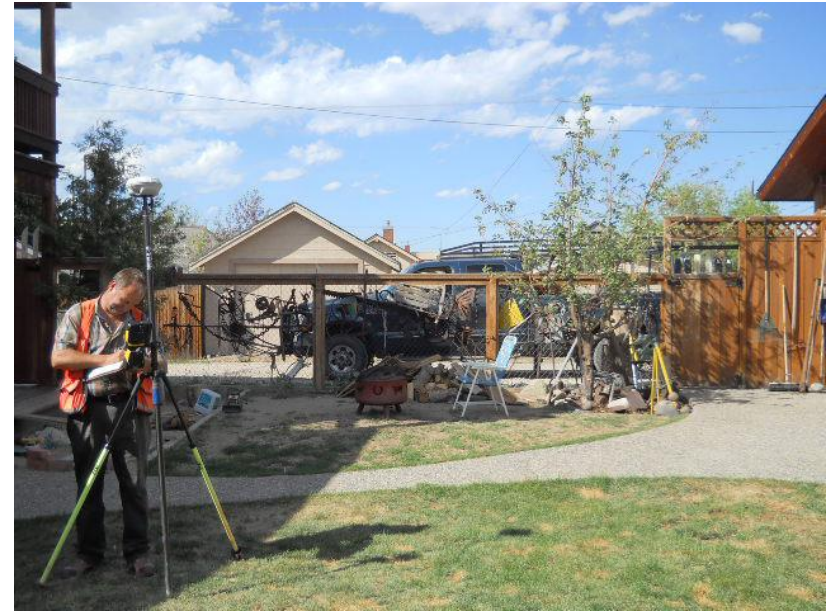
8/22/2011 4:01:00 PM  
View north of backyard; surveyor standing near area of settlement  
512 Adams Avenue South, Red Lodge, MT  
2011-0062.JPG

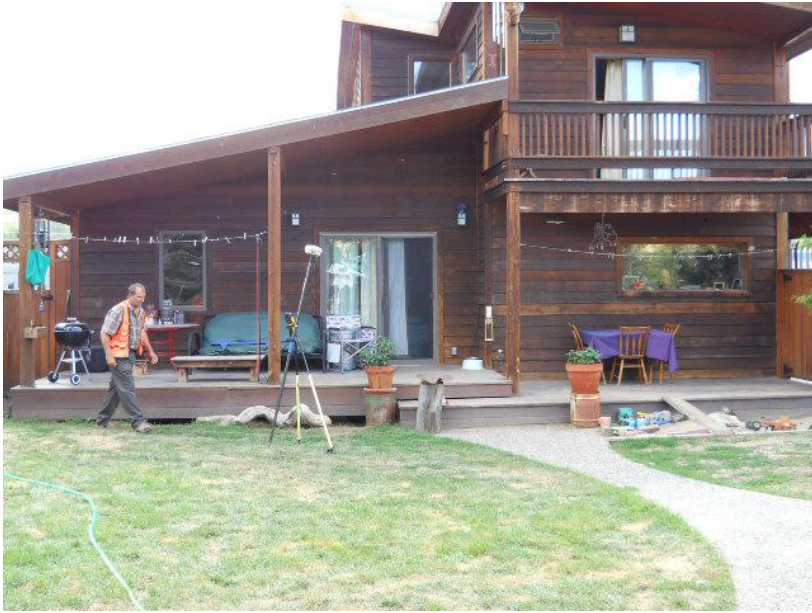
View northwest of yard, porch and east side of house; surveyor near area of settlement  
512 Adams Avenue South, Red Lodge, MT  
2011-0065.JPG

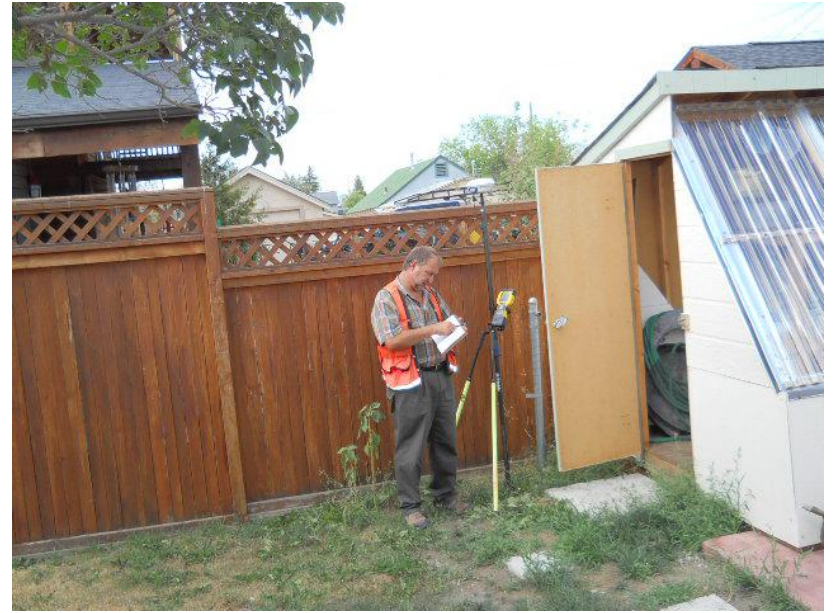
View northeast of green house; note surveyor near area of settlement  
518 Adams Avenue South, Red Lodge, MT  
2011-0066.JPG

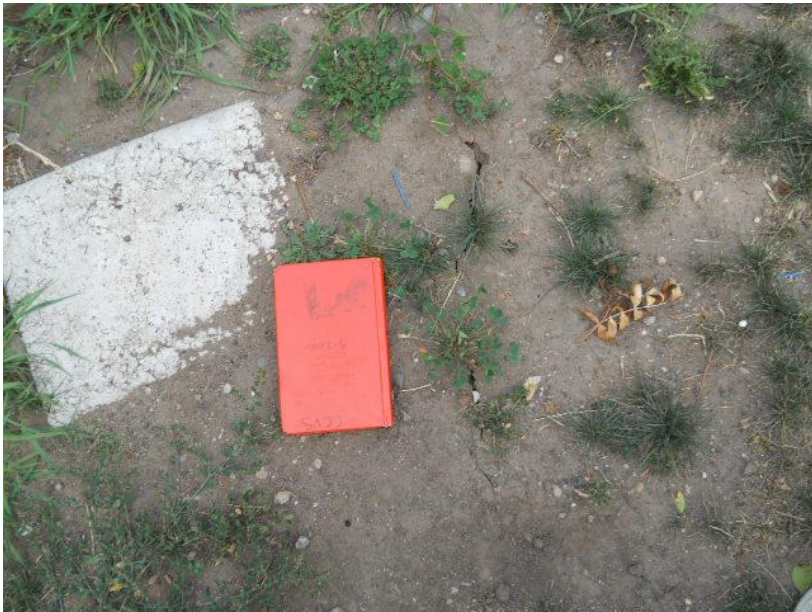
The back yard of 518 Adams Avenue South, just south of the approximate shaft location was also inspected and photographed. Open cracks with what appeared to be a “down to the north” component were observed on the ground approximately 8 to 10 feet south of the fence line. The cracks were oriented east-west to slightly southeast-northwest. A small green-house located in the back yard of 518 Adams Ave. S. obscures the ground southeast of the shaft.

Open crack observed just right of field book  
518 Adams Avenue South, Red Lodge, MT  
2011-0067.JPG

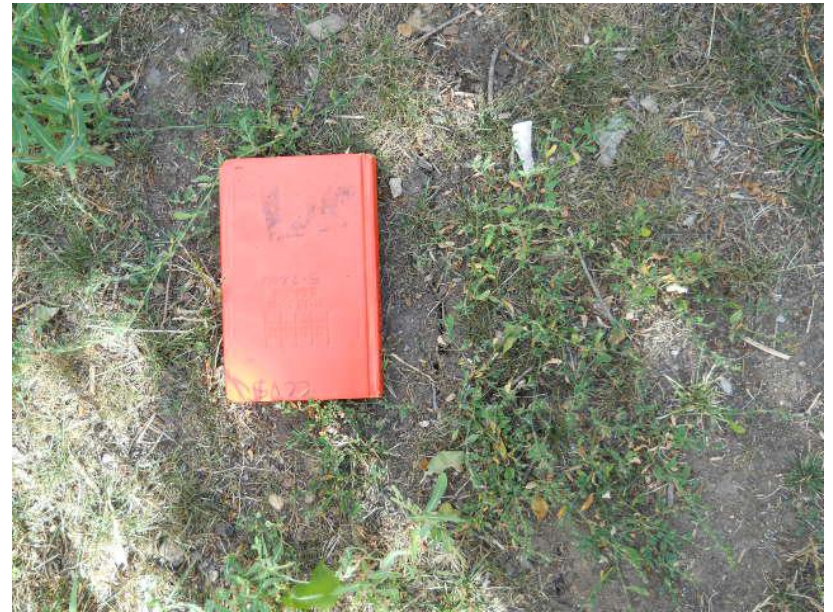
Open crack observed just right of field book  
518 Adams Avenue South, Red Lodge, MT  
2011-0068.JPG
