MONTANA RESOURCES, LLP YANKEE DOODLE TAILINGS IMPOUNDMENT

DAM BREACH RISK ASSESSMENT

VA101-126/12-3
Rev 3
March 13, 2018

**DAM BREACH RISK ASSESSMENT
VA101-126/12-3**

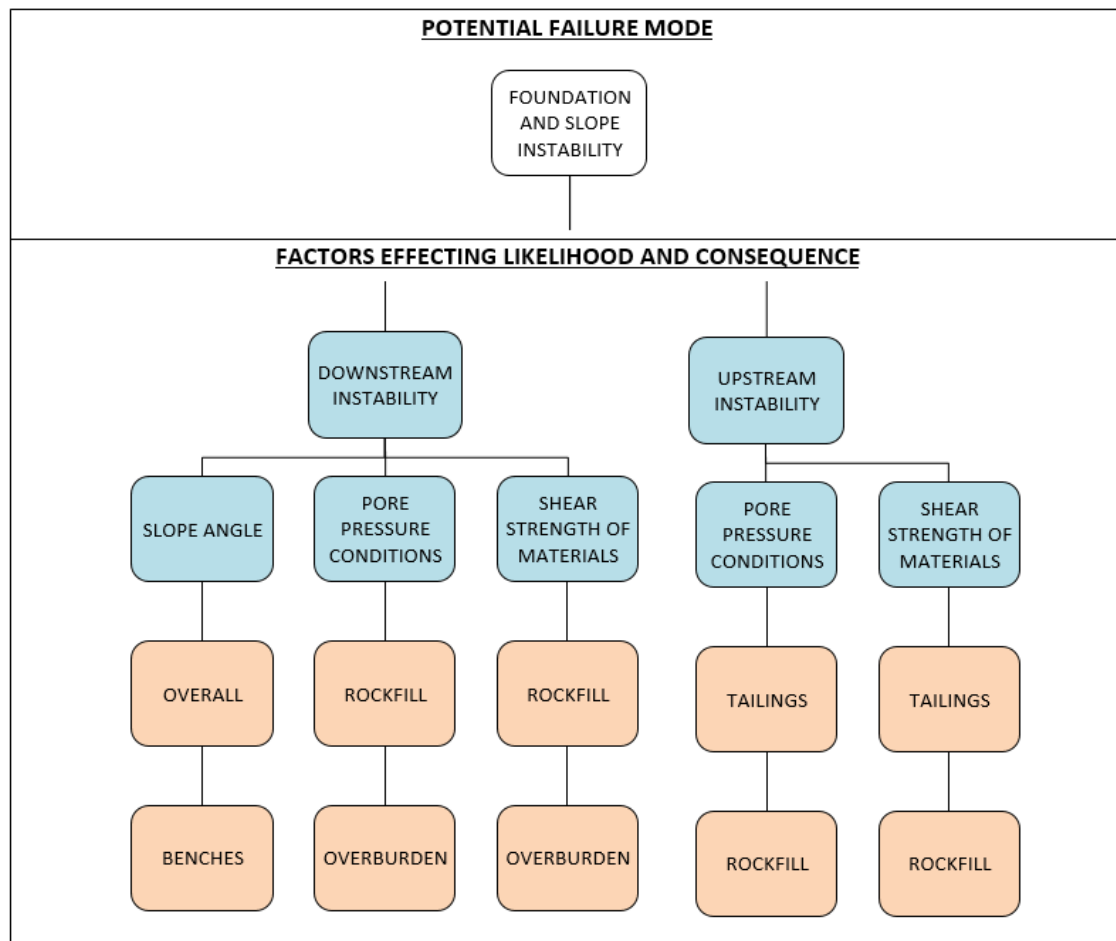
Figure 3.3 Factors Affecting Foundation and Slope Stability

The FS against foundation or slope instability is dependent on a number of factors. Figure 3.3 shows a summary of the factors affecting static slope stability.

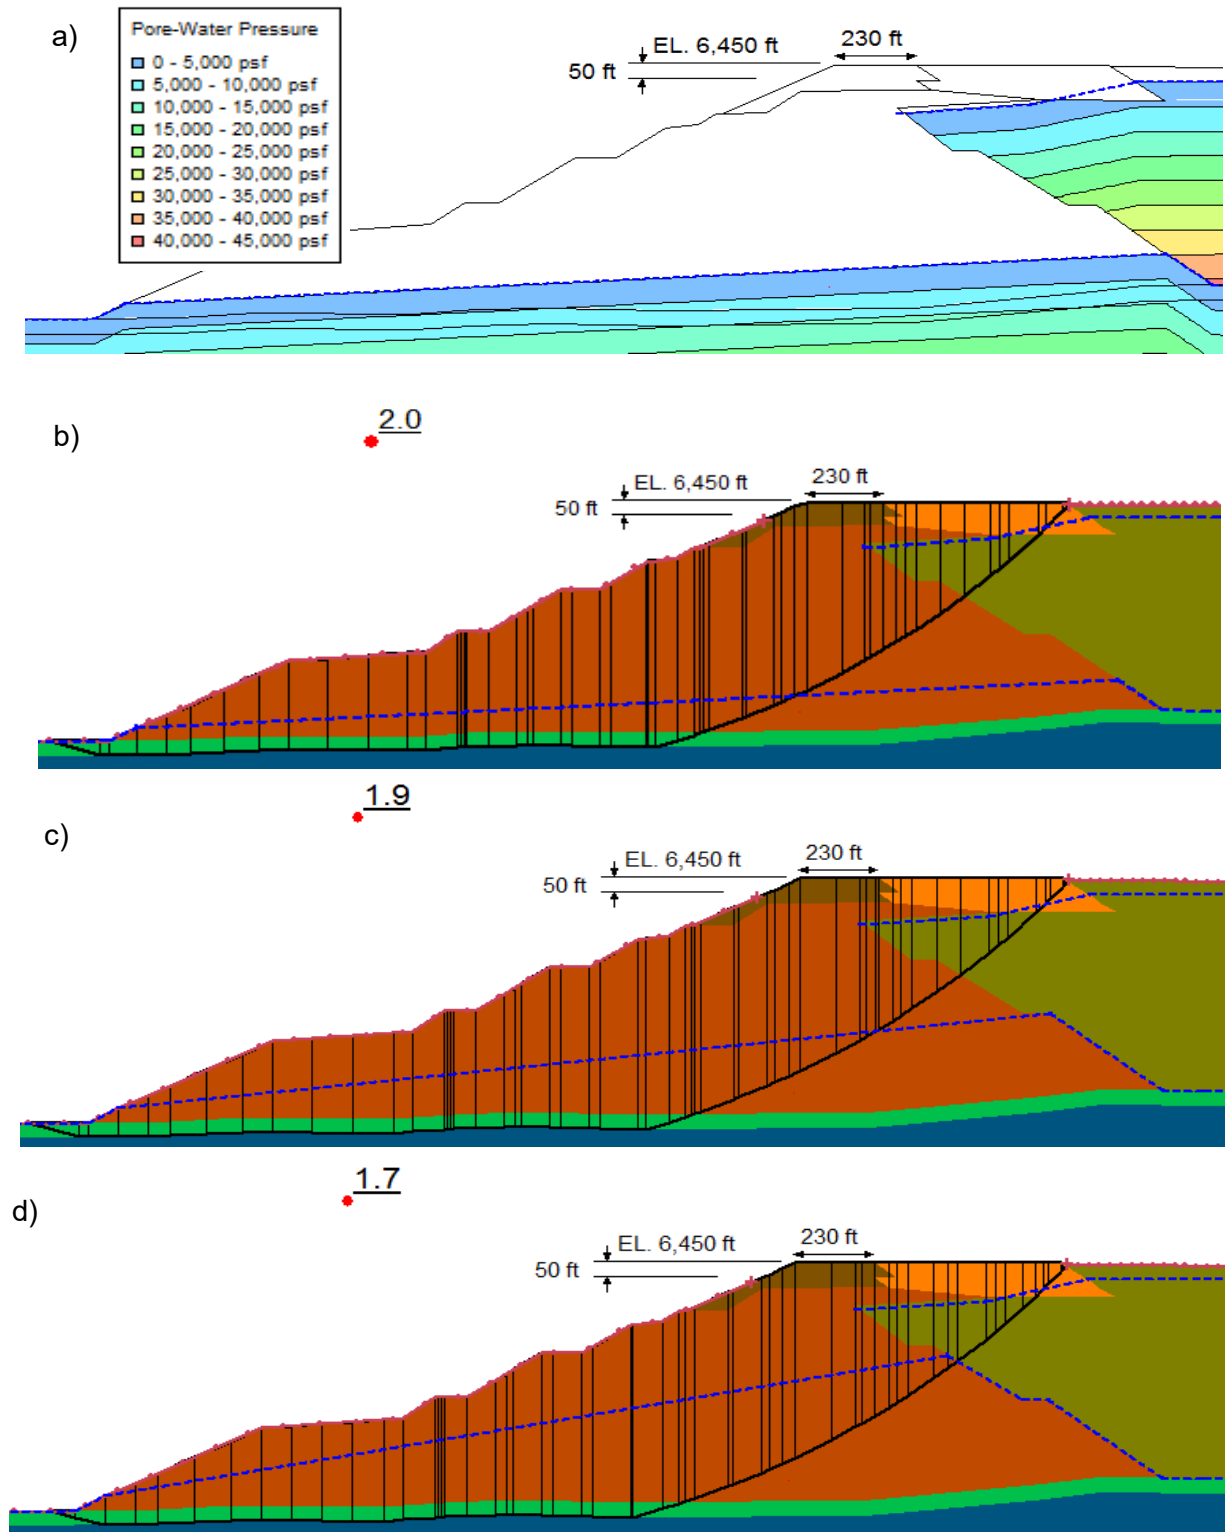
The sensitivity of the slope stability FS to pore pressure conditions was evaluated by manipulating the pore pressure conditions in the lower bench of the embankment and the foundation for Section 8+00W of the East-West Embankment. The piezometric surface was increased to mimic a static rise in pore pressures. The analysis was performed by incrementally increasing the piezometric line in the embankment on the upstream side as indicated on Figure 3.4. These analyses were used to evaluate the effect of pore pressure conditions on global stability of the embankment. The calculated FS are included in Table 3.4. ▲ R2

- a) PIEZOMETRIC CONDITIONS APPLIED IN SLOPE/W BASE CASE.
 b) FACTOR OF SAFETY (FS) CALCULATED FOR SLOPE/W BASE CASE.
 c) SENSITIVITY OF FS TO 150 FT STATIC PORE PRESSURE RISE.
 d) SENSITIVITY OF FS TO 300 FT STATIC PORE PRESSURE RISE.

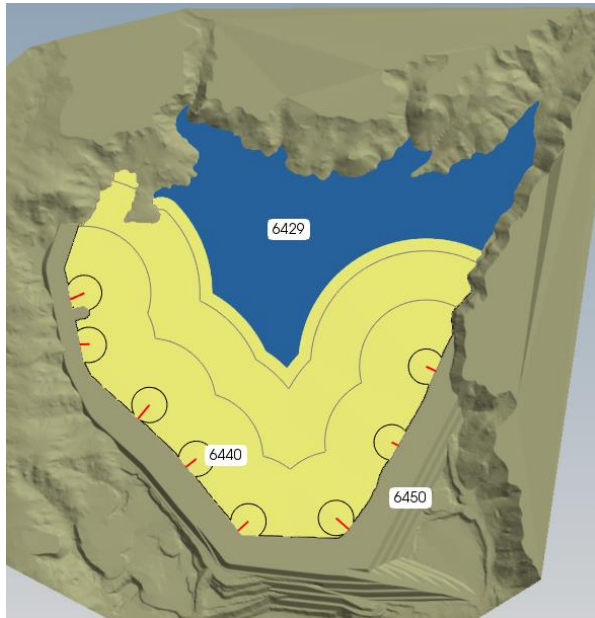
Normal Operating Conditions
Pond Volume - 25,000 acre-ft
Beach Length⁴ ~ 3,500 ft

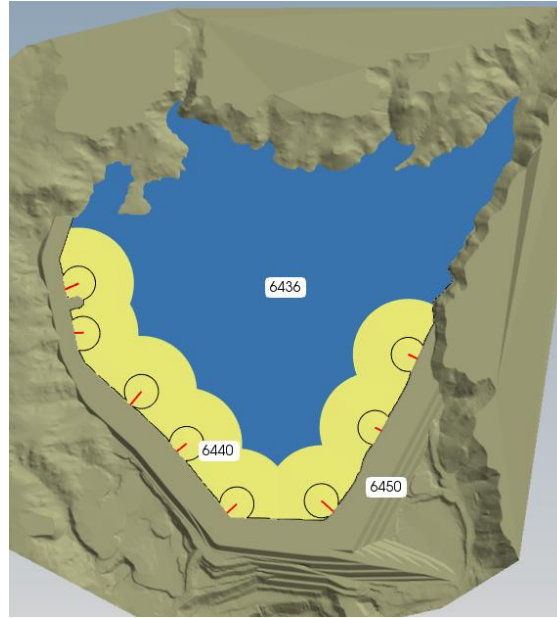
1 in 1,000 Year 30-day Rainfall Event
Total Volume - 31,500 acre-ft
Beach Length⁴ ~ 1,500 ft

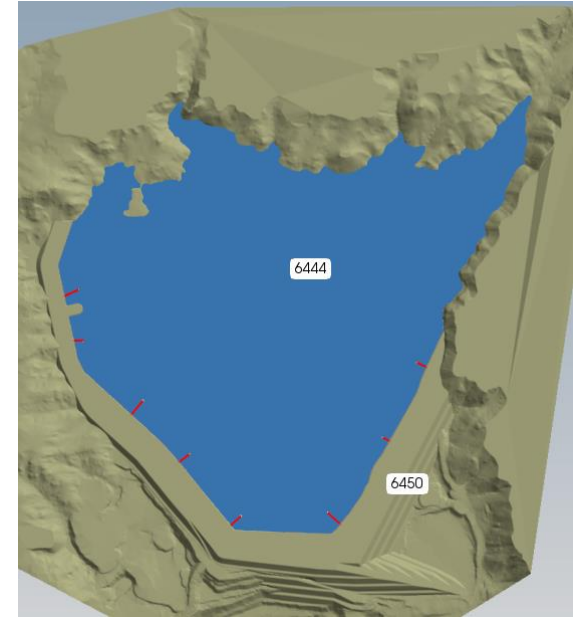
The results of the flood modelling indicate that under these flood conditions the pond will rise above normal operating level and remain below the embankment crest. Therefore, failure due to overtopping is 'Very Low'. In summary, the risk ratings for flood-induced overtopping of the embankments are as follows:

- Probability of Loading Condition: **Very Rare** for the PMF, and **Unlikely** for the 1 in 1,000 Year 30 Day Rainfall
- Probability of Coincident Failure: **Very Low**
- Consequences of Failure: **Catastrophic**

PMF Event
Total Volume - 45,000 acre-ft
Pond Against Embankment

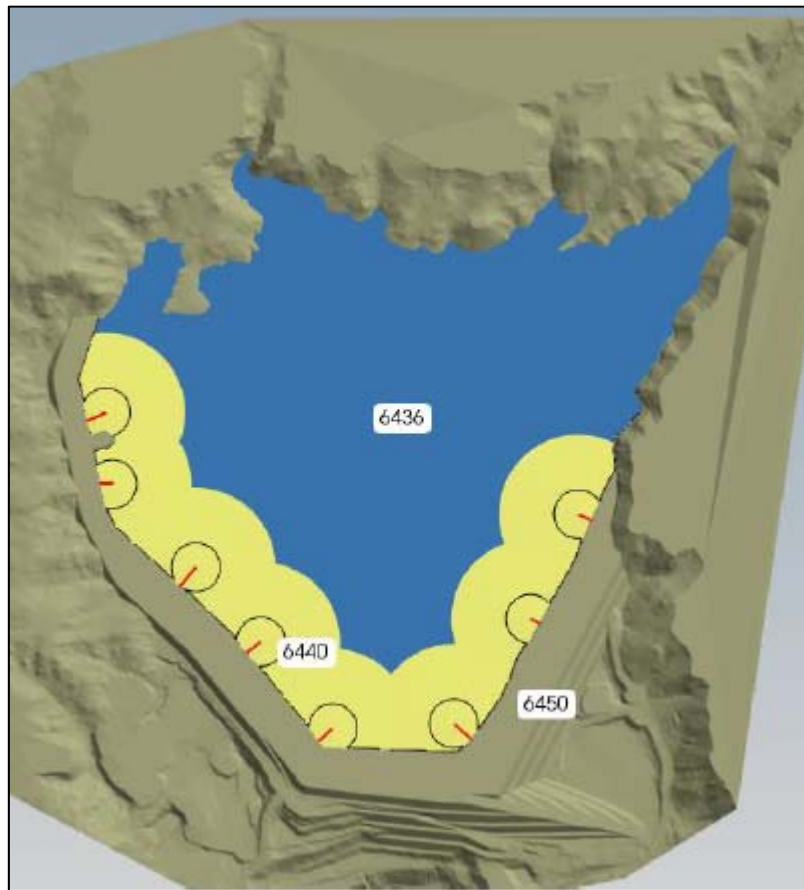
Figure 5.1 Modelled Pond Extents for 1 in 1,000 Year Event

- Probability of Loading Condition: **Unlikely**
- Probability of Coincident Failure: **Low**
- Consequences of Failure: **Minor to Catastrophic**

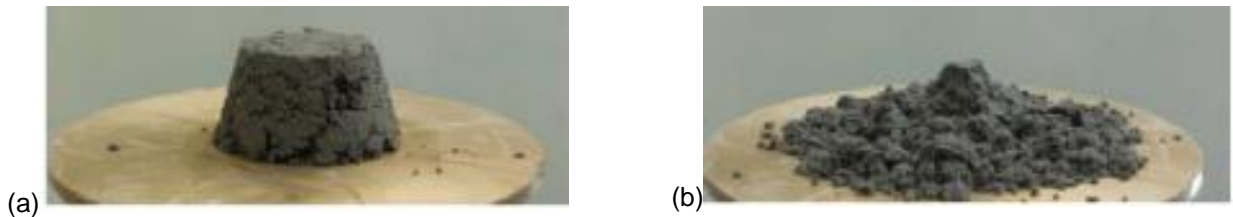
Figure 11 TML Test Specimen showing fragmentation (a) before test and (b) at completion

Typical photos of the TML tests for the tailings samples are shown on Figure 11 and Figure 12. The tests begin with a truncated circular pyramid of compacted tailings that is statically stable. The specimen diameter increases as the specimen and flow table shake. The diameter increase occurs from specimen fragmentation at low moisture contents (Figure 11) and due to liquefaction and viscous spreading at higher moisture contents (Figure 12).

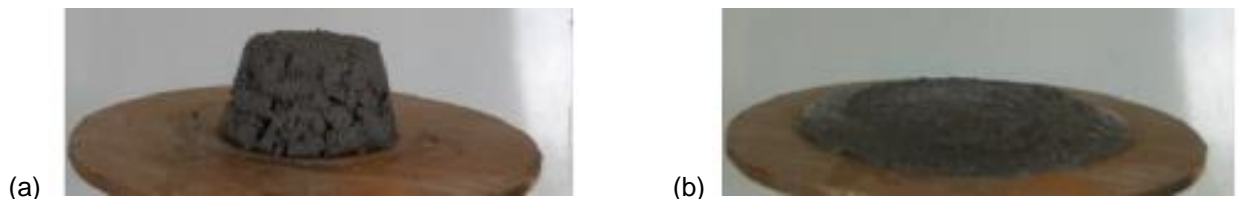
Figure 12 TML Test Specimen showing liquefaction (a) before test and (b) at completion

Photographs of the TML testwork for each sample are provided in Appendix B. The photographs indicate that isolated liquefaction begins at approximately 23% moisture content, with deformation characterized by slow, highly viscous flow deformation (similar to squeezed mayonnaise). Full liquefaction resulting in less viscous fluid-like flow of the whole specimen (similar to squeezed ketchup) did not occur until the moisture content was increased to

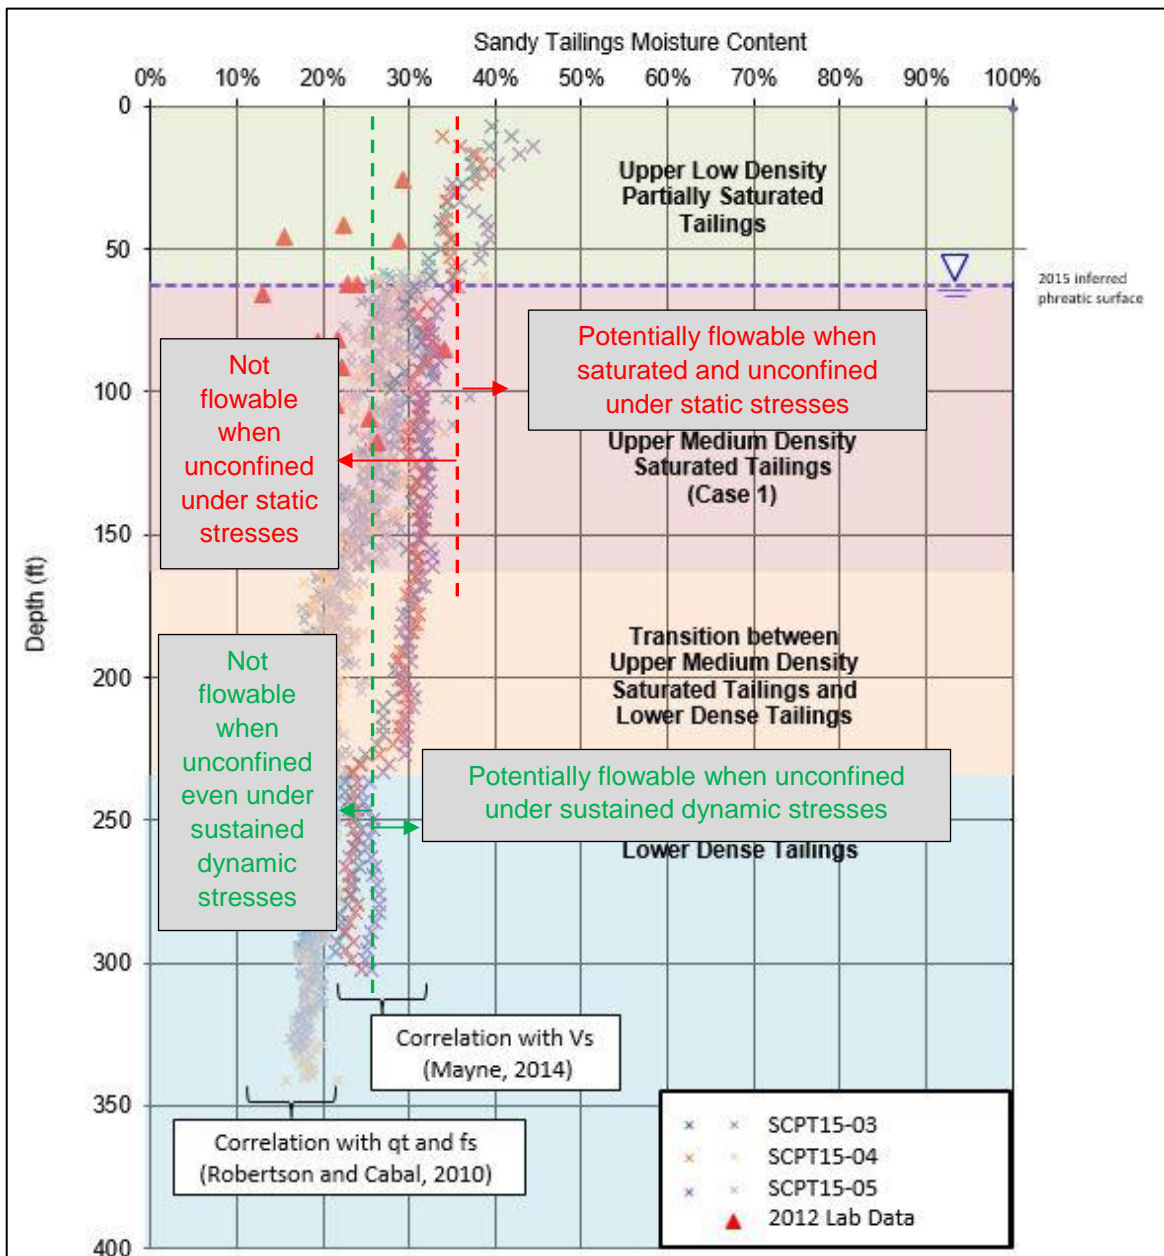
Figure 13 Silty Sand Tailings Flowability Potential

The potential for the tailings to flow due to static and dynamic stresses can be evaluated based on the inferred in-situ saturated moisture content from the CPT soundings and the laboratory tailings characterization testing. The tailings flowability testwork was completed at low confining stresses equivalent to a maximum of 1 m of cover. The results are judged representative of the potential static and dynamic behaviour of the tailings in the unlikely scenario that the tailings become unconfined and need to be self-supporting (i.e. the vertical and horizontal confining stresses from overburden loading and/or embankment confinement were instantaneously removed). A comparison between the moisture content of the tailings and interpretation of the results of the rheology and TML testing is shown on Figure 13.

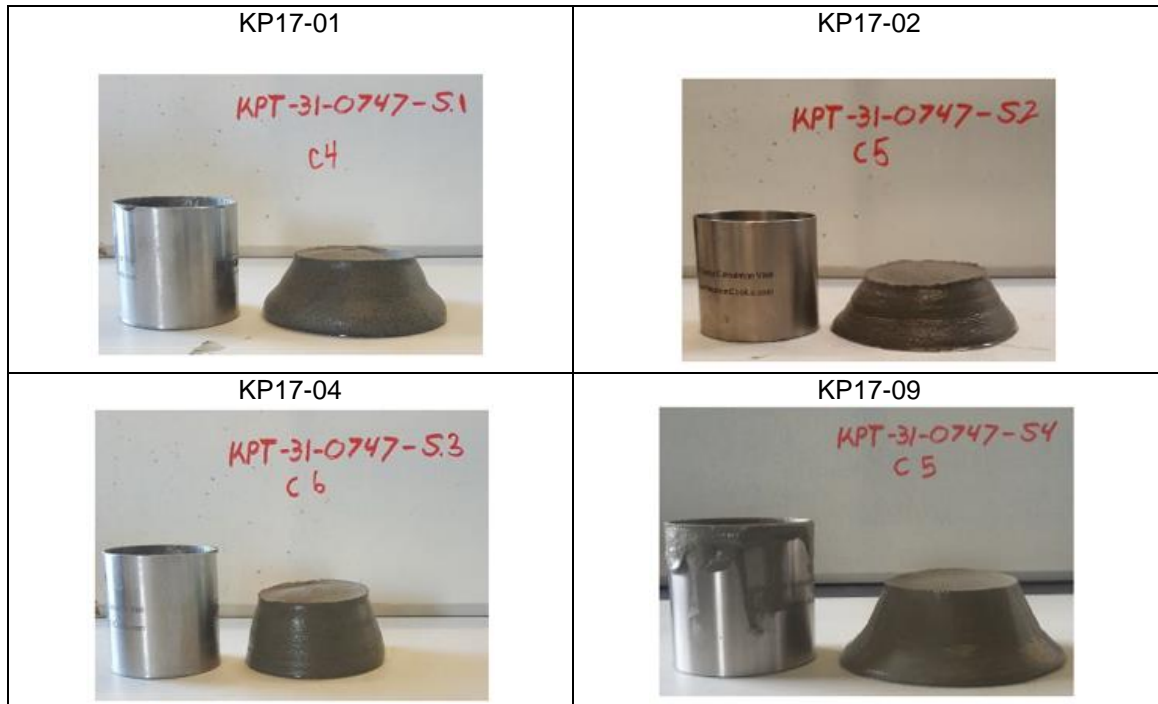
Figure 14 Static Angle of Repose for Silty Sand Tailings with 35% Moisture Content (100 Pa Yield Stress)

The static angle of repose (i.e. Factor of Safety of 1.0) for tailings at 35% moisture content (corresponding to approximately 100 Pa yield stress) is approximately 45 degrees (1H:1V) or greater at low effective stresses as illustrated on Figure 14.

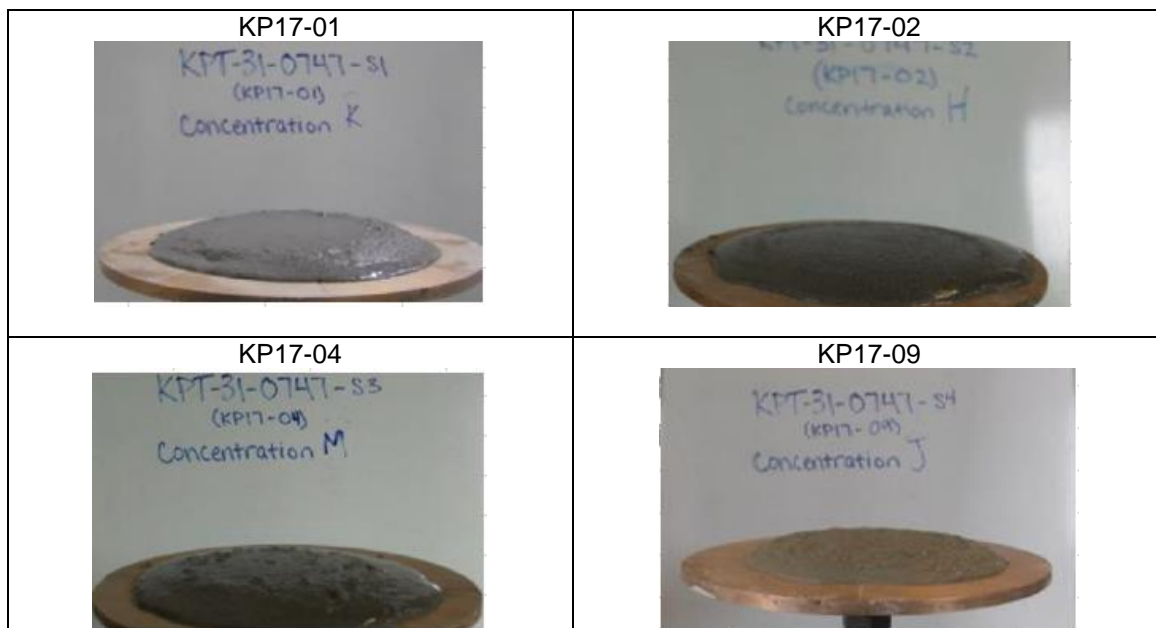
Figure 15 Dynamic Angle of Repose for Silty Sand Tailings with 25% Moisture Content

The dynamic angle of repose, which may occur if the tailings liquefy and are allowed to flow, varies from approximately 10 to 20% for these tailings at 25% moisture content as shown on Figure 15 and is expected to decrease as the moisture content of the tailings increases.

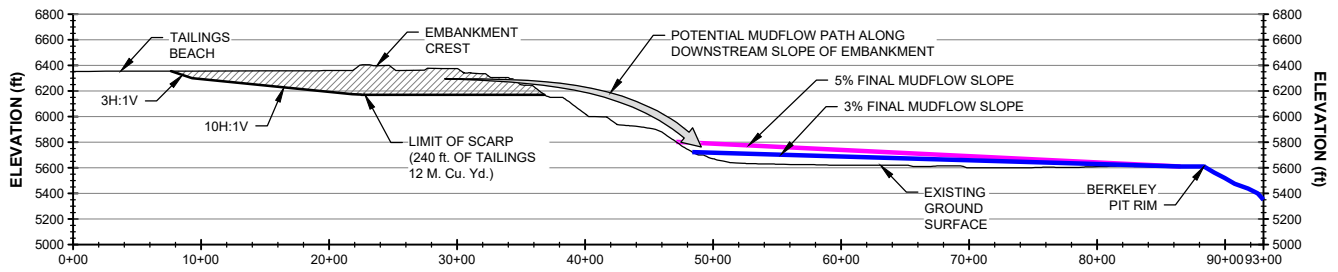
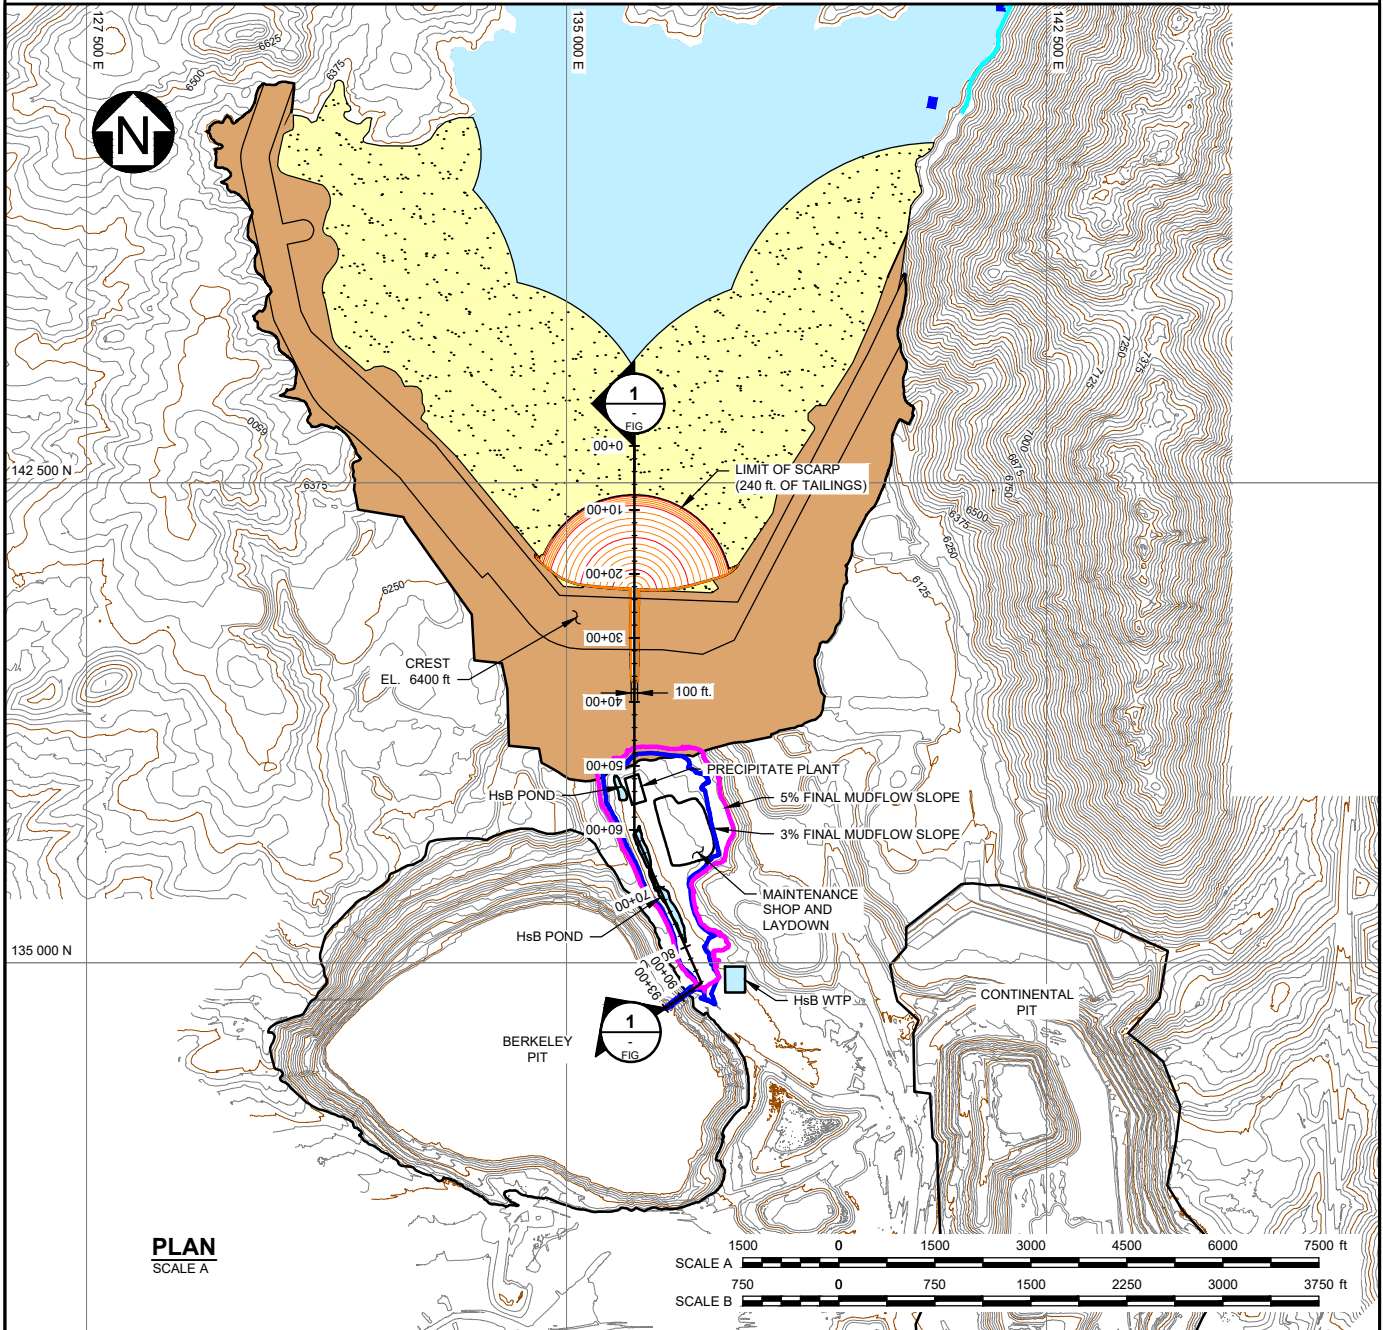
1
FIG
SECTION
PROFILE ALONG POTENTIAL MUDFLOW PATH
SCALE B

The extents of this hypothetical mudflow would be limited to within the project area. The hypothetical mudflow would flow down gradient towards Berkeley Pit. The geometric conditions indicate that the mudflow would pass through the Horseshoe Bend (HsB) Area and bypass the HsB Water Treatment Plant (WTP). The mudflow would stop moving adjacent to the WTP, prior to the Berkeley Pit. The maximum potential limits are illustrated on Figure 16. The total volume of the mudflow would be in the order of up to 12 million cubic yards of tailings for a hypothetical 240 ft deep scarp. This hypothetical event would be preceded by an extreme earthquake ground motion directly in the vicinity of the project, which would initiate emergency response procedures even prior to the possible initiation of described potential consequences.
