**ATTACHMENT A – ANALYSIS OF BASE PARAMETER DATA AND EROSION  
INVENTORY DATA FOR SEDIMENT TMDL DEVELOPMENT WITHIN THE  
FLINT CREEK TPA**

# **ANALYSIS OF BASE PARAMETER DATA AND EROSION INVENTORY DATA FOR SEDIMENT TMDL DEVELOPMENT WITHIN THE FLINT CREEK TPA**

**Water & Environmental Technologies, PC**  
480 East Park Street, #200  
Butte, MT 59701

February 2010

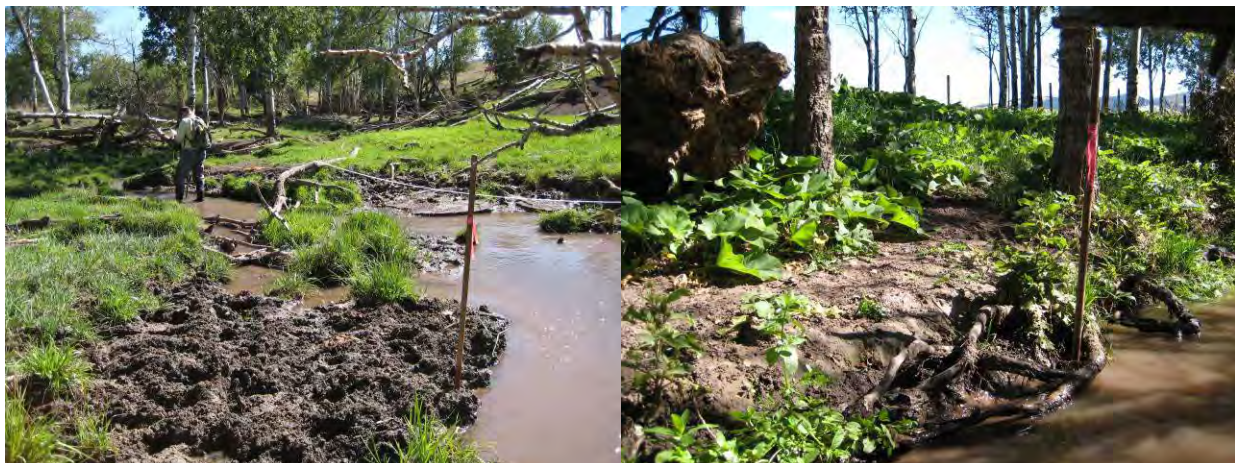
Eroding banks are generally similar throughout the reach with major pugging and hummocking. Three bank types were identified in this reach including near vertical banks in downcutting straight sections, exposed banks on outside meander bends, and the primary type included low angle banks that were trodden down by cattle. Typical eroding streambank conditions are depicted for this reach in **Figure 4-1** and sediment loading results are provided in **Table 4-5**.

**Figure 4-1. Typical eroding streambank conditions in Barnes Creek Reach 11-01.**

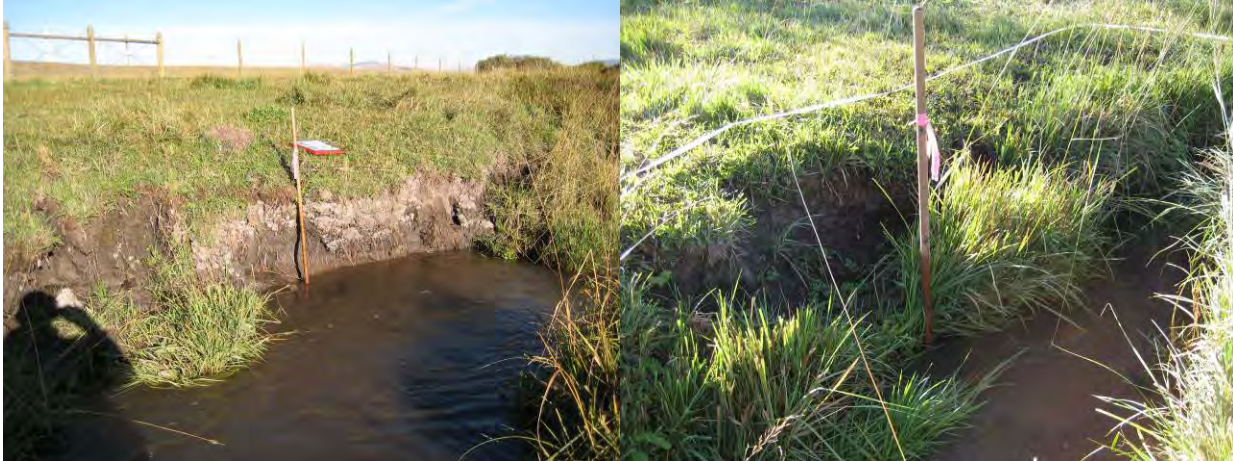
Three primary bank types were identified in this reach, including near vertical banks on meander bends, banks that were trodden by cattle, and one low angle bank at a cattle crossing. Typical eroding streambank conditions are depicted in **Figure 4-2** and sediment loading results are provided in **Table 4-5**.

**Figure 4-2. Typical eroding streambank conditions in Barnes Creek Reach 13-01.**

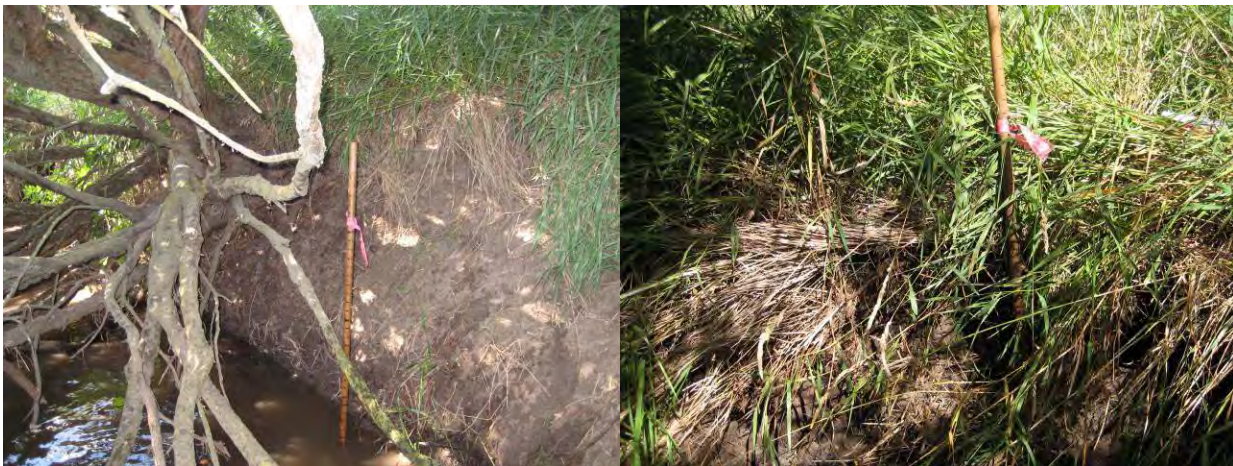
Three primary bank types were identified in this reach, including two actively eroding types and a heavily vegetated slowly eroding bank type. Most streambank erosion was associated with large woody debris. Bank composition was primarily fines which create a stable bank. Typical eroding streambank conditions are depicted in **Figure 4-3** and sediment loading results are provided in **Table 4-5**.

**Figure 4-3. Typical eroding streambank conditions in Barnes Creek Reach 13-03.**

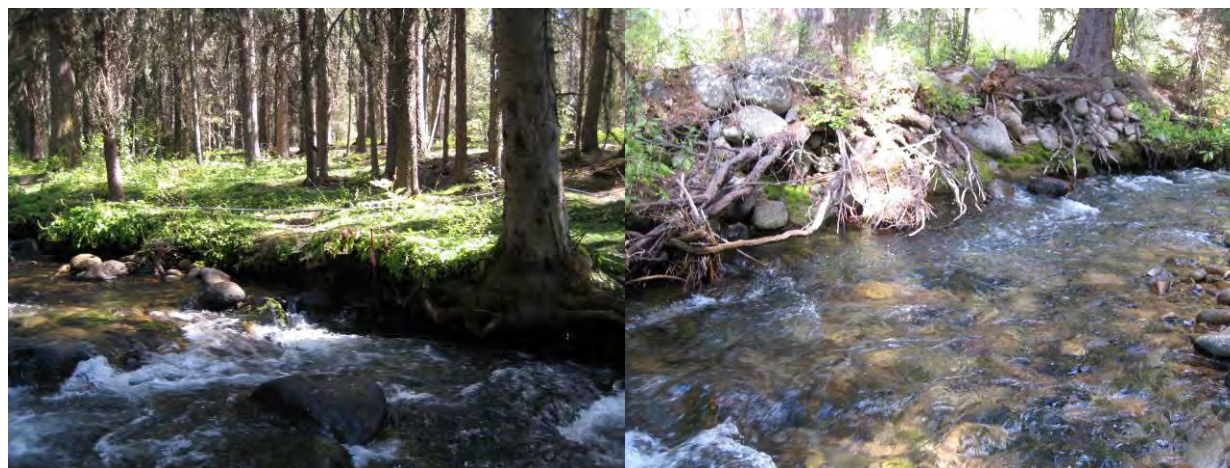
Only three slowly eroding banks were identified in this reach. Banks are well armored with large cobbles and boulders, and erosion sources are 100% natural. Eroding banks typically occur at base of large conifers. Typical eroding streambank conditions are depicted for this reach in **Figure 4-4** and sediment loading results are provided in **Table 4-6**.

**Figure 4-4. Typical eroding streambank conditions in Boulder Creek Reach 16-01.**

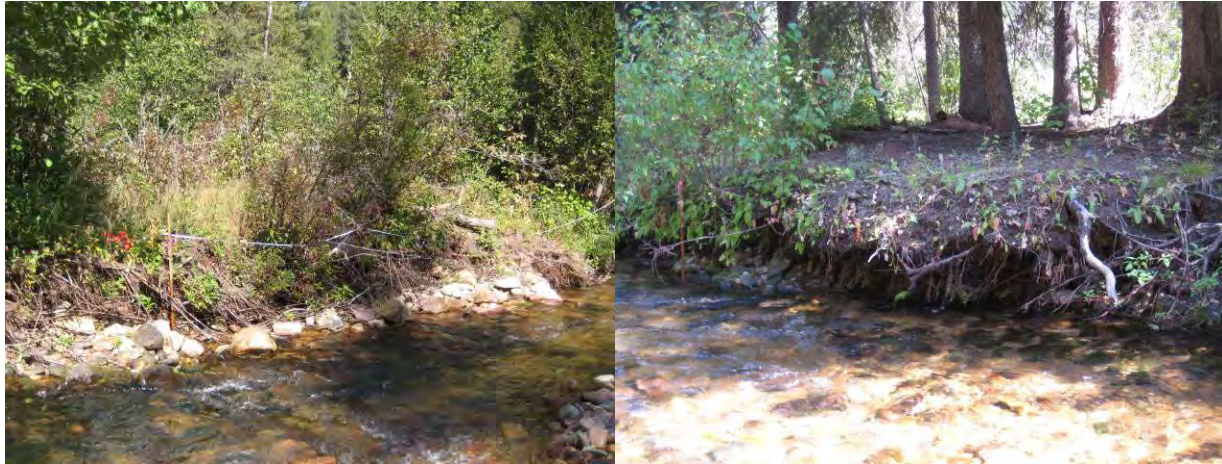
root wads. Typical eroding streambank conditions are depicted for this reach in **Figure 4-5** and sediment loading results are provided in **Table 4-6**.

**Figure 4-5. Typical eroding streambank conditions in Boulder Creek Reach 21-02.**

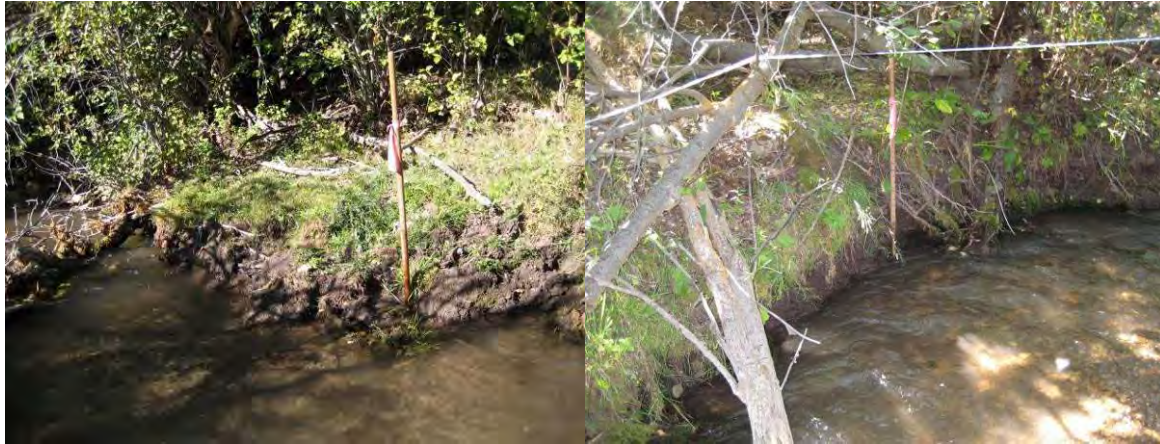
This site has 18 total eroding banks and 3 primary bank types, including slowly eroding banks that are near vertical and held together with vegetation or clay, heavily trampled low angle banks with pugging and hummocking, and one trampled bank on an outside bend. Typical eroding streambank conditions are depicted for this reach in **Figure 4-6** and sediment loading results are provided in **Table 4-7**.

Figure 4-6. Typical eroding streambank conditions in Douglas Creek (North) Reach 07-01.

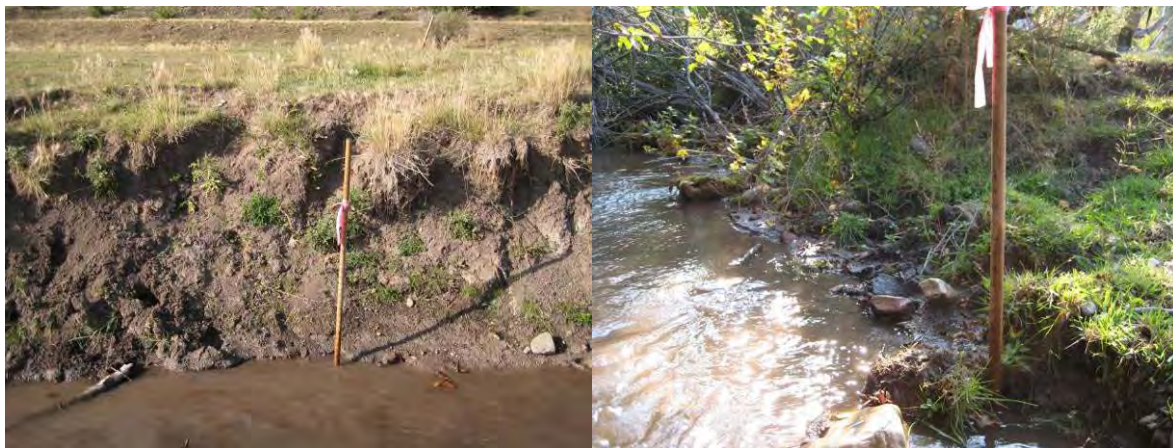
This site has 15 eroding streambanks and 2 primary bank types, including tall moderately-angled actively eroding banks, and short near-vertical banks typically occurring in slower water. Typical eroding streambank conditions are depicted for this reach in **Figure 4-7** and sediment loading results are provided in **Table 4-7**.

Figure 4-7. Typical eroding streambank conditions in Douglas Creek (North) Reach 08-02.

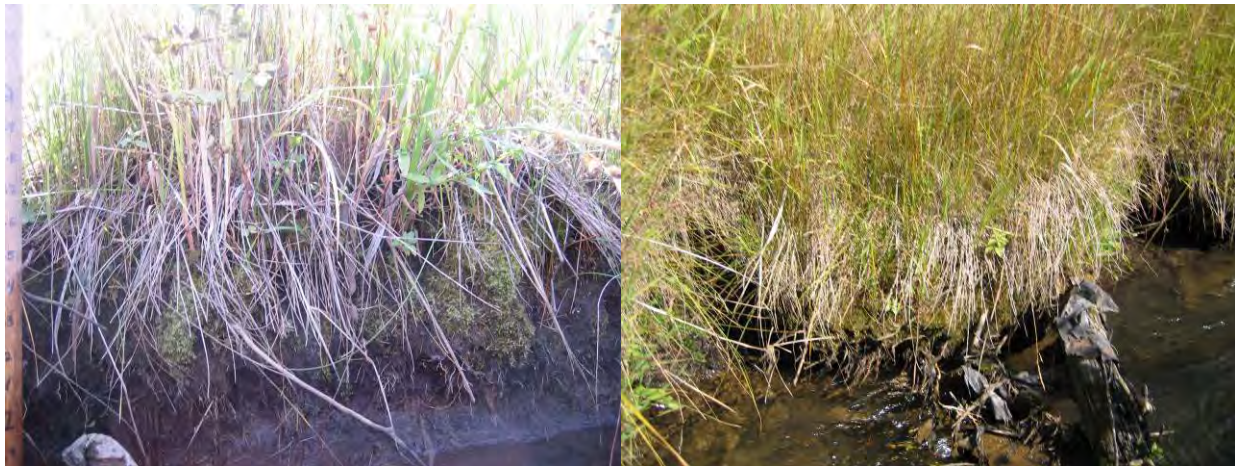
One 500’ reach was evaluated on Douglas Creek (South). This reach is straight and channelized, and much of the reach is alternating between near vertical and undercut slowly eroding banks; however, bank composition is primarily fine material. Typical eroding streambank conditions are depicted in **Figure 4-8** and sediment loading results are provided in **Table 4-8**.

**Figure 4-8. Typical eroding streambank conditions in Douglas Creek (South) Reach 19-02.**

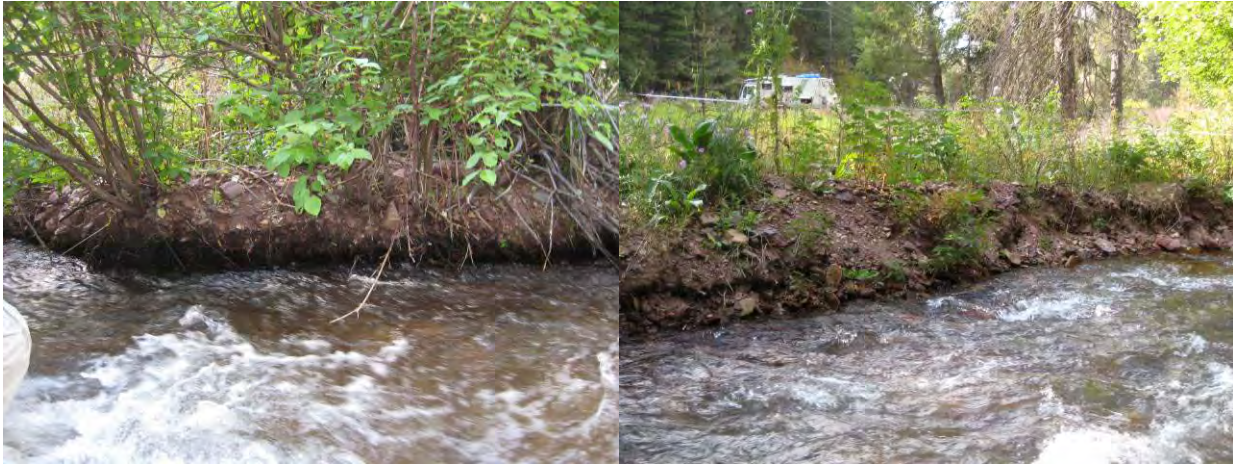
This reach recorded 7 eroding streambanks and 2 primary bank types, including actively eroding banks with low root density and exposed cobble soil, and slowly eroding banks (sometimes undercut) in forested areas with high root density and fine substrate. Typical eroding streambank conditions are depicted in **Figure 4-9** and sediment loading results are provided in **Table 4-9**.

**Figure 4-9. Typical eroding streambank conditions in Flint Creek Reach 06-02.**

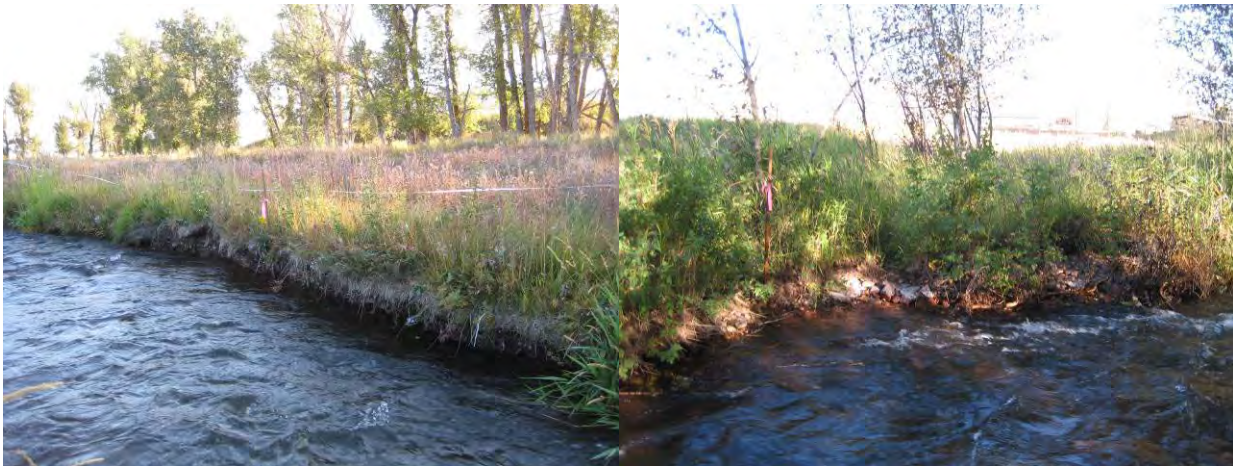
This reach has 7 eroding banks and 3 primary eroding bank types, including actively eroding undercut banks with some cobble, actively eroding banks that are sloped or near vertical with fine bank material, and slowly eroding banks on outside meander bends with good protection from cobbles. Typical eroding streambank conditions are depicted in **Figure 4-10** and sediment loading results are provided in **Table 4-9**.

**Figure 4-10. Typical eroding streambank conditions in Flint Creek Reach 09-02.**

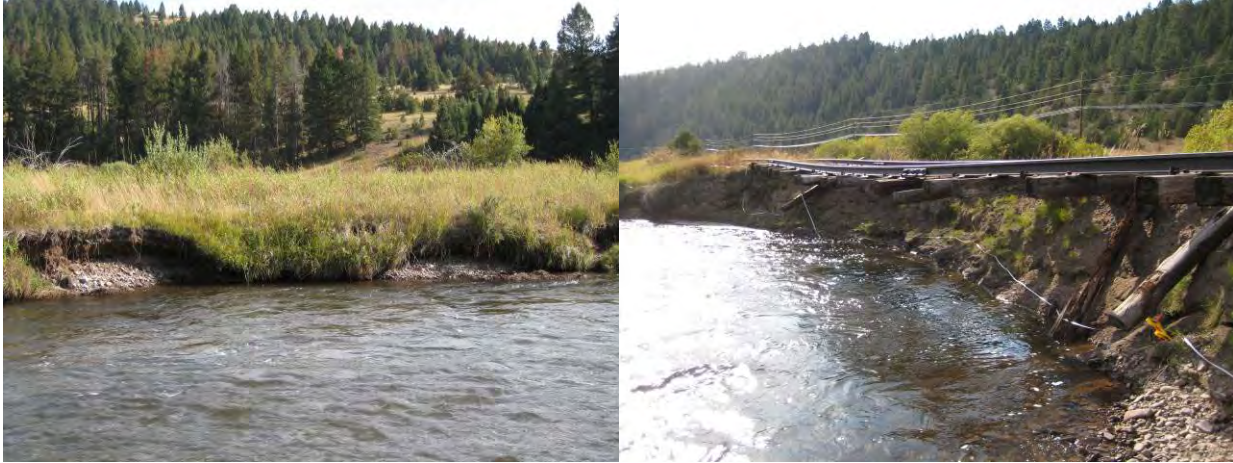
This reach has 9 long actively eroding streambanks and 3 primary bank types, including tall undercut banks primarily occurring on outside bends, tall sloped banks, and one very tall long bank that is undercutting an abandoned railroad bed. Typical eroding streambank conditions are depicted in **Figure 4-11** and sediment loading results are provided in **Table 4-9**.

**Figure 4-11. Typical eroding streambank conditions in Flint Creek Reach 11-01.**

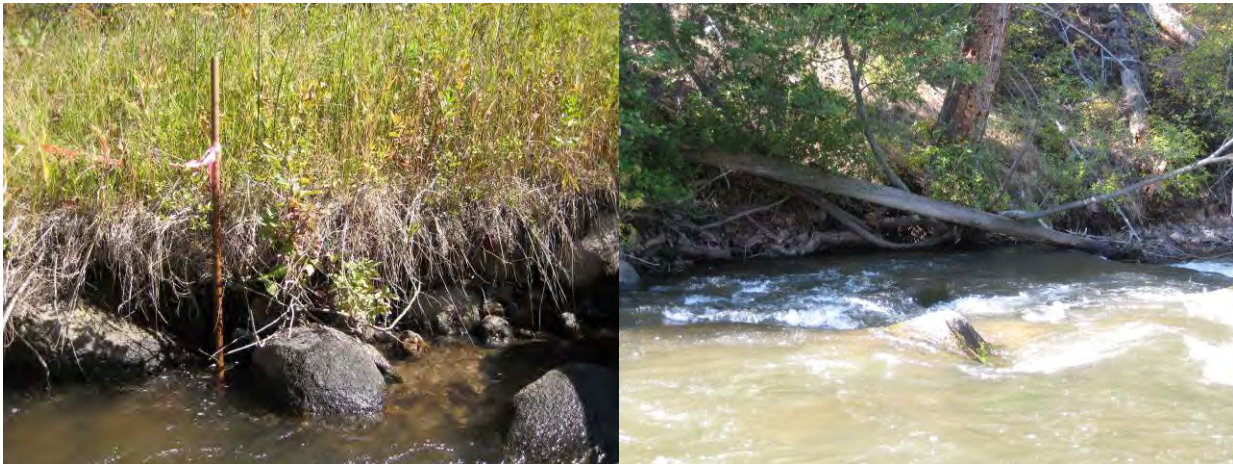
This site has very minimal streambank erosion with only two slowly eroding banks that are protected by cobble and dense roots. Typical eroding streambank conditions are depicted in **Figure 4-12** and sediment loading results are provided in **Table 4-9**.

**Figure 4-12. Typical eroding streambank conditions in Flint Creek Reach 11-04.**

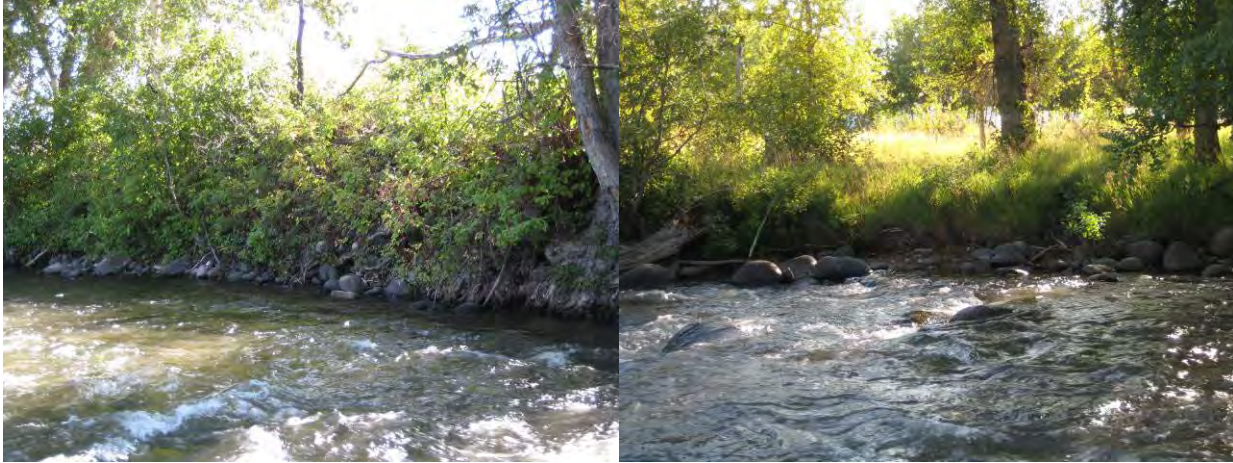
This reach has 8 slowly eroding banks and 2 primary bank types. One bank type is slightly undercut with cobble armor, and occurs in small areas throughout the reach where the bank is influenced by high stream velocities. The other bank type includes sloped banks downstream of inside bends that are also heavily protected by cobble. Typical eroding streambank conditions are depicted in **Figure 4-13** and sediment loading results are provided in **Table 4-9**.

**Figure 4-13. Typical eroding streambank conditions in Flint Creek Reach 17-01.**

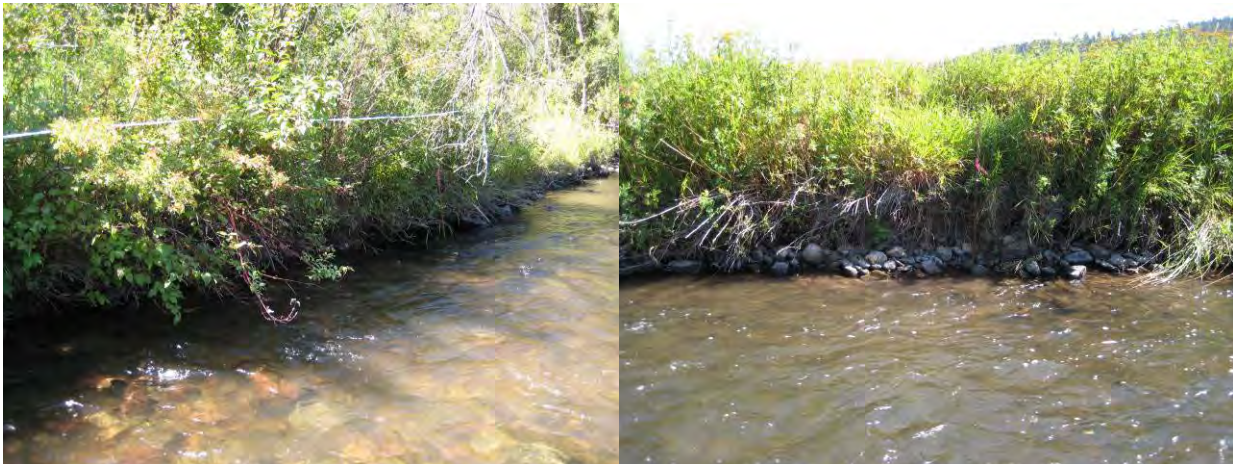
This reach has five slowly eroding banks of the same bank type. These banks are very stable, heavily armored, well vegetated, and have a dense root mass. Typical eroding streambank conditions are depicted in **Figure 4-14** and sediment loading results are provided in **Table 4-9**.

**Figure 4-14. Typical eroding streambank conditions in Flint Creek Reach 18-02.**

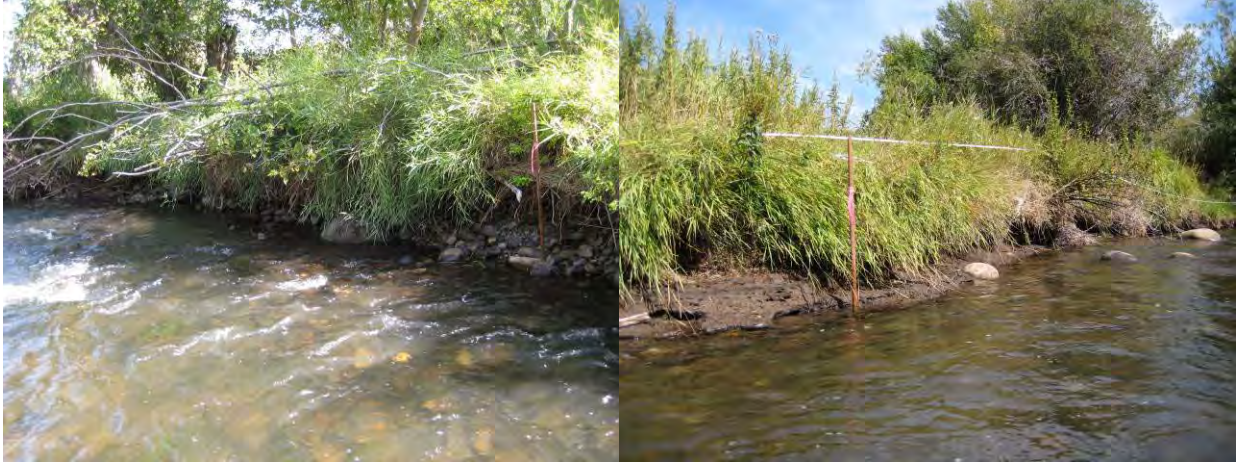
This reach has 7 eroding banks and 3 bank types, although most are slowly eroding undercut banks protected by woody debris. Most banks have cobble substrate, although one is composed of fine material and may occur in an area previously dammed by beavers. Typical eroding streambank conditions are depicted in **Figure 4-15** and sediment loading results are provided in **Table 4-9**.

**Figure 4-15. Typical eroding streambank conditions in Flint Creek Reach 18-05.**

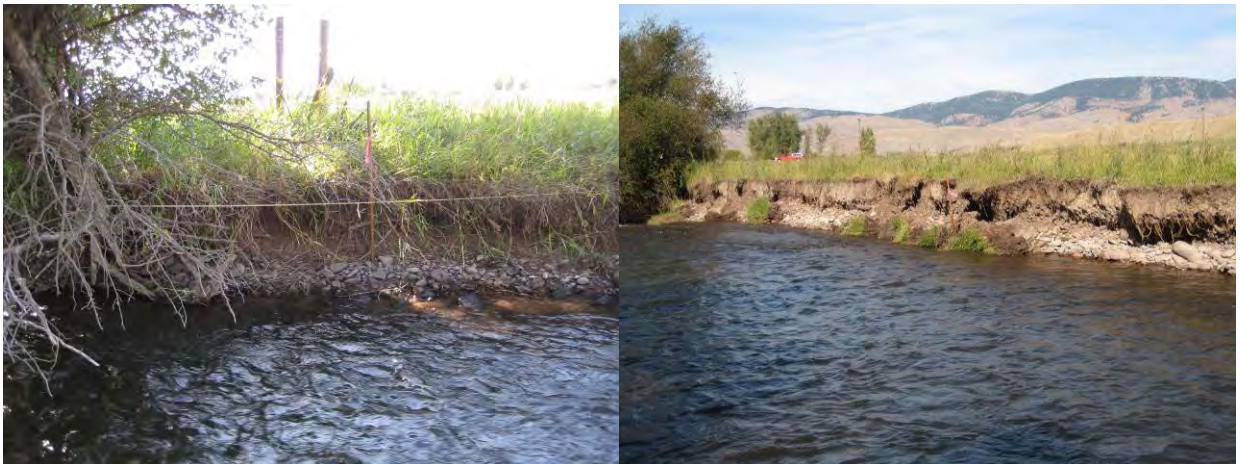
This reach has 7 eroding banks and 4 primary banks types including slowly eroding low angle banks with cobble, actively eroding near vertical banks with little vegetation, actively eroding near vertical banks with cobble, and actively eroding banks with rip-rap and concrete slabs for protection. Typical eroding streambank conditions are depicted in **Figure 4-16** and sediment loading results are provided in **Table 4-9**.

**Figure 4-16. Typical eroding streambank conditions in Flint Creek Reach 19-01.**

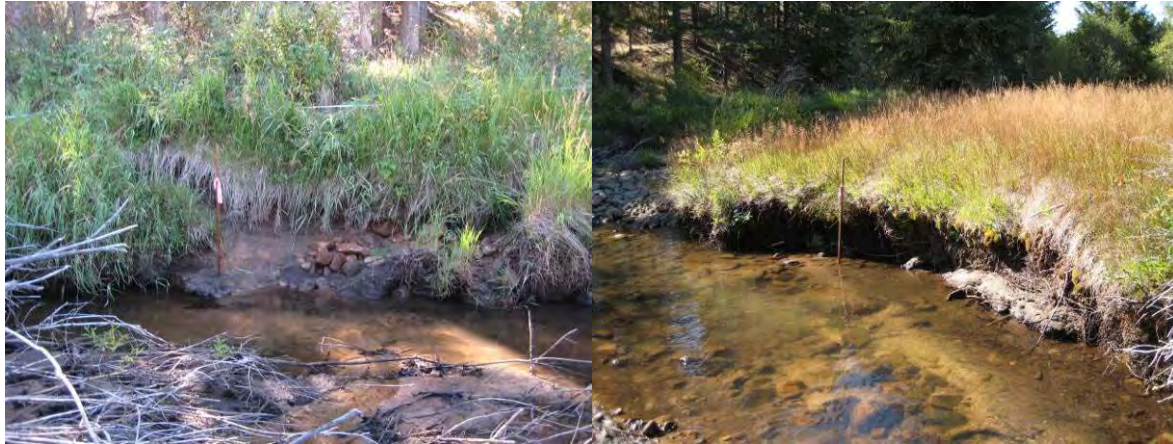
This reach has 12 eroding streambanks and 4 primary bank types, including slowly eroding near vertical banks, slowly eroding undercut banks, actively eroding tall banks with some vegetation, and tall actively eroding banks with mixed substrate and poor root density. Typical eroding streambank conditions are shown in **Figure 4-17** and sediment loading results are provided in **Table 4-10**.

Figure 4-17. Typical eroding streambank conditions in Fred Burr Creek Reach 29-02.

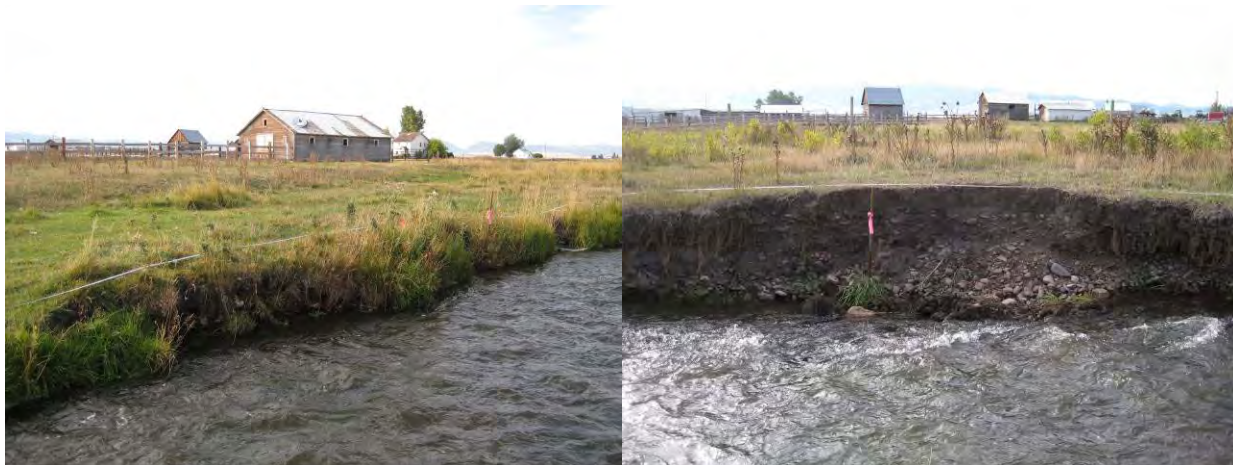
This reach has 6 eroding banks and 3 bank types, including short slowly eroding banks that are near vertical, undercut actively eroding banks, and tall actively eroding banks. All banks have some protection from cobble substrate. Typical eroding streambank conditions are depicted in **Figure 4-18** and sediment loading results are provided in **Table 4-11**.

Figure 4-18. Typical eroding streambank conditions in Lower Willow Creek Reach 02-05.

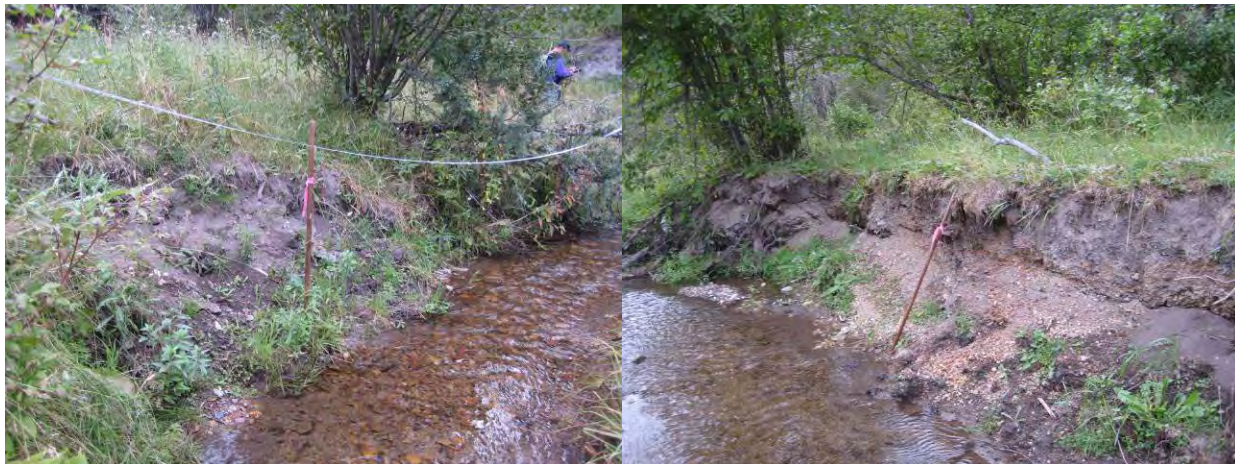
This reach has 10 actively eroding streambanks and 4 primary bank types, including banks with fine substrate and little vegetative cover, banks with fine substrate and some surface cover, stratified banks on outside meander bends, and a tall eroding bank under a tree. Eroding banks in this reach are quite tall for the size of the stream with little vegetative cover, low root density, and stratification of bank substrate. Typical eroding streambank conditions are depicted in **Figure 4-19** and sediment loading results are provided in **Table 4-12**.

**Figure 4-19. Typical eroding streambank conditions in Smart Creek Reach 13-01.**

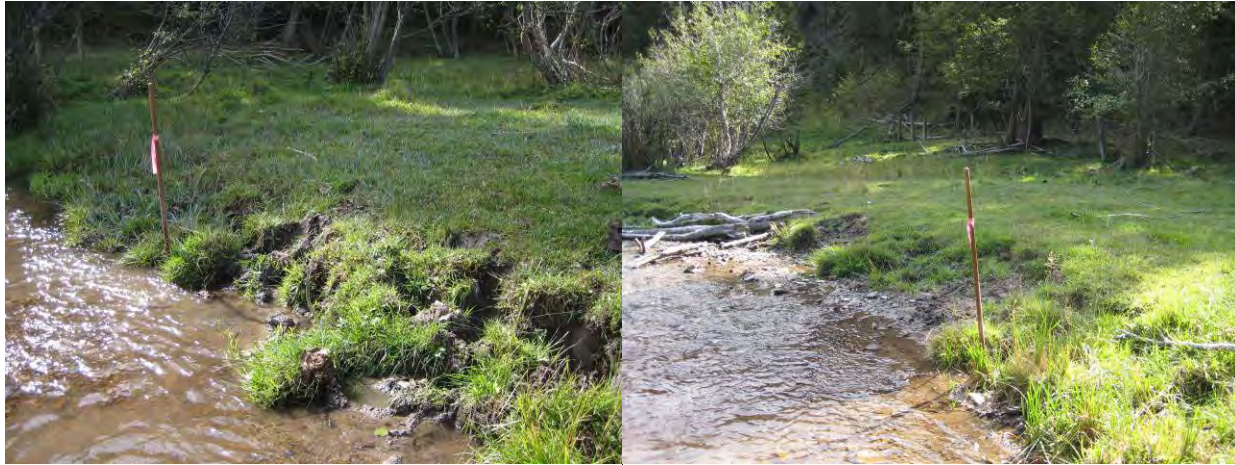
This reach is the unfenced section paired with fenced reach SMAR 18-01-2 upstream. This reach has 7 eroding banks and 2 bank types including slowly eroding low angle grassy banks that have been exposed to hoof shear, and actively eroding banks similar to those above but occurring on outside meander bends. Typical eroding streambank conditions are shown in **Figure 4-20** and sediment loading results are provided in **Table 4-12**.

**Figure 4-20. Typical eroding streambank conditions in Smart Creek Reach 18-01-1.**

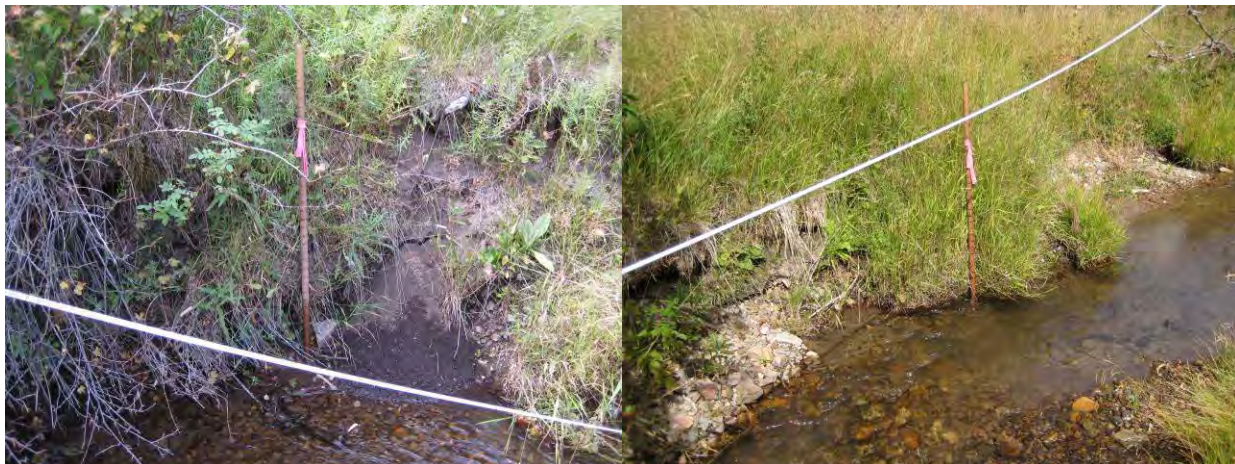
This reach has riparian fencing and is paired with unfenced reach SMAR 18-01-1 downstream. Only four eroding banks were recorded in this reach, including both active and slowly eroding types with good surface protection. Typical eroding streambank conditions are depicted in **Figure 4-21** and sediment loading results are provided in **Table 4-12**.

**Figure 4-21. Typical eroding streambank conditions in Smart Creek Reach 18-01-2.**

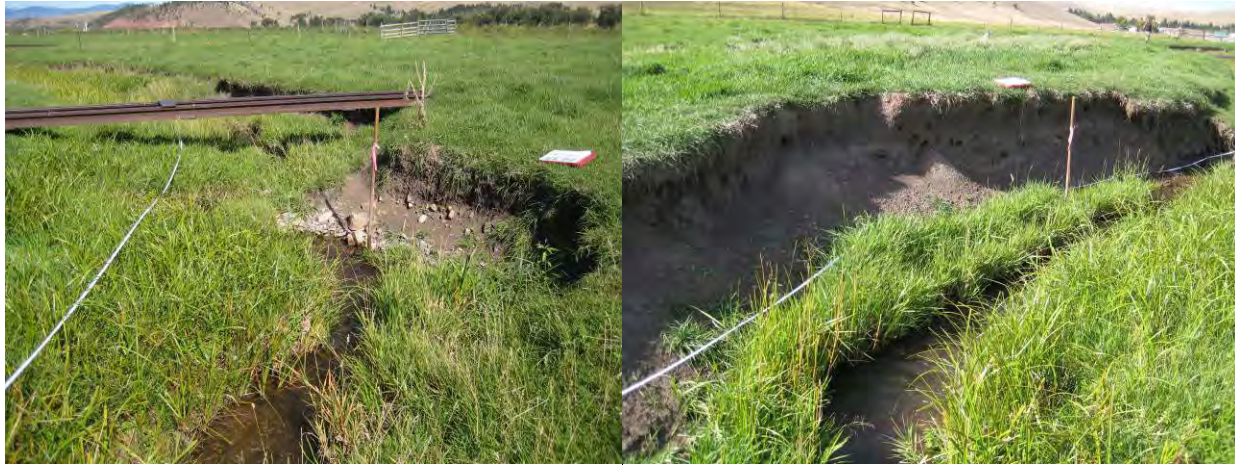
This reach has 12 eroding streambanks and 3 primary bank types, including actively eroding banks with moderate angle and fine substrate, actively eroding undercut banks with gravel and cobble substrate, and slowly eroding undercut banks occurring on outside bends where banks have previously slumped. Typical eroding streambank conditions are depicted in **Figure 4-22** and sediment loading results are provided in **Table 4-12**.

Figure 4-22. Typical eroding streambank conditions in Smart Creek Reach 21-01.

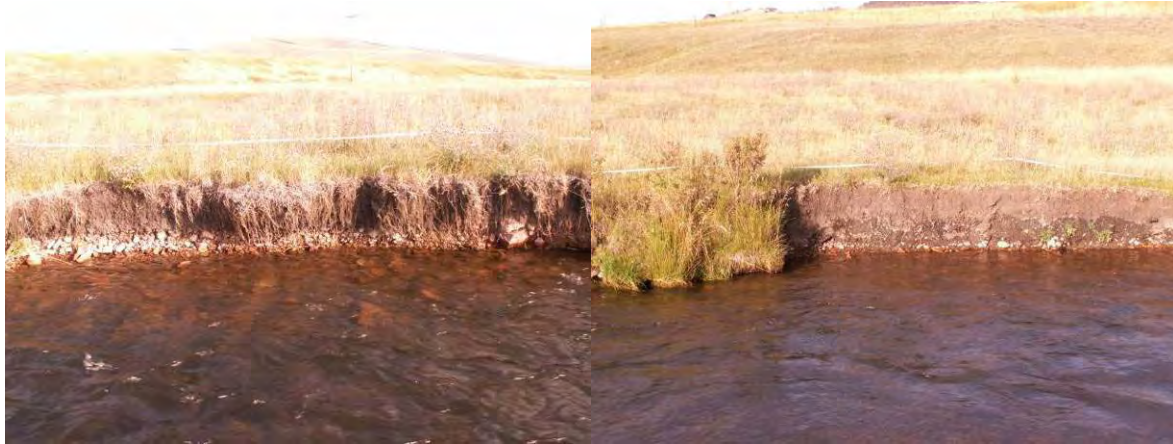
This reach is highly sinuous and has 10 eroding banks and 2 primary bank types, including slowly eroding undercut or near vertical banks that are well vegetated, and similar banks that have less vegetative protection that typically occur on outside meander bends with invasive plant species. Typical eroding streambank conditions are depicted in **Figure 4-23** and sediment loading results are provided in **Table 4-13**.

**Figure 4-23. Typical eroding streambank conditions in Trout Creek Reach 09-03.**

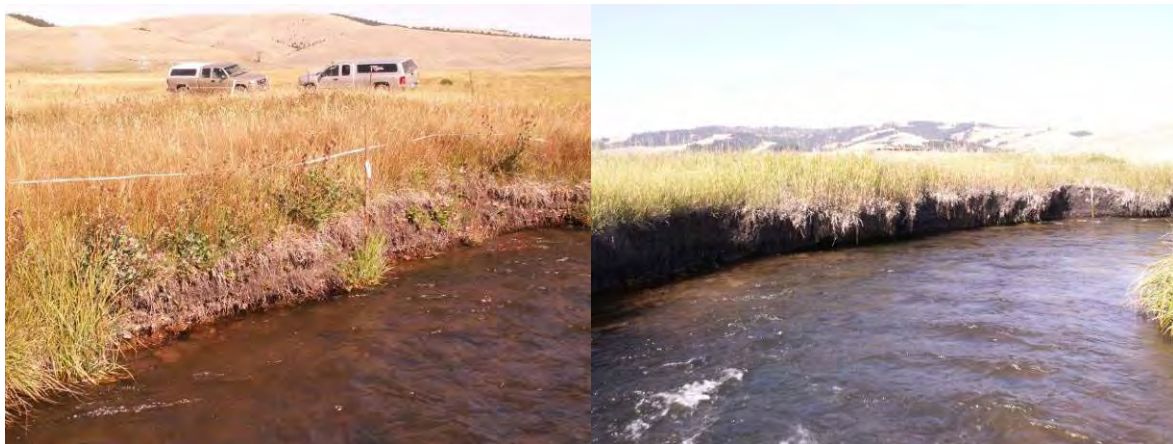
This reach has only two eroding streambanks which are actively eroding, near vertical, and have little surface protection. Typical eroding streambank conditions are depicted in **Figure 4-24** and sediment loading results are provided in **Table 4-13**.

**Figure 4-24. Typical eroding streambank conditions in Trout Creek Reach 10-01.**
