**BONNER MILL**  
**JUNE 2016 SEMIANNUAL REPOSITORY INSPECTION FORM**

**BONNER MILL  
SEPTEMBER 2016 SEMIANNUAL REPOSITORY INSPECTION  
FORM**

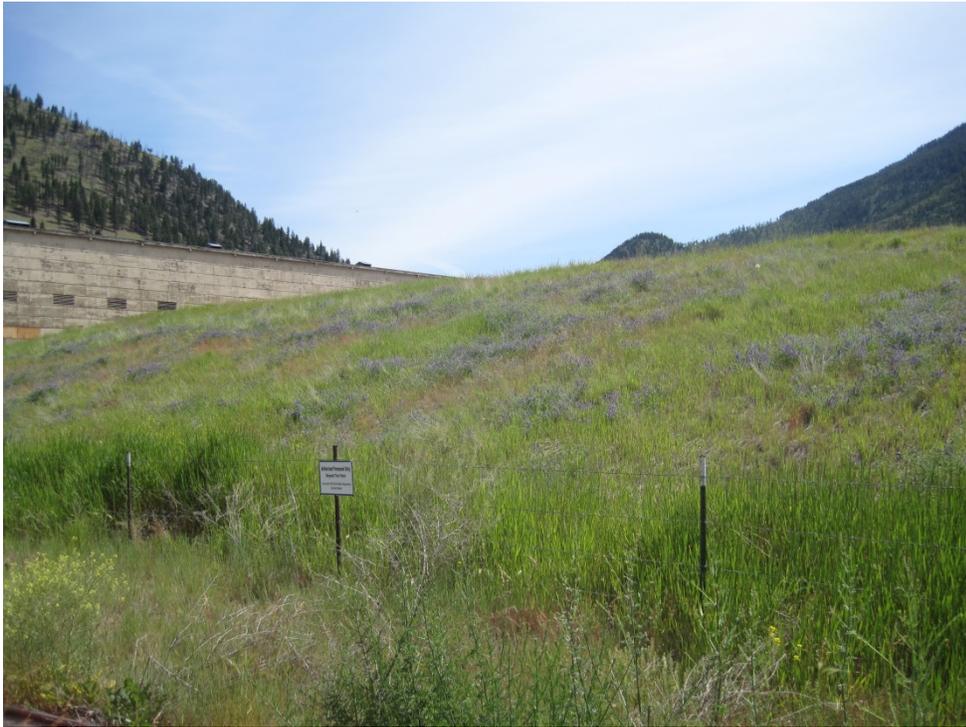
Photo 1. West slope looking NNE.

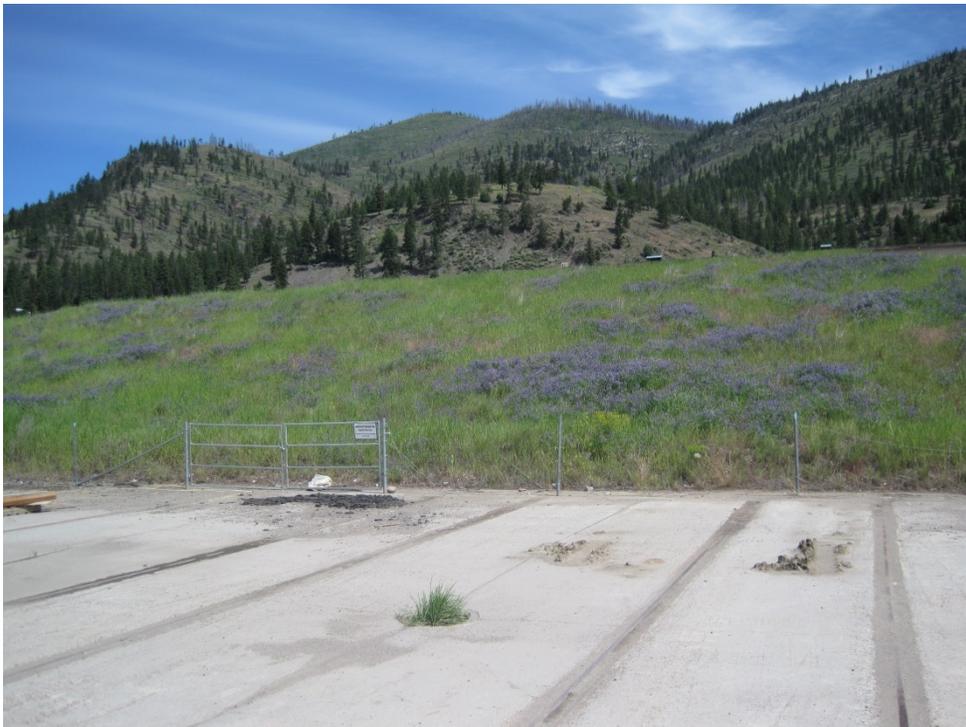
Photo 2. South slope looking N.

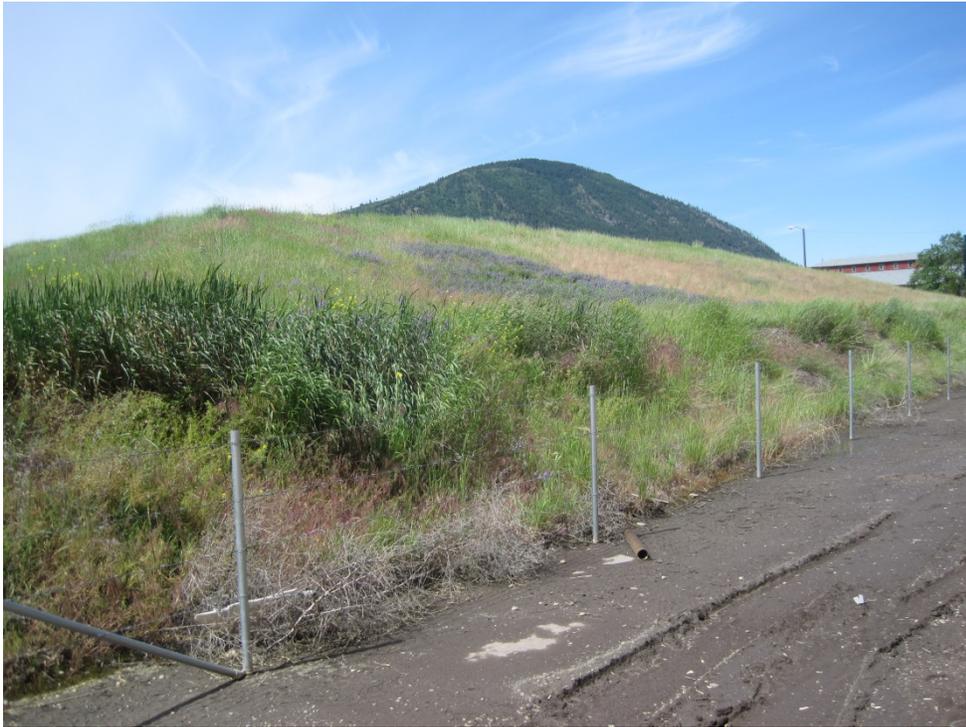
Photo 3. NE corner  
from base, looking SW.

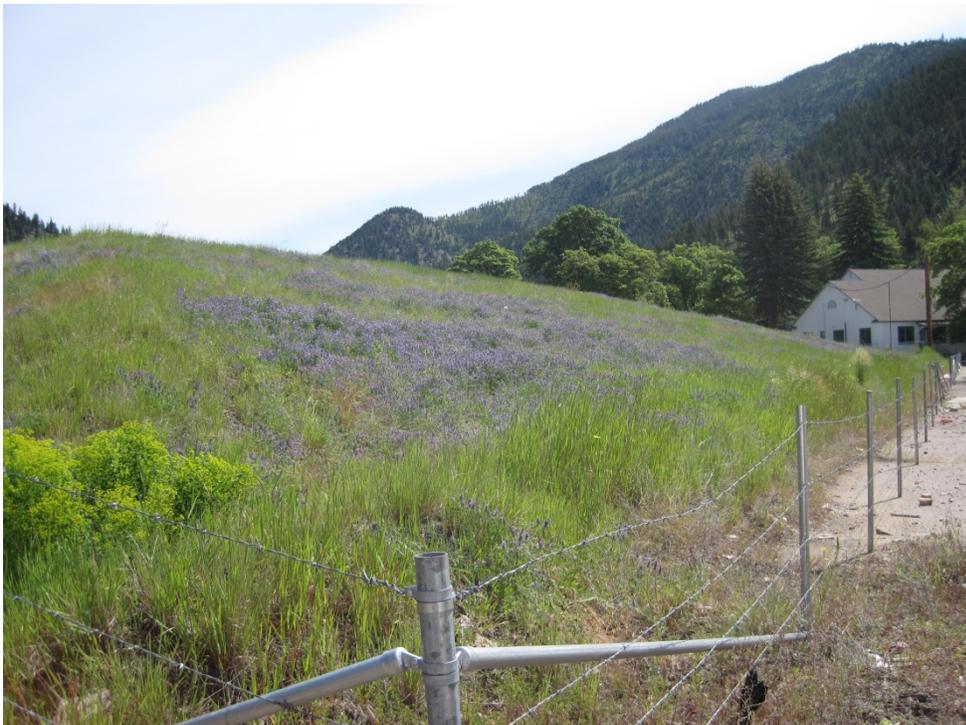
Photo 4. SW corner  
from base, looking E.

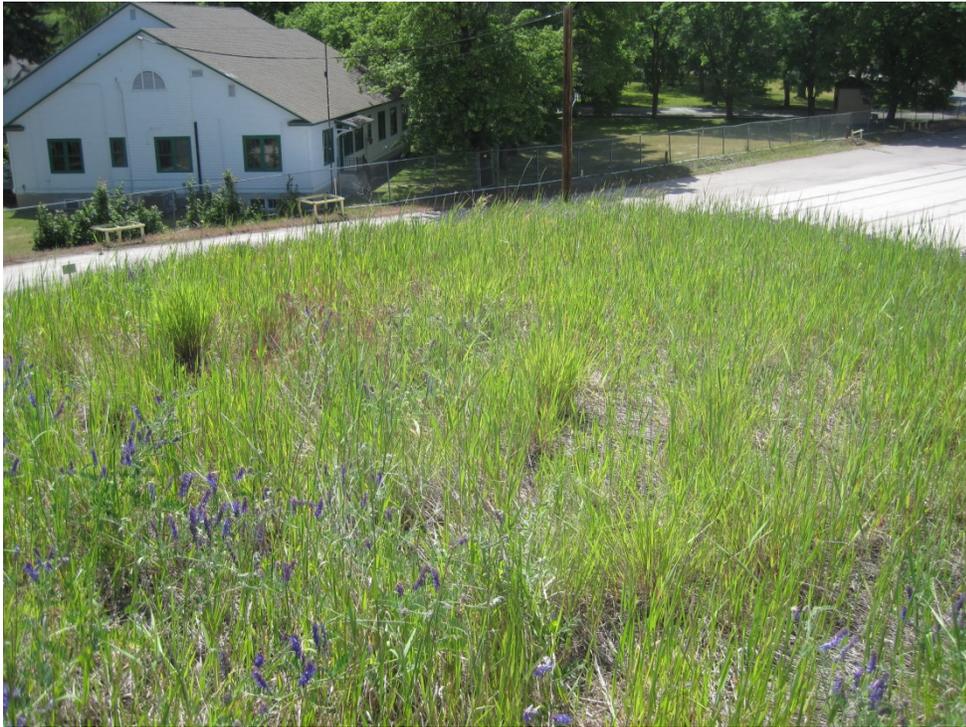
Photo 5. Top from SE, looking SE.

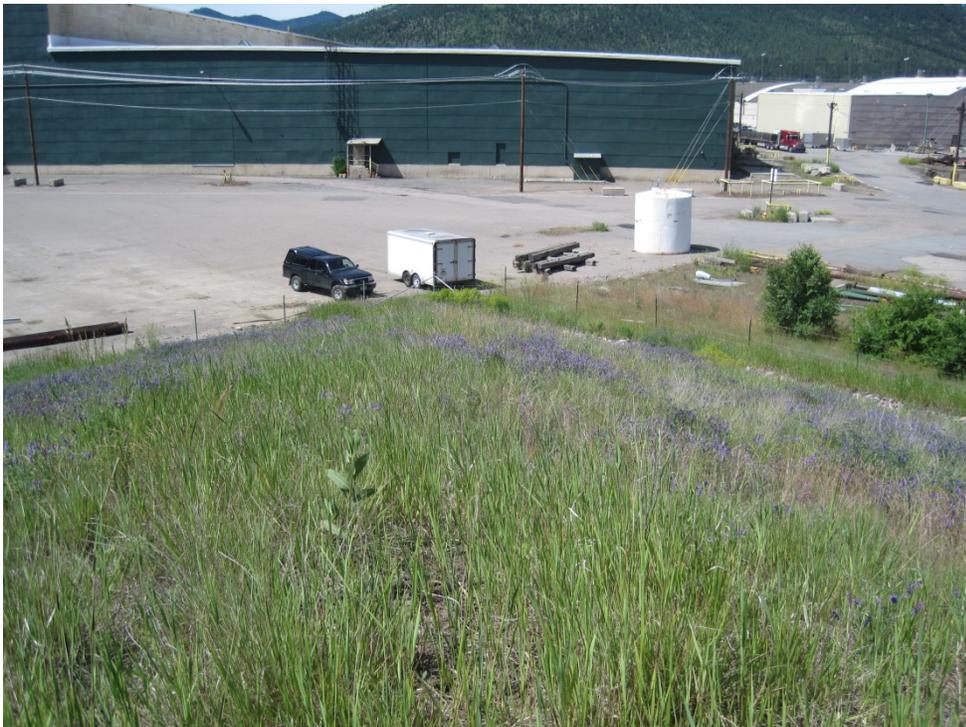
Photo 6. SW corner from top, looking SW.

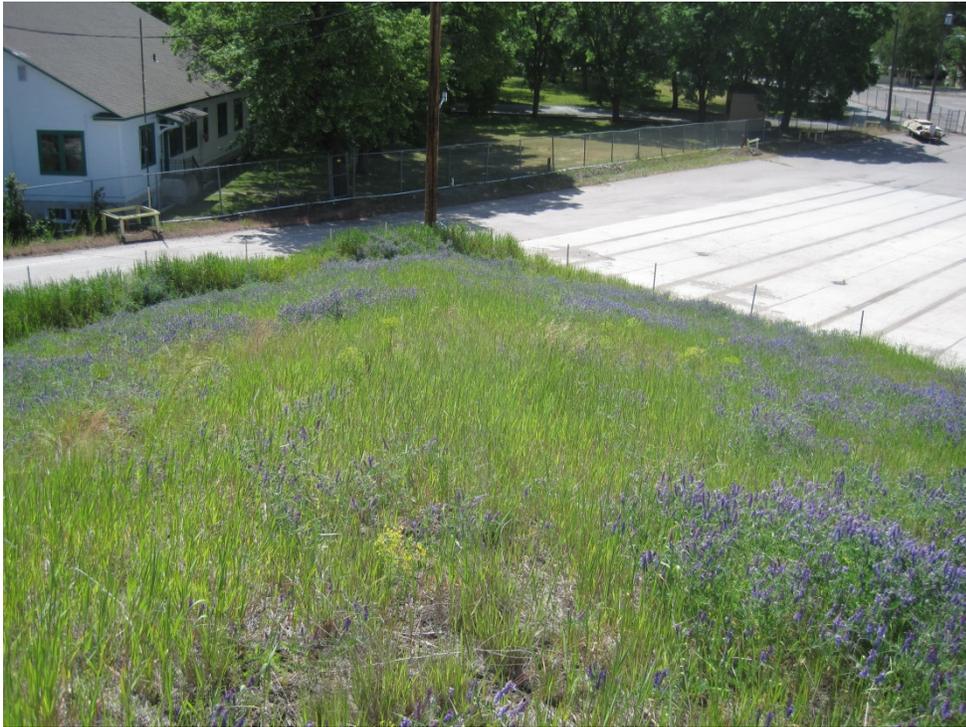
Photo 7. SE corner from top, looking SE.

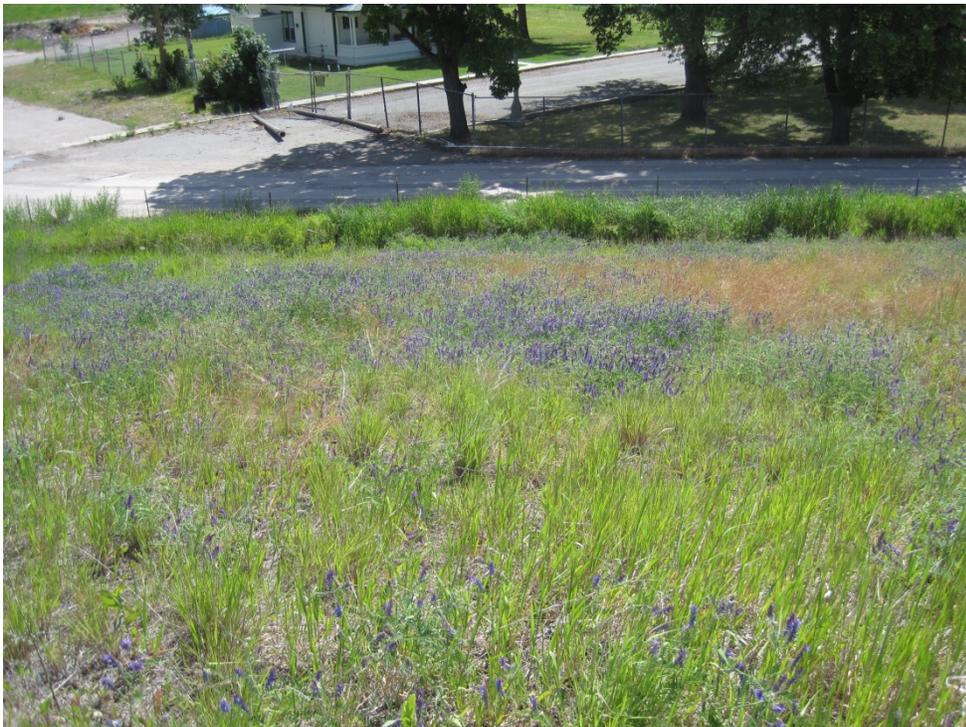
Photo 8. E slope from top, looking E.

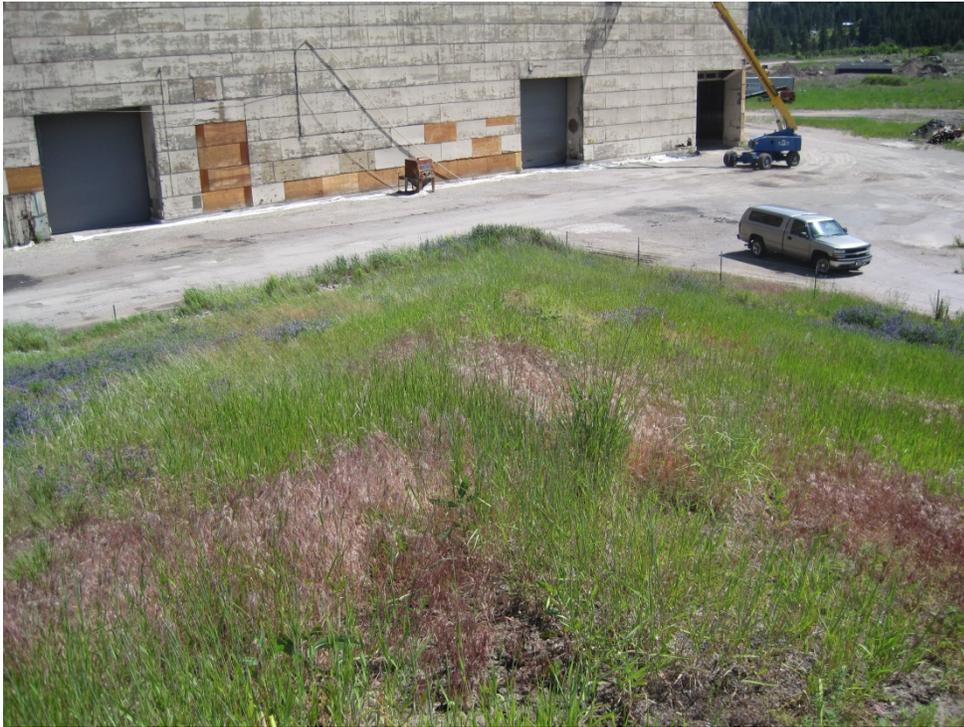
Small bare batches on northeast corner.  
\_\_\_\_\_  
\_\_\_\_\_

Photo 9. Top NE corner, looking NE.

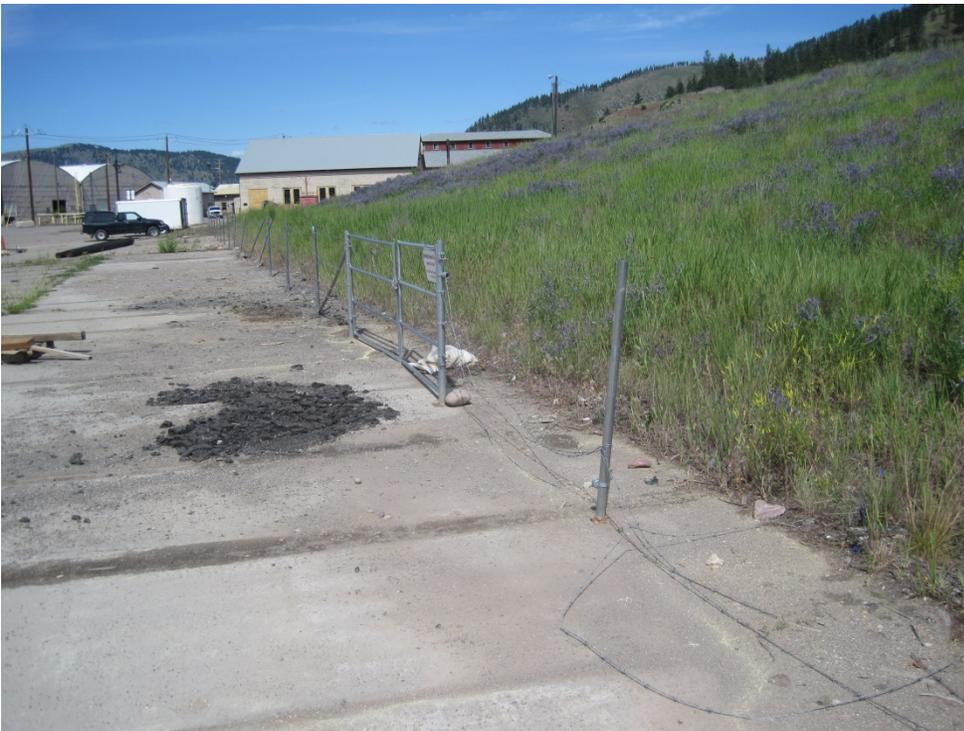
Good condition on east, west and north side. Poor condition on south side and needs repair.  
\_\_\_\_\_  
\_\_\_\_\_

Gate is locked. Poor security due to damaged fence next to gate (see photos).  
\_\_\_\_\_  
\_\_\_\_\_

Possible sign of intrusion at broken fence.  
\_\_\_\_\_  
\_\_\_\_\_

Photo 10. Damaged fence near gate.

General condition of repository is good, need to repair fence on south side.

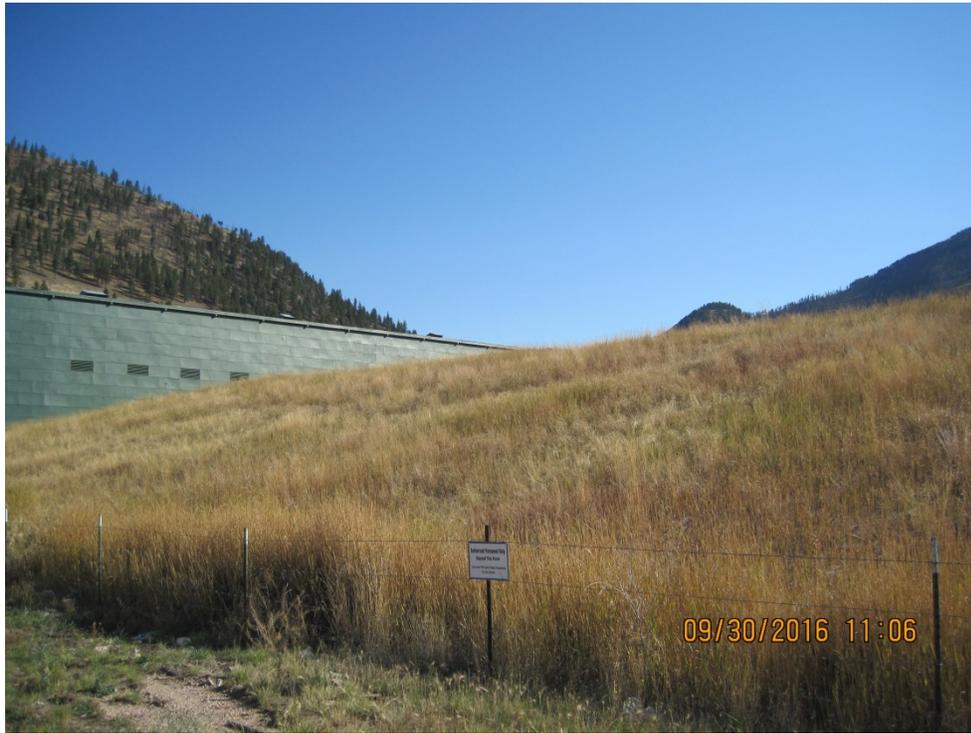
Photo 1. West slope looking NNE.

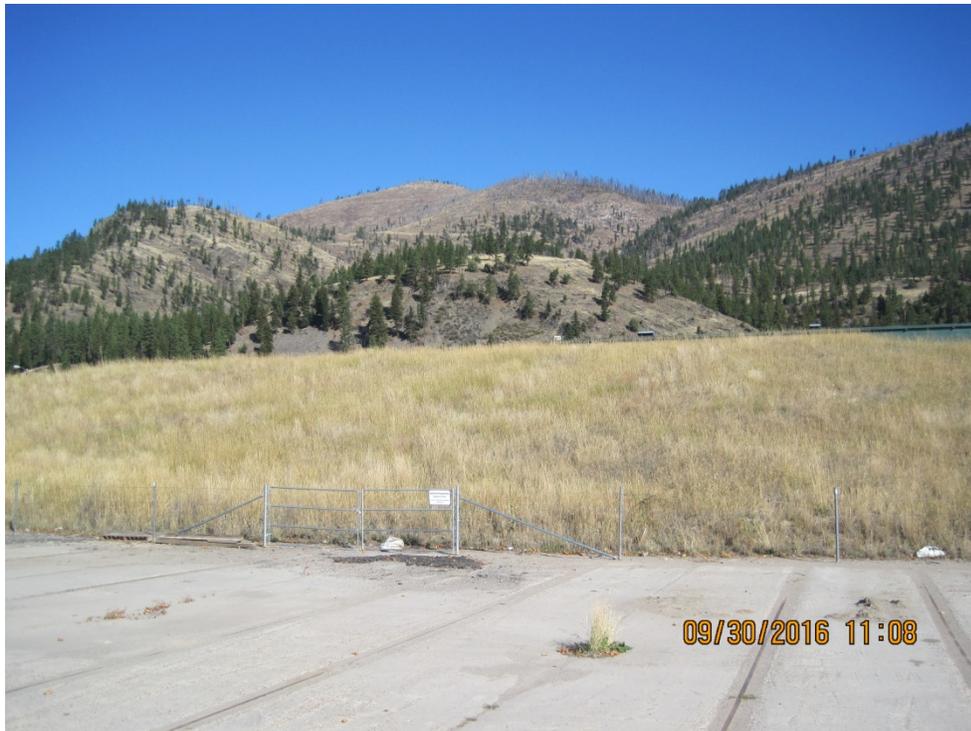
Photo 2. South slope looking N.

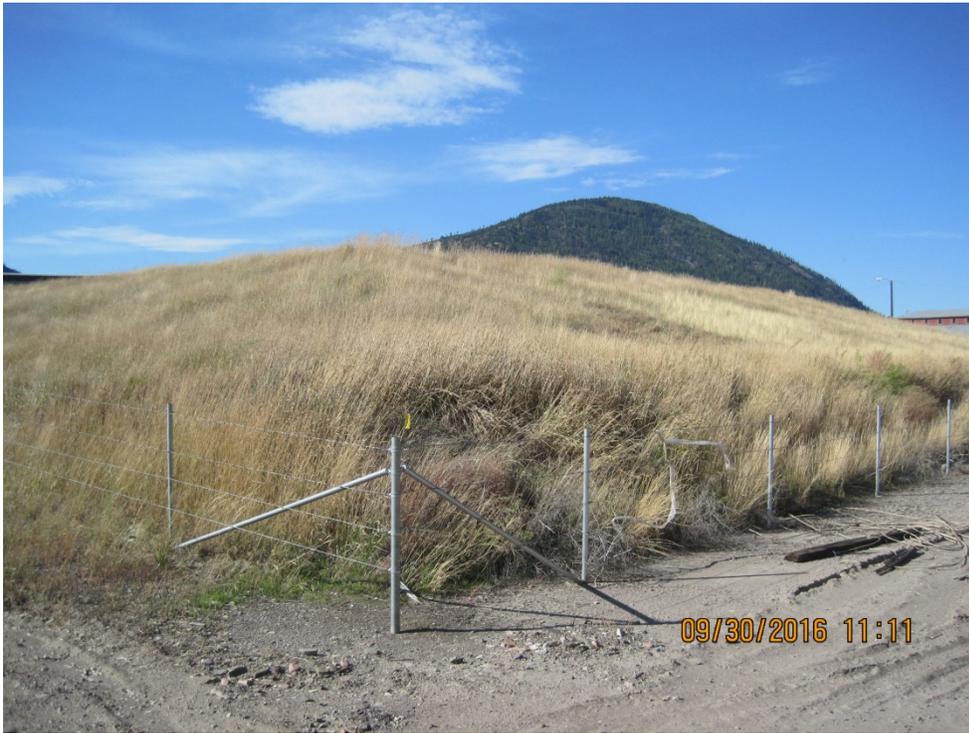
Photo 3. NE corner  
from base, looking SW.

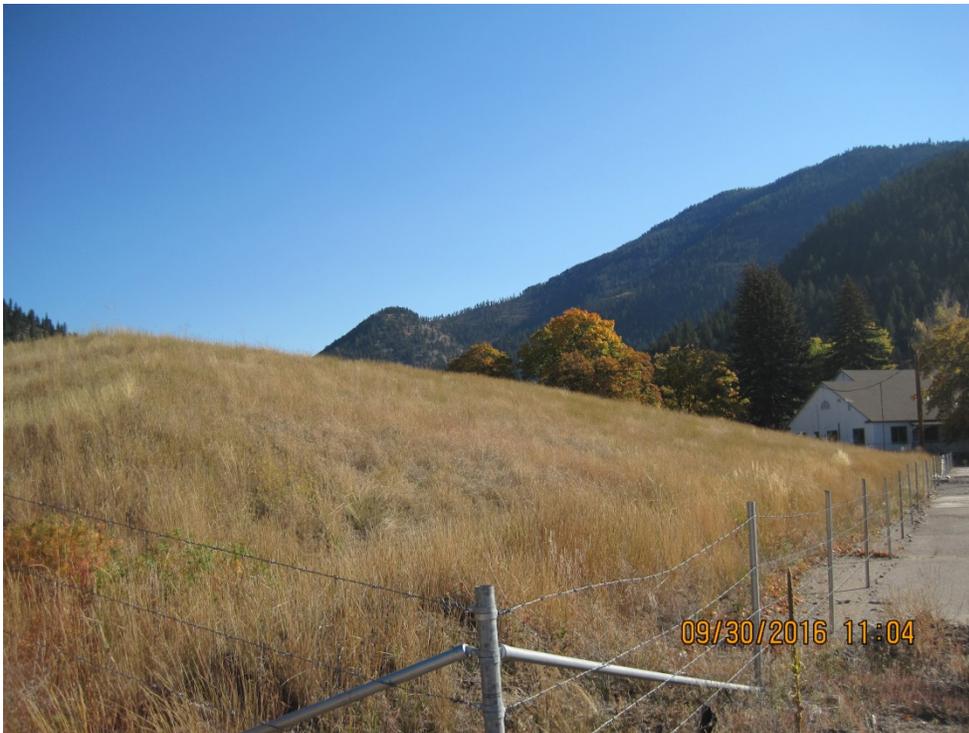
Photo 4. SW corner  
from base, looking E.

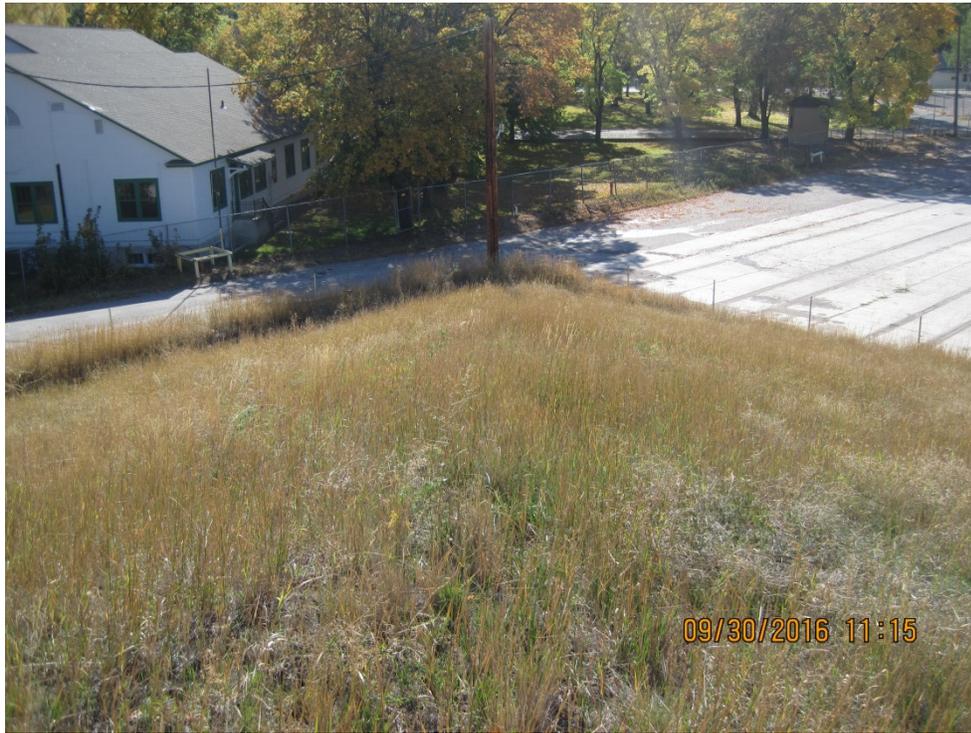
Photo 5. Top from SE, looking SE.

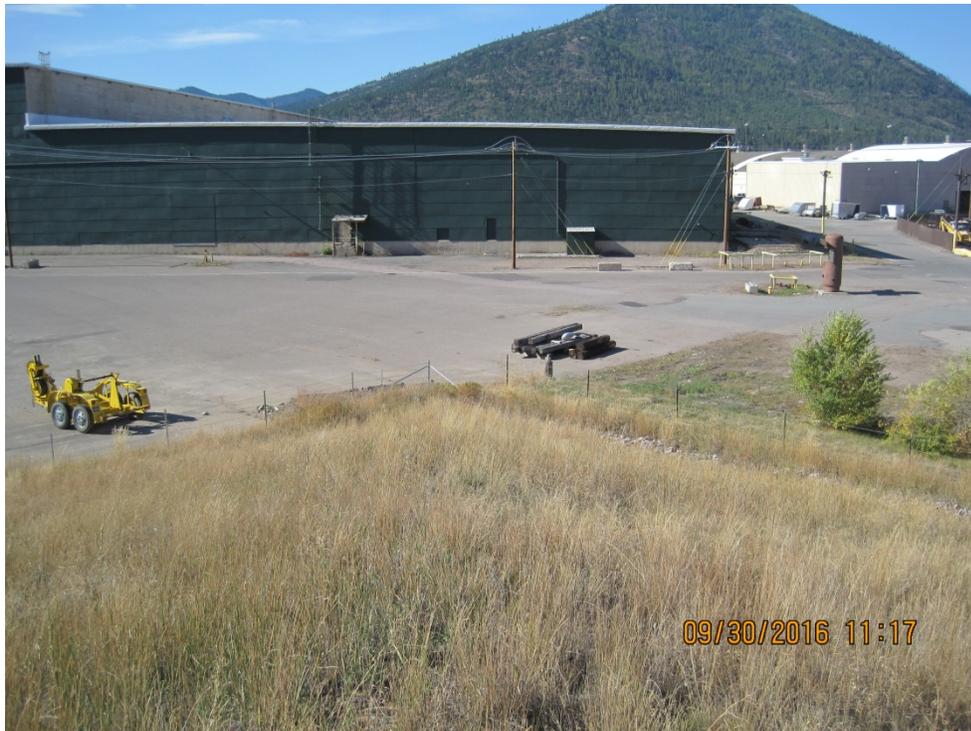
Photo 6. SW corner from top, looking SW.

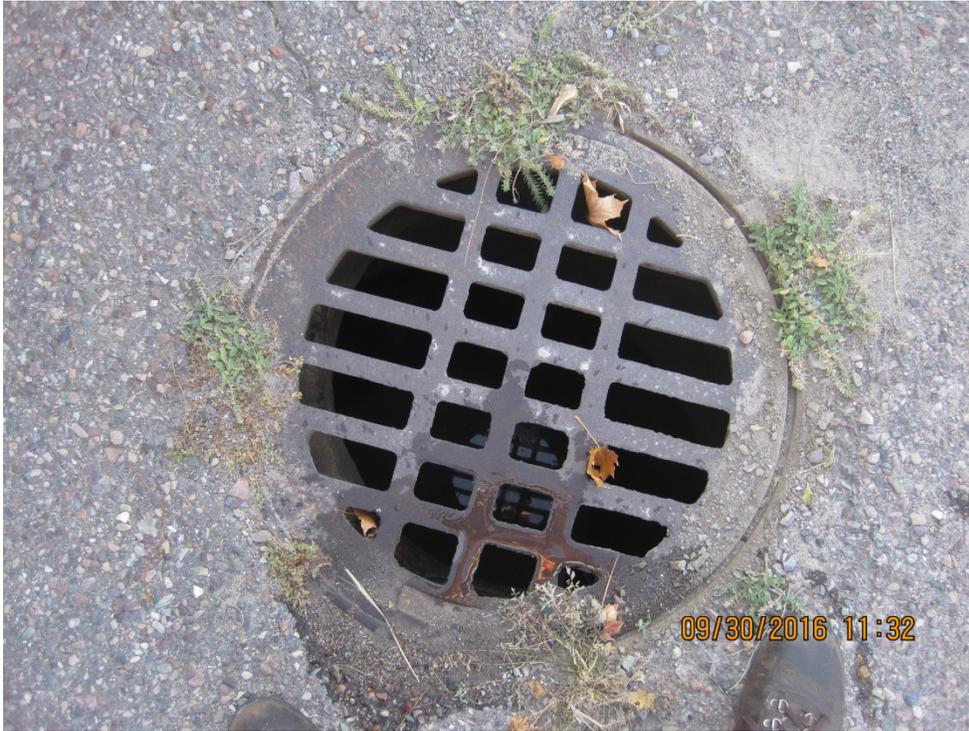
Notes: Only one of the four dry wells contained water during the sampling event and was sampled. The Southwest well (SDW-1) was sampled by NewFields hydrologist Dan Hoffman with a disposable plastic bailer. The sample was stored on ice in a sample cooler and shipped directly to Energy Laboratories. Concentration of Aroclor 1254 was reported as 0.42 ug/L, all other results were non-detect. The reported concentration of Aroclor 1254 is below the Montana WQB-7 groundwater standard of 0.5 ug/L. A copy of the lab report is included as Appendix A.

Photo 7. SW Dry well, stormwater sample collection site.

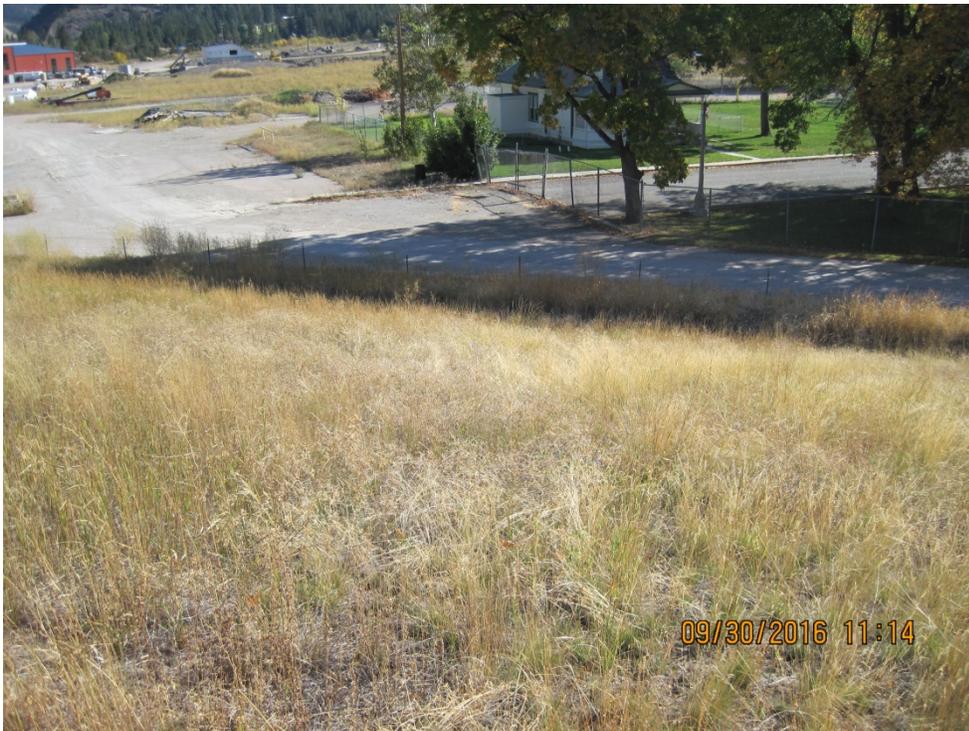
Photo 8. E slope from top, looking E.

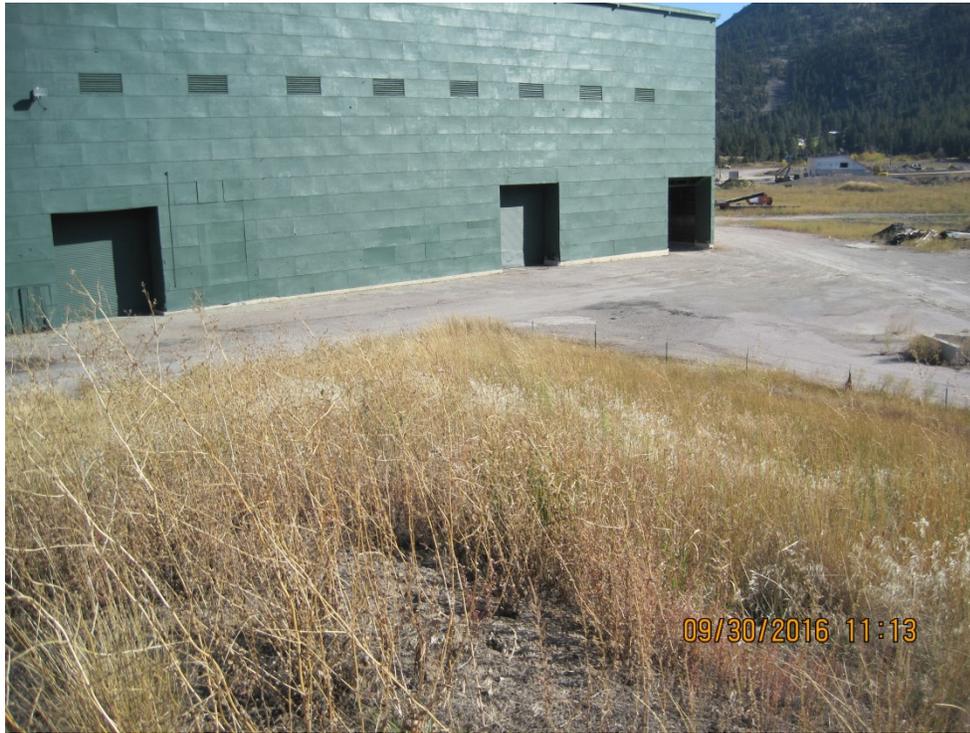
\_\_\_ Small bare patches on northeast corner. \_\_\_\_\_  
\_\_\_\_\_  
\_\_\_\_\_

Photo 9. Top NE corner, looking NE.

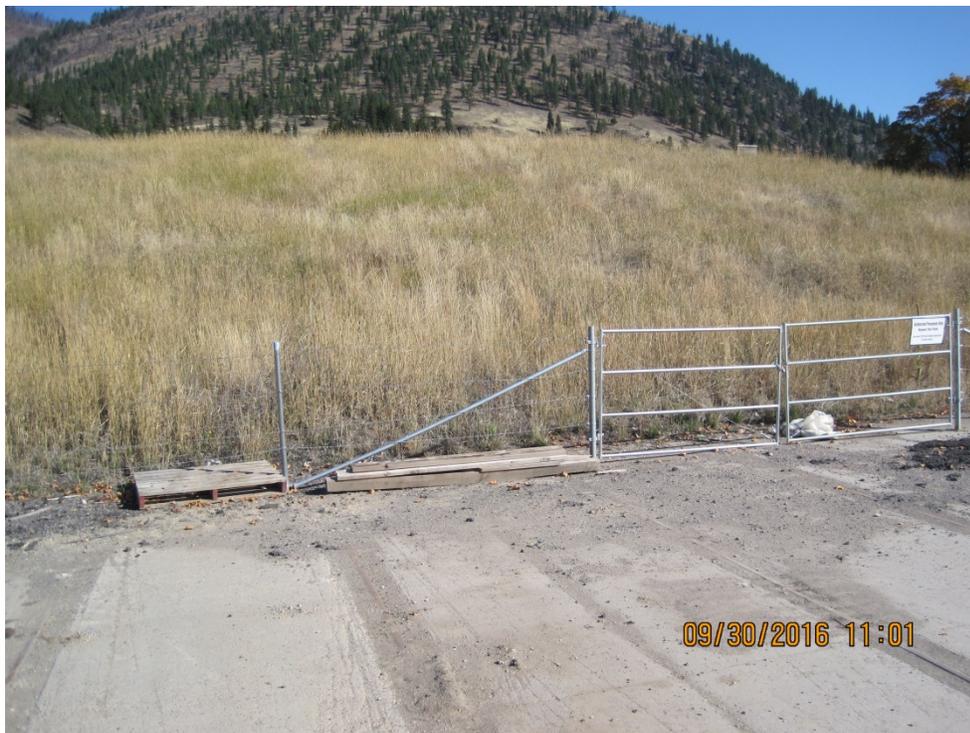
\_\_\_ Good Condition – fence repaired since June visit. \_\_\_\_\_  
\_\_\_\_\_  
\_\_\_\_\_

Condition of repository is good, fence has been repaired.

Photo 10. Repaired fence near gate.
