**The Lumberjack Saloon  
Public Water Supply  
( PWS # MT0000803 )**

**Source Water  
Delineation and Assessment Report**

**Date of Report: June 2012**

**Prepared by:  
Jeffrey Frank Herrick  
Source Water Protection Program  
Montana Department of Environmental Quality**

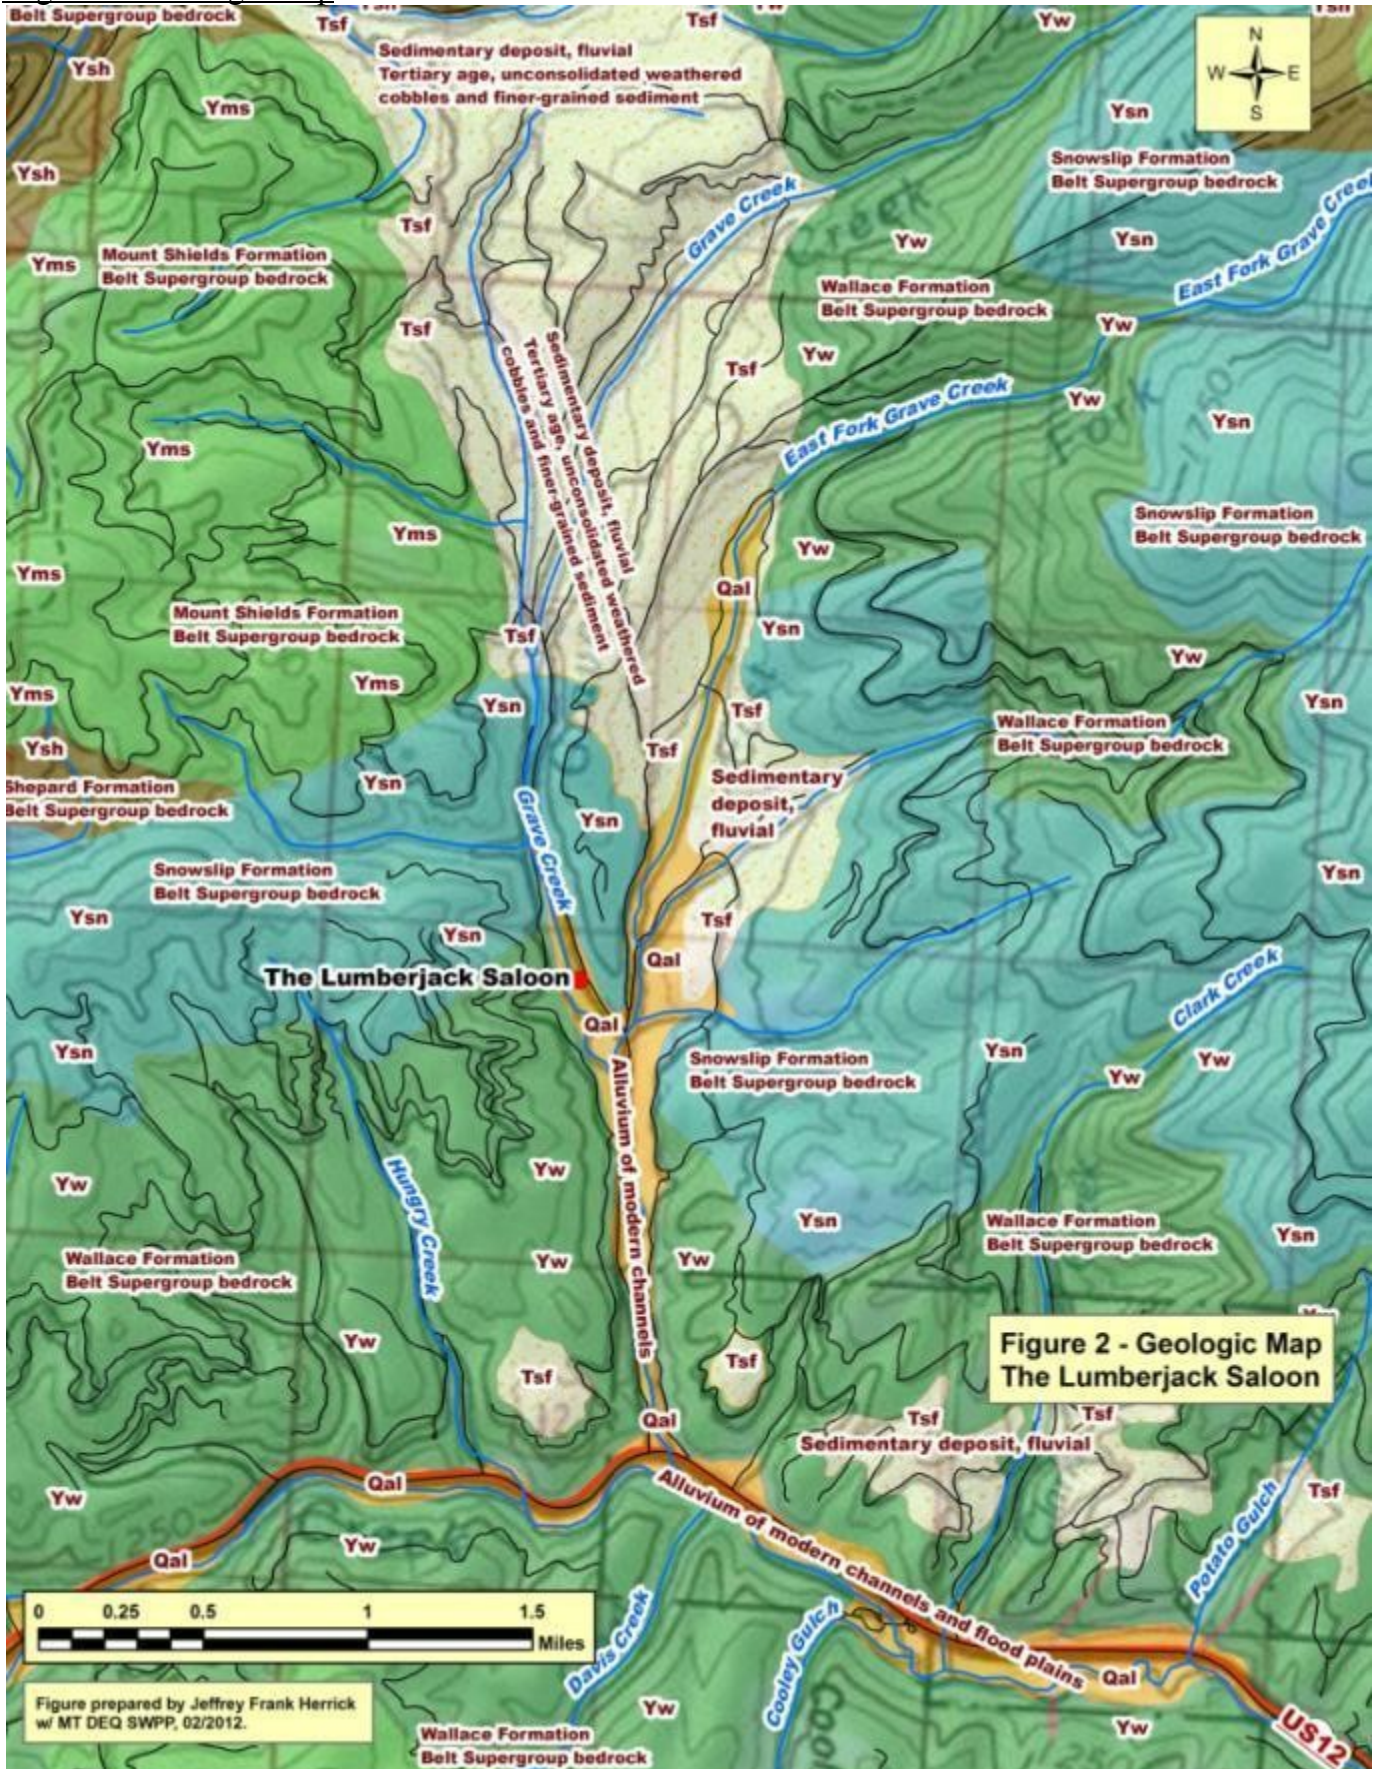
Figure 2 – Geologic Map

The Lumberjack Saloon and neighborhood buildings sit on Tertiary fluvial sedimentary deposits. These sediments are made up of shallow (15-17 feet thick) alluvial gravel and clay that blankets the local fractured meta-sedimentary bedrock. Nearby wells seem to have encountered groundwater at ~20 feet bgs (below ground surface), which places the groundwater below this sediment and within the fractured bedrock. Well depths are strictly dependent upon where sufficient inter-connected water-bearing fractures in the bedrock that are encountered during the well drilling process. The Lumberjack Saloon's well is 420 feet deep, the Babcock well is 260 feet deep, and the probably much older Larkin well is only 38 feet deep. These logs are found at the end of this SWDAR.

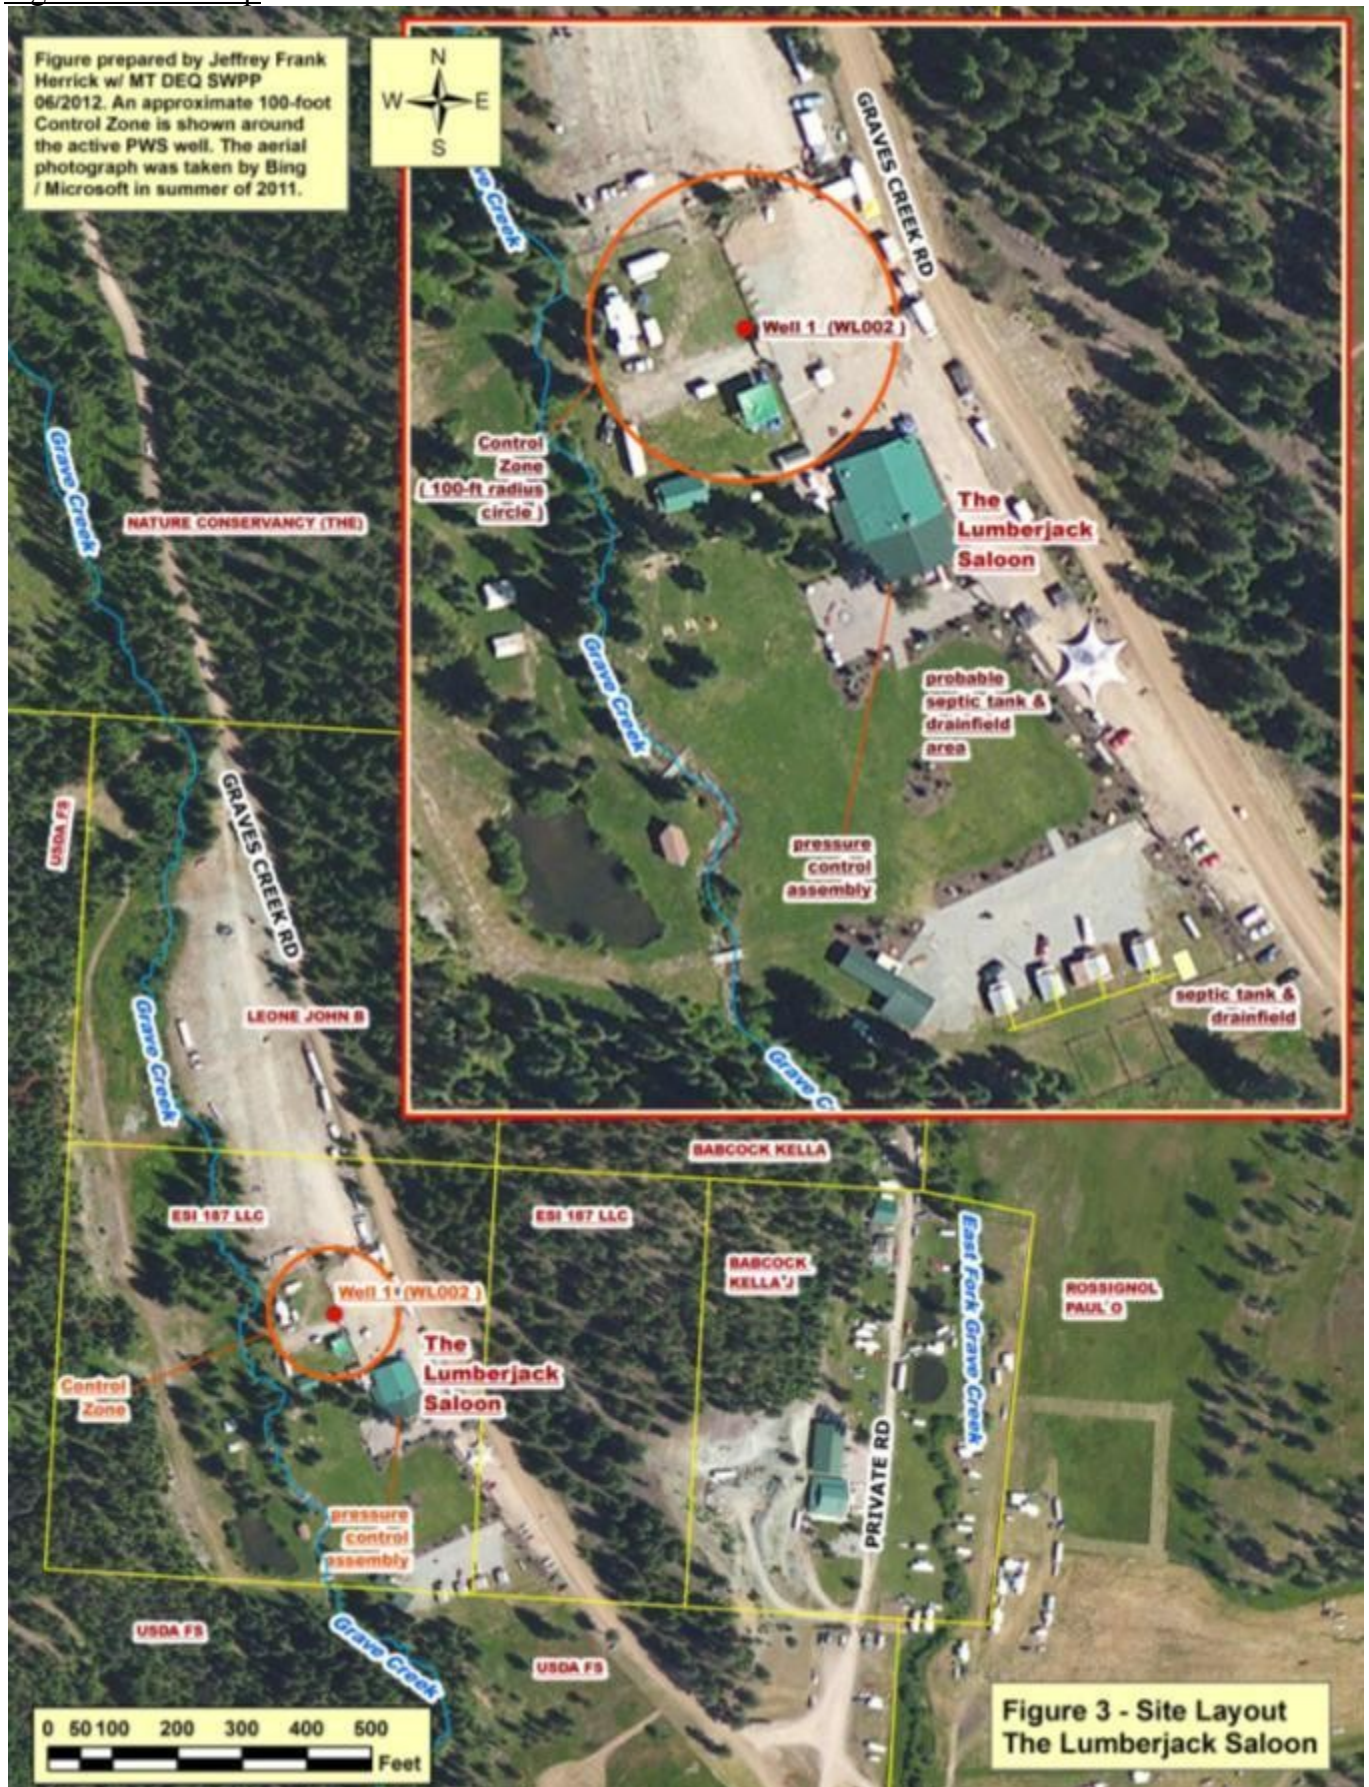
A 100-foot radius Control Zone is delineated for the Lumberjack Saloon's active PWS well. All potential contaminant sources should be excluded from this region. Refer to Figure 3 – Site Map for a depiction of the Control Zone and surrounding properties.

The Control Zone includes an open lot north of the saloon building and a grassed area directly west of the open lot. Grave Creek is located directly west of the Control Zone. The high-resolution aerial photo base used for Figure 3 was collected in the summer of 2011, so it is actually the most recent aerial photo of the property available at the time of this report. There are at least a couple of onsite septic disposal systems (septic tanks; pump chambers; sewer lines; and drainfields) servicing this property. One septic collection and disposal system appears to service the 4 cabins (and possibly a mobile home) located south of the saloon. The submittal plans and specification documents for this septic system indicated that the septic tank and drainfield are located to the east and probably southeast of the cabins. I assume that a septic tank and drainfield are associated with the saloon, but I couldn't find records to describe its construction or location. This septic system is classified as a large capacity septic system because of the number of people using it. My estimation is that the septic tank and drainfield servicing the saloon is in the lawn area directly south of the saloon building. If this assumption is wrong, please contact DEQ and provide a more accurate location. I did not find any records indicating that any of the mobile homes or house trailers seen in the aerial photo (located northwest of the saloon) connect directly to its septic system or are allowed to periodically dump to this system. It appears that both onsite septic systems (for the saloon and cabins) are located downgradient and outside of the Control Zone. The 2011 aerial photograph indicates the presence of several unidentified buildings in the area near the wellhead. These structures may be temporary/seasonal tents or other similar structures. If these small buildings are used to store chemicals, paint products, or fuel, then they should be moved outside of the Control Zone for the well. There are a couple of mobile homes / house trailers located within or on the perimeter of the Control Zone. If these trailers are connected to the septic system servicing the saloon, their septic lines would probably run through the Control Zone. The integrity of these lines would be a concern. If these trailers are not serviced by the saloon's septic system (which is more likely), they will have on-board wastewater and septic waste reservoirs. It appears that the wellhead is located directly adjacent to the parking lot and to a roadway used to move these trailers in and out of this area. The hazard from these and other mobile homes occurs when moving, maneuvering, and parking these vehicles or trailers. During passage of these vehicles past or near the wellhead, they might back into or collide with the wellhead and rupture their sewage and wastewater storage tanks. Such a spill near the well may increase the odds that this sewage will migrate down along the outside of the well casing and reach the water table 20 feet below the ground surface.

The PWS should be vigilant to ensure that potential sources of contamination are excluded from the Control Zone and that positive drainage away from the well casing is maintained. A positive drainage away from the wellhead can be created by the placement of sufficient soil in the area of the well such that no water can collect and pool at the surface. Even when a well is properly grouted, the sediment along the outside of the well casing is a preferred pathway for surface water infiltration. The positive drainage away from the wellhead will significantly reduce the likelihood of this sort of water movement that can seriously contaminate water quality in the drinking water system.

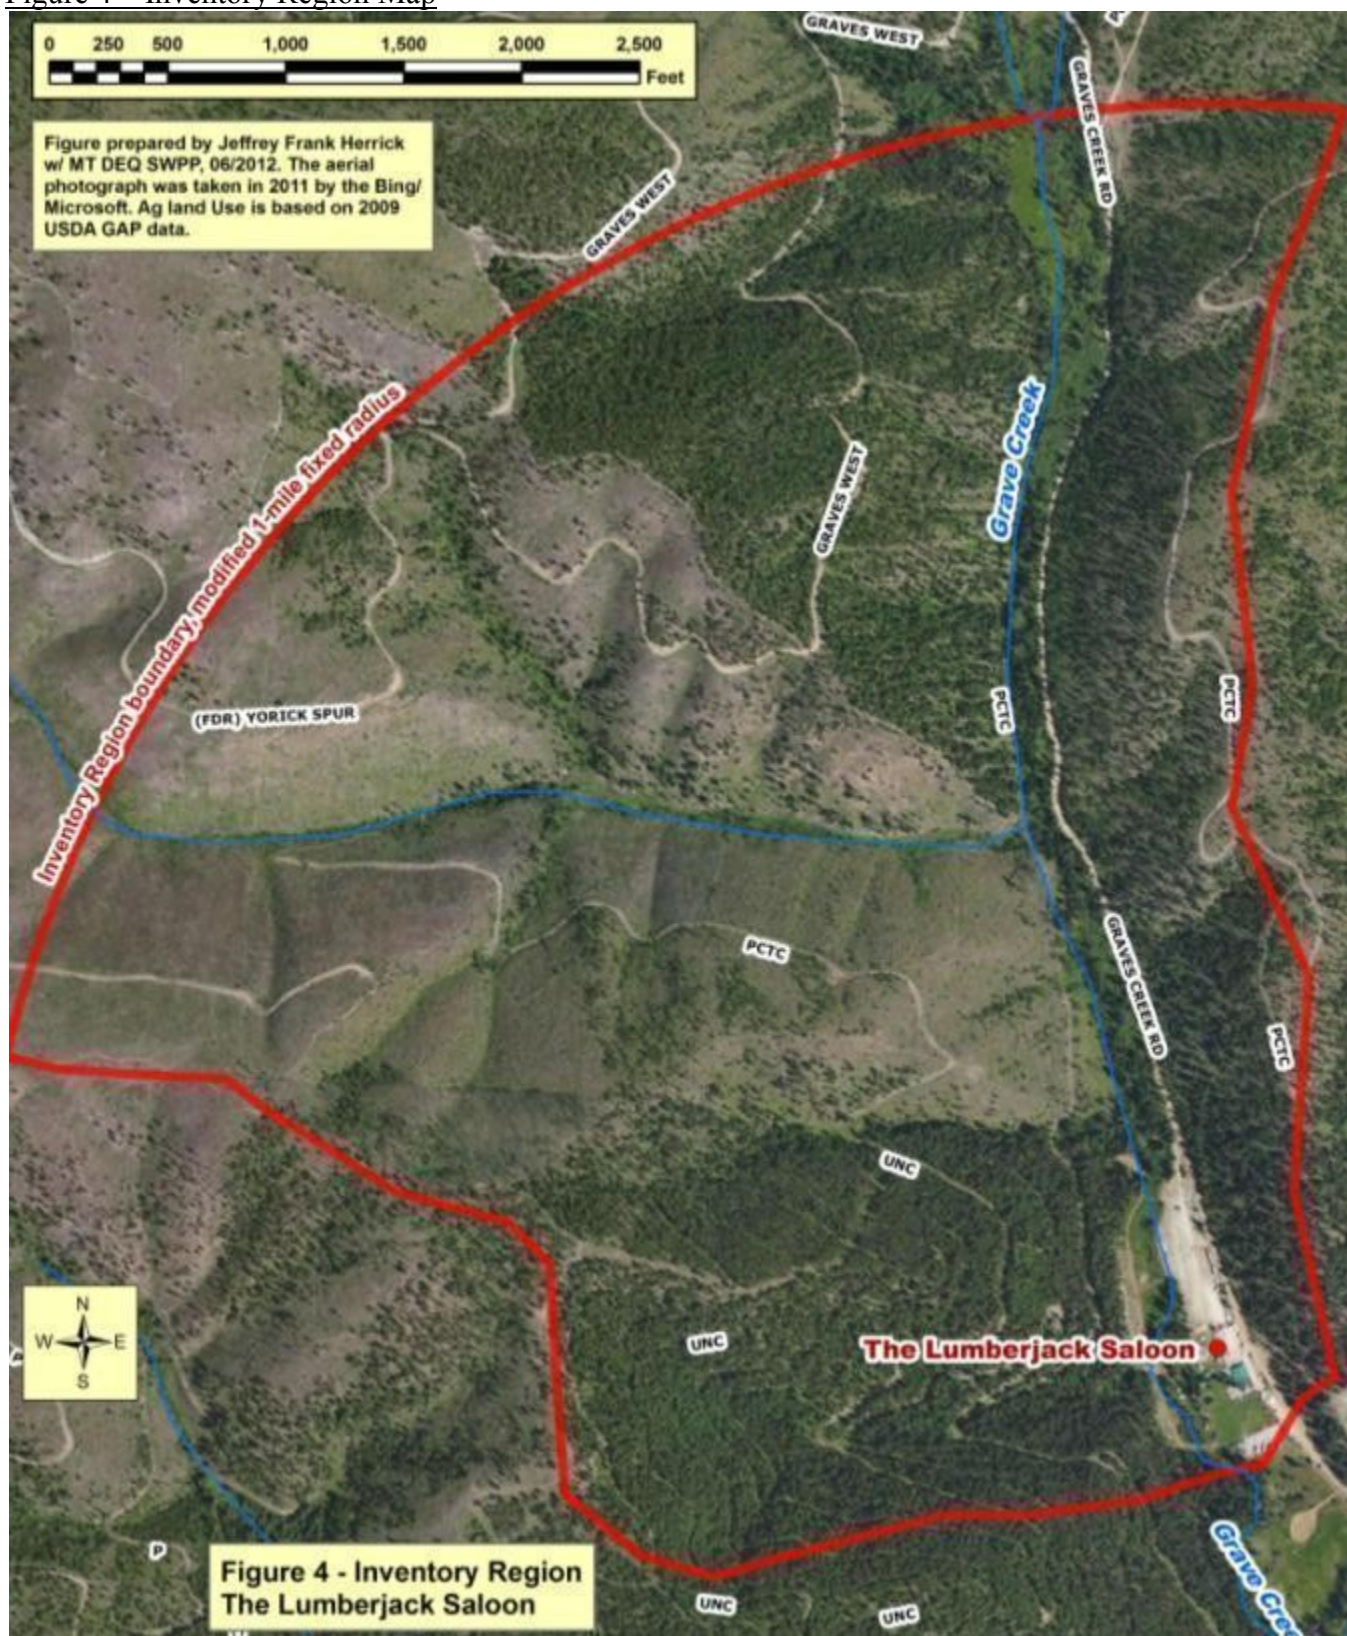
Figure 4 – Inventory Region Map

The inventory results for the Lumberjack Saloon PWS's Inventory Region are summarized in Table 4 and are shown on Figure 4. The inventory of significant potential contaminant sources (PCSs) includes the

large capacity septic system serving the Lumberjack Saloon. Also present in the region are extensive scattered areas that have been clear-cut logged. Erosion of soil (and nitrate from these soils) off of the clear-cut slopes and roads has a small potential of allowing contamination reach groundwater beneath the valley floor of Grave Creek. Large vehicles such as trucks and motor homes have the capacity to carry large amounts of fuel. If one of these vehicles that is parked along Graves Road and near the valley margin (near very shallow soils or exposed bedrock), any spill of fuel (or septic effluent) would easily recharge groundwater through the fractured rock. I believe this to be an extremely infrequent event with a very small potential of impacting groundwater. As such, it is mentioned here, but will not be included in the list of hazards or the assessment of susceptibility in the following pages. It is not considered a significant potential contaminant source. All the same, I suggest that you do not park fuel trucks along the valley margin and near areas that are essentially windows into the bedrock.

Of these inventoried PCSs found outside of the Control Zone, but within the Inventory Region, only the large capacity septic system has any real potential to allow nitrates and/or pathogens to reach groundwater near the PWS well. The potential hazard assigned these PCSs is presented in Table 4 below. The actual potential susceptibility of the PWS well to these PCSs is assessed in the next section. Susceptibility reflects the fact that there are several types of barriers that may stand between a PCS and the PWS well.
