Stoneville Saloon

Source Water Delineation and Assessment Report

Public Water Supply: Stoneville Saloon
(PWSID #MT0001184)

Report Date: July 24, 2003

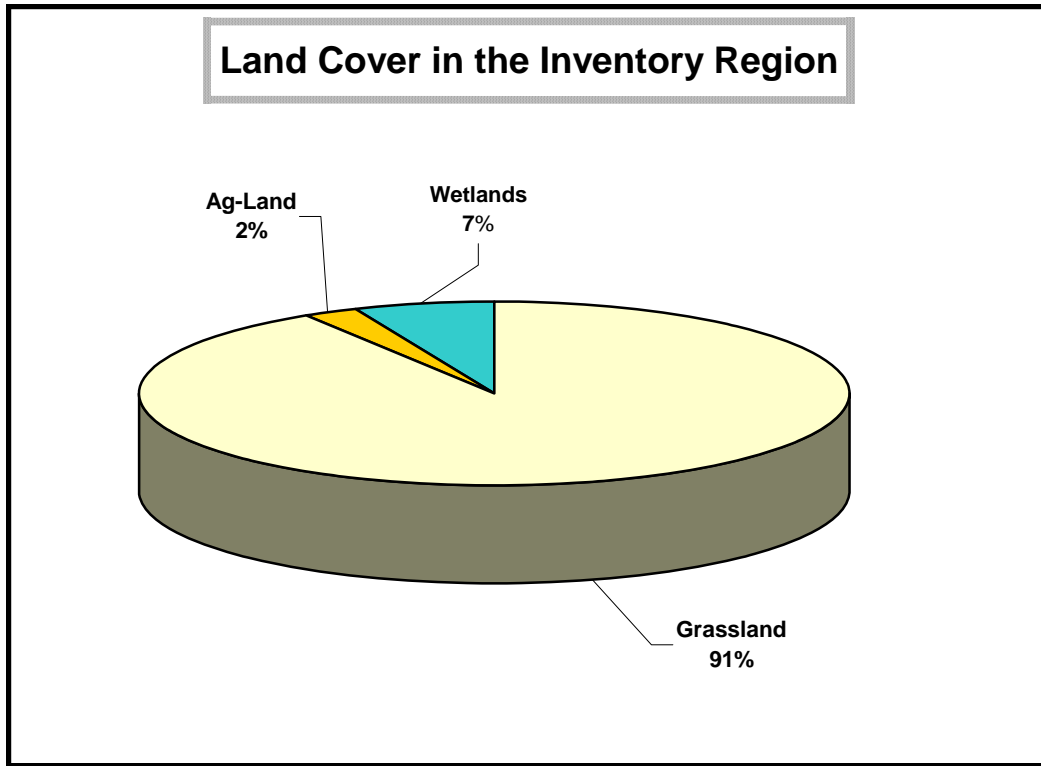
Figure 2: Land use pie chart

Analysis of the area surrounding the Stoneville Saloon complex reveals that the predominant land covers include grassland (91%), wetlands (7%), and agricultural land (2%). See figure 2 for a pie chart summarization of this data. Only agricultural land poses a threat to the well and due to the very small percentage of landuse attributed to agriculture, the threat is minimal ([Figure 1-C](#)).
