Reimel Creek TMDL Implementation Evaluation

February 2016

Planning, Protection and Assistance Division
Watershed Protection Section

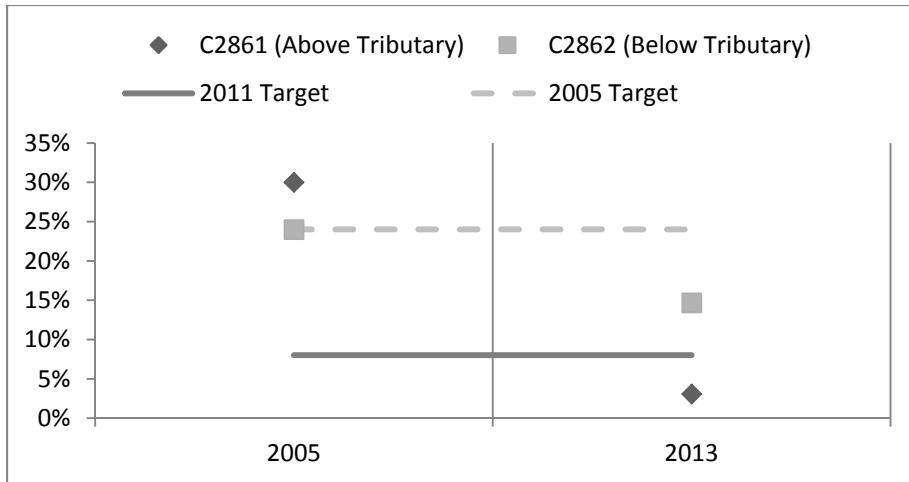
Figure 3-1. Cumulative Percent Fine Sediment <2mm, 2005 versus 2013

In July 2013, DEQ and a BNF representative collected sediment data at two locations on Reimel Creek. Fine sediment data collected is summarized in **Table 3-1**. In 2011, DEQ published new sediment targets for the Idaho Batholith (DEQ, 2011). Data collected in 2013 is compared to the 2011 targets instead of those in the 2005 TMDL because DEQ recognizes these new targets as being more accurate. The data collected in 2013 indicates percent fine sediment has decreased at both sites (see **Figures 3-1 and 3-2**). These data suggest water quality is improving but that additional time is needed for the system to recover and meet current sediment targets.
