## DEARBORN TMDL PLANNING AREA

### *Channel and Riparian Aerial Assessment*

**LAND & WATER CONSULTING, INC.**  
PO Box 8254  
Missoula, MT 59807

July 2004

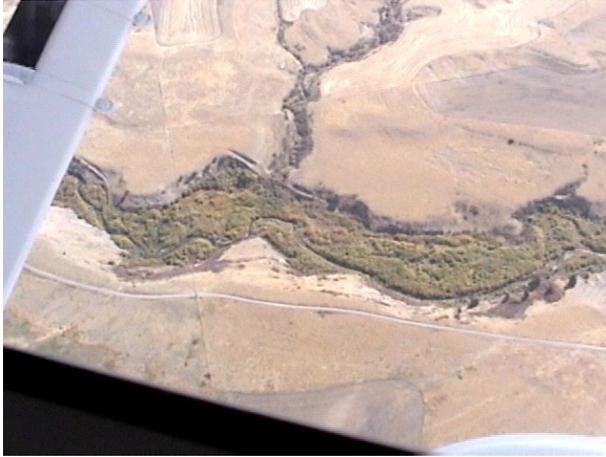
**Figures 3-9 and 3-10** contrast the ‘good’ and ‘poor’ riparian conditions for the South Fork of the Dearborn in the lower reach SF1. Woody species were predominately shrub/willow in ‘good’ reaches. Loss of riparian corridor due to conversion to agricultural uses resulted in reduced riparian buffer widths in many locations.

**Figure 3-9. Central Portion of South Fork SF1 ‘Good’**

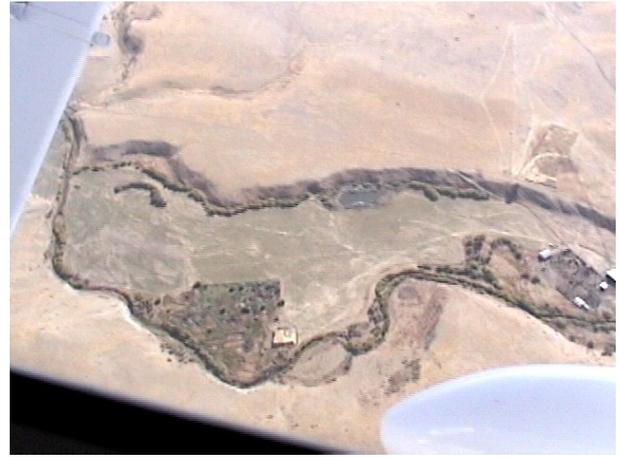
**Figure 3-10. Central Portion of South Fork SF1 ‘Poor’**

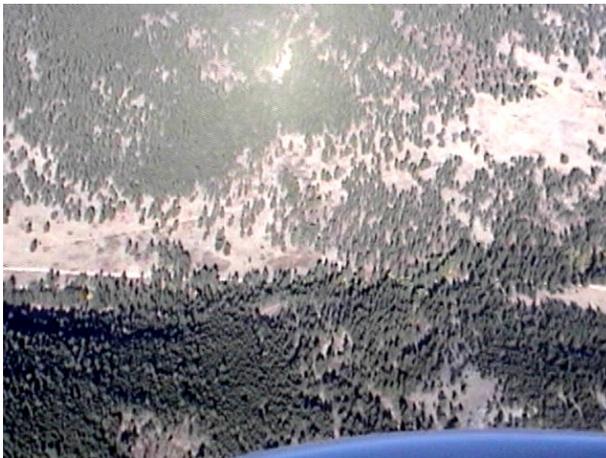
The headwaters portion of the South Fork SF2 was primarily coniferous forest and did not show any significant influence from anthropogenic activities (**Figure 3-11**). Portions of the central and lower section of South Fork reach SF2 appeared to reflect the impacts of logging and riparian vegetation clearing (**Figure 3-12**). The aerial assessment could not determine whether grazing also impacted riparian coverage in this reach.

**Figure 3-11. Upper Portion of South Fork SF2 ‘Good’**

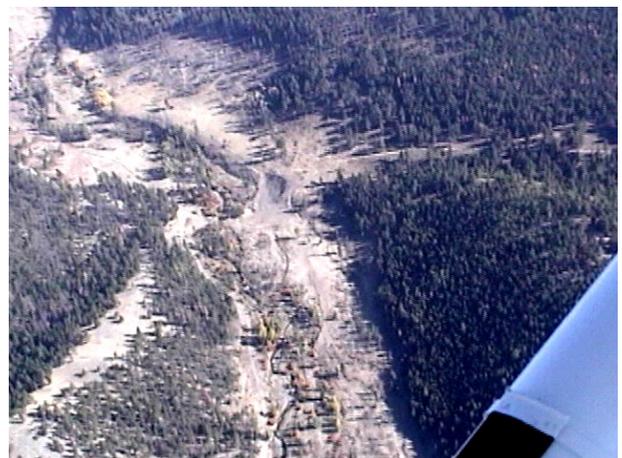
**Figure 3-12. Lower Portion of South Fork SF2 ‘Poor’**

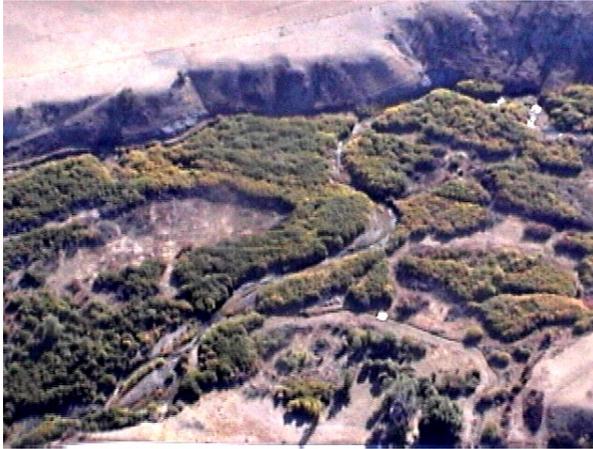
**Figures 3-13 to 3-15** contrast ‘good’ and ‘poor’ riparian conditions for the Middle Fork in the lower reach MF1. Woody species in the lower reach of the Middle Fork (MF1) were primarily woody shrubs. Tree components were not a significant part of the overall riparian coverage in ‘good’ reaches (**Figure 3-13**). Extensive clearing of riparian vegetation was apparent in the lower reach of the Middle Fork (**Figures 3-14 and 3-15**). The upper reach MF2 in the headwaters of the Middle Fork was mainly coniferous forest and was not significantly impacted by land use (**Figure 3-16**). Encroachment on riparian vegetation by Highway 200 was minimal except in a short section at the lower end of reach MF2.

**Figure 3-13. Middle Fork Dearborn (MF1) ‘Good’ Reach**

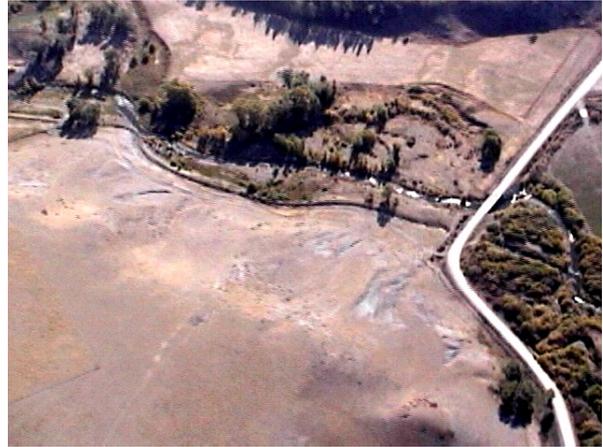
**Figure 3-14. Middle Fork Dearborn (MF1) ‘Fair’ Reach**

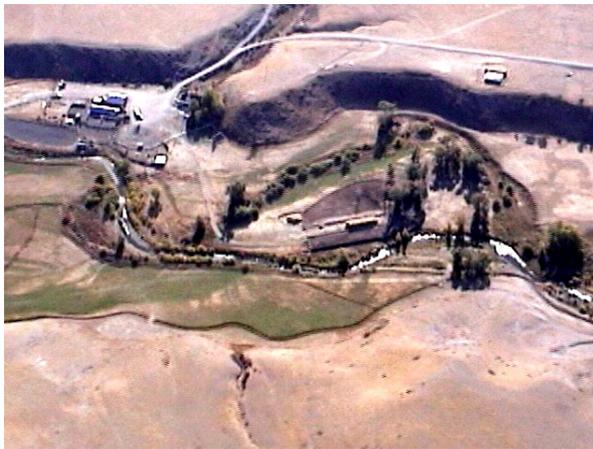
**Figure 3-15. Middle Fork Dearborn (MF1) ‘Poor’ Reach**

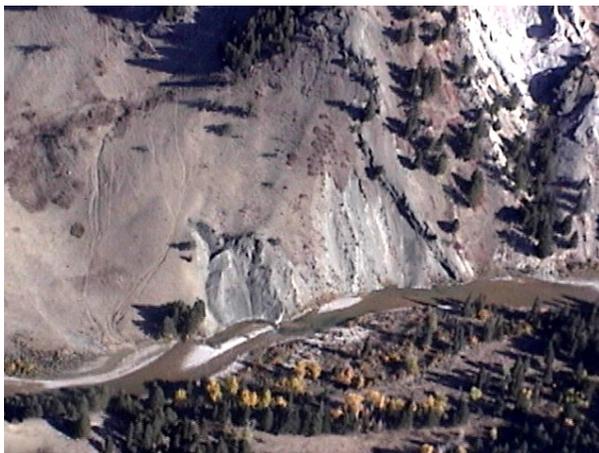
Mass failure was an uncommon source for sediment within the Dearborn and tributaries. A single location on the Dearborn mainstem showed evidence of active mass failure in Reach DR6, and was related to natural processes. Shallow-seated slumps were located on unconsolidated parent material, and contributed sediment directly to the Dearborn mainstem in this location (**Figure 3-31**). Limited areas of dry ravel/rilling were present but infrequent on steep slopes adjacent to the active channel in Reach DR4 (**Figure 3-32**). These natural sources of sediment would be expected to contribute fines to the channel during extreme rainfall events and also during peak flow events that erode the toe of the slope.

**Figure 3-31. Slumps in Dearborn Mainstem Reach 6**

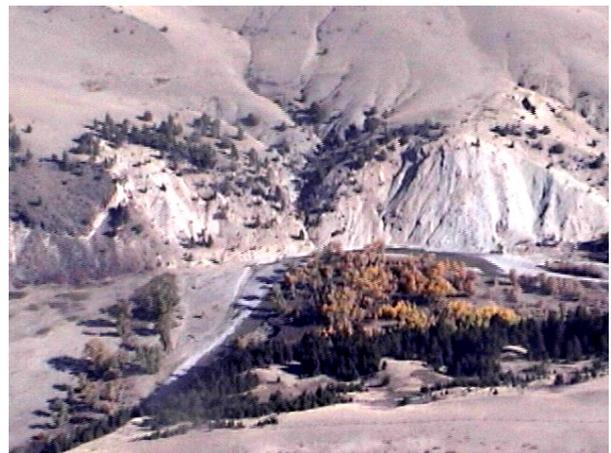
**Figure 3-32. Dry Ravel/Rilling in the Dearborn Mainstem Reach 4**

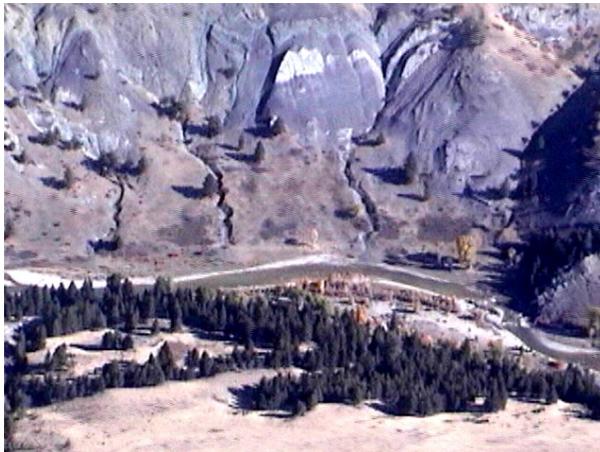
A series of three gullies were observed along reach DR5 in the Dearborn mainstem (**Figure 3-33**). These gullies appeared stable and may be a remnant of heavy precipitation/surface runoff in the spring of 1964 or other intense rainfall events.

**Figure 3-33. Gullies in the Dearborn Mainstem Reach 5**

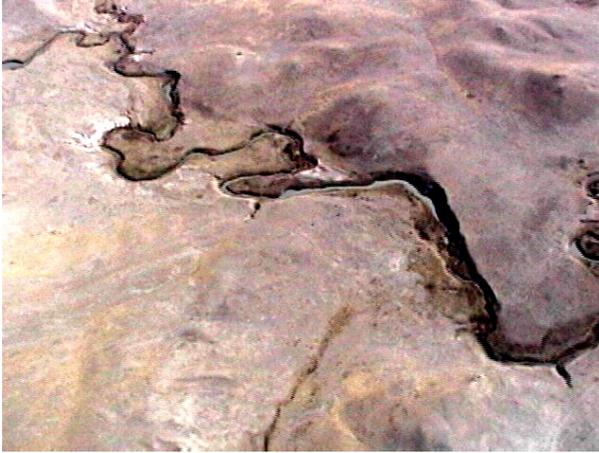
**Figure 3-35. Hogan Creek, Tributary to Flat Creek Reach 4.**

Upland sources of sediment in Hogan Creek warrant additional field investigation to establish whether they are a significant contributor to impairment in Flat Creek.

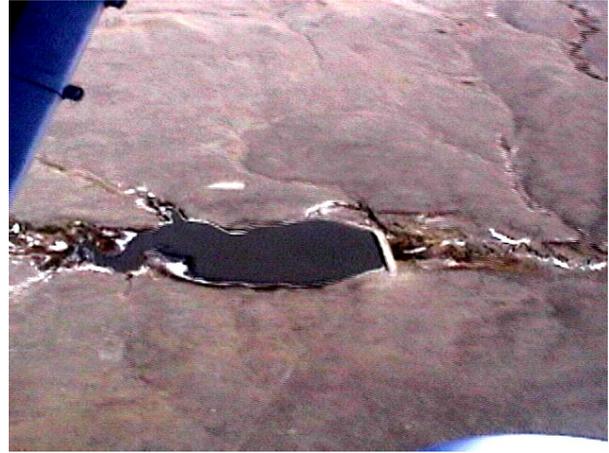
**Figure 3-36. Upper Hogan Creek, Tributary to Flat Creek Reach 4.**

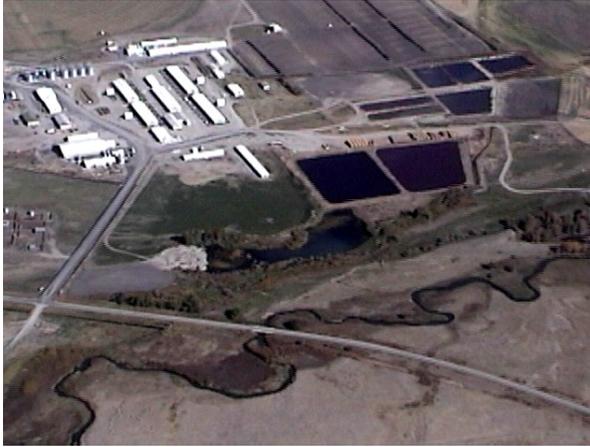
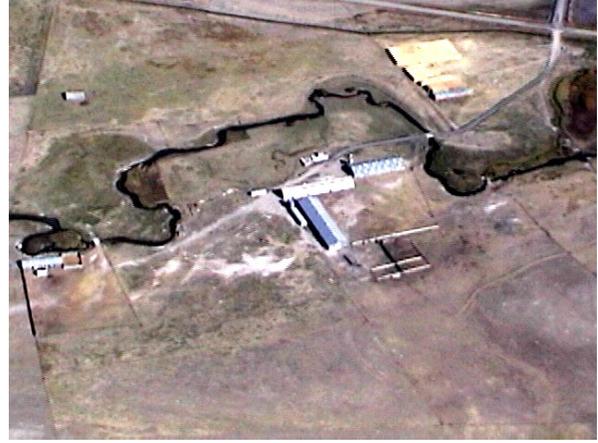
**Figure 3-37. Milford Colony**

No major anthropogenic point sources for sediment or temperature impairment were noted. The Milford Colony has several lagoons/holding ponds located along the riparian corridor of Flat Creek (**Figures 3-37, 3-38**). Water quality in these lagoons is unknown and potential impacts to Flat Creek could not be determined in this study. The possible influence of these features on water quality may warrant additional investigation, although the potential to affect sediment or thermal impairments is likely to be minimal.
