ATTACHMENT B – 2009 LOWER GALLATIN TMDL PLANNING AREA NUTRIENT, ALGAE AND *E. COLI* SOURCE ASSESSMENT

December, 2009

OASIS Environmental, Inc.
PO Box 582
Livingston, MT 59047

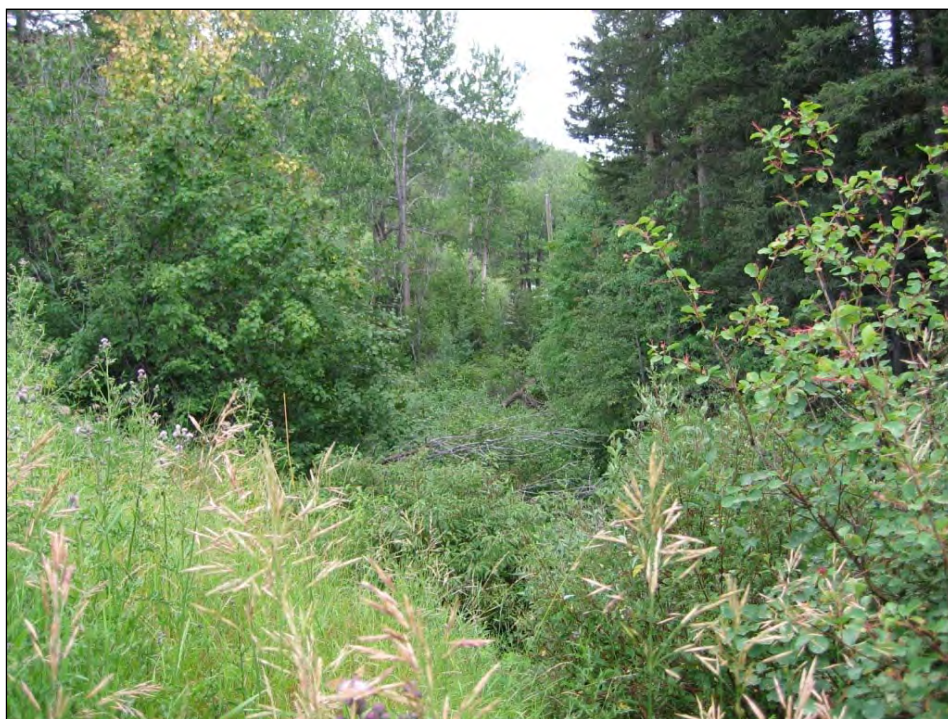
The dominant land uses within the reach are forested land and rural residential. Although several residences are located along the reach, overall the riparian vegetation is robust and healthy, consisting of a mixed conifer-cottonwood overstory with a willow-grass-forb understory (Figure 9). Bank erosion was very low and was limited to natural erosion in the fine, erosive soils present within Bear Canyon. The unpaved Bear Canyon Road encroaches on the stream for a third of a mile within the reach (Figure 10). Vegetation along the encroached area was generally dense, but the unpaved road could potentially be a sediment source during large storm events and during spring snowmelt. Two small irrigation withdrawals were identified within the reach. The irrigation withdrawals were not confirmed on the aerial or in the field.

FIGURE 9. DENSE CONIFER-COTTONWOOD RIPAIRAN IN REACH BEAR 02 N

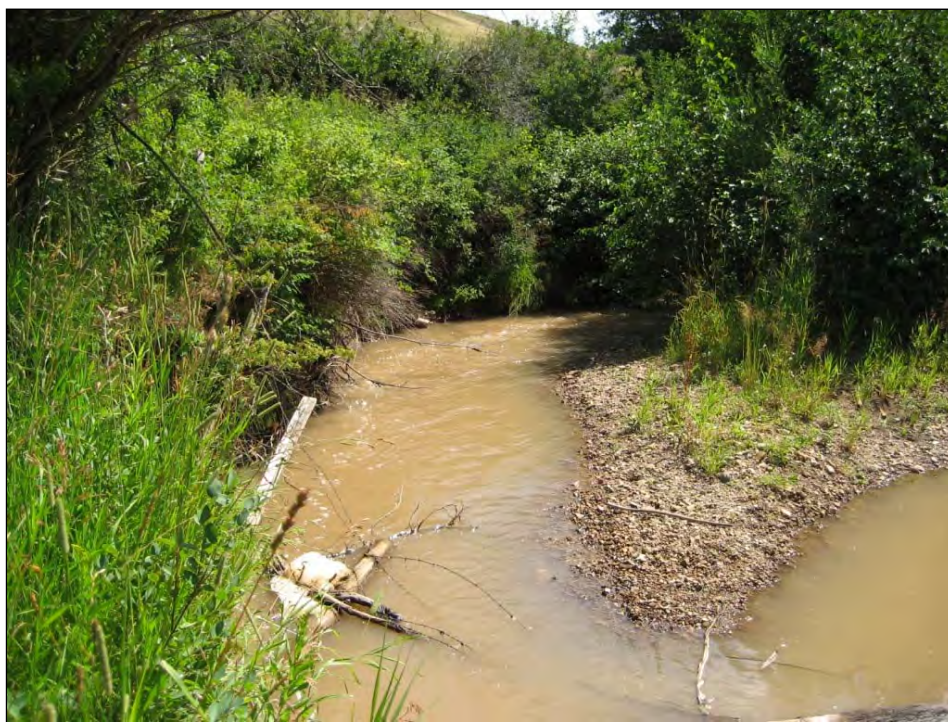
The dominant land uses within the reach are hay production, irrigated horse and cattle pasture, and scattered residences. Although the riparian zone is narrower than in reach BEAR 02 N, it is still relatively dense and robust, composed of cottonwood with a shrub understory in the upper reach, and willow, dogwood and alder in the lower reach (Figure 13). Bank erosion was low within the reach, limited to areas of pasture encroachment where stabilizing riparian vegetation has transitioned to shallower-rooted cultivar grasses (Figure 14). The unpaved Bear Canyon Road encroaches on the stream for 300 feet within the reach (Figure 15). Vegetation along the encroached area was generally dense, but the unpaved road could potentially be a sediment source during large storm events and during spring snowmelt. Two irrigation withdrawals remove water within the reach. Neither of the withdrawals were observed in the field.

FIGURE 13. ROBUST SHRUB RIPARIAN ZONE IN LOWER REACH BEAR 03 N

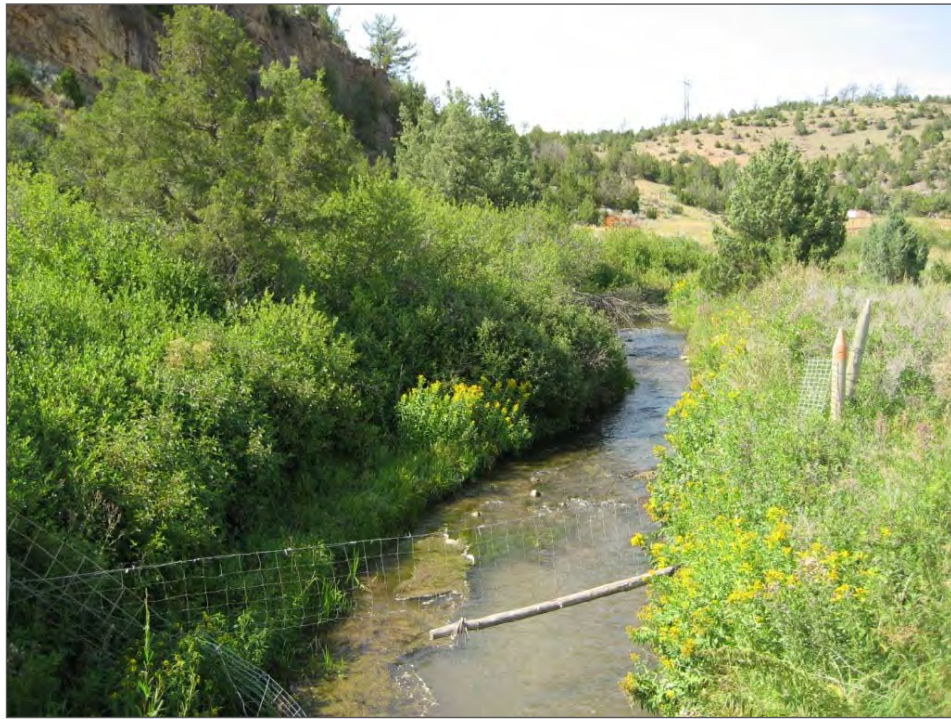
The dominant land uses within the reach are rangeland, and irrigated and dry crops (primarily hay production). The riparian vegetation is relatively healthy and dense throughout the reach, composed of willow, chokecherry, reed canarygrass and scattered juniper (Figure 5). The exception to the healthy riparian is the section for $\frac{3}{4}$ of a mile downstream of Menard Road which is heavily grazed and devoid of riparian vegetation in certain areas (Figure 6). Bank erosion was considered moderate with banks ranging to highly stable where riparian vegetation was dense, to severe erosion such as downstream of Menard Road (Figure 6). Soils within the reach are also highly erosive, leading to some areas of partly-natural erosion on outer meander bends where some grazing has also reduced stabilizing vegetation (Figure 7). North Dry Creek Road encroaches for a total of approximately 1000 ft in two locations: upstream (Figure 8) and downstream of Biggs Haugland Road. Both sections of encroachment are well vegetated and were not considered significant potential sediment sources. One irrigation withdrawal was identified on the aerial north of Menard Rd but was not confirmed in the field.

FIGURE 5. DENSE RIPARIAN UPSTREAM OF NORTH DRY CREEK RD

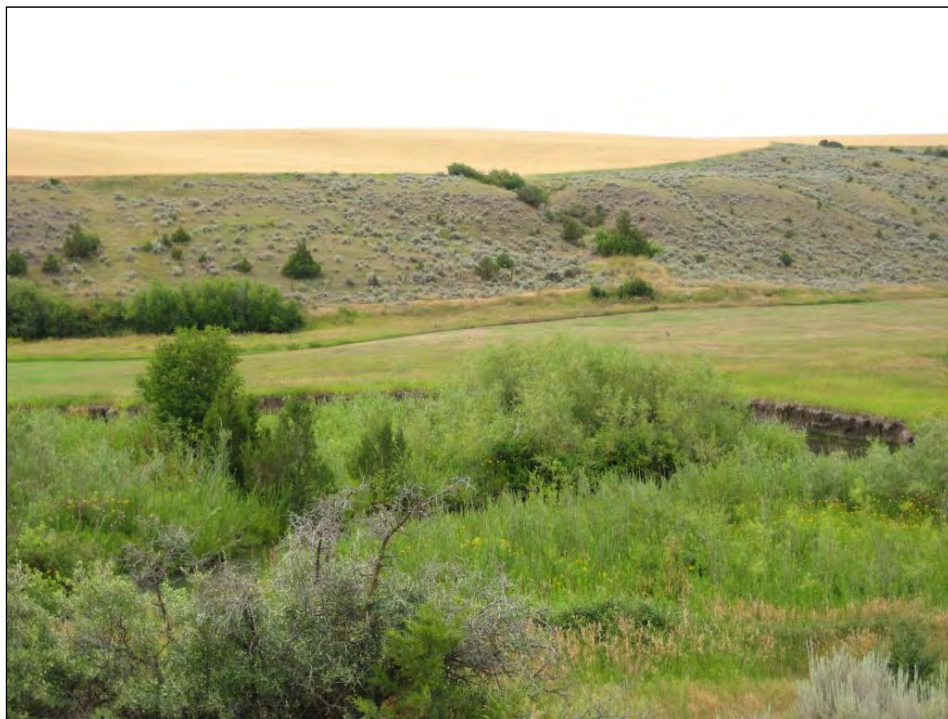
The dominant land uses within the reach are wheat and barley production, hay production, pasture, and rangeland. The riparian vegetation is generally healthy, although significant pasture encroachment was observed (Figure 11). Riparian vegetation was composed of a chokecherry, willow and juniper understory with dense reed canarygrass; cottonwoods were present in the lowest 1 to 3 miles of the reach (Figure 12). Banks were generally stable due to the dense riparian, however soils are naturally erosive and some erosion was observed where pasture encroached on the stream at outer meander bends (Figure 11). Four irrigation withdrawals were identified during the assessment. Of those, two were only possibly confirmed on the aerial while the other two were more definitively confirmed as significant diversions based on potential flow paths. None of the withdrawals were confirmed in the field. No roads encroach on the stream in this reach.

FIGURE 11. PASTURE ENCROACHMENT AND BANK EROSION ON MEANDER BEND

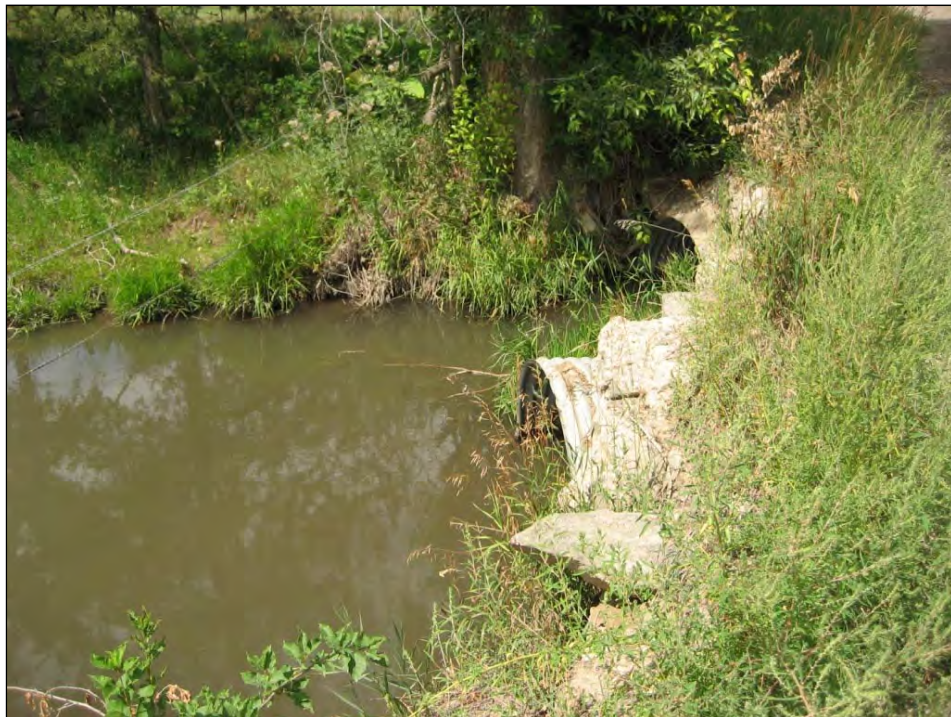
FIGURE 17. CULVERT DOWNSTREAM OF NORTH DRY CREEK ROAD; MINOR SEDIMENT SOURCE

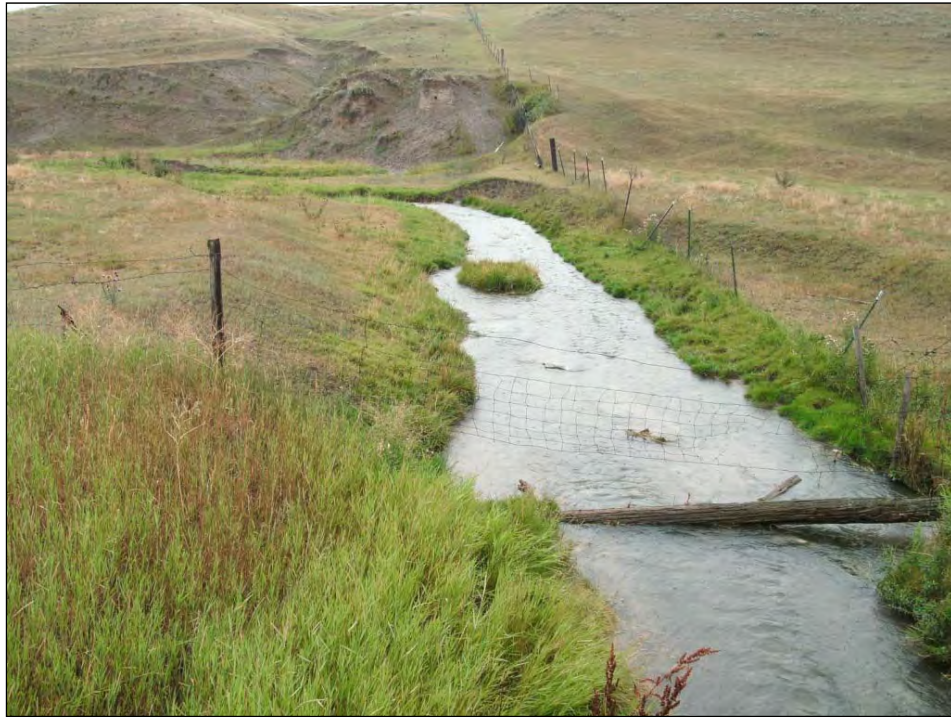
FIGURE 9. OVERGRAZED RIPARIAN DOWNSTREAM OF CHURCHILL ROAD BUT RELATIVELY STABLE BANKS

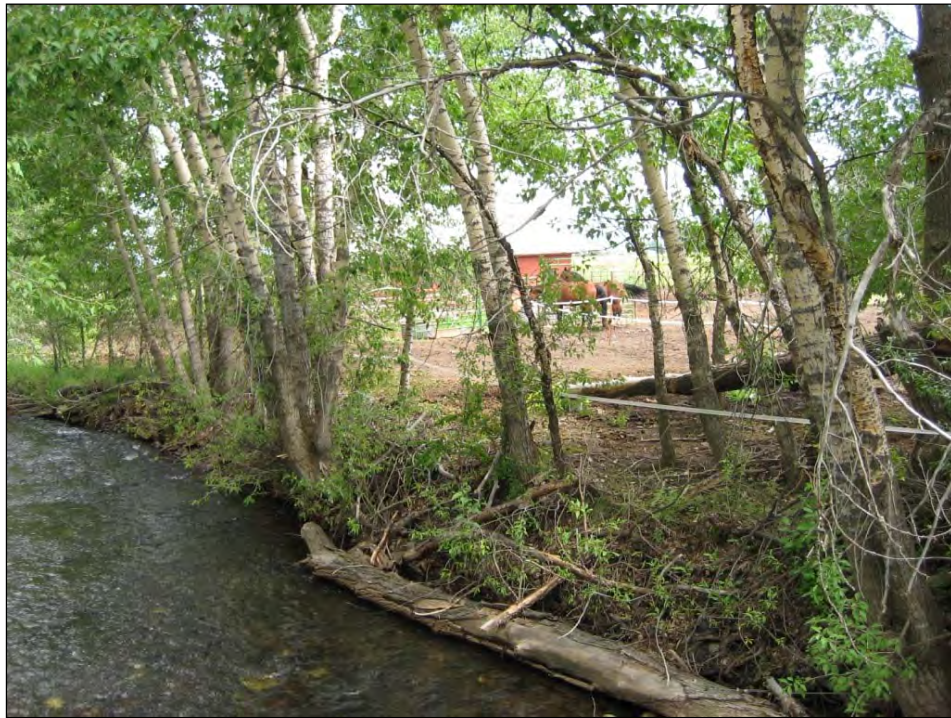
FIGURE 16. HORSE CORRAL WITHIN 5 FT OF STREAM IN HYAL 04 N

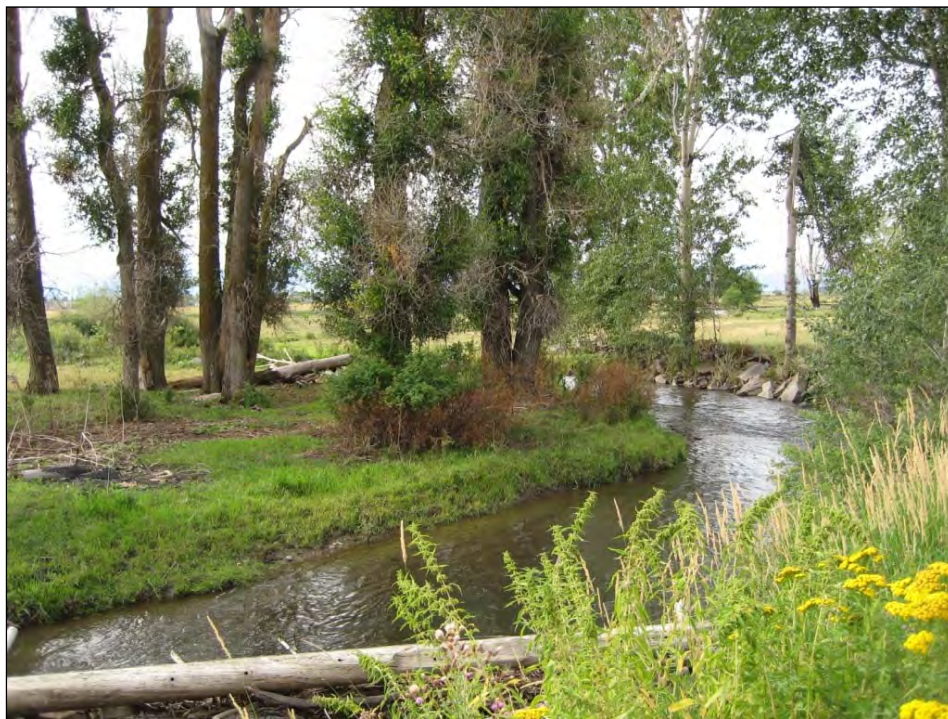
FIGURE 24. OVERGRAZED RIPARIAN WITH UNHEALTHY COTTONWOODS UPSTREAM OF CAMERON BRIDGE ROAD

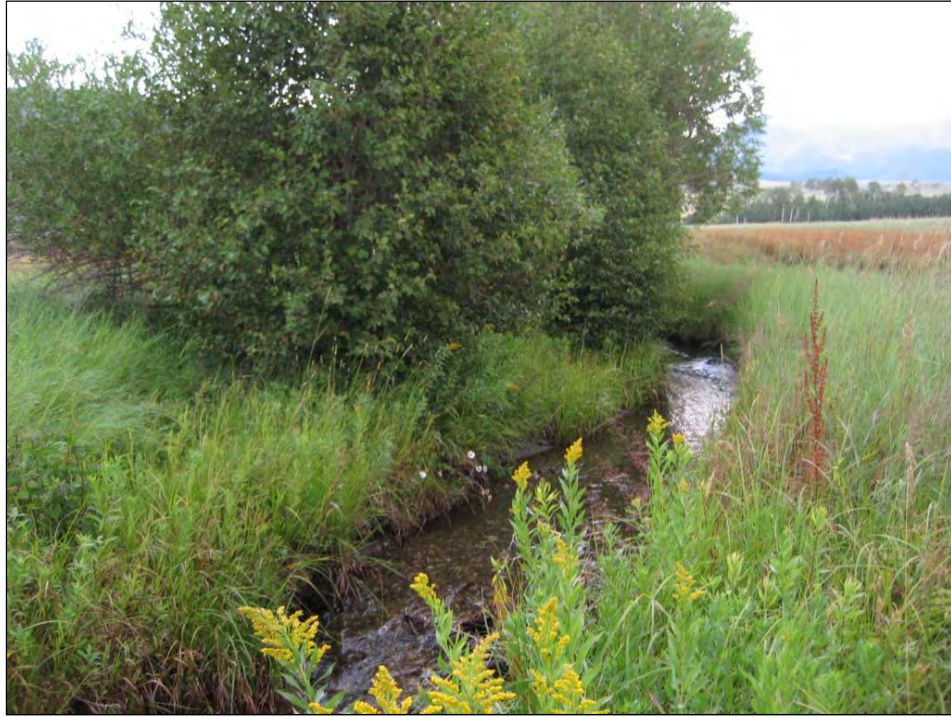
FIGURE 7. HEALTHY RIPARIAN WITH STABLE BANKS UPSTREAM OF GEE NORMAN RD

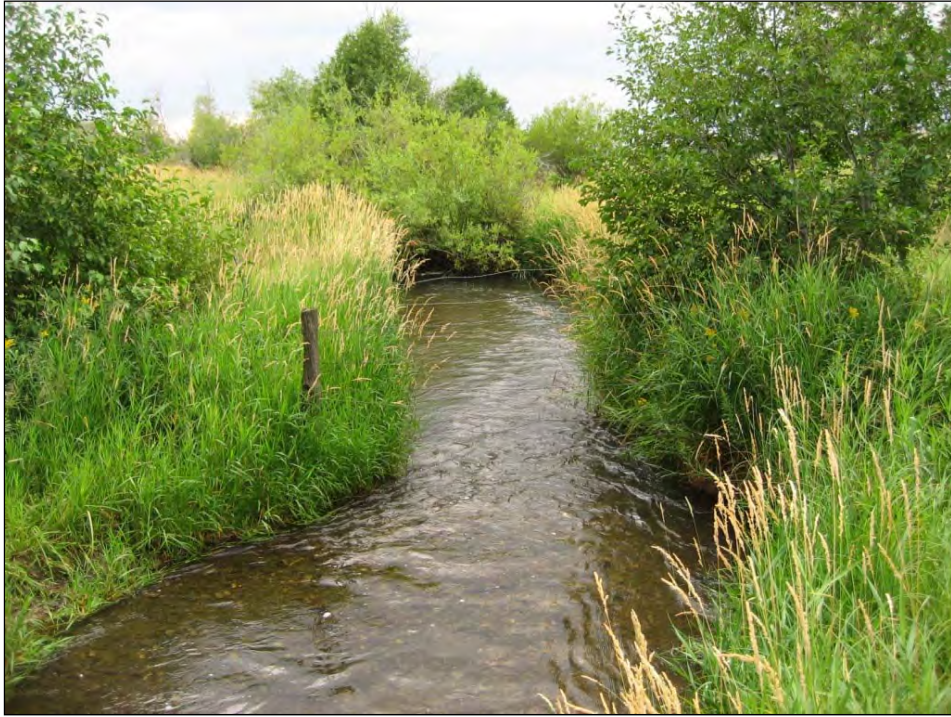
FIGURE 10. DENSE RIPARIAN WITH STABLE BANKS DOWNSTREAM OF HAMILTON RD

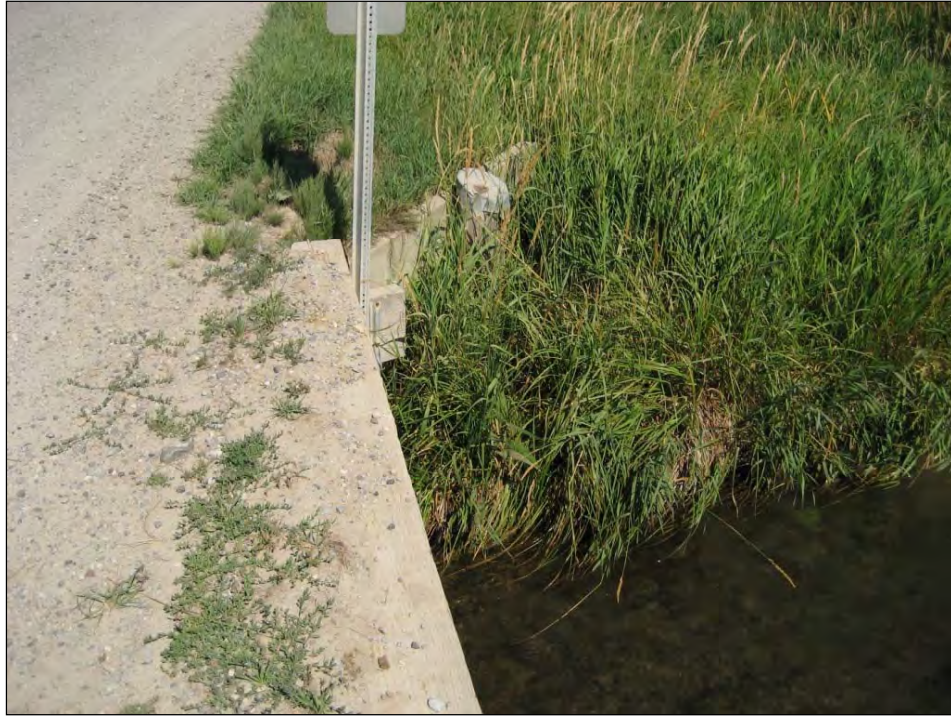
FIGURE 14. WELL-VEGETATED ABUTMENT WITH GRAVEL ON DECKING AT HAMILTON BRIDGE RD
