APPENDIX A

FIELD SEDIMENT SOURCE SURVEYS

Yaak River TMDL Planning Area

Appendix A provides examples of the Field Sediment Source Survey data sheets. Field Sediment Source Surveys were conducted by the Yaak Headwaters Restoration Partnership in the Seventeenmile Creek, Lap Creek, and South Fork Yaak River Watersheds during the summers of 2004, 2005, and 2006.

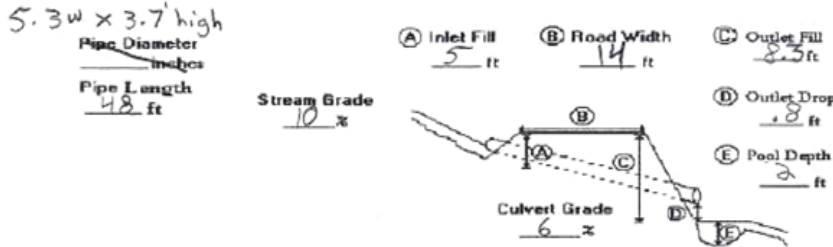
MAP SITE NO. 336 ROAD NO. 600
 W. RSHED 17 Mile Main TRIB NO. 136
 SURVEYORS Owen / Oakland DATE 9-8-05

±43'
0596130
5380855
 Scour channel above culvert? (Y/N) (Y)
 If yes, average bankfull channel width in riffle section above influence of culvert: 17 ft
 Is there flow at the culvert now? (Y/N) (Y) Streamflow: 100 gpm MEASURED or ESTIMATED
 If no, is there evidence of flow from the culvert? (Y/N) (Y)

Can you see through culvert? (Y/N) (Y) If no, apparent cause: SAG BLOCKED
 Is inlet obstructed? (Y/N) (N)
 If yes, cause(s) are: DENTED FILLED W/SEDIMENT BLOCKAGE AT INLET
 _____ % opening obstructed Estimate maximum depth of sediment in the culvert: _____ in
 Is culvert aligned with channel? (Y/N) (Y)
 Scouring around inlet of culvert? (Y/N) (Y) very well armoured!
 Evidence of culvert being overtopped? (Y/N) (N) Describe: _____

Is outlet obstructed? (Y/N) (N) If yes, cause(s) are: DENTED FILLED W/SEDIMENT BLOCKAGE AT OUTLET
 _____ % Obstructed
 Scour hole at outlet? (Y/N) (Y) Dimensions of scour hole: (Max. Width X Length) 9 x 6 ft
 Is scour hole undercutting fillslope? (Y/N) (N)
 Does channel appear to be disturbed for more than 100 feet downstream of scour hole? (Y/N) (N)

Ditch draining into stream? NO ONE SIDE TWO SIDES
 Ditch length draining to stream: Left _____ ft Right 95 ft
 Is there water currently flowing in the ditch? (Y/N) (N)
 Evidence of sediment being carried by ditch? (Y/N) (N) well filtered
 Source(s): DITCH SCOUR CUTSLOPE SLUMPING CUTSLOPE RILLING
 ROADWAY RILLING WHEEL TRACK RUTTING OTHER: _____

Does water run off of road surface at stream crossing? (Y/N) (N) Cause? _____
 If yes, is there rilling on road surface? (Y/N) (N) Fillslope rilling or slumping? (Y/N) (N) Shoulder cracking? (Y/N) (N)

Is sediment delivered to stream at this crossing? (Y/N) (N) Quantity? MINOR MODERATE SUBSTANTIAL
 High Priority Maintenance Needs: None. Healed.
