**RECLAMATION DESIGN REPORT  
FOR THE  
McLAREN TAILINGS ABANDONED MINE SITE  
COOKE CITY, MONTANA**

## **APPENDIX A**

### **PHOTO LOG**

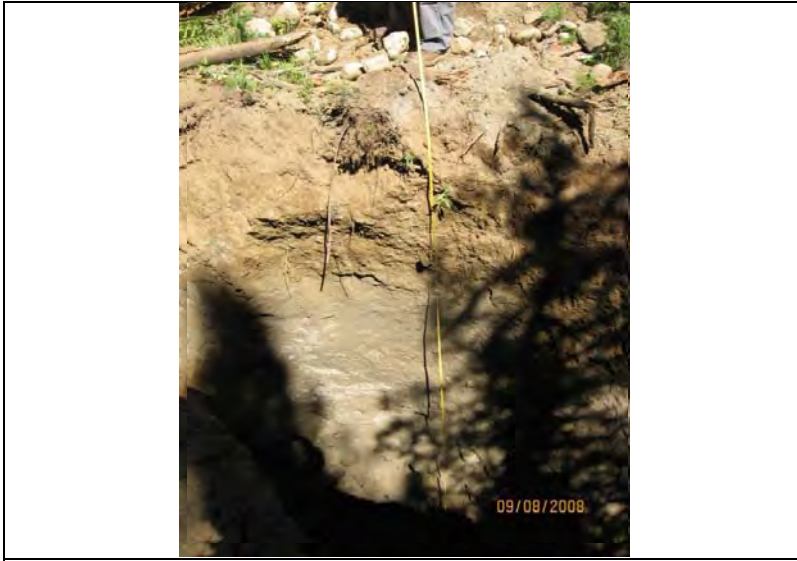
Picture #: McLaren RA Project\Site Investigation Photos\Julies Photos\McLaren SI 001

Description: Looking north at north wall of RA-1

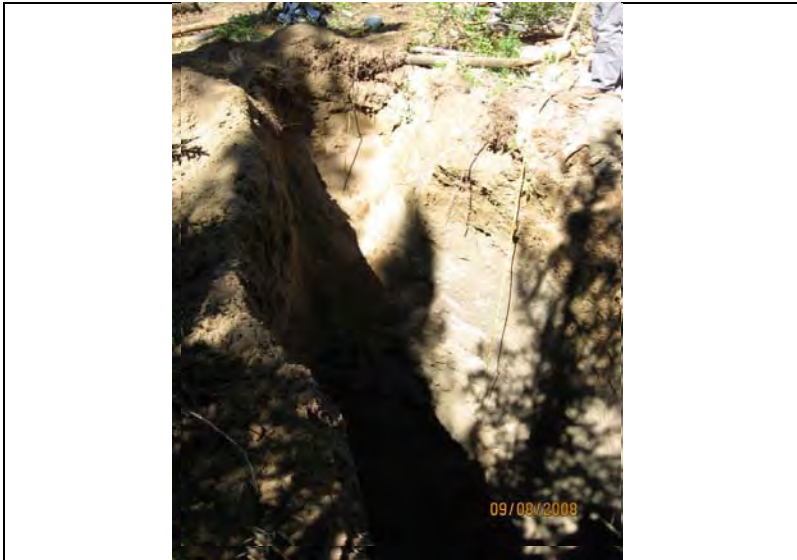
Picture #: McLaren RA Project\Site Investigation Photos\Julies Photos\McLaren SI 002

Description: Looking west at west wall at RA-1

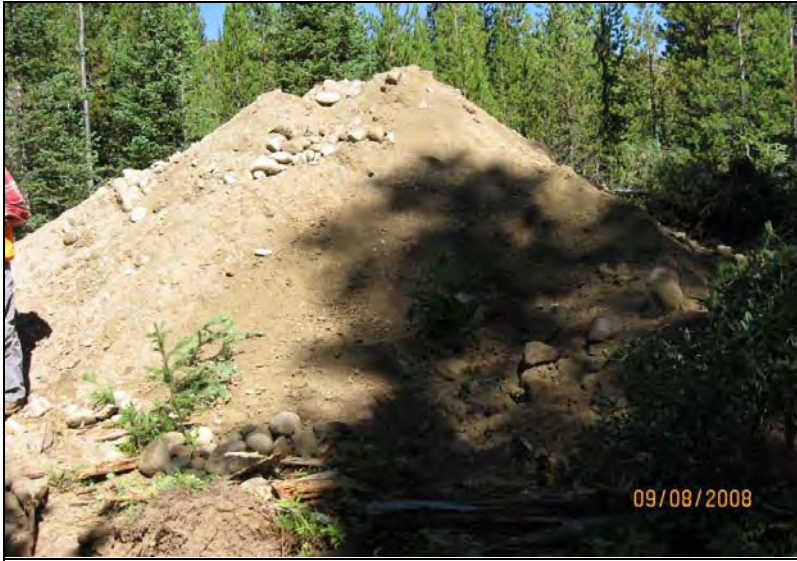
Picture #: McLaren RA Project\Site Investigation Photos\Julies Photos\McLaren SI 003

Description: Looking north at spoils pile fom RA-1

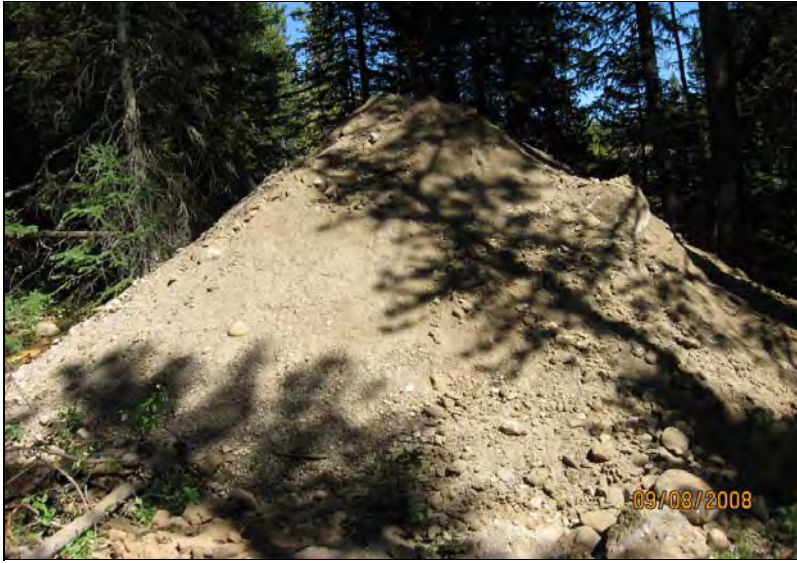
Picture #: McLaren RA Project\Site Investigation Photos\Julies Photos\McLaren SI 005

Description: Looking north at spoils pile from RA-2

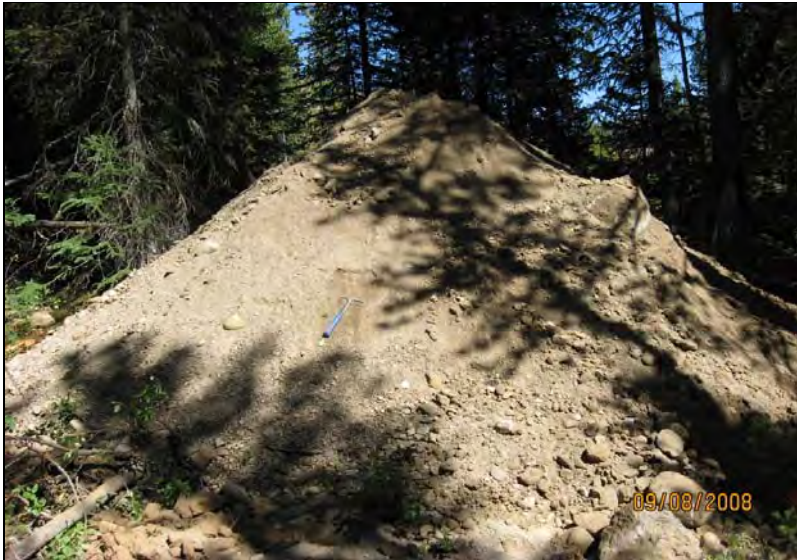
Picture #: McLaren RA Project\Site Investigation Photos\Julies Photos\McLaren SI 006

Description: Looking north at spoils pile from RA-2

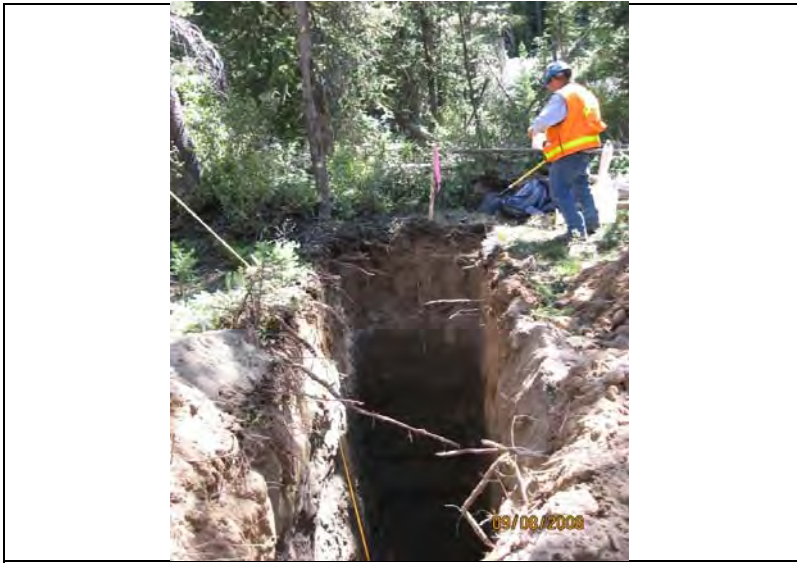
Picture #: McLaren RA Project\Site Investigation Photos\Julies Photos\McLaren SI 007

Description: Looking west at RA-2 with stake

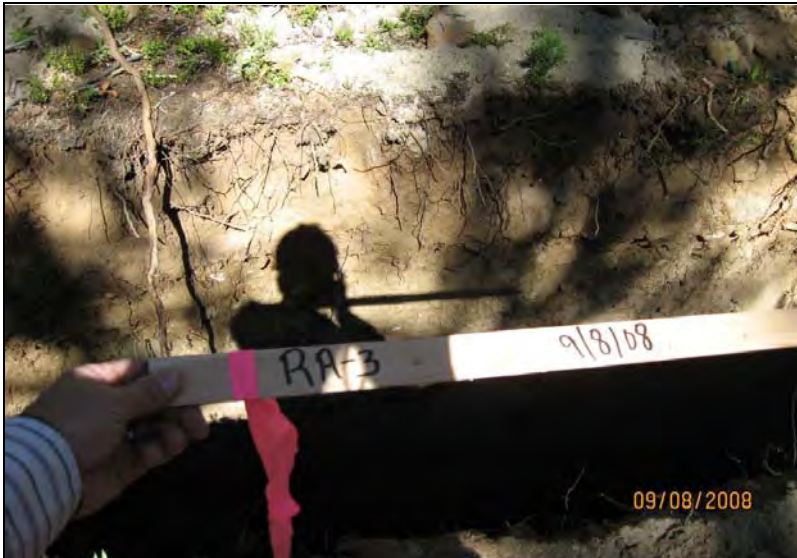
Picture #: McLaren RA Project\Site Investigation Photos\Julies Photos\McLaren SI 008

Description: Looking west at RA-3 test pit

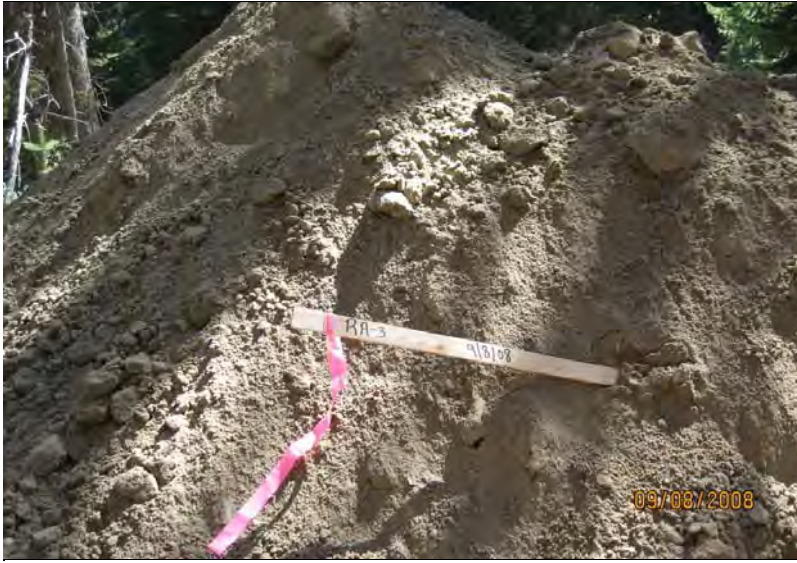
Picture #: McLaren RA Project\Site Investigation Photos\Julies Photos\McLaren SI 009

Description: Looking east at spoils pile from RA-3

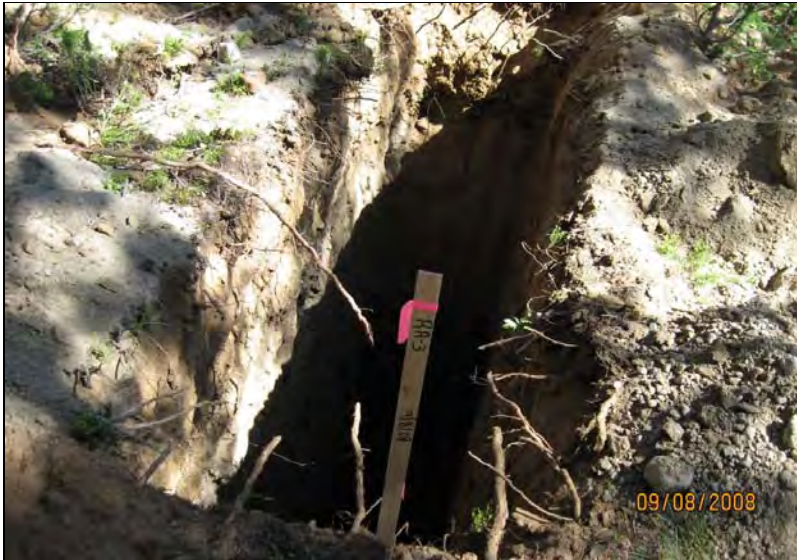
Picture #: McLaren RA Project\Site Investigation Photos\Julies Photos\McLaren SI 010

Description: Looking north at RA-3 test pit

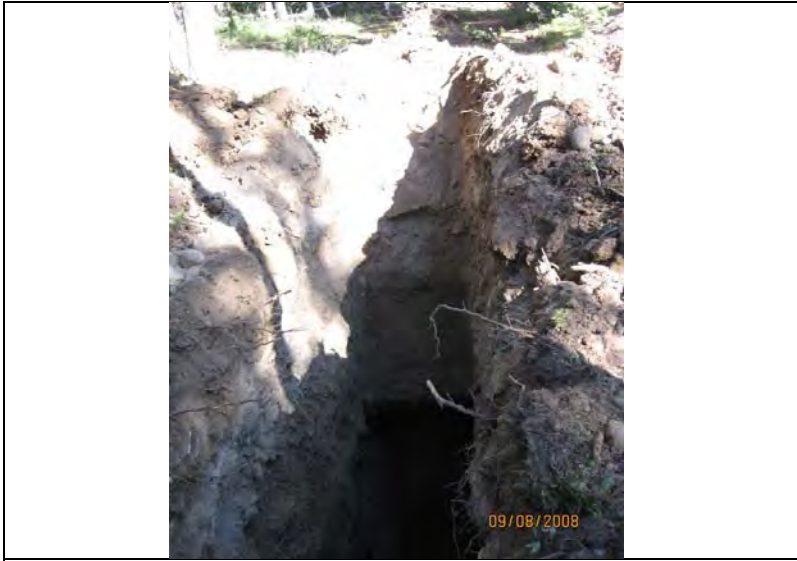
Picture #: McLaren RA Project\Site Investigation Photos\Julies Photos\McLaren SI 011

Description: Looking north at RA-4

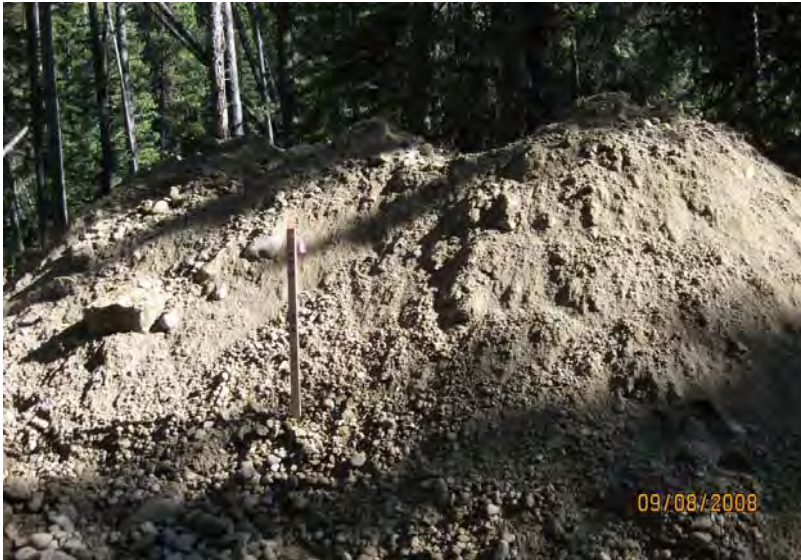
Picture #: McLaren RA Project\Site Investigation Photos\Julies Photos\McLaren SI 012

Description: Looking northwest at RA-4 spoils pile

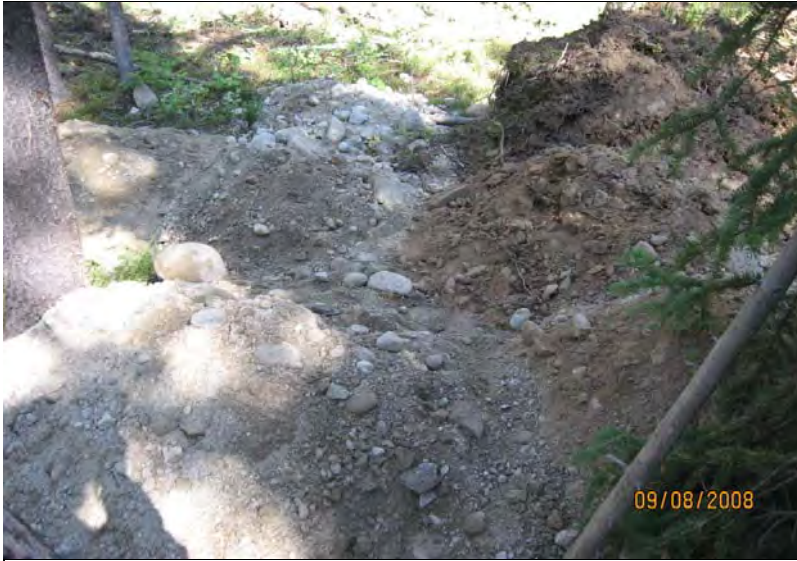
Picture #: McLaren RA Project\Site Investigation Photos\Julies Photos\McLaren SI 013

Description: Looking north at small separated piles from RA-4

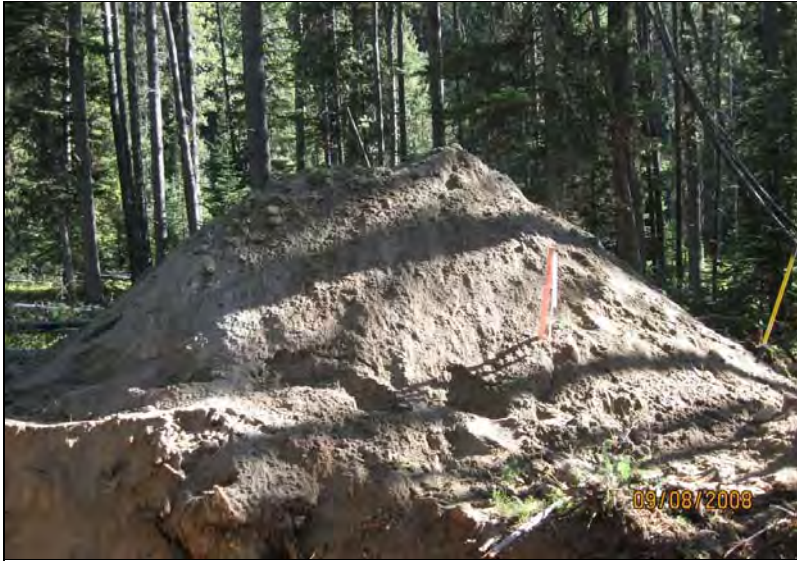
Picture #: McLaren RA Project\Site Investigation Photos\Julies Photos\McLaren SI 015

Description: Looking east at spoils pile from RA-5

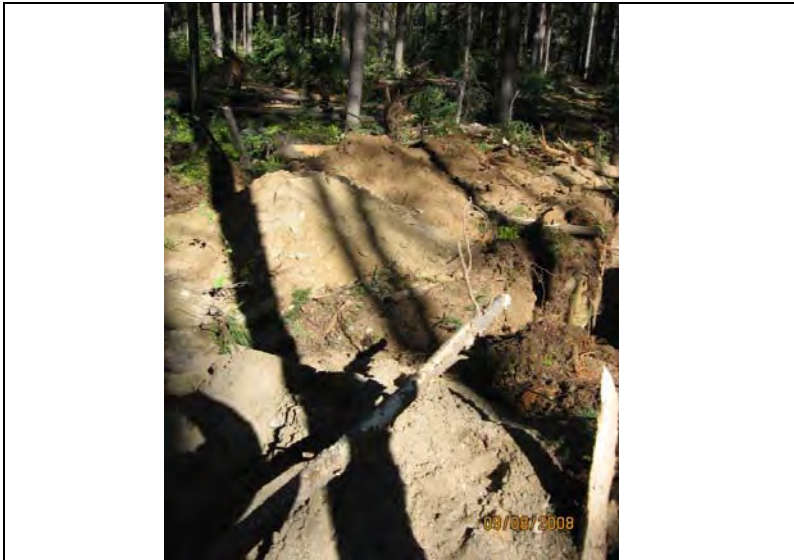
Picture #: McLaren RA Project\Site Investigation Photos\Julies Photos\McLaren SI 016

Description: Looking north at small spoil piles of layers from RA-5

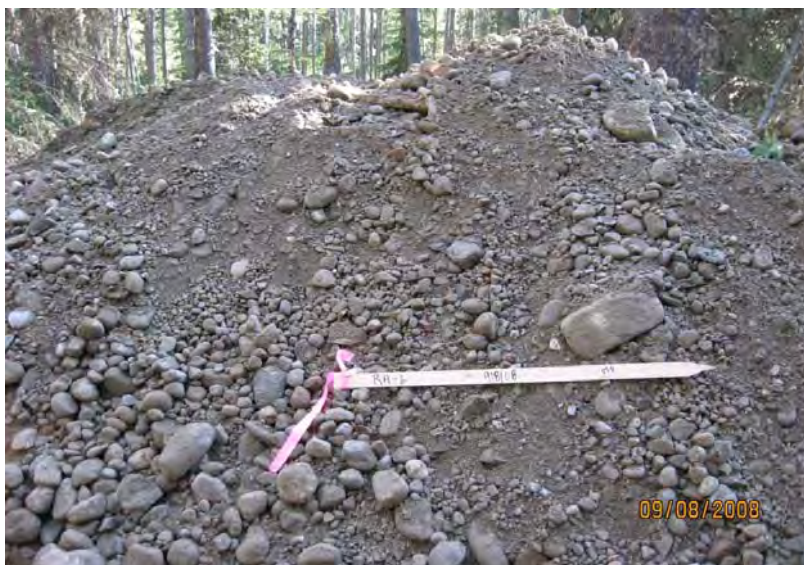
Picture #: McLaren RA Project\Site Investigation Photos\Julies Photos\McLaren SI 017

Description: Looking south at RA-6 spoils pile

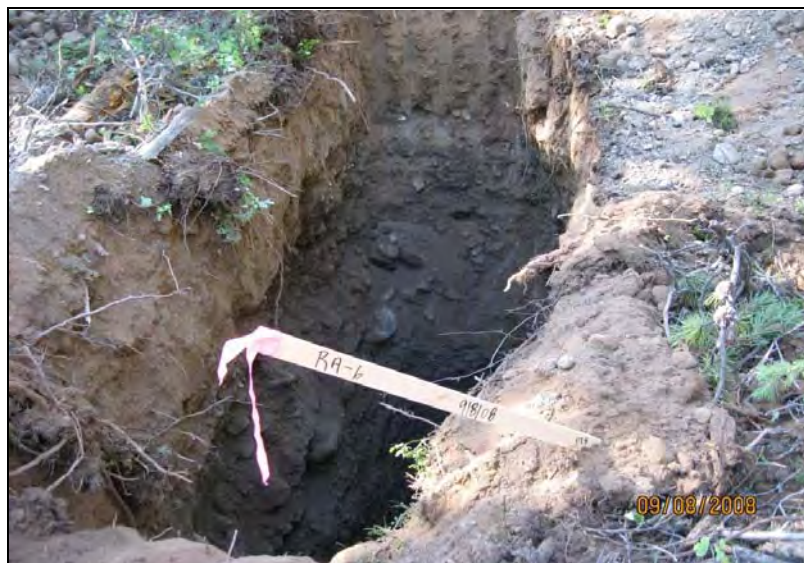
Picture #: McLaren RA Project\Site Investigation Photos\Julies Photos\McLaren SI 018

Description: Looking north at RA-6 test pit

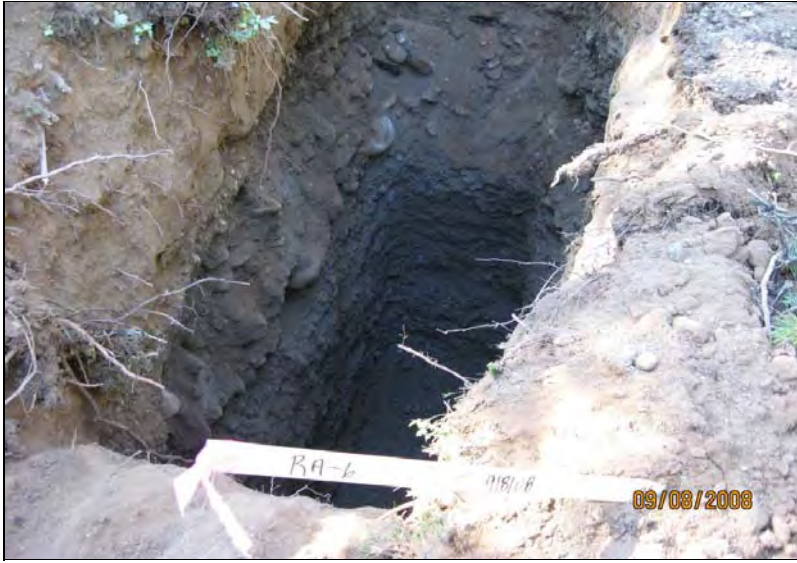
Picture #: McLaren RA Project\Site Investigation Photos\Julies Photos\McLaren SI 019

Description: Looking north at RA-6 test pit

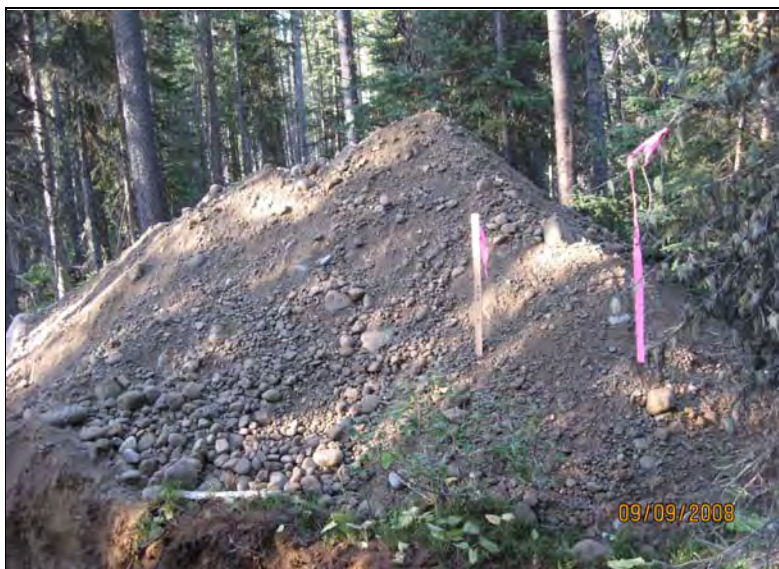
Picture #: McLaren RA Project\Site Investigation Photos\Julies Photos\McLaren  
SI 021

Description: Looking south at spoils pile from RA-7

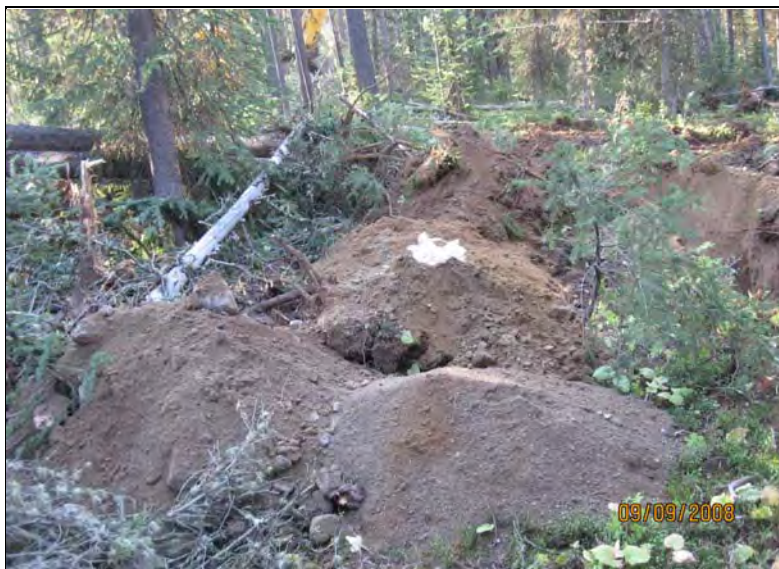
Picture #: McLaren RA Project\Site Investigation Photos\Julies Photos\McLaren  
SI 022

Description: Looking east at layer spoil piles from RA-7

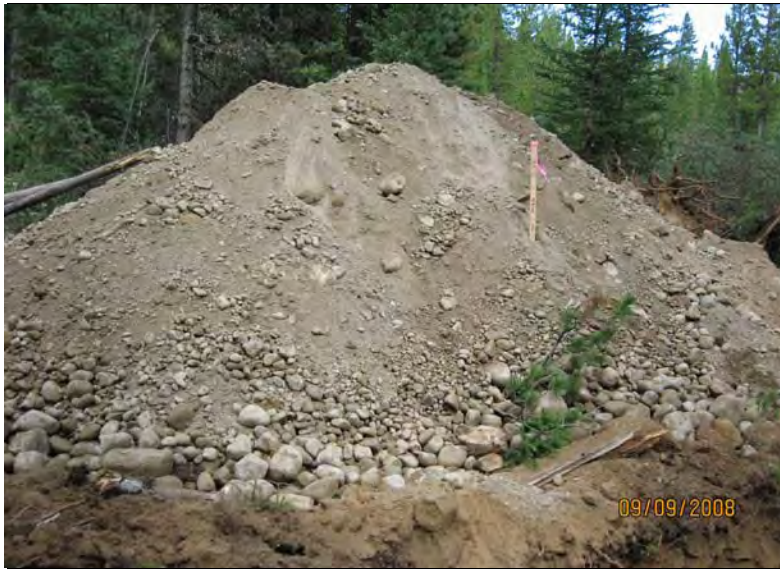
Picture #: McLaren RA Project\Site Investigation Photos\Julies Photos\McLaren  
SI 039

Description: Looking west at spoils pile from RA-13 with stake

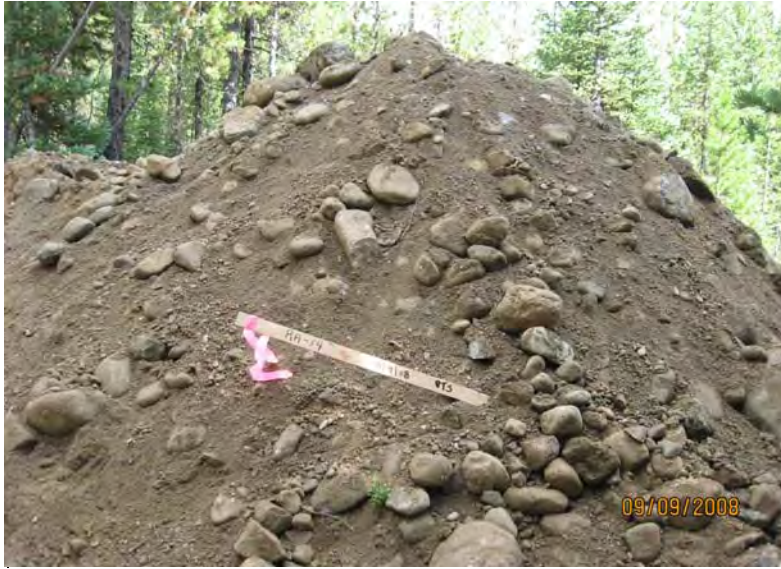
Picture #: McLaren RA Project\Site Investigation Photos\Julies Photos\McLaren  
SI 043

Description: Looking north at stockpile from RA-14

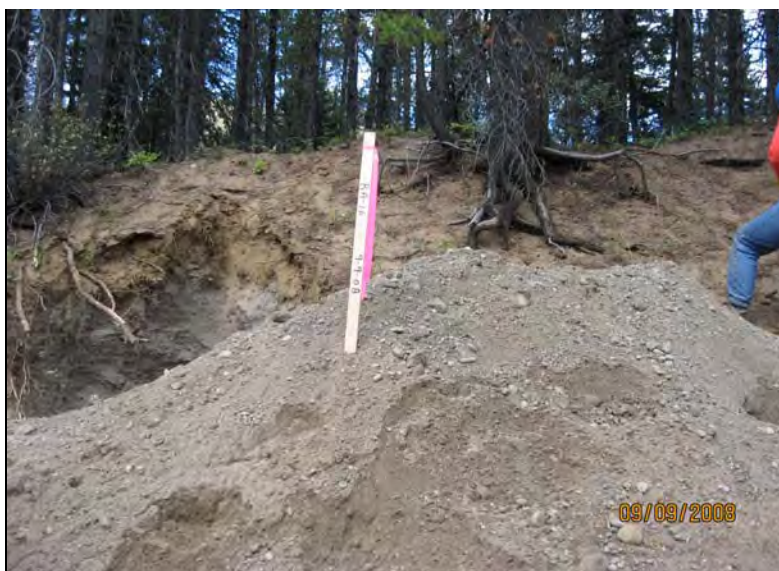
Picture #: McLaren RA Project\Site Investigation Photos\Julies Photos\McLaren  
SI 049

Description: Looking west at spoils pile from RA-16

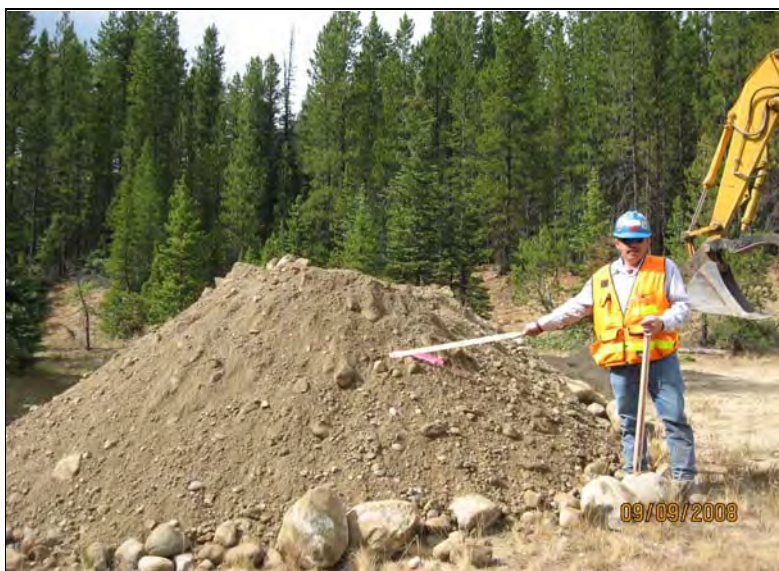
Picture #: McLaren RA Project\Site Investigation Photos\Julies Photos\McLaren  
SI 050

Description: Looking south at spoils pile from RA-17

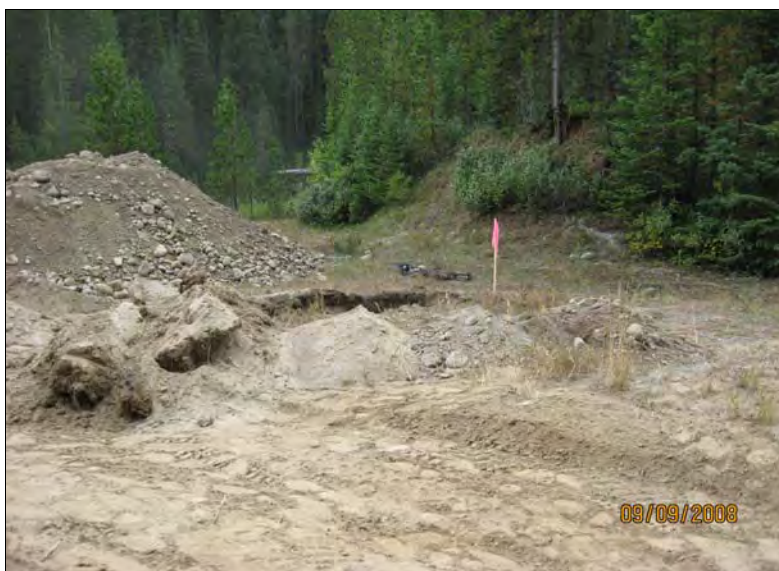
Picture #: McLaren RA Project\Site Investigation Photos\Julies Photos\McLaren  
SI 053

Description: Looking east at small spoil piles representing layers from RA-17

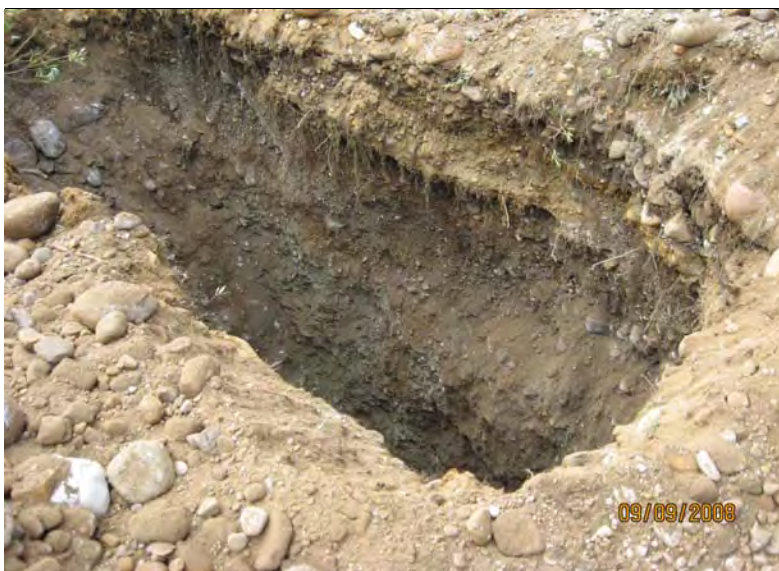
Picture #: McLaren RA Project\Site Investigation Photos\Julies Photos\McLaren  
SI 054

Description: Looking east at RA-18 test pit

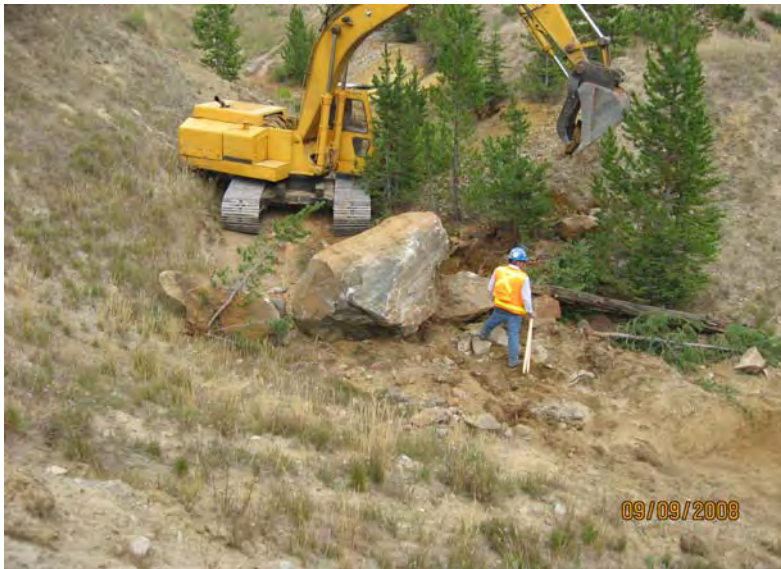
Picture #: McLaren RA Project\Site Investigation Photos\Julies Photos\McLaren SI 056

Description: South of RA-18 - rocks were placed to block valley below

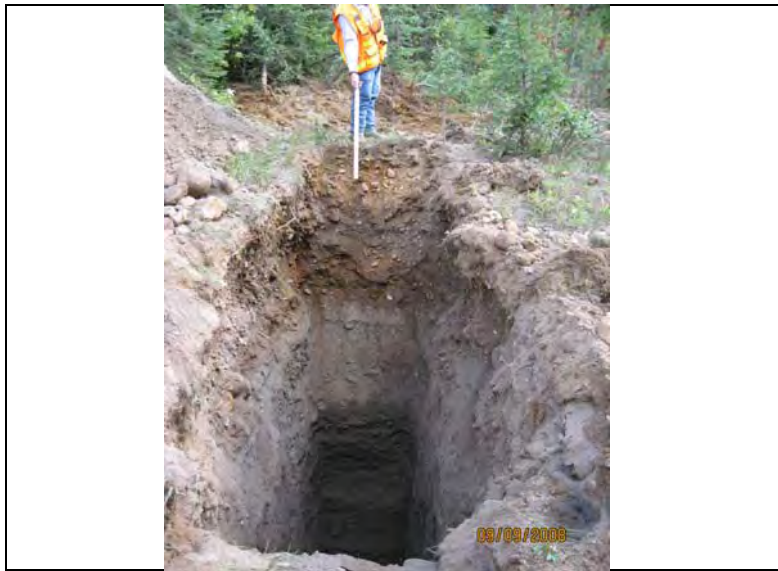
Picture #: McLaren RA Project\Site Investigation Photos\Julies Photos\McLaren  
SI 058

Description: Northeast wall of RA-19 test pit
