# Qualitative Rapid Assessment 2015-2017 Status Report

Milltown Reservoir / Clark Fork River NPL Site Clark Fork River Operable Unit, Reach A, Phase 1, Phase 2 and Phases 5 and 6

Qualitative Rapid Assessment, 2015-2017 Status Report Milltown Reservoir / Clark Fork River NPL Site Clark Fork River Operable Unit, Reach A

> > January, 2018

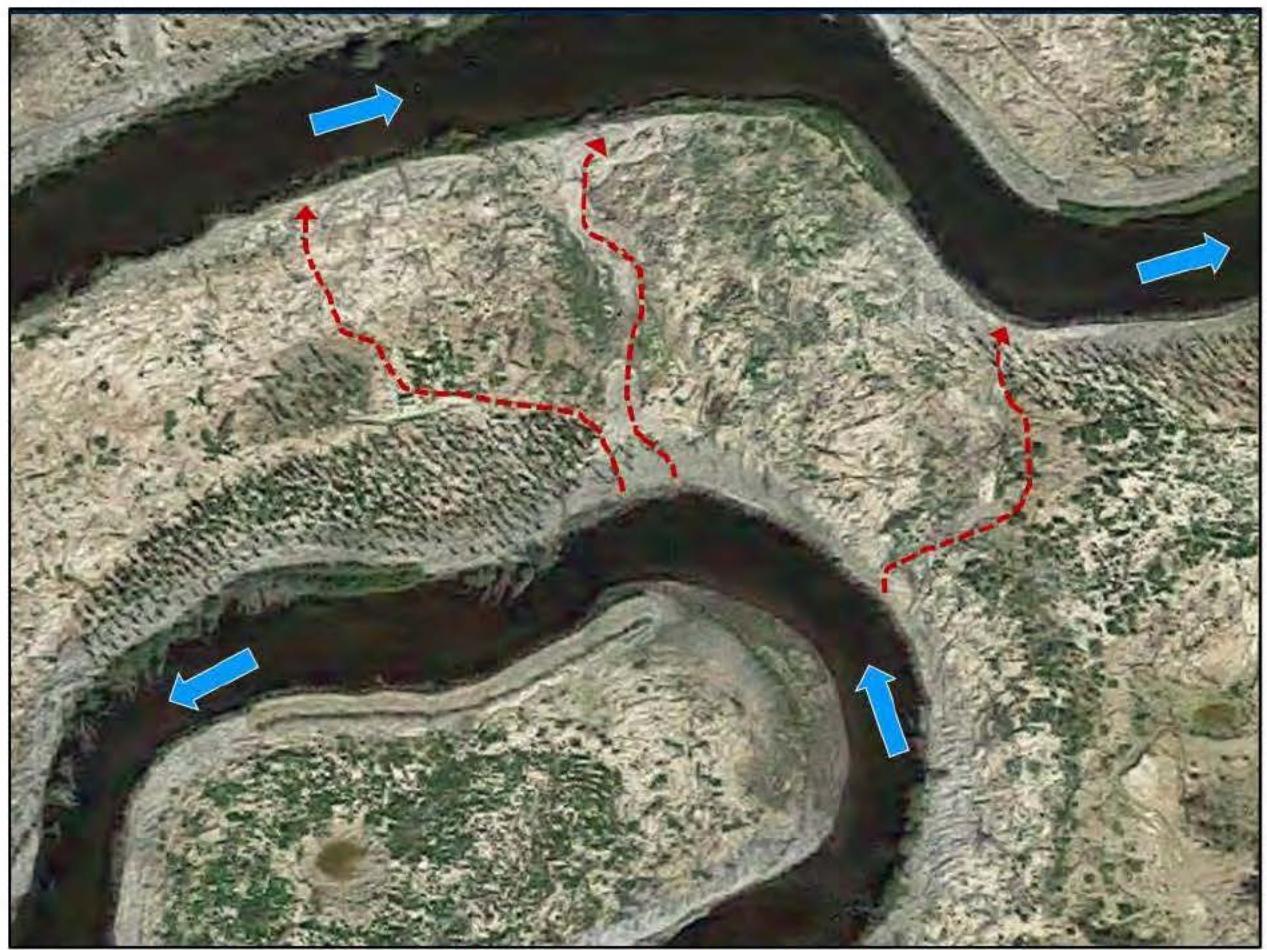
Figure 3. Mapped overflow channels (dashed red lines) that formed in Phase 1 following 2014 spring runoff.

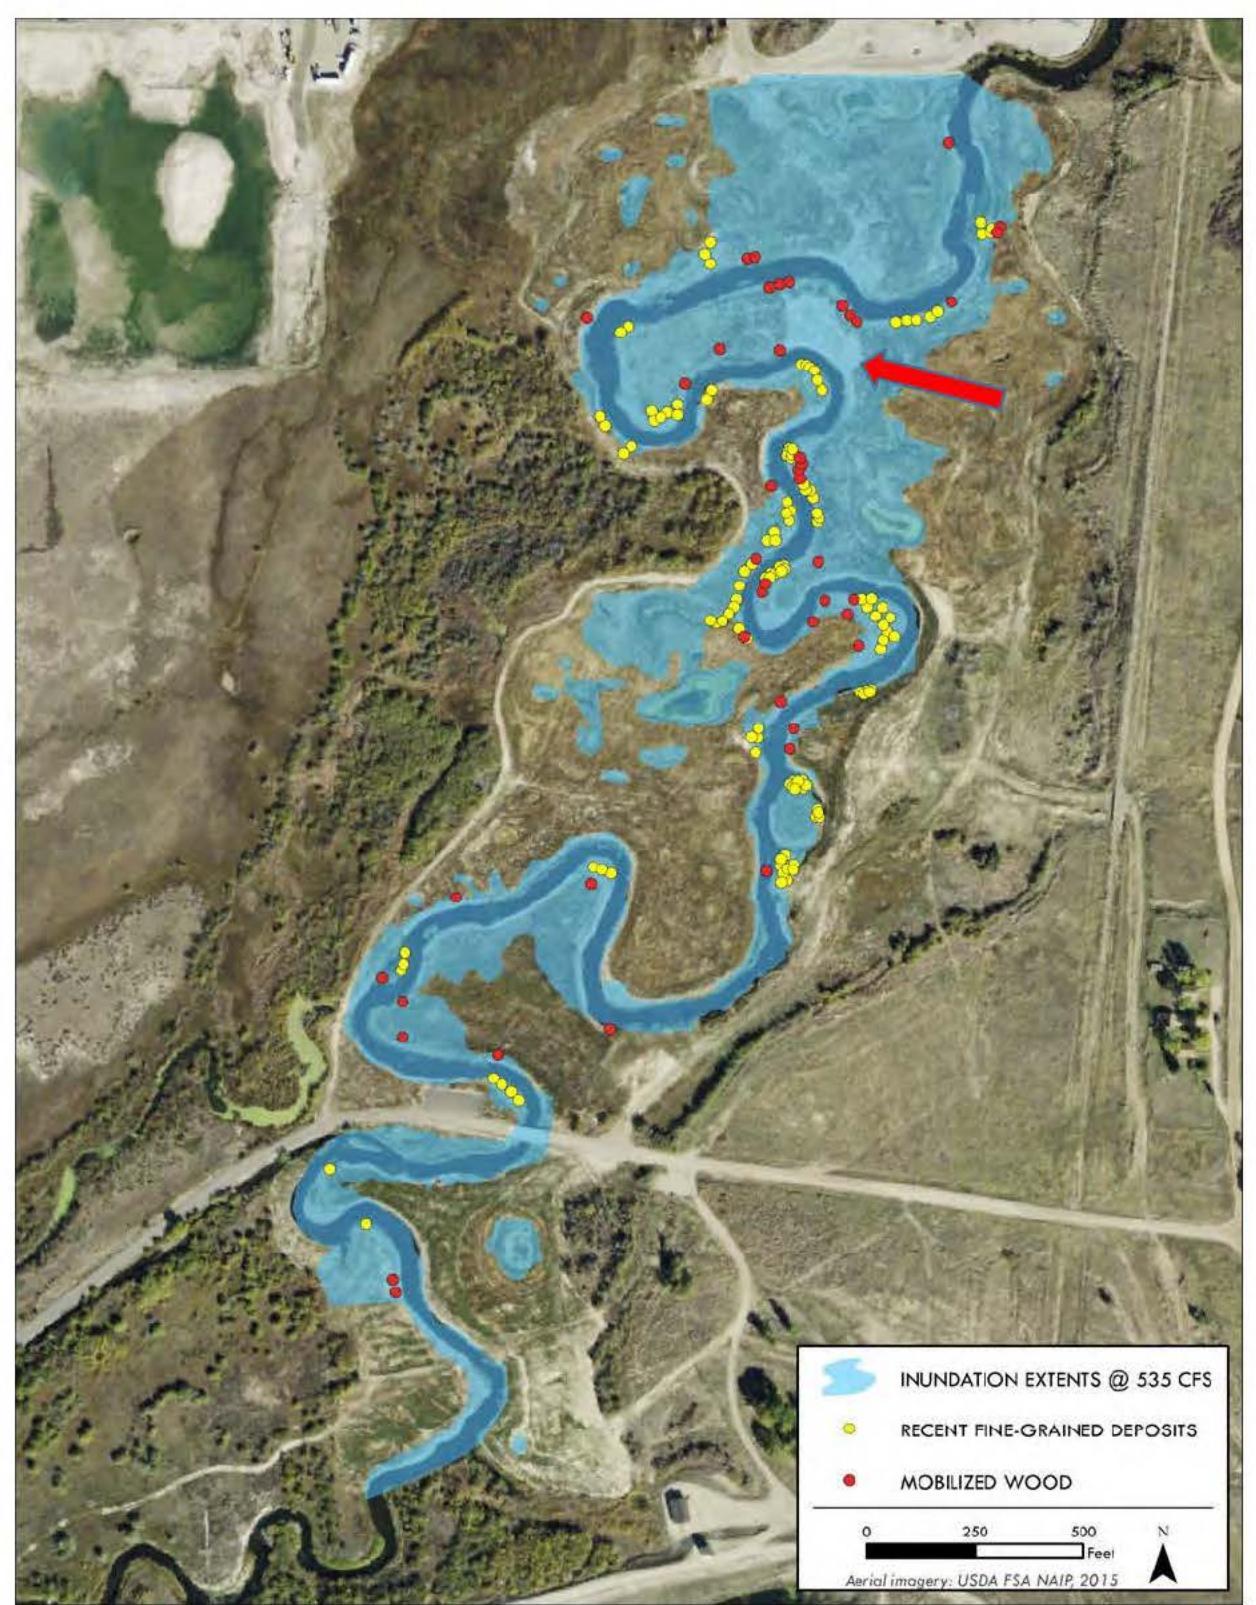
Figure 4. Mapped floodplain inundation in Phase 1 in spring 2014 and locations where floodplain inundation indicators were observed during the QRA. Red arrow indicates where the floodplain channel formed in spring 2014 and was repaired in fall 2014.

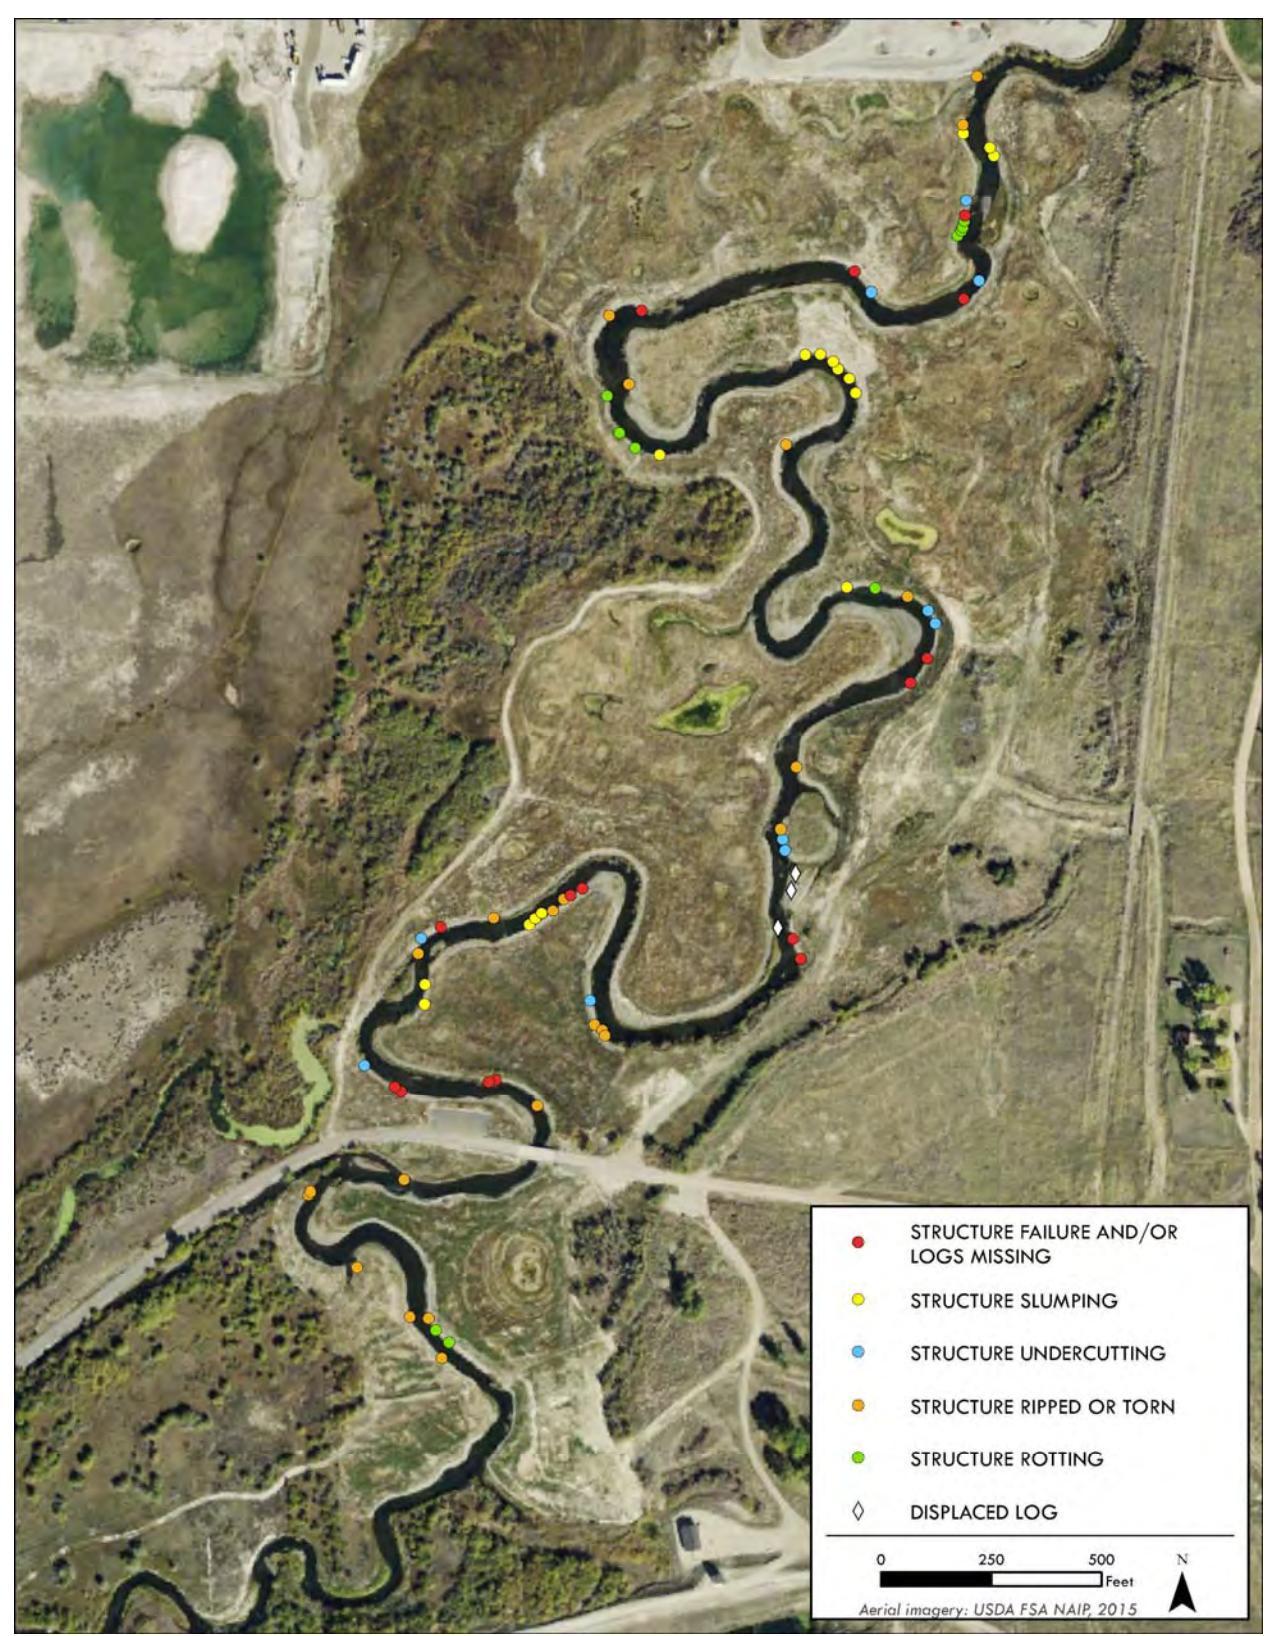
Figure 5. Results of DEQ inventory of all Phase 1 streambanks where structure degradation was observed in fall 2015 ('logs' in the legend refer to coir logs installed in DVSL treatments).

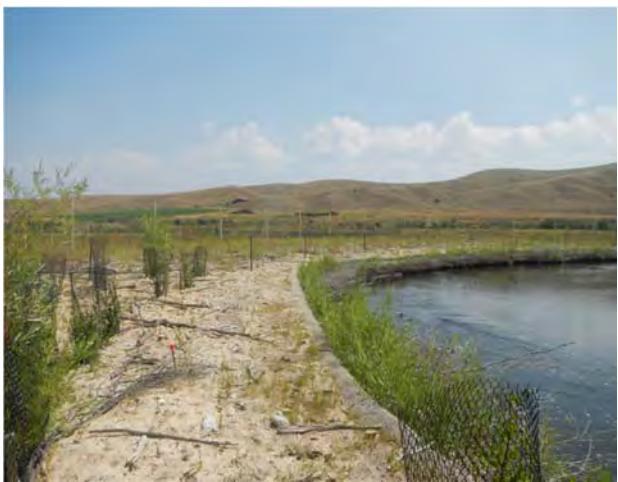
Figure 8. Bankline that was repaired following the 2014 overflow event (photo is looking upstream).

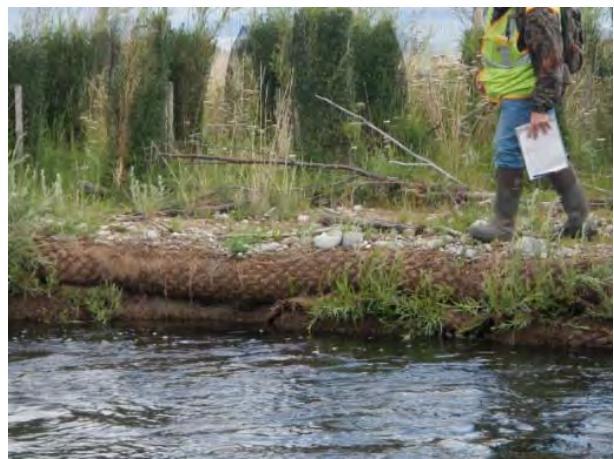
The DVSL bank treatment had a substantial amount of fabric decay which was observed on both the upper and lower lifts of structures in 2016 (Figure 10). Some fabric decay, particularly on north-facing upper lifts, may have been from ice build up or movement. Where the lifts were constructed on steep clay banks, ice accumulation appeared to have displaced the toe alluvium causing slumping below the lifts. The QRA team discussed the potential to mitigate for this by adding coarse wood into the toe along the entire length of the treatment or at intervals along the treatment.

Figure 10. DVSL streambank with fabric decay and exposed coir log.

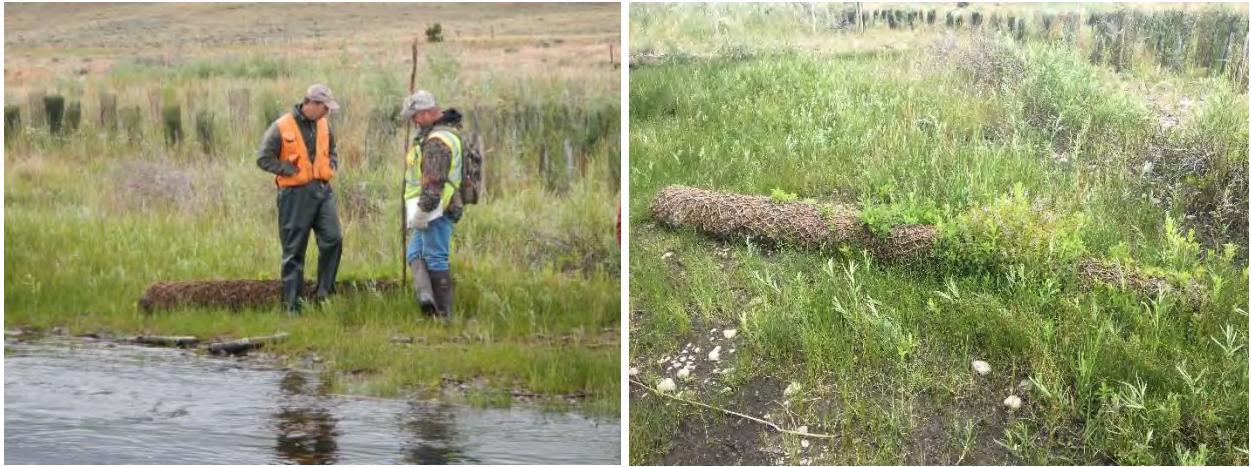
In a few areas, the coir fabric had degraded and the exposed coir logs were displaced (RB-N-5, RB-N-14, RB-N-19, RB-N-23, LB-N-33, RB-N-47). At streambank RB-N-14, the displaced coir log had deposited on a low bar just downstream (Figure 11). Due to the ability of coir fibers to retain high moisture, the displaced coir log was supporting wetland vegetation such as rushes and mint (Figure 11). The QRA team discussed whether displaced coir logs should be removed, and the consensus was that they should remain in place to support vegetation and naturally degrade with time.

Figure 11. Coir log displaced from bank RB-N-19 and deposited on floodplain surface immediately downstream. Herbaceous wetland vegetation is growing in the coir log (right photo).

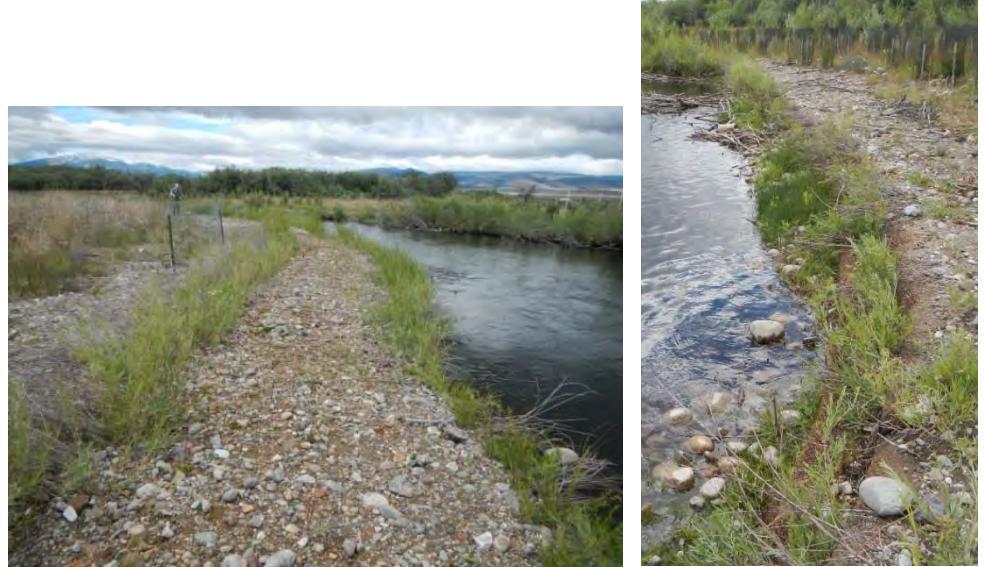
Figure 15. Bare alluvium placed behind streambank treatment.

In 2016, the geomorphology QRA team discussed adding vegetative backfill to the 10 feet of alluvium left bare behind streambanks because little vegetation was observed in this area (Figure 15). At a follow up meeting with the full QRA team, Amy Sacry with Geum described the intent behind leaving these areas bare alluvium as: 1) alluvium provides short-term erosion control (i.e. if soil is placed here prior to vegetation establishment it washes away and this increase risk to the streambank structure; and 2) bare alluvium allows for natural expansion and natural recruitment of woody vegetation; vegetative backfill would support herbaceous vegetation which is not as desirable as woody vegetation along streambanks. The placement of bare alluvium in this location creates the conditions needed for native willows and cottonwoods to colonize.

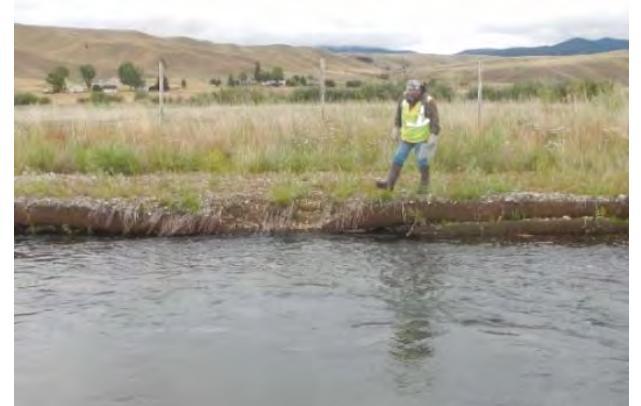
**RB-N-5** (**DVSL** with constructed toe): Substantial toe loss and slumping (cantilever failure) were observed at this structure site. This structure is located across from an island in an area of locally high shear stress. The bank had undercut approximately 1.5 feet since construction, and some of the fabric was torn (Figure 16). Willow survival and cover was low so there was minimal rooting to slow down erosion and help stabilize the toe. The bench created by the slumped lower lift was trapping fine sediment. Specific future design considerations based on observations of this structure include: paying more careful attention to quantity and/or quality of constructed toe and adding sacrificial toe in areas where high shear stresses are anticipated to reduce the potential for short-term toe erosion that may lead to structure slumping that could compromise vegetative growth in the structure. There are no immediate risks from continued erosion at this location so no maintenance actions were recommended at the time of the 2016 QRA.

Figure 16. Streambank RB-N-5 with fabric degradation and toe material loss.

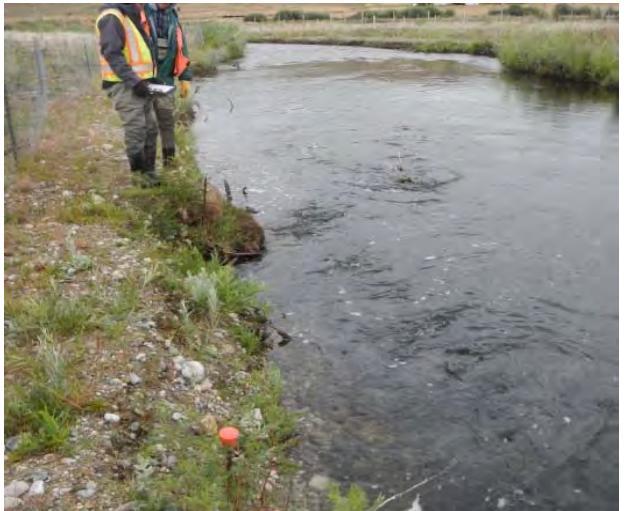
(woody debris) in this short section would reduce the short-term risk of flanking the DVSL downstream. Access to this site is easy so it would be possible to install a gap treatment with minimal damage to other establishing vegetation. The QRA team ultimately decided that treating this streambank was not an imminent need, but because it would be an easy fix, it should be kept on the list to consider for future maintenance. As described in the next section, during the 2017 QRA conditions at this site were unchanged and no maintenance was recommended.

Figure 17. Streambank LB-N-7A (No Treatment) with scour at upstream end.

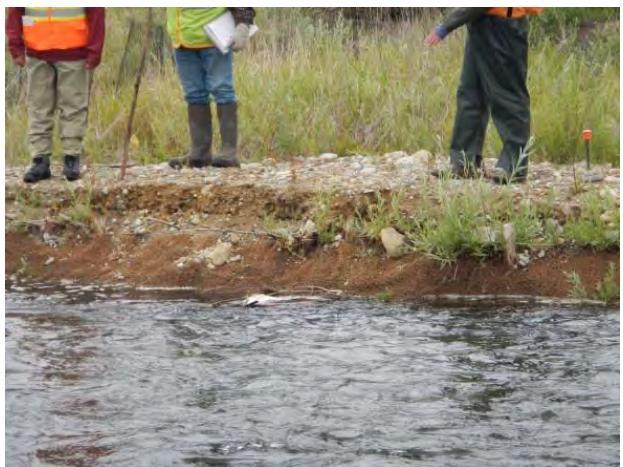
Figure 18. Streambank RB-N-14 DVSL showing loss of coir logs and bank erosion.

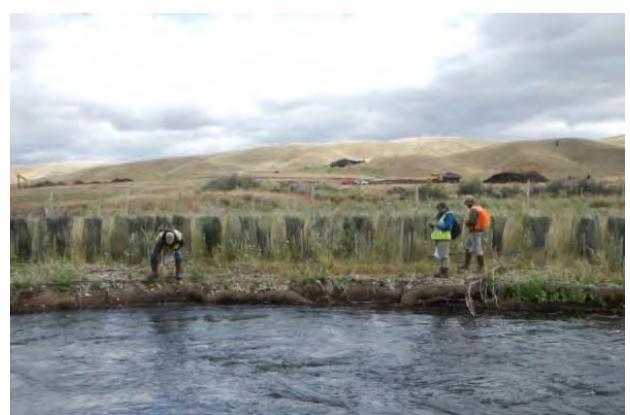
Figure 19. Streambank RB-N-47 DVSL showing fabric degradation and loss of coir logs.

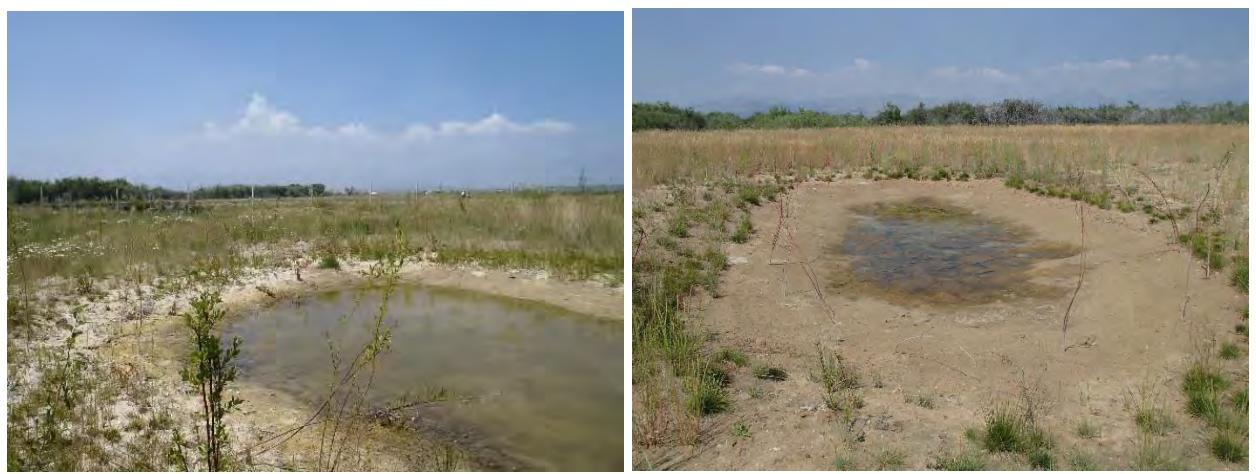
Figure 23. Survival monitoring plot SO81 (left photo) assigned to woody vegetation cover Category 3 (<10%) and survival Category 2 (50 to 80%). Swale S056 (right photo) with low survival and herbaceous cover.

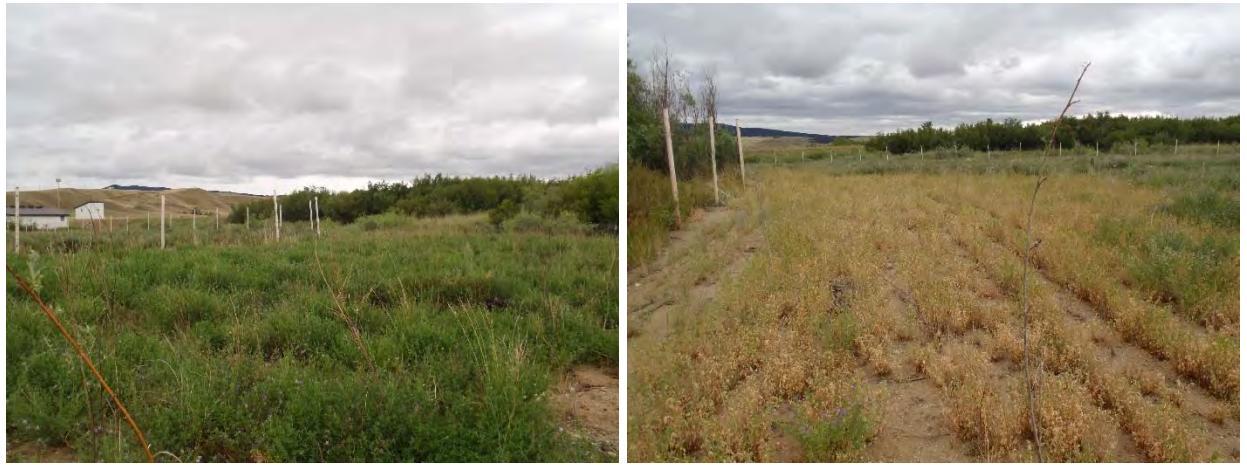
Figure 32. Planting units upstream of the bridge with decreased survival in 2016. Planting unit OM01 shown on the left with decreased survival due to droughty conditions, browse and competition with alfalfa. Planting unit TW02 shown on the right with poor survival due to droughty conditions.

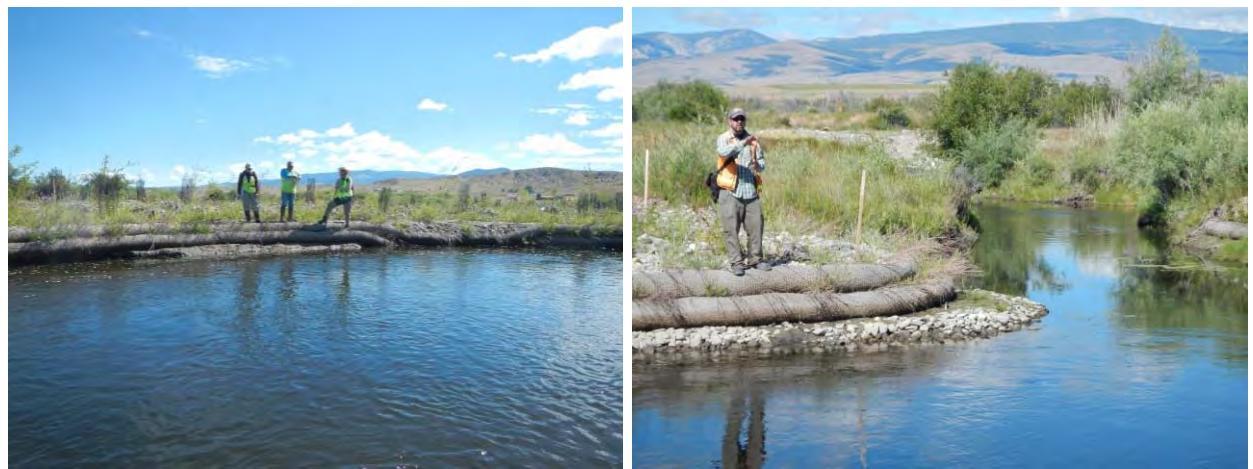
Figure 39. Phases 5 and 6 LB-46-DVSL toe loss and structure slumping (left photo) and streambank that appeared to be installed higher than Q2 (right photo).

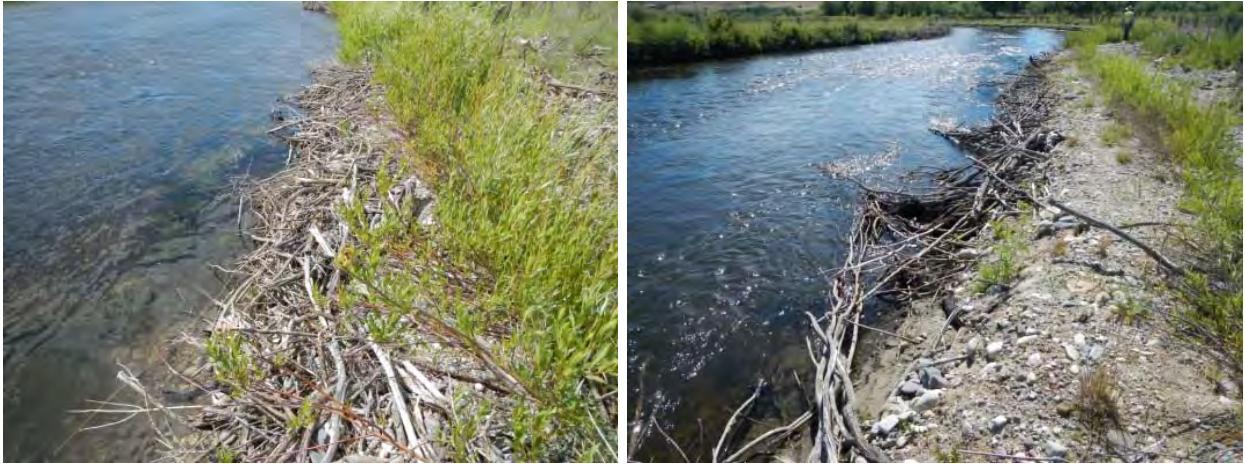
Figure 40. Left photo of brush matrix (gap) treatment with some viable brush material and right photo showing a brush matrix treatment with no viable brush material.

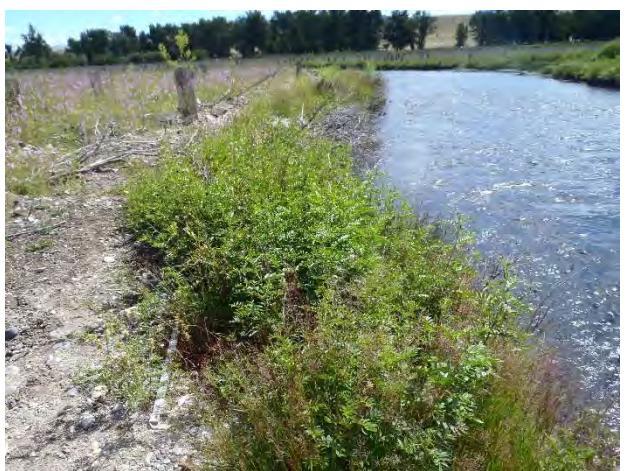
Figure 41. Streambank treatment with low woody vegetation cover (Category 3). Photo is of preserve vegetation treatment LB-34A which has high cover of herbaceous vegetation but low cover of woody vegetation in the short sections of this bank where gap treatments were installed.

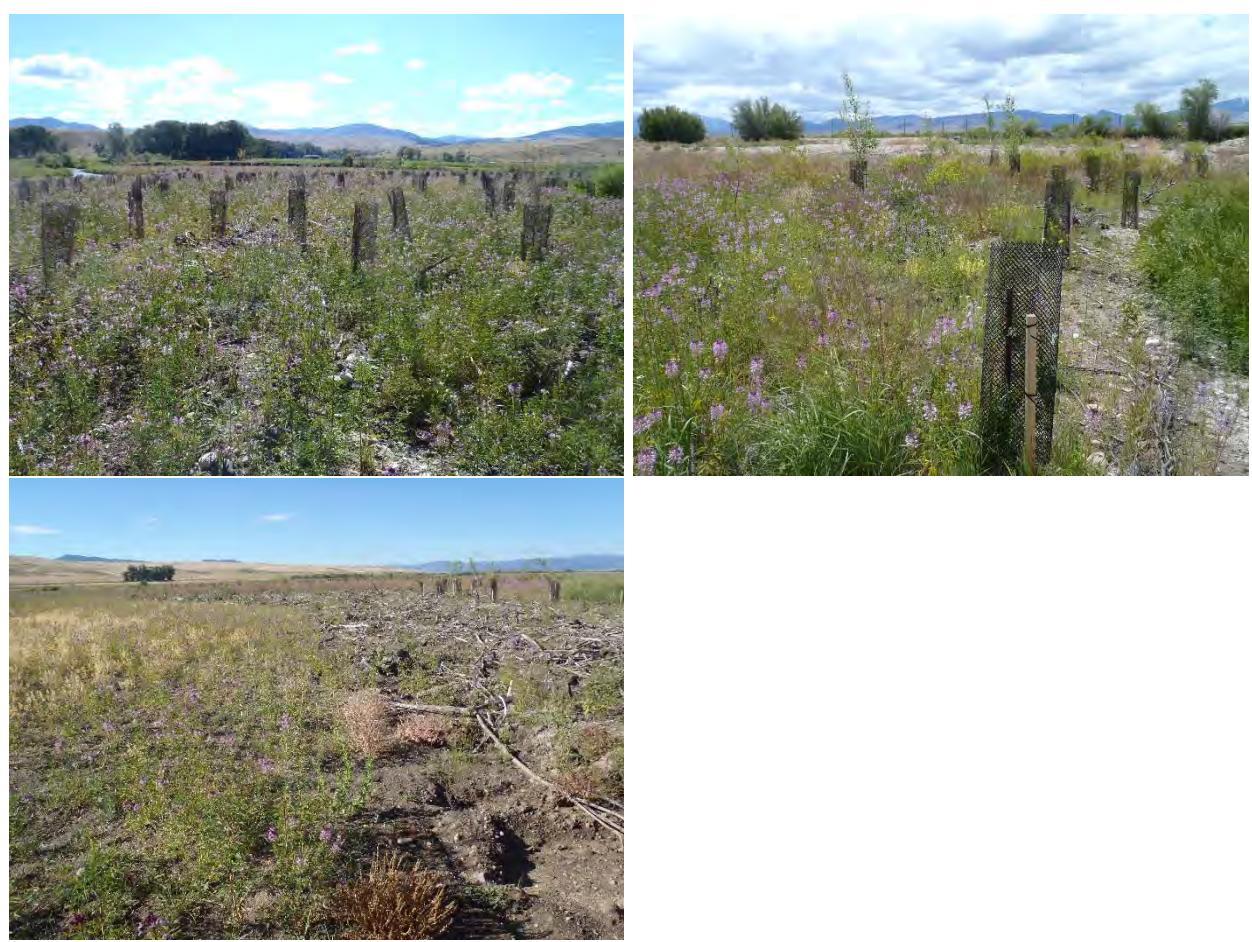
Figure 43. Top left photo shows planting unit OM15 in RWZ4W where survival appeared to be the lowest and beaver activity was high. Top right photo shows planting unit OM43 where survival was high. Bottom photo shows higher cover in drill seeded (left side of photo) compared to hand broadcast seeded (right side of photo).

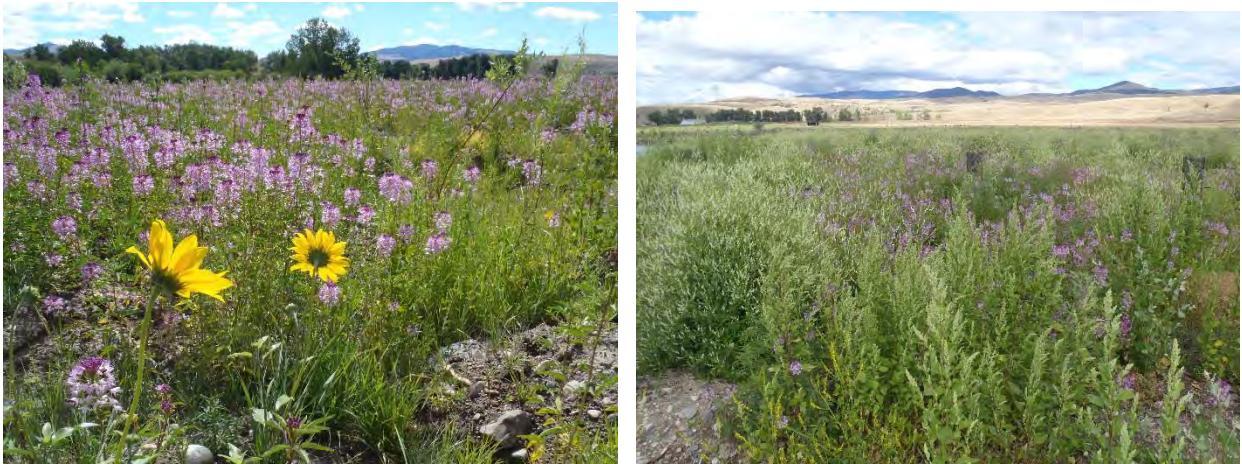
Figure 45. Photos of Rocky Mountain bee plant dominating seeded floodplain areas in Phase 5.

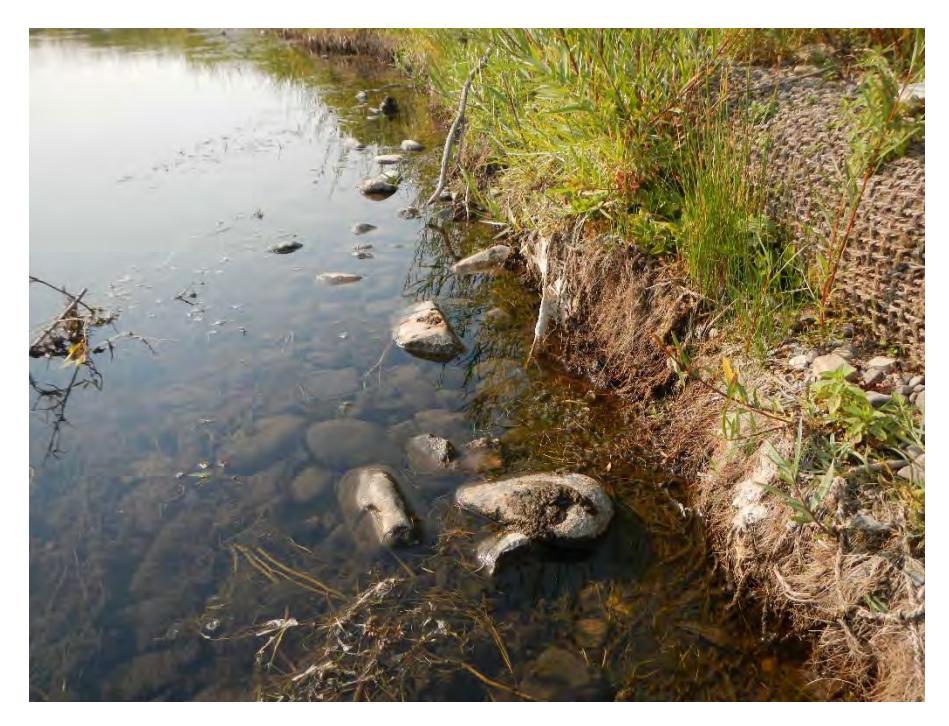
Photo 14. Example of continued fabric decay coupled with vegetative expansion.

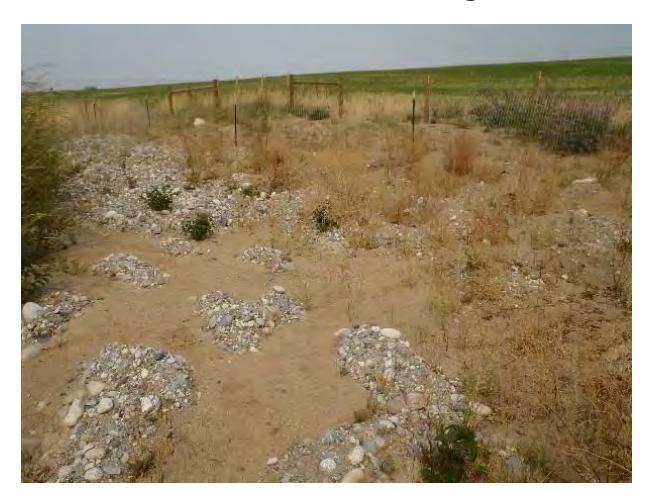
Photo 4. Fine sediment deposited along streambank alluvium from slope erosion from irrigation prior to seed establishment.
