Deep Creek Watershed Restoration Plan

PREPARED BY:

Denise Thompson, Broadwater Conservation District
Ron Spoon, Montana Fish, Wildlife & Parks

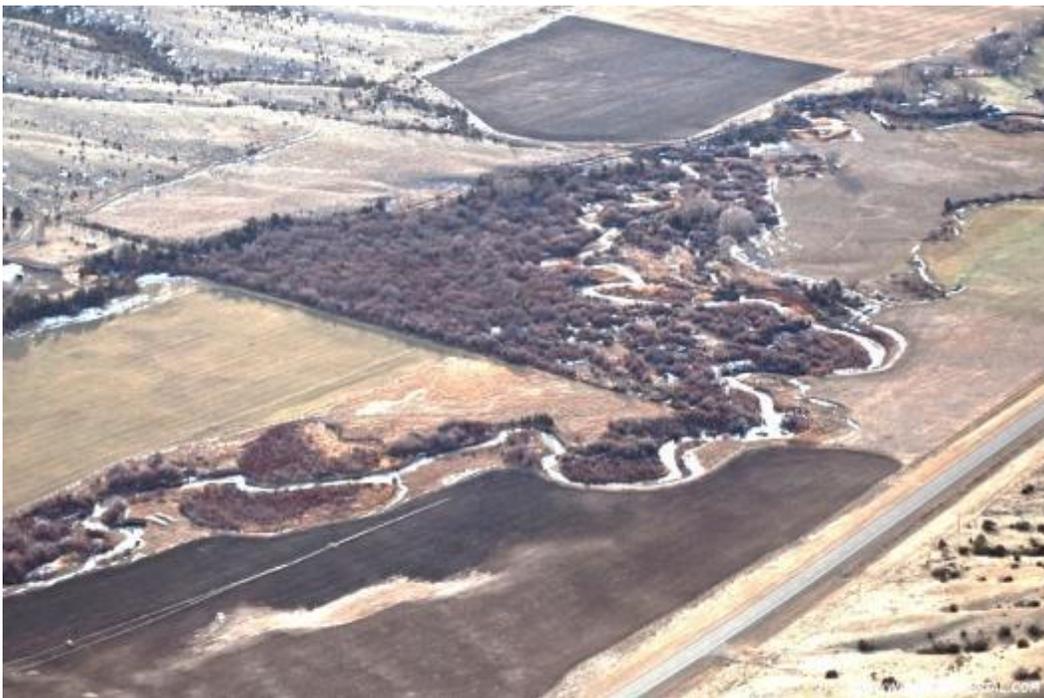
Figure 6. Aerial view showing discontinuous conversion of riparian floodplain to agricultural land use.

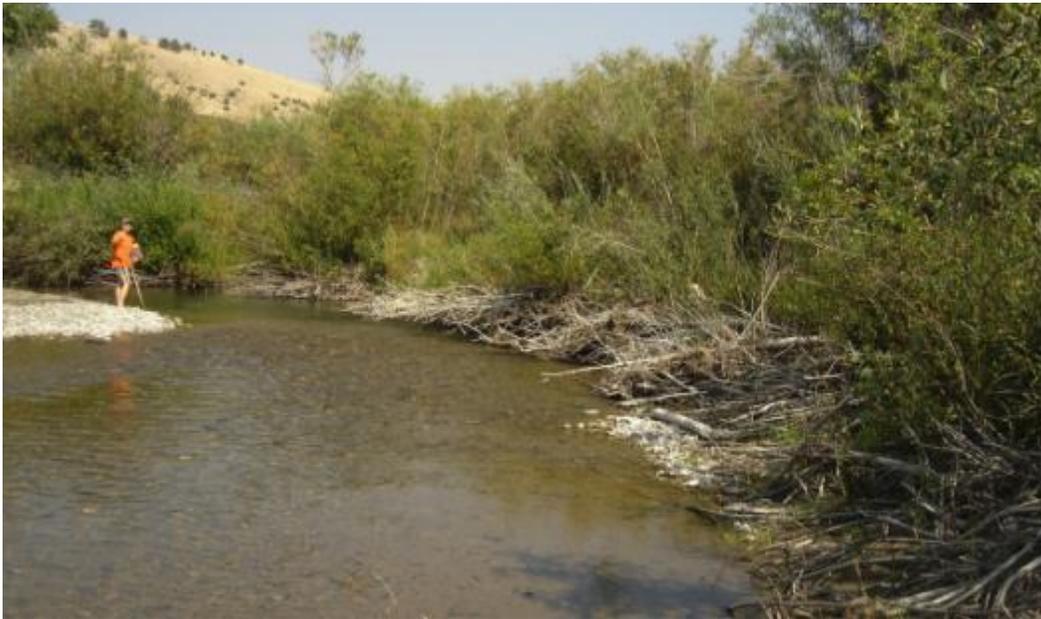
Figure 12. Juniper revetment with effective revegetation, Reach 11. (R. Spoon photo, 2012)

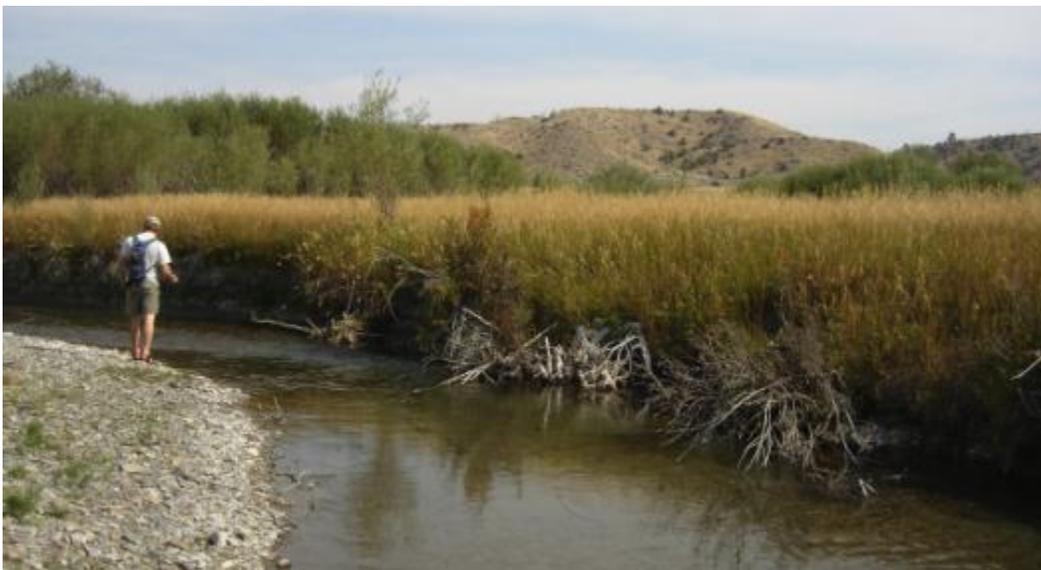
Figure 13. Juniper revetments have partially washed away, though they still provide some protection at the toe of the bank, Reach 13. (R. Spoon photo, 2012)

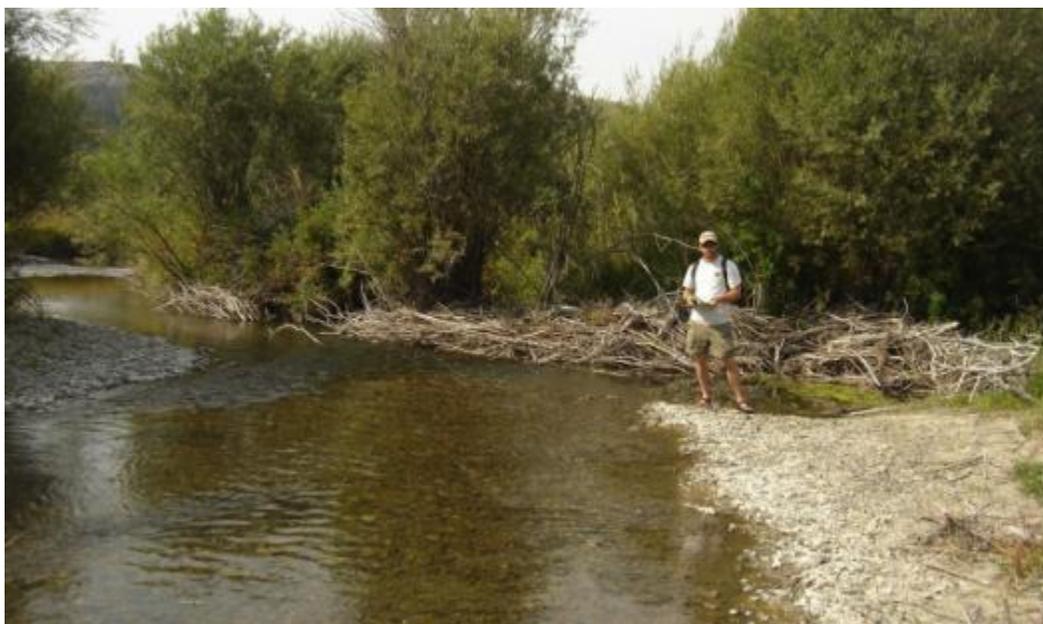
Figure 14. Debris jam of washed out junipers, Reach 13. Such jams can provide fish habitat through pool scour and cover. (R. Spoon photo, 2012)

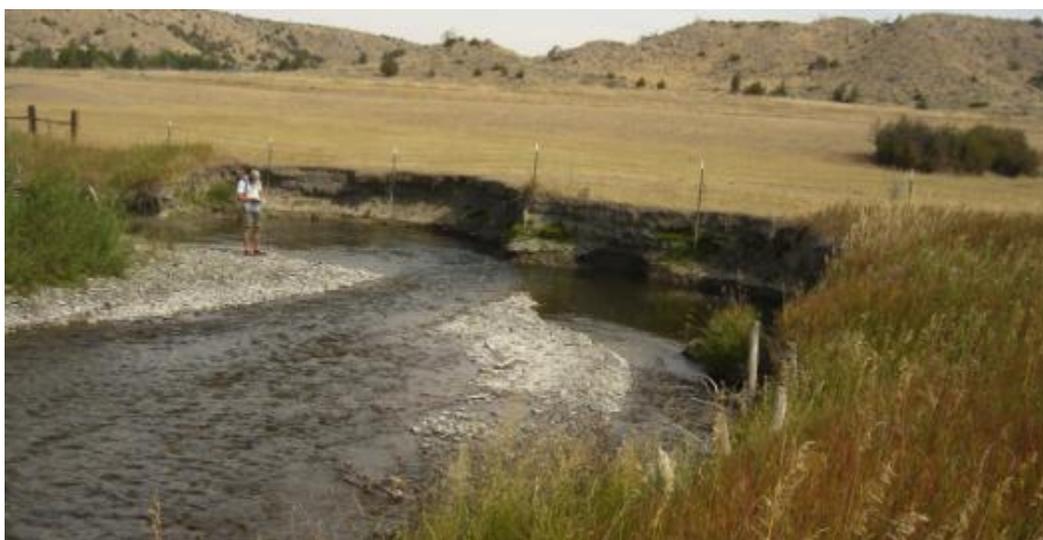
Riparian fencing was an additional TMDL implementation strategy and was installed through much of Reaches 6-14. In 2012, FWP inventoried “fences at risk” where riparian fencing, intended to exclude or manage grazing within the riparian corridor, was observed to be failing or at risk of failing (Figure 15). Locations of fence at risk points were plotted on reach maps by Skidmore and Boyd (2013) and have been provided to Broadwater Conservation District in GIS format. The overall condition of riparian fencing was poor, and in many cases fences were sited too close to the active channel.

Figure 15. Example of fence at risk, Reach 13. (R. Spoon photo, 2012)

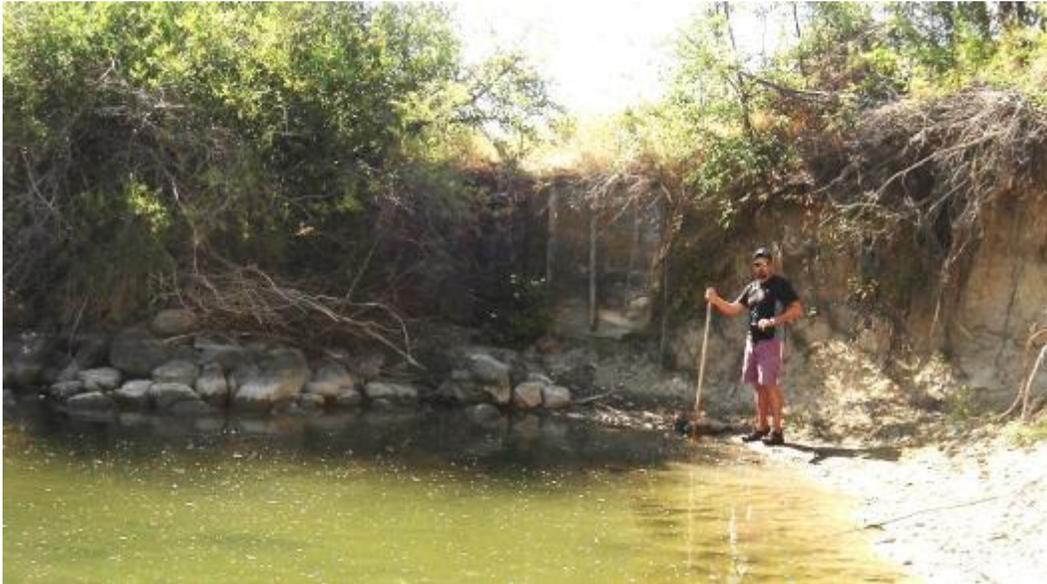
Evidence of both historic and ongoing channel evolution is abundant (Figures 18-20). For example, Figure 20 shows the typical widening and aggrading following downcutting (Class 5) with a higher elevation terrace, or historic floodplain, which is no longer hydrologically connected to the channel. Despite this, the terrace is supporting dense riparian vegetation, which suggests that the downcutting has occurred over the last several decades.

Figure 18. Perched headgate in lower end of Reach 8 (RM 8.9) indicating channel bed degradation and associated entrenchment. (R. Spoon photo, 2012)

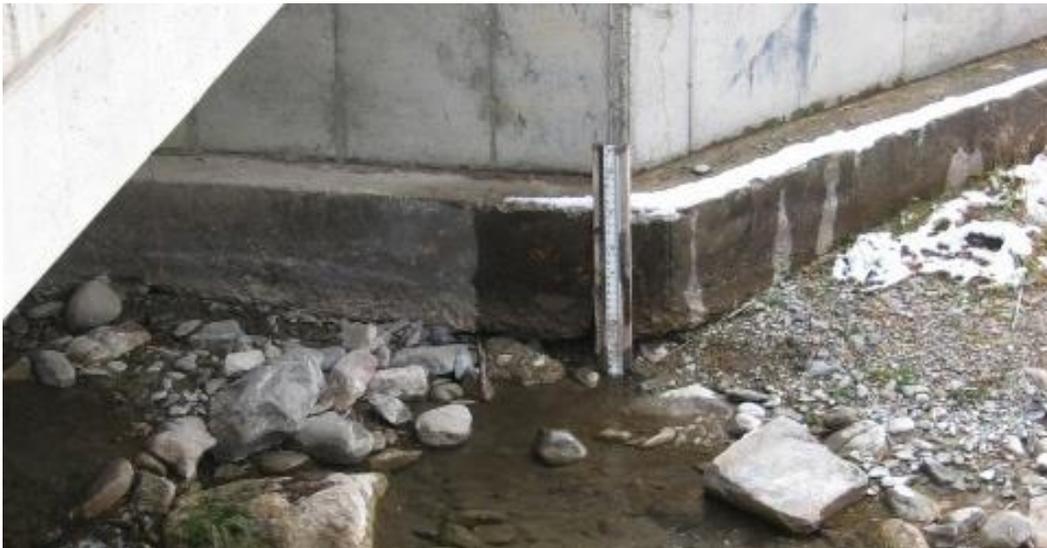
Figure 19. Exposed bridge pier footer indicating channel bed degradation, Reach 10. (P. Skidmore photo, 2012)

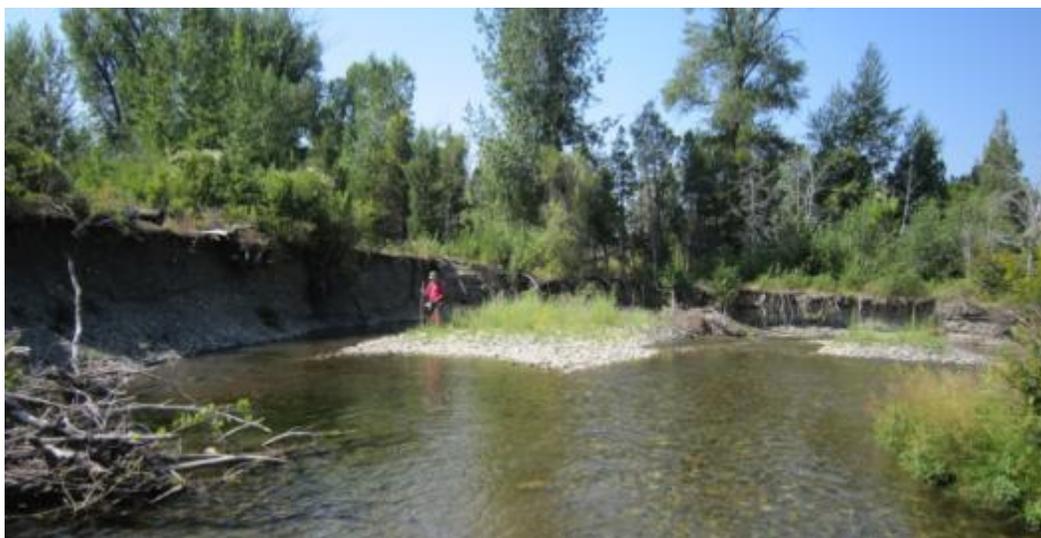
Figure 20. Entrenched stream channel and perched historic floodplain with mature riparian vegetation, Reach 14. (R. Spoon photo, 2012)

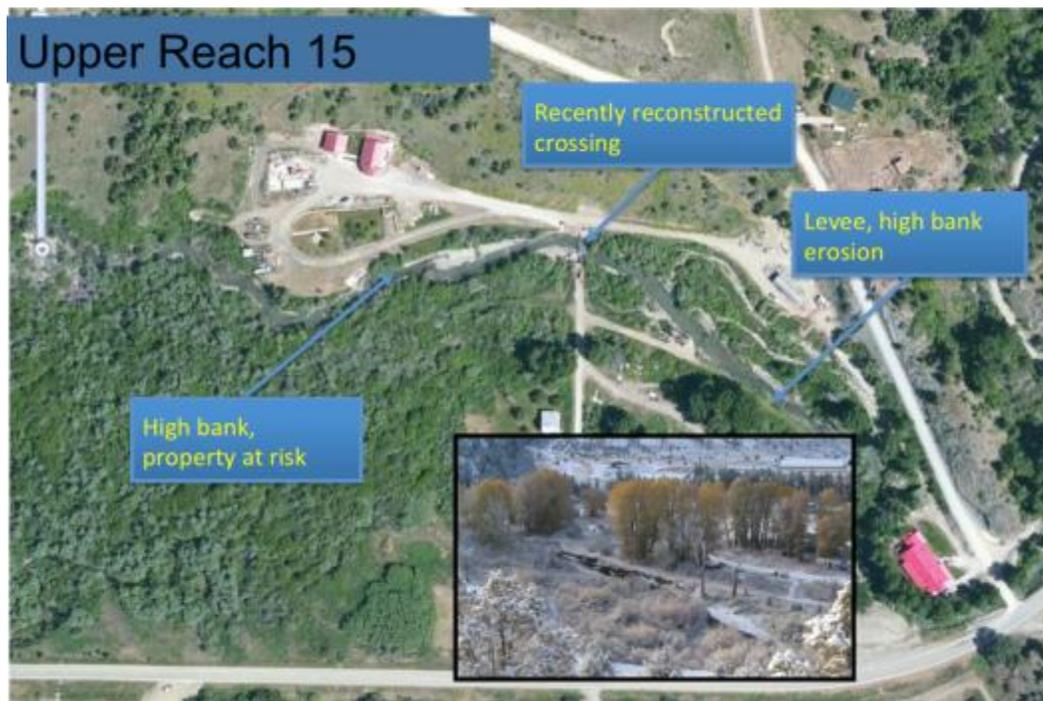
The highway corridor (U.S. Highway 12) upstream of Reach 15 results in additional challenges for maintaining natural stream process and managing sediment supply in Deep Creek. The significant encroachment of the road bed on the natural floodplain and the close proximity of the road surface to the stream channel results in increased supply of road sand entering the channel. Incoming material is readily transported to downstream reaches due to the confined channel in the canyon reach.

Figure 23. Example of concentrated infrastructure within an unstable stream reach immediately below the Deep Creek canyon in Reach 15.
