# Cramer Creek TMDL Implementation Evaluation

**March 2019**

**Figure 2** Photos taken from approximately the same point pre-project (top left), after waste removal in 2004 (top right), during seeding and mulching in 2004 (bottom left), and post-project in 2006 (bottom right). Images provided by the Missoula Field Office, BLM.

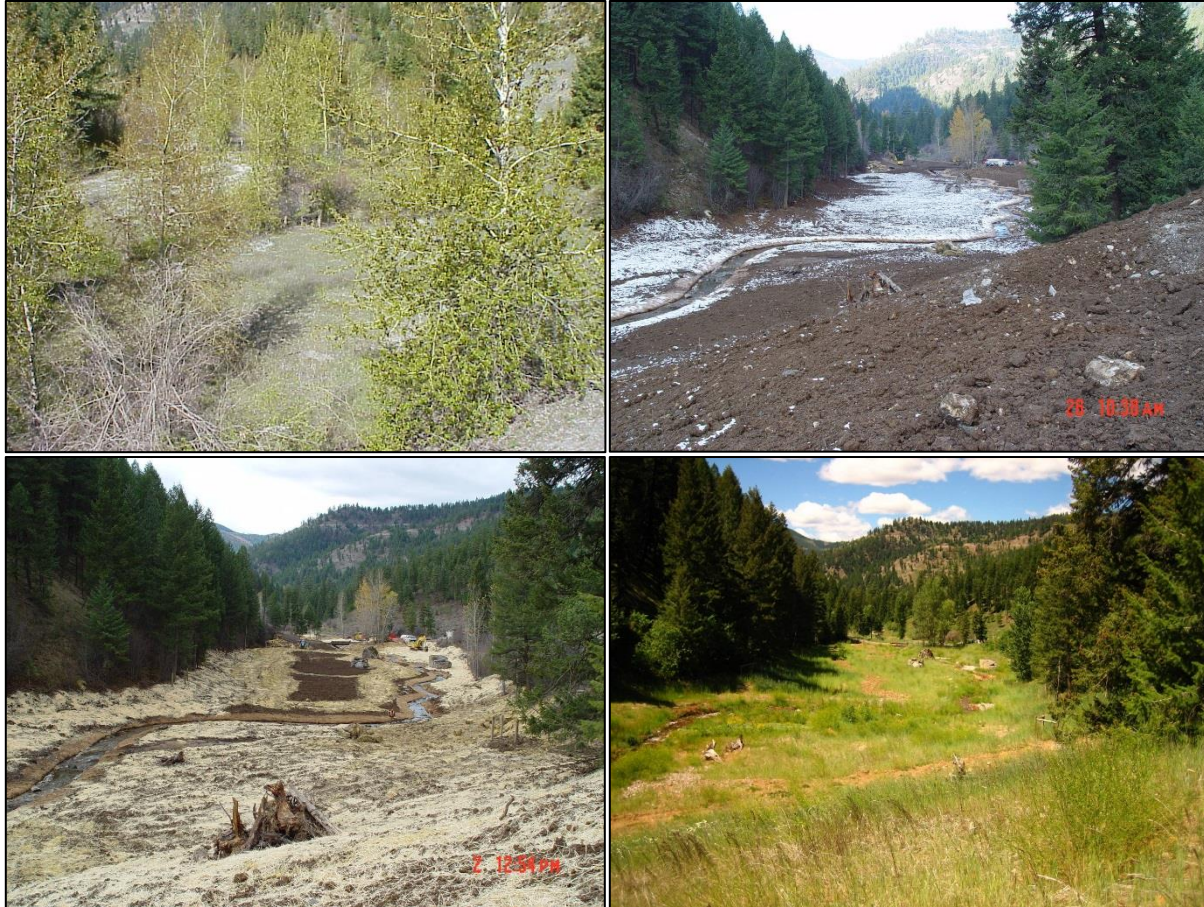
DEQ included the Linton mine as a Priority Abandoned Mine and referred cleanup to the Bureau of Land Management (BLM), which manages the mine land. Between 2004 and 2005, BLM led reclamation activities that removed 130,000 cubic yards of mine waste from a 1,700-foot reach of floodplain and stream channel across public and private property (Figures 2). Additionally, BLM replaced a culvert with a bridge to aid in reducing road-related sediment inputs to Cramer Creek. In 2006, BLM installed approximately 7,500 willow, alder, and dogwood plants along the project reach, and used fascines to stabilize reconstructed banks. In 2007, large woody debris structures were added to the stream, and 350 potted trees and shrubs were planted along streambanks in the public portion of the project reach. Monitoring showed 80% survival of planted trees and shrubs after 2 years, and by 2009 vegetation covered 60 to 80% of streambanks along the reconstructed channel (RRG 2009). Effects of the reclamation should increase through time as vegetation matures, filters out pollutants, and stabilizes streambanks (Figure 3).

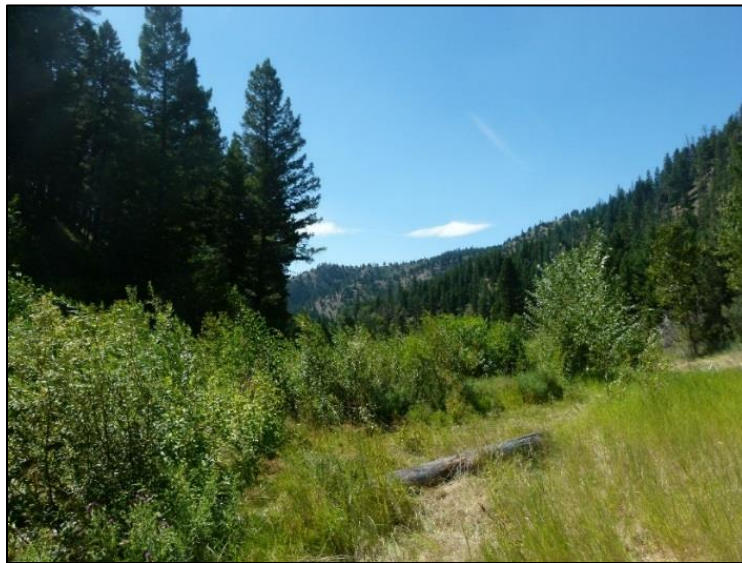
**Figure 3** Cramer Creek reclamation reach in July 2013 on BLM property. Riparian habitat conditions continue to improve. Image provided by the Missoula Field Office, BLM.
