# APPENDIX B - SEDIMENT DATA COLLECTION METHODS AND SUMMARIES OF MONITORED WATERBODIES WITH NO TMDL WRITTEN

## B1.0 INTRODUCTION

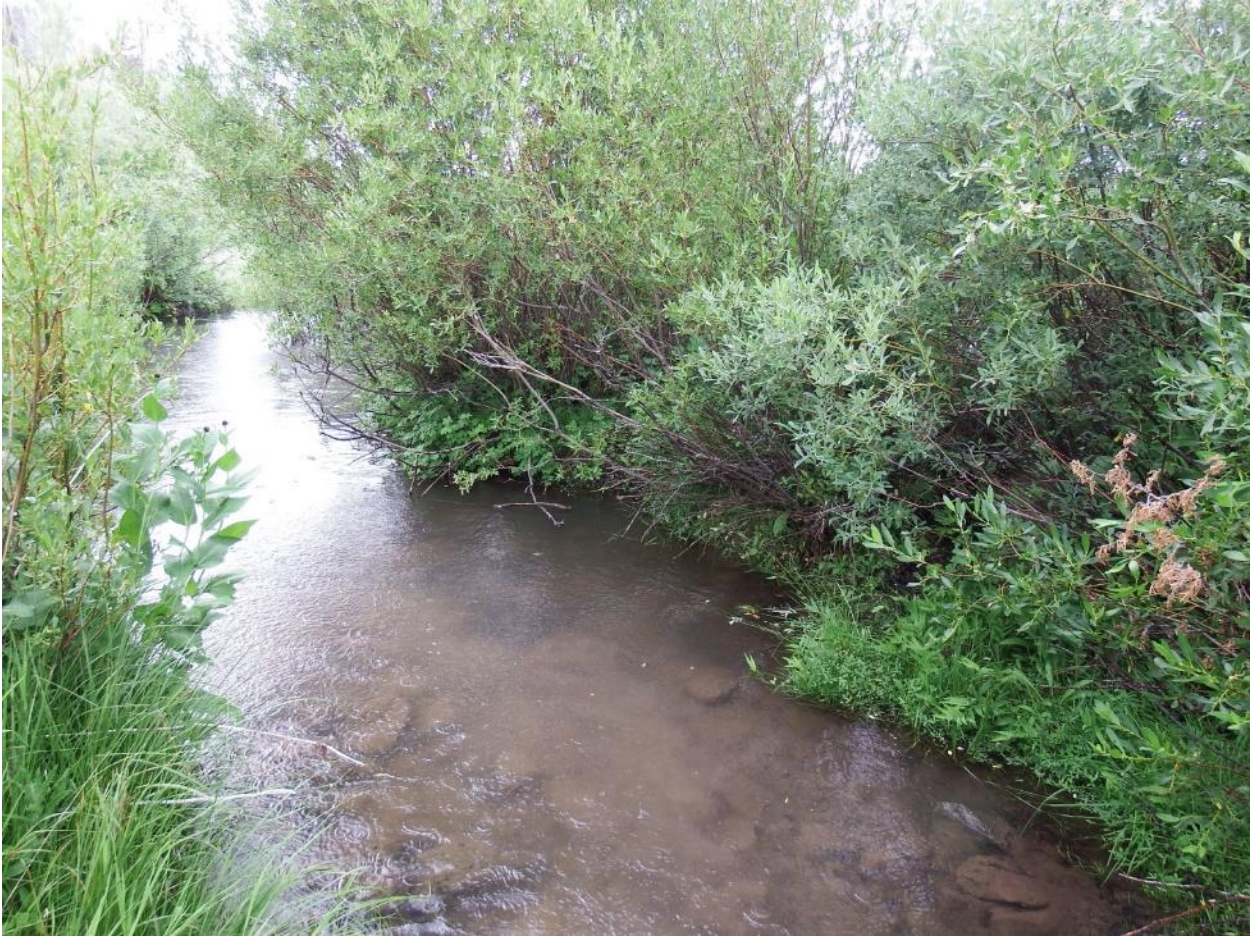
In 2014 DEQ collected sediment and habitat data from two sites on Buford Creek (BFRD 06-01, BFRD 07-01; **Figure B-3**). BFRD 06-01 was the upstream site in this segment and had no sign of human impacts (DEQ 2014). The site was well vegetated with willows, sedges, and native grasses and forbs with about 50% of the vegetation being grass/forbs, and 45.5% being shrub/tree; 4.5% of the ground cover was rock (DEQ 2014, 2015; **Figure B-3**). No disturbed bare ground or hummocking was observed at the site. Streambanks were stable at the site and were composed of sand/clay (10-100%) and fine gravel (0-90%) (DEQ 2015). About 34% of the site length had eroding banks with all being attributed to natural processes. A periphyton sample from the site yielded a 55% probability of the site having excess fine sediment.

**Figure B-3. Healthy riparian vegetation conditions at BFRD 06-01**

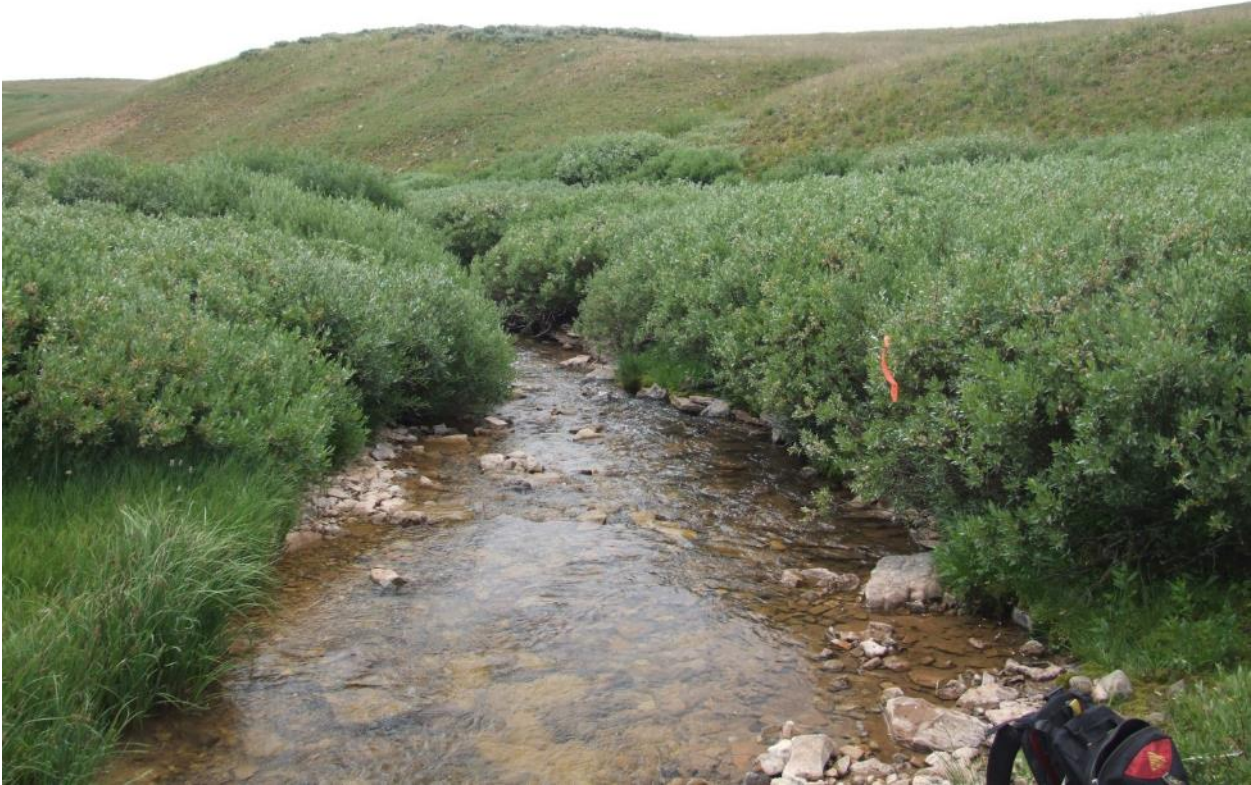
Sediment and habitat data were collected from the Elk River by PIBO at one site in 2009 and 2014 and by DEQ at one site in 2013 and another in 2014 (ELKR 04-01, ELKR 18-01/2734 (PIBO)); **Figure B-1**). ELKR 04-01 was the upstream site sampled by DEQ in this segment. Vegetation at the site consisted of willow, sedges, grass, and forbs with about 52% of the vegetation being wetland species, 1% grass/forbs, and 36% being shrub/tree (DEQ 2014, 2015; **Figure B-4**). Disturbed ground and rock comprised about 6% and 5% of the site respectively with no hummocking observed. Streambanks were composed primarily of sand/clay (60-70%) with lesser amounts of fine gravel (10-20%) and coarse gravel or larger sediment (20-30%) (DEQ 2015). About 25% of the site length had eroding banks with 100% being attributed to natural processes. A periphyton sample from the site yielded a 55.7% probability of the site having excess fine sediment.

**Figure B-4. Willow growth within the riparian zone at ELKR 04-01**

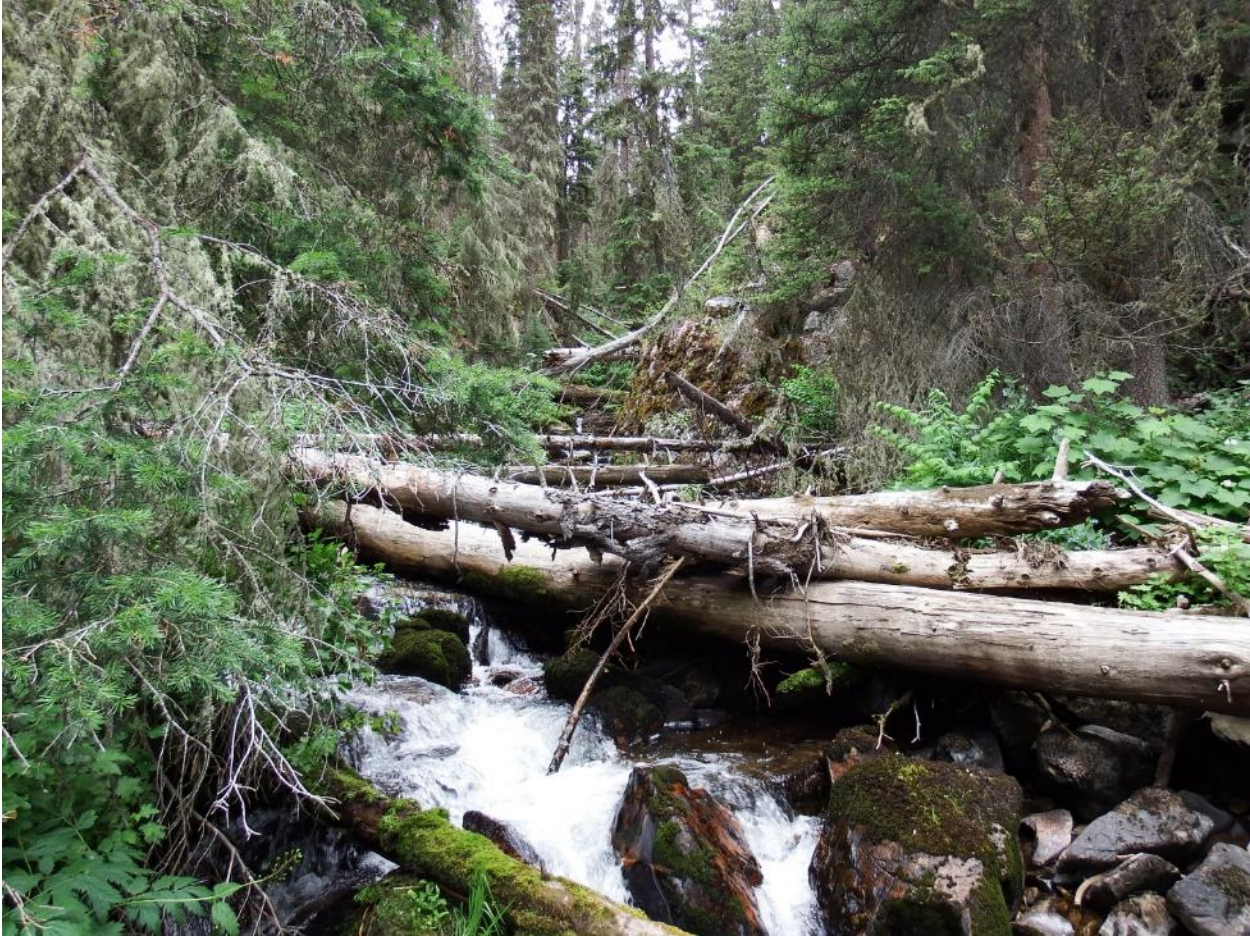
Sediment and habitat data were collected from Gazelle Creek by PIBO at one site in 2008 and 2013 and by DEQ at two sites in 2014 (2601 (PIBO), GAZL 09-01, GAZL 16-01; **Figure B-1**). GAZL 09-01 was the upstream site in this segment and was located in a lightly grazed setting (DEQ 2014). The site was well vegetated with currant, conifer, sedge, thimbleberry, willow, and dogwood with about 31% of the vegetation being wetland species, 36% grass/forbs and 18% being shrub/tree (DEQ 2014, 2015; **Figure B-5**). Large woody debris was prevalent within the site and limited cattle access to riparian areas. Rock covered about 15% of the site and there was hummocking within 1%; no disturbed bare ground was observed. Streambanks were composed entirely of sand/clay (DEQ 2015). About 90% of the site length had eroding banks with 90% being attributed to natural processes and the remainder being riparian grazing. A periphyton sample from the site yielded a 42.9% probability of the site having excess fine sediment.

**Figure B-5. Vegetation and large woody debris at GAZL 09-01**

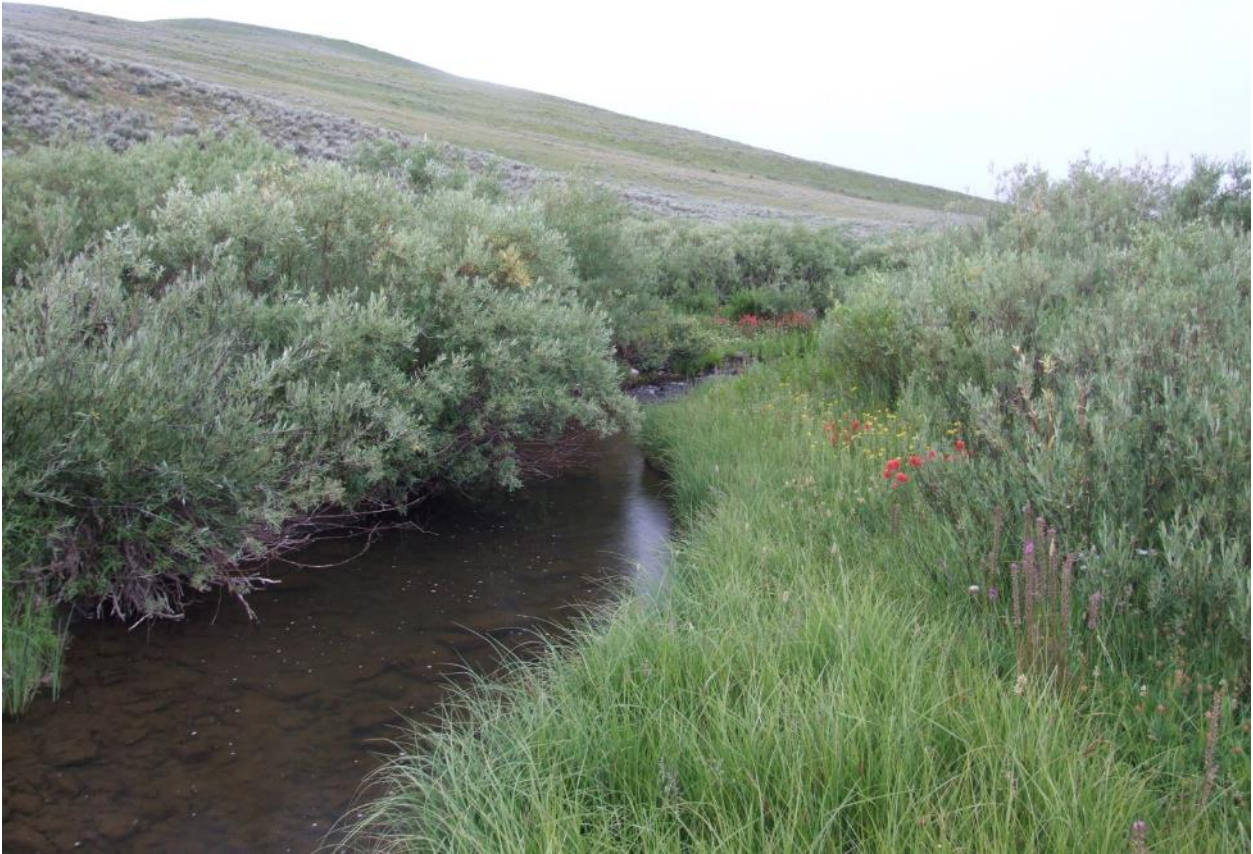
Sediment and habitat data were collected from the West Fork Madison River at one site by PIBO in 2009 and 2014, one site by DEQ in 2013 and two sites by DEQ in 2014 (2740 (PIBO), WFMA 14-02, WFMA 25-01, WFMA 26-01; **Figure B-1**). WFMA 14-02 was the most upstream site visited by DEQ in this segment and was located in an area that was heavily grazed in the past; cattle are now excluded from the riparian area (DEQ 2015). The site had a healthy riparian vegetation community that consisted of willow, sedges, and forbs with about 34% of the vegetation being wetland species, 4% grass/forbs, and 50% being shrub/tree (DEQ 2014, 2015; **Figure B-6**). Disturbed bare ground and rock each made up 4% and 8% of the site respectively; hummocking covered about 10% of the site. Streambanks were primarily composed of sand/clay (50-80%) with lesser amounts of fine gravel (5-10%) and coarse gravel or larger sediment (15-40%) (DEQ 2015). About 20% of the site length had eroding banks with 62% being attributed to natural processes and the remainder to riparian grazing.

**Figure B-6. Riparian conditions at WFMA 14-02**

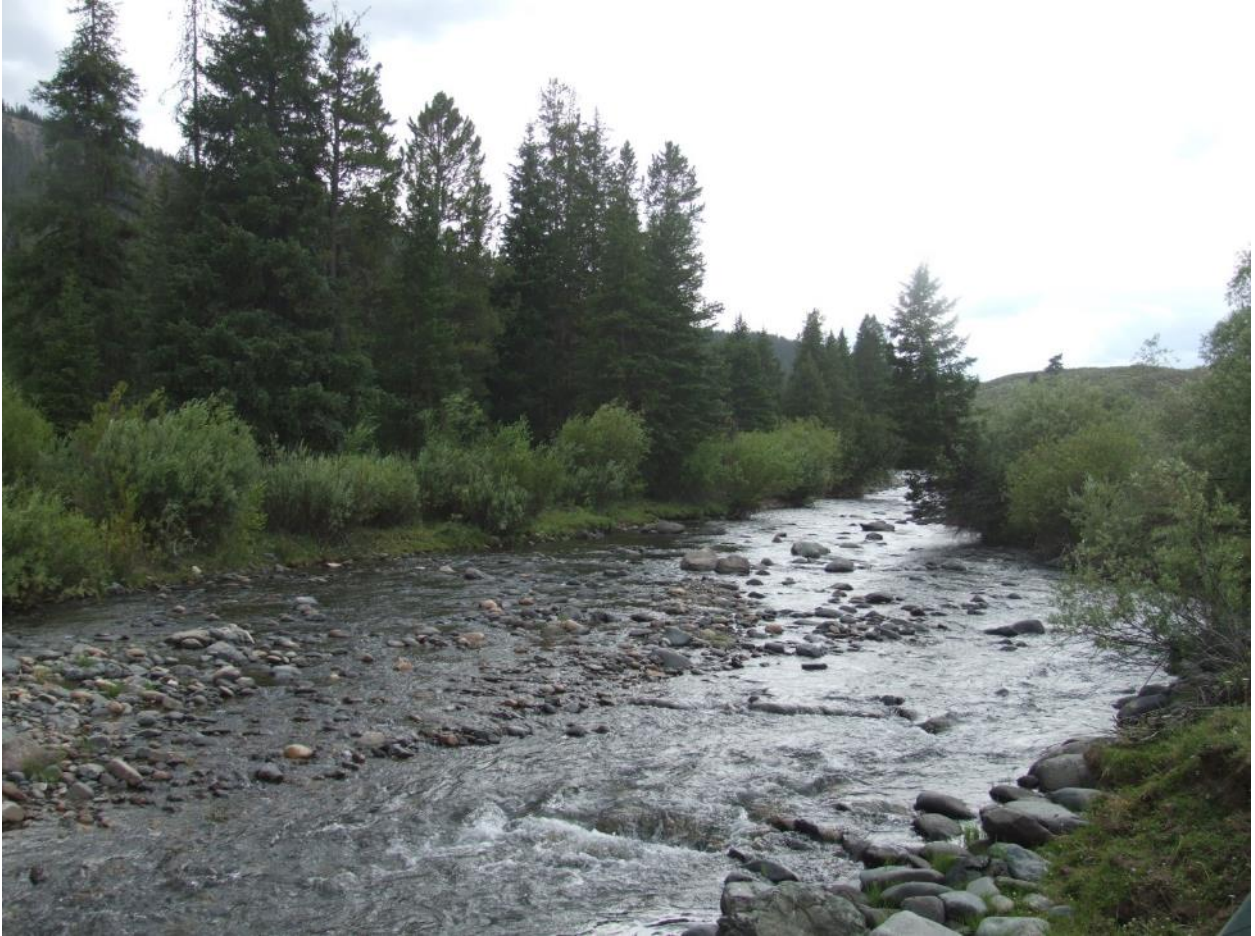
WFMA 25-01 was located about 19.5 miles downstream of WFMA 14-02, downstream of the confluence with the Elk River. The site was vegetated with willow, conifer, grasses, and forbs with about 3.5% of the vegetation being grass/forbs and 64% being shrub/tree (DEQ 2014, 2015, **Figures B-6 and B-7**). Disturbed bare ground and rock made up 17.5% and 15% of the site respectively; no hummocking was observed. About 1000 feet of riparian fencing was recently installed downstream of the site (DEQ 2015). Streambanks were primarily composed of sand/clay (80%) with lesser amounts of fine gravel (10%), and coarse gravel or larger sediment (10%) (DEQ 2015; **Figure B-7**). About 12% of the site length had eroding banks with 98% being attributed to riparian grazing and the remainder to natural processes (**Figure B-8 and Figure B-9**). A periphyton sample from the site yielded a 47% probability of the site having excess fine sediment.

**Figure B-7. Relatively healthy riparian conditions at WFMA 25-01**

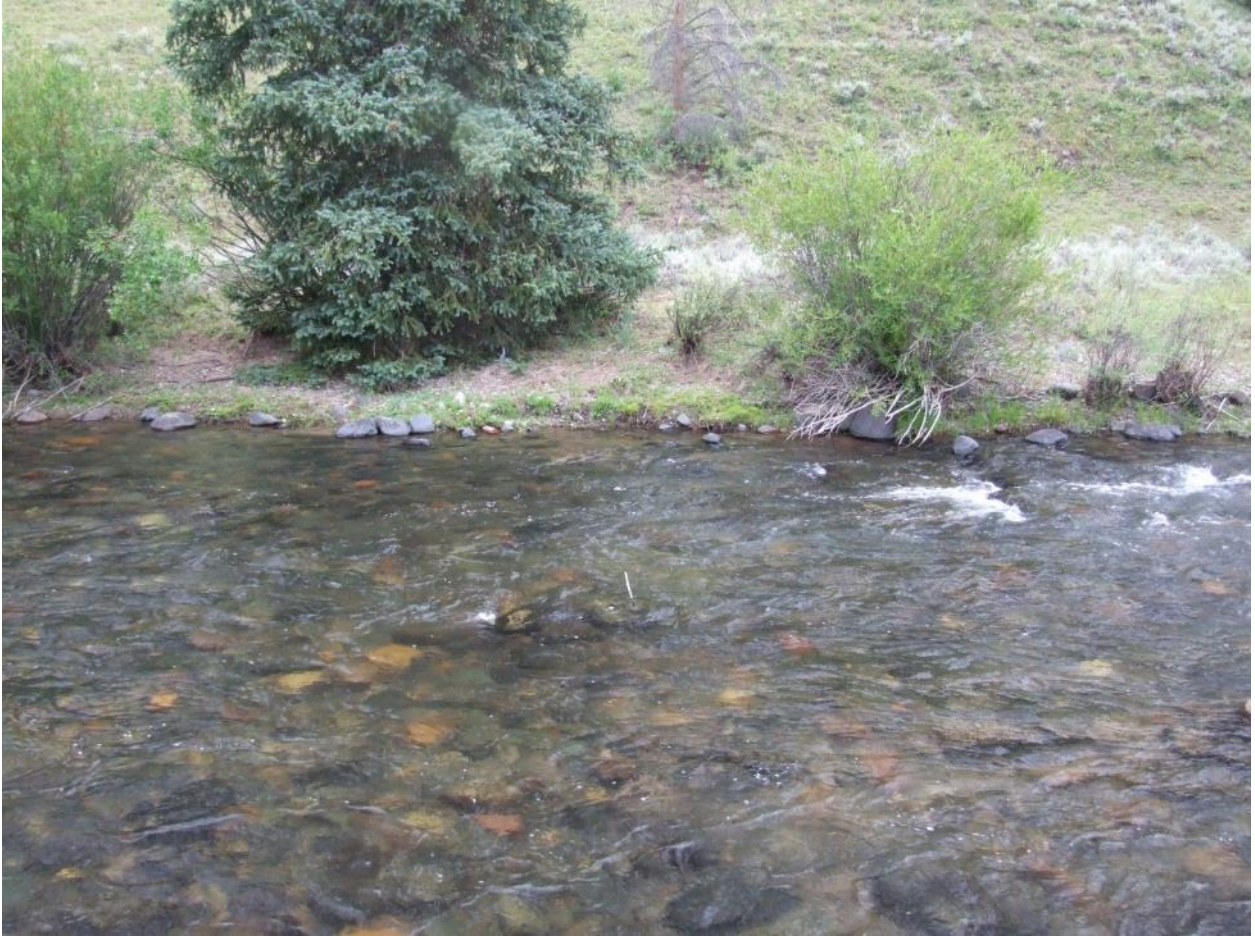
**Figure B-8. Grazed riparian conditions at WFMA 25-01**

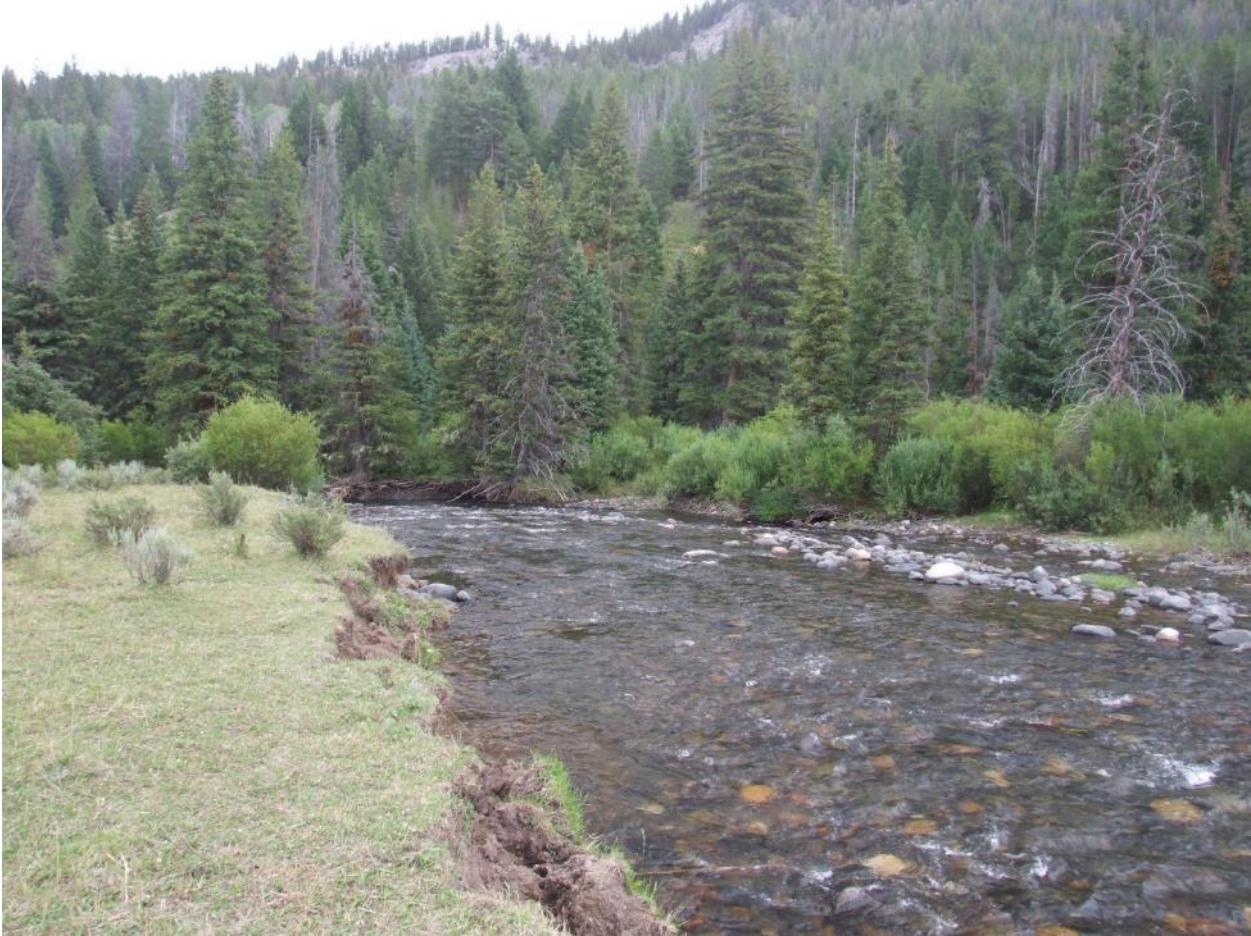
**Figure B-9. Eroding streambank at WFMA 25-01**
