APPENDIX B - SEDIMENT AND HABITAT DATA COLLECTION METHODS

B1.0 INTRODUCTION

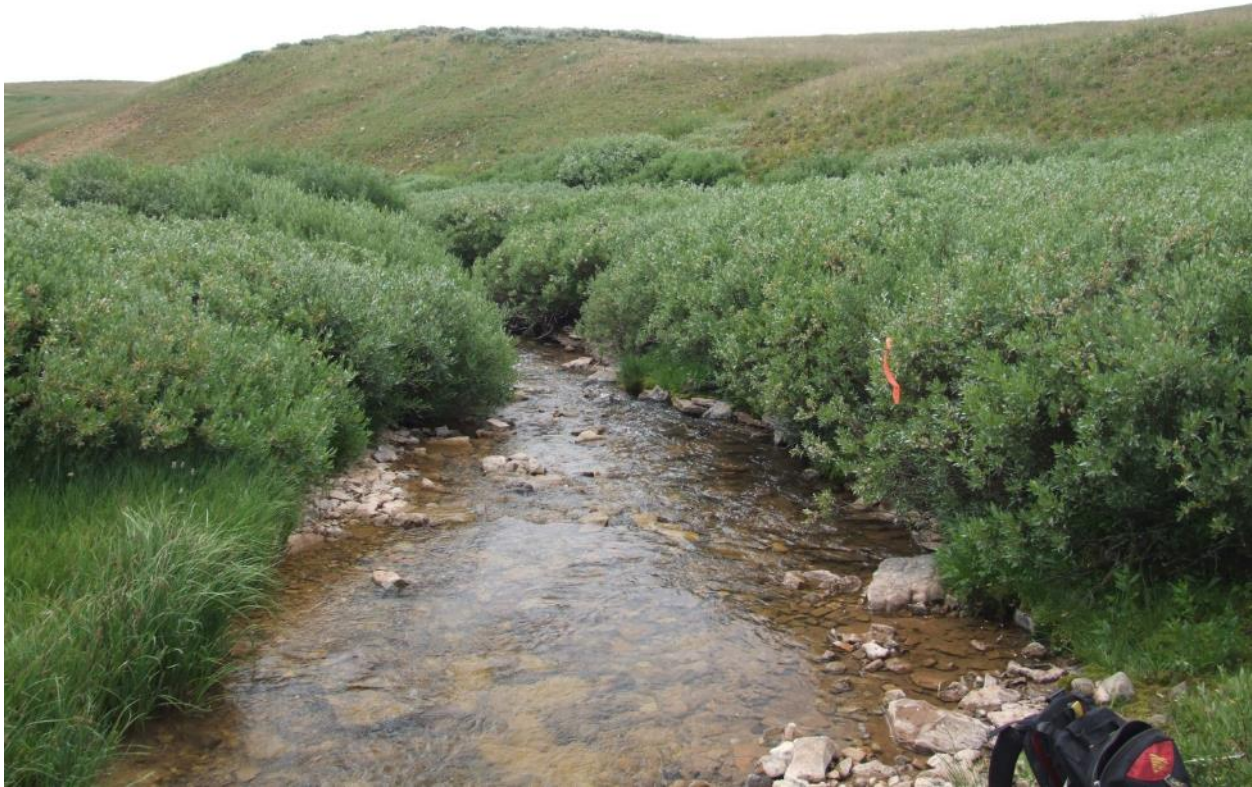
Figure B-4. Willow growth within the riparian zone at ELKR 04-01

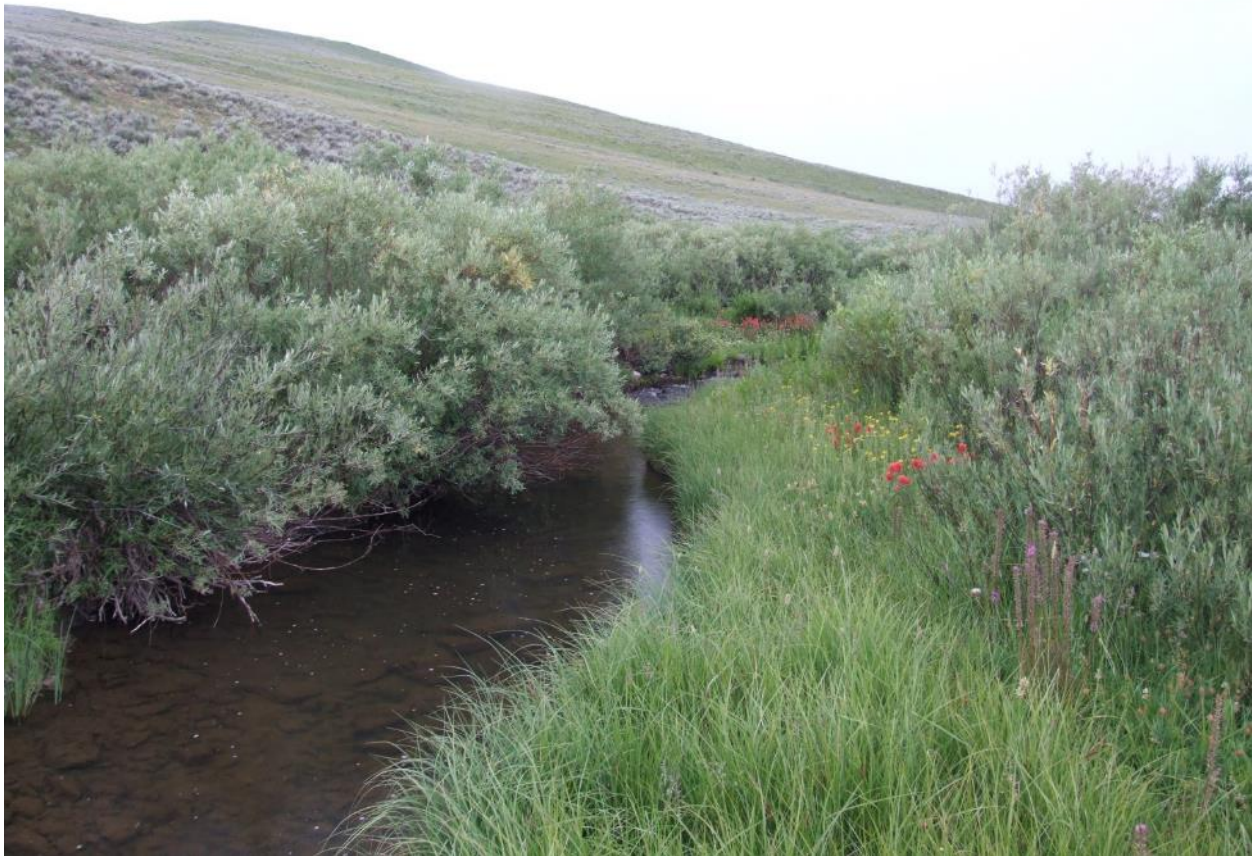
Sediment and habitat data were collected from the West Fork Madison River at one site by PIBO in 2009 and 2014, one site by DEQ in 2013 and two sites by DEQ in 2014 (2740 (PIBO), WFMA 14-02, WFMA 25-01, WFMA 26-01; **Figure B-1**). WFMA 14-02 was the most upstream site visited by DEQ in this segment and was located in an area that was heavily grazed in the past; cattle are now excluded from the riparian area (DEQ 2015). The site had a healthy riparian vegetation community that consisted of willow, sedges, and forbs with about 34% of the vegetation being wetland species, 4% grass/forbs, and 50% being shrub/tree (DEQ 2014, 2015; **Figure B-6**). Disturbed bare ground and rock each made up 4% and 8% of the site respectively; hummocking covered about 10% of the site. Streambanks were primarily composed of sand/clay (50-80%) with lesser amounts of fine gravel (5-10%) and coarse gravel or larger sediment (15-40%) (DEQ 2015). About 20% of the site length had eroding banks with 62% being attributed to natural processes and the remainder to riparian grazing.

Figure B-6. Riparian conditions at WFMA 14-02

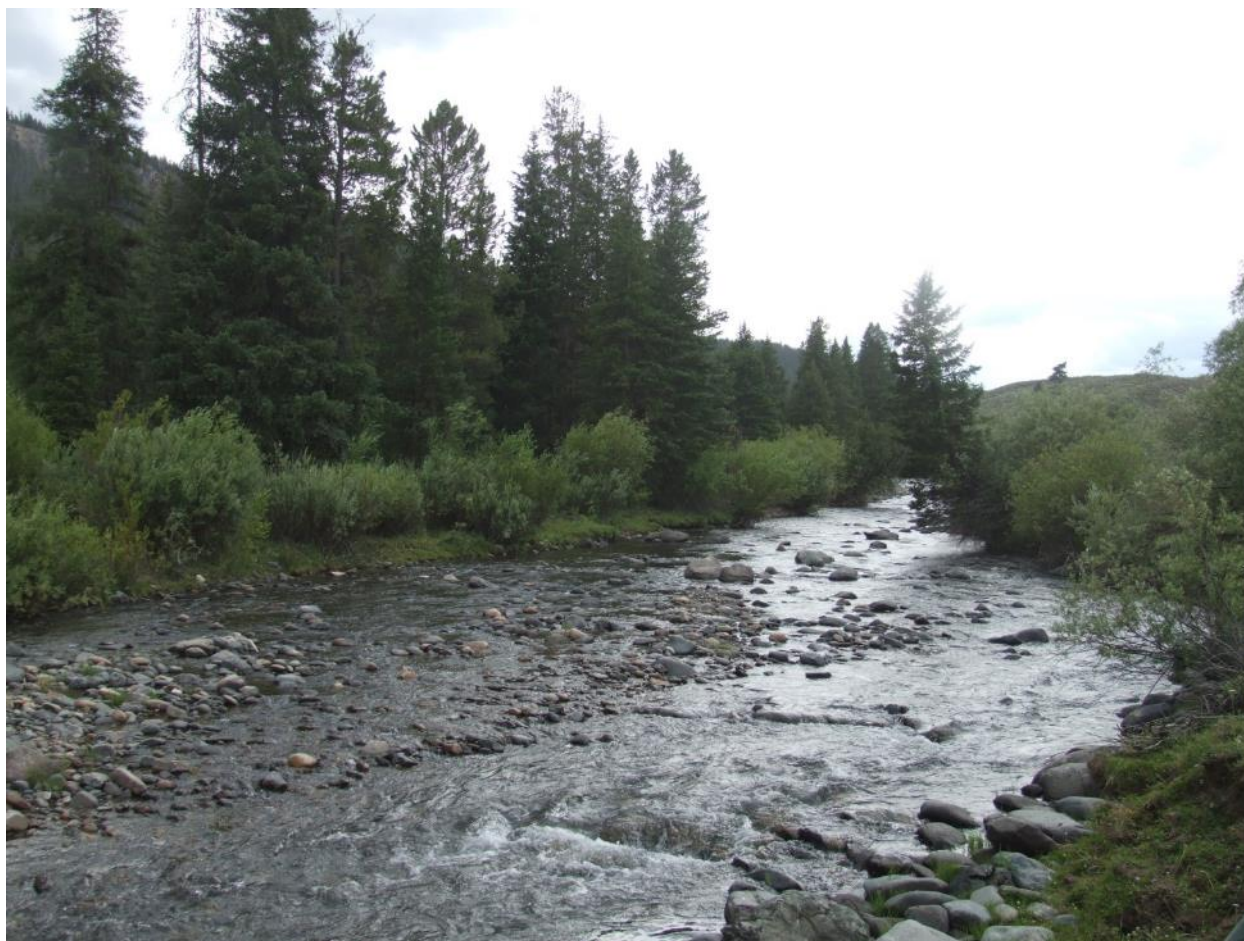
Figure B-7. Relatively healthy riparian conditions at WFMA 25-01

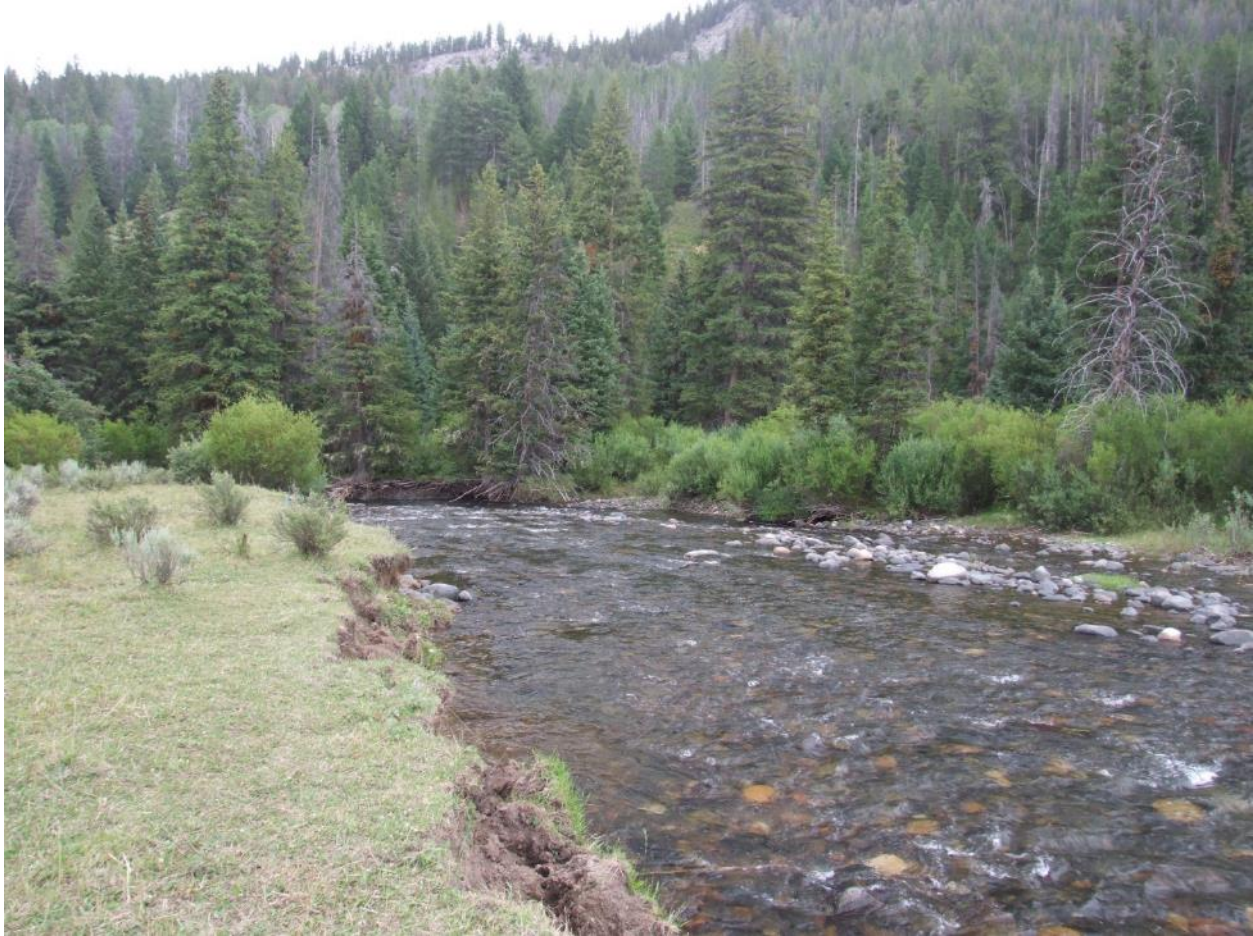
observed. About 1000 feet of riparian fencing was recently installed downstream of the site (DEQ 2015). Streambanks were primarily composed of sand/clay (80%) with lesser amounts of fine gravel (10%), and coarse gravel or larger sediment (10%) (DEQ 2015; **Figure B-7**). About 12% of the site length had eroding banks with 98% being attributed to riparian grazing and the remainder to natural processes (**Figure B-8** and **Figure B-9**). A periphyton sample from the site yielded a 47% probability of the site having excess fine sediment.

Figure B-9. Eroding streambank at WFMA 25-01
