**APPENDIX C**  
**2004 AERIAL PHOTO REVIEW AND FIELD SOURCE ASSESSMENT,**  
**UPPER JEFFERSON RIVER WATERSHED**

### **1.1 Upper Jefferson Watershed 2004 Aerial Photo Review and Field Source Assessment**

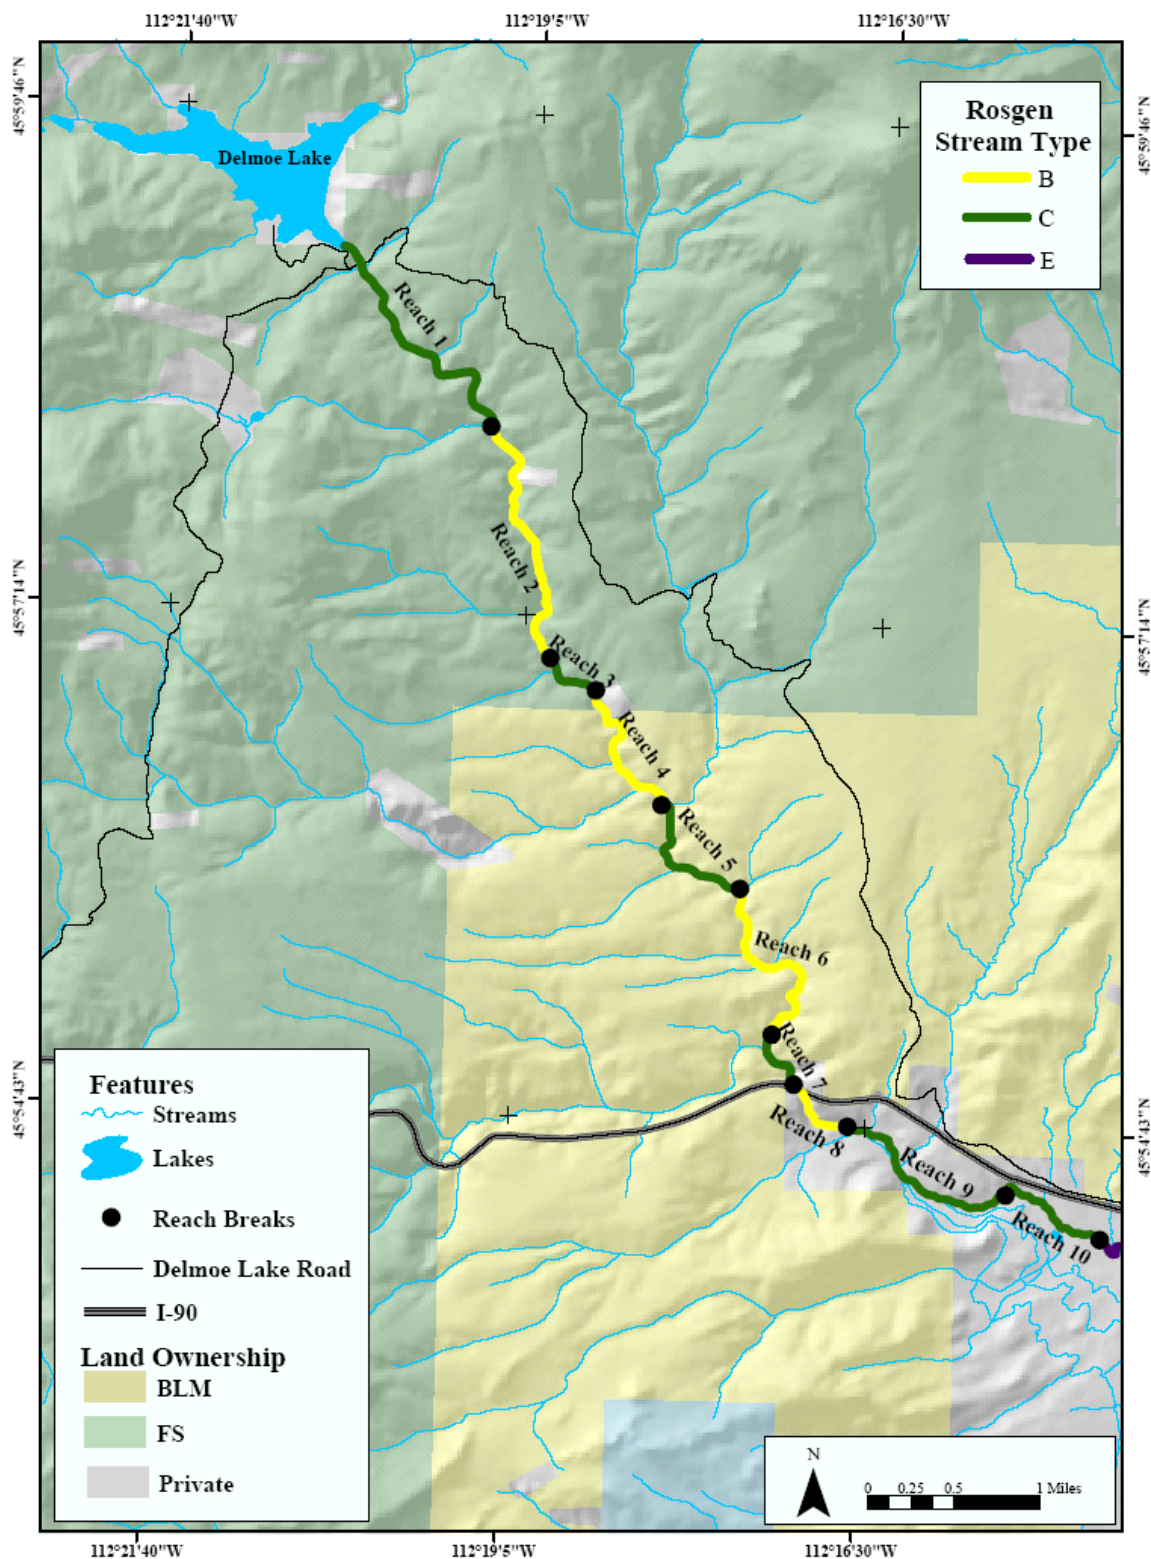
Figure 2-7. Upper Big Pipestone Creek Rosgen Stream Types

The channel forms of Big Pipestone Creek above Interstate 90 are predominantly controlled by landform structure, as well as reservoir releases from Delmoe Lake (**Figure 2-7**). The prominent landform geology, the Boulder Batholith, has resulted in valley bottom formation along weathered joints. Narrow valley bottoms dominated by granitic boulders (B-type reaches), as well as less confined valley bottom areas are found (C-type reaches). Portions of Reaches 1 and 2 viewed during the field survey exhibited B and F channel types. B-type sections were found

where the stream was more structurally controlled (lower W/D ratio and less entrenched). After the field review, it was noted that Reach 1 could probably have been broken into 2 reaches as most of the reach appeared unconfined on the air photos, but only the upper 10 percent of the reach was viewed in the field (mostly F-type). The portion of Reach 7 viewed in the field exhibited a C-type channel. Delmoe Lake releases have greatly increased the flow of the creek. It is the professional opinion of the surveyor that without the lake releases natural channel form would alternate between B and Eb stream types. There were no significant changes in channel form between 1983 and 2001.

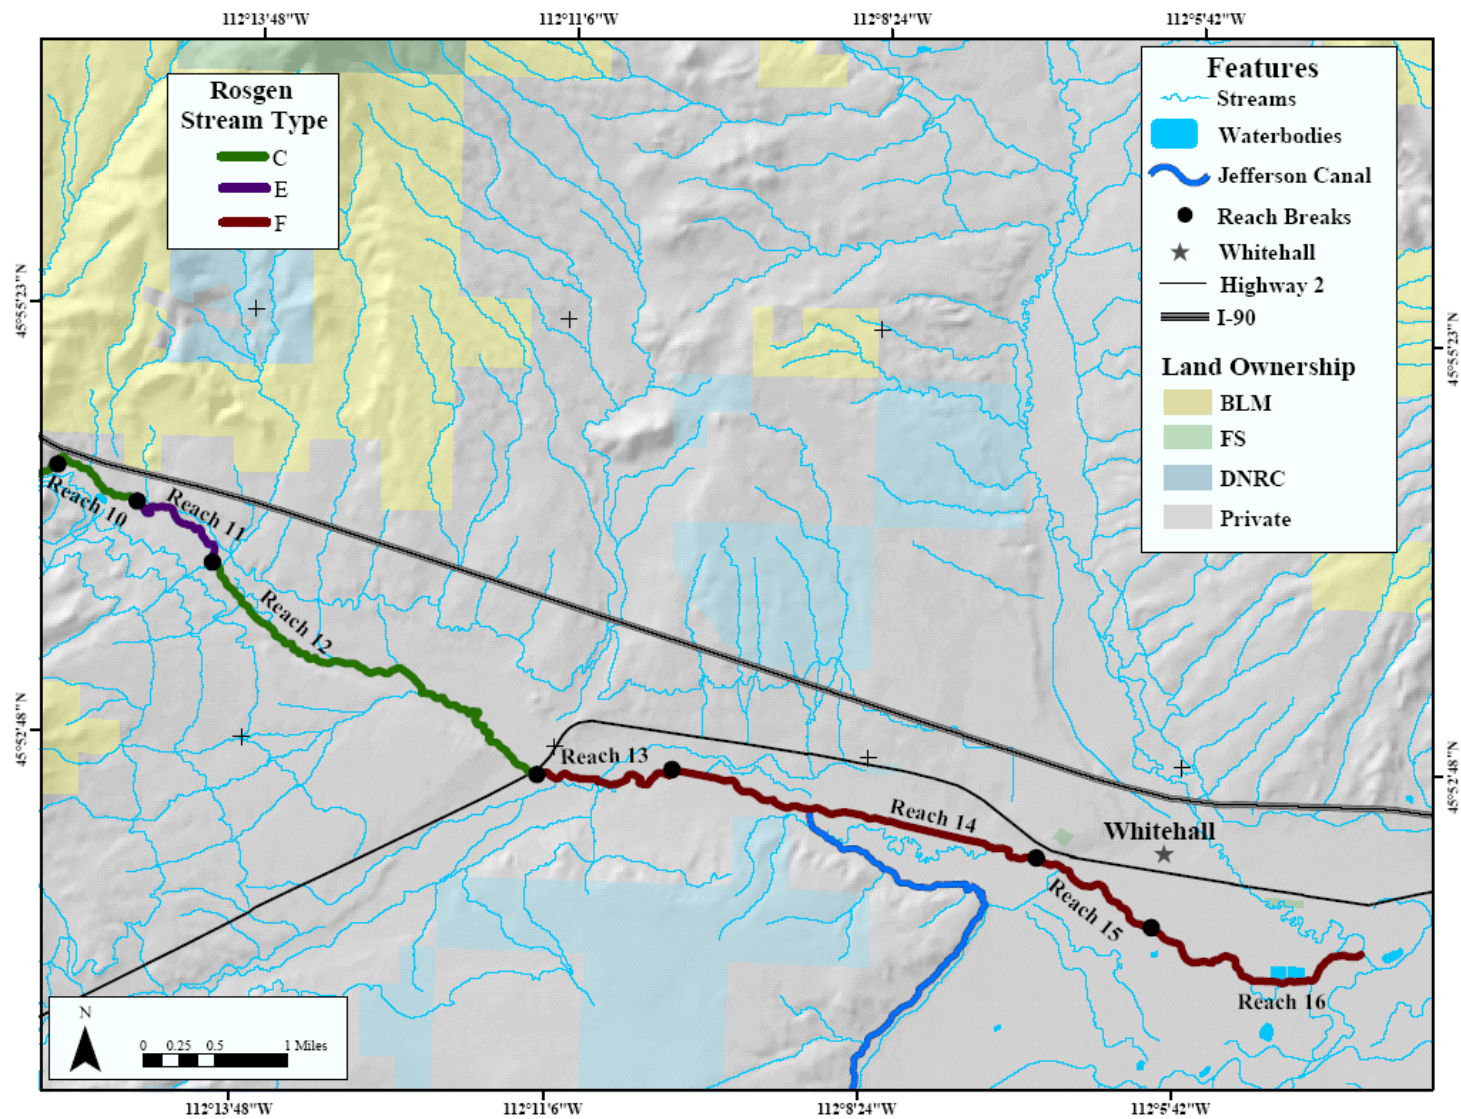
Figure 2-8. Lower Big Pipestone Creek Rosgen Stream Types

Many of the channel forms of Big Pipestone Creek below Interstate 90 are controlled by historical and current landuse activities (**Figure 2-8**). The predominant valley type (VIII) would typically result in an unconfined stream type (C or E), yet water level alterations for flow diversions and channelization have resulted in stream types out of balance with the valley type. Portions of Reaches 10, 12, and the upper part of Reach 13 viewed during the field survey exhibited C-type channels, while the portion of Reach 11 viewed, and some areas of Reach 12 exhibited E-type stream channels. Channel form in the valley was variable, with many areas observed as incised. Remnants of beaver dams were found in Reaches 10, 11, 12 and 13. From about the middle of Reach 13 to the mouth, numerous alterations to the channel have occurred, such that Rosgen stream typing is somewhat inapplicable (constructed channel versus alluvial channel). However, F-type sections were noted in Reaches 13 and 14. Reach 14 is where the stream was channelized for the railway. The channelization was probably the cause of extreme headcutting observed in this reach. At Reach 15, the stream appeared to return to its natural channel, while over half of Reach 16 appeared to be a constructed channel. The portion of Reach 16 viewed in the field appeared to be more of an E-type channel (low W/D ratio, no point bars), however stream type was classified as an F due to the large area of the reach not observed in proximity to the channelized reach (14). For the valley portion of Big Pipestone Creek, only one time period was analyzed so significant changes in channel form since 1983 could not be determined.

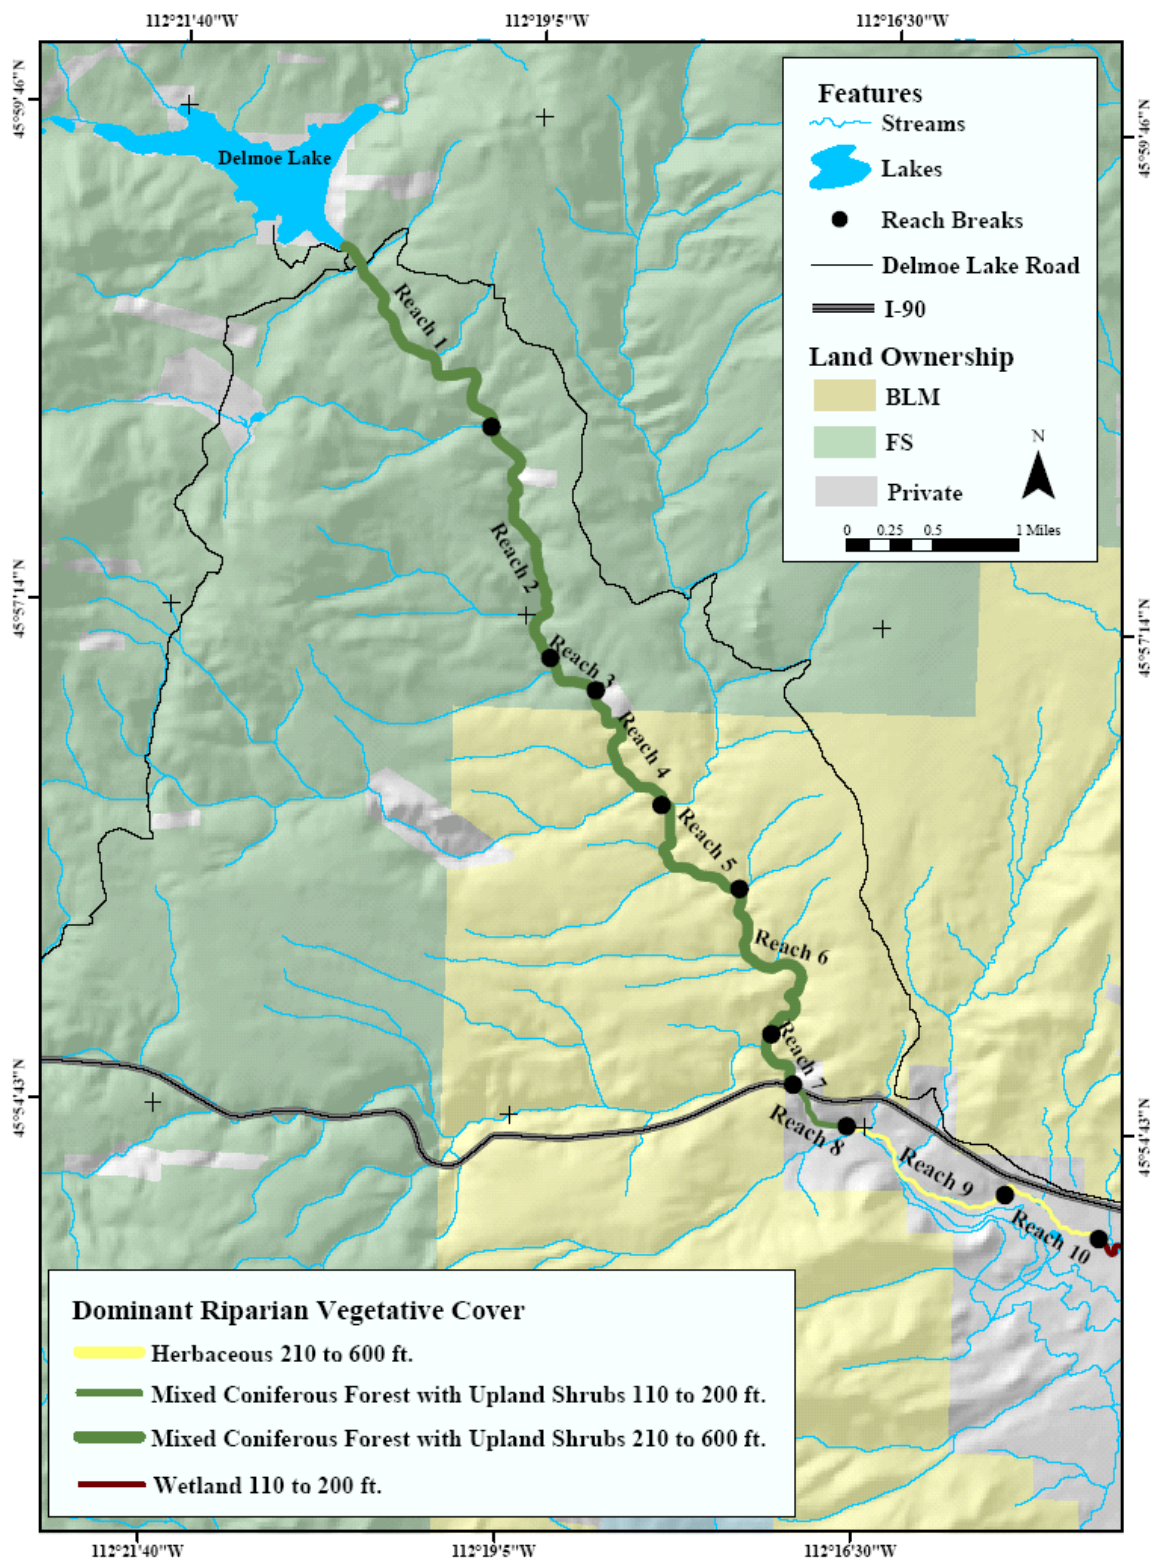
Figure 2-9. Upper Big Pipestone Creek Riparian Vegetation

The dominant riparian cover along Big Pipestone Creek above Interstate 90 was mixed coniferous forest with upland shrubs (**Figure 2-9**). Buffer widths were generally greater than 100 feet wide along both sides of the stream. The buffer widths represented the distance of vegetation surrounding the stream before any disturbance was observed, as opposed to the actual width of 'wet' vegetation (alders, willows, etc.). The relative health category assigned to all of the upper reaches was: 'Fair. Vegetation appears healthy, but some disturbance is present.' During the field review, willows, alders, rose, red osier, and grasses were noted as extending to a maximum of 30 feet from the channel within the conifer forest. Some areas of thistle infestation were present. Between 1983 and 2001, the riparian buffer widths in Reaches 4 and 7 appeared to increase by an average of 25 percent.

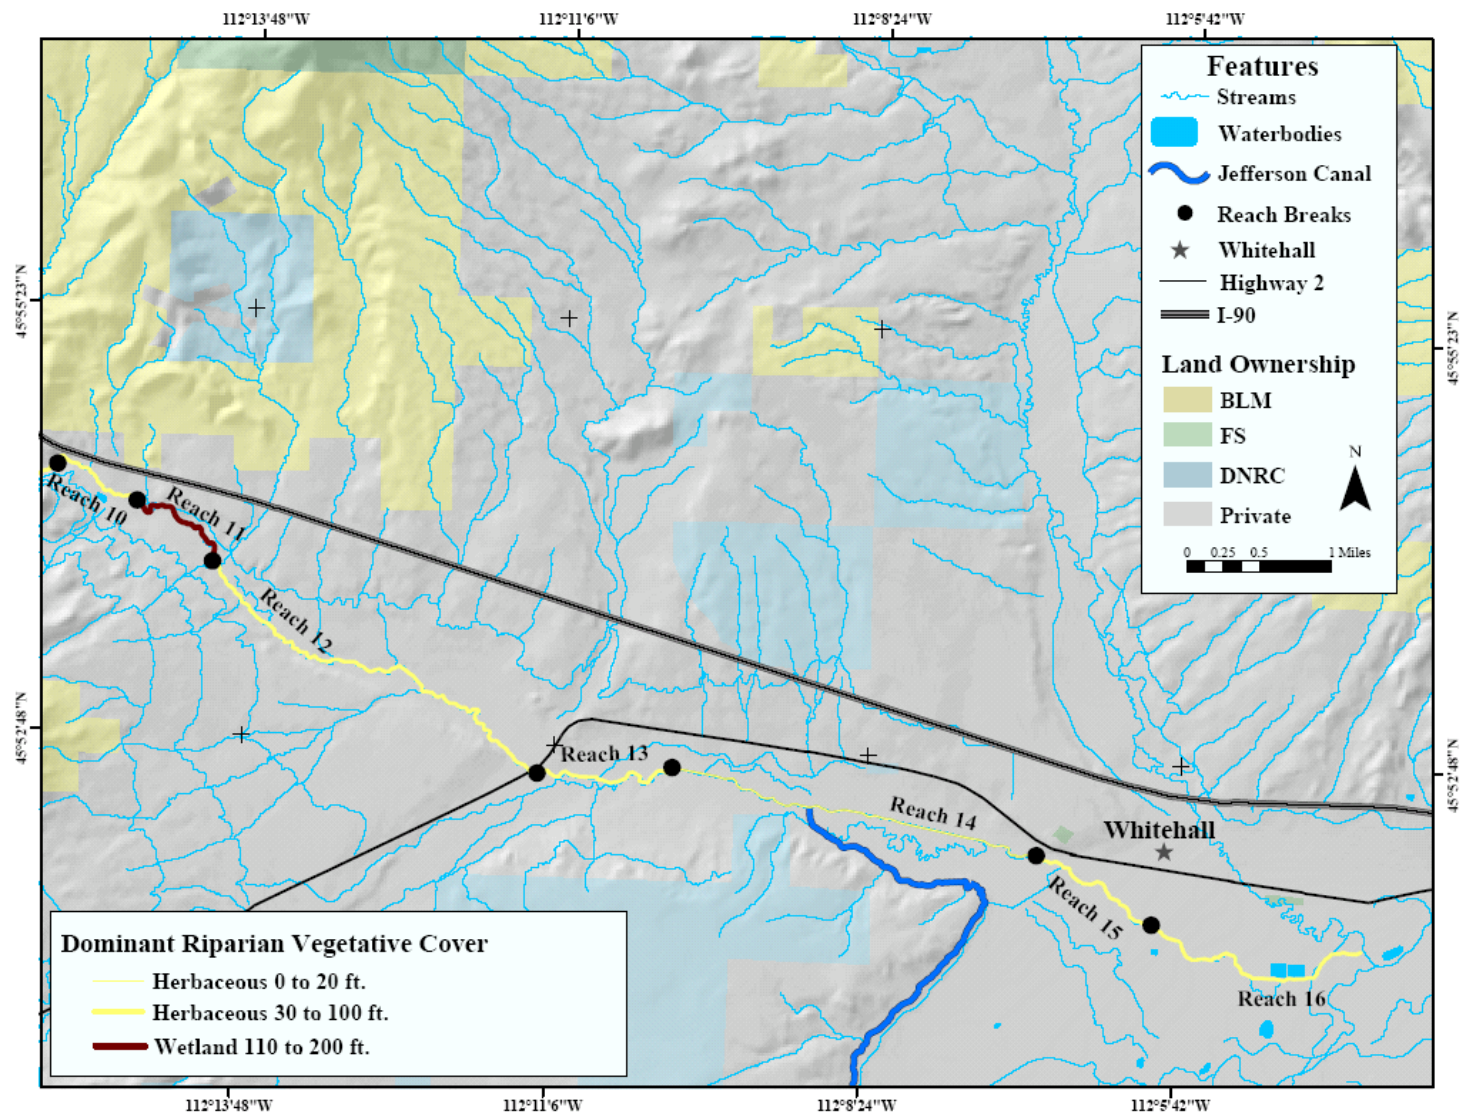
Figure 2-10. Lower Big Pipestone Creek Riparian Vegetation

The dominant riparian cover along Big Pipestone Creek below Interstate 90 was herbaceous; whereby, the grasses or forbs were being grown into the riparian and almost no woody vegetation was present (**Figure 2-10**). The one exception to this was Reach 11, which dominantly exhibited wetland characteristics. The buffer widths of these lower reaches represented the actual width of 'wet' vegetation (alders, willows, etc.). Buffer widths were generally less than 100 feet wide along both sides of the stream. The relative health category assigned to most of the valley reaches was: 'Fair. Vegetation appears healthy, but some disturbance is present.' Reaches 13, 14, and 16 were assigned a rating of 'Poor' due to notable disturbance. During the field review, willows, cottonwood, rose, and grasses were noted as extending generally to a maximum of 40 feet from the channel in Reaches 10 and 12. In Reaches 13 and 14, grasses, decadent willows, and roses were the predominant vegetation. Some areas of thistle and knapweed infestations were present. For the valley portion of Big Pipestone Creek, only one time period was analyzed so significant changes in riparian vegetation since 1983 could not be determined.

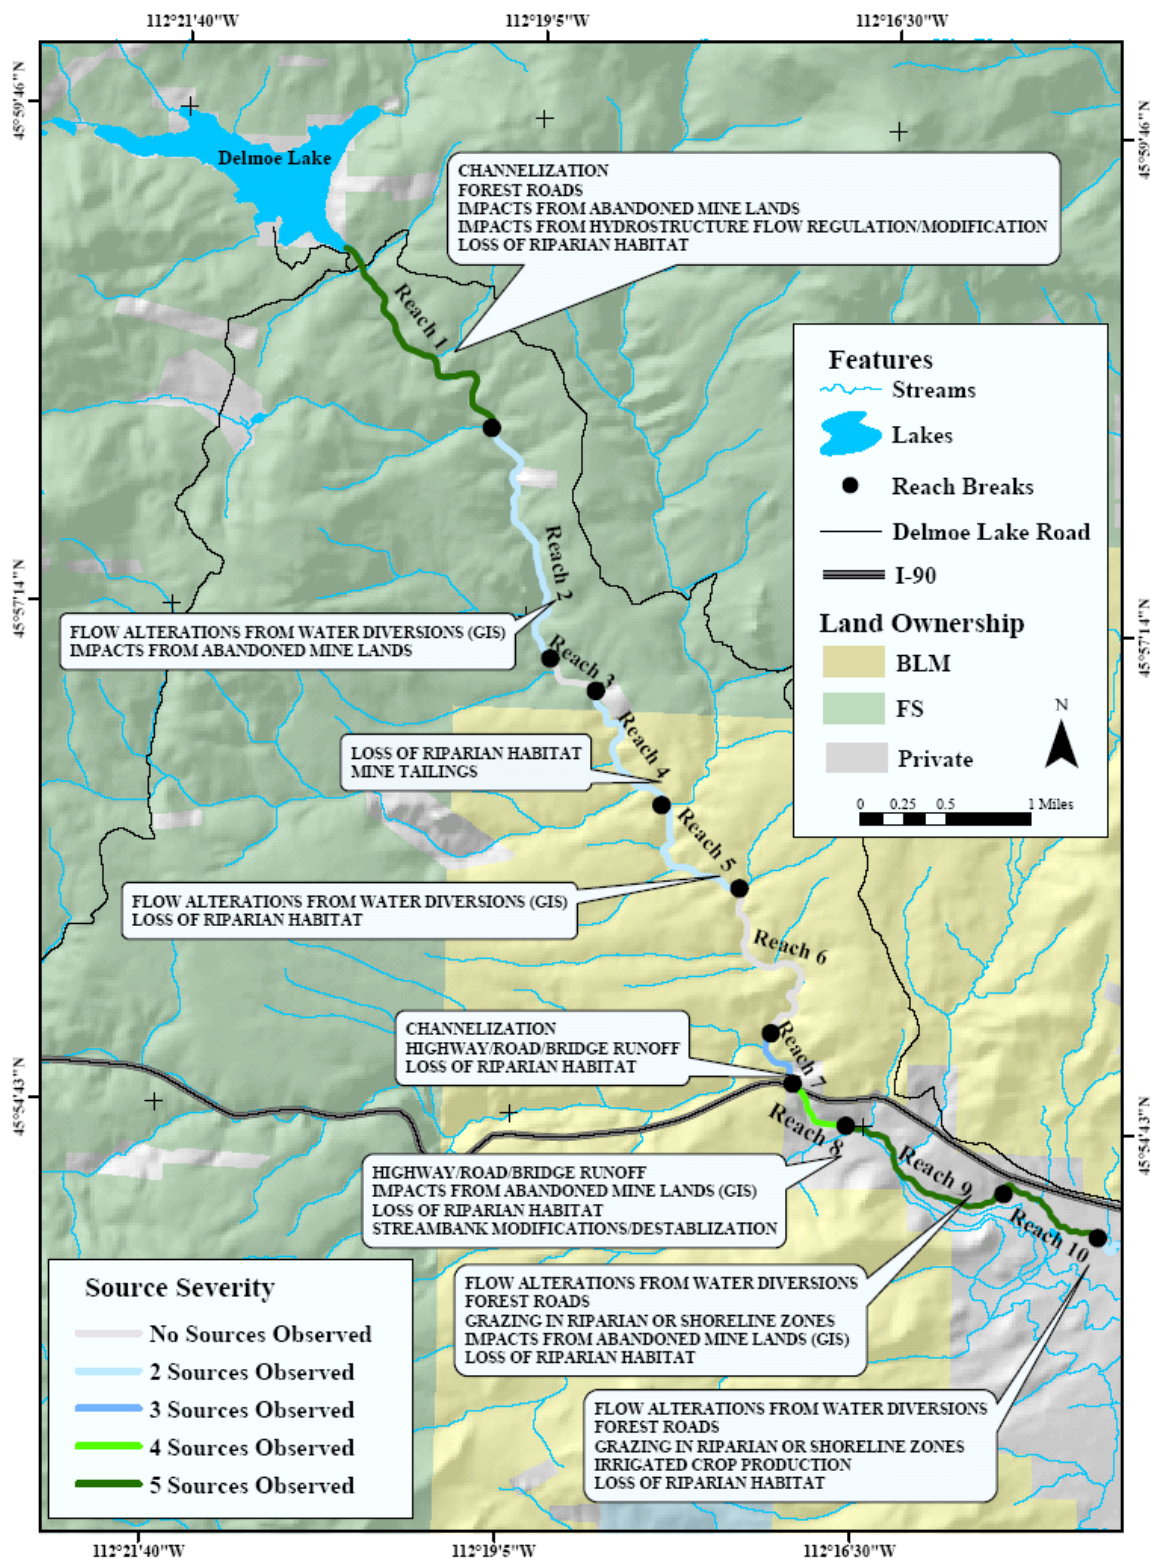
Figure 2-11. Upper Big Pipestone Creek Pollution Sources

**Figure 2-11** displays the pollution sources assigned to the upper reaches of Big Pipestone Creek. Many pollution sources observed along Big Pipestone Creek above Interstate 90 were related to the operation of Delmoe Lake Dam, and unpaved roads and trails. In many instances, the sources of flow alterations from water diversions and impacts from abandoned mine lands were taken from GIS layers which located water rights claims and abandoned mines. The GIS identified sources have generally not been field verified. During the field source assessment, heavy algal growth just below the Delmoe lake outlet, road sediment delivery sites, and channelization from rock walls were observed in Reach 1. In Reach 2, sediment delivery sites from ATV/motorcycle trails, and trash from an old mining operation (wood, metal, tires, furniture) were observed in the stream. The portion of Reach 7 that was surveyed looked fairly healthy, with vigorous riparian vegetation. There were no significant changes in pollution sources between 1983 and 2001.

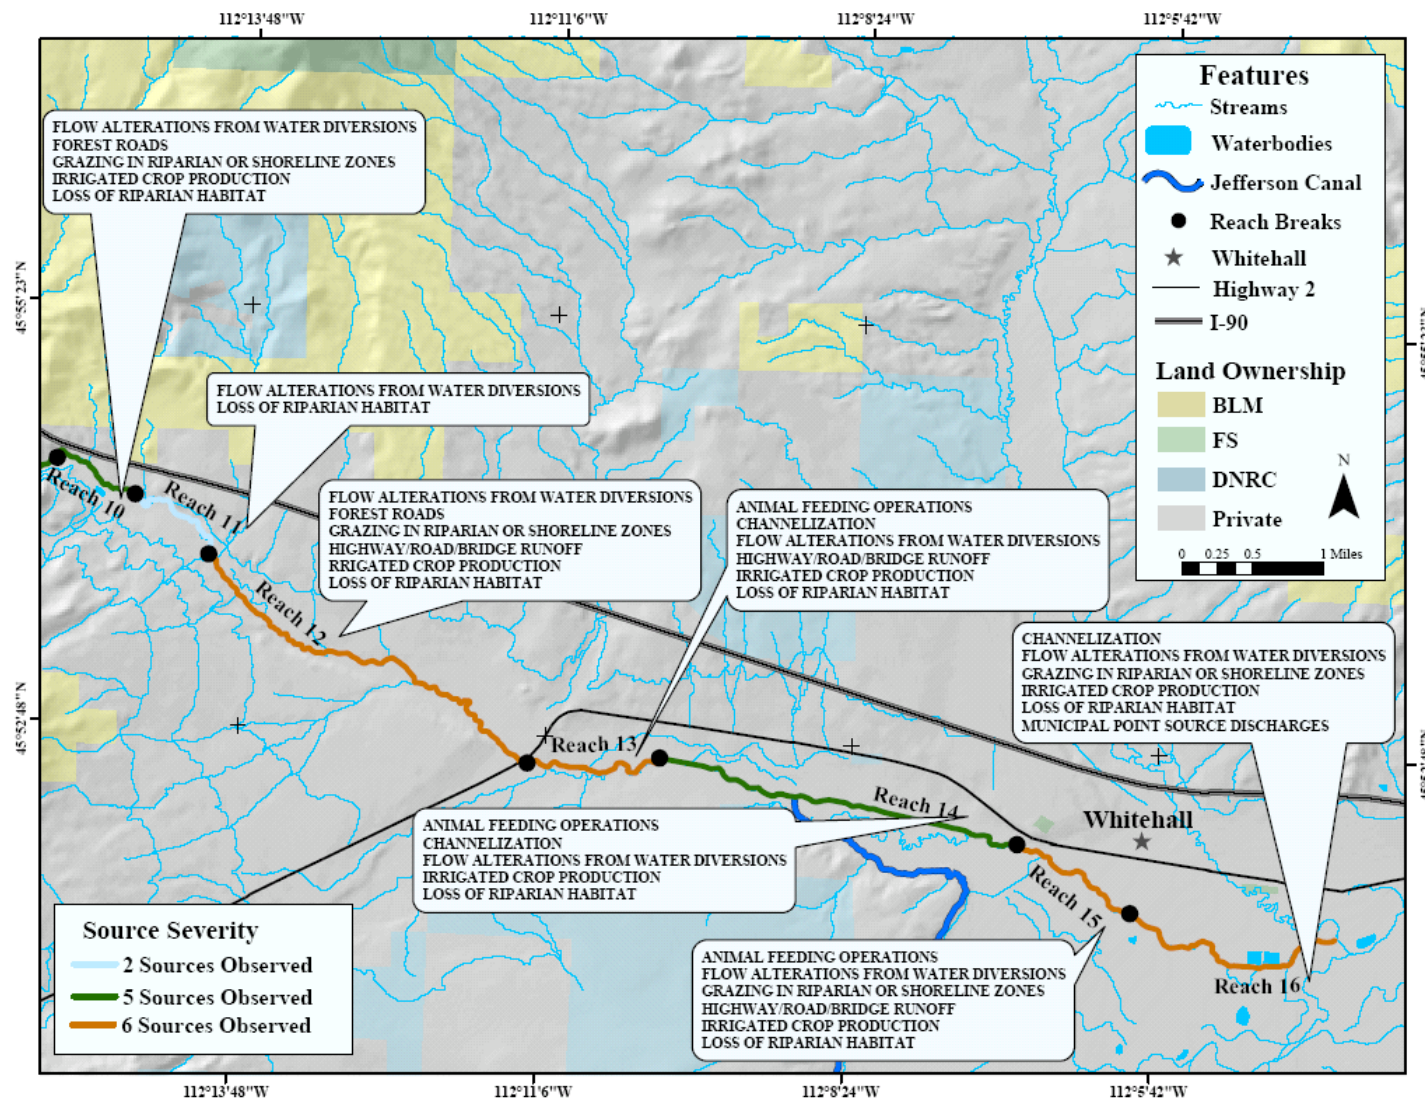
Figure 2-12. Lower Big Pipestone Creek Pollution Sources

**Figure 2-12** displays the pollution sources assigned to the lower reaches of Big Pipestone Creek. Many pollution sources observed along Big Pipestone Creek below Interstate 90 were related to agricultural operations. During the field source assessment, grazing impacts (trampled banks, overwidened channel, channel braids) were observed in all of the field surveyed reaches, except for Reach 11. Alterations for irrigation diversions were observed in Reaches 11, 13, 14, and 16. In general, stream condition deteriorates in a downstream manner from Reach 10 to Reach 14. For the valley portion of Big Pipestone Creek, only one time period was analyzed so significant changes in pollution sources since 1983 were not determined.

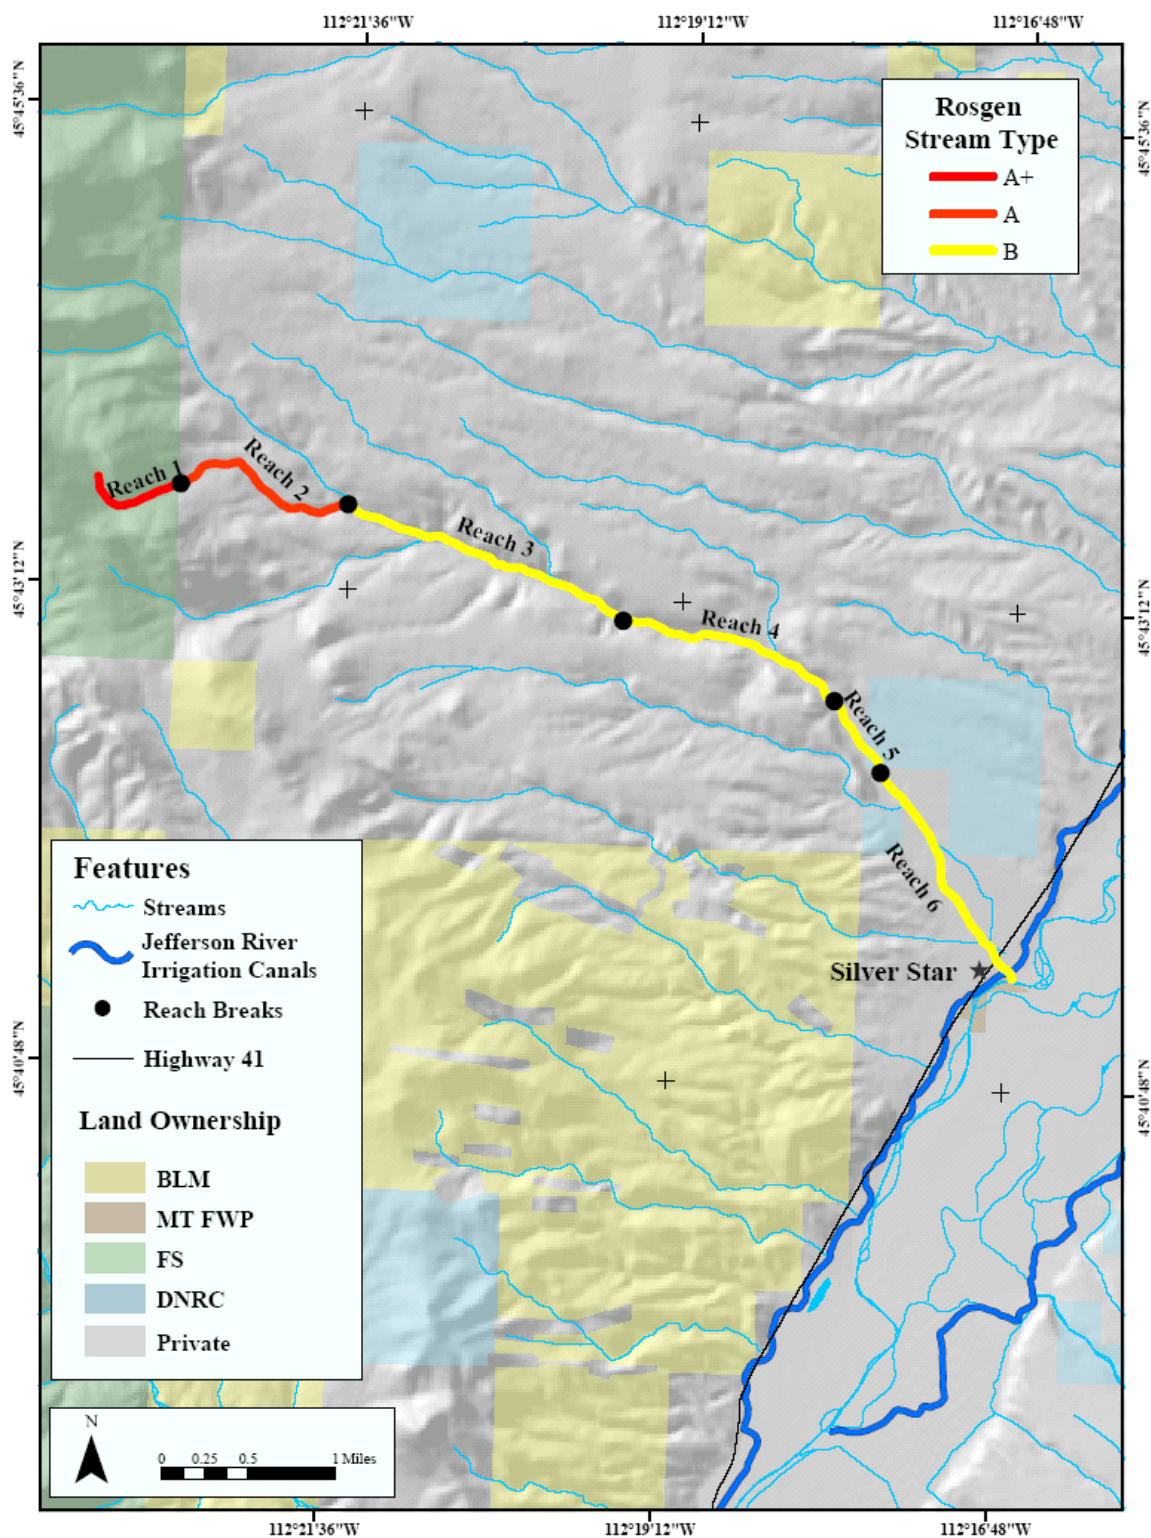
Figure 2-13. Cherry Creek Rosgen Stream Types

The channel forms of Cherry Creek are primarily controlled by landform structure (**Figure 2-7**). The prominent landform geology, the Boulder Batholith, has resulted in valley bottom formation along weathered joints. The stream headwaters on relatively steep slopes (A-type) and then progresses downstream to more moderate slopes. The valley bottom is fairly confined (B-type reaches) until exiting the canyon to the alluvial fan (B and Eb reaches). The portion of Reach 2 viewed during the field survey exhibited A, Ea, and G channel types. The Ea section was observed in a steep aspen meadow area, while the stream alternated between G (grazing impacts) and A type sections where the stream was more confined. Reach 3 was surveyed from the confluence of the North Fork of Cherry Creek downstream. Reach 3 exhibited B and Ba-type sections. The portion of Reach 6 viewed in the field exhibited an Eb-type channel. The section of Reach 6 surveyed was below a large irrigation diversion, but diminished flow effects were not observed. According to the property owner, flow is fairly constant; however a landowner further downstream reported that the stream often goes dry during the irrigation season (section not observed). There were no significant changes in channel form between 1983 and 2001.

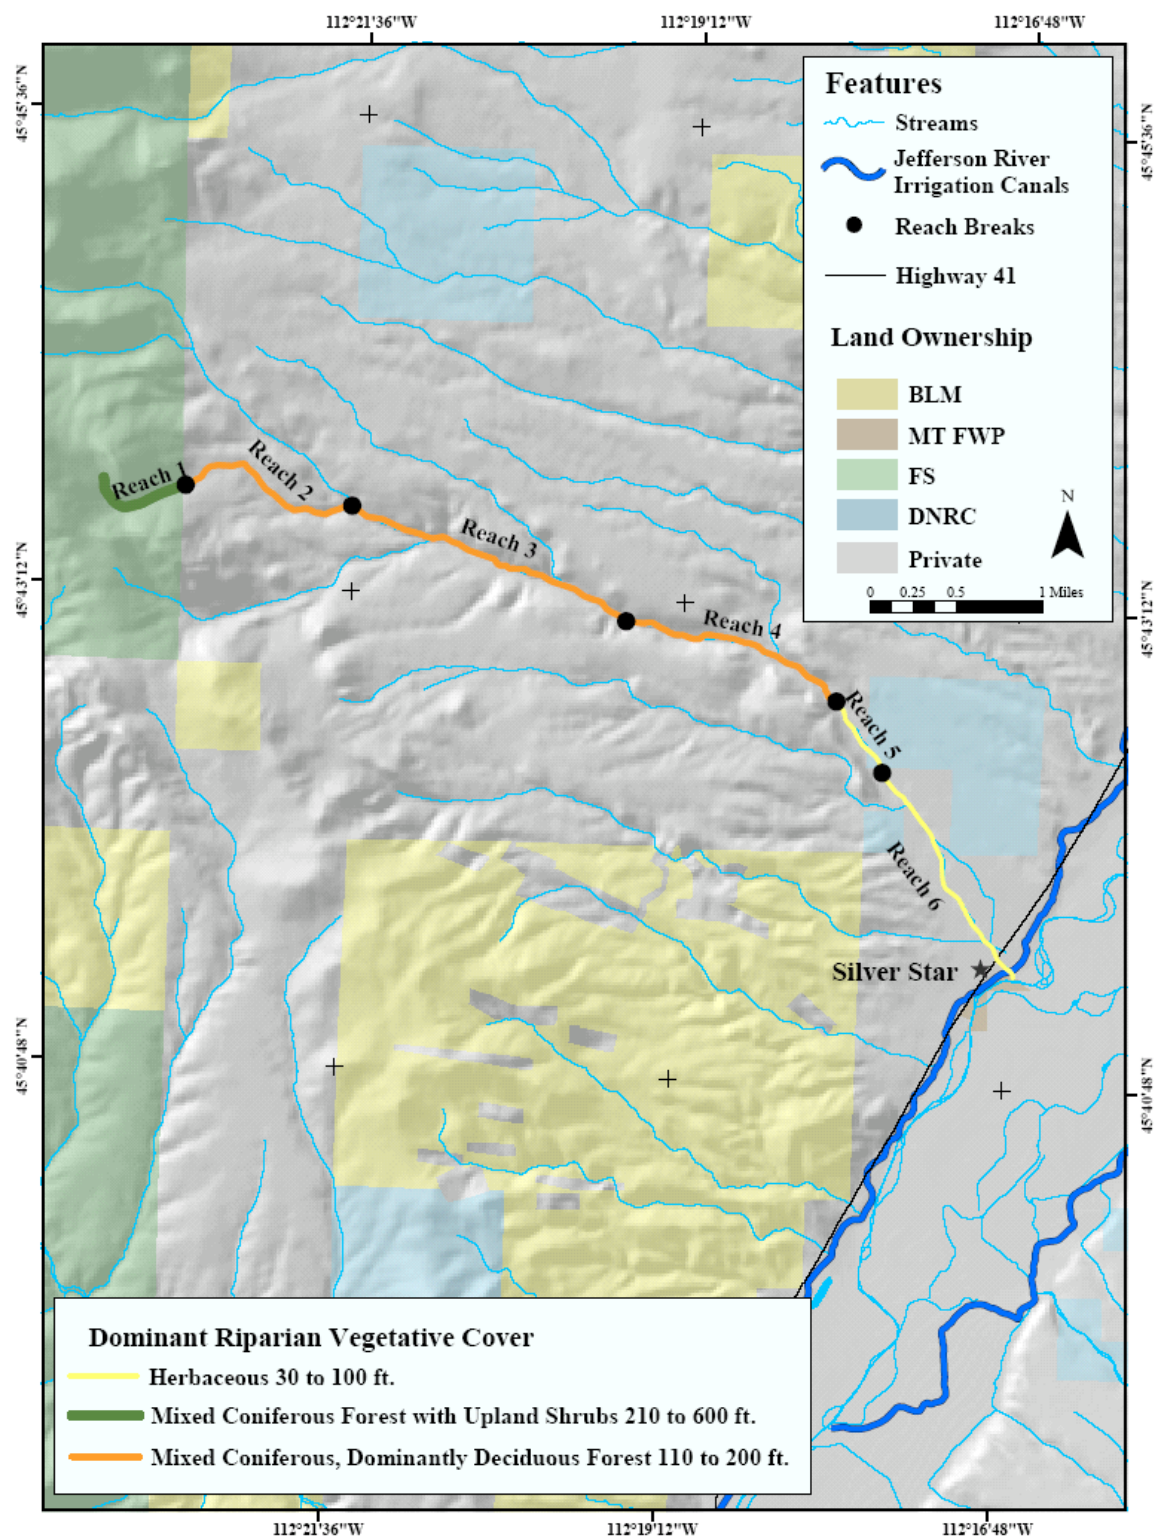
Figure 2-14. Cherry Creek Riparian Vegetation

The dominant riparian cover in the headwaters of Cherry Creek was mixed coniferous forest with upland shrubs (**Figure 2-14**). Buffer widths were generally greater than 300 feet wide along both sides of the stream. The buffer widths represented the distance of vegetation surrounding the stream before any disturbance was observed, as opposed to the actual width of 'wet' vegetation (alders, willows, etc.). The relative health category assigned to Reach 1 was: 'Excellent. Vegetation appears to be vigorous, with various age classes present (little or no disturbance).'

The dominant riparian cover along the canyon sections of Cherry Creek was mixed coniferous, dominantly deciduous forest. Buffer widths were generally greater than 60 feet wide along both sides of the stream. The buffer widths represented the distance of vegetation surrounding the stream before any disturbance was observed, or vegetation type changed. Buffer widths were generally limited by valley bottom width, as opposed to unnatural factors. During the field review, willows, aspen, current, alder, and sedges were noted as extending to a maximum of 20 feet from the channel. Some areas of thistle, leafy spurge, and mullein were present. The relative health category assigned to Reaches 2 to 4 was: 'Fair. Vegetation appears healthy, but some disturbance is present.' Between 1983 and 2001, the riparian buffer widths in Reaches 3 and 4 appeared to increase by an average of 40 percent and 25 percent respectively.

The dominant riparian cover along the alluvial fan portion of Cherry Creek was herbaceous, whereby, the grasses or forbs were being grown into the riparian and almost no woody vegetation was present (**Figure 2-14**). The buffer widths of these lower reaches represent the actual width of 'wet' vegetation. Buffer widths were generally less than 50 feet wide along both sides of the stream. The relative health category assigned to Reach 5 was 'Fair'; while the relative health category assigned to Reach 6 was 'Poor' due to notable disturbance. During the field review in Reach 6, cottonwood (regenerating), willows, alder, rose, and sedges were noted as extending generally to a maximum of 20 feet from the channel. Between 1983 and 2001, the riparian buffer width in Reach 6 appeared to increase by an average of 25 percent.

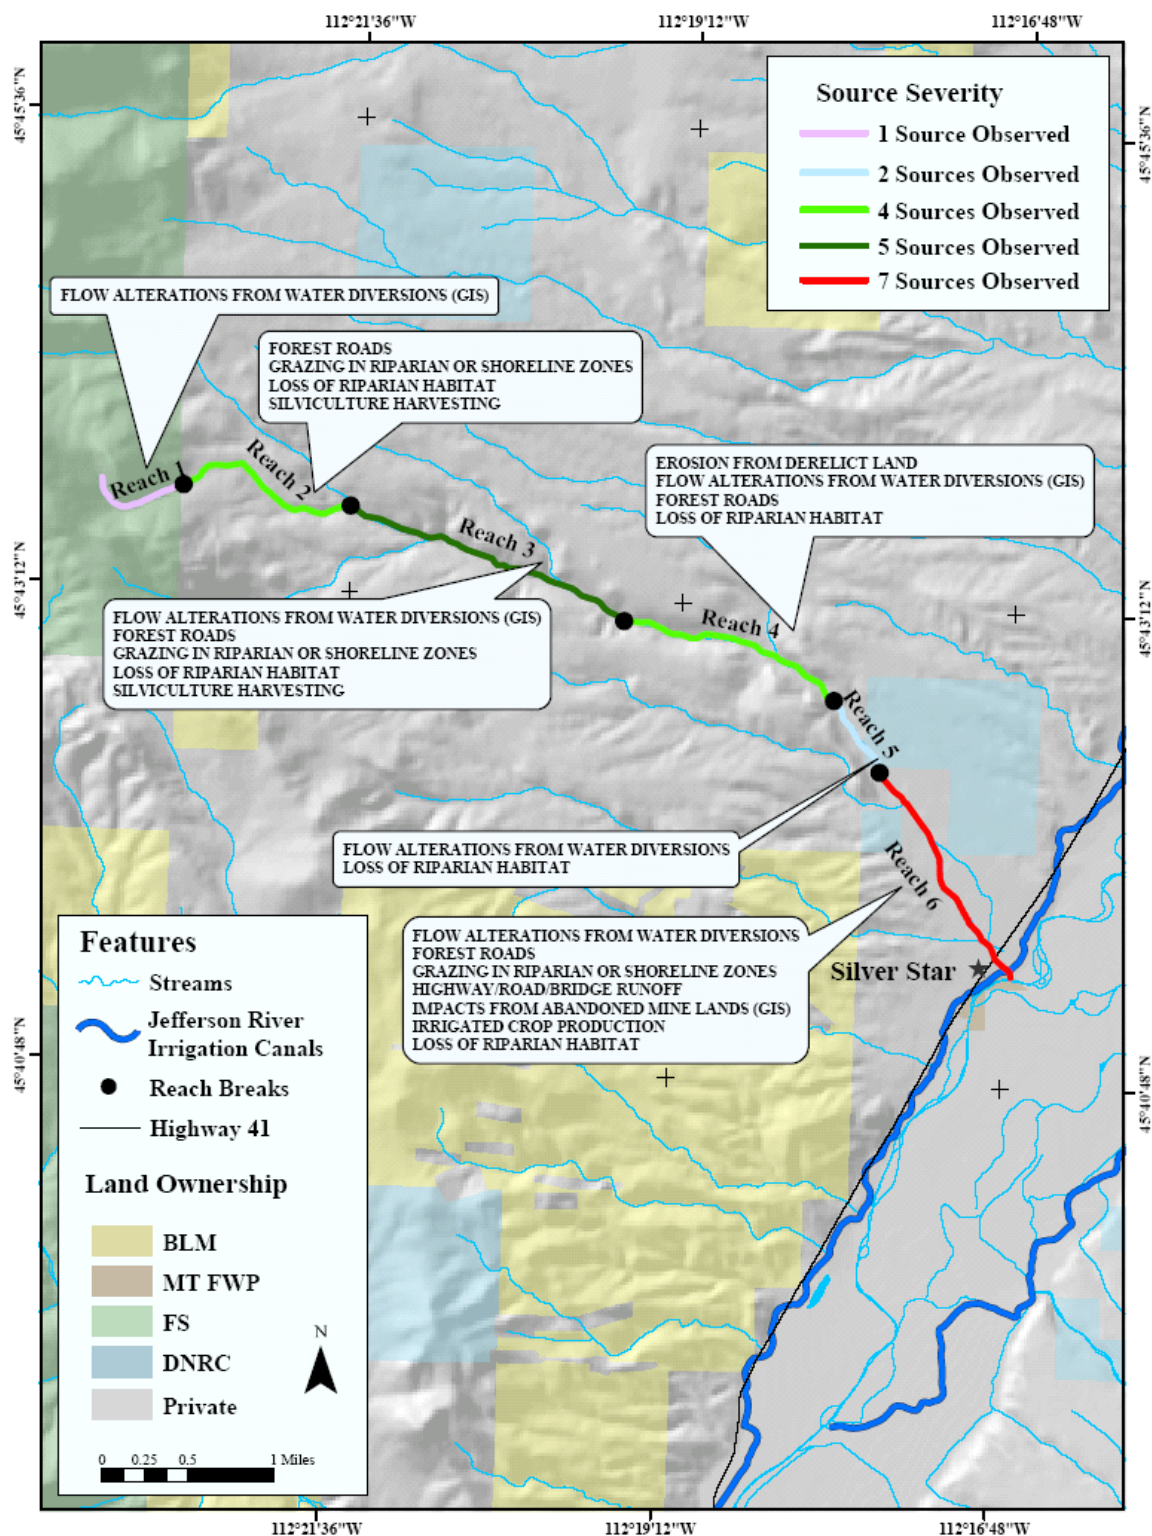
Figure 2-15. Cherry Creek Pollution Sources

**Figure 2-15** displays the pollution sources assigned to Cherry Creek. Many pollution sources observed along Cherry Creek were related to riparian grazing and unpaved roads. In the upper reaches of the creek, the source of flow alterations from water diversions was taken from a GIS layer which located water rights claims. In Reach 6 the impacts from abandoned mine lands was also taken from a GIS layer. The GIS identified sources have not been field verified. Silviculture harvest has occurred upslope from Cherry Creek (south side) and any runoff associated with the harvest would enter in Reaches 2 and 3. Again harmful effects from this impact were not field verified. Grazing impacts observed in the field were more detrimental in Reach 2 than in any of the other reaches observed. Sediment input from unpaved roads was fairly minimal. Loss of riparian habitat was associated with development in the floodplain (roads, crops, housing). There were no significant changes in pollution sources between 1983 and 2001.

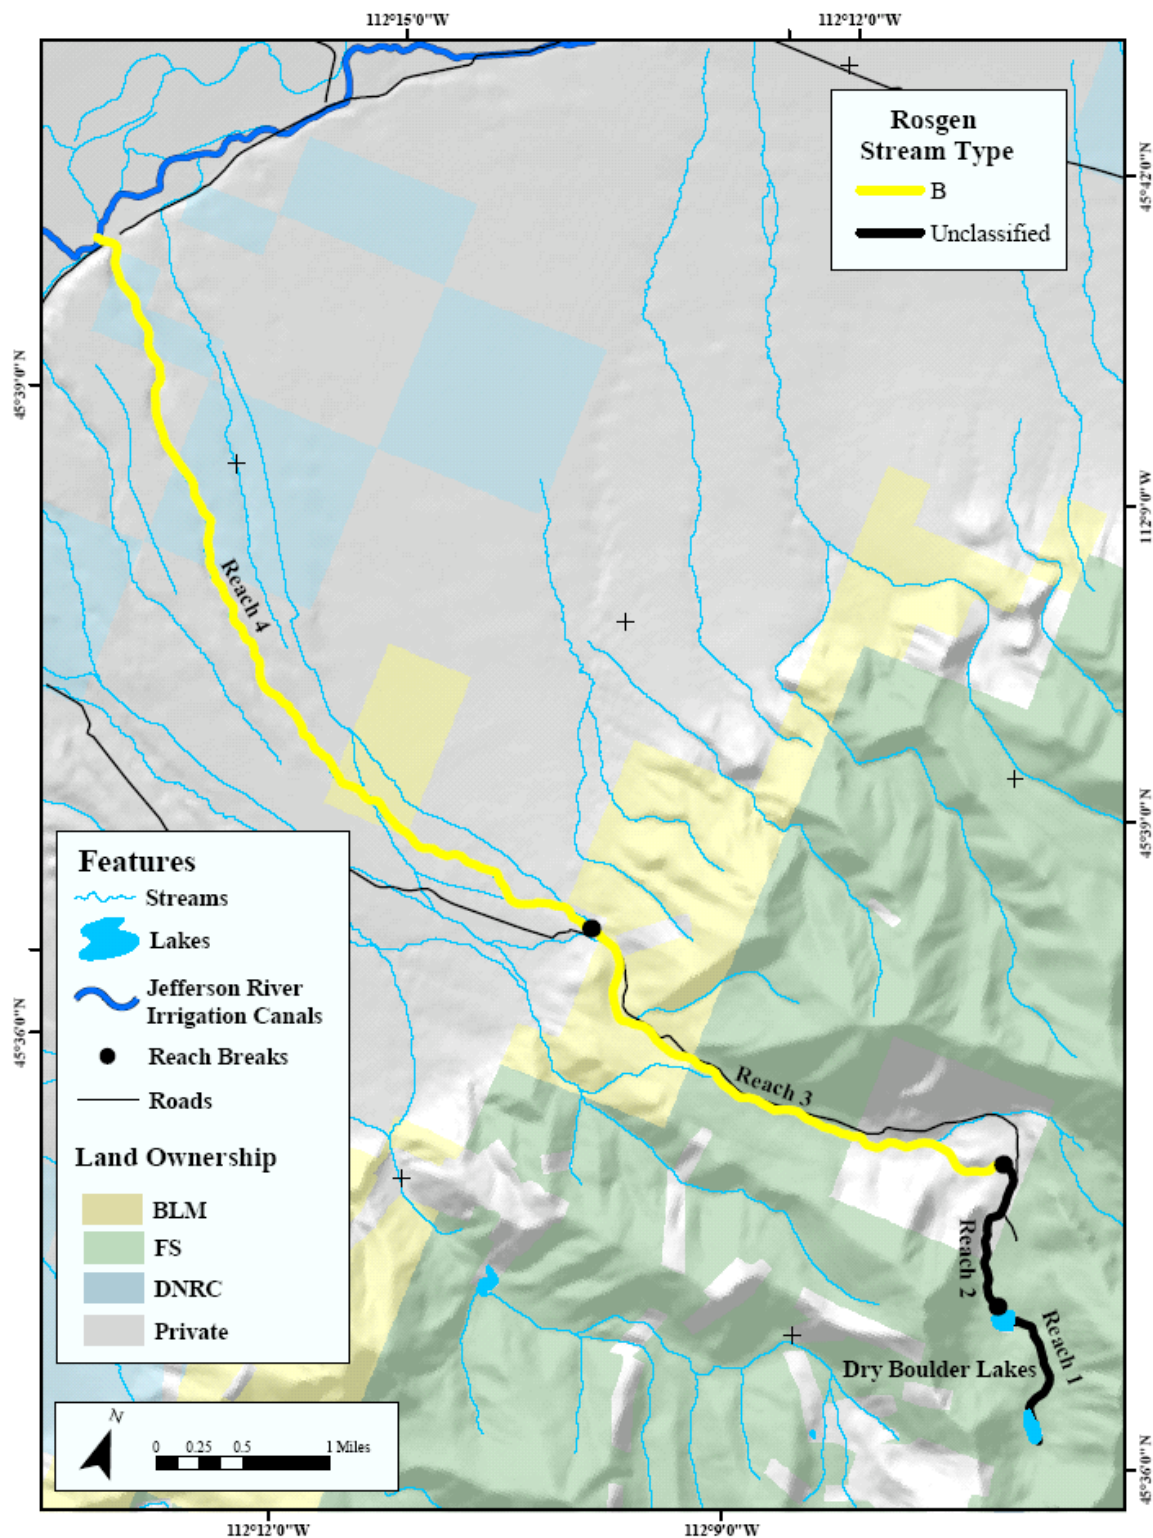
Figure 2-16. Dry Boulder Creek Rosgen Stream Types

**Figure 2-16** displays the Rosgen channel types assigned to Dry Boulder Creek. The structural controls on the channel forms of Dry Boulder Creek have led to diverse channel types in the headwaters. For this reason, the channel classifications for Reaches 1 and 2 were 'unclassified' after the field review. Channel forms in Reaches 1 and 2 are influenced by past glaciation. In Reach 1, many Rosgen channel types exist. Most likely the channel starts at the mouth of Upper Boulder Lake as an E or C type stream (not observed in field), but then changes type where the stream hits a nickpoint (A-type, observed). At the base of the falls (A), the channel quickly changes to a Ba type, then to an E type, but with multiple channels and areas of braiding where the stream flows into Lower Boulder Lake. Reach 2 is also difficult to type in areas because of the steep gradient, high entrenchment ratio, and braiding. Ea, A, Ba, and E (meadow area) channel types were observed in this reach. The portions of Reaches 3 and 4 observed in the field exhibited B and Ba type channels. After the field review, it was noted that Reach 4 should have probably be broken into at least two reaches on the alluvial fan, possibly around the 5400' contour interval where contour spacing starts to spread further apart (slope and substrate size probably change here). There were no significant changes in channel form between 1983 and 2001.
