**APPENDIX C**  
**2004 AERIAL PHOTO REVIEW AND FIELD SOURCE ASSESSMENT,**  
**UPPER JEFFERSON RIVER WATERSHED**

### **1.1 Upper Jefferson Watershed 2004 Aerial Photo Review and Field Source Assessment**

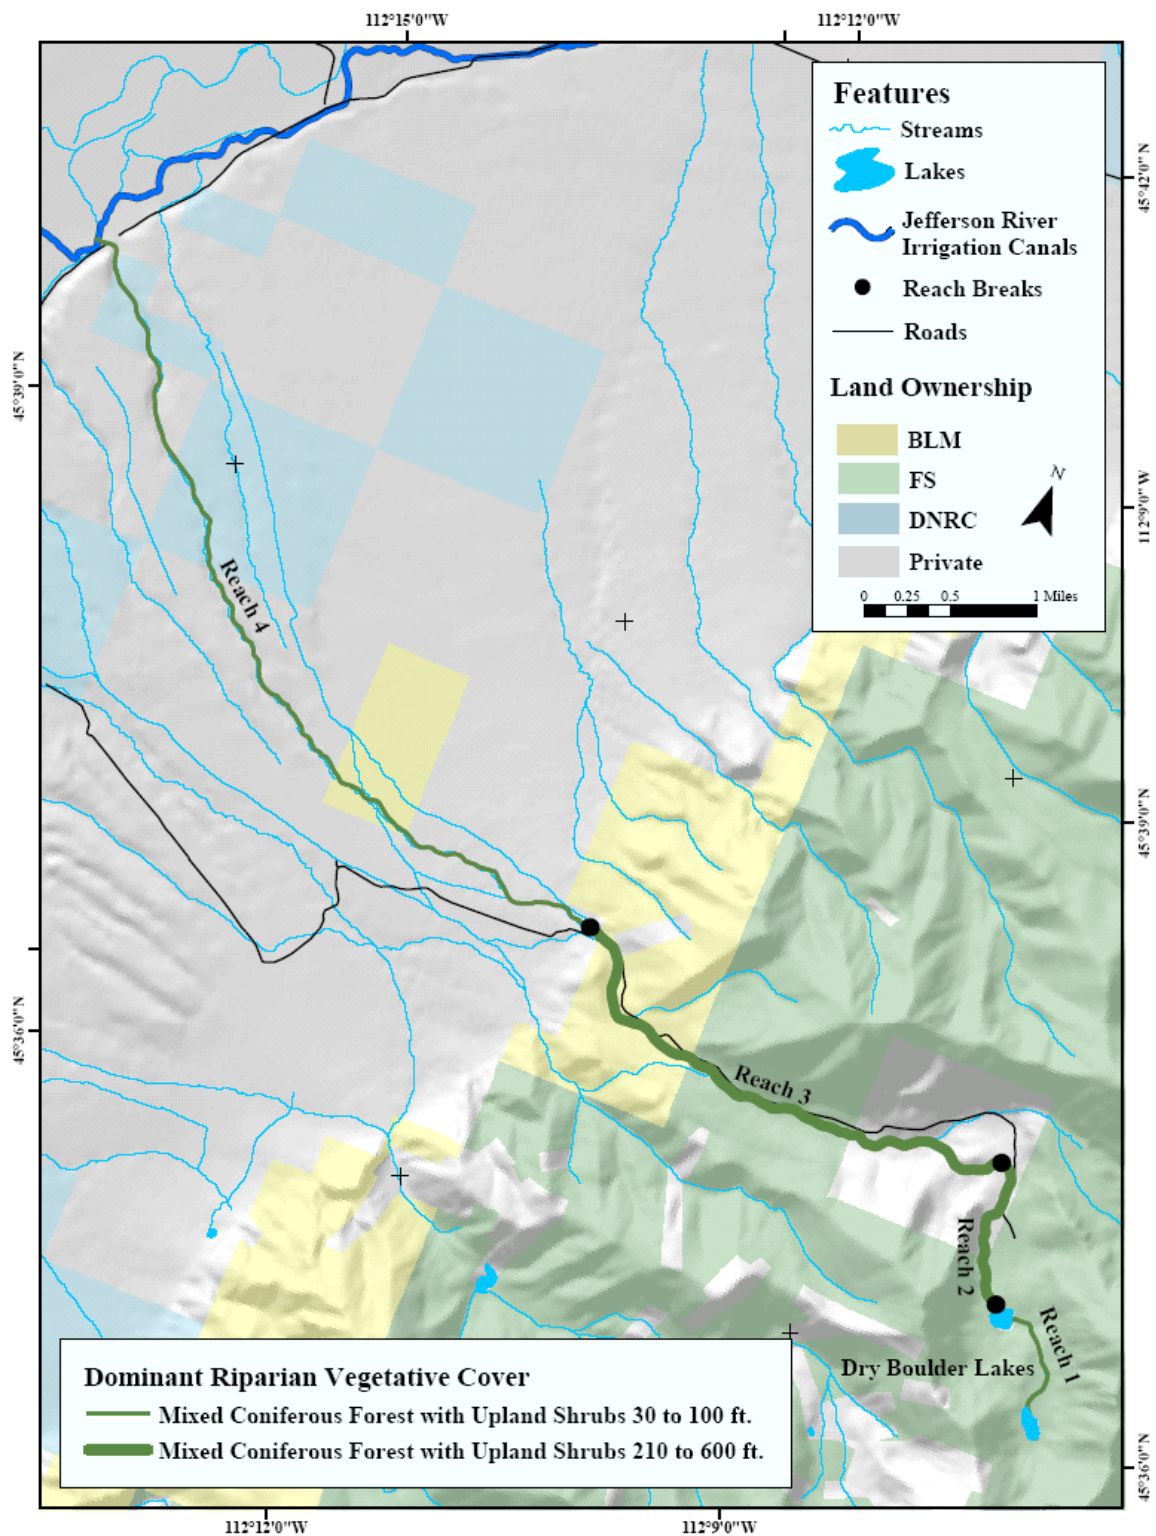
Figure 2-17. Dry Boulder Creek Riparian Vegetation

The dominant riparian cover along Dry Boulder Creek was mixed coniferous forest with upland shrubs (**Figure 2-17**). In the headwaters reaches (1 and 2), vegetative width was generally limited by natural factors and could probably be classified as alpine wetland. During the field review, sedges, alpine flowers, and conifers were observed in Reaches 1 and 2. In Reach 3, buffer widths were generally greater than 100 feet wide along both sides of the stream. In Reaches 3 and 4, the riparian vegetation was mostly conifers with some deciduous vegetation growth (cottonwood, chokecherry, maple). Near the mouth, more deciduous vegetation was observed. Along the areas observed in Reach 4, riparian vegetative width was limited by moisture. The relative health category assigned to all of the reaches was: 'Fair. Vegetation appears healthy, but some disturbance is present.' There were no significant changes in riparian vegetation between 1983 and 2001.

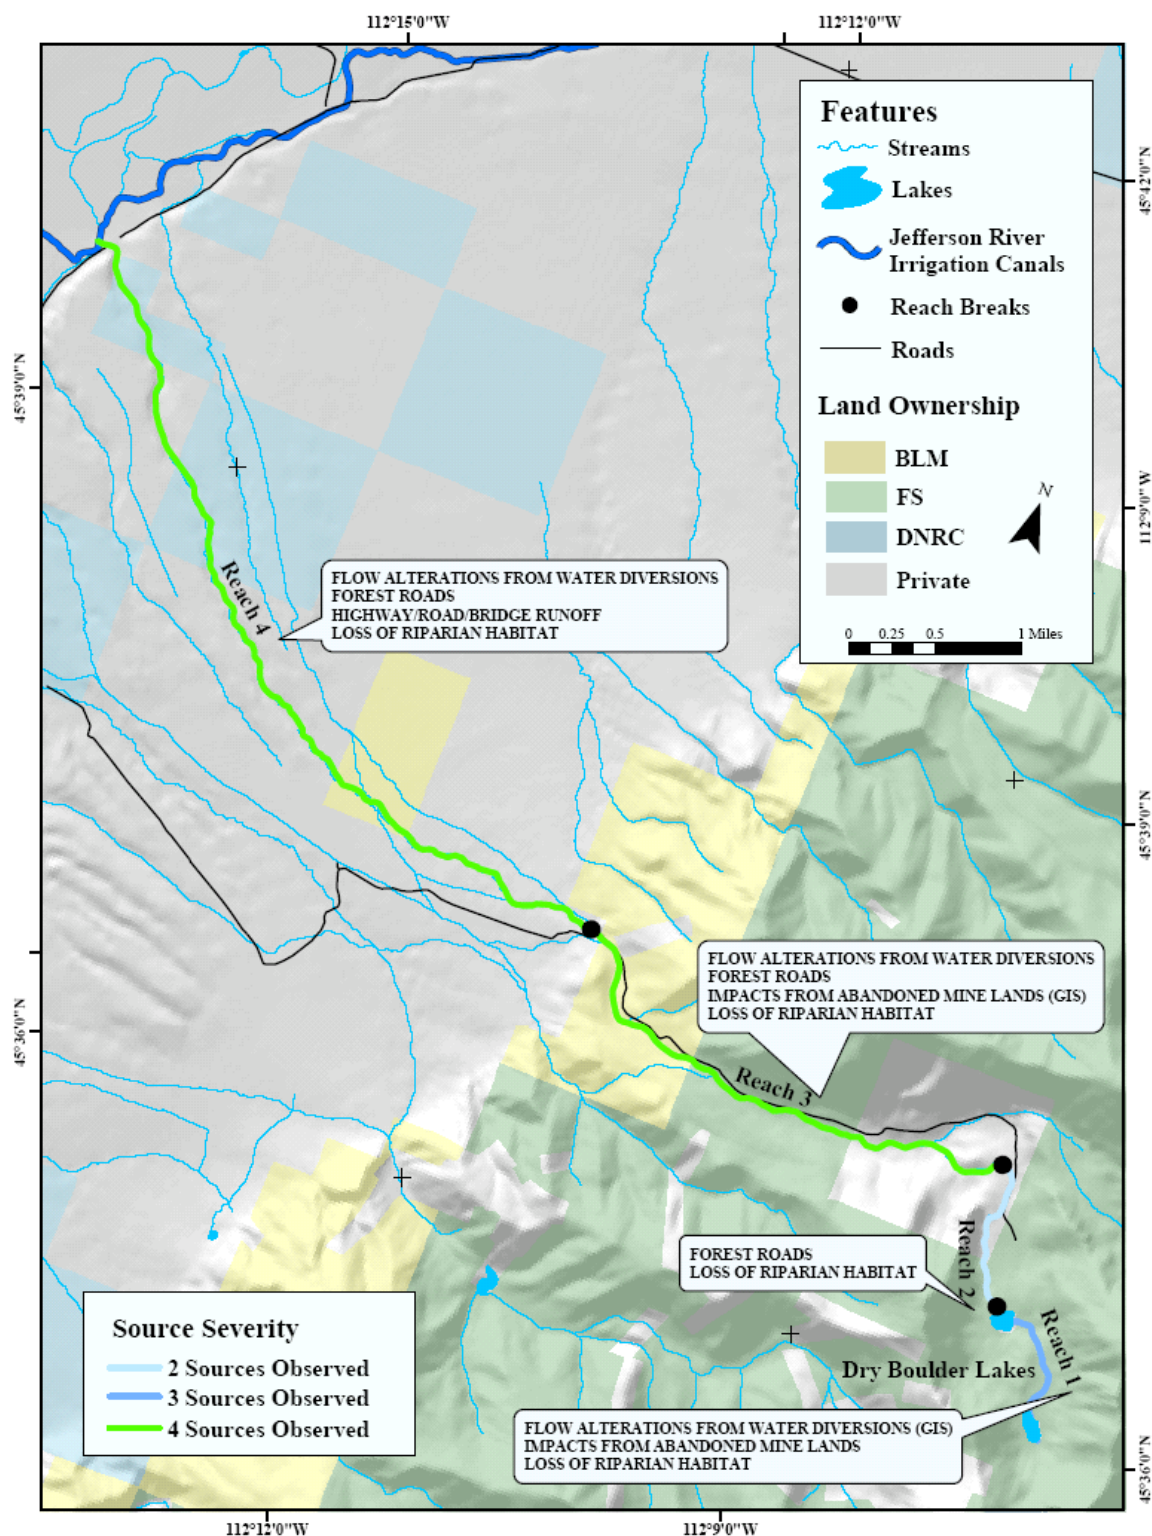
Figure 2-18. Dry Boulder Creek Pollution Sources

**Figure 2-18** displays the pollution sources assigned to Dry Boulder Creek. Few pollution sources were observed in the field. The most detrimental source observed was a road sediment delivery site near the end of Reach 3. In some instances, the sources of flow alterations from water diversions and impacts from abandoned mine lands were taken from GIS layers which located water rights claims and abandoned mines. The GIS identified sources have generally not been field verified. Some habitat disturbance in the vicinity of an old mine site in Reach 1 was visible on the aerial photos, but this section of the stream was difficult to access and not field observed. Unfortunately, the canal diversion to Coal Creek (Reach 3) was not noted before the field assessment, and thus it could not be determined if this canal takes all of the stream's flow. It is suspected that the change in lithology from crystalline rocks to porous carbonate rocks in Reach 3 may contribute to natural stream dewatering. On the alluvial fan (Reach 4) the stream goes distributary and probably does not carry flow, except during spring runoff and intense rainfall events (fairly characteristic of streams on alluvial fans in arid environments). There were no significant changes in pollution sources between 1983 and 2001.

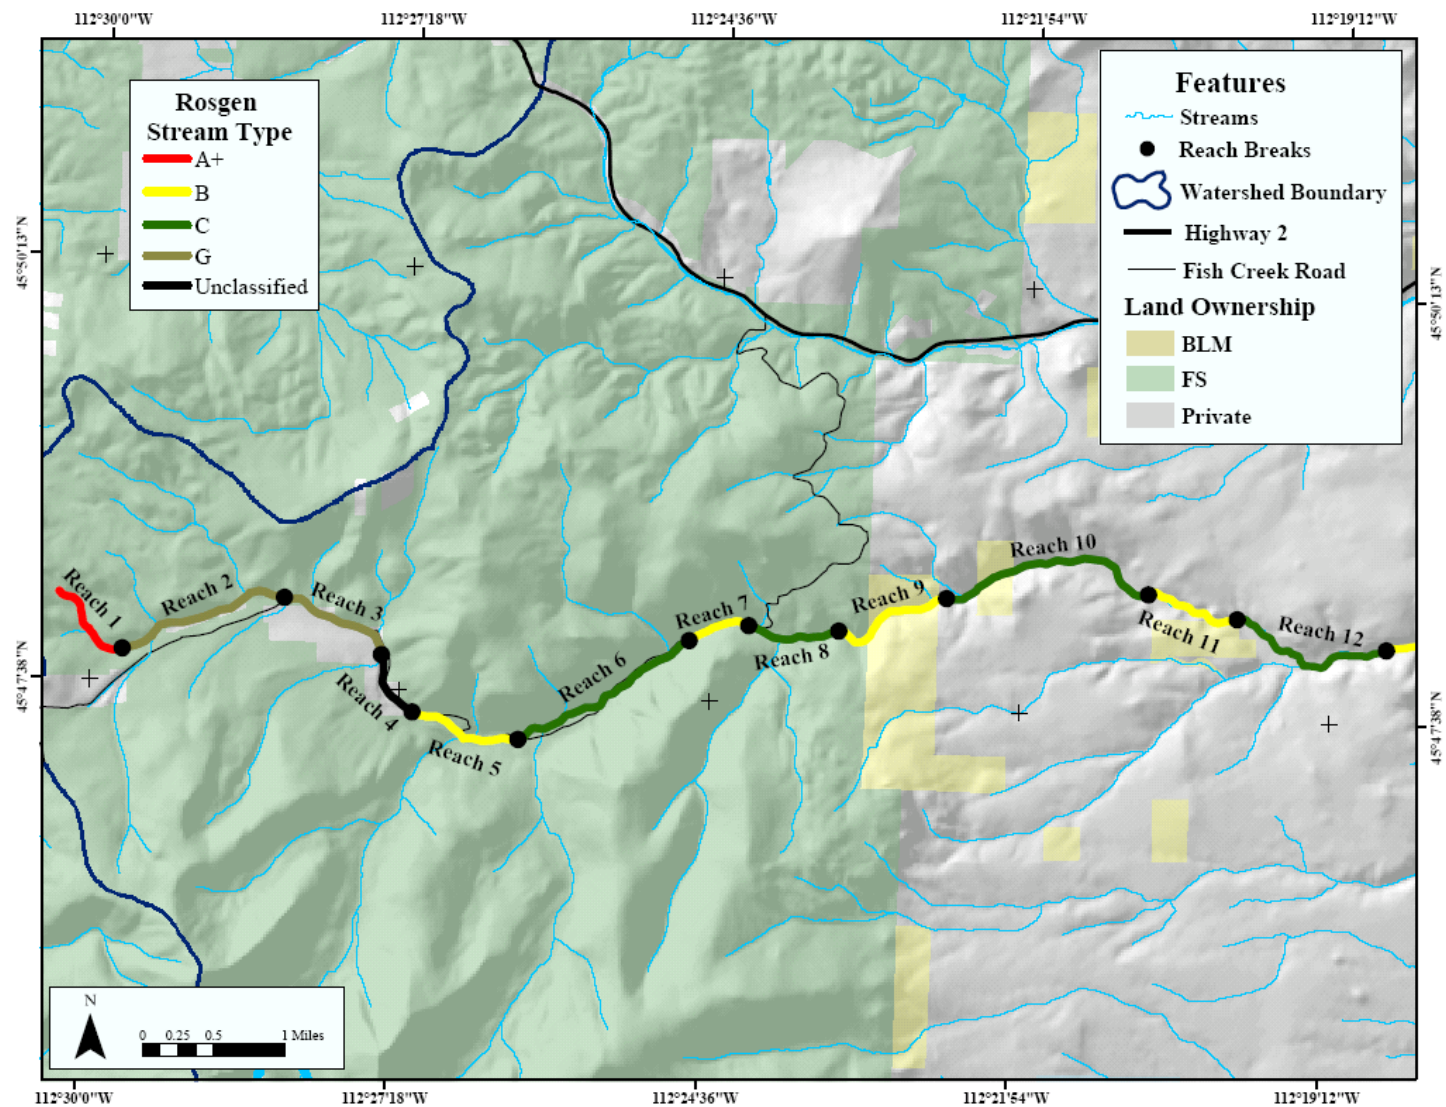
Figure 2-19. Upper Fish Creek Rosgen Stream Types

The channel forms of Fish Creek within the Highland Mountains are predominantly controlled by landform structure, as well as historical land uses (**Figure 2-19**). The upper reaches have been affected by faulting and glaciation, and more recently by placer mining and logging related activities. The entire length of Reach 3 was surveyed and channel form was found to be variable. The reach begins with transition from a B-type to C-type stream, close to the middle of the reach the stream is channelized and exhibits a G-type channel. There were areas of Reach 3 and Reach 4 that were not classifiable, mostly due to the effects of placer mining. Reach 5 was noted as a good potential for a reference B-type channel. Reach 6 appeared to have been altered by the removal of beaver dams (straightened, incised) and had characteristics of C and Bc type channels. From Reach 7 to 13 (**Figure 2-20**), the Boulder Batholith geology has weathered into

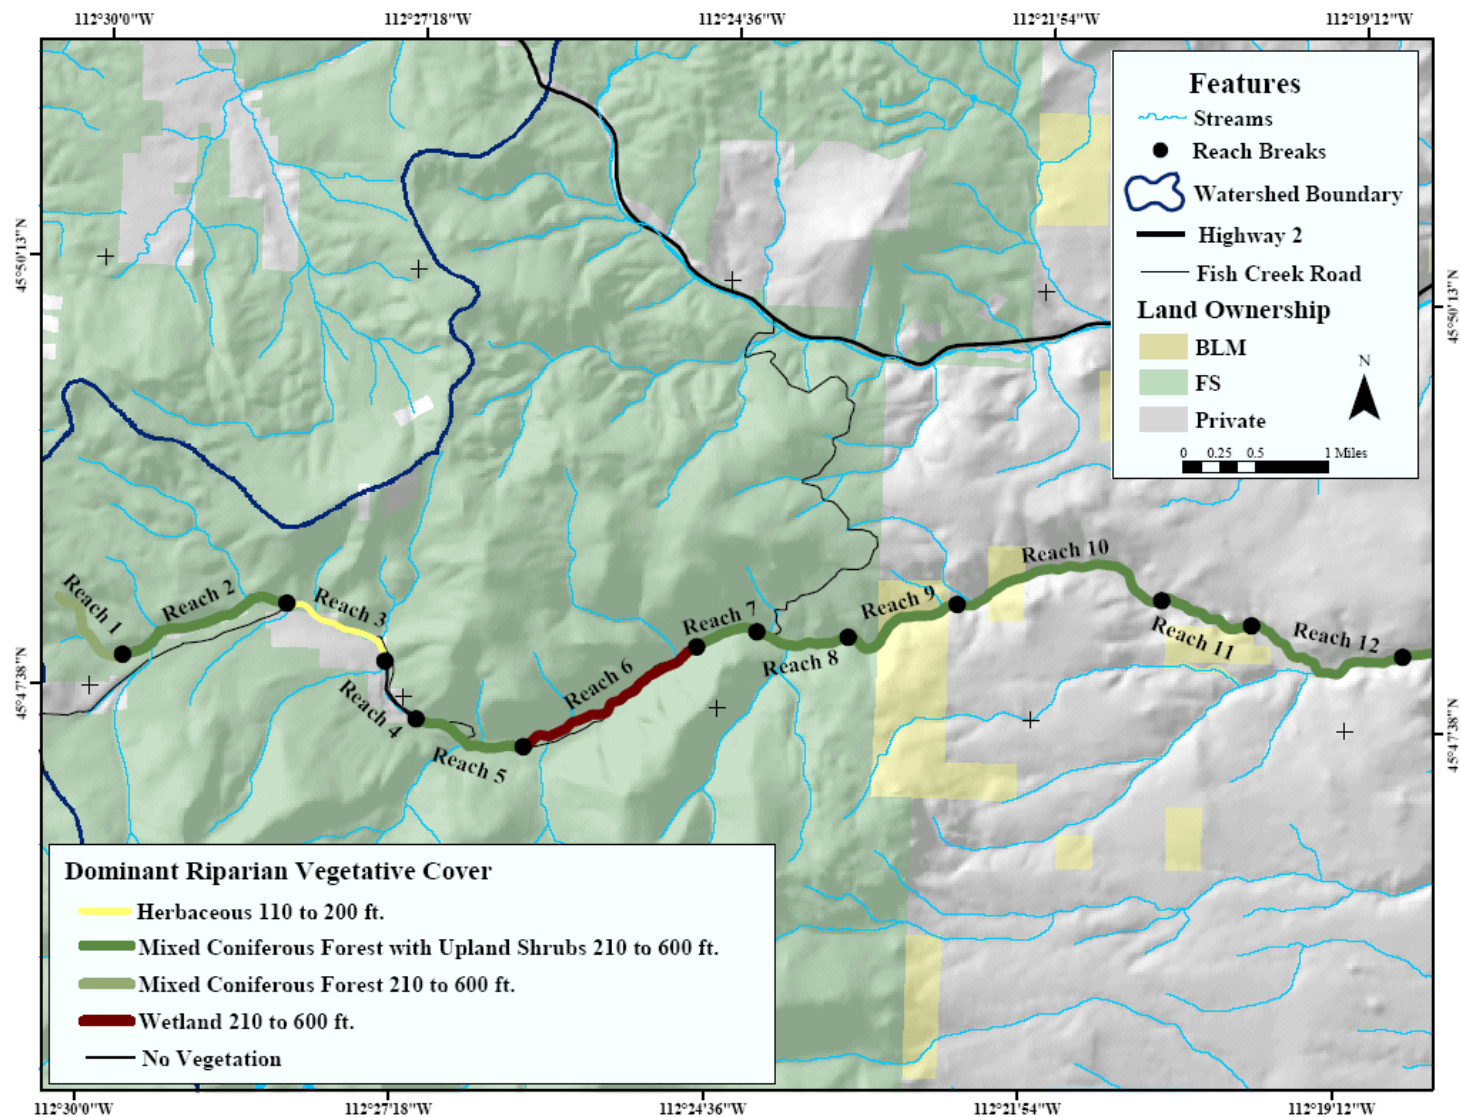
Figure 2-21. Upper Fish Creek Riparian Vegetation

The dominant riparian cover along Fish Creek within the Highland Mountains was mixed coniferous forest with upland shrubs (**Figure 2-21**). Reach 13 is also within the Highland Mountains (**Figure 2-22**). Buffer widths were generally greater than 100 feet wide along both sides of the stream. The buffer widths represented the distance of vegetation surrounding the stream before any disturbance was observed, as opposed to the actual width of 'wet' vegetation (alders, willows, etc.). Healthy riparian vegetation was virtually absent in Reaches 3 and 4, and could probably be attributed to many sources (grazing, logging, placer mining, and roads). The relative health categories in the upper reaches varied from 'Excellent' to 'Poor' depending on the amount of disturbance visible. In Reach 6, the willows were decadent and dying and a thistle infestation was present. Between 1983 and 2001, the riparian buffer widths in Reach 2 appeared to decrease by an average of 20 percent, but in Reach 10 appeared to increase by an average of 90 percent.

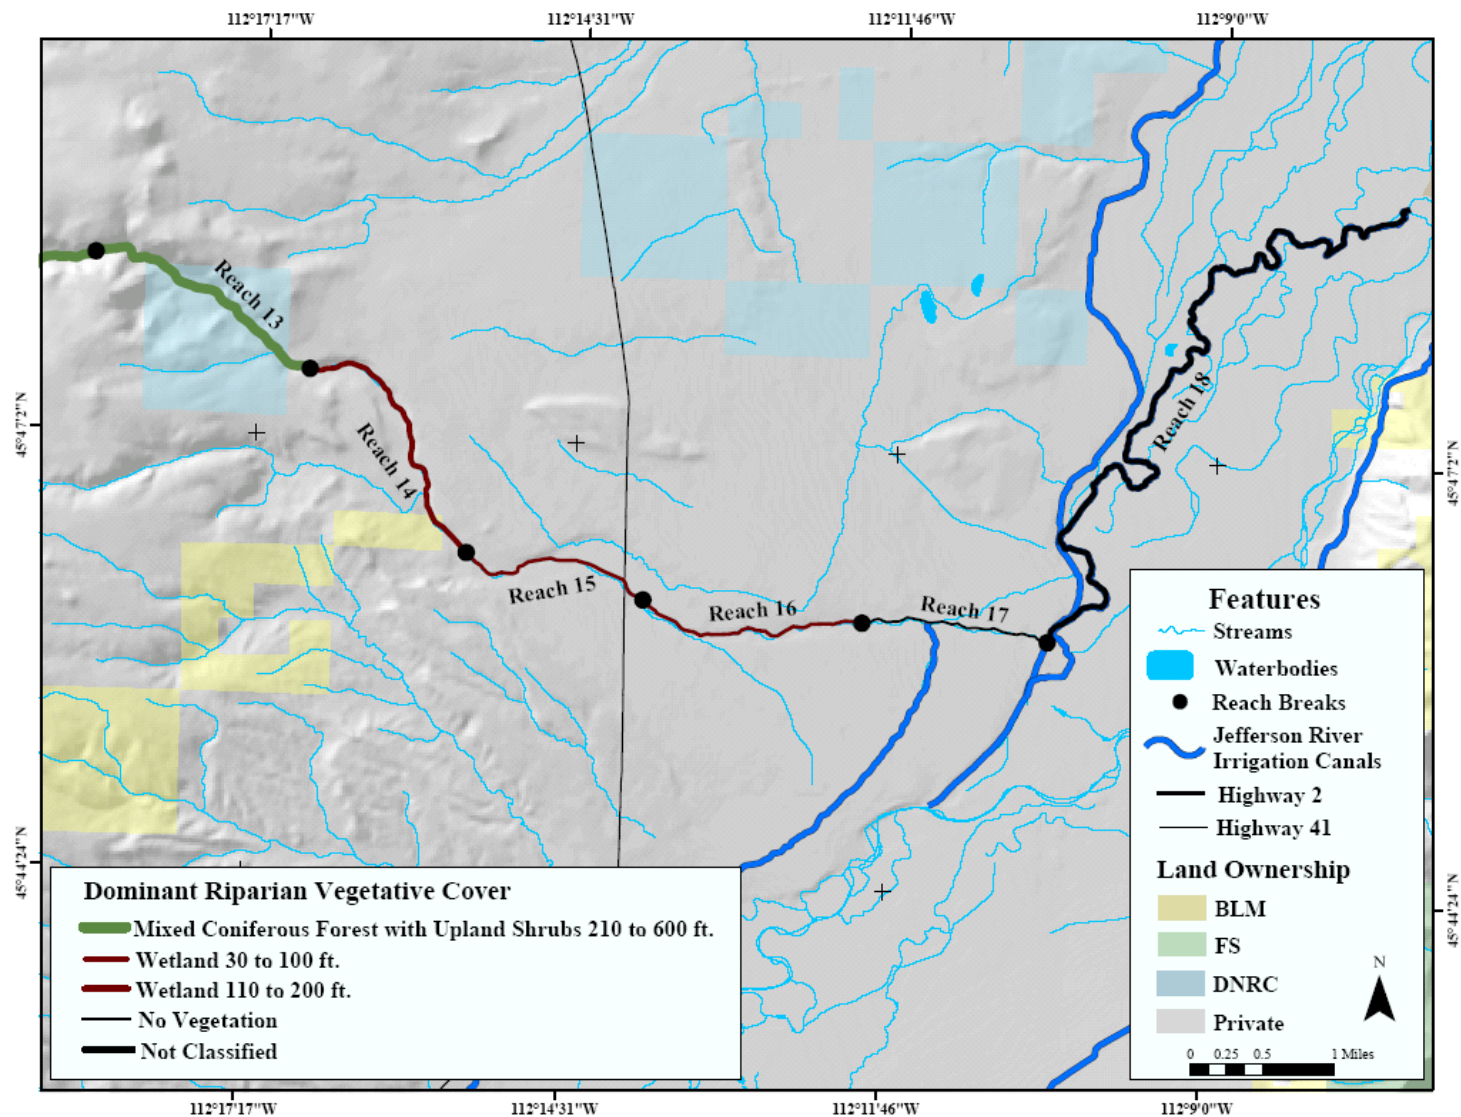
Figure 2-22. Lower Fish Creek Riparian Vegetation

The dominant riparian plants along Fish Creek in the Jefferson Valley were wetland species (**Figure 2-22**). The exception to this was Reach 17, where vegetation was basically absent. The buffer widths of these lower reaches represented the actual width of 'wet' vegetation (alders, willows, etc.). Buffer widths were generally less than 100 feet wide along both sides of the stream. The relative health category assigned to most of the valley reaches was: 'Fair'. During the field review in Reach 14, service berry, alder, rose, red osier, and willows were noted as extending generally to a maximum of 50 feet from the channel. Some areas of knapweed and leafy spurge were observed in Reaches 14 and 15. For the valley portion of Fish Creek, only one time period was analyzed so significant changes in riparian vegetation since 1983 could not be determined.

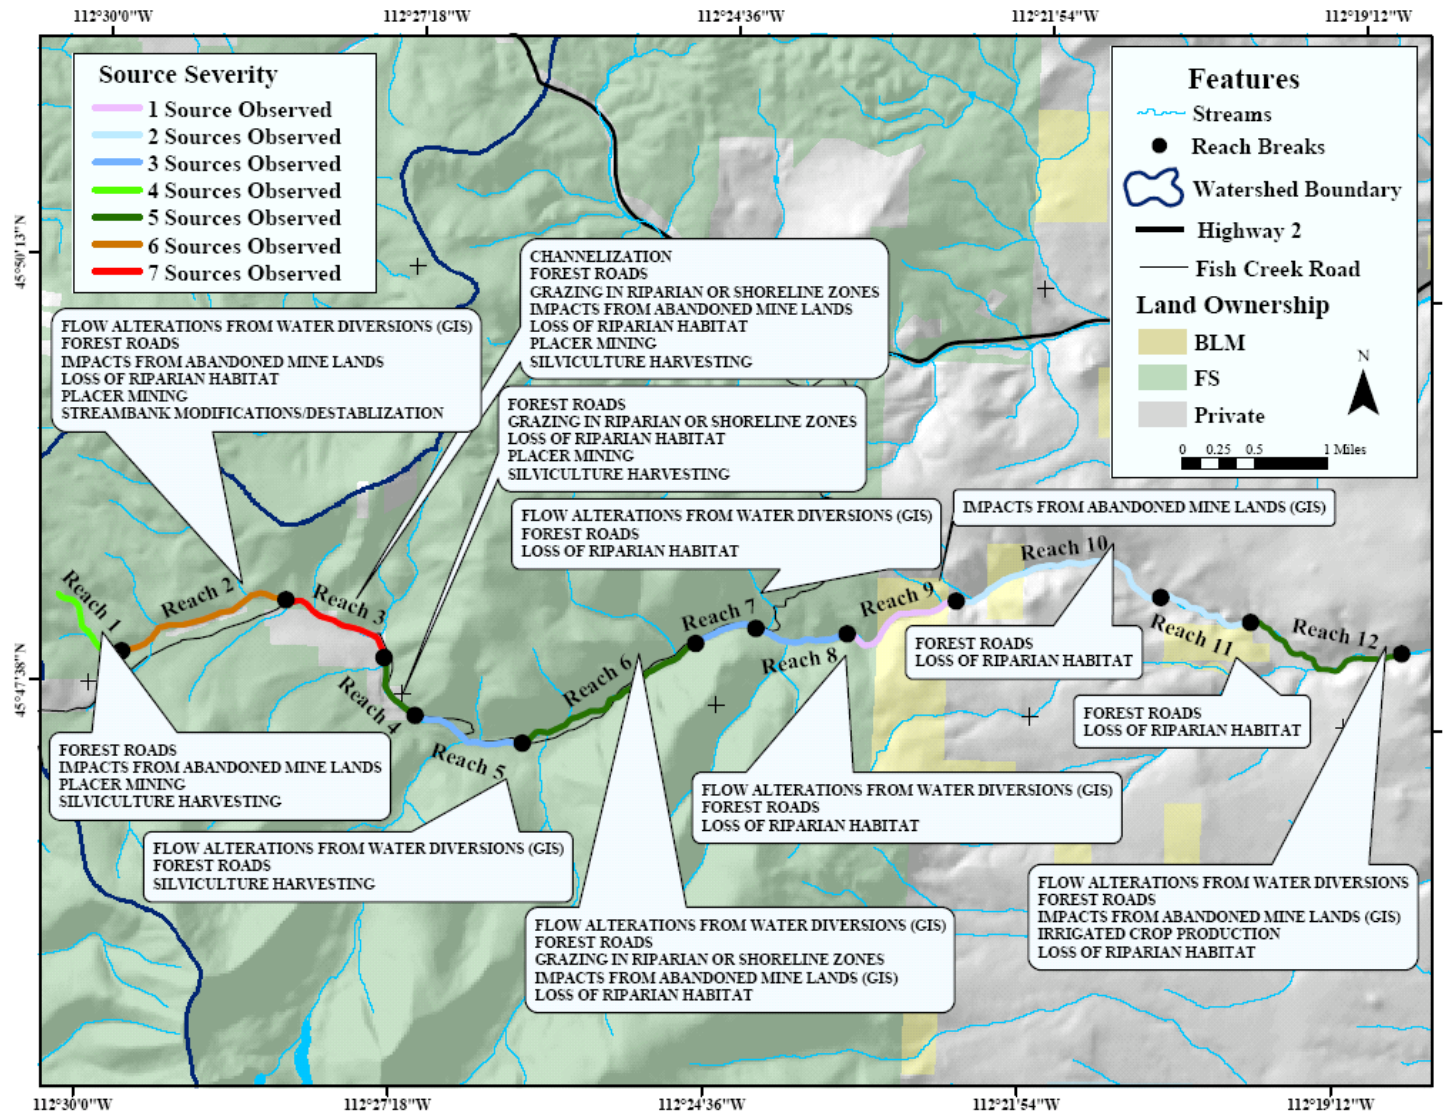
Figure 2-23. Upper Fish Creek Pollution Sources

**Figure 2-23** displays the pollution sources assigned to the upper reaches of Fish Creek. Many pollution sources observed along upper Fish Creek were related to placer mining, riparian grazing, and unpaved roads. In many instances, the sources of flow alterations from water diversions and impacts from abandoned mine lands were taken from GIS layers which located water rights claims and abandoned mines. The GIS identified sources have generally not been field verified. Silviculture harvests before 1983 have occurred upslope from and adjacent to Fish Creek. Any runoff associated with the harvests would enter in Reaches 1 through 5. Harmful effects from this impact were not observed in the field. An interesting observation was made during the field survey that the extreme channel modifications in Reach 4, which have lowered the base level for this reach, actually benefit the creek because a lot of the sediment generated in Reach 3 is not able to flow into Reach 4. There were no significant changes in pollution sources between 1983 and 2001.

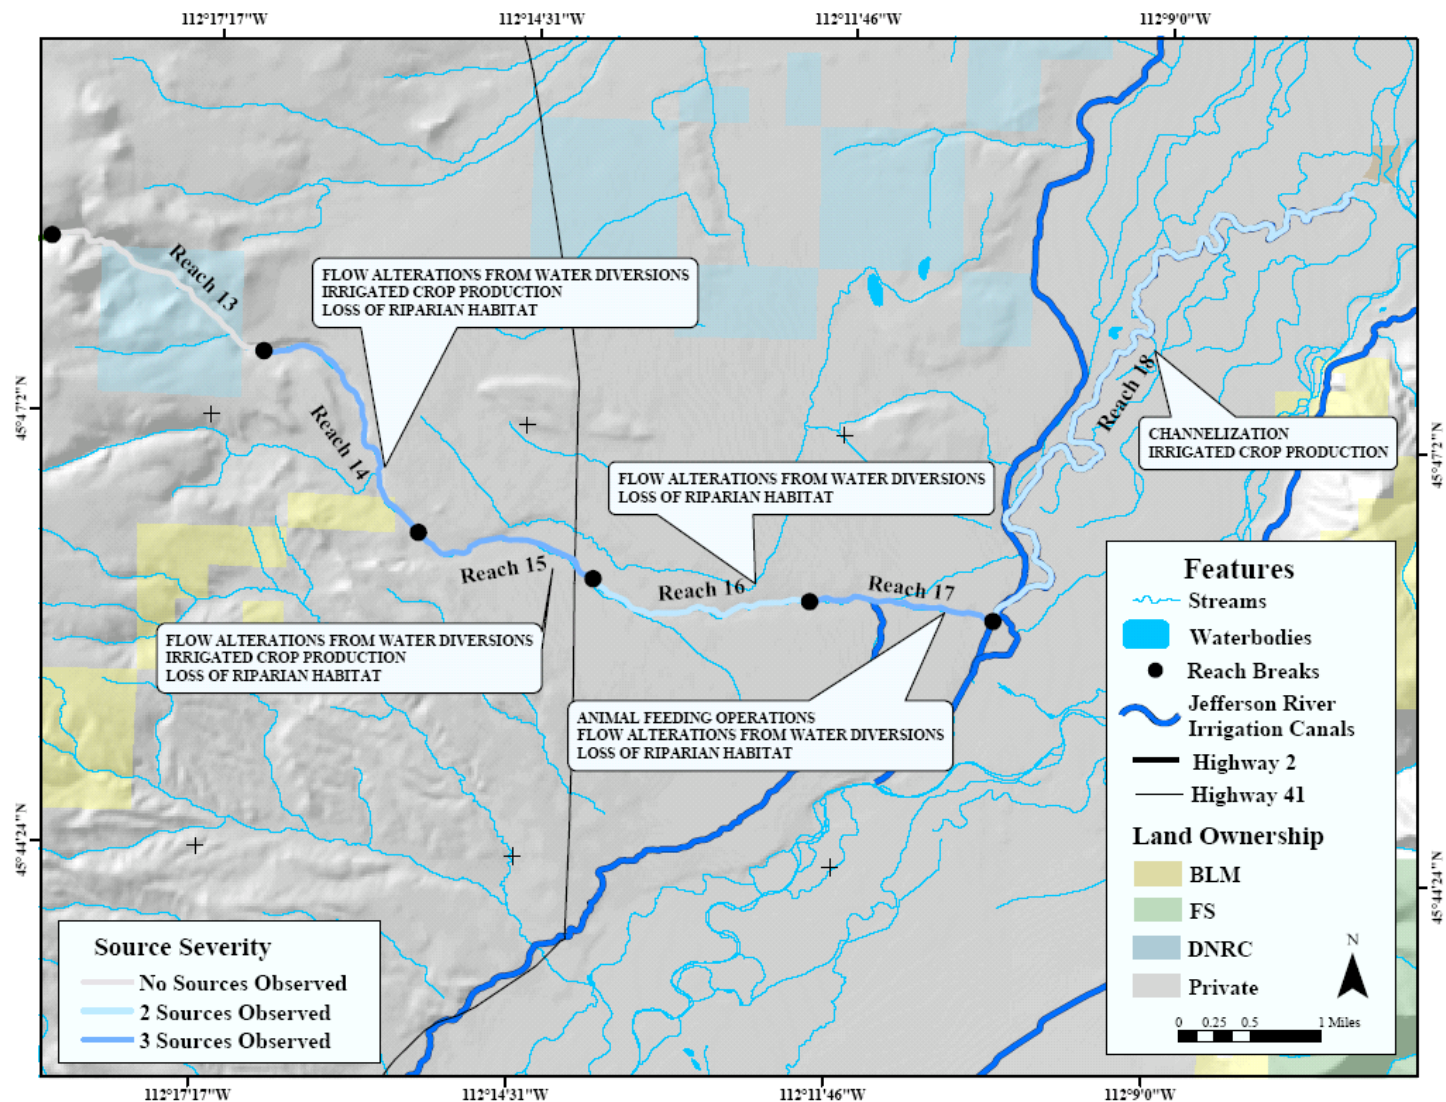
Figure 2-24. Lower Fish Creek Pollution Sources

**Figure 2-24** displays the pollution sources assigned to the lower reaches of Fish Creek. Many pollution sources observed on the aerial photographs for lower Fish Creek were related to agricultural operations (irrigation diversions, cropping, and loss of riparian area). During the field source assessment, active beaver dams were observed in Reach 14. The landowner did not eradicate beavers on the property in order to help to maintain flow levels and soil moisture. Discussions with the landowner revealed that dewatering of the creek results in isolation of a genetically pure westslope cutthroat trout population, which apparently thrives in the reaches above the alluvial fan. For the valley portion of Fish Creek, only one time period was analyzed so significant changes in pollution sources since 1983 were not determined.

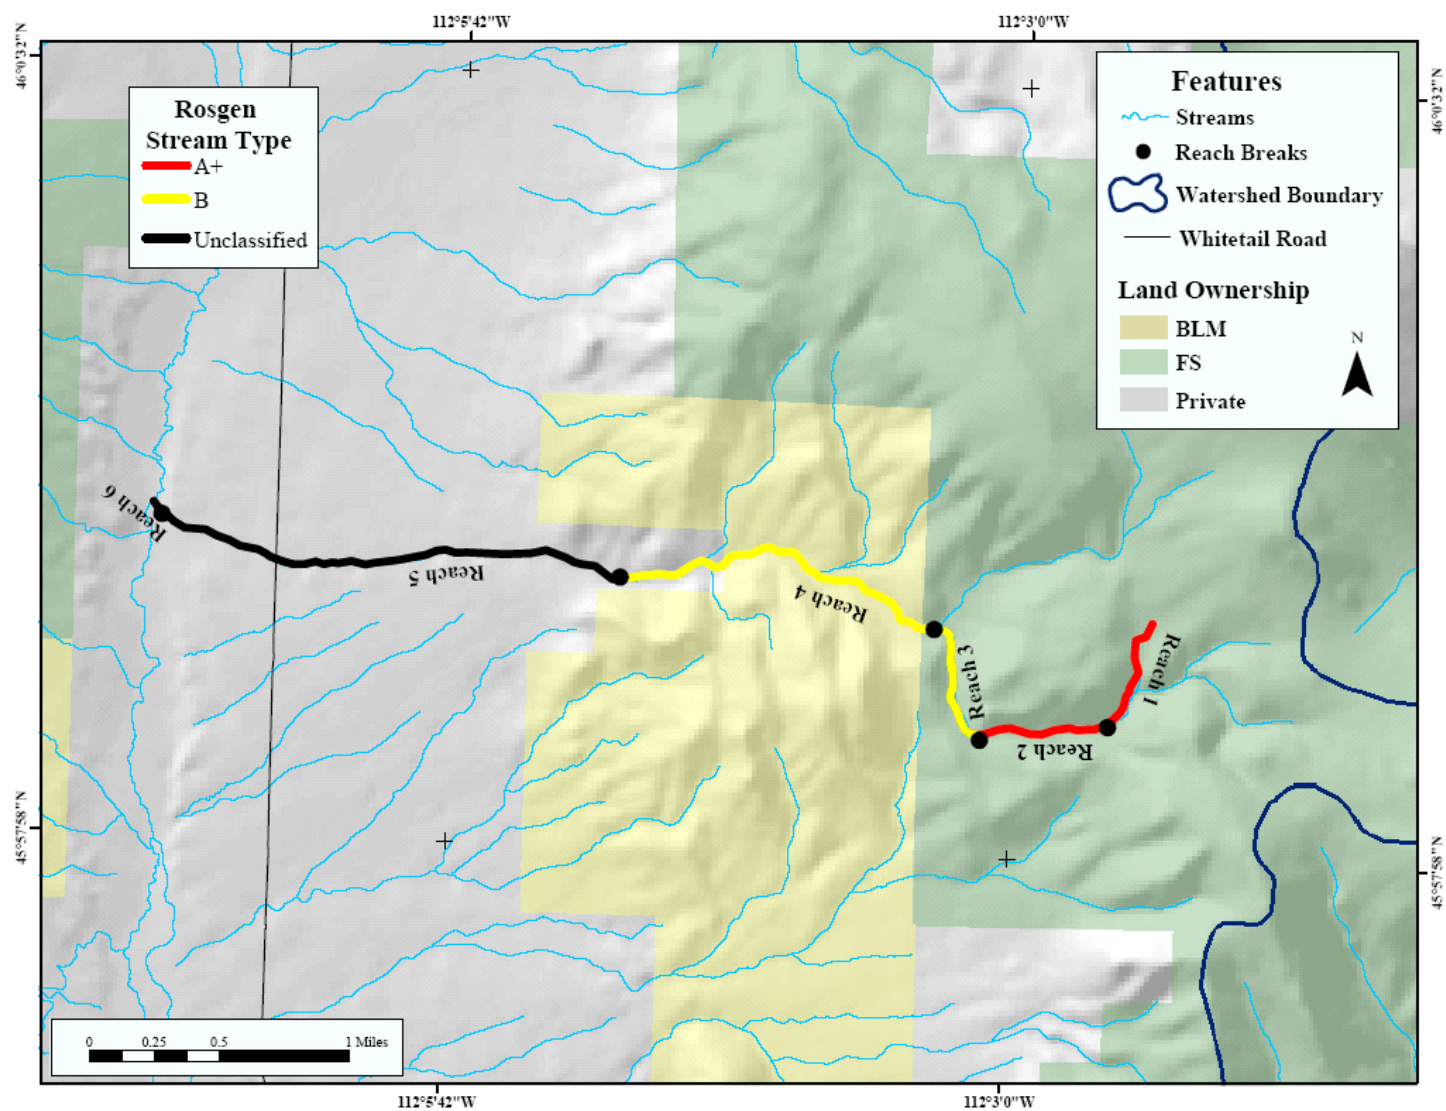
Figure 2-25. Fitz Creek Rosgen Stream Types

The channel forms of Fitz Creek are primarily controlled by landform structure (**Figure 2-25**). The stream headwaters on relatively steep slopes (A-type) and then progresses downstream to more moderate slopes. The valley bottom is fairly confined (B-type reaches) along the canyon and alluvial fan sections, until entering the floodplain of Little Whitetail Creek. The small section of Reach 4 observed in the field appeared to transition from an Eb to B-type channel near the head of the alluvial fan. On the alluvial fan, the stream goes distributary and definition of the main channel was tenuous at best. For this reason, the channel classification for Reach 5 was changed to 'unclassified' after the field review. During the field review, the largest channel walked in, Reach 5 exhibited characteristics of B and mostly G-type channels. Reach 6 was not classified either due to the difficulty of locating the channel on recent photos for this small section of the stream. In 1983, Reaches 3 and 6 were observed as having stream flow. This led to a significant decrease in active channel width between 1983 and 1995.

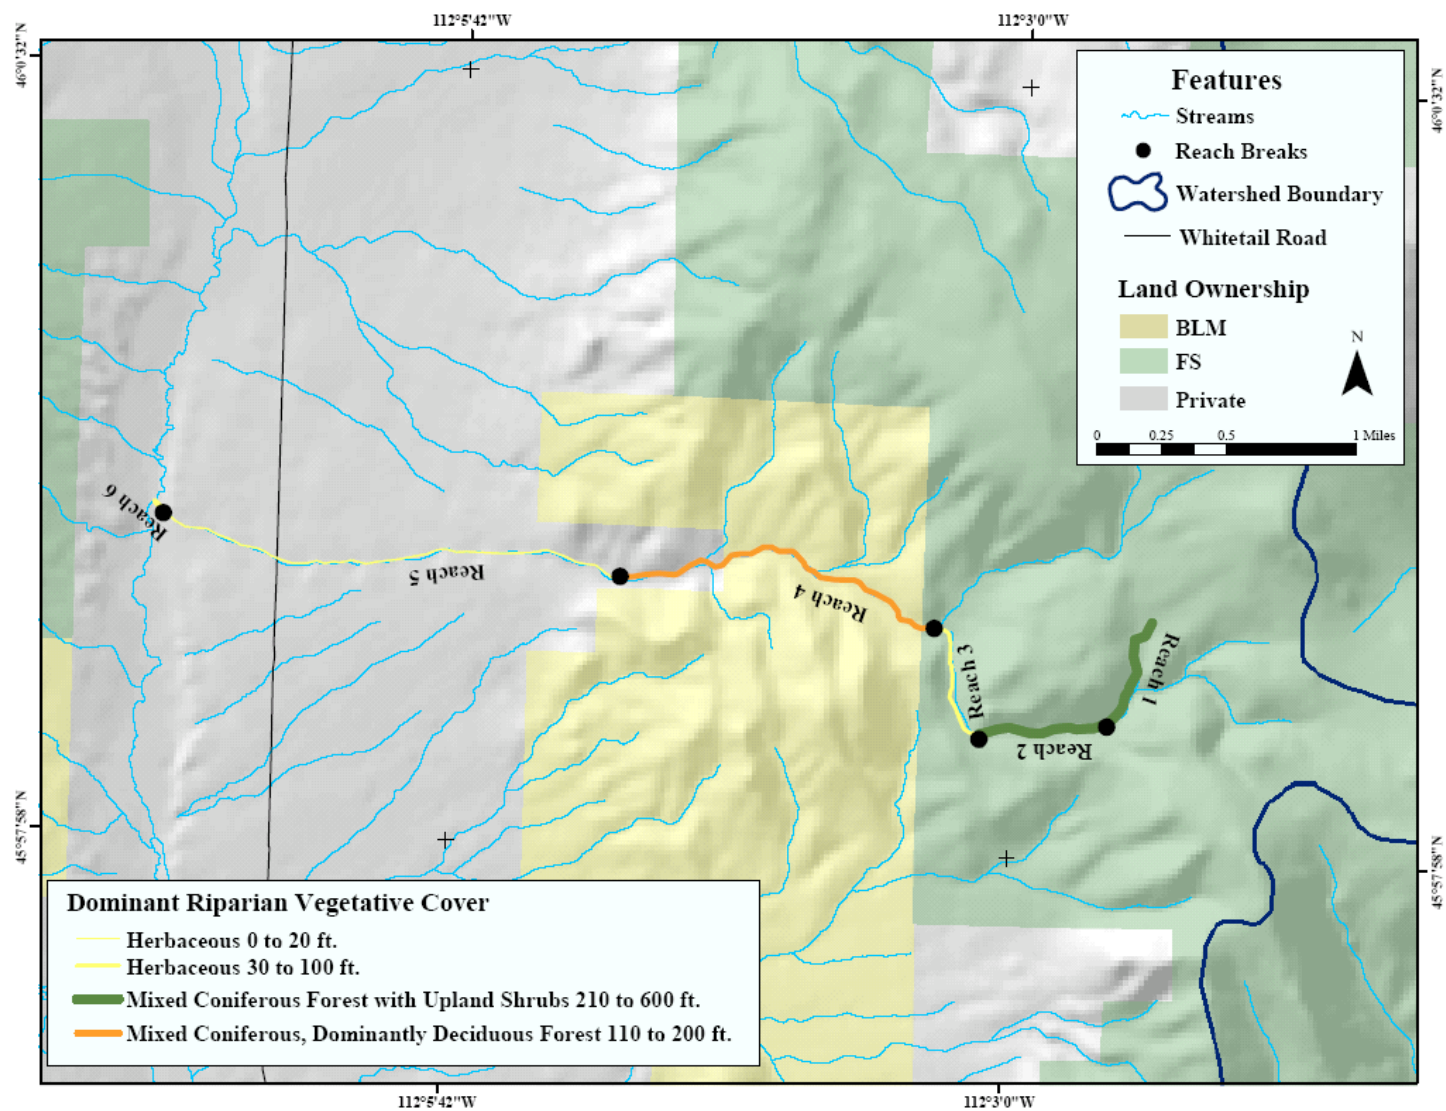
Figure 2-26. Fitz Creek Riparian Vegetation

The dominant riparian cover in the headwaters of Fitz Creek was mixed coniferous forest with upland shrubs (**Figure 2-26**). Buffer widths were generally greater than 300 feet wide along both sides of the stream. The buffer widths represented the distance of vegetation surrounding the stream before any disturbance was observed, as opposed to the actual width of 'wet' vegetation (alders, willows, etc.). The relative health category assigned to Reaches 1 and 2 was: 'Fair', due to the presence of an unpaved road.

The dominant riparian cover along Reach 4 was mixed coniferous, dominantly deciduous forest. Buffer width was generally greater than 50 feet wide along both sides of the stream. The buffer widths represented the distance of vegetation surrounding the stream before any disturbance was observed, or vegetation type changed. Buffer widths were generally limited by valley bottom width. During the field review, aspen, rose, sedges, and grasses were observed in the field. The relative health category assigned to Reach 4 was: 'Fair', due to the presence of an unpaved road. Between 1983 and 2001, the riparian buffer width in Reach 4 appeared to increase by an average of 20 percent.

The dominant riparian cover along the Reaches 3, 5, and 6, was herbaceous, whereby, the grasses or forbs were being grown into the riparian and almost no woody vegetation was present (**Figure 2-26**). The buffer widths of these lower reaches represent the actual width of 'wet' vegetation. Buffer widths were generally less than 10 feet wide along both sides of the stream. The relative health category assigned to all of the reaches was 'Fair'. The riparian area in Reach 5 appeared to be limited by moisture. In 1983, Reaches 3 and 6 were observed as having stream flow. This led to a significant decrease in riparian buffer width between 1983 and 1995.

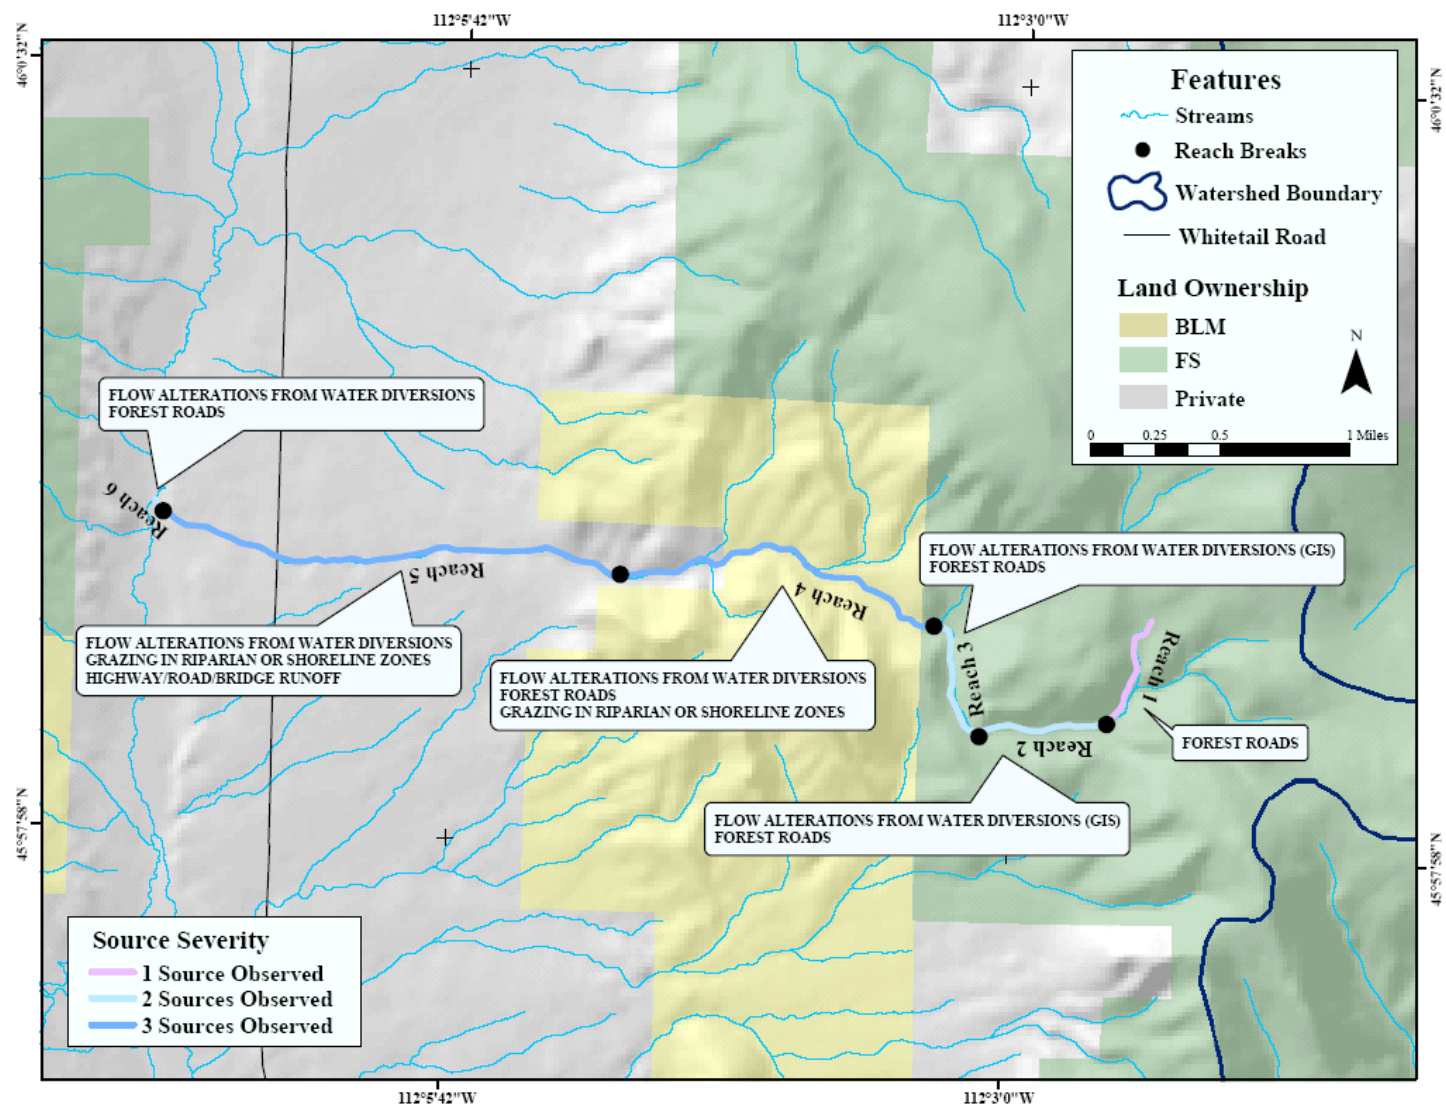
Figure 2-27. Fitz Creek Pollution Sources

**Figure 2-27** displays the pollution sources assigned to Fitz Creek. Most of the pollution sources observed on the aerial photos were related to flow alterations and unpaved roads. In many instances, the source of flow alterations from water diversions was taken from a GIS layer, and was not field verified. Grazing was observed along much of Reach 5, but the impacts were fairly minimal due to the lack of water. During the field source assessment the stream was observed as naturally going dry at the head of the alluvial fan. On the alluvial fan (Reach 5) the stream goes distributary and probably does not carry flow, except during spring runoff and intense rainfall events (fairly characteristic of streams on alluvial fans in arid environments). There were no significant changes in pollution sources between 1983 and 2001.

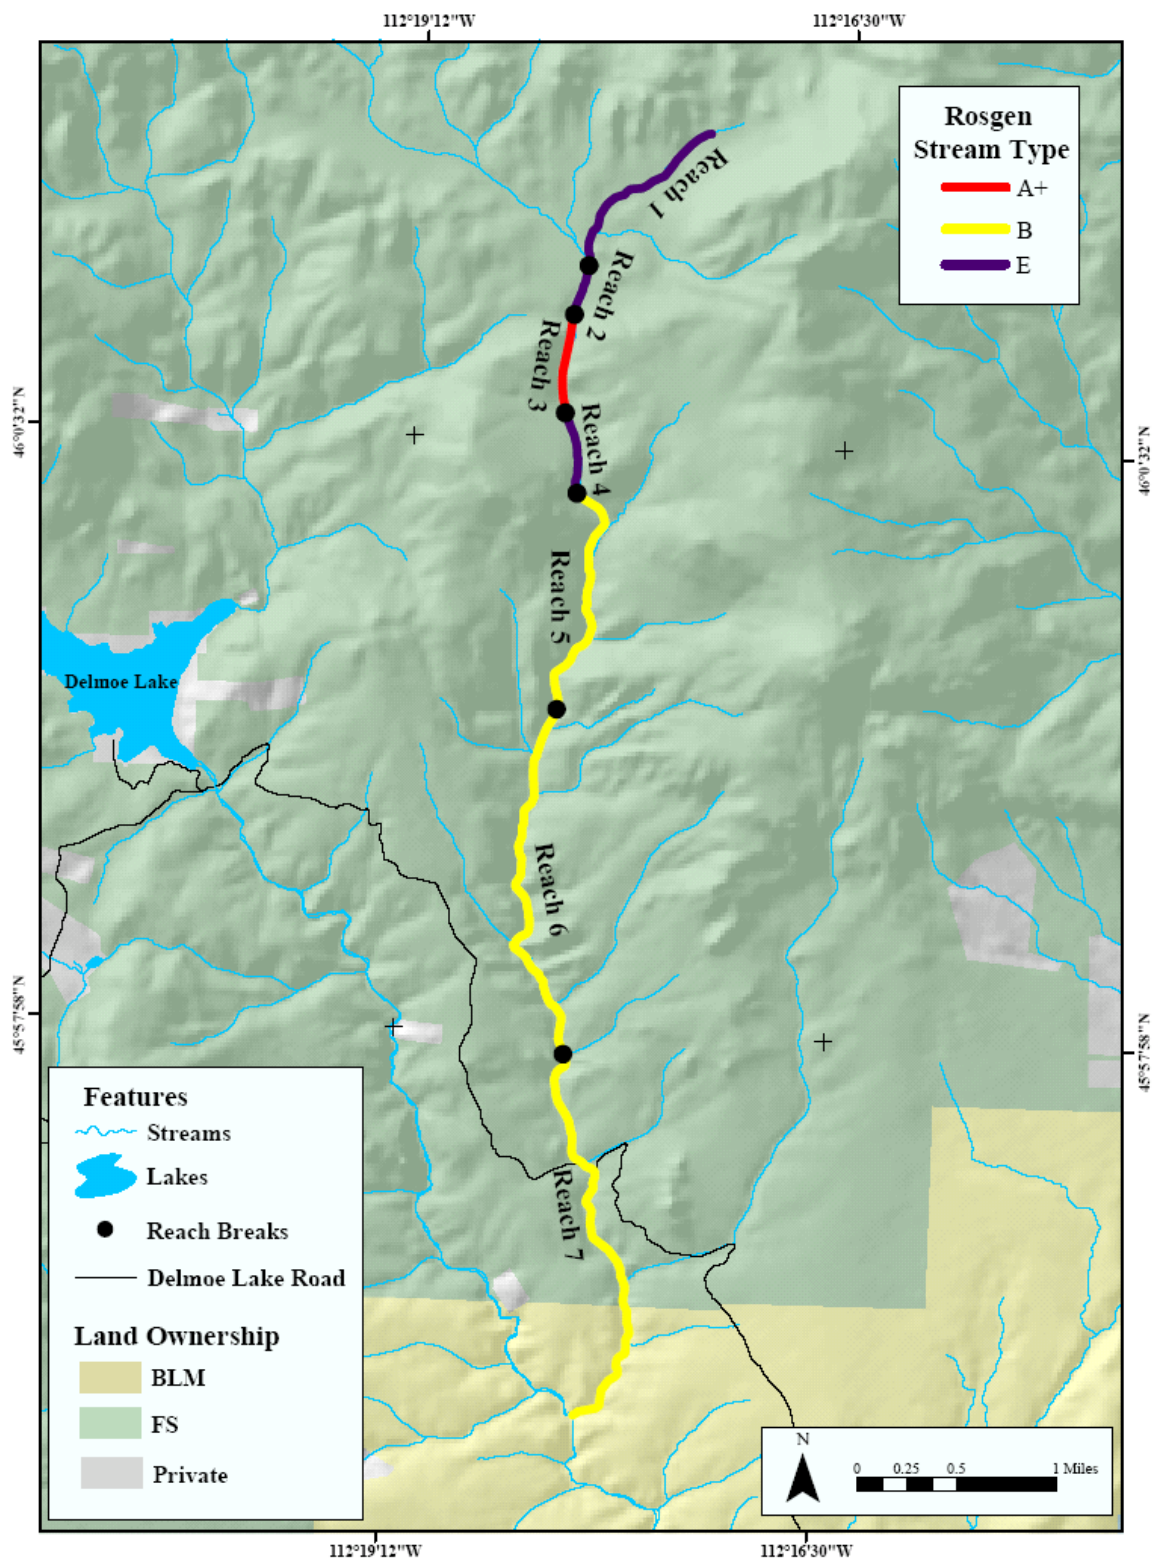
Figure 2-28. Halfway Creek Rosgen Stream Types

The channel forms of Halfway Creek are predominantly controlled by landform structure (**Figure 2-28**). Halfway Park, the headwater area, is a broad wetland meadow with fairly gentle slopes. Channel form here is thought to be an E-type channel. Reach 2 was broken into a separate reach due to an unknown disturbance, which has resulted in a widening of the channel and ponding at the end of the reach. Once the stream leaves Halfway Park, gradient steepens (A-type) and flow is confined to the canyon. From Reaches 4 to 7 the Boulder Batholith geology has weathered into less confined valley bottom sections (Ea and Eb-type reaches), as well as narrow valley bottom areas (B-type reaches). A portion of Reach 6 viewed during the field survey exhibited a B-type channel, with some sections trending toward Eb form. The portion of Reach 7 viewed in the field exhibited a slightly incised, B-type channel. There were no significant changes in channel form between 1983 and 2001.
