**APPENDIX C**  
**2004 AERIAL PHOTO REVIEW AND FIELD SOURCE ASSESSMENT,**  
**UPPER JEFFERSON RIVER WATERSHED**

### **1.1 Upper Jefferson Watershed 2004 Aerial Photo Review and Field Source Assessment**

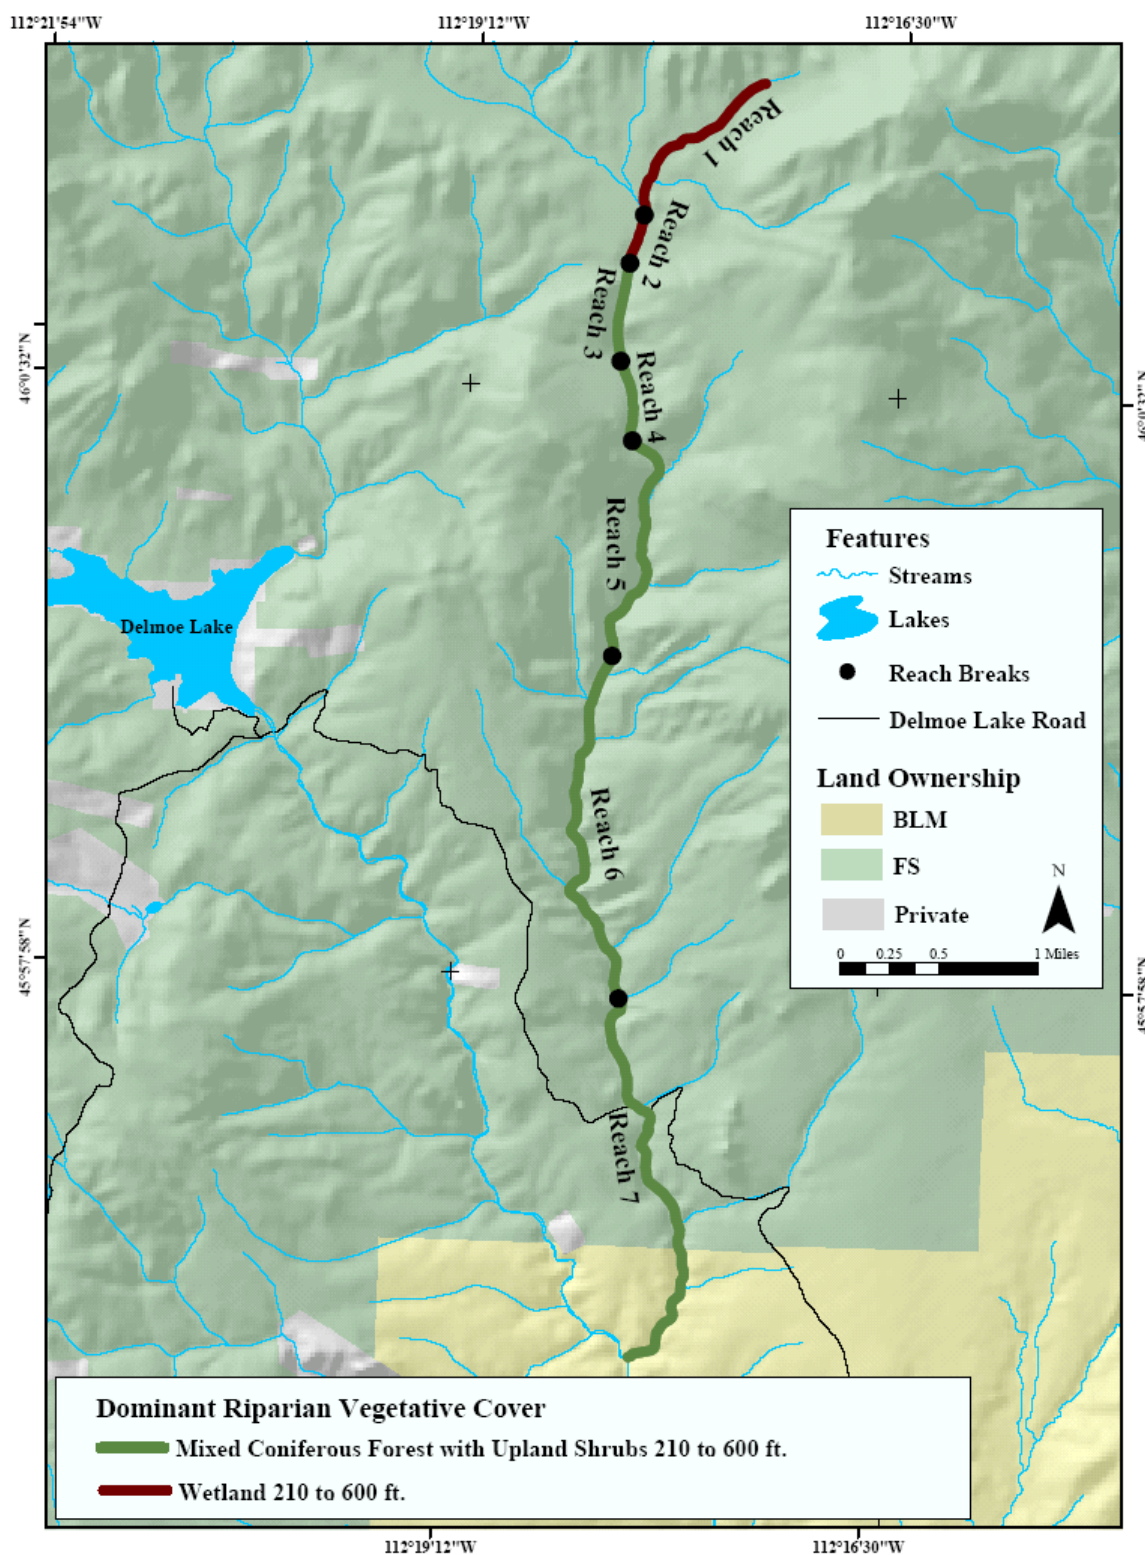
Figure 2-29. Halfway Creek Riparian Vegetation

The dominant riparian cover along Halfway Creek in the headwaters was wetland, while the canyon sections were predominantly mixed coniferous forest with upland shrubs (**Figure 2-29**). The headwater wetland buffer widths were generally greater than 100 feet wide along both sides of the stream. The wetland buffer widths represented the distance of vegetation surrounding the stream before any disturbance was observed, and included some area of mixed coniferous forest with upland shrubs. The relative health category assigned to the wetland dominated reaches was 'Fair', due to disturbance from unpaved roads. Mixed coniferous forest buffer widths were generally greater than 200 feet wide along both sides of the stream. GIS layers indicated that no roads exist from Reaches 3 to 5. During the field observation of Reaches 6 and 7, unpaved ATV/motorcycle trails were observed less than 100 feet from the stream, but often were not visible on the aerial photos. During the field review, alder, willows, red osier, rose, current, sedges, and grasses were noted as extending to a maximum of 40 feet from the channel within the conifer forest. The relative health category assigned to the mixed coniferous forest dominated reaches was 'Excellent' in Reaches 3 to 6, but 'Fair' in Reach 7 due to disturbance from unpaved roads. Some areas of thistle and mullein infestation were present. Between 1983 and 2001, the riparian buffer widths in Reaches 6 and 7 appeared to increase by an average of 30 percent and 15 percent respectively.

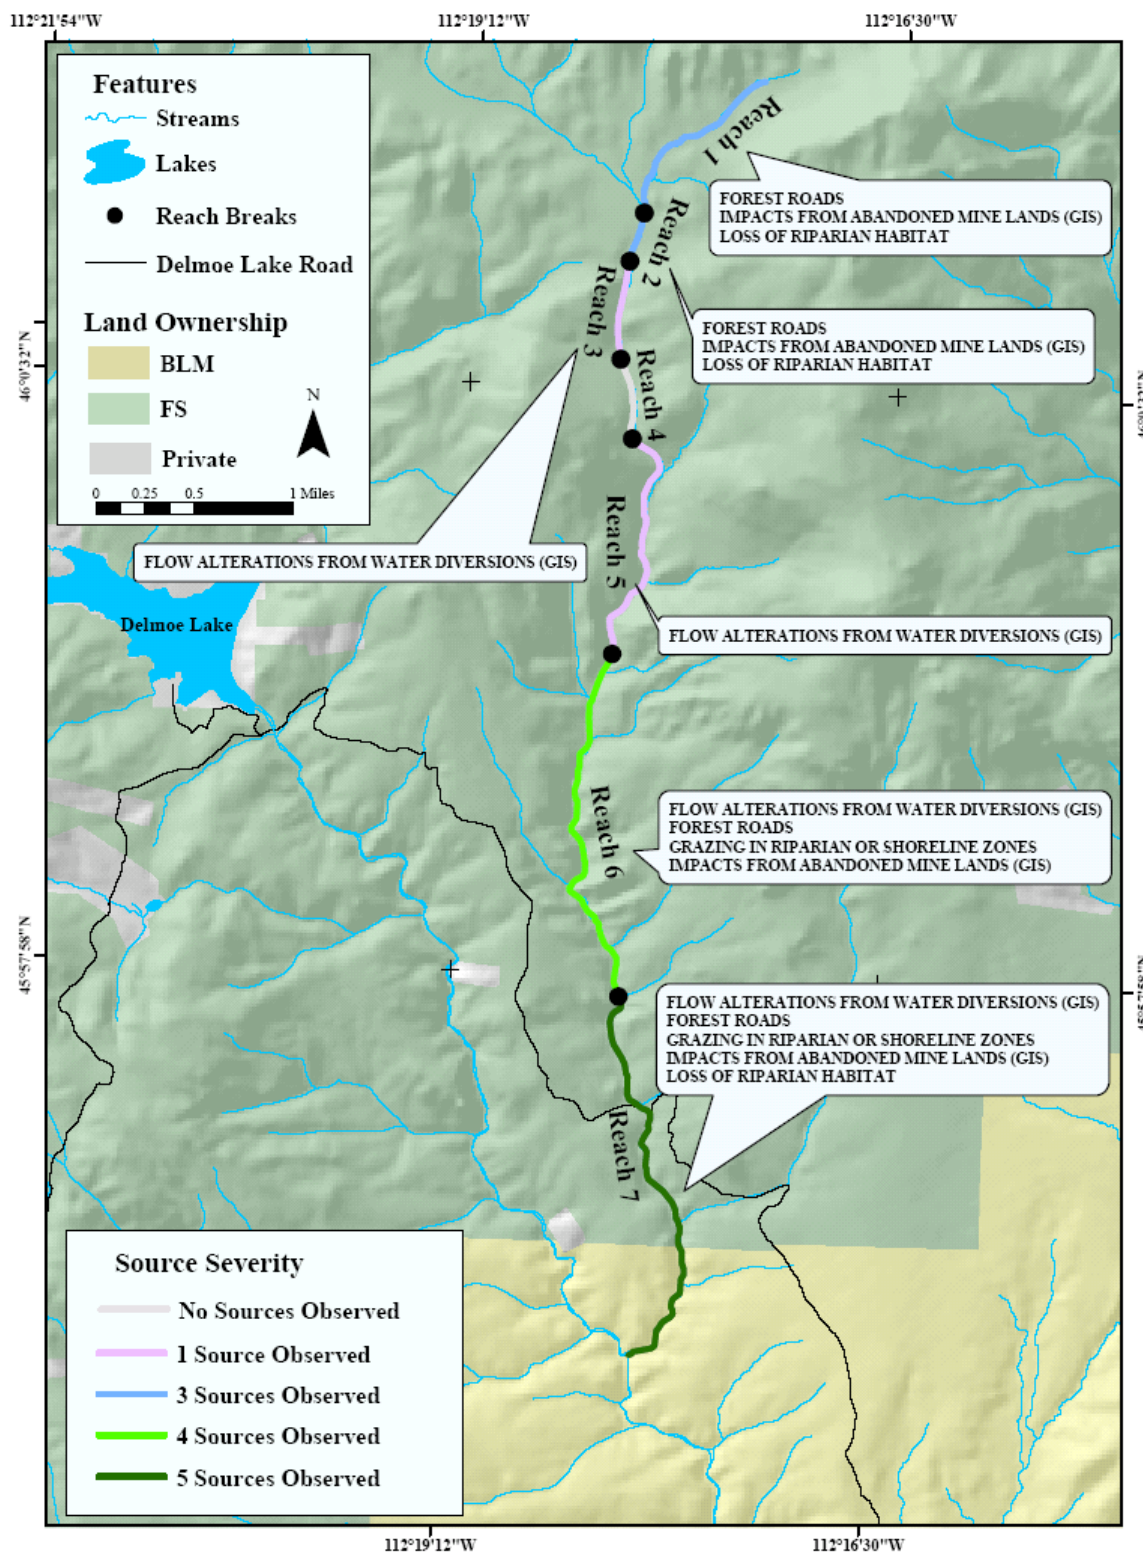
Figure 2-30. Halfway Creek Pollution Sources

**Figure 2-30** displays the pollution sources assigned to Halfway Creek. The sources of flow alterations from water diversions and impacts from abandoned mine lands were taken from GIS layers which located water rights claims and abandoned mines. The GIS identified sources have not been field verified. Loss of riparian habitat was associated with road development and grazing. Many pollution sources observed along Halfway Creek were related to riparian grazing and unpaved roads and trails (overwidened channel, bank erosion, loss of vegetation). During the field source assessment, channel condition appeared to degrade in a downstream manner. There were no significant changes in pollution sources between 1983 and 2001.

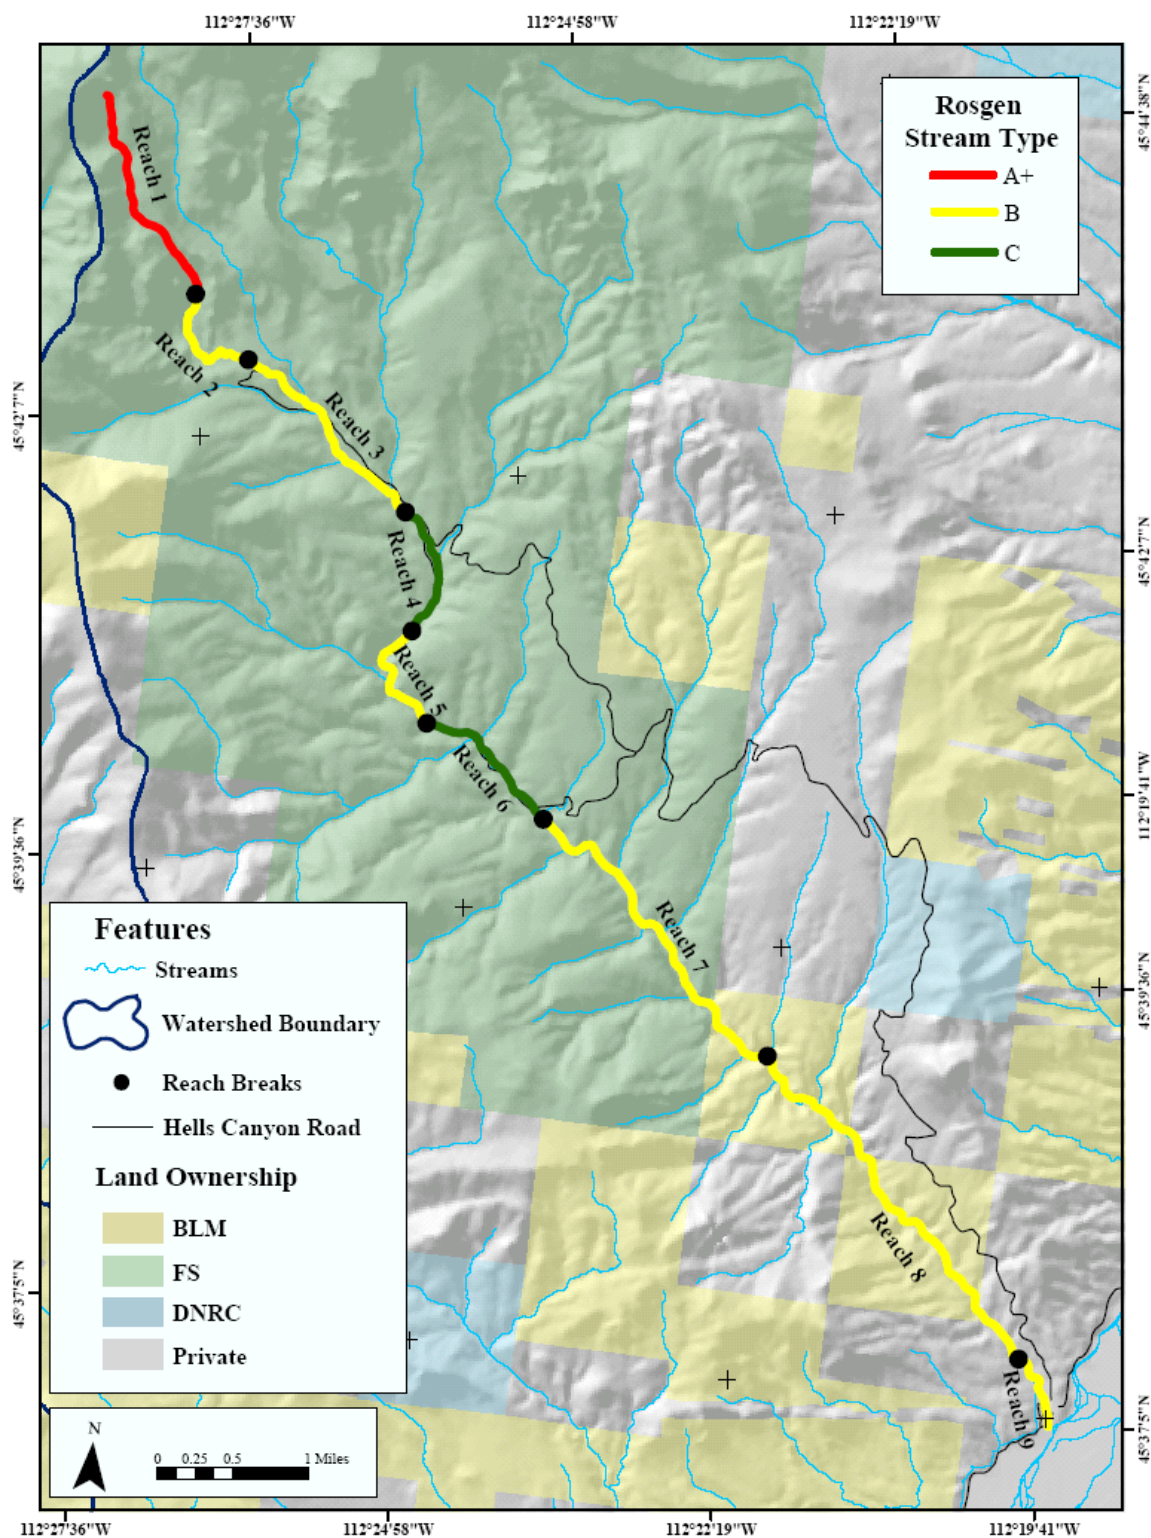
Figure 2-31. Hells Canyon Creek Rosgen Stream Types

The channel forms of Hells Canyon Creek are predominantly controlled by landform structure, as well as historic and current land uses (**Figure 2-31**). The prominent landform geology, the Boulder Batholith, has resulted in valley bottom formation along weathered joints. The stream headwaters on steep slopes (A-type) and then progresses downstream to more moderate slopes. The canyon valley bottom alternates between confined (B-type) and unconfined sections (C-type). In Reach 9, the stream is also fairly confined within the alluvial fan until reaching the floodplain of the Jefferson River. The portion of Reach 4 viewed during the field survey exhibited C and Bc channel types. Reach 5 exhibited a B-type channel. The portion of Reach 6 viewed in the field exhibited C, Bc, and B-type channel sections. Remnants of beaver dams were observed in Reach 4 and Reach 6. It is suspected that the removal of beaver dams has altered channel form (straightened, incised), and that channel type would probably have naturally trended towards an E-type stream in these reaches. The section of Reach 9 surveyed exhibited a somewhat incised B-type channel on the alluvial fan but was unconfined at the mouth. There was one significant difference in channel measurements between 1983 and 2001. For the 1983 analysis a series of ponds were visible in Reach 2, but in 2001 no ponds were visible.

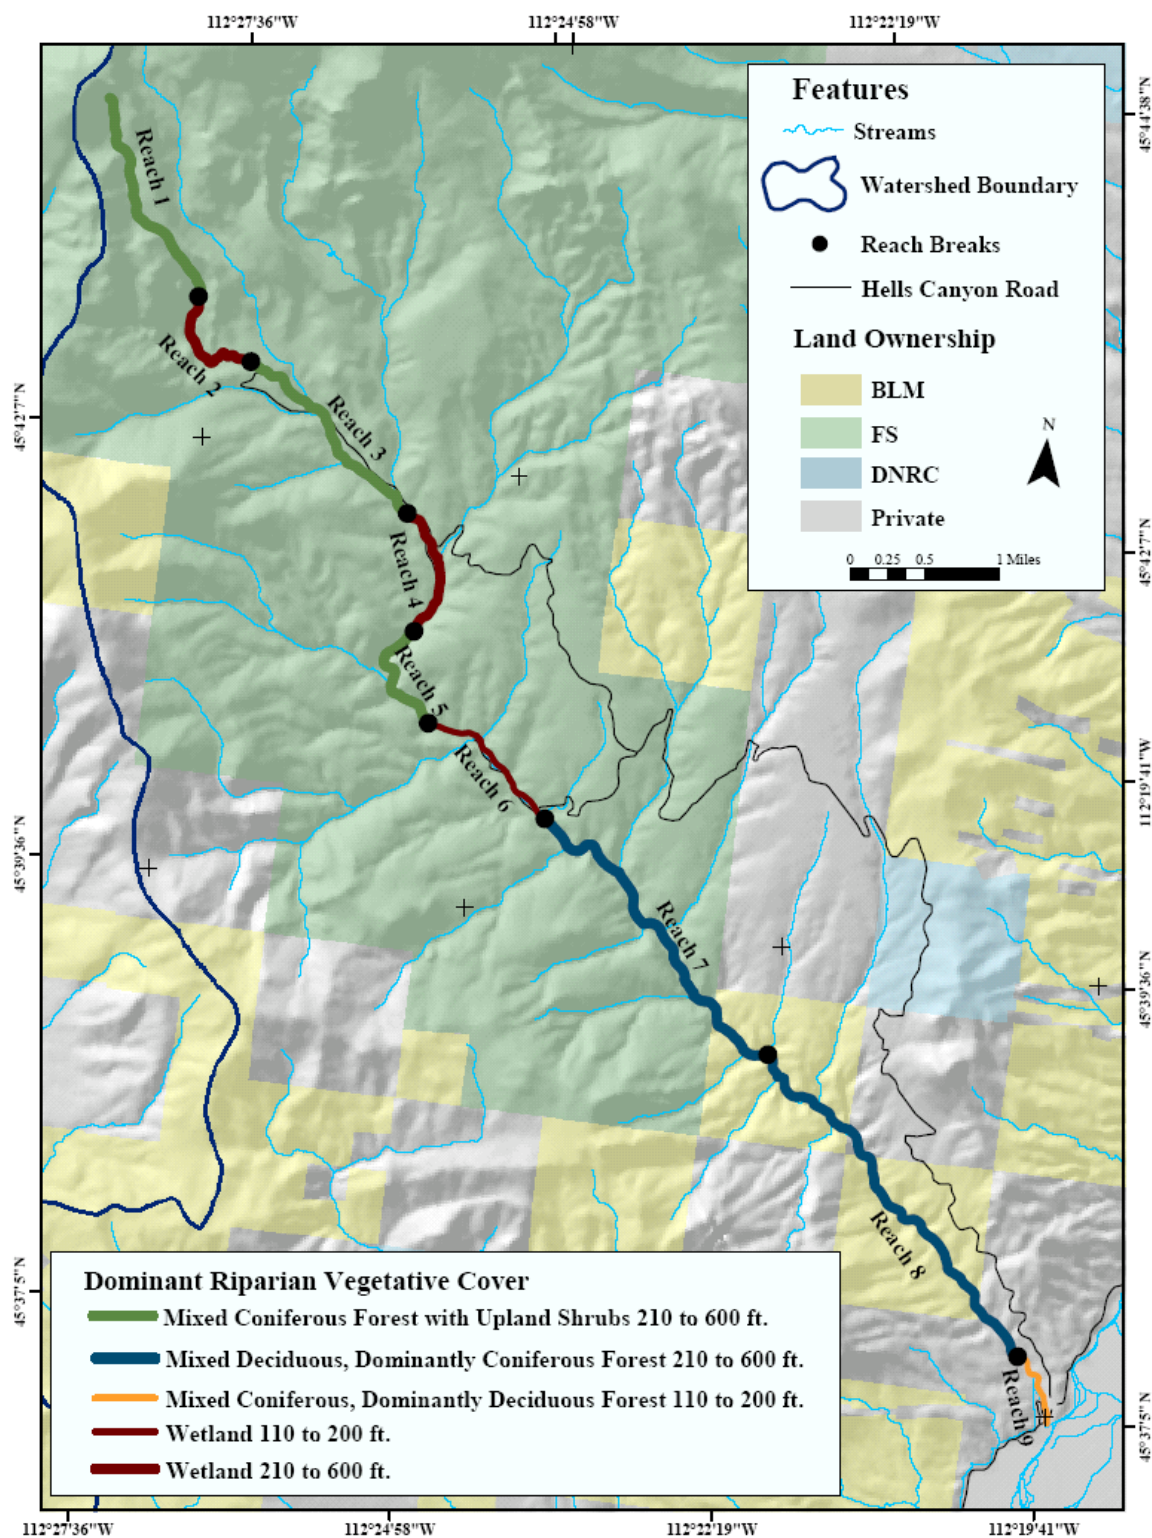
Figure 2-32. Hells Canyon Creek Riparian Vegetation

The dominant riparian cover along the alluvial fan (Reach 9) portion of Hells Canyon Creek was mixed coniferous, dominantly deciduous forest (**Figure 2-32**). Buffer width was generally less than 50 feet wide along both sides of the stream. The relative health category assigned to Reach 9 was 'Fair' due to development near the floodplain. During the field review, cottonwood (with some runners), willows, alder, rose, and grasses were noted as extending generally to a maximum of 40 feet from the channel. Thistles were also present. Between 1983 and 2001, the riparian buffer width in Reach 9 appeared to increase by an average of 15 percent.

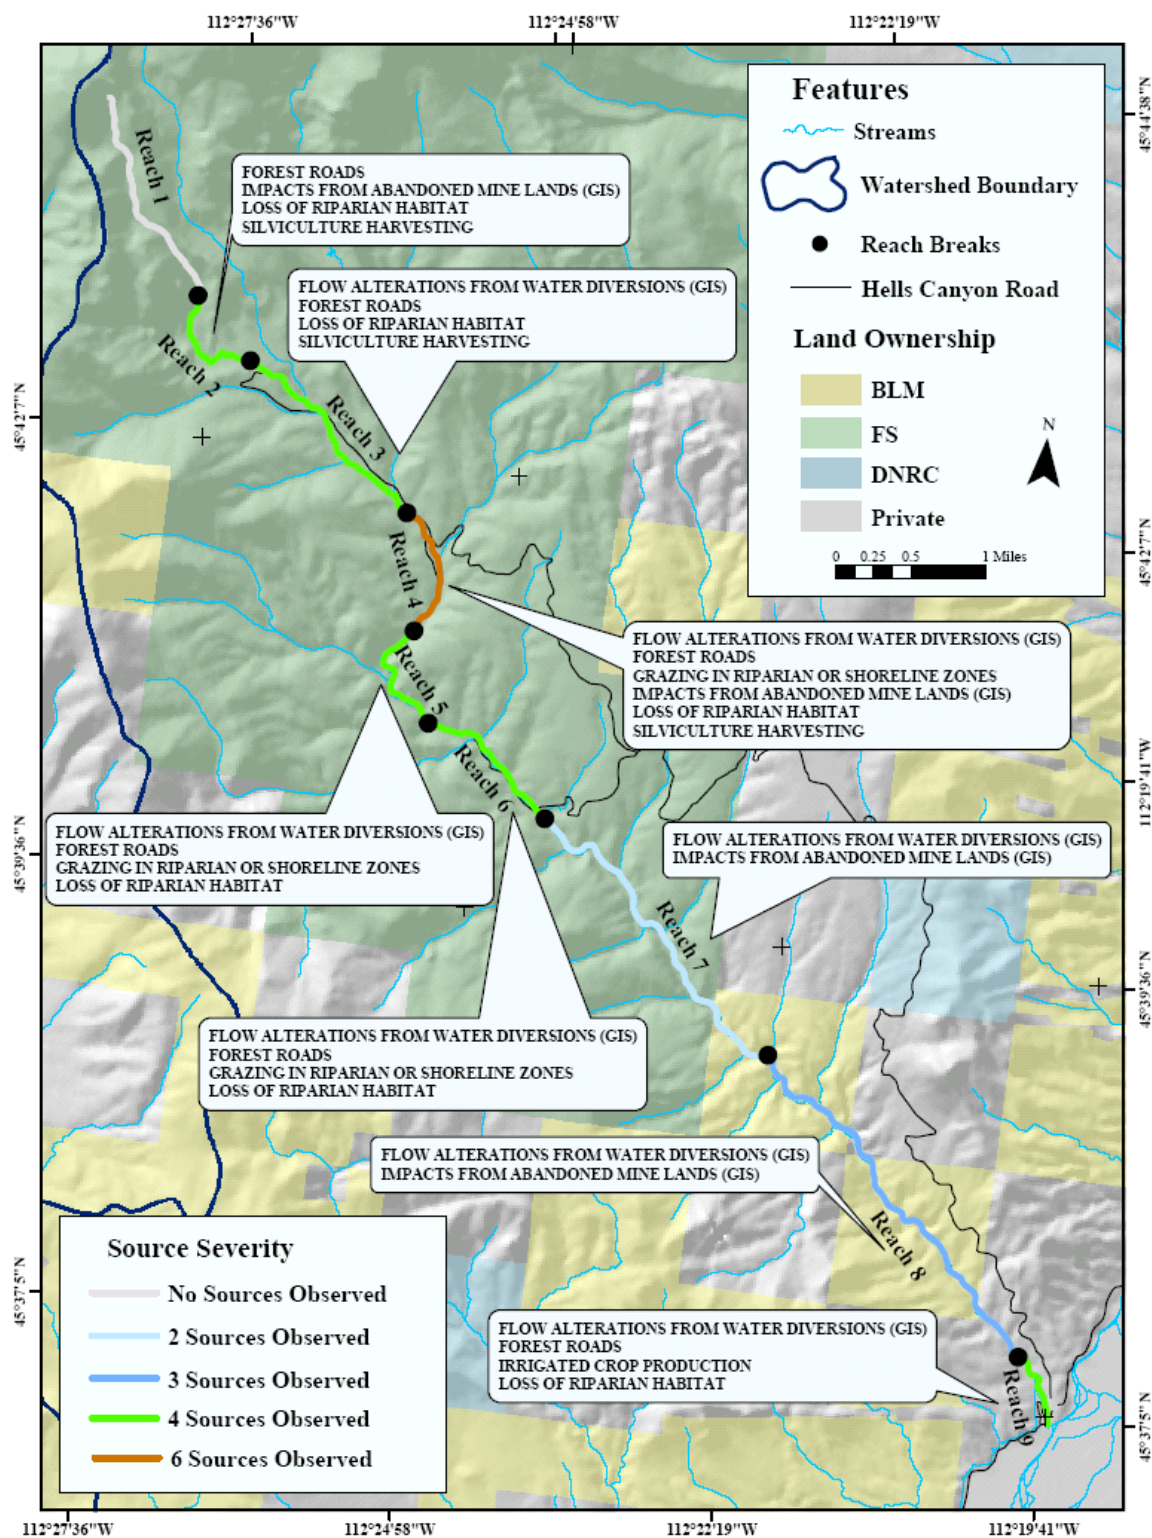
Figure 2-33. Hells Canyon Creek Pollution Sources

**Figure 2-33** displays the pollution sources assigned to Hells Canyon Creek. Most pollution sources observed along upper Hells Canyon Creek were related to riparian grazing and unpaved roads. The sources of flow alterations from water diversions and impacts from abandoned mine lands were taken from GIS layers which located water rights claims and abandoned mines. The GIS identified sources were not field verified. Silviculture harvests occurred before 1983, upslope from and adjacent to Hells Canyon Creek. Any runoff associated with the harvests would enter in Reaches 2 through 4. Harmful effects from this impact were not observed in the field. Loss of riparian habitat was generally associated with road development and grazing. There were no significant changes in pollution sources between 1983 and 2001.

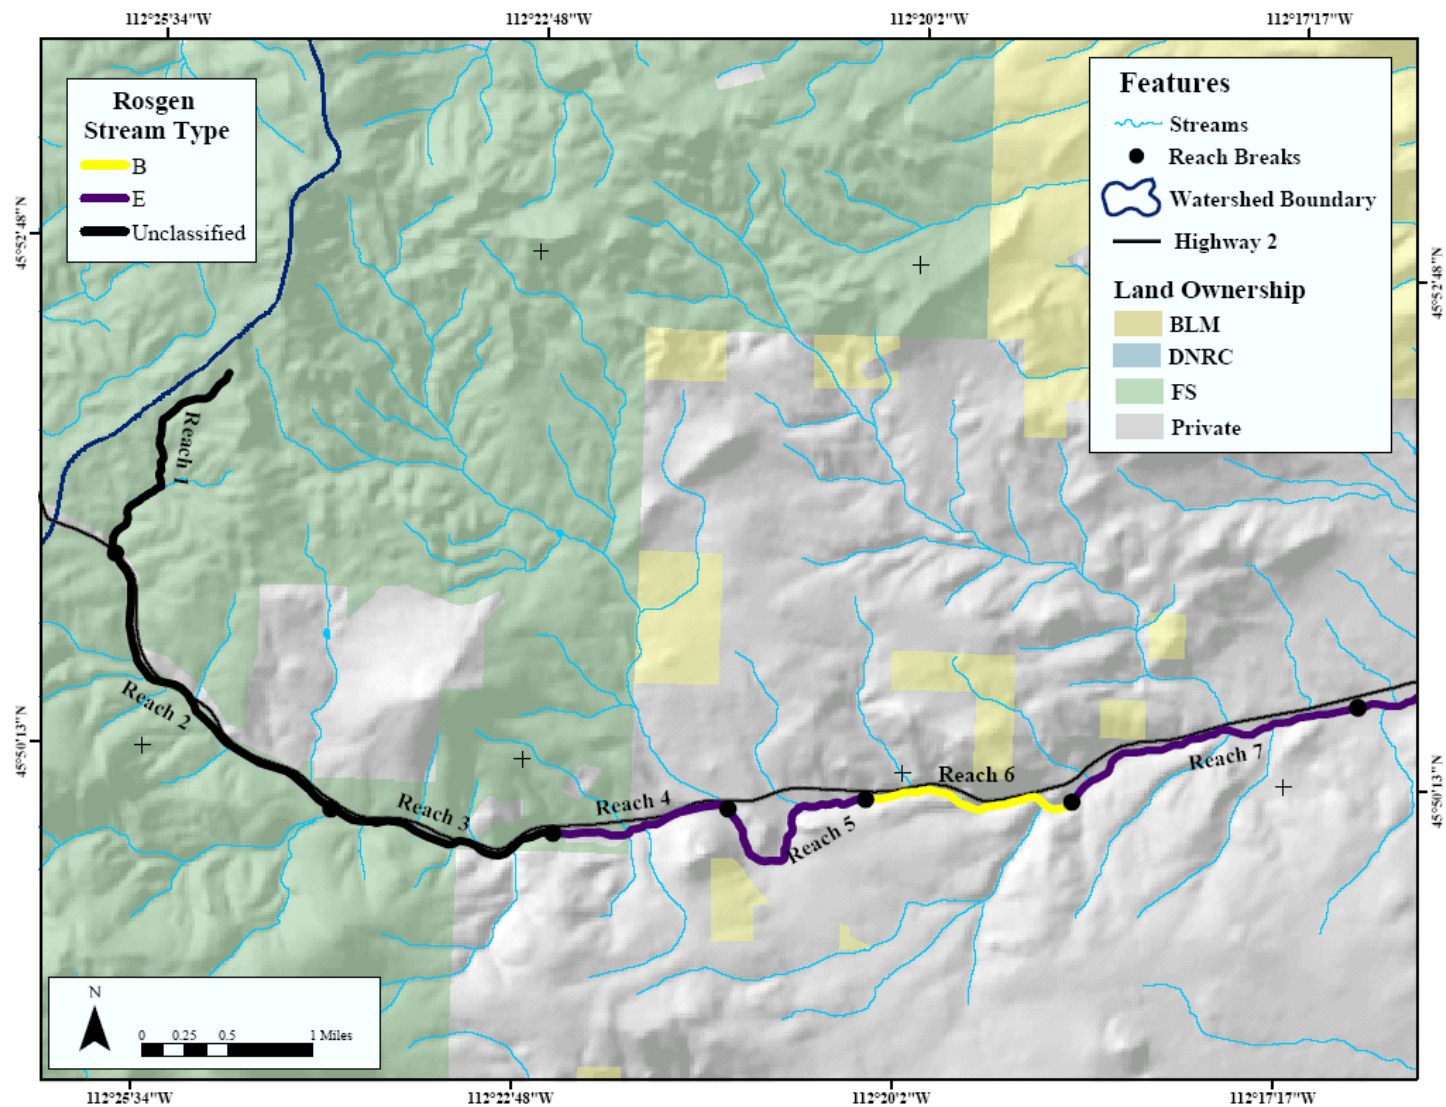
Figure 2-34. Upper Little Pipestone Creek Rosgen Stream Types

The channel forms of Upper Little Pipestone Creek are predominantly controlled by landform structure, as well as historical and current landuse activities (**Figure 2-34**). The channel forms of Little Pipestone Creek in Reaches 1 to 3 were difficult to type in areas because of channelization and grazing impacts. As well during the aerial review, the channel was not visible until Reach 4. For these reasons, the channel classifications for Reaches 1, 2, and 3 were changed to 'unclassified' after the field review. The area surveyed in Reach 1 was more of a flooded wet meadow than an actual stream. There were ponded areas from earthen dams, and some areas of multiple threads with E-type channel characteristics. Reach 2 was affected by channelization between Highway 2 and the railway. Channel forms observed in Reach 2 were characteristic of E and mostly G-type streams. The portion of Reach 3 observed in the field trended from an Eb to a B-type channel. The channel was less confined in Reaches 4, 5, and 7, and was thought to have characteristics on an E-type channel. Structural controls in Reach 6 led to the classification of a B-type reach. The Boulder Batholith is the prominent geology of the upper reaches. There were no significant changes in channel form between 1983 and 2001.

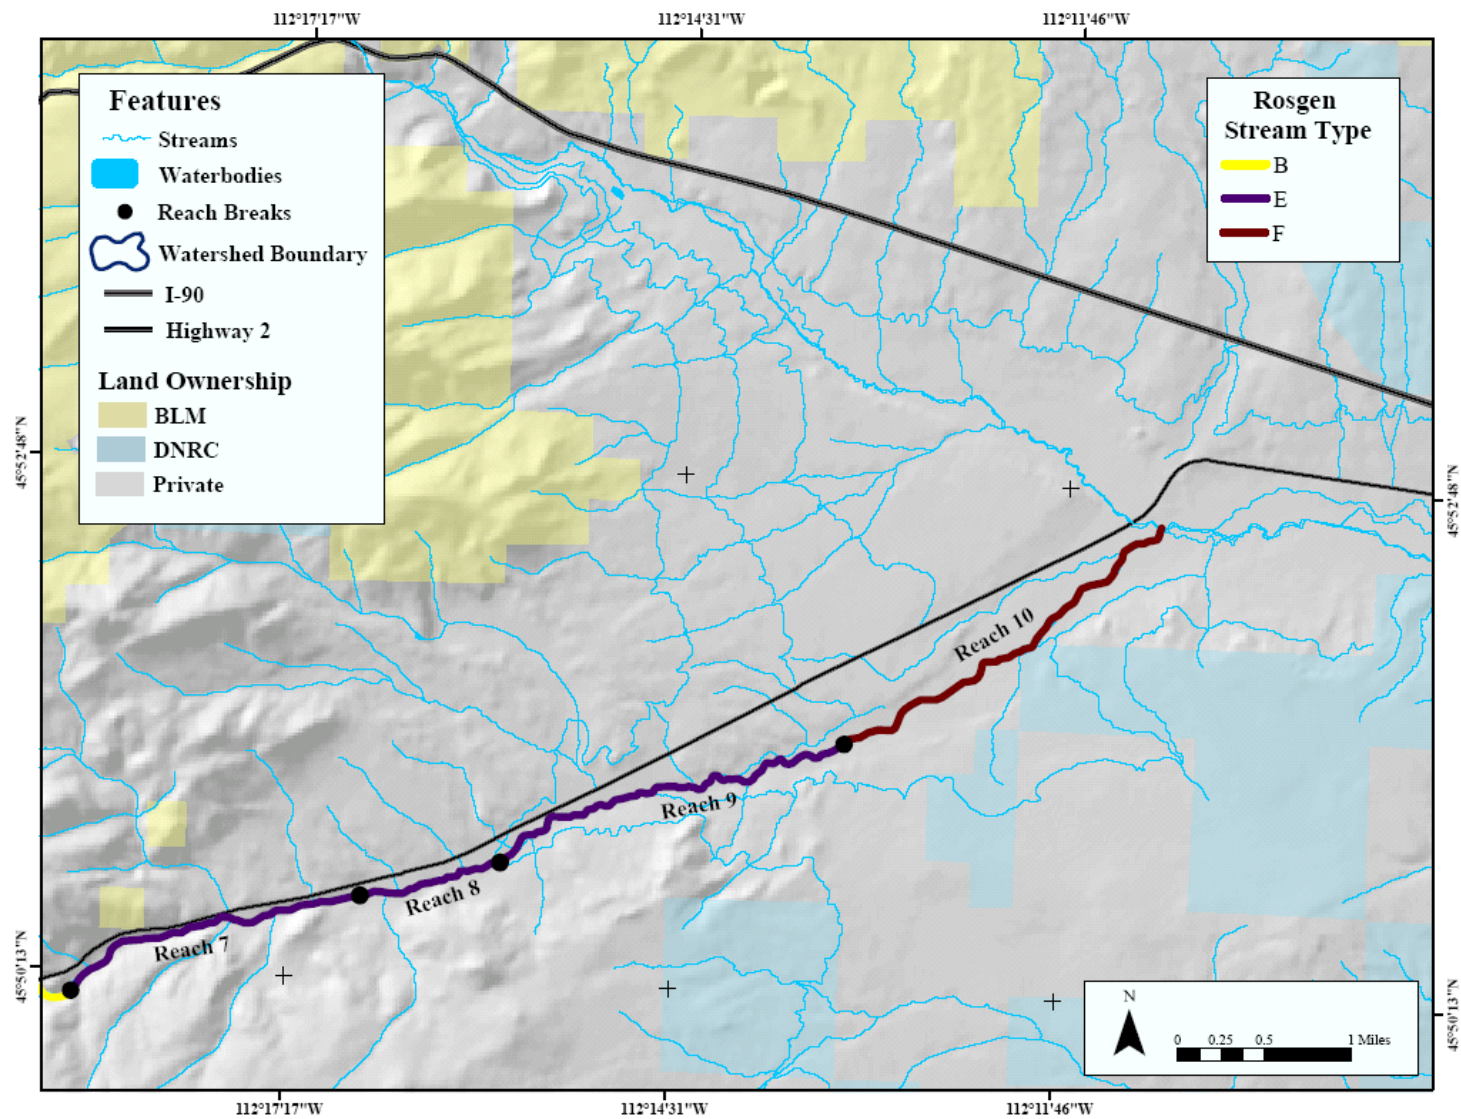
Figure 2-35. Lower Little Pipestone Creek Rosgen Stream Types

The channel forms of Lower Little Pipestone Creek are also predominantly controlled by landform structure, and historical and current landuse activities (**Figure 2-35**). The predominant valley type (VIII) would typically result in an unconfined stream type (C or E), yet channel alterations have resulted in stream types out of balance with the valley type (directly observed in Reach 10). The small section of Reach 8 viewed in the field exhibited E-type channel characteristics. Active beaver dams were observed on the creek above Highway 41 in this reach. It is suspected that channel form in Reach 9 could possibly be an F-type due to the Delmoe Ditch irrigation diversion and disruption of riparian habitat in this reach. Observed channel forms in Reach 10 were variable, but an overall classification of F-type was given to this reach. Areas of braiding were observed, along with overwidened sections, as well as a large downcut section. For the lower portion of Little Pipestone Creek, only one time period was analyzed so significant changes in channel form since 1983 could not be determined.

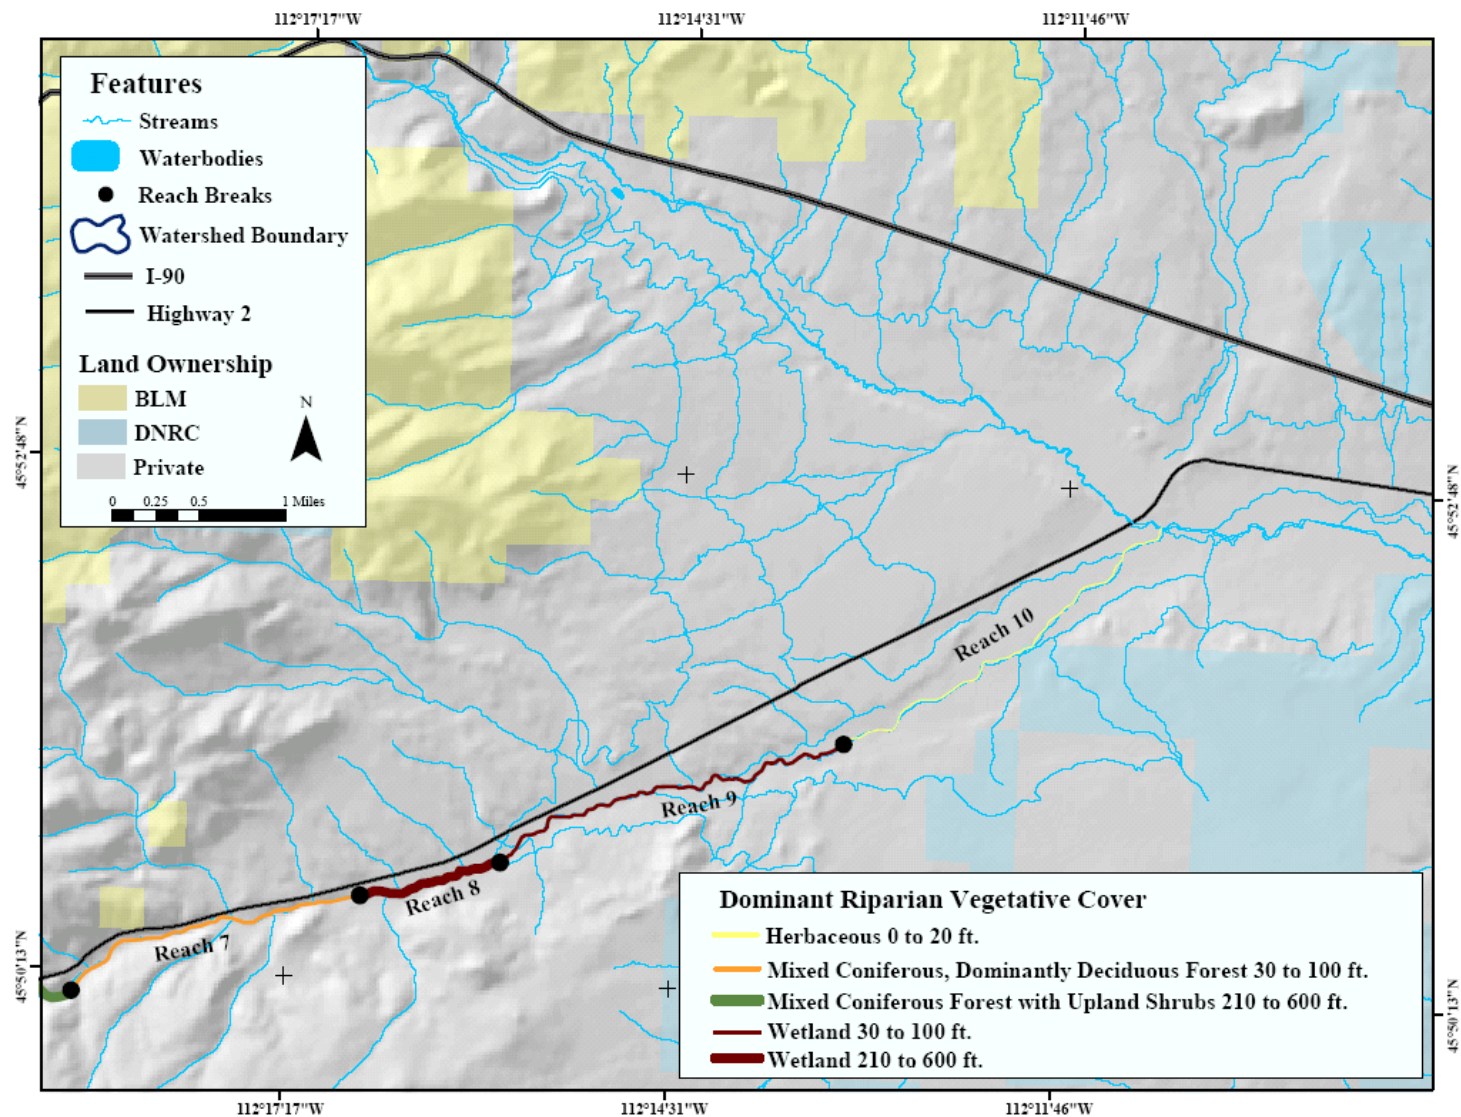
Figure 2-37. Lower Little Pipestone Creek Riparian Vegetation

Riparian vegetative cover along Lower Little Pipestone Creek progressed from predominantly deciduous, to wetland, to herbaceous (**Figure 2-37**). Buffer widths were generally less than 50 feet wide along both sides of the stream, except for in Reach 8. The relative health category assigned to the lower reaches progressed from 'Fair' to 'Poor' in a downstream manner. During the field review, decadent hedged willows and sedges were noted as extending to a maximum of 20 feet from the channel in Reach 10. For the lower portion of Little Pipestone Creek, only one time period was analyzed so significant changes in riparian vegetation since 1983 could not be determine

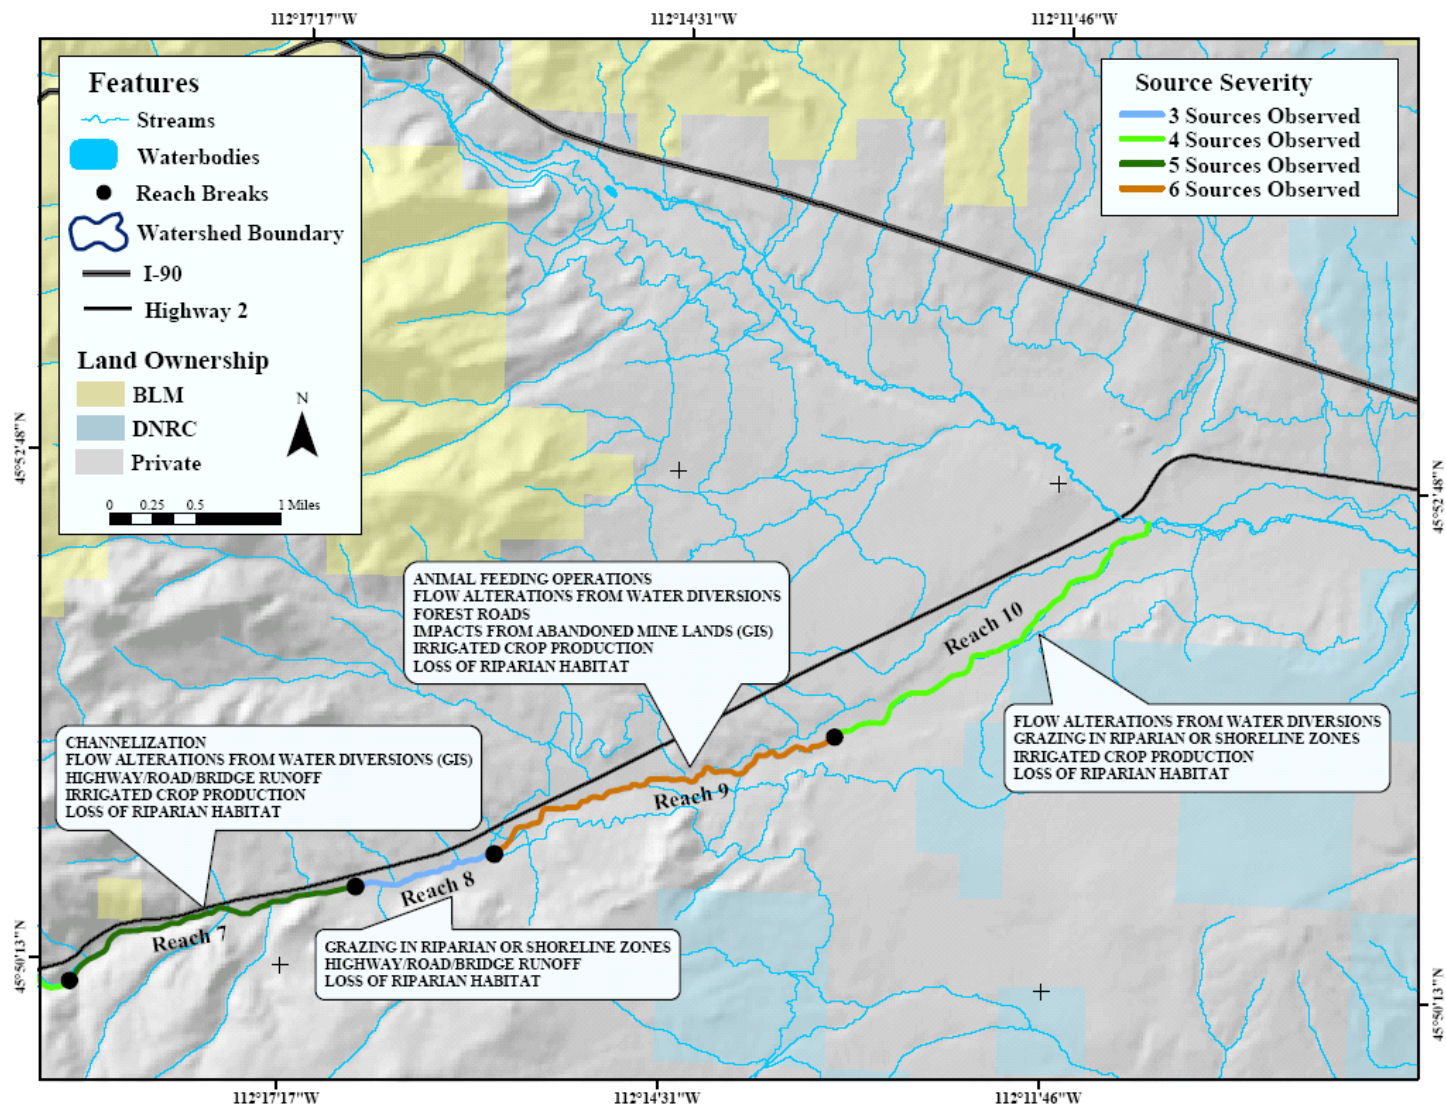
Figure 2-39. Lower Little Pipestone Creek Pollution Sources

**Figure 2-39** displays the pollution sources assigned to the lower reaches of Little Pipestone Creek. Many pollution sources observed along Lower Little Pipestone Creek were related to agricultural operations and rural housing development. Alterations for irrigation diversions were observed in reaches 9 and 10. During the field source assessment, grazing impacts and flow alterations were observed in Reach 10. In general, stream condition deteriorates in a downstream manner from Reach 8 to Reach 10. For the lower portion of Little Pipestone Creek, only one time period was analyzed so significant changes in pollution sources since 1983 were not be determined.

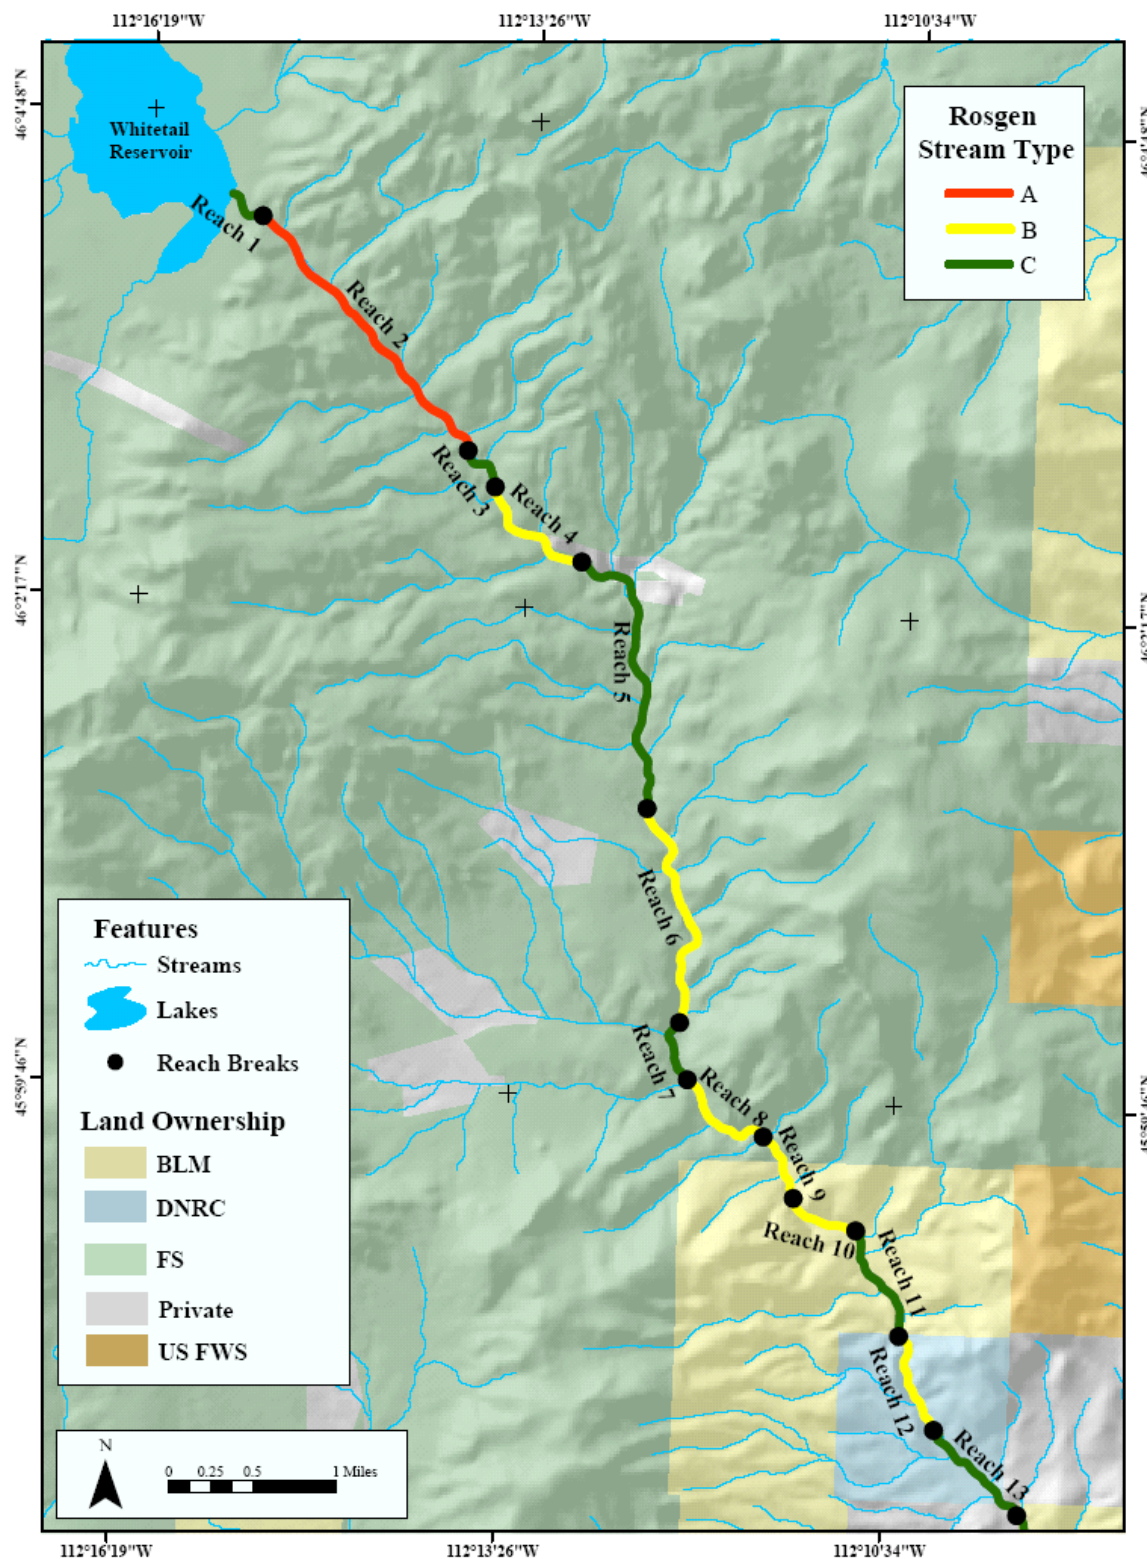
Figure 2-40. Upper Whitetail Creek Rosgen Stream Types

The channel forms of Upper Whitetail Creek are predominantly controlled by landform structure, and flow releases from Whitetail Reservoir (**Figure 2-40**). The landform geology of Reaches 1 to 6 is the Boulder Batholith, while intrusive volcanic rocks are prominent in reaches 7 to 12. The stream headwaters in Whitetail Park at the outlet of Whitetail Reservoir (C-type) and then flows through a steep, narrow canyon (A-type). The canyon gradient lessens and valley bottom openings alternate between relatively confined (B-type reaches), and unconfined areas (C-type reaches). The area of Reach 5 viewed during the field survey exhibited a C-type channel with transformation to a B-type channel at the end of the reach. The beginning of Reach 6 was noted as a good potential for a reference B-type channel. Reach 12 was observed as a B-type channel trending to C-type in less confined areas, while Reach 13 had characteristics of a C-type channel. There were no significant changes in channel form between 1983 and 2001.

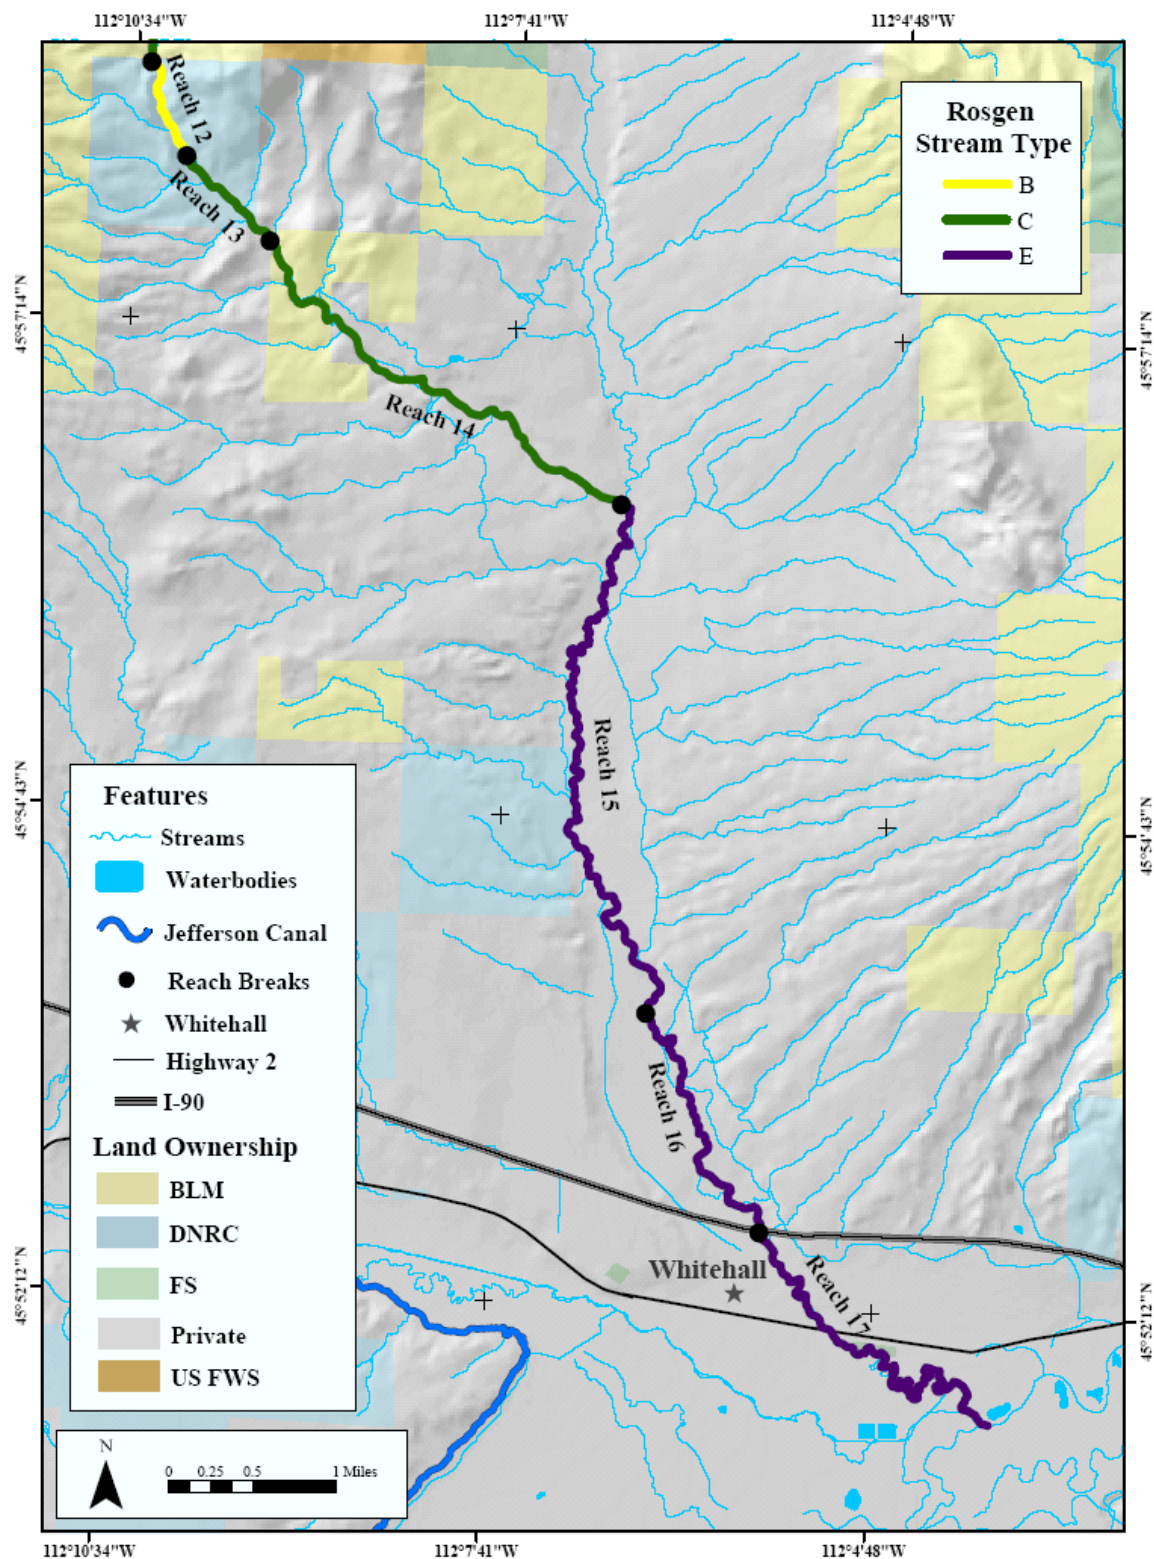
Figure 2-41. Lower Whitetail Creek Rosgen Stream Types

The channel forms of Lower Whitetail Creek are controlled by landform and historical and current landuse activities (**Figure 2-41**). The predominant valley type (VIII) would typically
