**APPENDIX C**  
**2004 AERIAL PHOTO REVIEW AND FIELD SOURCE ASSESSMENT,**  
**UPPER JEFFERSON RIVER WATERSHED**

### **1.1 Upper Jefferson Watershed 2004 Aerial Photo Review and Field Source Assessment**

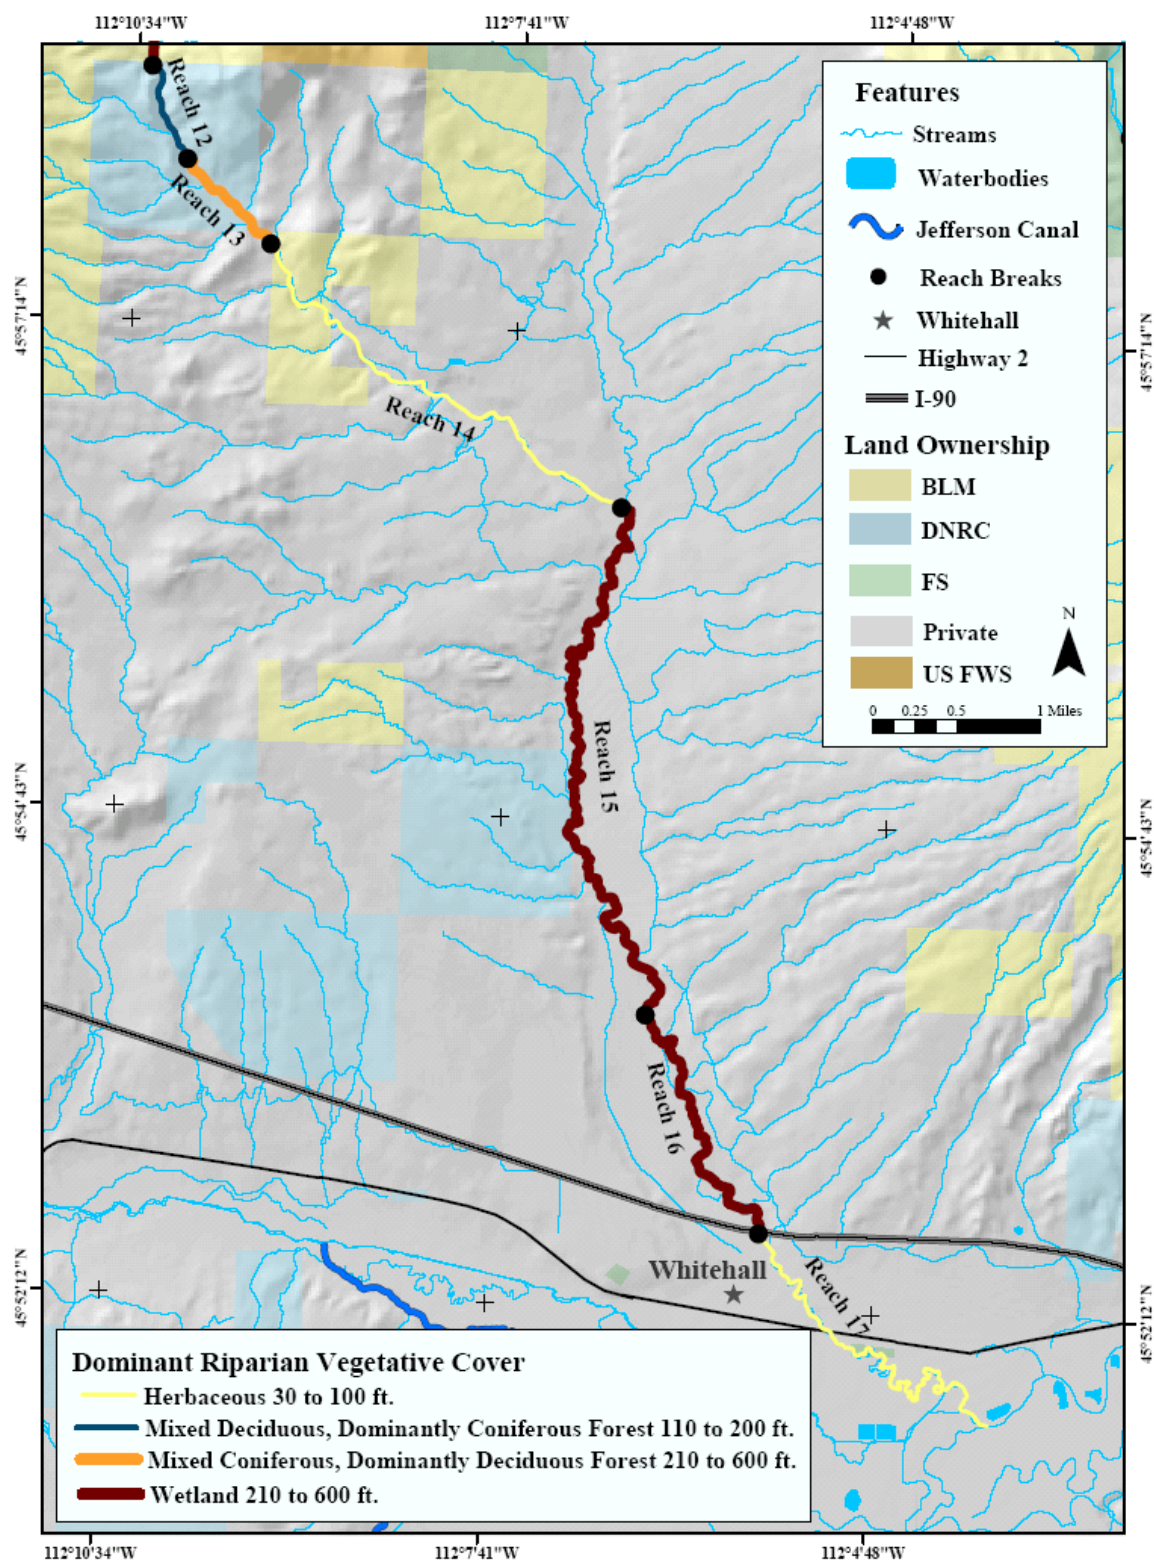
Figure 2-43. Lower Whitetail Creek Riparian Vegetation

Riparian cover along Lower Whitetail Creek transitioned from herbaceous, to wetland, to herbaceous (**Figure 2-43**). This is largely a reflection of landuse. It is suspected that a lowering of the water table in Reach 14 is one factor in the decrease of deciduous vegetation. During the field survey in Reach 14, decadent and dying cottonwood, intermixed with willow, alder, current, and red osier were confined to a narrow corridor along stream. Reaches 15 and 16 were dominated by willows. The riparian area appeared to be more intact in Reach 15 than in Reach 16, and may reflect the fact that land ownership was more subdivided in Reach 16 versus Reach 15. The herbaceous category for Reach 17 was due to development and farming in the riparian zone. The relative health category assigned to most of the lower reaches was: 'Poor'. For the lower portion of Whitetail Creek, only one time period was analyzed so significant changes in riparian vegetation since 1983 could not be determined.

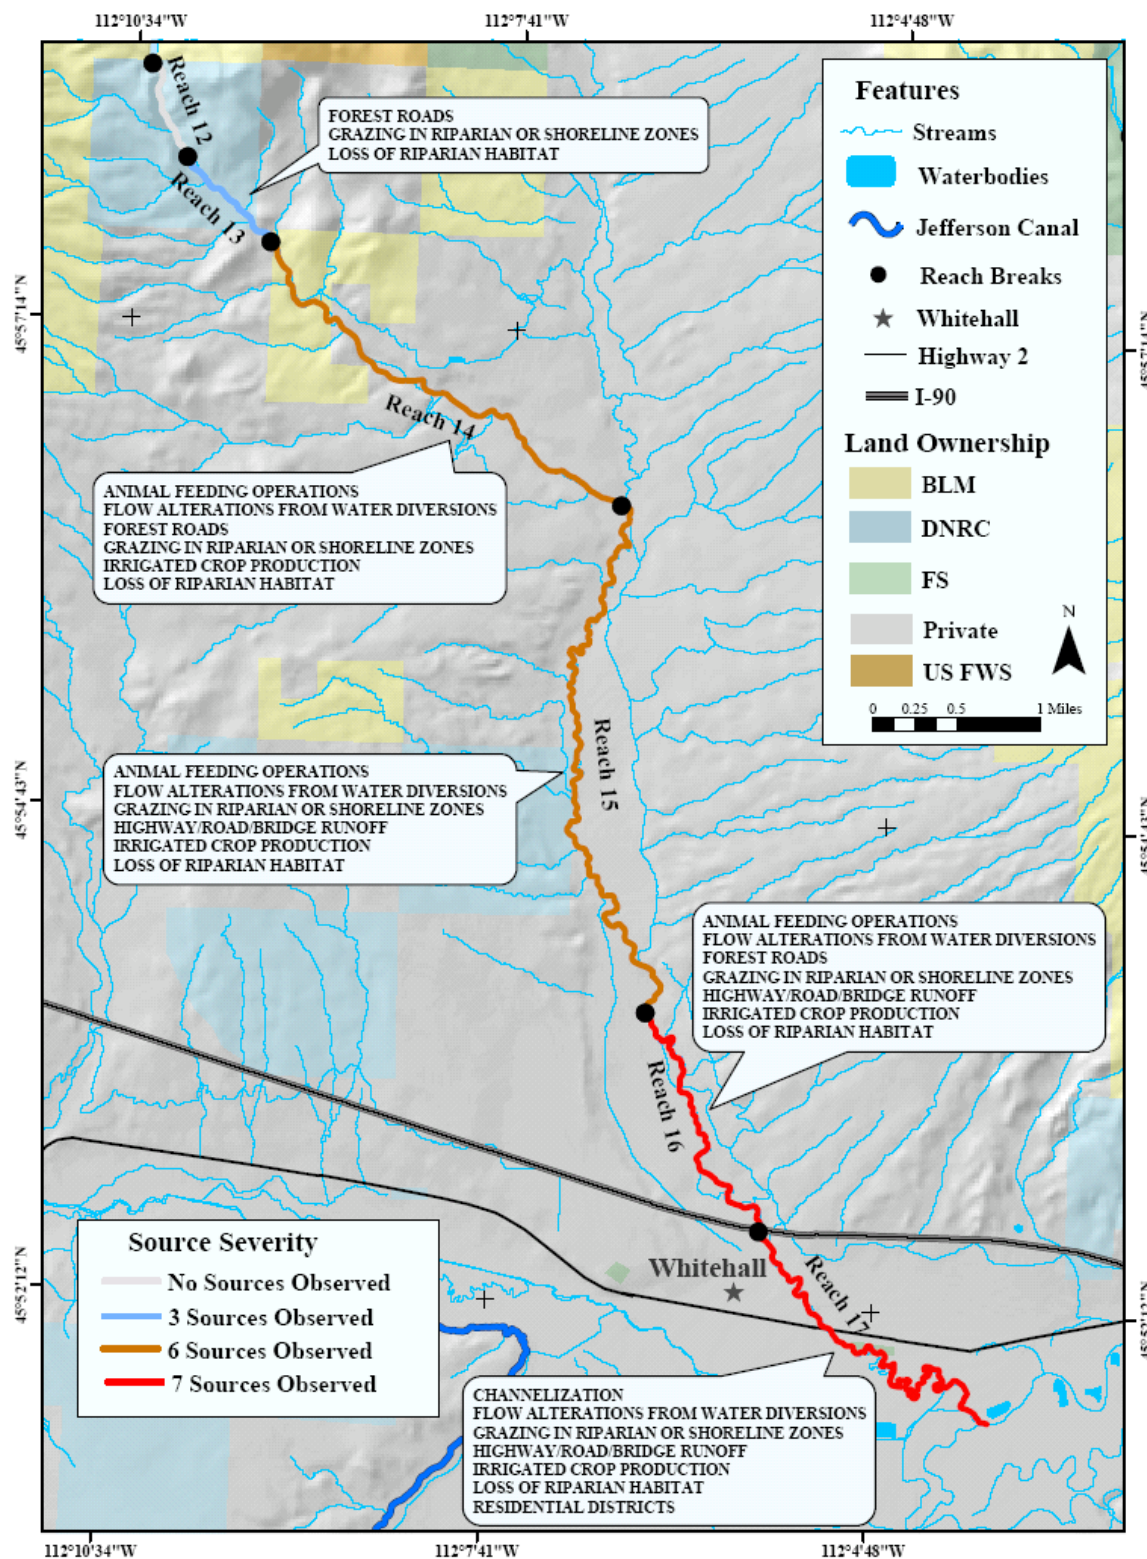
Figure 2-45. Lower Whitetail Creek Pollution Sources

**Figure 2-45** displays the pollution sources assigned to the lower reaches of Whitetail Creek. Many pollution sources observed along Lower Whitetail were related to agricultural operations. During the field source assessment, grazing impacts were observed in all of the field surveyed reaches. Alterations for irrigation diversions were observed in reaches 14, 16, and 17. The sources observed were localized by the property owner's land use, such as confined feedlots, removal of riparian vegetation, and small grazing pastures. For the valley portion of Whitetail Creek, only one time period was analyzed so significant changes in pollution sources since 1983 were not be determined.
