OTTER CREEK MINE - BASELINE REPORT 325A

**PHOTOS OF SURFACE WATER RUNOFF MANAGEMENT STRUCTURES,  
SEPTEMBER, 2013**

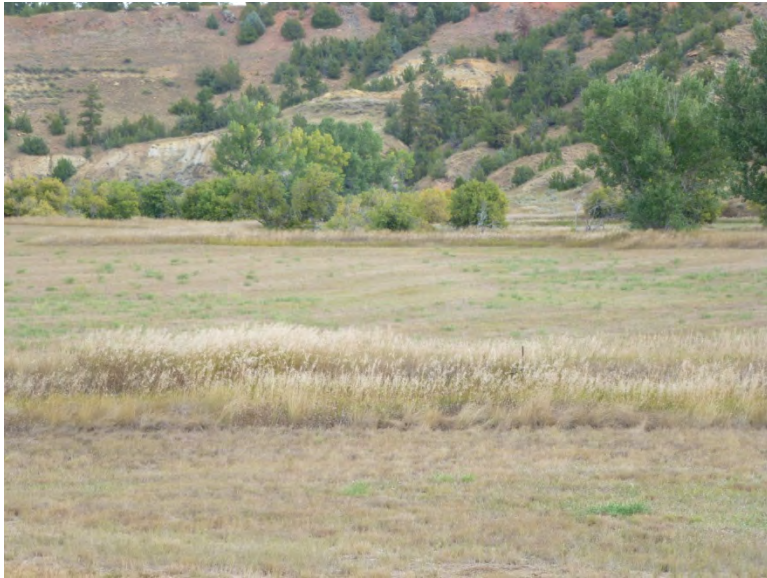
1. Ditches channeling runoff from upper Otter Creek.

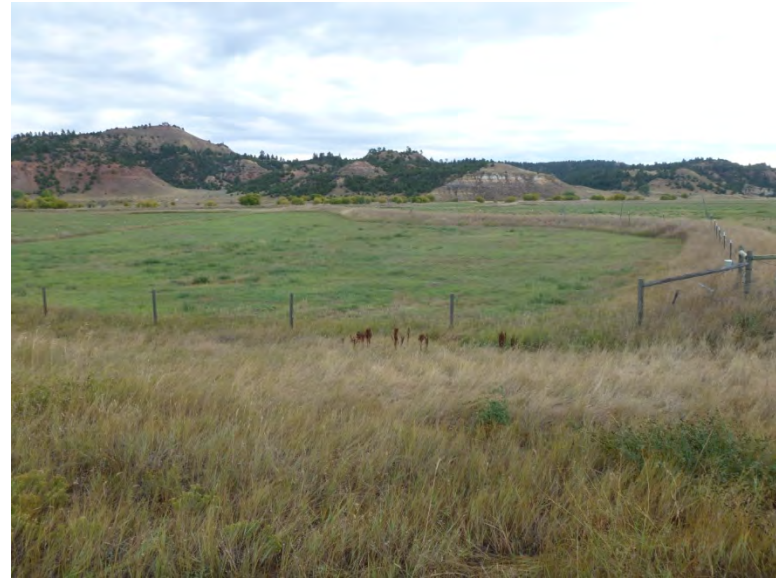
2. Upper Otter Creek spreader dike.

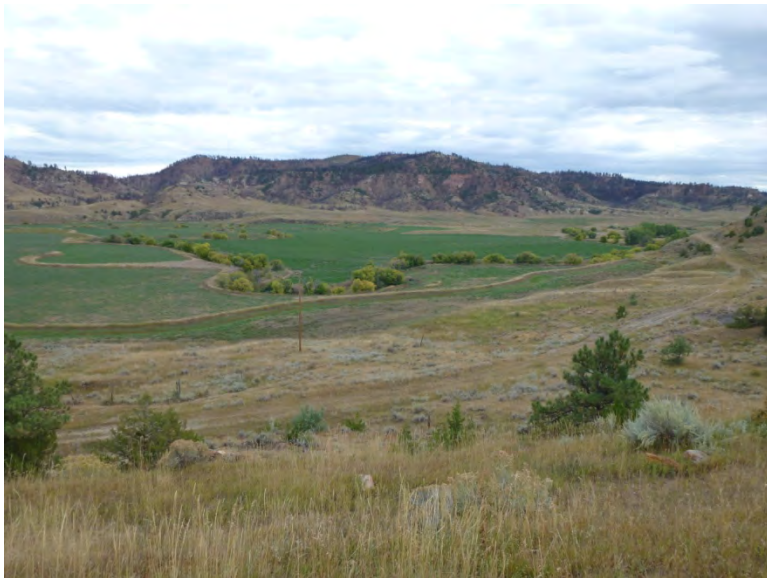
3. Upper Otter Creek spreader dikes.

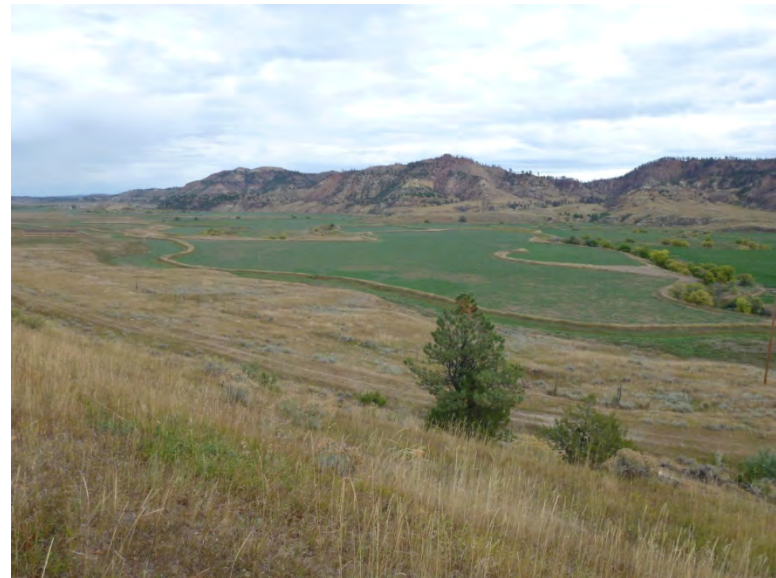
4. Upper Otter Creek spreader dikes.

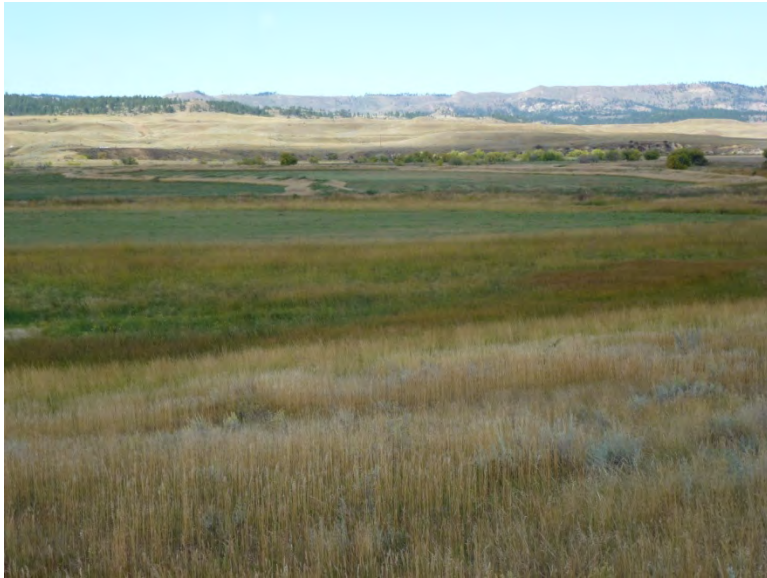
5. Otter Creek at mouth of 15-Mile Creek; spreader dikes.

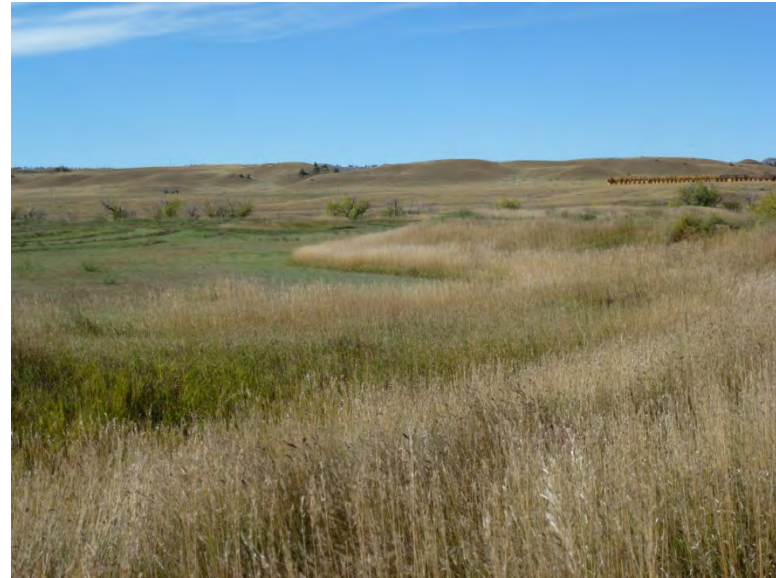
6. Otter Creek at mouth of 15-Mile Creek; dike along Otter Creek.

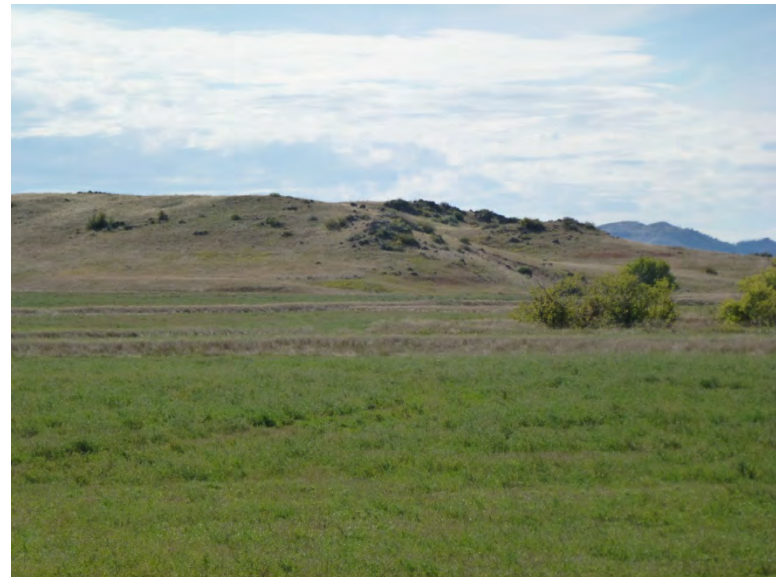
8. Tenmile Creek looking south; spreader dikes & dike along Otter Creek.

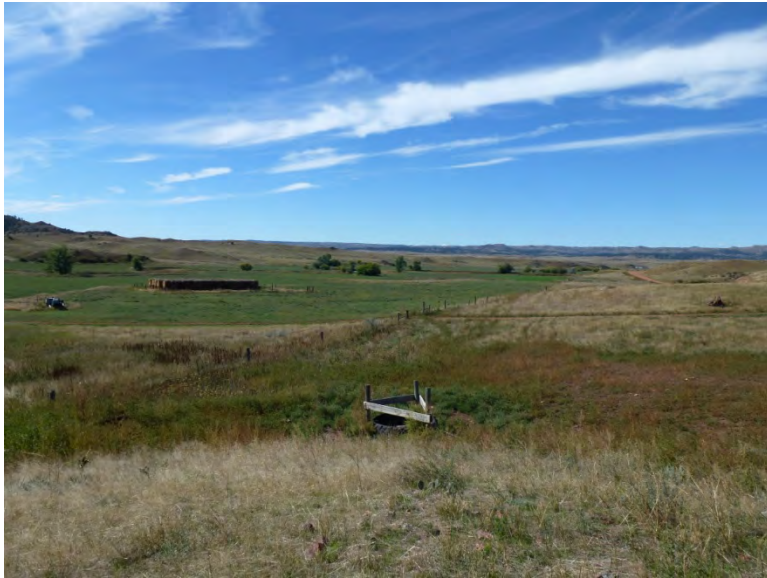
9. Tenmile Creek looking west from CNF boundary.

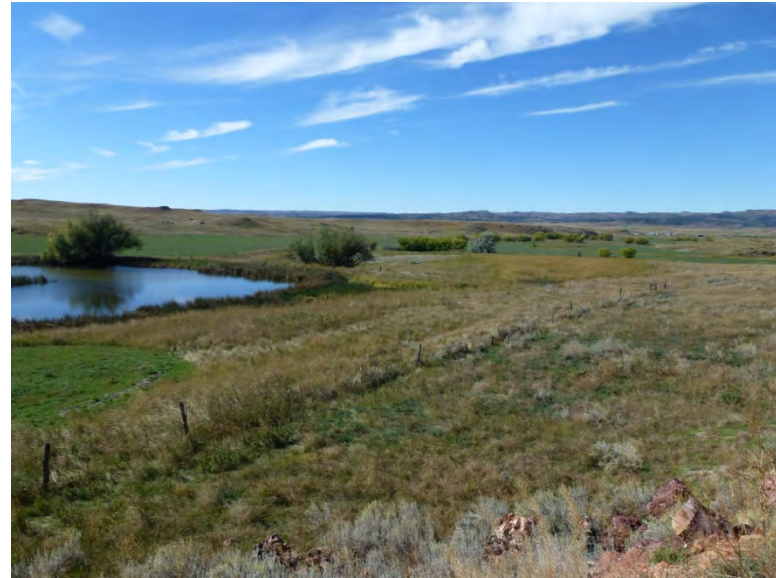
10. Tenmile Creek looking SW below CNF boundary. Dike below pond.

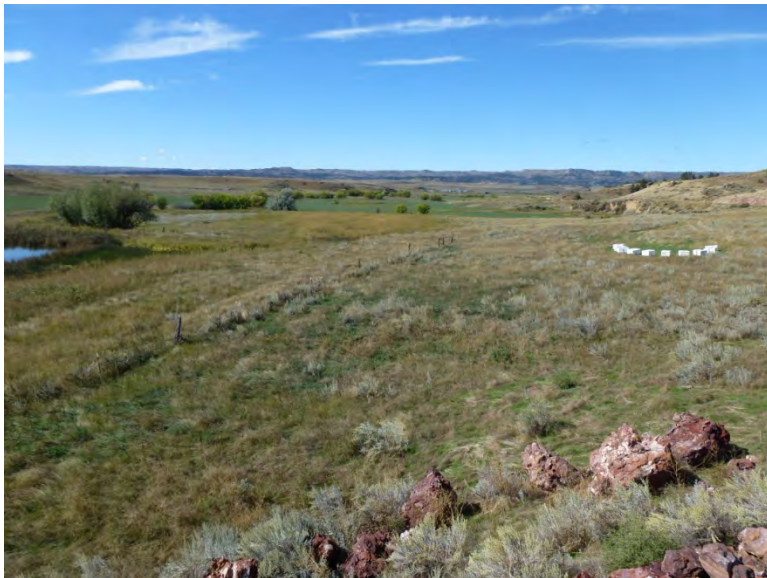
11. Tenmile Creek looking west toward Otter Creek.

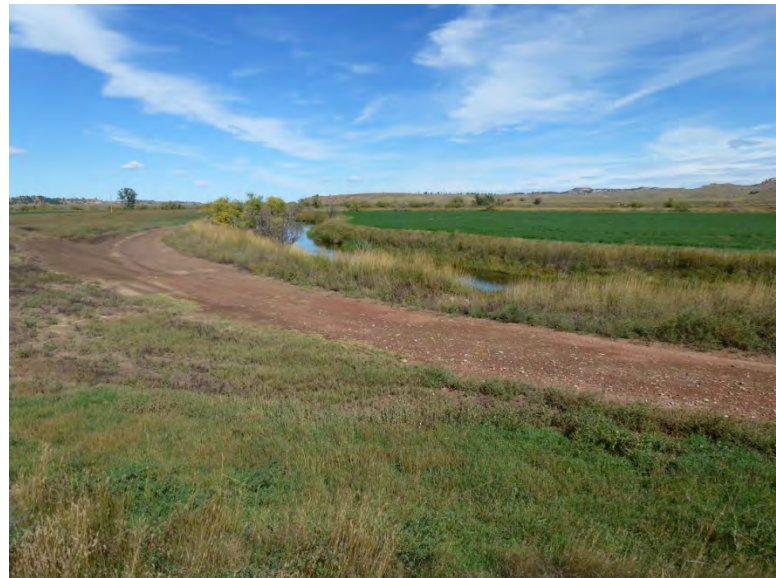
12. Otter Creek looking downstream from Tenmile Creek road; no diking.

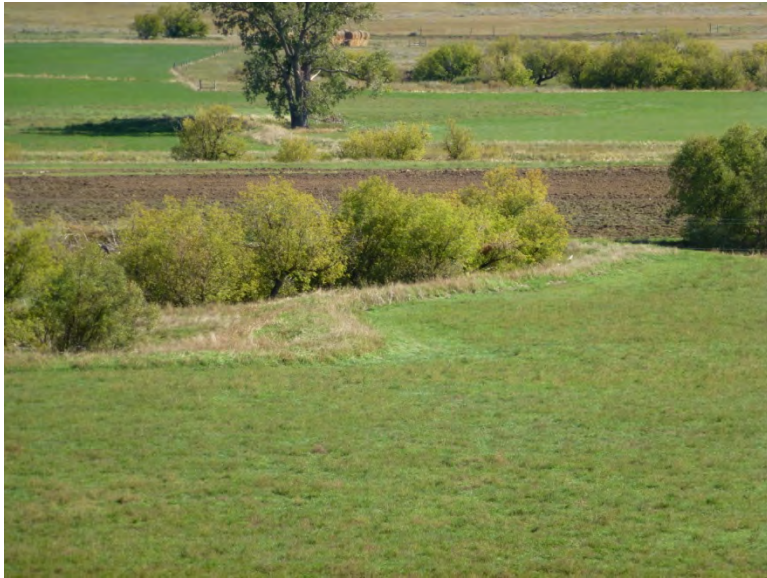
13. Dikes in field below mouth of Chromo Creek.

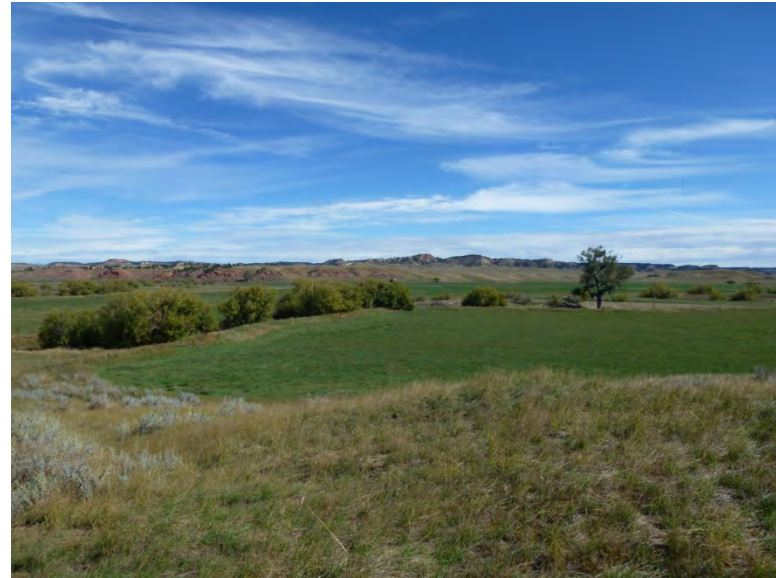
14. Dikes in field below mouth of Chromo Creek.

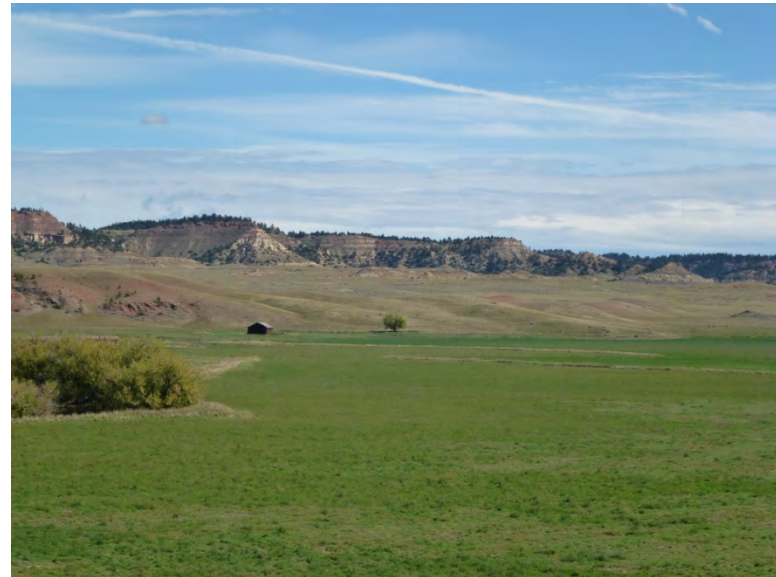
16. Spreader dikes E of Otter Crk below Tenmile Crk; dike along Otter Crk.

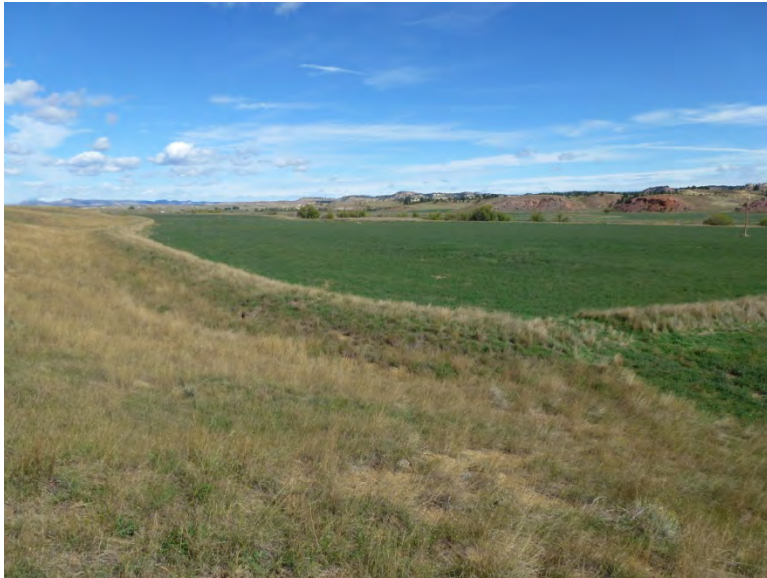
17. Lower end of dike directing Gene Creek flow to Otter Creek fields.

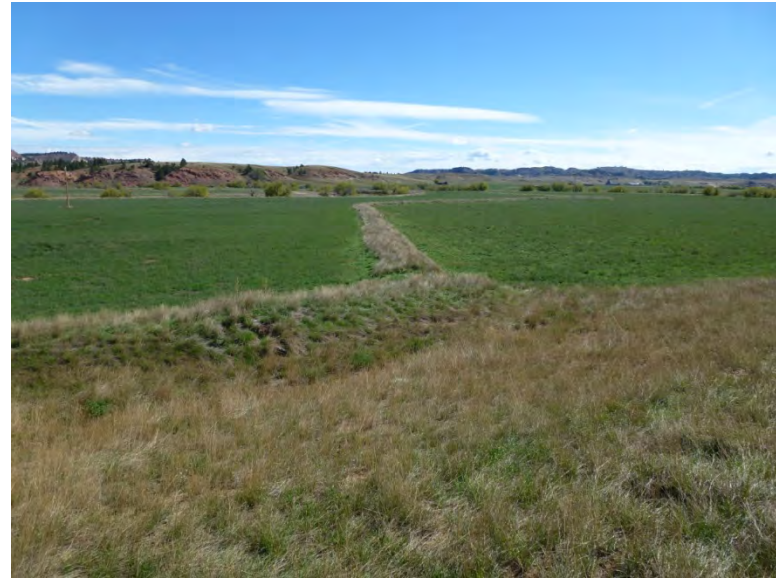
18. See Photo 17 caption; spreader dike. Note Culvert.

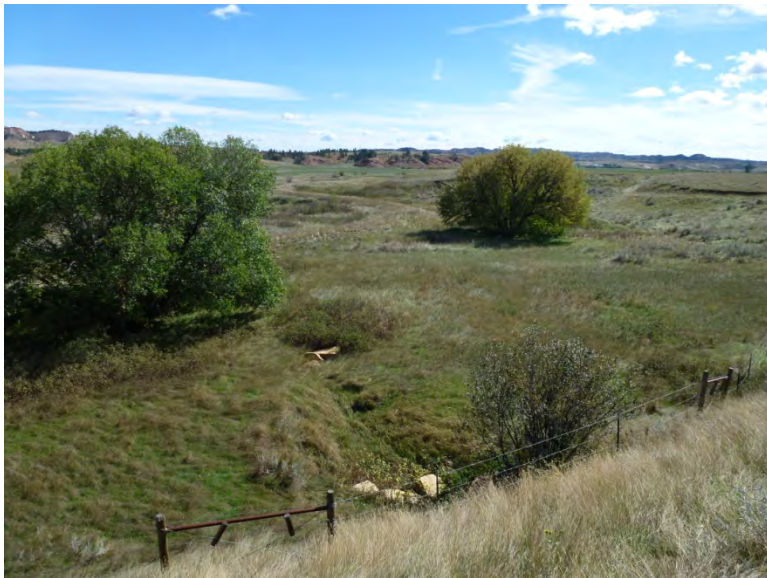
19. Gene Creek diversion dike below highway culvert.

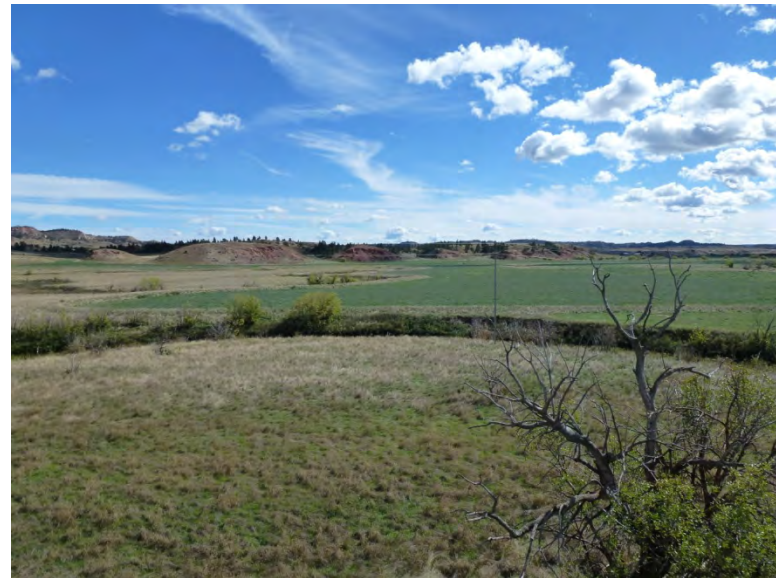
20. Otter Creek dike north of Gene Creek mouth.

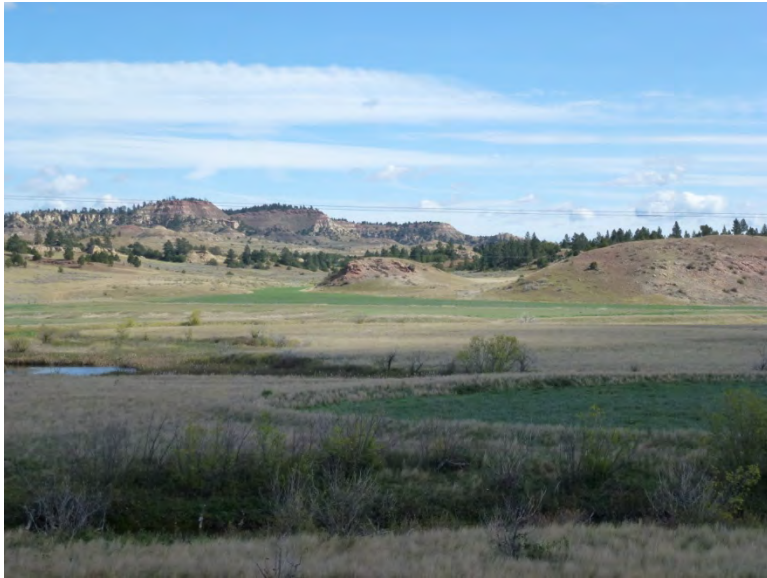
21. Spreader dikes below E side drainage in back. Otter Crk dike in front.

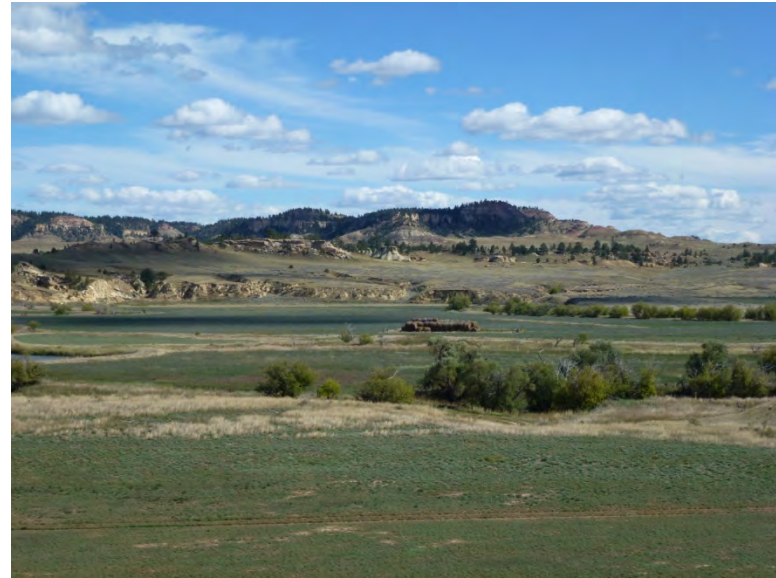
22. Spreader dikes capturing flow from east side drainages.

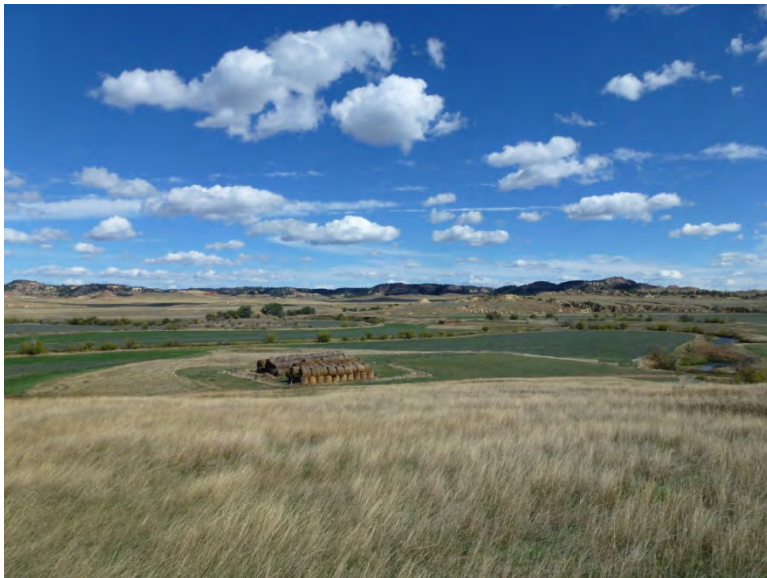
23. Spreader dike on west side of Otter Creek below small side drainage.

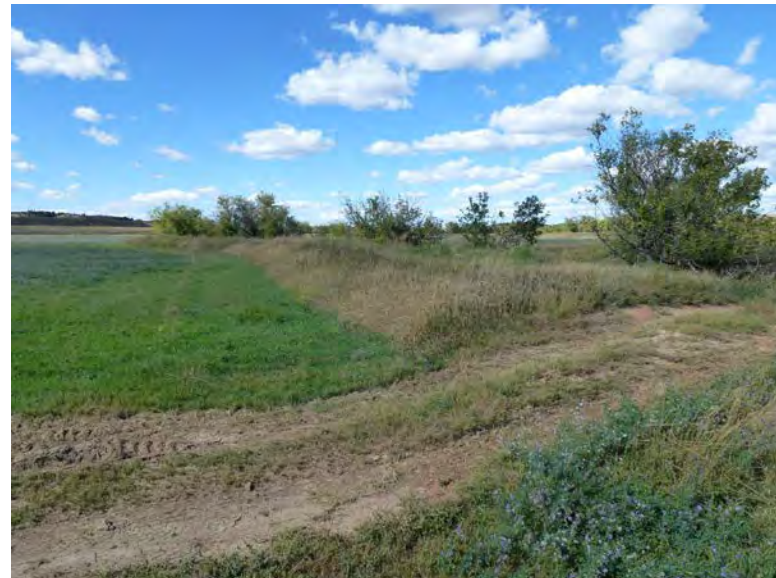
24. Dike along west side of Otter Creek at lower crossing.

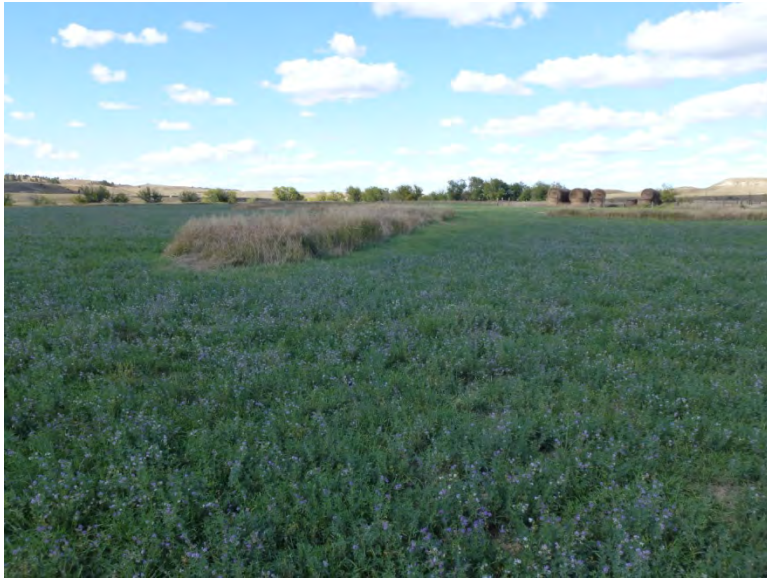
25. Spreader dike on east side of Otter Creek at lower crossing.

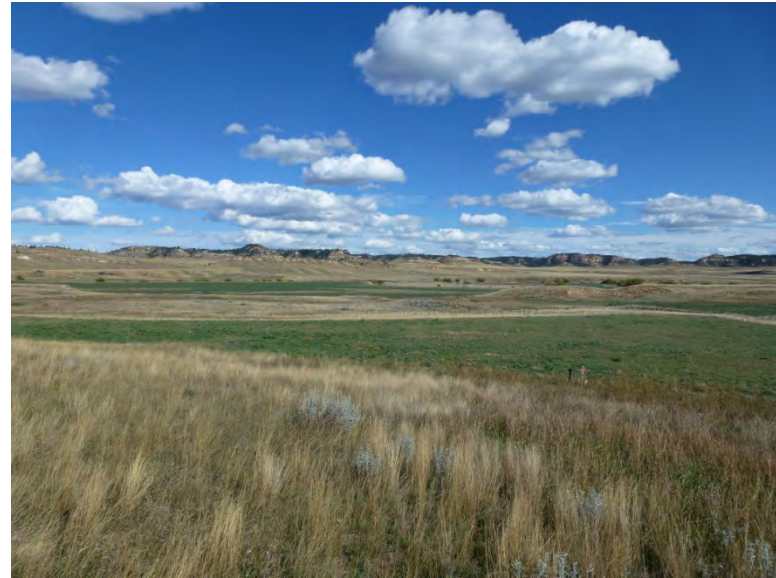
26. Spreader dikes below Newell Creek; AVF8P1 in foreground.

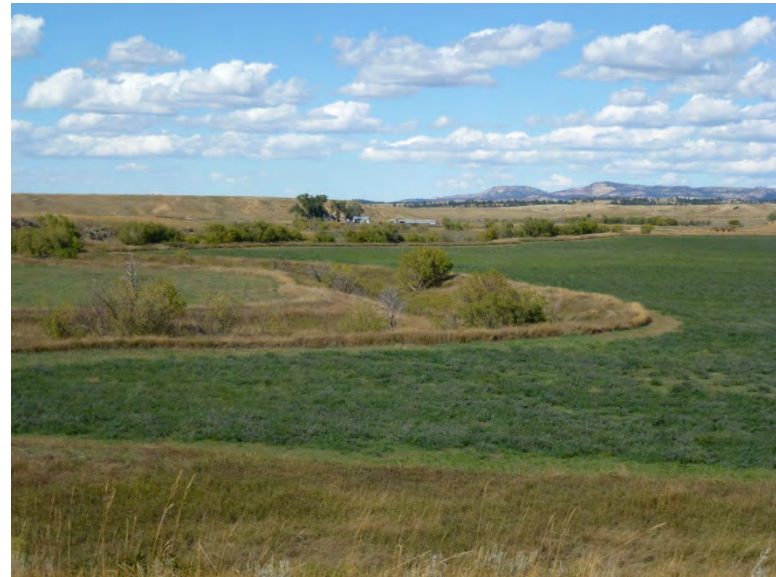
28. Dikes along Otter Creek.

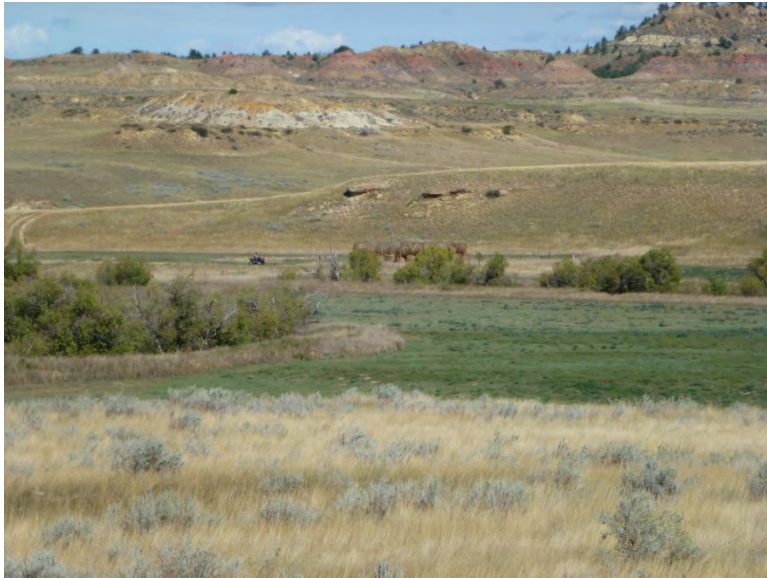
29. Dikes along Otter Creek.

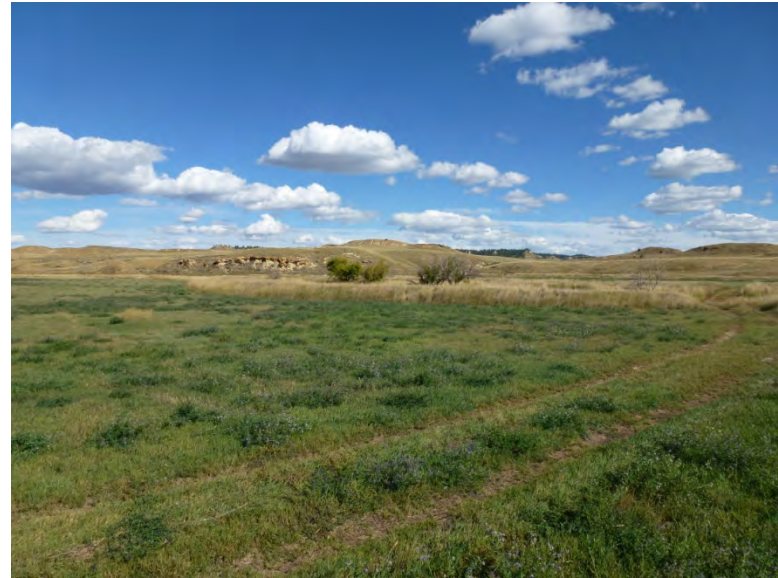
30. Dike along west side of Otter Creek at Badgett crossing.

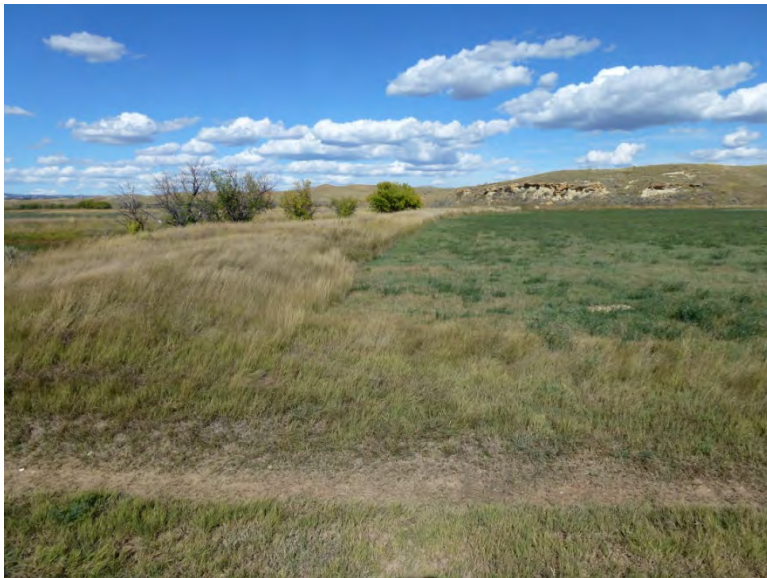
31. Dike along east side of Otter Creek at Badgett crossing.

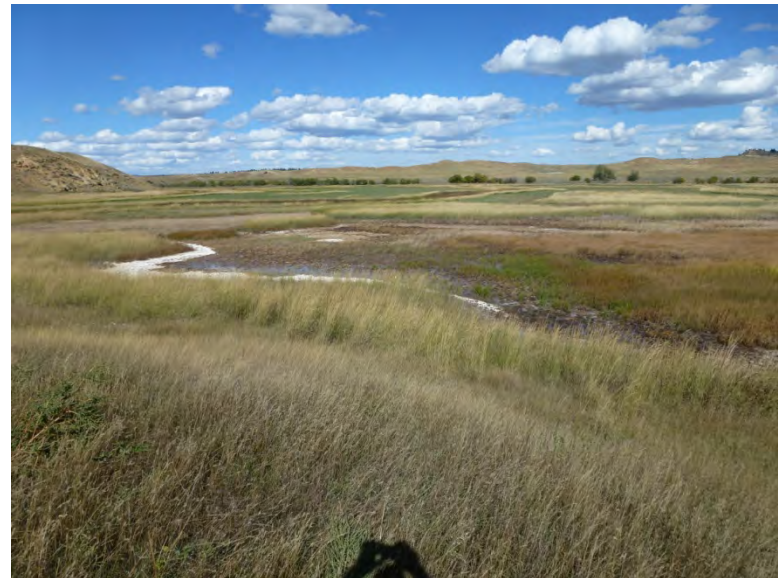
32. Otter Creek below Badgett house. Very wet with little if any diking.

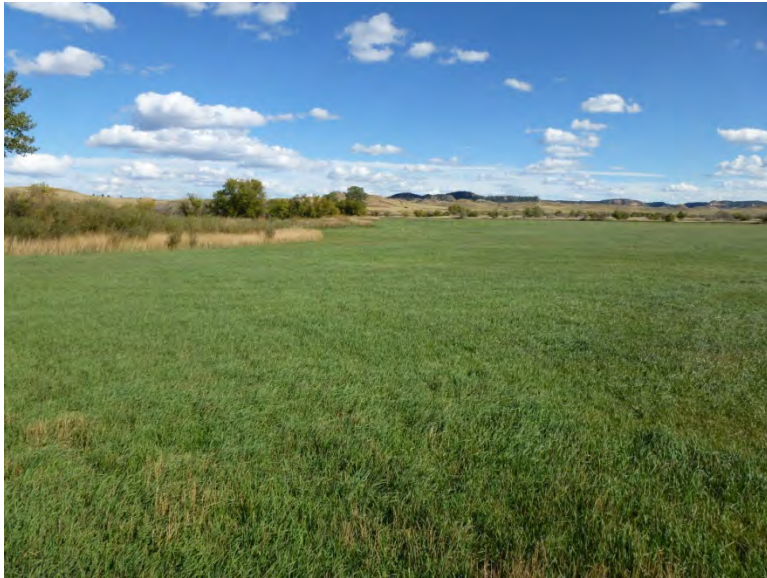
33. Dike on west side of Otter Creek south of old house.

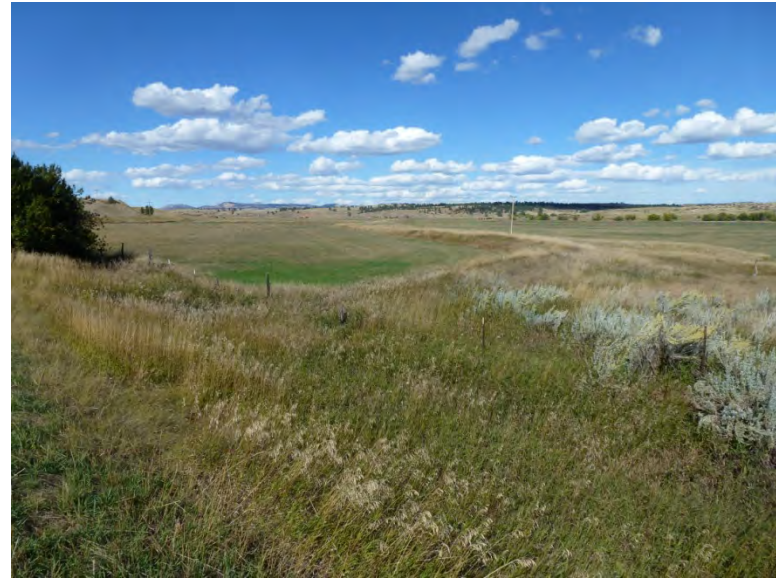
34. Dike along edge of upper terrace below side drainage.

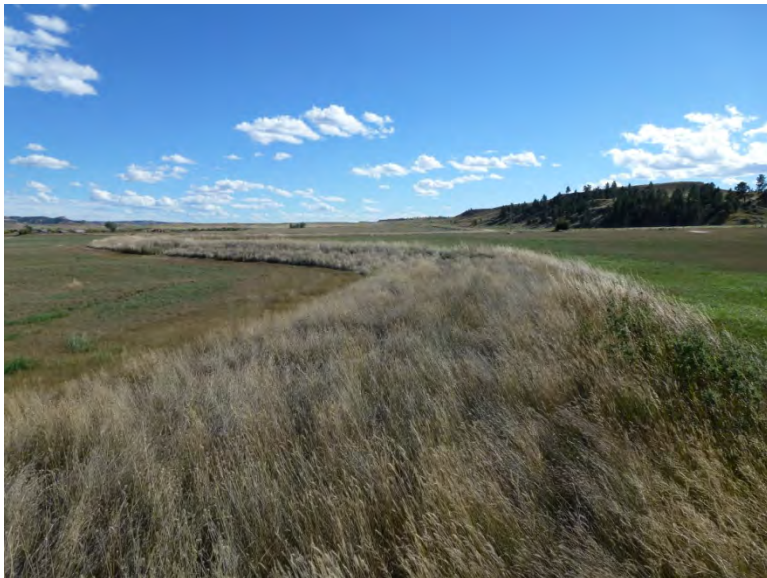
35. Dike along edge of upper terrace below side drainage looking south.

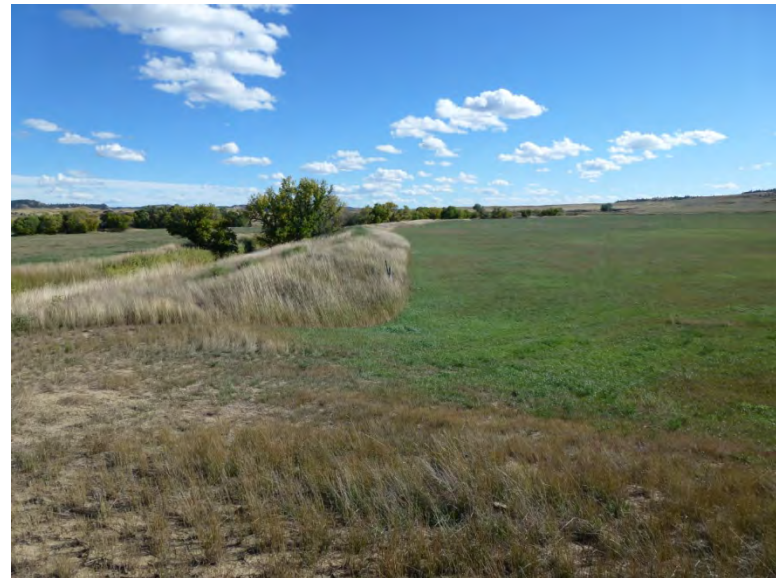
36. Dike along W side of Otter Creek below diked upper terrace looking south.

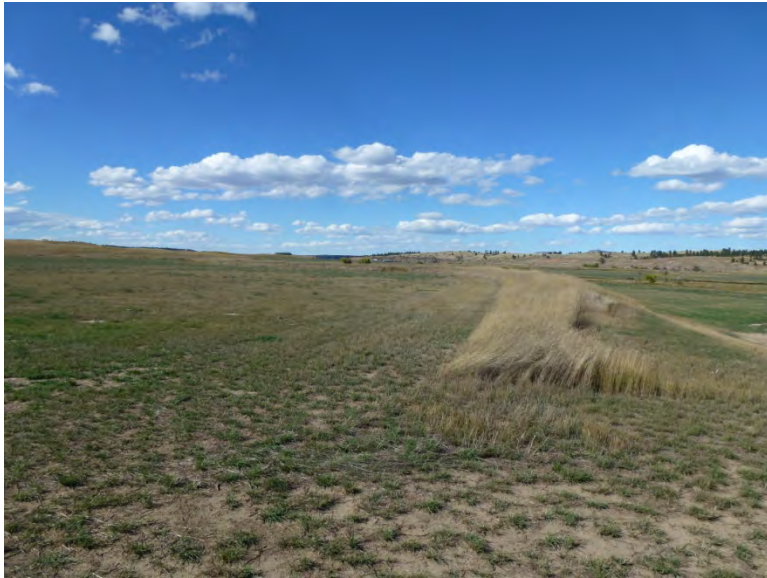
37. Dike along upper terrace below side drainage looking north.

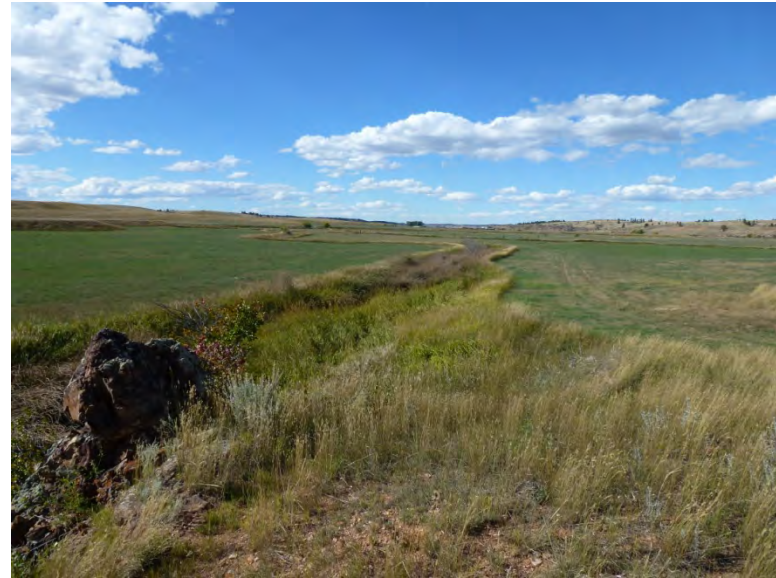
38. Otter creek downstream from Stevens crossing; no dikes.

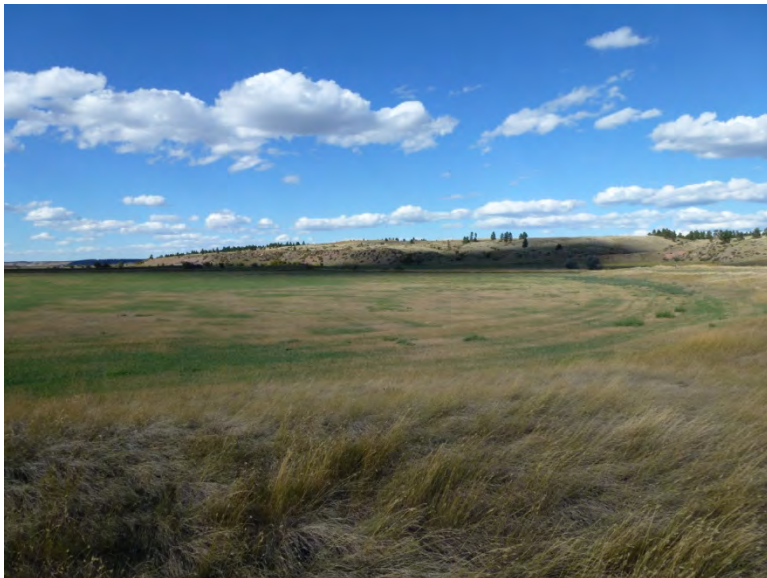
39. Otter Creek looking downstream from Gratwohl house. No dikes.

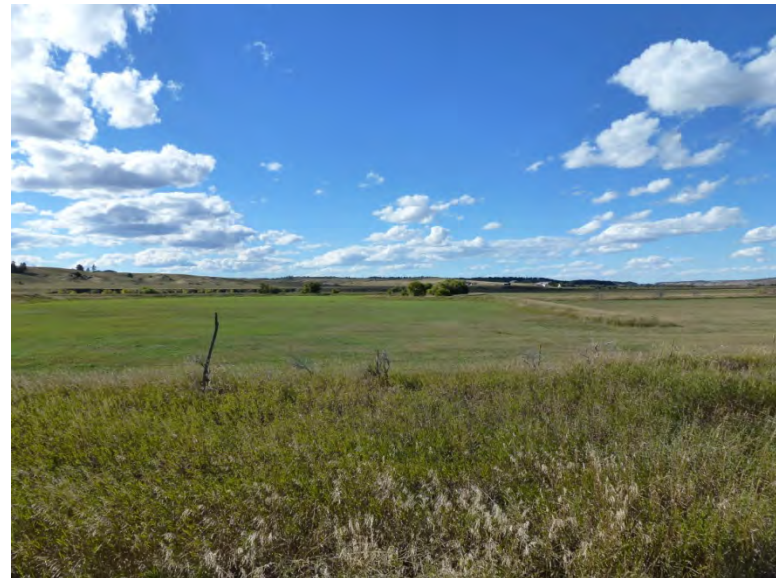
40. Spreader dike and dike along Otter Creek west of road.

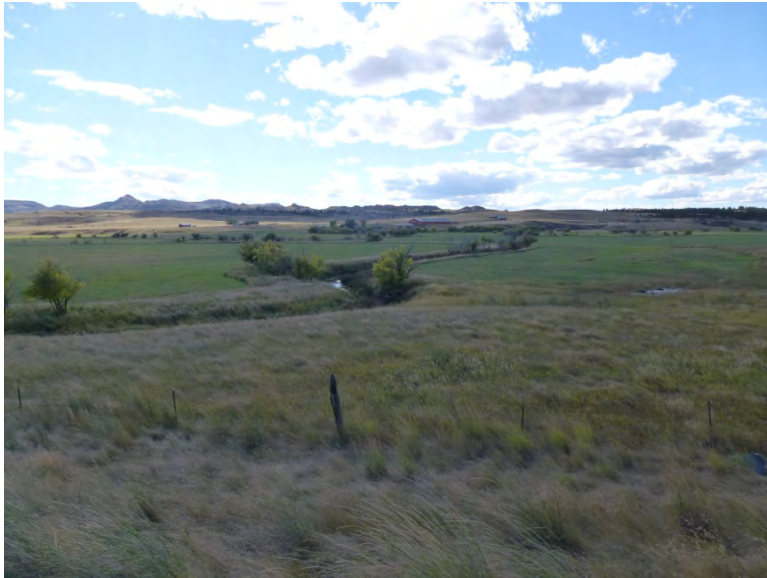
41. West of Road; no dikes along Otter Creek.

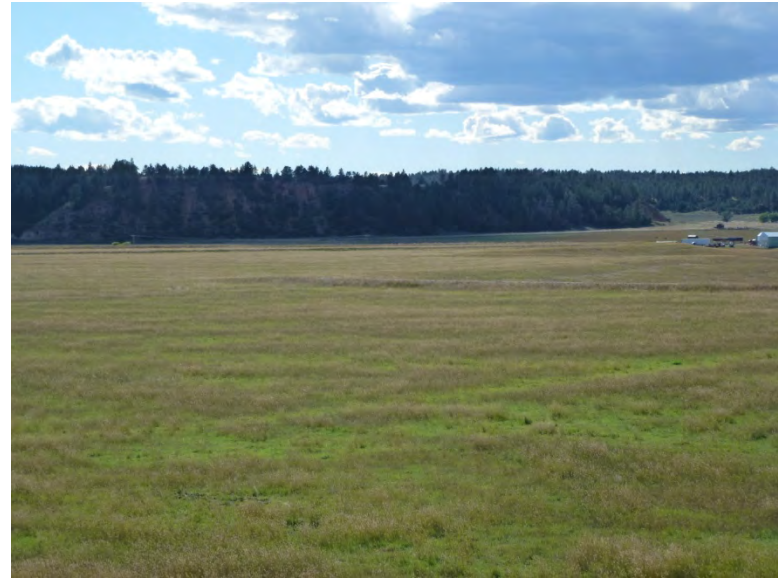
42. Spreader dikes on higher terraces south of East Fork.

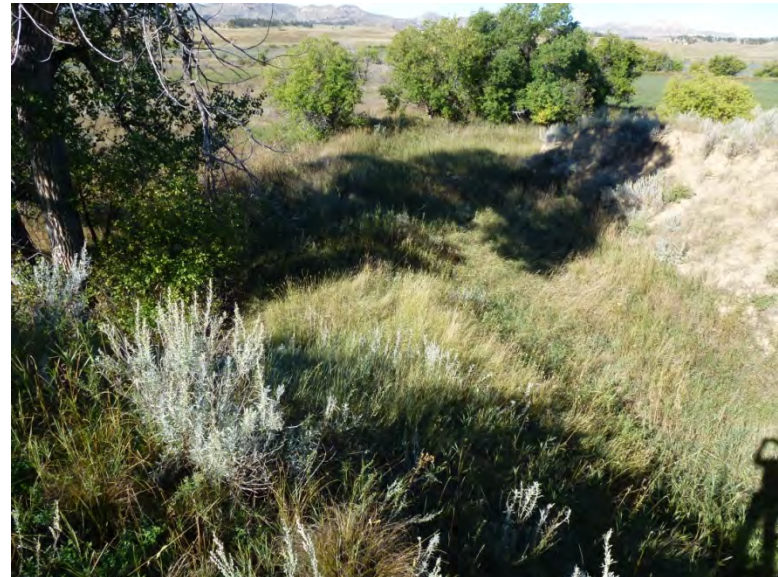
44. Dike at mouth of Fortune Coulee diverting flow to a field to N.

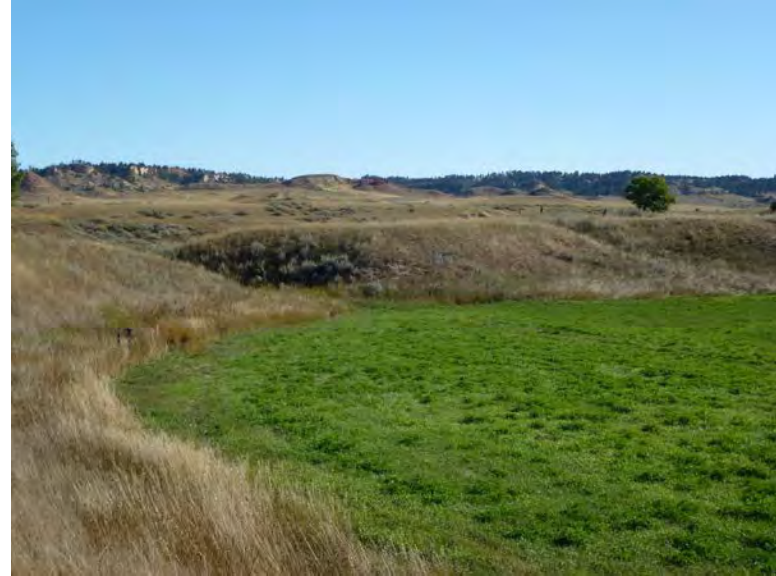
46. Diversion outlet into field at mouth of Fortune Coulee. Well AVF4-2 and Piezometer AVF4-P5 at edge of field.

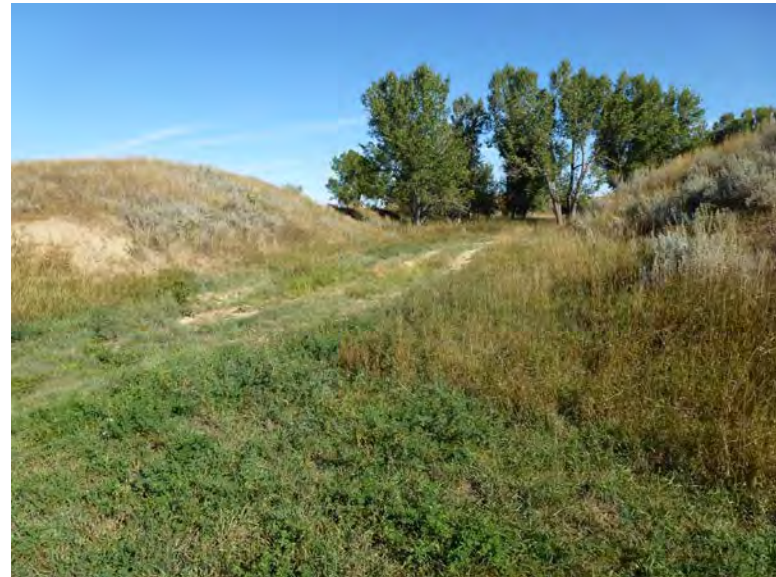
48. Direct view of diversion outlet shown on Photo 46.

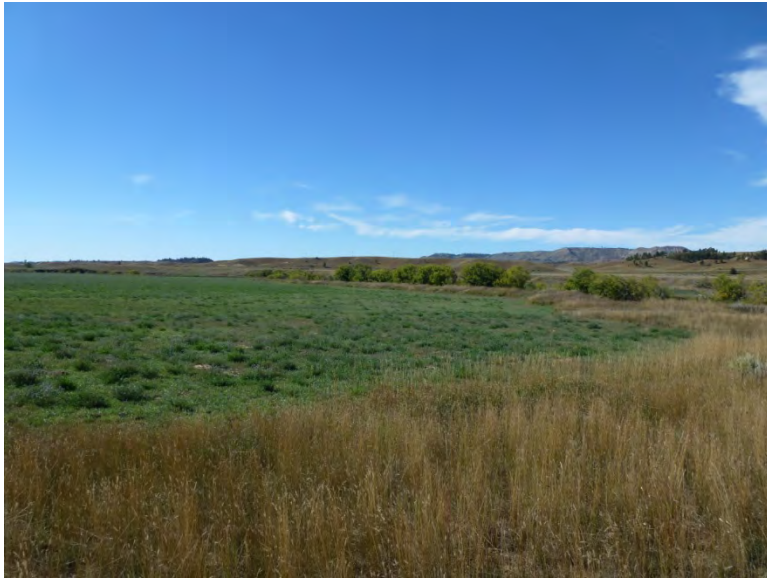
49. Dike on east side of Otter Creek at Badgett crossing looking south.

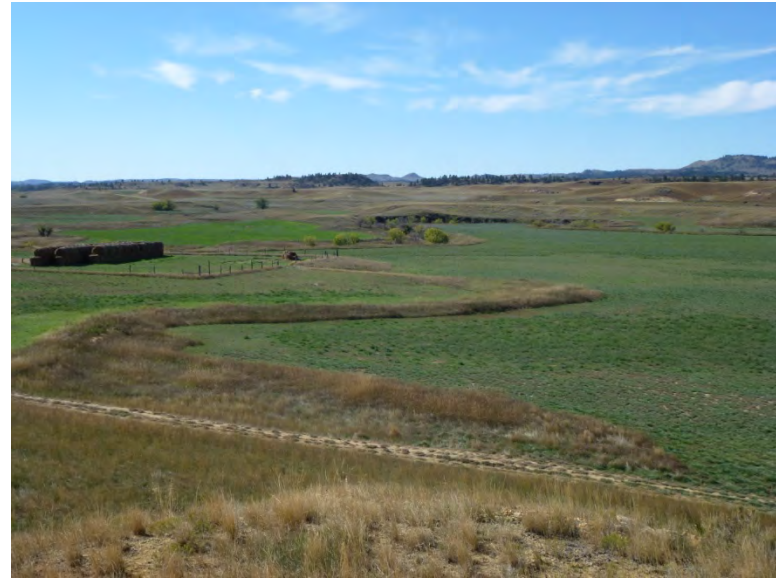
50. Spreader dike below mouth of east side drainage below Badgett crossing.

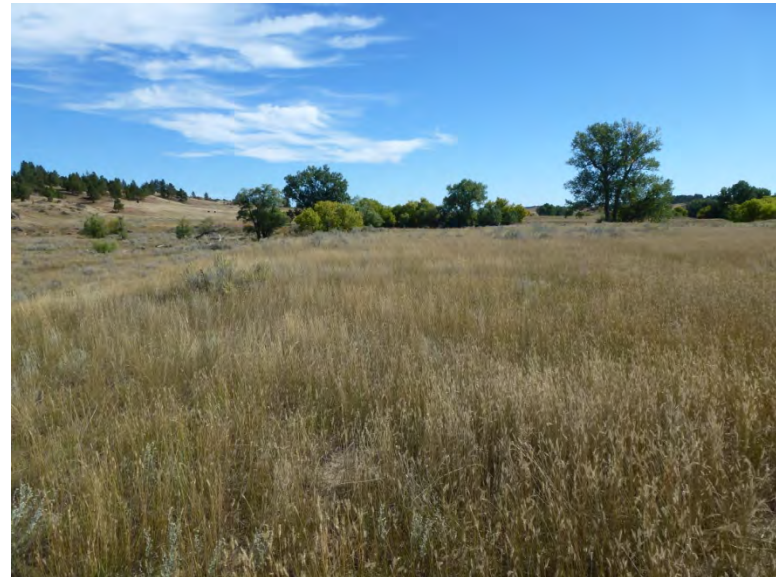
52. Mouth of Threemile Creek looking upstream; dike visible.

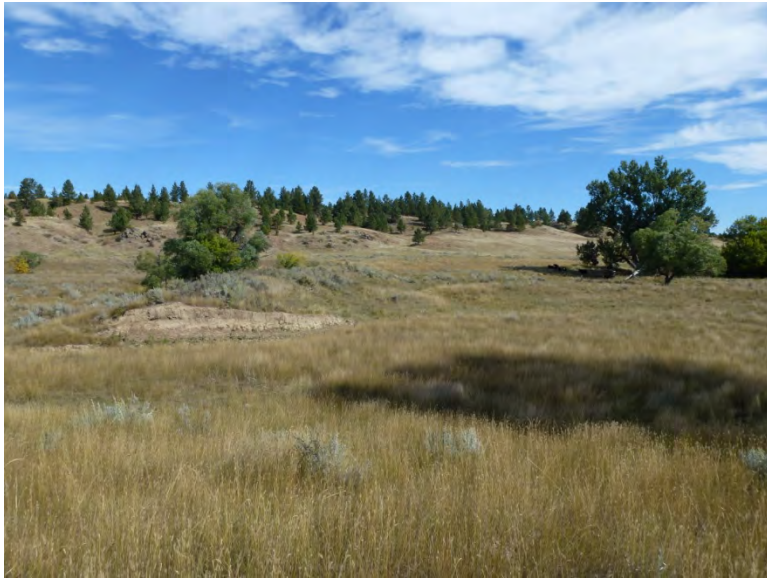
53. Close-up view of dike near mouth of Threemile Creek.

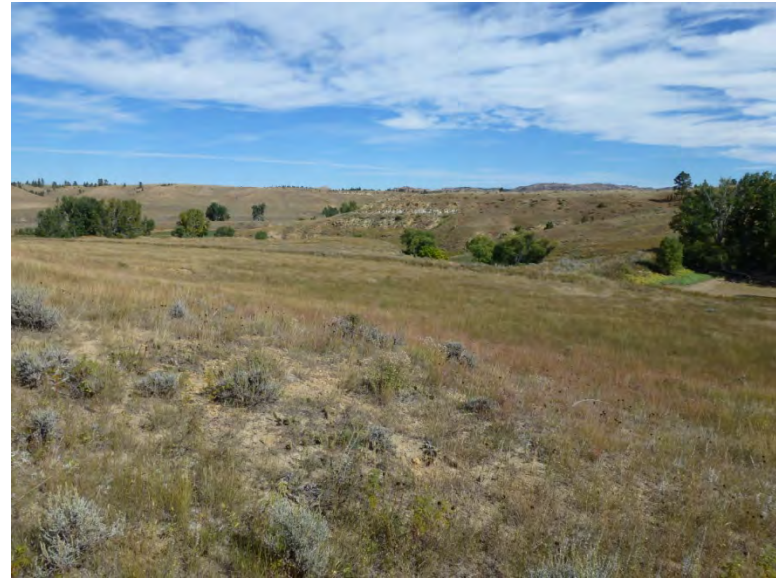
54. Diversion ditch from overflow of Pond 4 to field on upper bench on upper Threemile Creek.

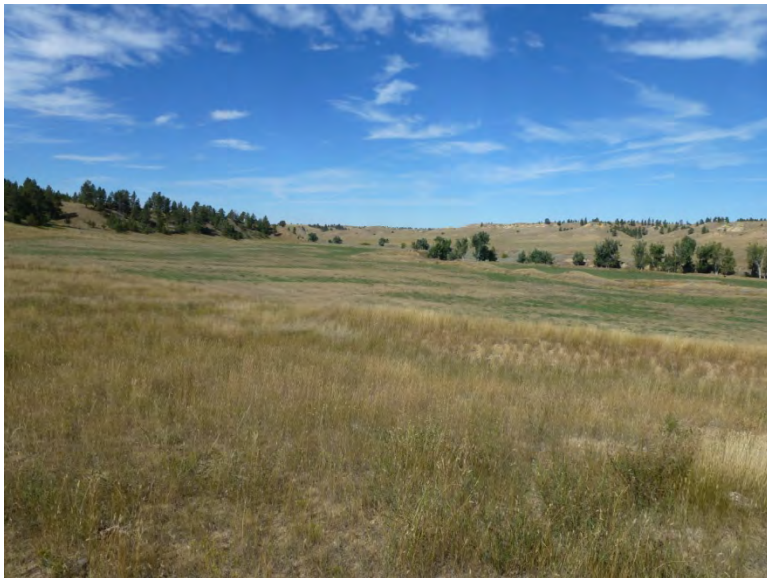
55. Outlet of diversion shown in Photo 54; dike along lower edge.

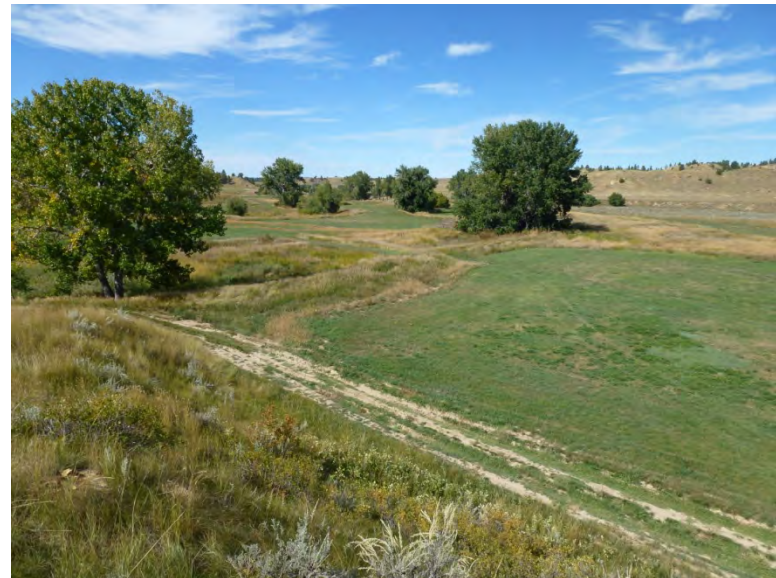
56. Spreader dike at lower edge of uppermost field on Threemile Creek.

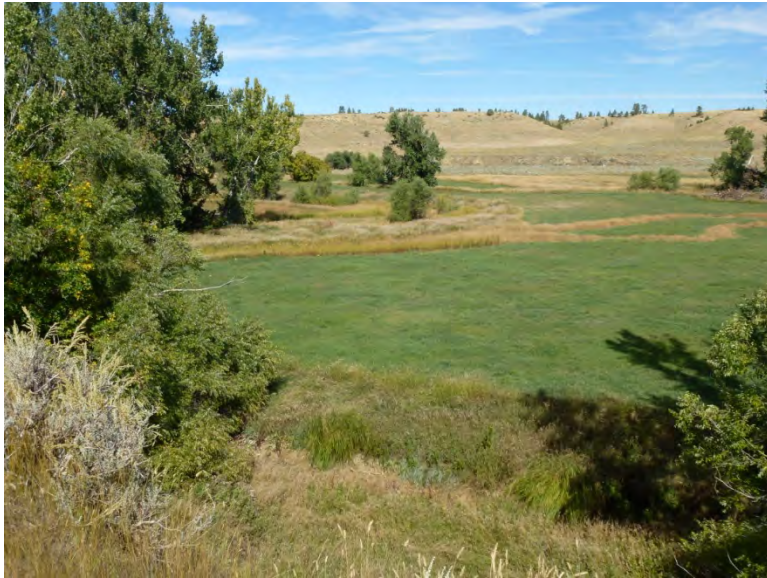
57. Second dike on Threemile Creek below Photo 56.
