OTTER CREEK MINE - BASELINE REPORT 325A

**PHOTOS OF SURFACE WATER RUNOFF MANAGEMENT STRUCTURES,  
SEPTEMBER, 2013**

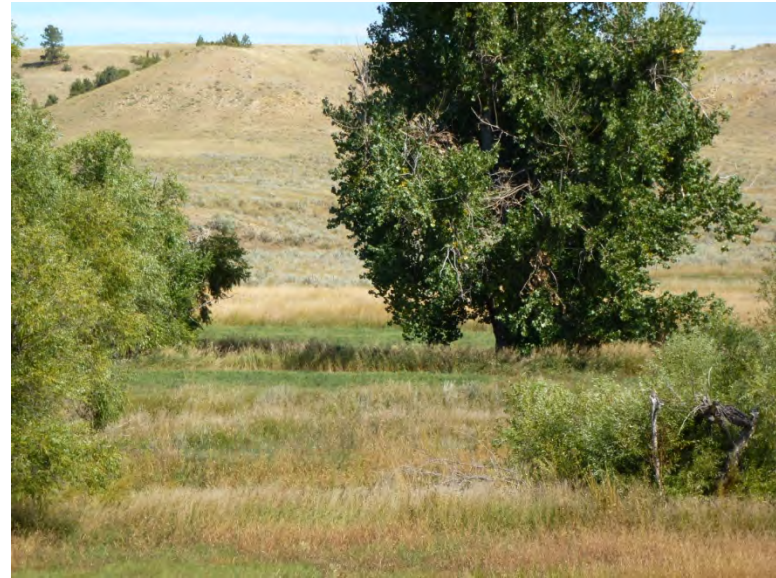
58. Third dike.

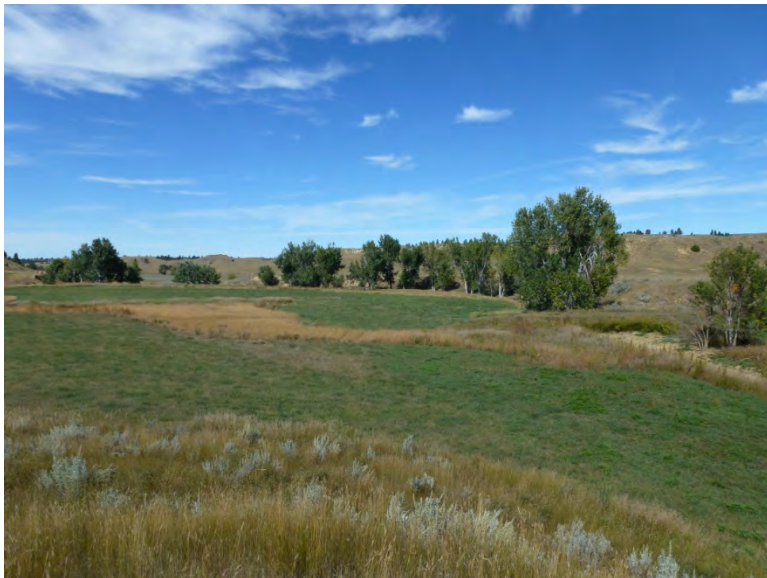
59. Fourth and fifth dikes. Note dike along lower edge of field in background.

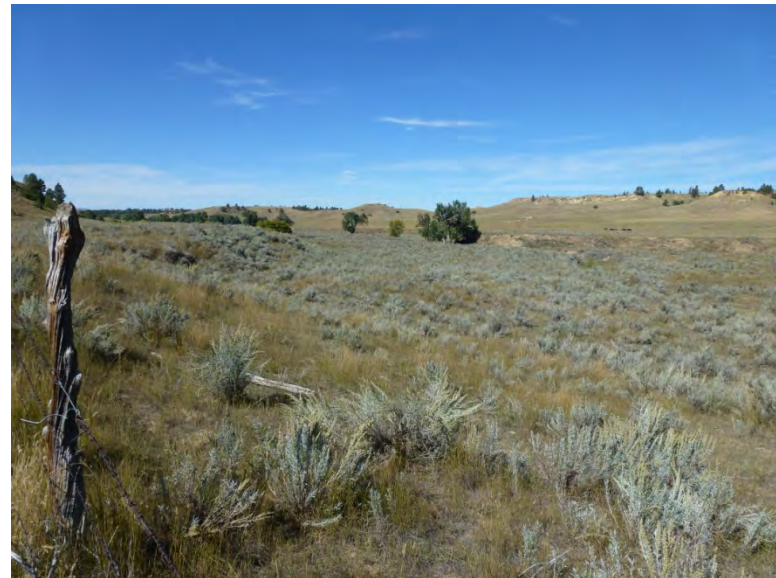
60. Upper Threemile Creek below Section 12.

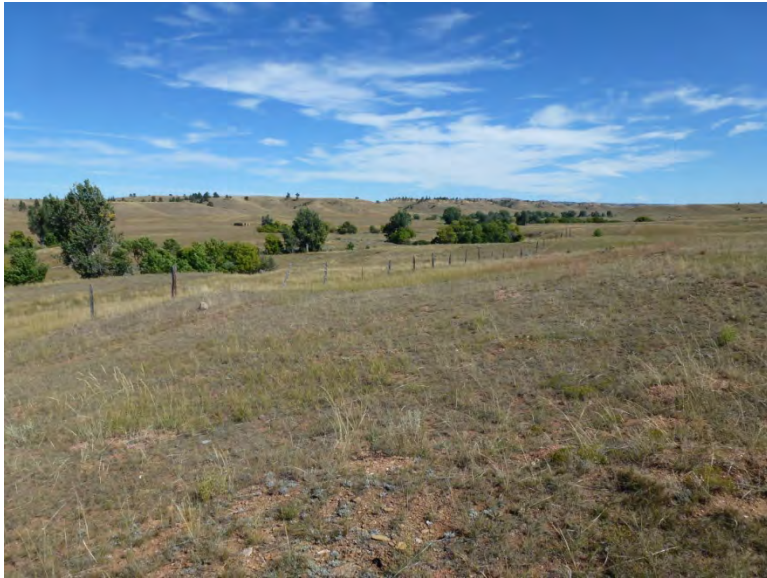
61. Threemile Creek above Stevens corrals.

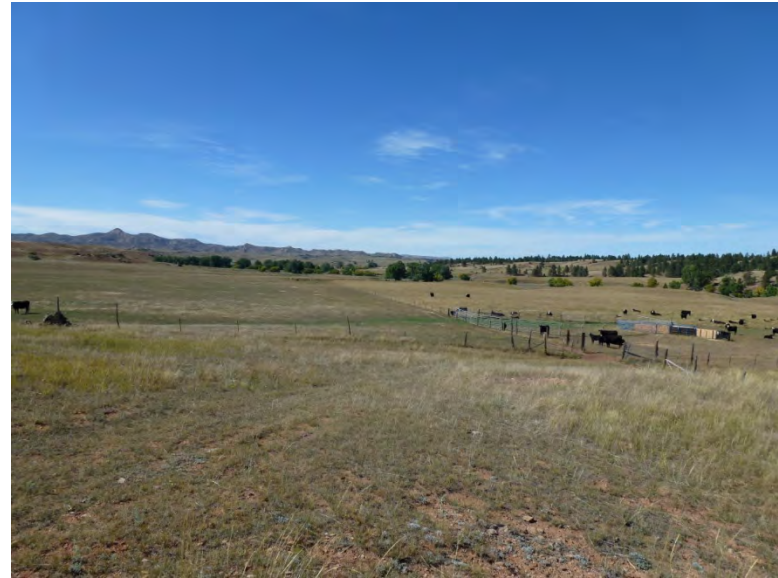
62. Threemile Creek below Stevens corrals.

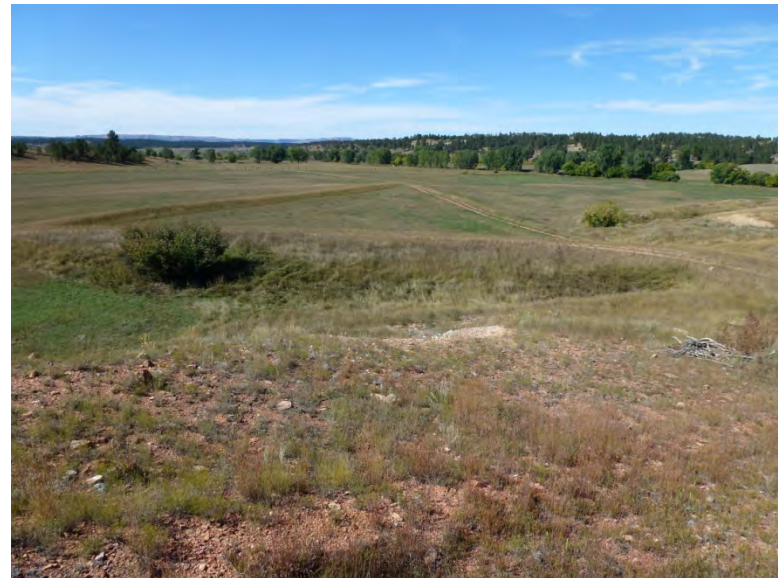
64. Dam and diversion/spreader dikes below S side drainage on Home Creek.

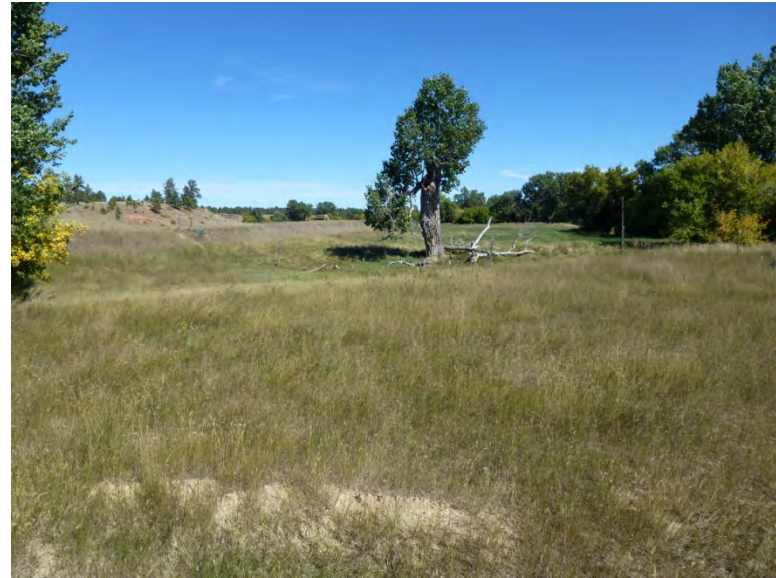
66. Diversion dike on lower Home creek diverting entire flow.

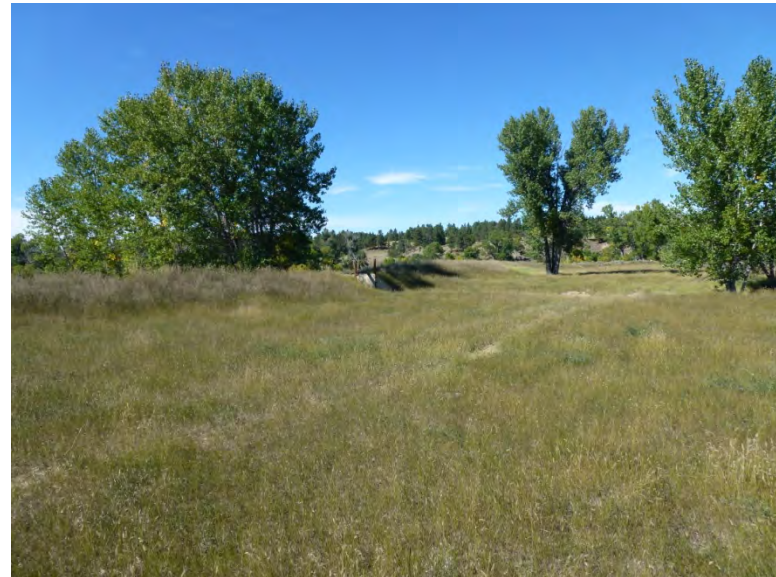
68. Perpendicular dike with head gate below Photo 67.

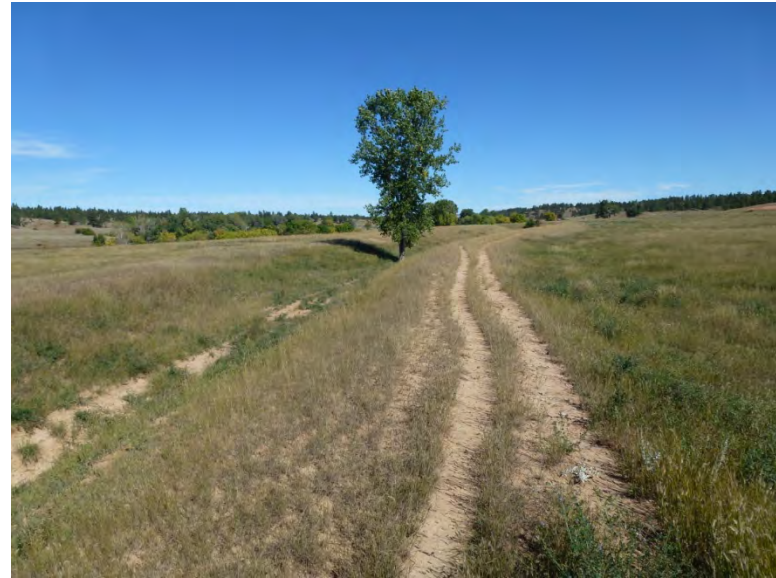
70. Ditch looking upstream.

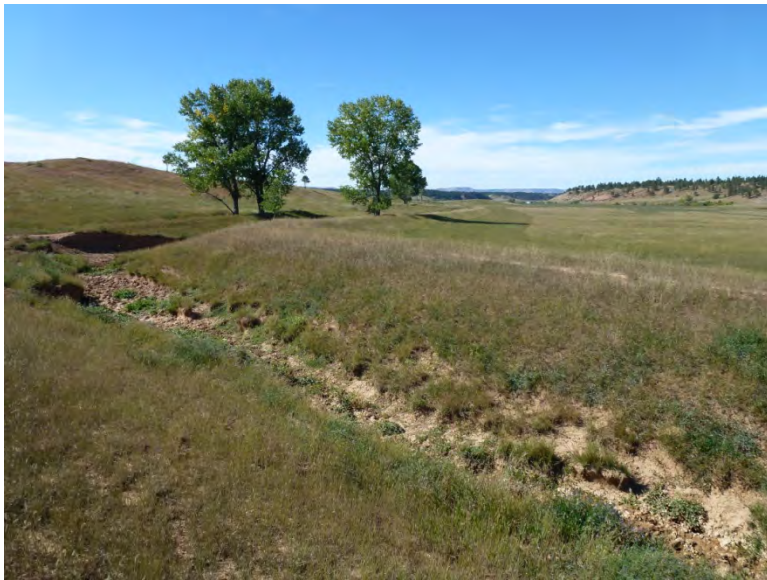
71. Ditch looking downstream to outlet at upper edge of field.

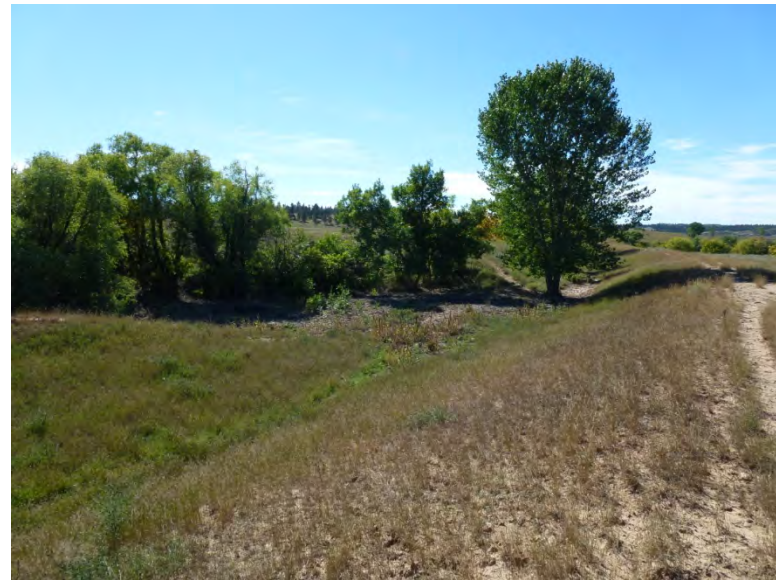
72. Interception of side drainage by lower Home Creek ditch.

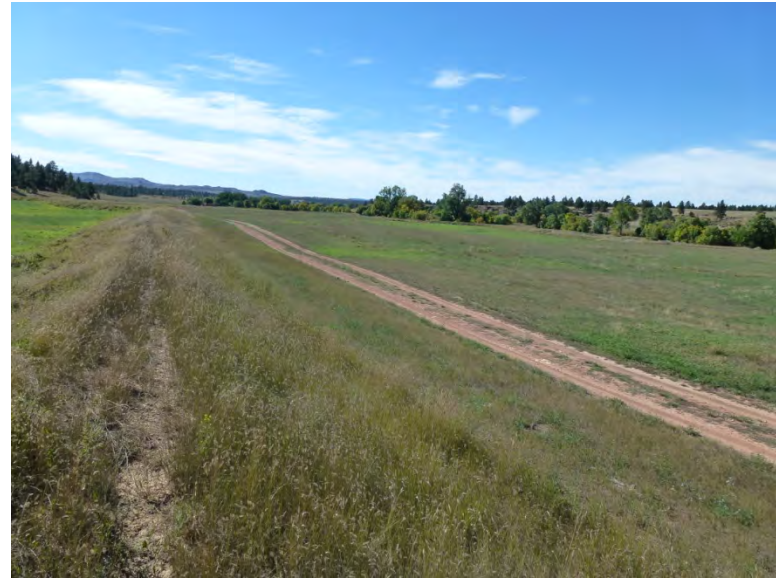
74. Spreader/diversion dike below side drainage on south side of Home Creek just below Stevens barn.

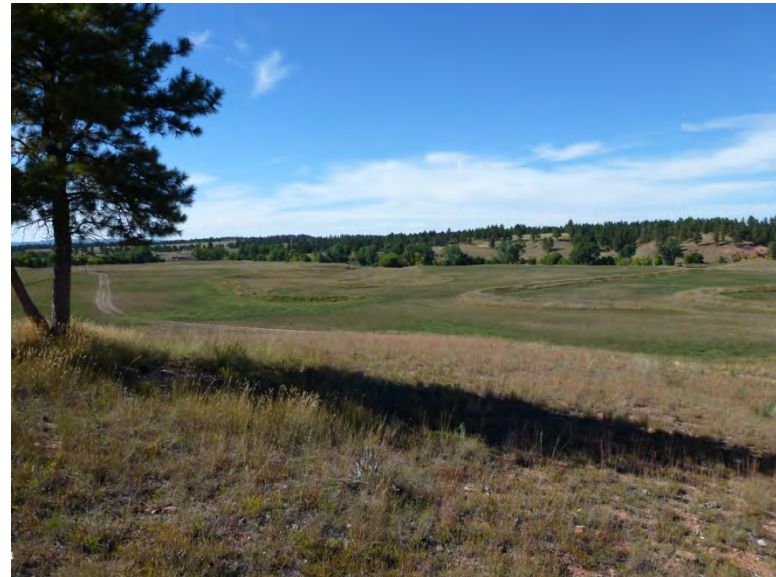
76. Home Creek spreader dikes.

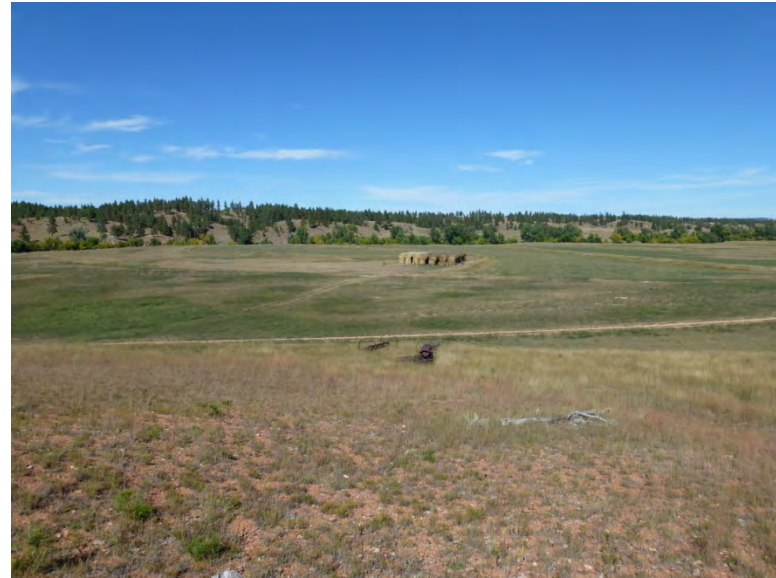
78. Home Creek spreader dikes.

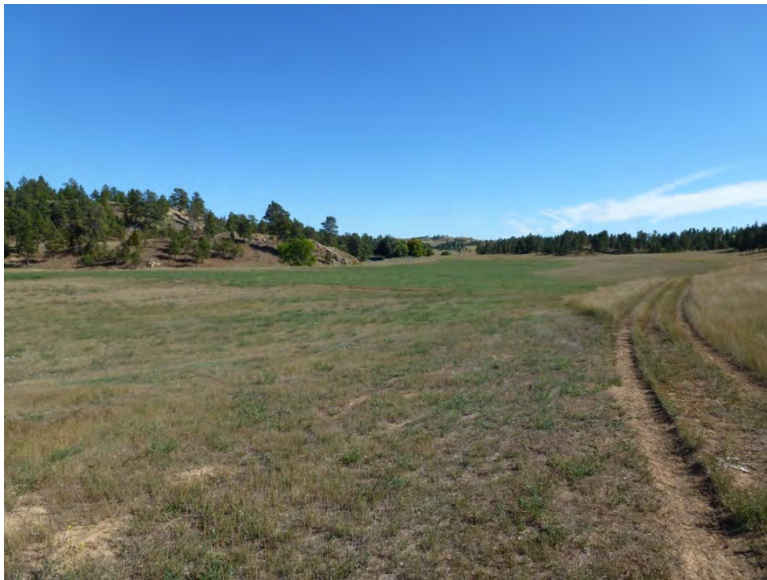
79. Spreader dikes below upper Home Creek side drainage.

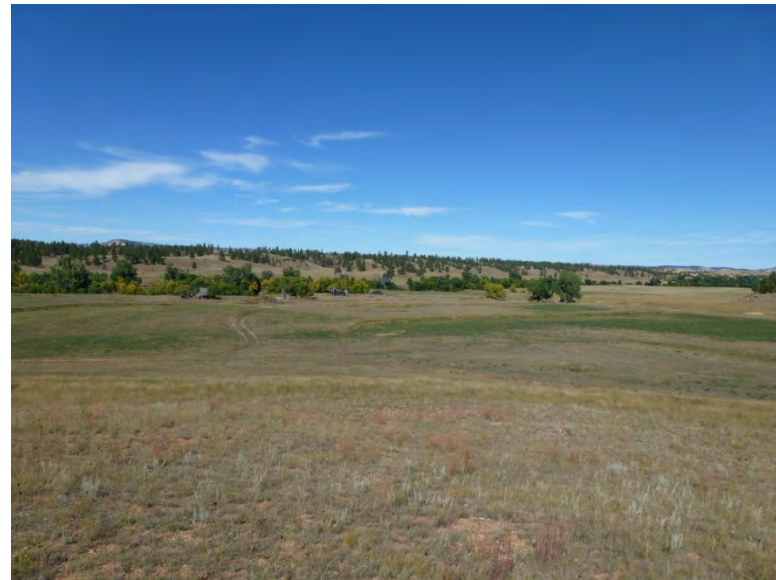
80. Spreader dikes below upper Home Creek side drainage (below Photo 79).

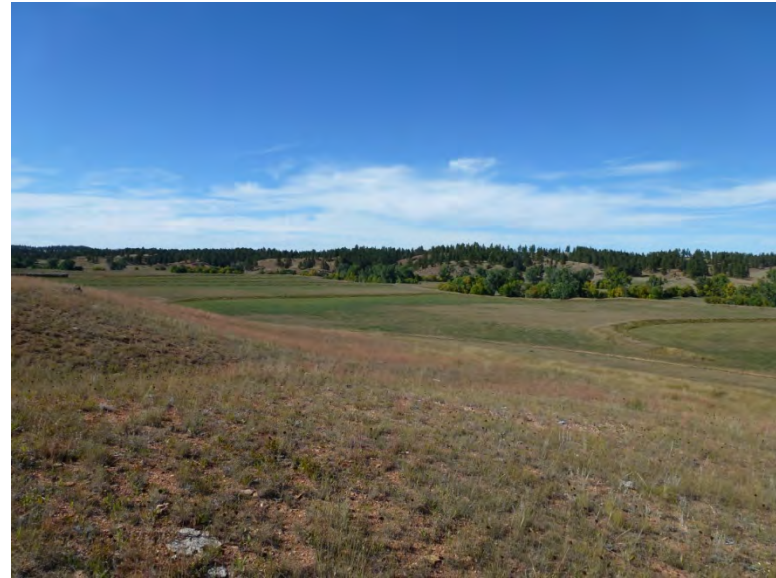
82. Spreader dikes below upper Home Creek side drainage (below Photo 81).

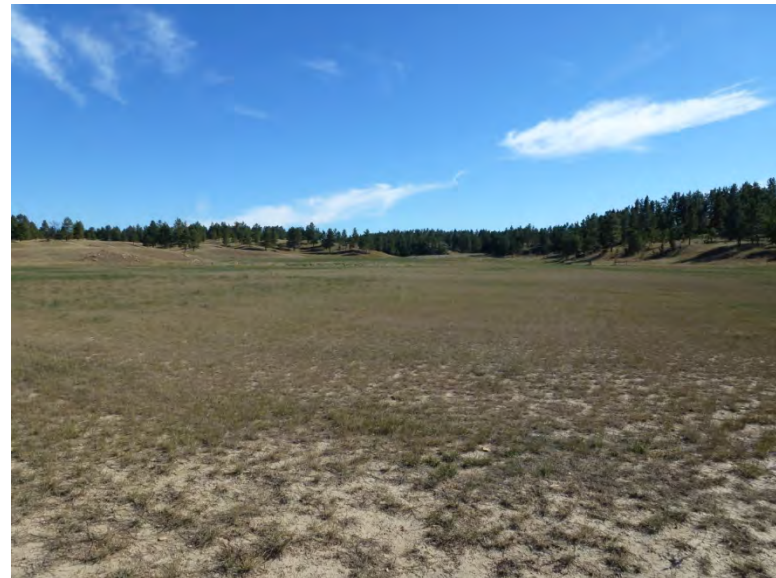
84. Spreader dikes in upper Home Crk side drainage just above Stevens barn.

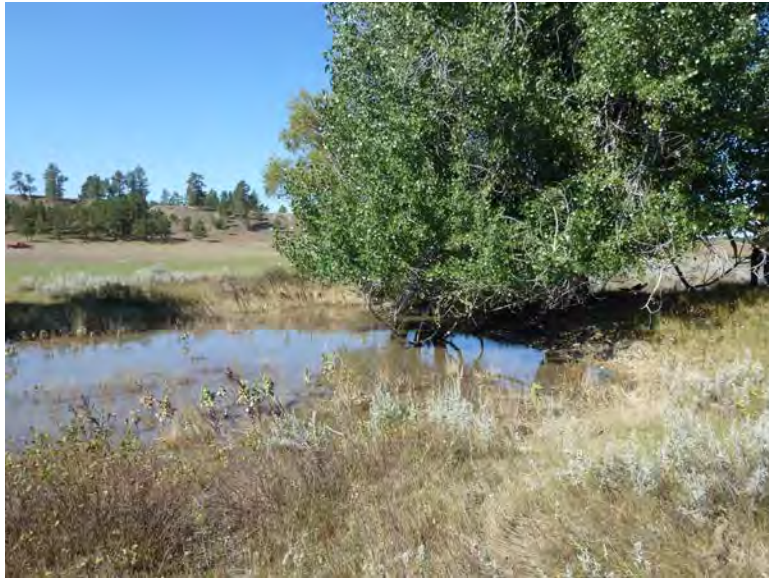
85. Dike across ephemeral tributary of Home Creek diverting flow to hay field.

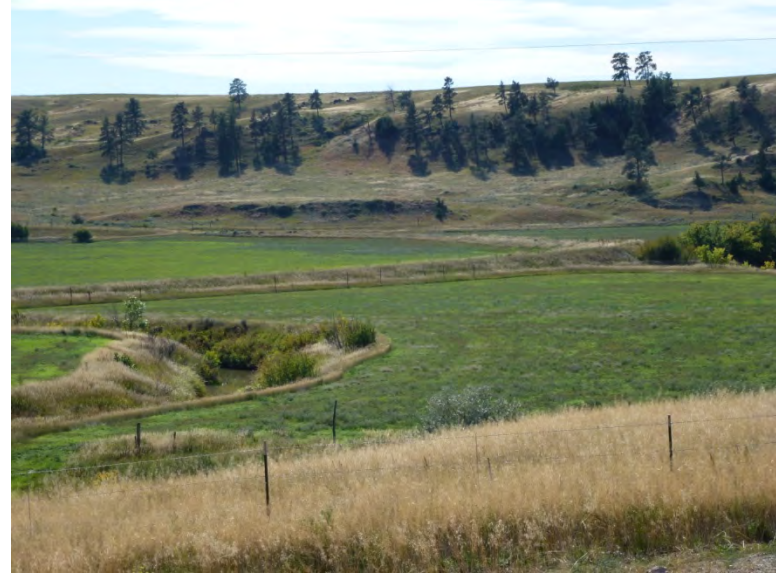
86. Spreader/interception dike along W side of Otter Crk (from Hwy 212).
