Keystone XL Pipeline Montana Stream Crossing Inspections Report

December 18, 2009

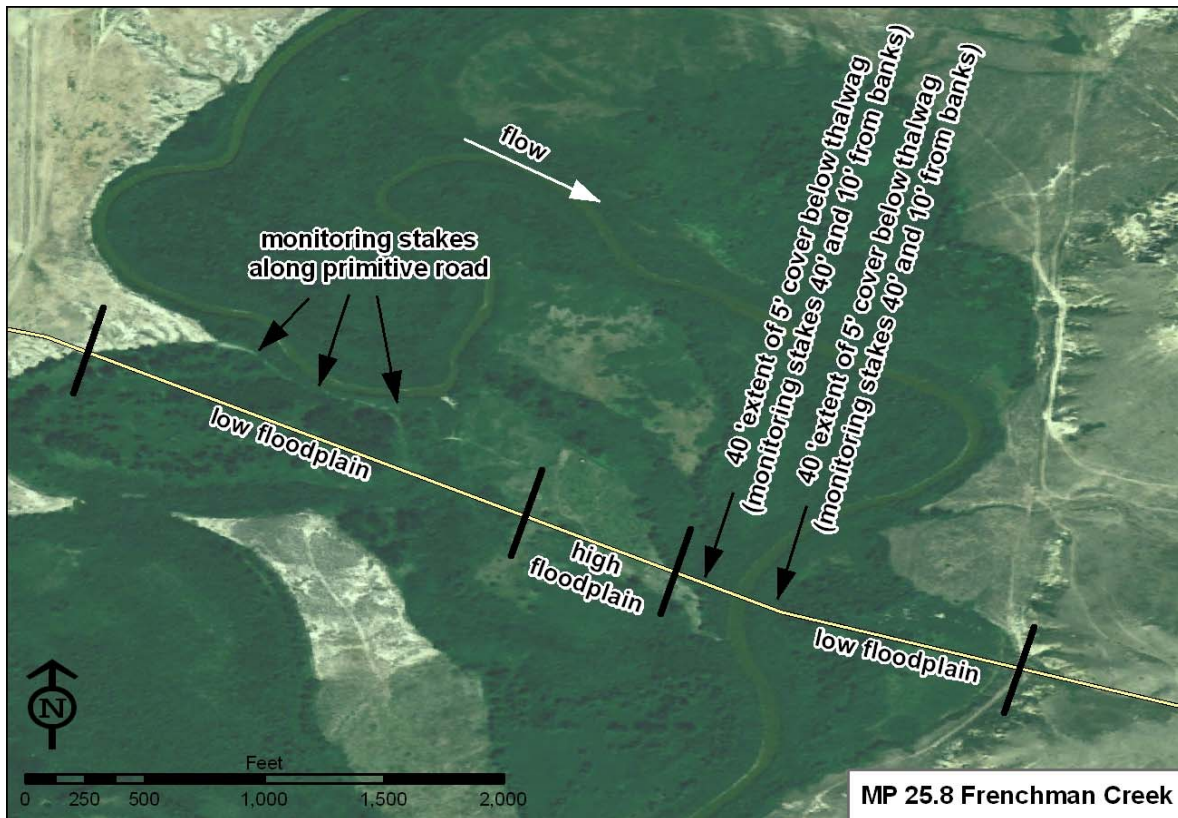
Figure 3.1-1 Burial Depth and Extent for Frenchman Creek

Two lines of documented evidence suggest that Frenchman Creek at MP 25.8 has migrated laterally throughout the alluvial valley bottom. These lines of evidence include 1) the channel meanders across the entire valley bottom upstream and downstream, 2) at the proposed crossing site the right low floodplain is a relic oxbow feature that the channel once occupied. The presence of Frenchman Reservoir immediately downstream of the proposed pipeline route has significantly altered the hydraulics at the site. The reservoir acts as grade control reducing the potential for scour and incision, and has likely greatly reduced flood velocities and associated shear stresses on the channel bed and banks, making lateral migration unlikely over the lifespan of the project. To provide protective measures the pipe could be buried to a minimum 5 feet below the channel thalweg, and maintained at that elevation 40 feet beyond both the left and right banks (approximately 140 feet in length) (Figure 3.1-1). In addition, an adaptive management plan could be used to monitor changes in the channel and implement preventative protective measures if erosion were to occur after construction is complete. At Frenchman Creek (MP 25.8) this plan would include placing field stakes 40 feet and 10 feet from the right and left channel banks where the pipeline crosses the stream. Additional monitoring stakes should be placed along the primitive road between the river upstream and the low right floodplain. During routine field inspections the location of the channel relative to the stakes should be documented. If the channel were to migrate beyond either stake placed 10 feet from the channel banks or beyond the primitive road on the right floodplain (Figure 3.1-1), preventative protection measures would be put in place to prevent further lateral migration. A list and descriptions of preventative protection measures are provided in Section 4.

The presence of Frenchman Reservoir dam downstream of the proposed crossing poses a potential risk to the pipeline. Failure of the downstream structure would result in a rapid decrease in the channel bed elevation that would quickly migrate upstream and could potentially expose and damage the pipeline. An investigation into the structural integrity and maintenance requirements of the downstream structure to assess the stability of the structure and its potential to fail during the lifetime of the project was beyond the scope of this analysis.

The proposed crossing method for Frenchman Creek would be an open cut. The crossing method will be determined at the time of construction based on site-specific conditions to ensure a successful crossing. To the extent possible the crossing should be constructed while the stream is dry or at seasonal low-flow to reduce the potential for turbid water release during construction of the crossing.

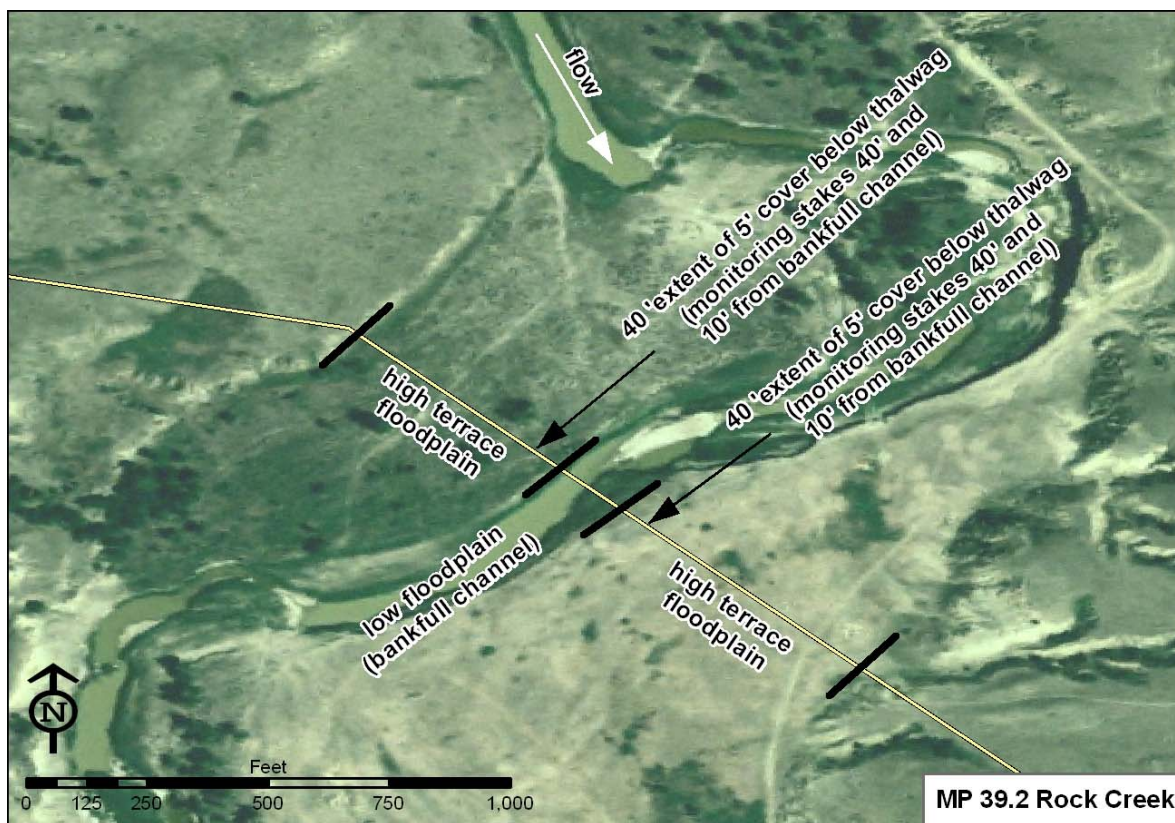
Figure 3.1-2 Burial Depth and Extent for Rock Creek

At both the upstream and downstream meander bends from the proposed crossing the channel is located at the margin of the alluvial valley bottom. The channel is actively eroding the valley margins creating high, nearly vertical cliffs composed of unconsolidated alluvium. Evidence of recent failure is present. A large failure of any of these high cliffs could potentially fill the channel at its base, causing widespread flooding and channel re-location.

if erosion were to occur after construction is complete. At Rock Creek (MP 39.2) this plan would include placing field stakes 40 feet and 10 feet from the right and left banks defining the bankfull channel where the pipeline crosses the stream (Figure 3.1-2). During routine field inspections the location of the channel relative to the stakes should be documented. If the channel were to migrate beyond either stake placed 10 feet from the bankfull boundary, preventative protection measures would be put in place to prevent further lateral migration. A list and descriptions of preventative protection measures are provided in Section 4.

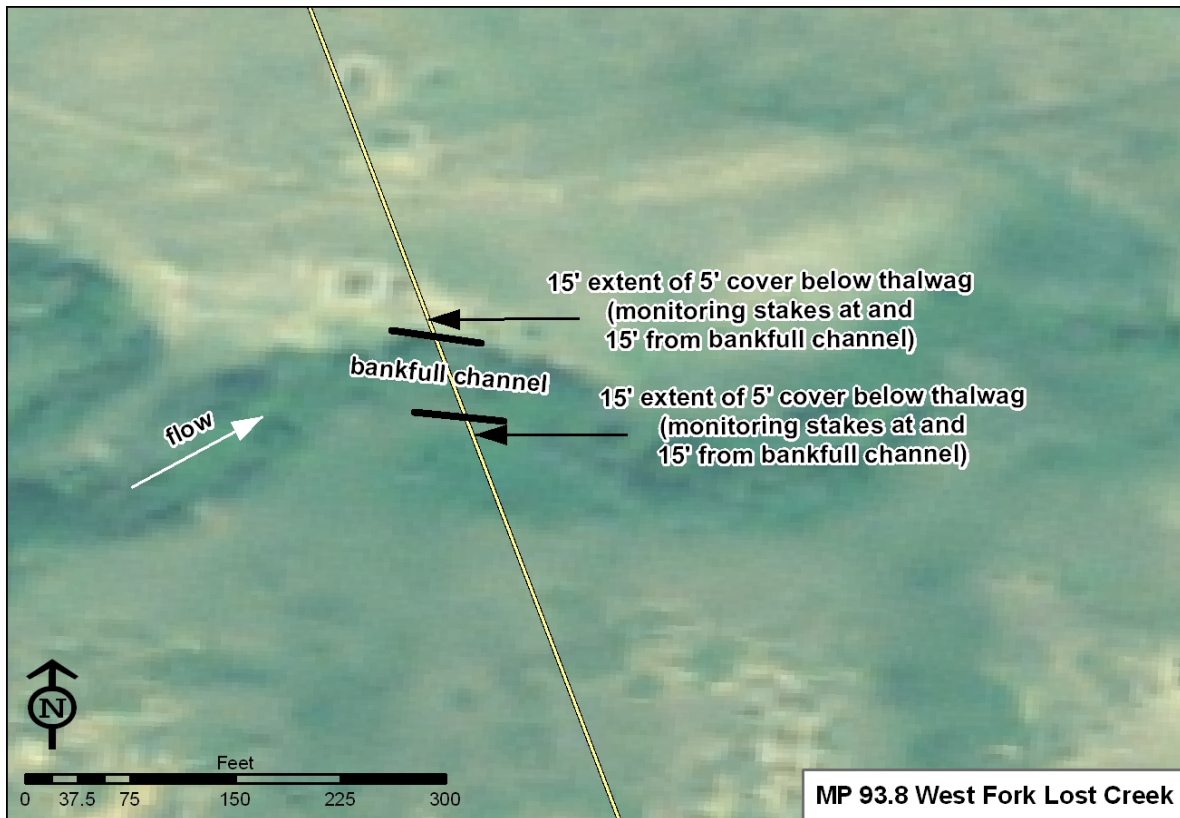
Figure 3.1-4 Burial Depth and Extent for West Fork Lost Creek

There is no evidence suggesting that West Fork Lost Creek has significantly migrated laterally. The entire stream system is confined within its valley and there is little available space to migrate. Much of the stability of the stream is from the riparian buffer along the banks and floodplain. Removal of this buffer during construction may potentially lead to accelerated bank erosion. To provide protective measures the pipe could be buried to a minimum 5 feet below the channel thalweg, and maintained at that elevation 15 feet beyond both banks (approximately 45 feet in length) (Figure 3.1-4). In addition, an adaptive management plan could be used to monitor changes in the channel and implement preventative protective measures if erosion were to occur after construction is complete. At West Fork Lost Creek (MP 93.8) this plan would include placing field stakes at and 15 feet from the right and left banks defining the bankfull channel where the pipeline crosses the stream (Figure 3.1-4). During routine field inspections the location of the channel relative to the stakes should be documented. If the channel were to migrate beyond either stake placed at the bankfull boundary, preventative protection measures would be put in place to prevent further lateral migration. A list and descriptions of preventative protection measures are provided in Section 4.

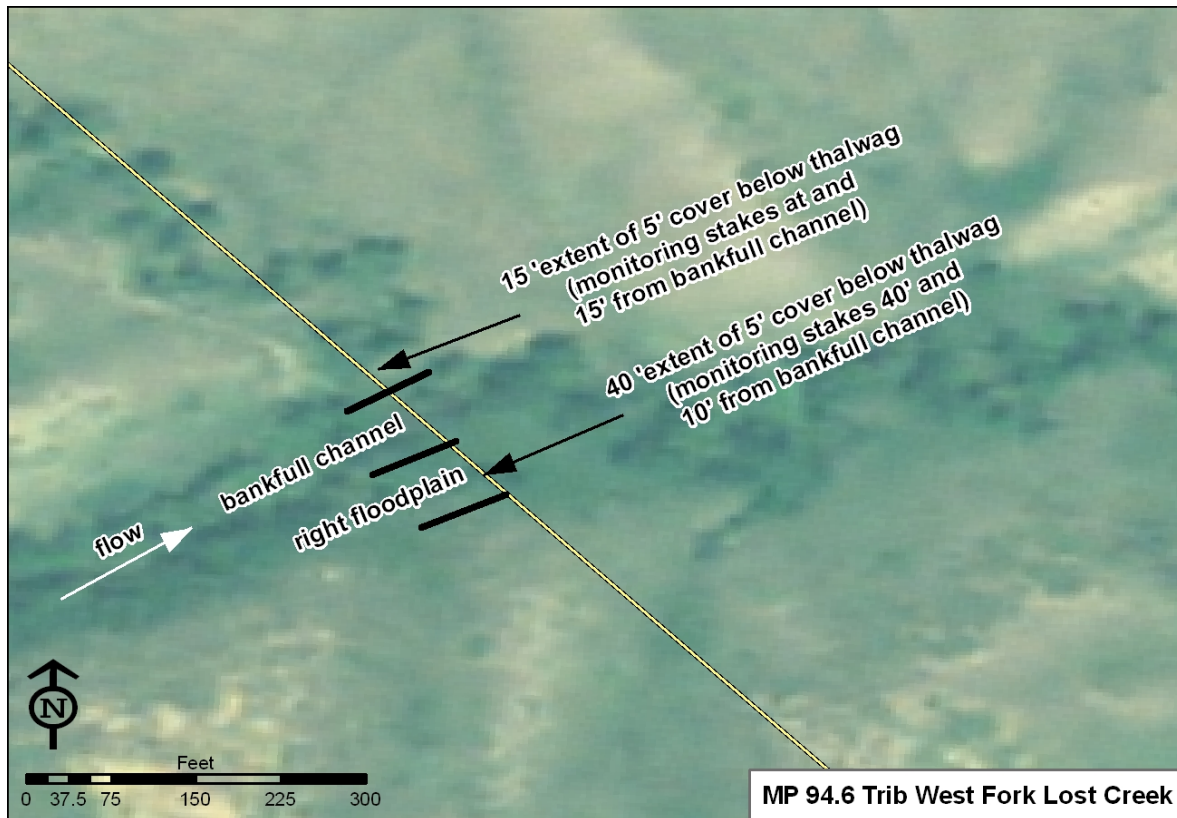
Figure 3.1-5 Burial Depth and Extent for Tributary to West Fork Lost Creek

There is no evidence suggesting that the Tributary to West Fork Lost Creek has significantly migrated laterally. The entire stream system is confined within its valley and there is little available space to migrate. Much of the stability of the stream is from the riparian buffer along the banks and floodplain. Removal of this buffer during construction may potentially lead to accelerated lateral migration into the right floodplain. To provide protective measures the pipe could be buried to a minimum 5 feet below the channel thalweg, and maintained at that elevation 15 feet beyond left bank and 40 feet beyond the right bank (approximately 95 feet in length) (Figure 3.1-5). In addition, an adaptive management plan could be used to monitor changes in the channel and implement preventative protective measures if erosion were to occur after construction is complete. At the Tributary to West Fork Lost Creek (MP 94.6) this plan would include placing a field stake at and 15 feet from the left bank defining the bankfull channel where the pipeline crosses the stream (Figure 3.1-5). Additional field stakes would be placed 40 feet and 10 feet from the bankfull boundary on the right (Figure 3.1-5). During routine field inspections the location of the channel relative to the stakes should be documented. If the channel were to migrate beyond either stake placed 10 feet from the right bankfull boundary or at the left bankfull boundary, preventative protection measures would be put in place to prevent further lateral migration. A list and descriptions of preventative protection measures are provided in Section 4.

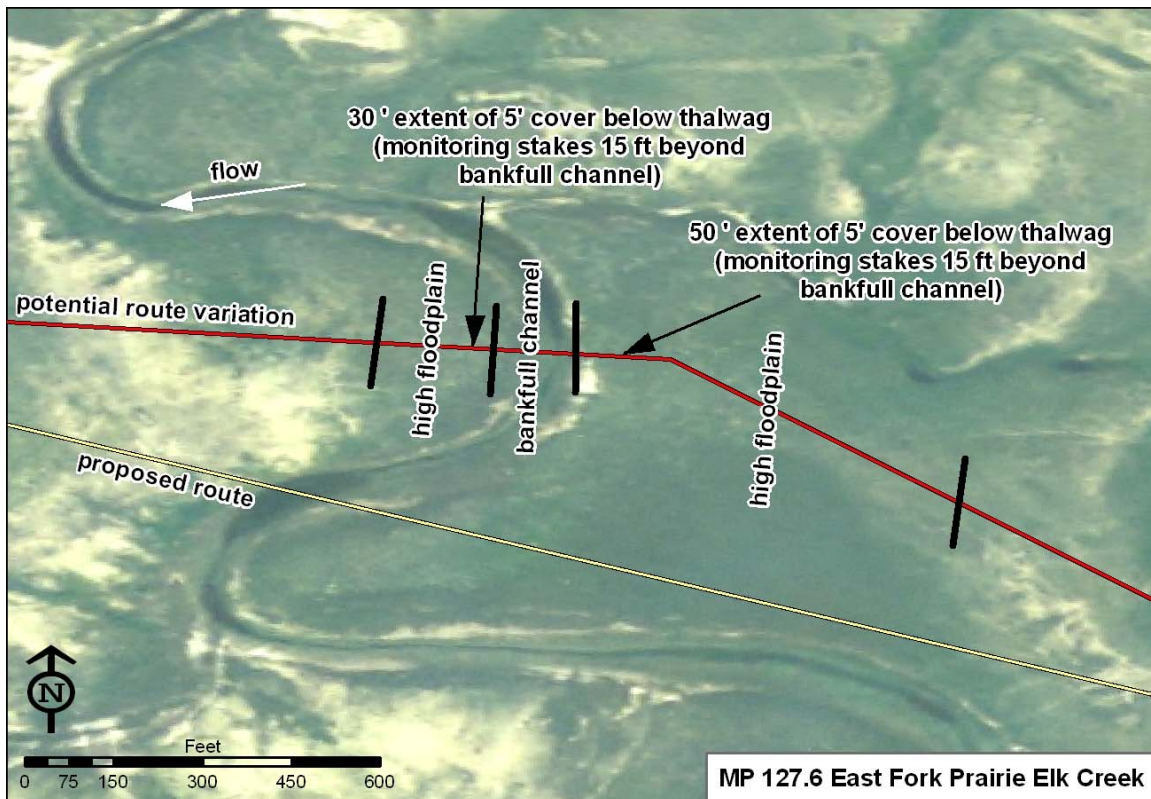
Figure 3.1-6 Burial Depth and Extent for East Fork Prairie Elk Creek

Two lines of documented evidence suggest that East Fork Prairie Elk Creek at the proposed adjusted crossing location has the potential to migrate laterally across the alluvial valley bottom. These lines of evidence include 1) the channel meanders across the entire valley bottom upstream and downstream, 2) at the proposed crossing site the 5-foot-high unvegetated right bank is composed of highly erodible material and has documented slump features. To provide protective measures the pipe could be buried to a minimum 5 feet below the channel thalweg, and maintained at that elevation 40 feet beyond both the left and right high (bankfull) banks (approximately 170 feet in length) (Figure 3.1-6). In addition, an adaptive management plan could be used to monitor changes in the channel and implement preventative protective measures if erosion were to occur after construction is complete. At East Fork Prairie Elk Creek this plan would include placing field stakes 40 feet and 10 feet from the right and left banks defining the bankfull channel where the pipeline crosses the stream (Figure 3.1-6). During routine field inspections the location of the channel relative to the stakes should be documented. If the channel were to migrate beyond either stake placed 10 feet from the bankfull boundary, preventative protection measures would be put in place to prevent further lateral migration. A list and descriptions of preventative protection measures are provided in Section 4.

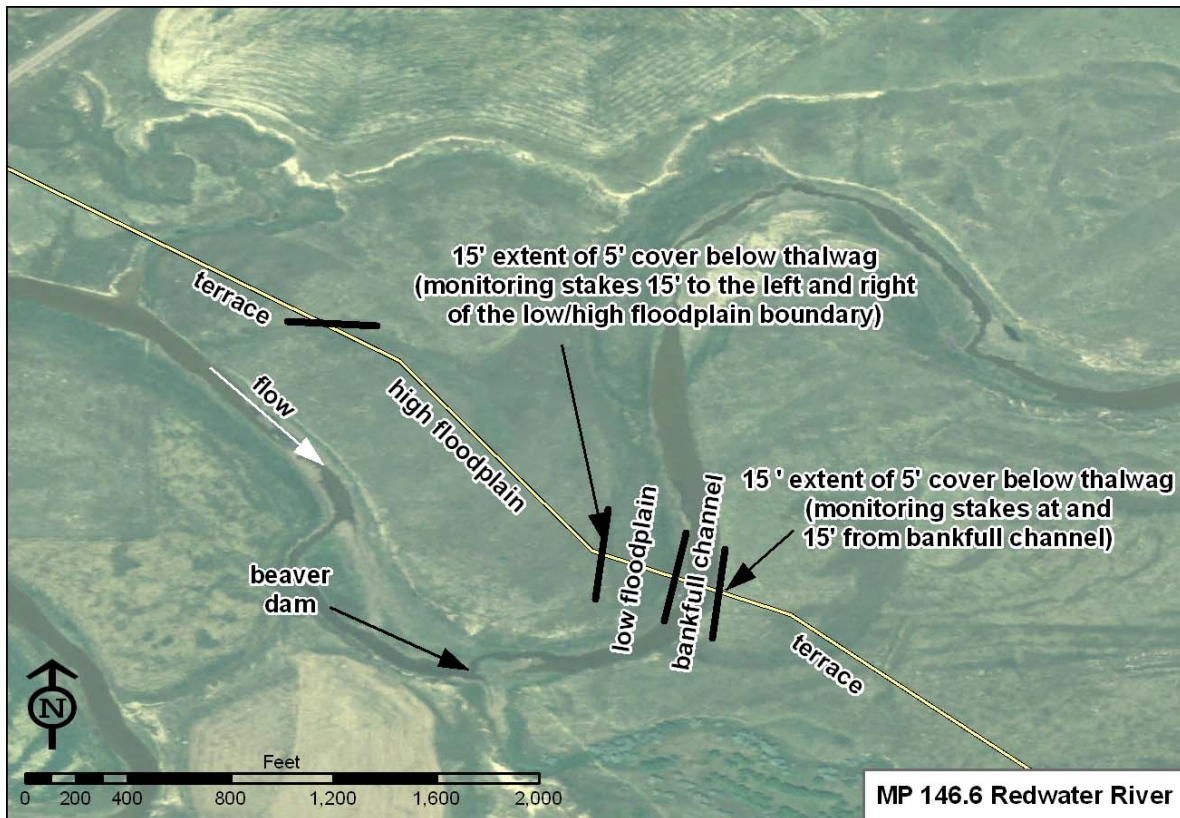
Figure 3.1-7 Burial Depth and Extent for Redwater River

Two lines of documented evidence suggest that the Redwater River at MP 146.6 has the potential to migrate laterally across the alluvial valley bottom. These lines of evidence include 1) the channel meanders across the entire valley bottom upstream and downstream, 2) at the proposed crossing site the 2-foot-high left bank has documented slump features. To provide protective measures the pipe could be buried to a minimum 5 feet below the channel thalweg, and maintained at that elevation 15 feet beyond the left low floodplain and 15 feet beyond the top of the 14-foot-high right bank (approximately 175 feet in length) (Figure 3.1-7). In addition, an adaptive management plan could be used to monitor changes in the channel and implement preventative protective measures if erosion were to occur after construction is complete. At the Redwater River (MP 146.6) this plan would include placing a field stake at and 15 feet from the right high bank defining the bankfull channel where the pipeline crosses the stream (Figure 3.1-7). Additional field stakes would be placed 15 feet to the left and right of the left low/high floodplain boundary (Figure 3.1-7). During routine field inspections the location of the channel relative to the stakes should be documented. If the channel were to migrate beyond either stake placed on the right of the bankfull boundary or 15 feet to the right of the left low/high floodplain boundary, preventative protection measures would be put in place to prevent further lateral migration. A list and descriptions of preventative protection measures are provided in Section 4.

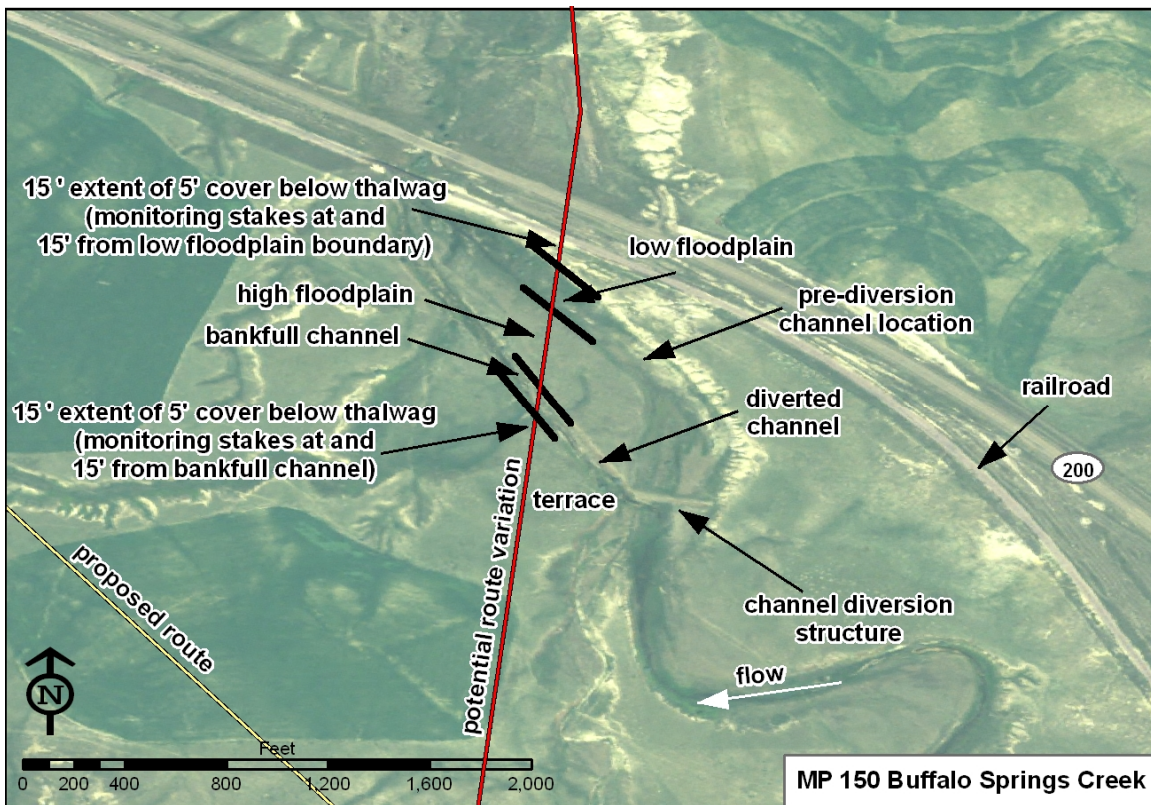
Figure 3.1-8 Burial Depth and Extent for Buffalo Springs Creek

The proposed crossing of Buffalo Springs Creek will likely be a more engineered solution than is provided in the discussion to follow, given the proposed route crosses a railroad and major highway adjacent to the stream crossing. The suggestions provided here account for the stream crossing only, and do not consider limitations to construction imposed from the adjacent railroad and highway crossings. To provide protective measures the pipe could be buried to a minimum 5 feet below the channel thalweg, and maintained at that elevation 15 feet beyond the left bankfull boundary and 15 feet beyond the right limit of the right low floodplain (approximately 270 feet in length) (Figure 3.1-8). In addition, an adaptive management plan could be used to monitor changes in the channel and implement preventative protective measures if erosion were to occur after construction is complete. At the Buffalo Springs Creek (MP 150) this plan would include placing a field stake at and 15 feet from the left high bank defining the bankfull channel where the pipeline crosses the stream (Figure 3.1-8). Additional field stakes would be placed on and 15 feet to the right of the right low floodplain boundary (Figure 3.1-8). During routine field inspections the location of the channel relative to the stakes should be documented. If the channel were to migrate beyond either stake placed on the left bankfull boundary or on the right low floodplain boundary, preventative protection measures would be put in place to prevent further lateral migration. A list and descriptions of preventative protection measures are provided in Section 4.

The presence of the diversion structure upstream of the proposed crossing poses a potential risk to the pipeline. Failure of the structure during flood would likely result in a highly erosive floodwave with the potential to expose and damage the pipeline. An investigation into the structural integrity and maintenance requirements of the diversion structure to assess the stability of the structure and its potential to fail during the lifetime of the project is beyond the scope of this assessment.

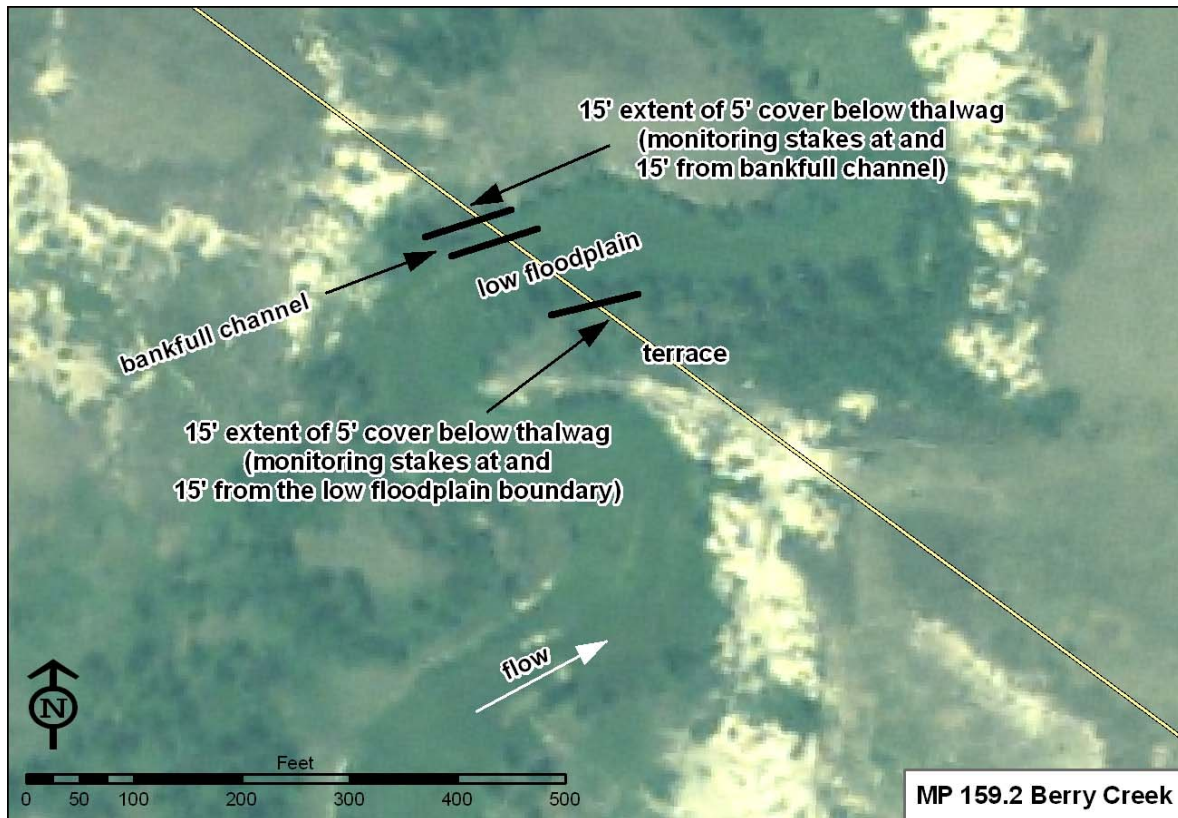
Figure 3.1-9 Burial Depth and Extent for Berry Creek

Given the incised nature of Berry Creek, flood flows do not have room to spread laterally during high water. This condition leads to deeper and faster flood flows with more erosive potential than a stream of similar drainage area that is not incised. To provide protective measures the pipe could be buried to a minimum 5 feet below the channel thalweg, and maintained at that elevation 15 feet beyond the left and right valley walls (approximately 110 feet in length) (Figure 3.1-9). In addition, an adaptive management plan could be used to monitor changes in the channel and implement preventative protective measures if erosion were to occur after construction is complete. At the Berry Creek (MP 159.2) this plan would include placing a field stake at and 15 feet from the right high bank defining the bankfull channel where the pipeline crosses the stream (Figure 3.1-9). Additional field stakes would be placed at and 15 feet to the right of the right low floodplain boundary (Figure 3.1-9). During routine field inspections the location of the channel relative to the stakes should be documented. If the channel were to migrate beyond either stake placed at the bankfull boundary or at the right low floodplain boundary, preventative protection measures would be put in place to prevent further lateral migration. A list and descriptions of preventative protection measures are provided in Section 4.

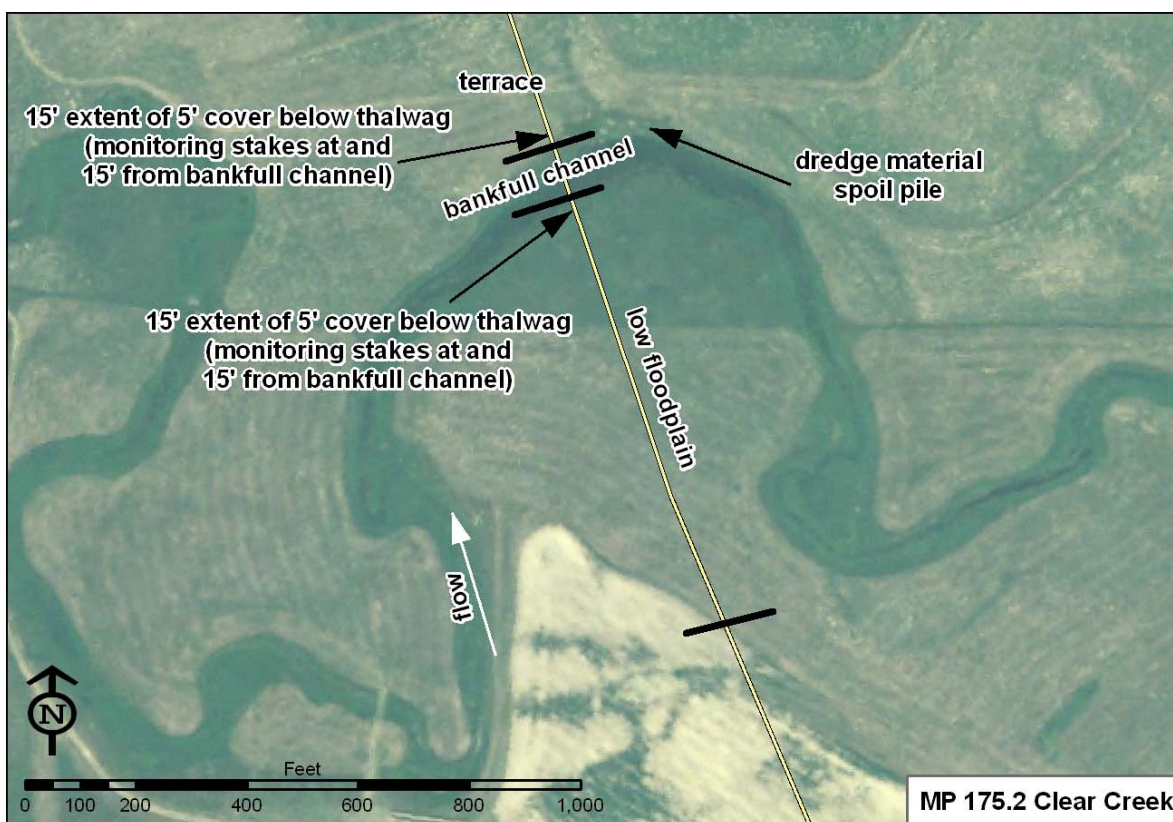
Figure 3.1-10 Burial Depth and Extent for Clear Creek

There is no documented evidence of recent lateral migration of Clear Creek at the MP 175.2 crossing and little to no evidence suggesting lateral migration is likely during the expected lifespan of the project. The only evidence suggesting lateral migration is the documented slumping along the left bank, however this slumping is likely due to oversteepening during dredging of the channel and not from erosion during flooding. To provide protective measures the pipe could be buried to a minimum 5 feet below the channel thalweg, and maintained at that elevation 15 feet beyond both the left and right bankfull banks (approximately 110 feet in length) (Figure 3.1-10). In addition, an adaptive management plan could be used to monitor changes in the channel and implement preventative protective measures if erosion were to occur after construction is complete. At Clear Creek (MP 175.2) this plan would include placing field stakes at and 15 feet from the right and left banks defining the bankfull channel where the pipeline crosses the stream (Figure 3.1-10). During routine field inspections the location of the channel relative to the stakes should be documented. If the channel were to migrate beyond either stake placed at the bankfull boundary, preventative protection measures would be put in place to prevent further lateral migration. A list and descriptions of alternative preventative protection measures are provided in Section 4. Continued excavation of the channel poses a risk of damage to the pipeline. If excavations were to continue after installation of the pipeline, then the pipe should be buried to a depth that would maintain a minimum of 5 feet of cover over the pipe from the maximum depth of excavation.

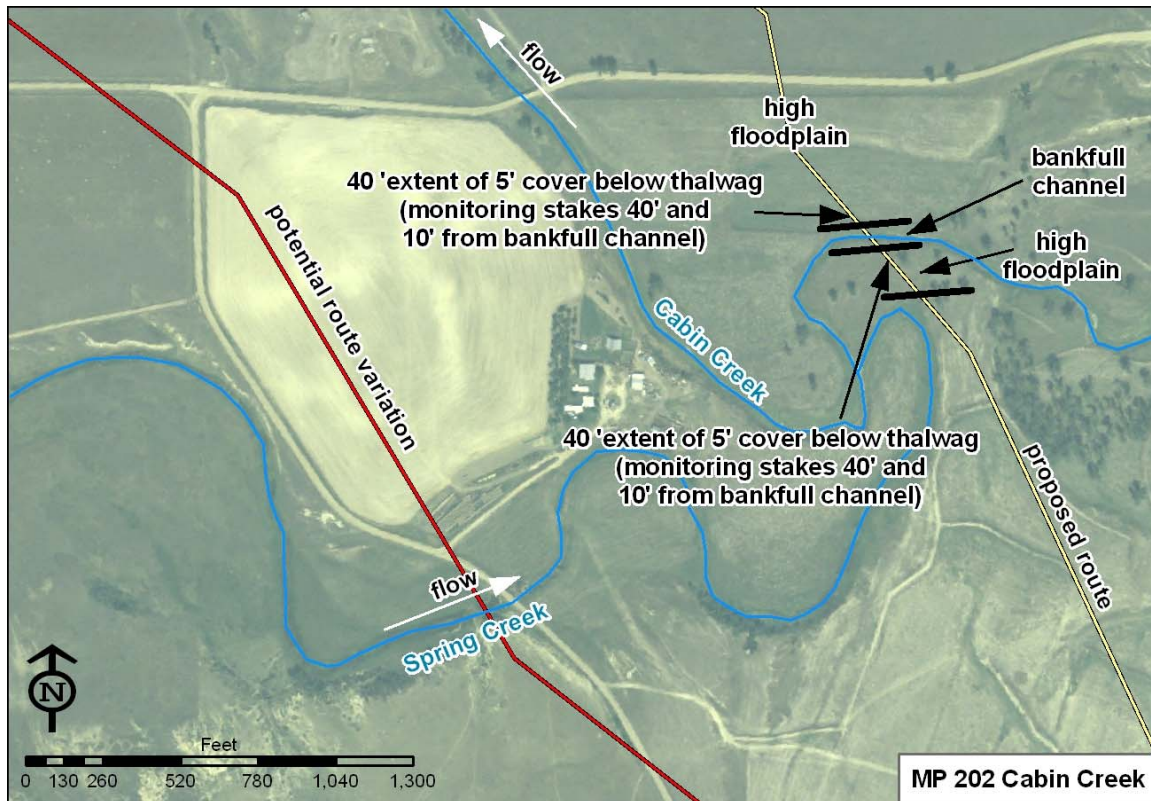
Figure 3.1-11 Burial Depth and Extent for Cabin Creek

The documented bank slumping and undercutting does not appear to be a result of gradual channel migration, but rather as a result of a highly incised channel with steep high banks. To provide protective measures the pipe could be buried to a minimum 5 feet below the channel thalweg, and maintained at that elevation 40 feet beyond the top of the 10-foot-high banks on either side of the channel (approximately 150 feet in length) (Figure 3.1-11). In addition, an adaptive management plan could be used to monitor changes in the channel and implement preventative protective measures if erosion were to occur after construction is complete. At Cabin Creek (MP 202) this plan would include placing field stakes 40 feet and 10 feet from the right and left banks defining the bankfull channel where the pipeline crosses the stream (Figure 3.1-11). During routine field inspections the location of the channel relative to the stakes should be documented. If the channel were to migrate beyond either stake placed 10 feet from the bankfull boundary, preventative protection measures would be put in place to prevent further lateral migration. A list and descriptions of preventative protection measures are provided in Section 4.

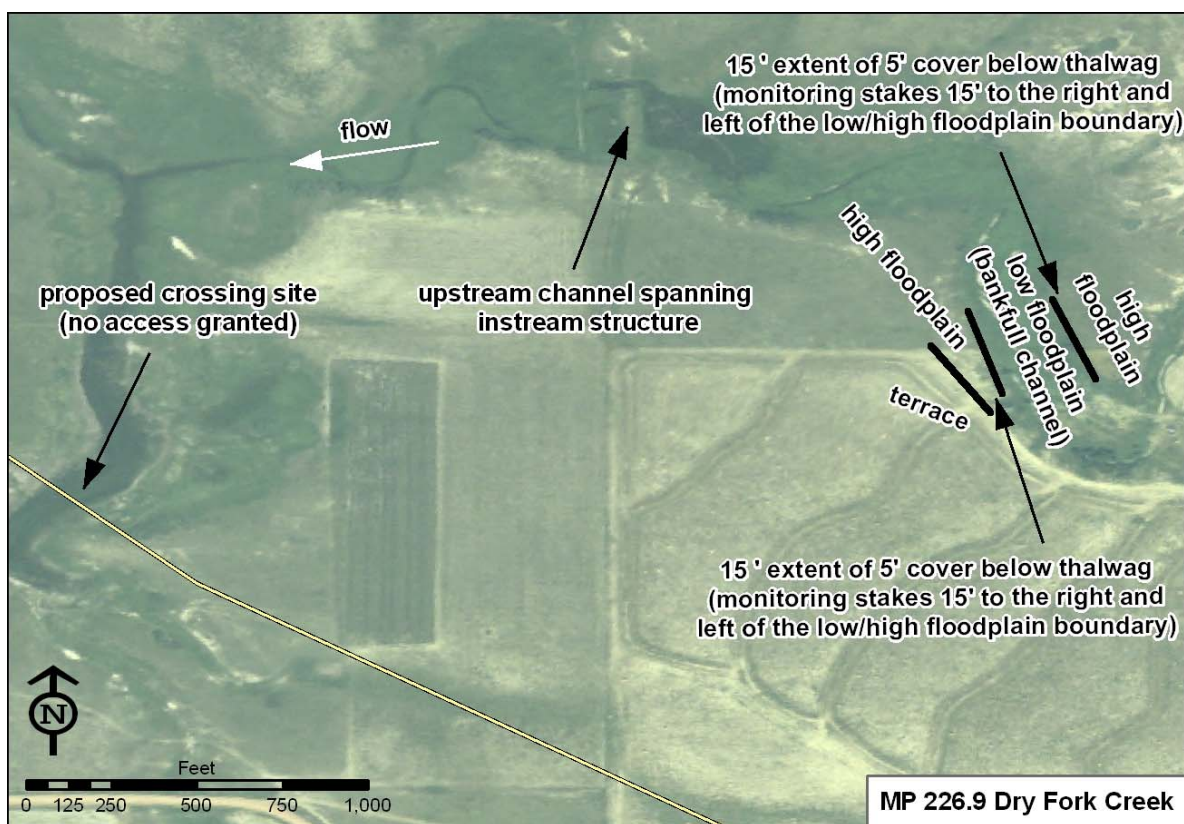
Figure 3.1-12 Burial Depth and Extent for Dry Fork Creek

Two lines of documented evidence suggest that Dry Fork Creek at MP 226.9 has the potential to migrate laterally throughout the alluvial valley bottom during the lifetime of the project. These lines of evidence include 1) the channel meanders across the entire valley bottom upstream and downstream, 2) the presence of a high flow channel within the left bank floodplain that conveys low flow discharges and has the potential to both locally scour and serve as an avulsion channel. To provide protective measures the pipe could be buried to a minimum 5 feet below the channel thalweg, and maintained at that elevation 15 feet beyond both the left and right low floodplains (approximately 350 feet in length) where present (Figure 3.1-12). In addition, an adaptive management plan could be used to monitor changes in the channel and implement preventative protective measures if erosion were to occur after construction is complete. At Dry Fork Creek (MP 226.9) this plan would include placing field stakes 15 feet beyond the right and left banks defining the low floodplain where the pipeline crosses the stream (Figure 3.1-12). Additional field stakes would be placed 15 feet within the right and left banks defining the low floodplain where the pipeline crosses the stream (Figure 3.1-12). During routine field inspections the location of the channel relative to the stakes should be documented. If the channel were to migrate beyond either stake placed 15 feet within the right or left low floodplain boundary, preventative protection measures would be put in place to prevent further lateral migration. A list and descriptions of preventative protection measures are provided in Section 4.

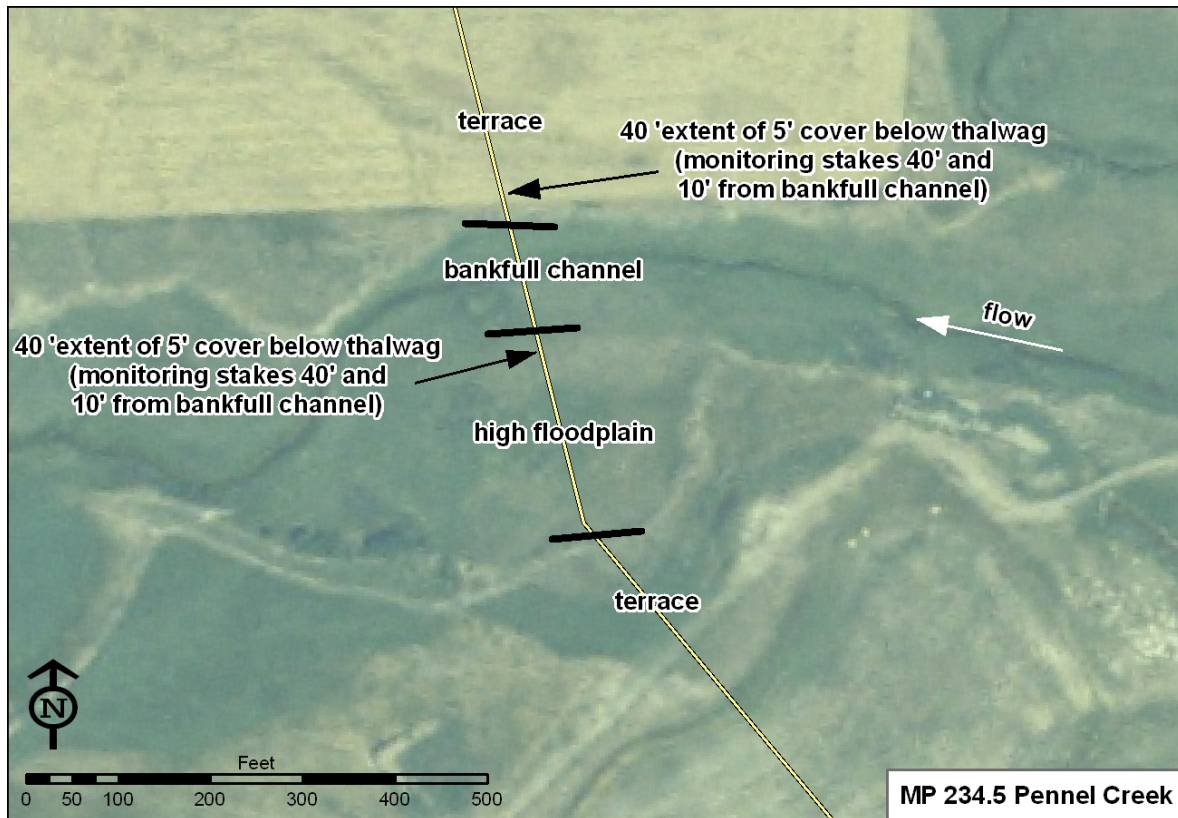
Figure 3.1-13 Burial Depth and Extent for Pennel Creek

Given the channel geometry similarity between the alternate assessment location and the proposed crossing, site-specific suggestions are provided for the proposed crossing location. Two lines of documented evidence suggest that the thalweg of Pennel Creek has the potential to migrate laterally throughout the bankfull channel during the lifetime of the project. These lines of evidence include 1) the thalweg meanders across the entire bankfull channel upstream and downstream, 2) active bank slumping was observed along the thalweg channel. To provide protective measures the pipe could be buried to a minimum 5 feet below the channel thalweg, and maintained at that elevation 40 feet beyond both the top of the left and right bankfull banks (approximately 180 feet in length) (Figure 3.1-13). In addition, an adaptive management plan could be used to monitor changes in the channel and implement preventative protective measures if erosion were to occur after construction is complete. At Pennel Creek (MP 234.5) this plan would include placing field stakes 40 feet and 10 feet from the right and left banks defining the bankfull channel where the pipeline crosses the stream (Figure 3.1-13). During routine field inspections the location of the channel relative to the stakes should be documented. If the channel were to migrate beyond either stake placed 10 feet from the bankfull boundary, preventative protection measures would be put in place to prevent further lateral migration. A list and descriptions of preventative protection measures are provided in Section 4.

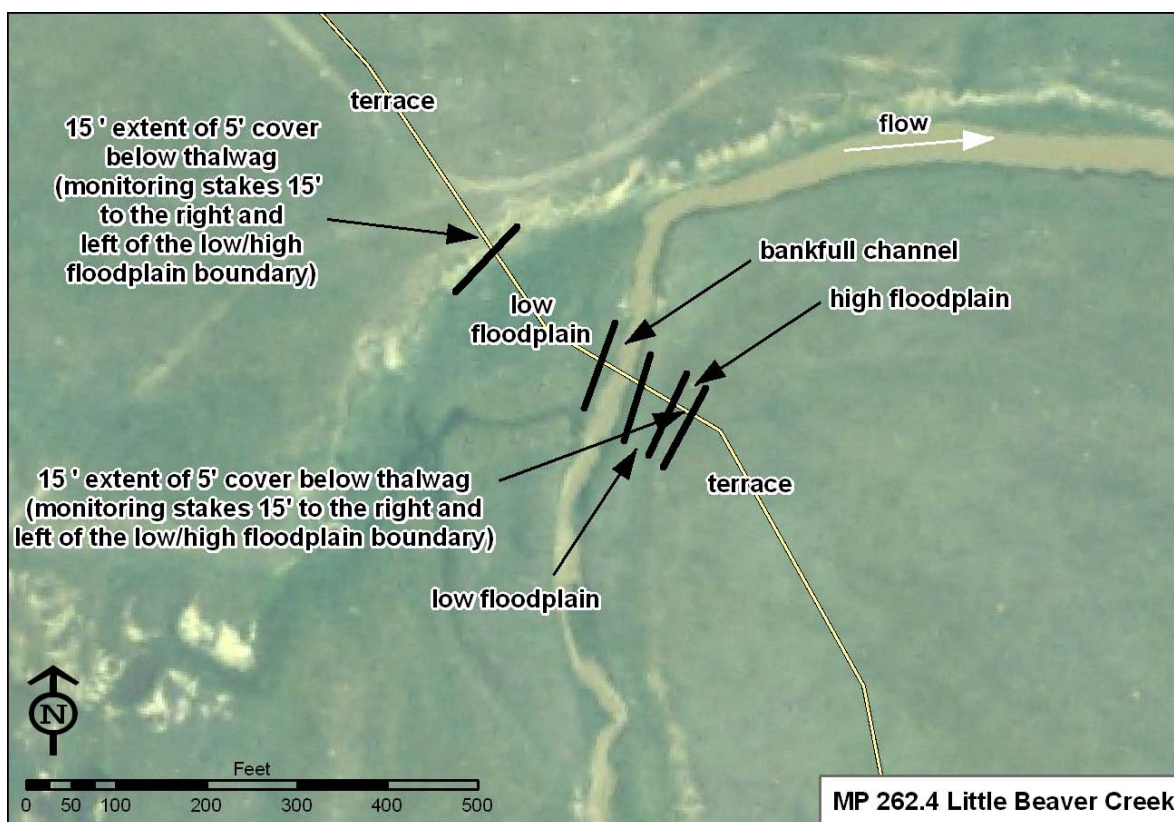
Figure 3.1-14 Burial Depth and Extent for Little Beaver Creek

Two lines of documented evidence suggest that Little Beaver Creek at MP 262.4 has the potential to migrate laterally. These lines of evidence include 1) the channel meanders across the entire valley bottom upstream and downstream, 2) at the proposed crossing site the 3-foot-high left bank has documented slump features. The pipe could be buried to a minimum 5 feet below the channel thalweg, and maintained at that elevation 15 feet beyond the top of the 35-foot bank defining the extent of the left floodplain and 15 feet beyond the top of the bank defining the limit of the right low floodplain (approximately 245 feet in length) (Figure 3.1-14). In addition, an adaptive management plan could be used to monitor changes in the channel and implement preventative protective measures if erosion were to occur after construction is complete. At Little Beaver Creek (MP 262.4) this plan would include placing field stakes 15 feet beyond the right and left banks defining the low floodplain where the pipeline crosses the stream (Figure 3.1-14). Additional field stakes would be placed 15 feet within the right and left banks defining the low floodplain where the pipeline crosses the stream (Figure 3.1-14). During routine field inspections the location of the channel relative to the stakes should be documented. If the channel were to migrate beyond either stake placed 15 feet within the right or left low floodplain boundary, preventative protection measures would be put in place to prevent further lateral migration. A list and descriptions of preventative protection measures are provided in Section 4.

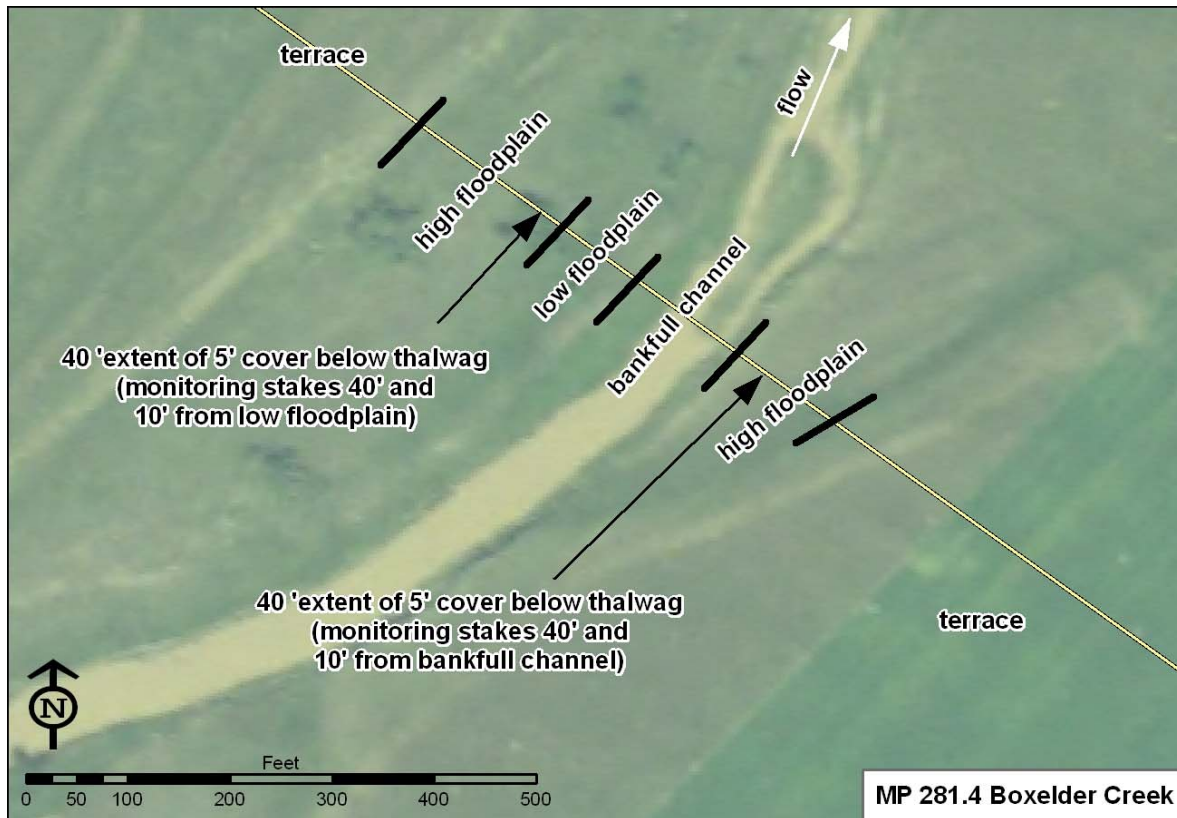
Figure 3.1-15 Burial Depth and Extent for Boxelder Creek

Two lines of documented evidence suggest that Boxelder Creek at MP 281.4 has the potential to migrate laterally. These lines of evidence include 1) the channel meanders across the entire valley bottom upstream and downstream, 2) at the proposed crossing site the 15 to 20-foot-high right bank has several locations of documented failure. To provide protective measures the pipe could be buried to a minimum 5 feet below the channel thalweg, and maintained at that elevation 40 feet beyond the top of the 15 to 20-foot right bank and 40 feet beyond the top of the left bank defining the limit of the low floodplain, (approximately 290 feet in length) (Figure 3.1-15). In addition, an adaptive management plan could be used to monitor changes in the channel and implement preventative protective measures if erosion were to occur after construction is complete. At Boxelder Creek (MP 281.4) this plan would include placing field stakes 40 feet and 10 feet from the right bankfull channel where the pipeline crosses the stream (Figure 3.1-15). Additional field stakes would be placed 40 feet and 10 feet to the left of the left low/high floodplain boundary (Figure 3.1-15). During routine field inspections the location of the channel relative to the stakes should be documented. If the channel were to migrate beyond either stake placed 10 feet from the bankfull boundary or 10 feet from the low/high floodplain boundary, preventative protection measures would be put in place to prevent further lateral migration. A list and descriptions of preventative protection measures are provided in Section 4.

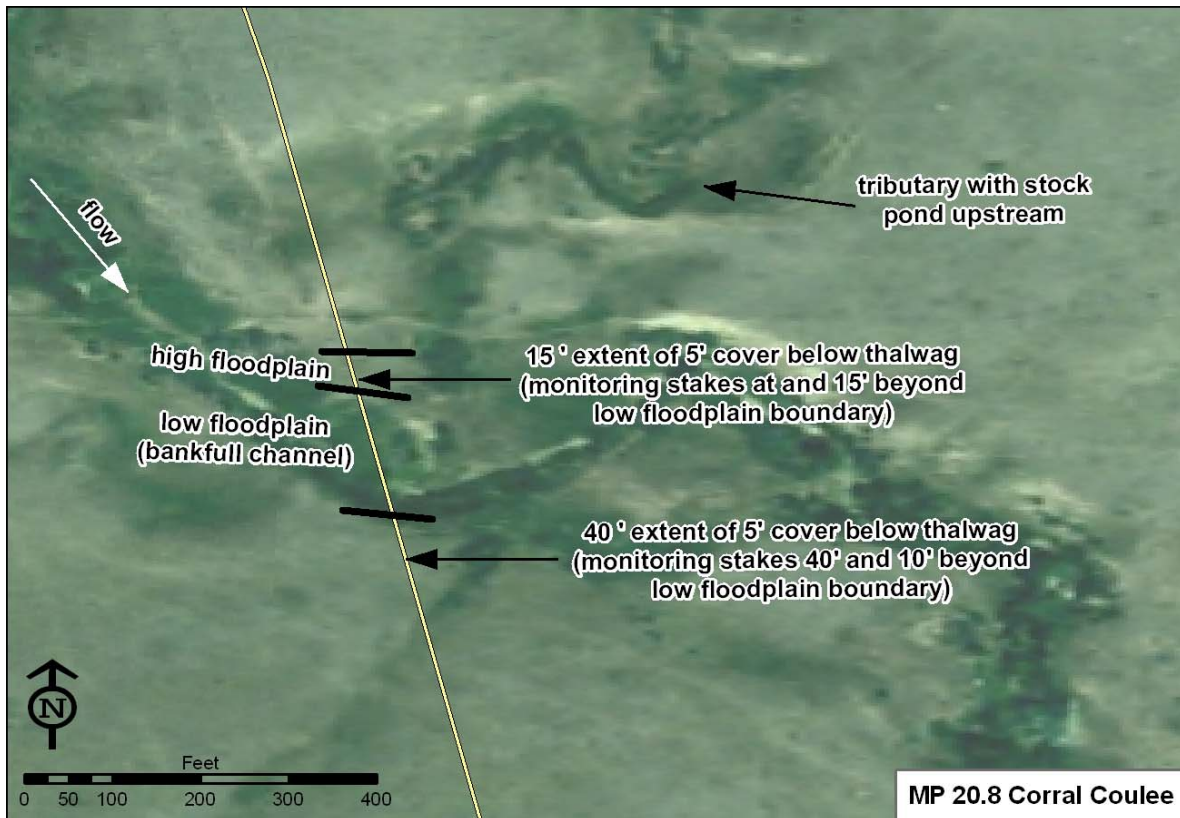
Figure 3.2-1 Burial Depth and Extent for Corral Coulee (MP 20.8)

Three lines of documented evidence suggest that Corral Coulee at MP 20.8 has the potential to migrate laterally throughout the alluvial valley bottom during the lifetime of the project. These lines of evidence include 1) the channel meanders across the entire valley bottom upstream and downstream, 2) at the proposed crossing site the left bank is actively migrating into the left low elevation floodplain, and 3) the presence of a high flow channel along the margin of the valley bottom on the right low floodplain conveys flows during moderate to high flows and has the potential to both locally scour and serve as an avulsion channel. To provide protective measures the pipe could be buried to a minimum 5 feet below the channel thalweg, and maintained at that elevation 15 feet beyond the left low floodplains and 40 feet beyond the right low floodplain (approximately 205 feet in length) (Figure 3.2-1). In addition, given the documented lateral erosion at the crossing site, an adaptive management plan could be used to monitor changes in the channel and implement preventative protective measures if erosion were to occur after construction is complete. At Corral Coulee (MP 20.8) this plan would include placing field stakes at and 15 feet beyond the boundary of the left low floodplain where the pipeline crosses the stream (Figure 3.2-1). Additional field stakes would be placed 40 feet and 10 feet beyond the right low floodplain boundary (Figure 3.2-1). During routine field inspections the location of the channel relative to the stakes should be documented. If the channel were to migrate beyond either stake placed 10' from the right low floodplain or at the left low floodplain boundary, preventative protection measures would be put in place to prevent further lateral migration. A list and descriptions of preventative protection measures are provided in Section 4.
