Keystone XL Pipeline Montana Stream Crossing Inspections Report

December 18, 2009

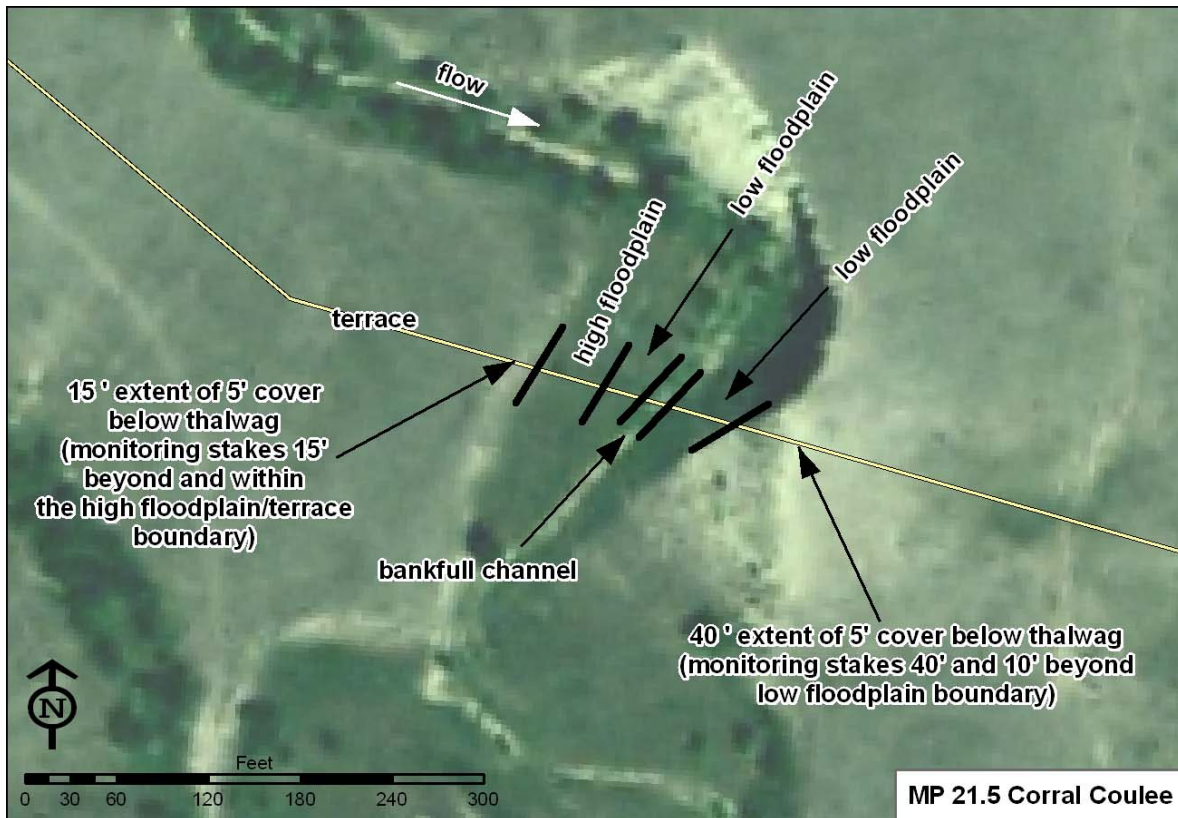
Figure 3.2-2 Burial Depth and Extent for Corral Coulee (MP 21.5)

Three lines of documented evidence suggest that Corral Coulee at MP 20.8 has the potential to migrate laterally during the lifetime of the project. These lines of evidence include 1) the channel meanders across the entire valley bottom upstream and downstream, 2) at the proposed crossing site the lower left floodplain is a channel lag deposit, and 3) the potential exists for mass failure of the 60-foot left valley margin, which would fill the channel completely and push it into the right floodplain. To provide protective measures the pipe could be buried to a minimum 5 feet below the channel thalweg, and maintained at that elevation 15 feet beyond the top of the bank defining the extent of the high right floodplain, and 40 feet beyond the left valley wall (approximately 200 feet in length) (Figure 3.2-2). In addition, an adaptive management plan could be used to monitor changes in the channel and implement preventative protective measures if erosion were to occur after construction is complete. At Corral Coulee (MP 21.5) this plan would include placing field stakes 40 feet and 10 feet beyond the boundary of the final grade left valley wall where the pipeline crosses the stream. Additional field stakes would be placed 15 feet to the left and right of the right high floodplain/terrace boundary (Figure 3.2-2). During routine field inspections the location of the channel relative to the stake should be documented. If the channel were to migrate beyond either the 10-foot stake from the left valley margin or the stake placed 15 feet within the right high floodplain/terrace boundary, preventative protection measures would be put in place to prevent further lateral migration. A list and descriptions of preventative protection measures are provided in Section 4.

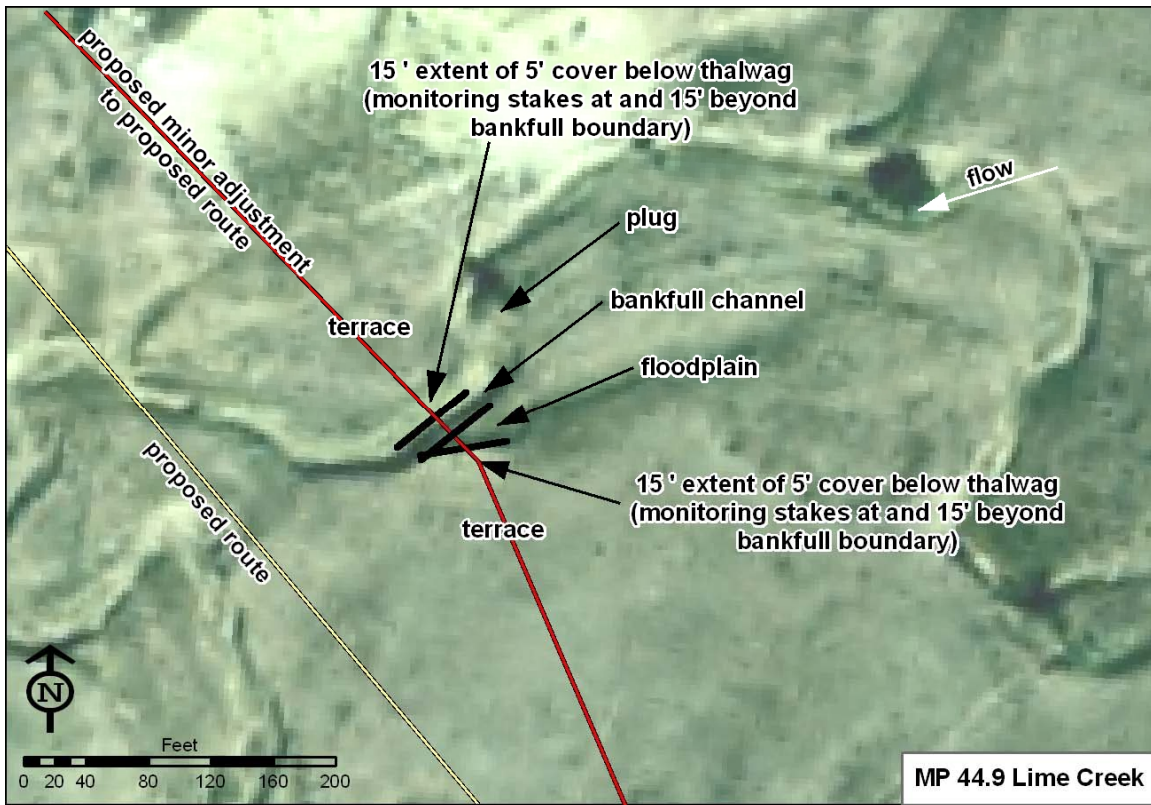
Figure 3.2-3 Burial Depth and Extent for Lime Creek

There is no evidence of previous movement of the channel laterally or vertically at the Lime Creek proposed adjusted crossing location. Therefore, to provide protective measures, the pipe could be buried to a minimum 5 feet below the channel thalweg and maintained at that elevation for 15 feet beyond the top of the bankfull banks on either side of the creek (approximately 60 feet in length) (Figure 3.2.-3). In addition, an adaptive management plan could be used to monitor changes in the channel and implement preventative protective measures if erosion were to occur after construction is complete. At Lime Creek proposed adjusted crossing location this plan would include placing field stakes at and 15 feet from the right and left banks defining the bankfull channel where the pipeline crosses the stream (Figure 3.2-3). During routine field inspections the location of the channel relative to the stakes should be documented. If the channel were to migrate beyond either stake placed at the bankfull boundary, preventative protection measures would be put in place to prevent further lateral migration. A list and descriptions of preventative protection measures are provided in Section 4.

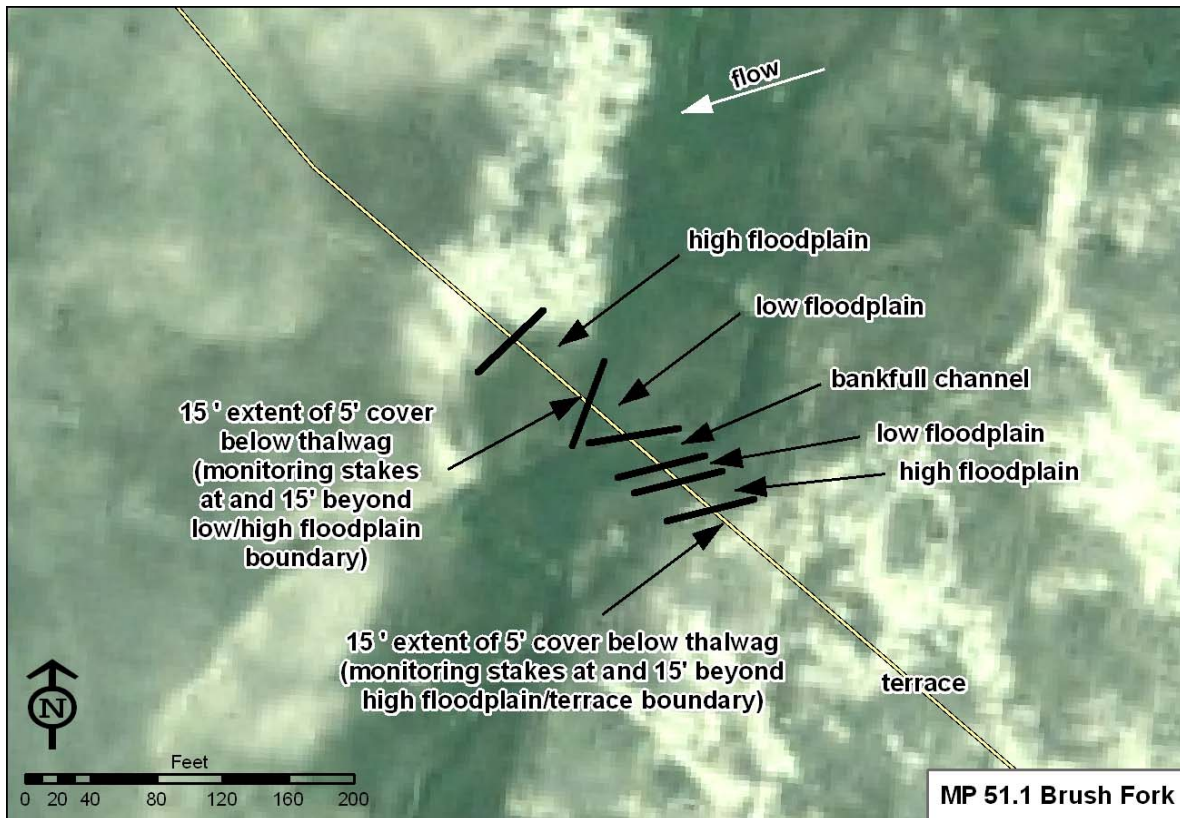
Figure 3.2-4 Burial Depth and Extent for Brush Fork

Immediately upstream of the proposed crossing of Brush Fork is a meander bend in the creek with a deep pool and a near vertical bank on the left outer bank. The meander bend is less than 30 feet from the proposed route. Given the proximity of the meander bend relative to the proposed route, to provide protective measures, the pipe could be buried to a minimum of 5 feet below the pool of the upstream meander bend and maintained at that elevation for 15 feet beyond the left high floodplain and 15 feet beyond the top of the bank defining the right high and low floodplain boundary (approximately 130 feet in length) (Figure 3.2-4). In addition, an adaptive management plan could be used to monitor changes in the channel and implement preventative protective measures if erosion were to occur after construction is complete. At the Brush Fork (MP 51.1) this plan would include placing a field stake at and 15 feet beyond the bank defining the right high/low floodplain boundary where the pipeline crosses the stream (Figure 3.2-4). Additional field stakes would be placed at and 15 feet beyond the left high floodplain/terrace boundary (Figure 3.2-4). During routine field inspections the location of the channel relative to the stakes should be documented. If the channel were to migrate beyond either stake placed at the right high/low floodplain boundary or at the left high floodplain/terrace boundary, preventative protection measures would be put in place to prevent further lateral migration. A list and descriptions of preventative protection measures are provided in Section 4.

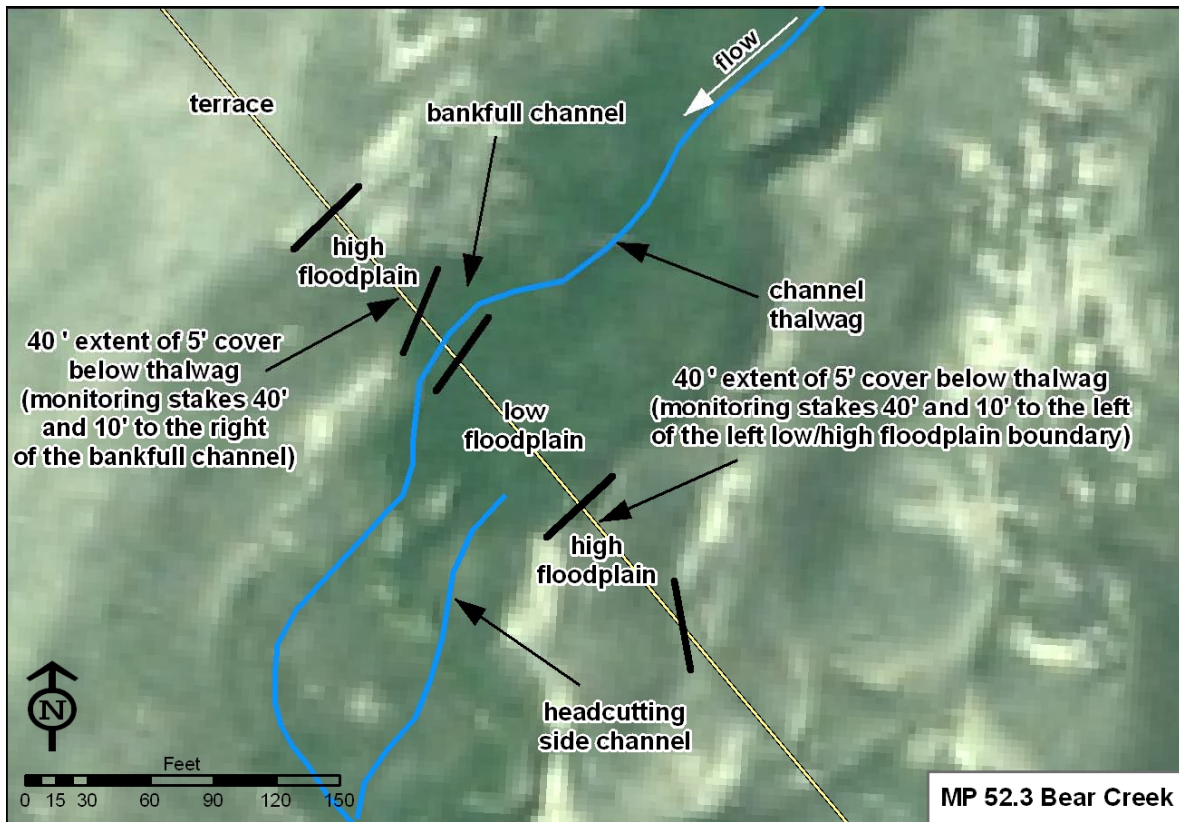
Figure 3.2-5 Burial Depth and Extent for Bear Creek

Immediately downstream of the proposed crossing of Bear Creek is an actively advancing headcutting side channel that is approximately 1 foot deeper than the current channel thalweg. The headcut is only 20 feet downstream from the proposed route and would pose an immediate threat to the pipe after construction. Given the observed instability within the low floodplain, to provide protective measures, the pipe could be buried to a minimum of 5 feet below the pool at the base of the downstream headcut and maintained at that elevation for 40 feet beyond the top of the bank defining the left low-high floodplain boundary, and 40 beyond the top of the right bankfull channel (approximately 200 feet in length) (Figure 3.2-5). In addition, an adaptive management plan could be used to monitor changes in the channel and implement preventative protective measures if erosion were to occur after construction is complete. At the Bear Creek (MP 52.3) this plan would include placing a field stake 40 feet and 10 feet beyond the right high bank defining the bankfull channel where the pipeline crosses the stream (Figure 3.2-5). Additional field stakes would be placed 40 feet and 10 feet to the left of the left low/high floodplain boundary (Figure 3.2-5). During routine field inspections the location of the channel relative to the stakes should be documented. If the channel were to migrate beyond either stake placed 10 feet from the right bankfull boundary or 10 feet to the left of the left low/high floodplain boundary, preventative protection measures would be put in place to prevent further lateral migration. A list and descriptions of preventative protection measures are provided in Section 4.

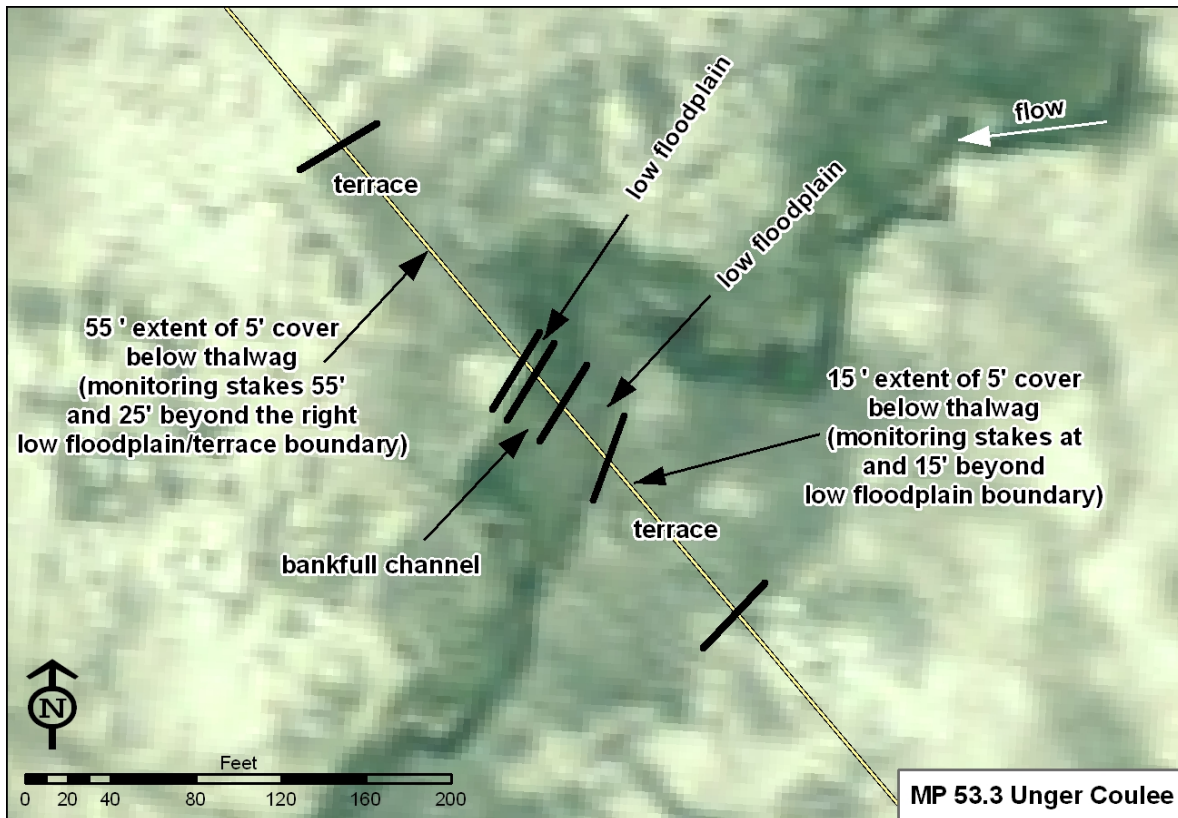
Figure 3.2-6 Burial Depth and Extent for Unger Coulee

Two lines of documented evidence suggest that Unger Coulee at MP 53.3 has the potential to migrate laterally during the lifetime of the project. These lines of evidence include 1) the channel meanders across the entire valley bottom upstream and downstream, 2) at the proposed crossing site both banks are undercut with active slumping. In addition, immediately upstream of the crossing is a meander bend with evidence of migration potential that is only 15 to 20 feet away from the proposed route on the right terrace. For protection, the pipe could be buried to a minimum 5 feet below the channel thalweg, and maintained at that elevation 15 feet beyond the top of the bank defining the extent of the floodplain on the left side of the bankfull channel, and 55 feet beyond the top of the bank defining the extent of the floodplain on the right side of the bankfull channel (approximately 130 feet in length) (Figure 3.2-6). In addition, an adaptive management plan could be used to monitor changes in the channel and implement preventative protective measures if erosion were to occur after construction is complete. At Unger Coulee (MP 53.3) this plan would include placing a field stake at and 15 feet beyond the left high bank defining the low floodplain/terrace boundary where the pipeline crosses the stream (Figure 3.2-6). Additional field stakes would be placed 55 feet and 25 feet to the right of the right low floodplain/terrace boundary (Figure 3.2-6). During routine field inspections the location of the channel relative to the stakes should be documented. If the channel were to migrate beyond either stake placed at the left low floodplain/terrace boundary or 25 feet to the right of the right low floodplain/terrace boundary, preventative protection measures would be put in place to prevent further lateral migration. A list and descriptions of preventative protection measures are provided in Section 4.

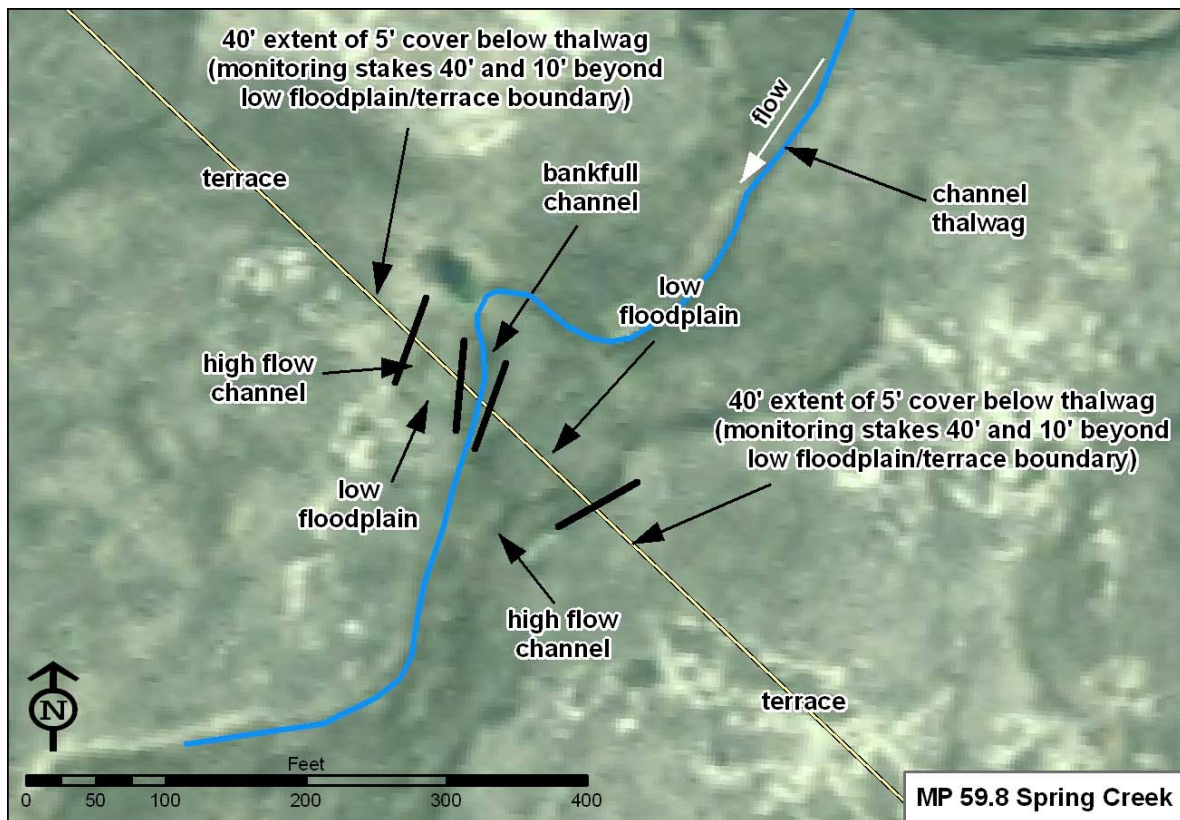
Figure 3.2-8 Burial Depth and Extent for Spring Creek

Two lines of documented evidence suggest that Spring Creek at MP 59.8 has the potential to migrate laterally during the lifetime of the project. These lines of evidence include 1) the presence of side channel on either floodplain, and 2) both of the bankfull banks are undercut. To provide protective measures the pipe could be buried to a minimum 5 feet below the channel thalweg, and maintained at that elevation 40 feet beyond the top of the bank defining the extent of the low floodplain on either side of the channel (approximately 220 feet in length) (Figure 3.2-8). In addition, an adaptive management plan could be used to monitor changes in the channel and implement preventative protective measures if erosion were to occur after construction is complete. At Spring Creek (MP 59.8) this plan would include placing field stakes 40 feet and 10 feet from the right and left banks defining the low floodplain/terrace boundary where the pipeline crosses the stream (Figure 3.2-8). During routine field inspections the location of the channel relative to the stakes should be documented. If the channel were to migrate beyond either stake placed 10 feet from the low floodplain/terrace boundary, preventative protection measures would be put in place to prevent further lateral migration. A list and descriptions of preventative protection measures are provided in Section 4.

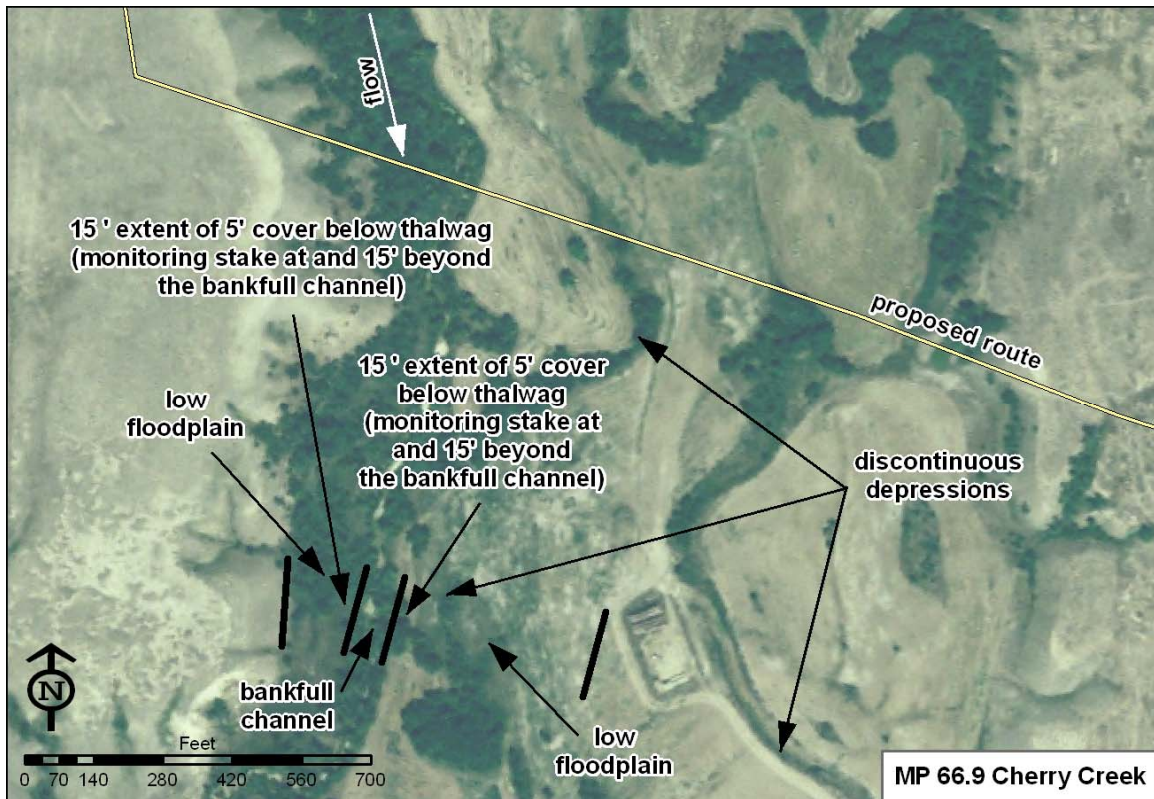
Figure 3.2-9 Burial Depth and Extent for Cherry Creek

The isolated depressions on both floodplains are remnant channels that retain and convey floodwater and rainfall. These features are well above the contemporary channel and do not pose a risk of lateral migration or incision. Therefore, to provide protective measures, the pipe could be buried to a minimum 5 feet below the channel thalweg and maintained at that elevation for 15 feet beyond the top of the bankfull banks on either side of the creek (approximately 80 feet in length) (Figure 3.2-9). In addition, an adaptive management plan could be used to monitor changes in the channel and implement preventative protective measures if erosion were to occur after construction is complete. At Cherry Creek (MP 66.9) this plan would include placing field stakes at and 15 feet beyond the right and left banks defining the bankfull channel where the pipeline crosses the stream (Figure 3.2-9). During routine field inspections the location of the channel relative to the stakes should be documented. If the channel were to migrate beyond either stake placed at the bankfull boundary, preventative protection measures would be put in place to prevent further lateral migration. A list and descriptions of preventative protection measures are provided in Section 4.

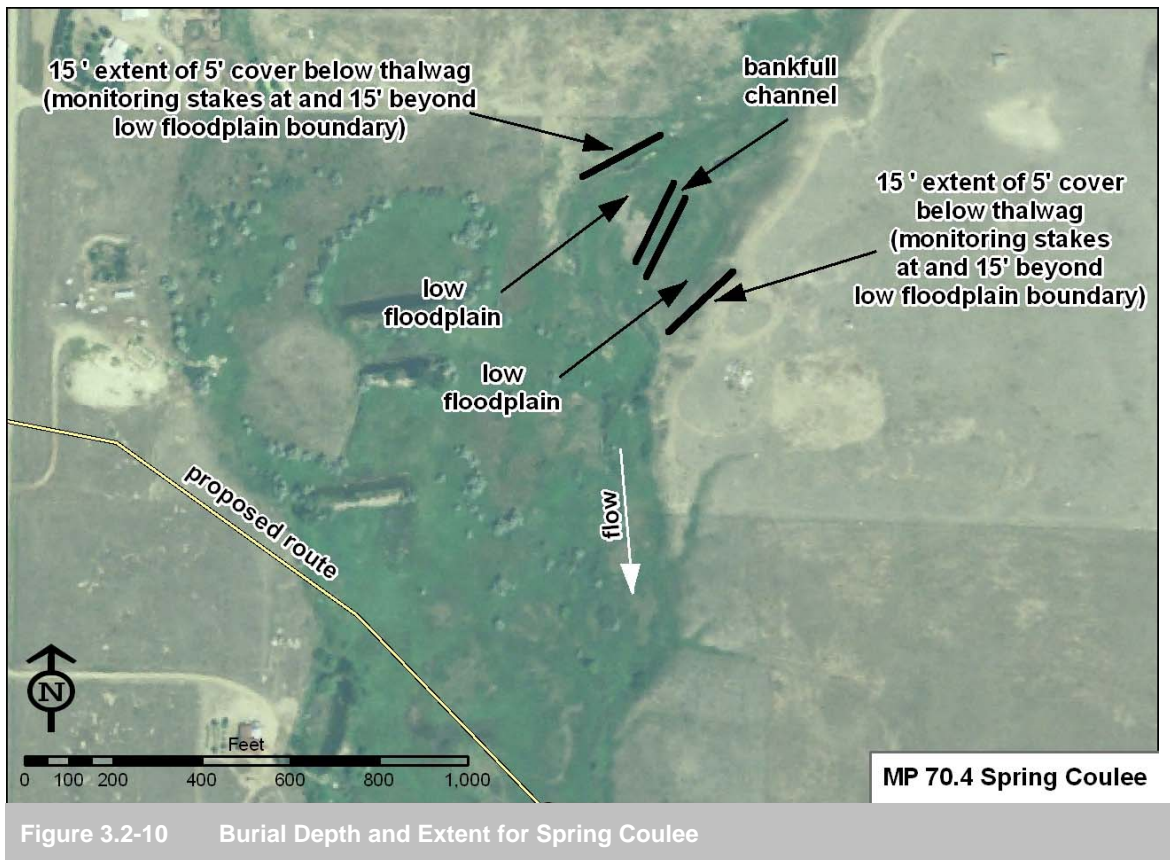
Figure 3.2-10 Burial Depth and Extent for Spring Coulee

There is no evidence of previous movement of the channel laterally or vertically at the Spring Coulee proposed adjusted crossing location. Therefore, to provide protective measures, the pipe could be buried to a minimum 5 feet below the channel thalweg and maintained at that elevation for 15 feet beyond the top of the floodplain banks on either side of the channel (approximately 380 feet in length) (Figure 3.2-10). In addition, an adaptive management plan could be used to monitor changes in the channel and implement preventative protective measures if erosion were to occur after construction is complete. At Spring Coulee (MP 70.4) this plan would include placing field stakes at and 15 feet from the right and left banks defining the limits of the low floodplain where the pipeline crosses the stream (Figure 3.2-10). During routine field inspections the location of the channel relative to the stakes should be documented. If the channel were to migrate beyond either stake placed on the outer boundary of the low floodplain, preventative protection measures would be put in place to prevent further lateral migration. A list and descriptions of preventative protection measures are provided in Section 4.

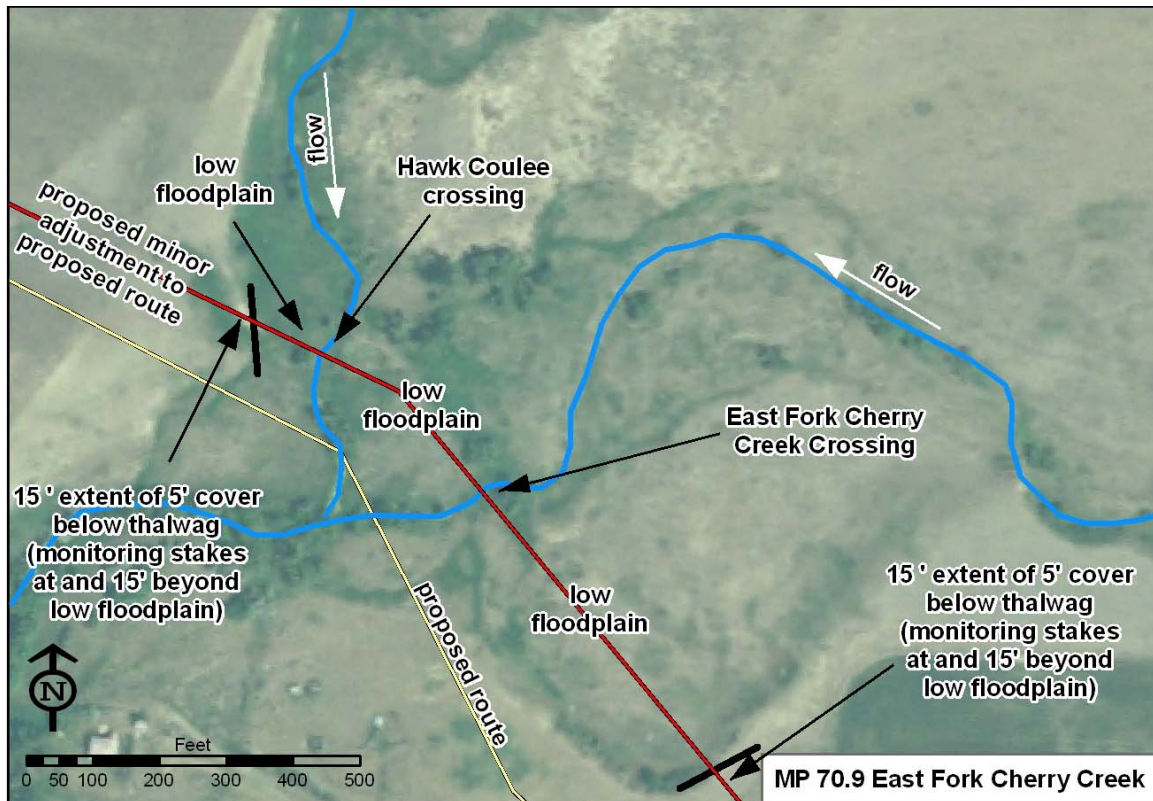
Figure 3.2.11 Burial Depth and Extent for East Fork Cherry Creek

The pool-swale nature of both the East Fork Cherry Creek and Hawk Coulee channels presents ample opportunity for either channel to avulse into a new location throughout the entire floodplain. Overbank flow would occur during even moderate flows in swale sections of the channels. This overbank flow has the potential to scour locally and form a new channel. Because the entire floodplain has side channels present that have the potential to capture the channel, to provide protective measures, the pipe could be buried to a minimum of 5 feet below the channel thalweg and maintained at that elevation for 15 feet beyond the top of the floodplain on either side of the channel (approximately 995 feet in length) (Figure 3.2-11). In addition, an adaptive management plan could be used to monitor changes in the channel and implement preventative protective measures if erosion were to occur after construction is complete. At East Fork Cherry Creek (MP 70.9) this plan would include placing field stakes at and 15 feet from the right and left banks defining the limits of the low floodplain where the pipeline crosses the stream (Figure 3.2-11). During routine field inspections the location of the channel relative to the stakes should be documented. If the channel were to migrate beyond either stake placed on the outer boundary of the low floodplain, preventative protection measures would be put in place to prevent further lateral migration. A list and descriptions of preventative protection measures are provided in Section 4.

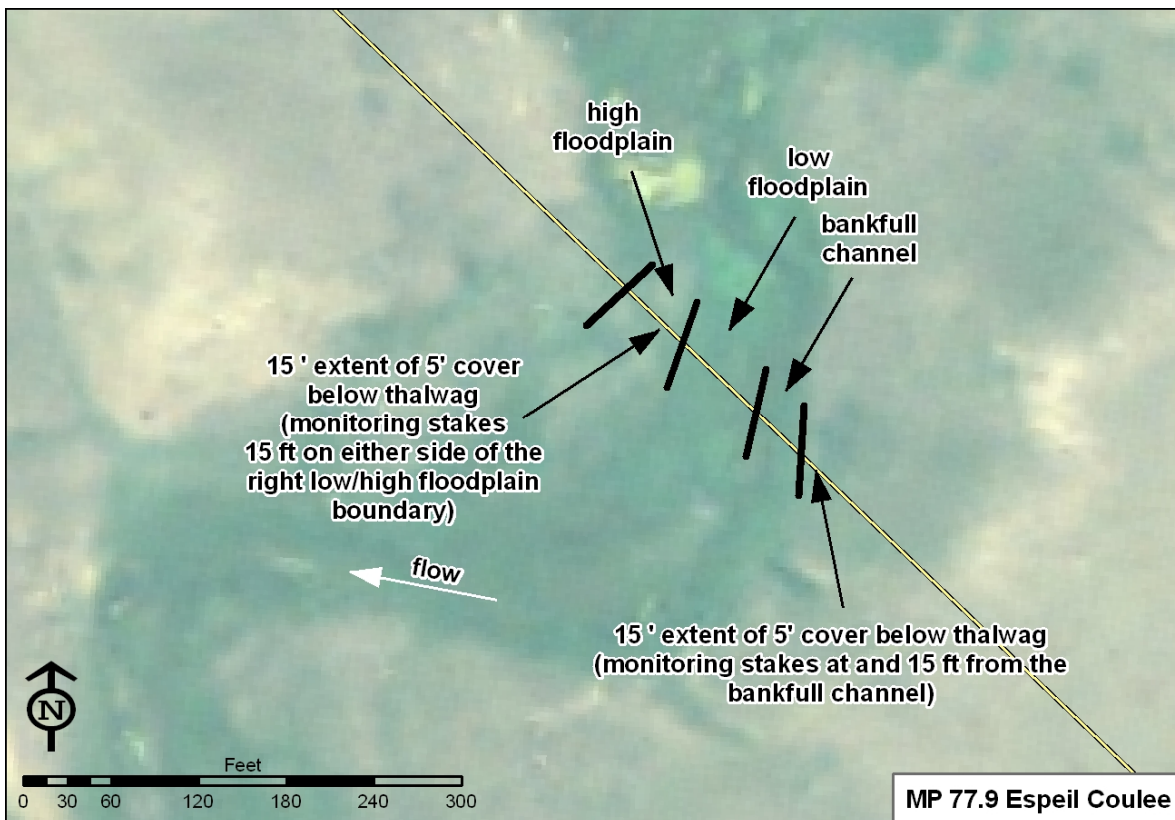
Figure 3.2-12 Burial Depth and Extent for Espeil Coulee

Little evidence suggests the potential for lateral migration at Espeil Coulee at the 77.9 MP crossing. The presence of deep scour pools and the hummocky right low floodplain does however suggest the potential for local scour during high flow events. To provide protective measures, the pipe be could buried to a minimum 5 feet below the channel thalweg, and maintained at that elevation 15 feet beyond the top of the right bankfull channel, and 15 feet beyond the top of the bank defining the boundary of the right low and high floodplain (approximately 150 feet in length) (Figure 3.2-12). In addition, an adaptive management plan could be used to monitor changes in the channel and implement preventative protective measures if erosion were to occur after construction is complete. At the Espeil Coulee (MP 77.9) this plan would include placing a field stake at and 15 feet from the left high bank defining the bankfull channel where the pipeline crosses the stream (Figure 3.2-12). Additional field stakes would be placed 15 feet to the left and right of the right low/high floodplain boundary (Figure 3.2-12). During routine field inspections the location of the channel relative to the stakes should be documented. If the channel were to migrate beyond either stake placed at the left bankfull boundary or 15 feet to the left of the right low/high floodplain boundary, preventative protection measures would be put in place to prevent further lateral migration. A list and descriptions of preventative protection measures are provided in Section 4.

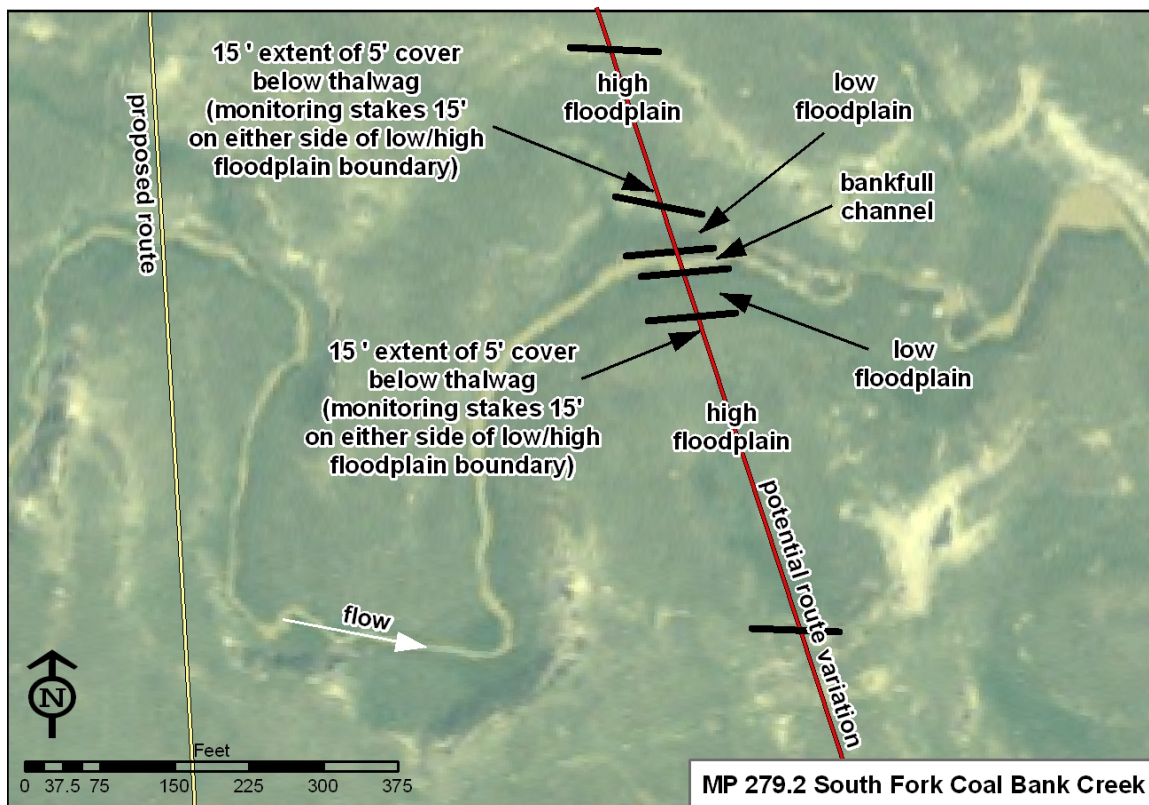
Figure 3.2-13 Burial Depth and Extent for South Fork Coal Bank Creek

The presence of bank slumping on both banks along the bankfull margin does suggest the potential for local scour during high flow. To provide protective measures, the pipe could be buried to a minimum 5 feet below the channel thalweg, and maintained at that elevation 15 feet beyond the top of the bank defining the boundary of the low and high floodplain on either side of the channel (approximately 140 feet in length) (Figure 3.2-13). In addition, an adaptive management plan could be used to monitor changes in the channel and implement preventative protective measures if erosion were to occur after construction is complete. At South Fork Coal Bank Creek (MP 279.2) this plan would include placing field stakes 15 feet on either side of the right and left low/high floodplain boundary where the pipeline crosses the stream (Figure 3.2-13). During routine field inspections the location of the channel relative to the stakes should be documented. If the channel were to migrate beyond either stake placed 15 feet within the low/high floodplain boundary, preventative protection measures would be put in place to prevent further lateral migration. A list and descriptions of preventative protection measures are provided in Section 4.
