# McLaren Tailings

## Project Update

### August 8, 2013

Montana Department of Environmental Quality

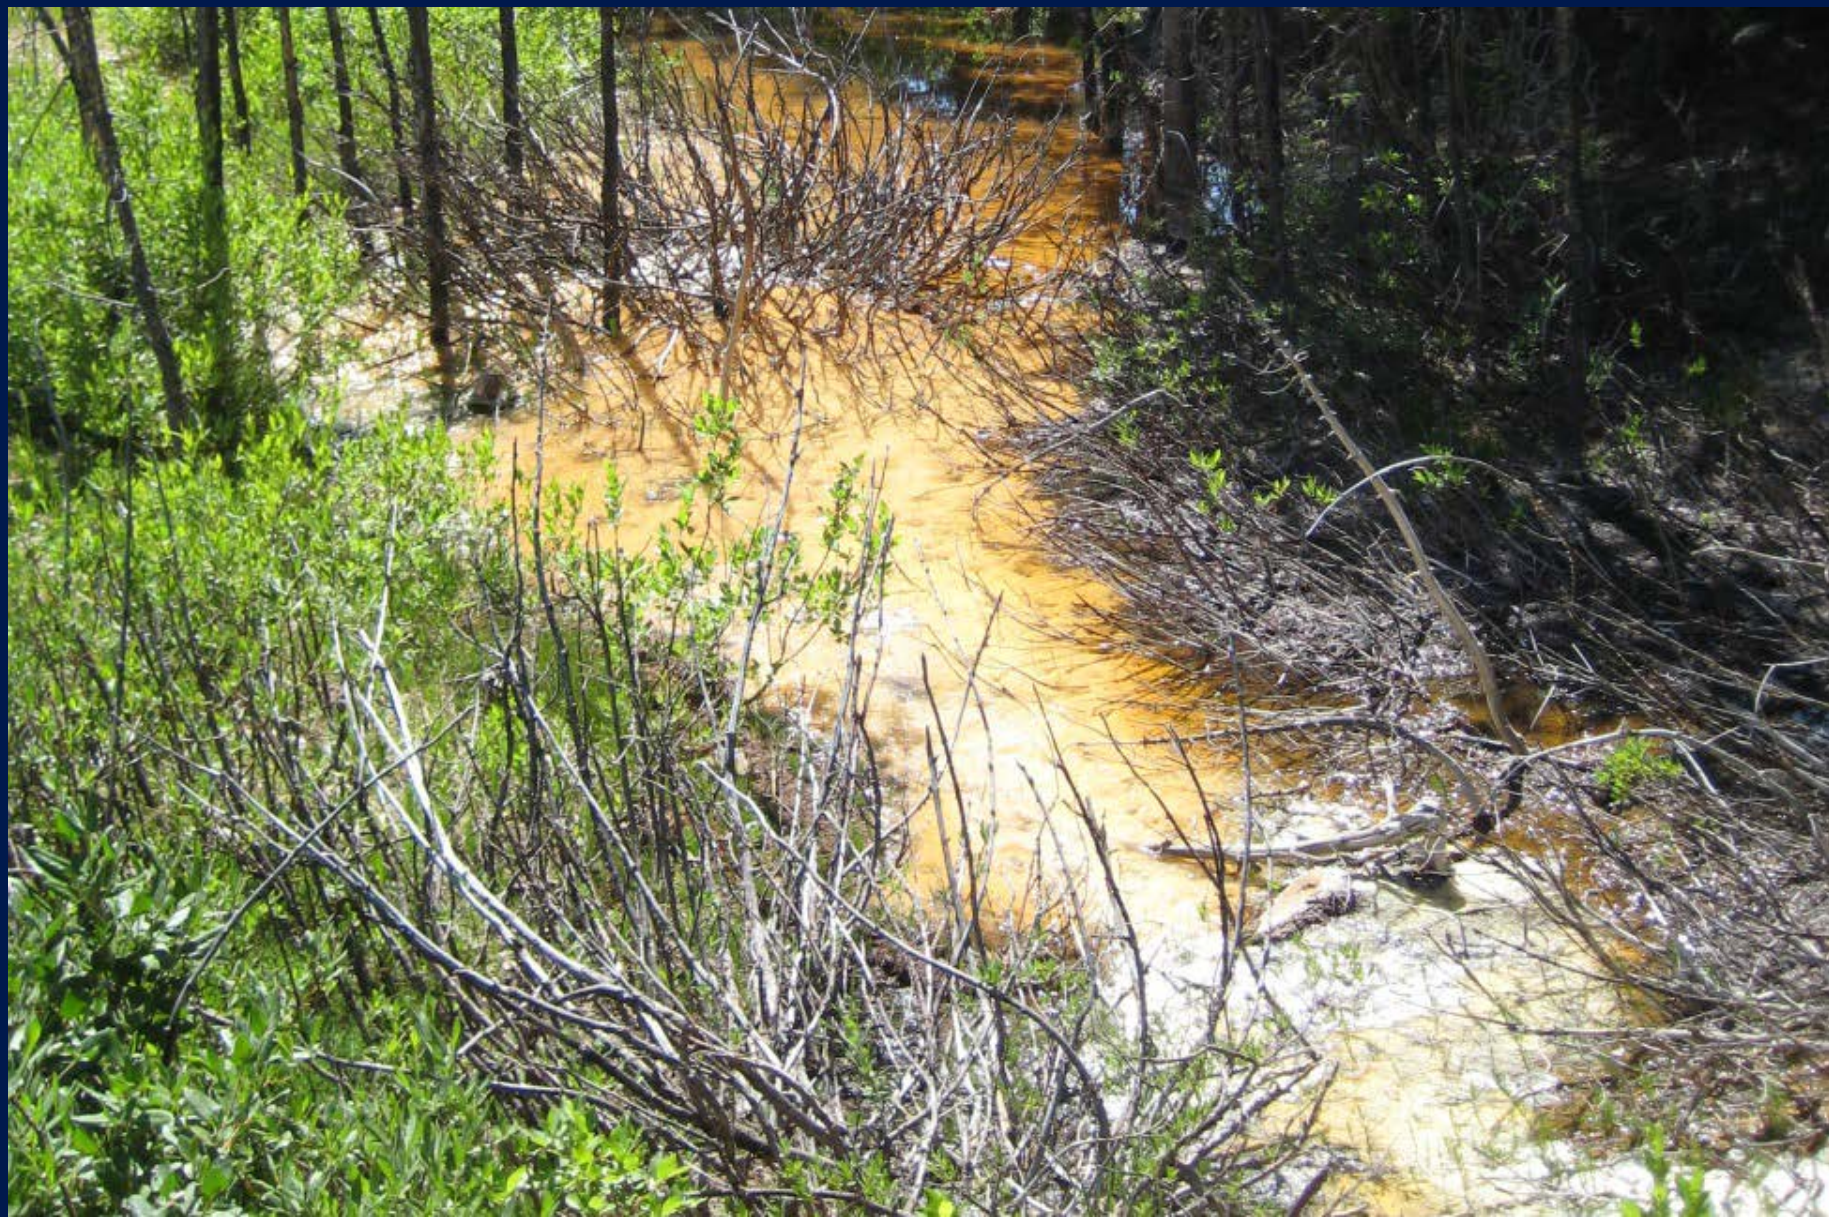
# AMD Discharges From Tailings Impoundment

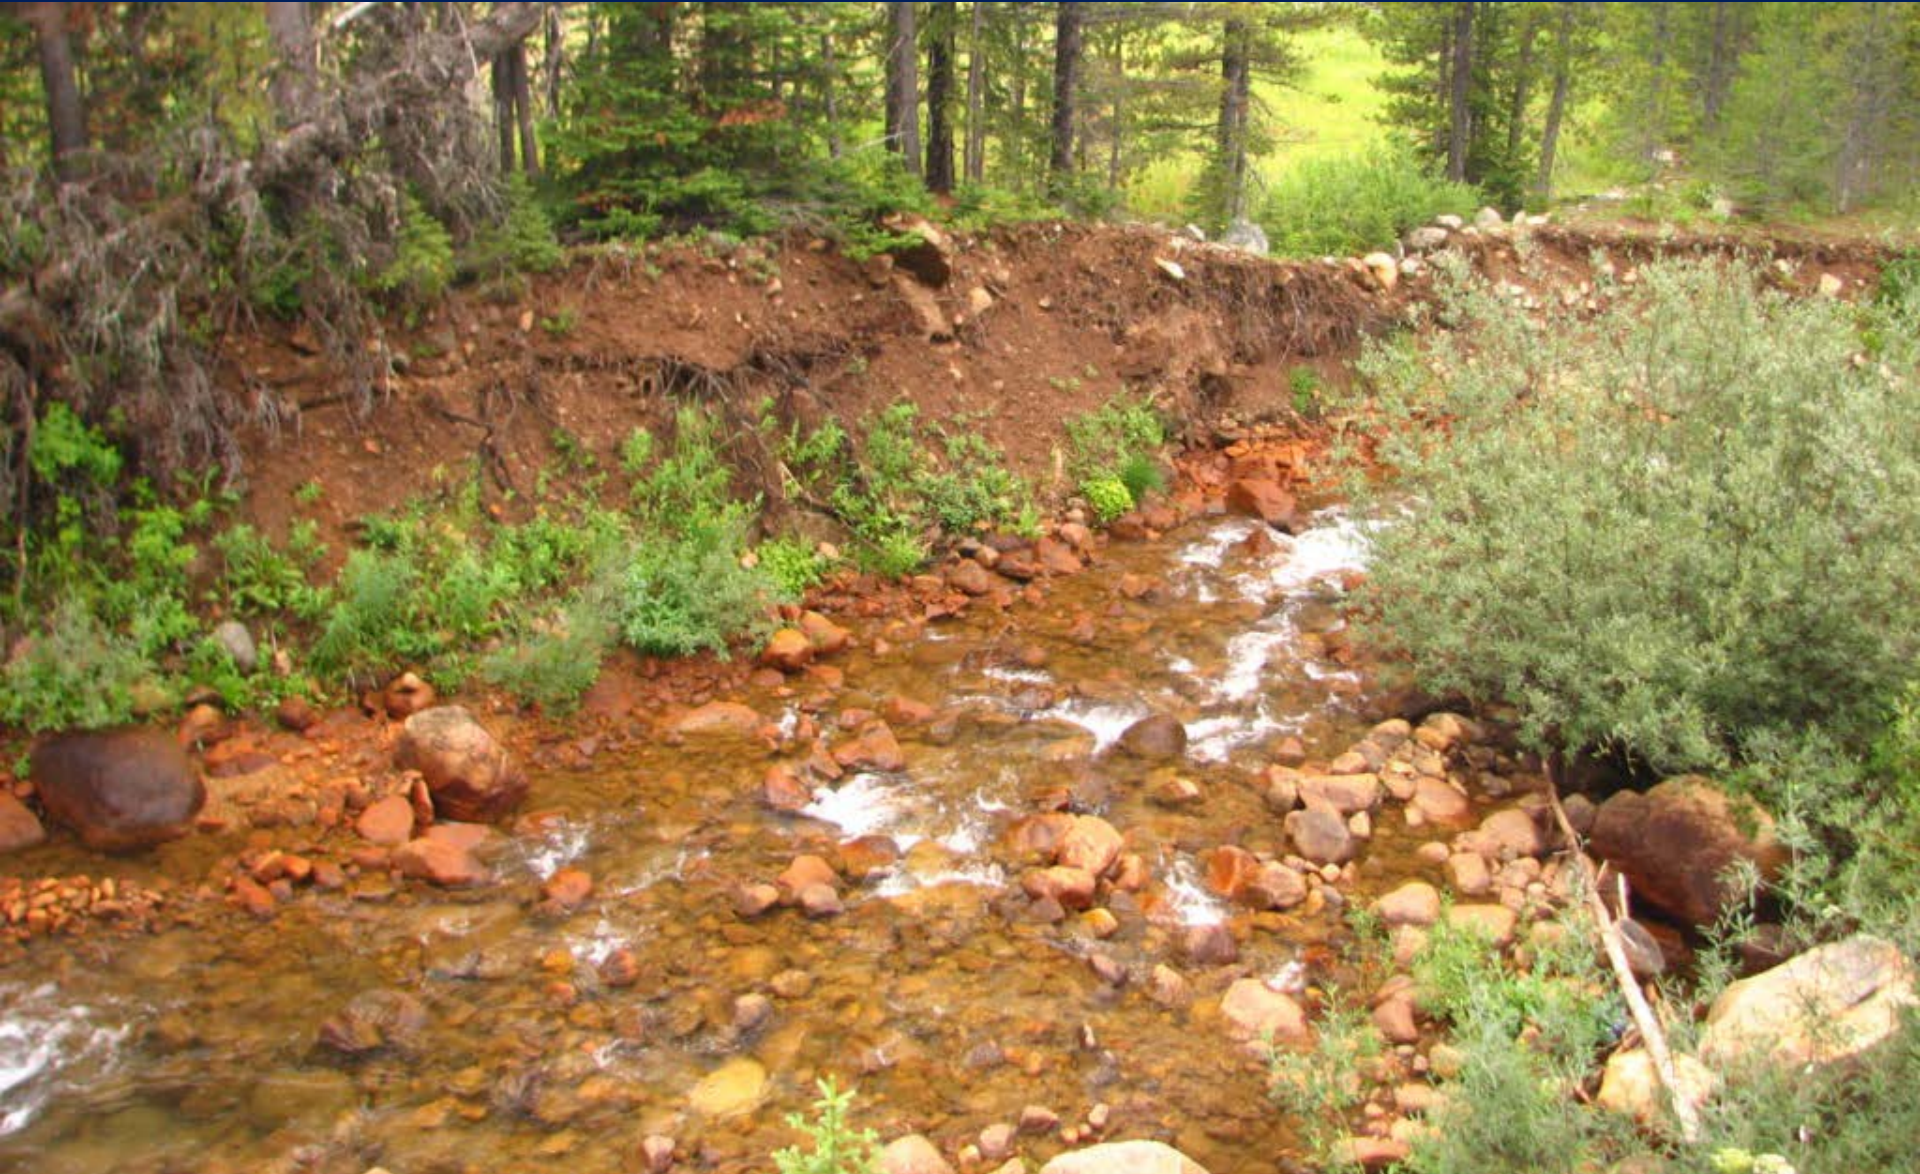
August 2009

# Soda Butte Creek - North Bypass Channel

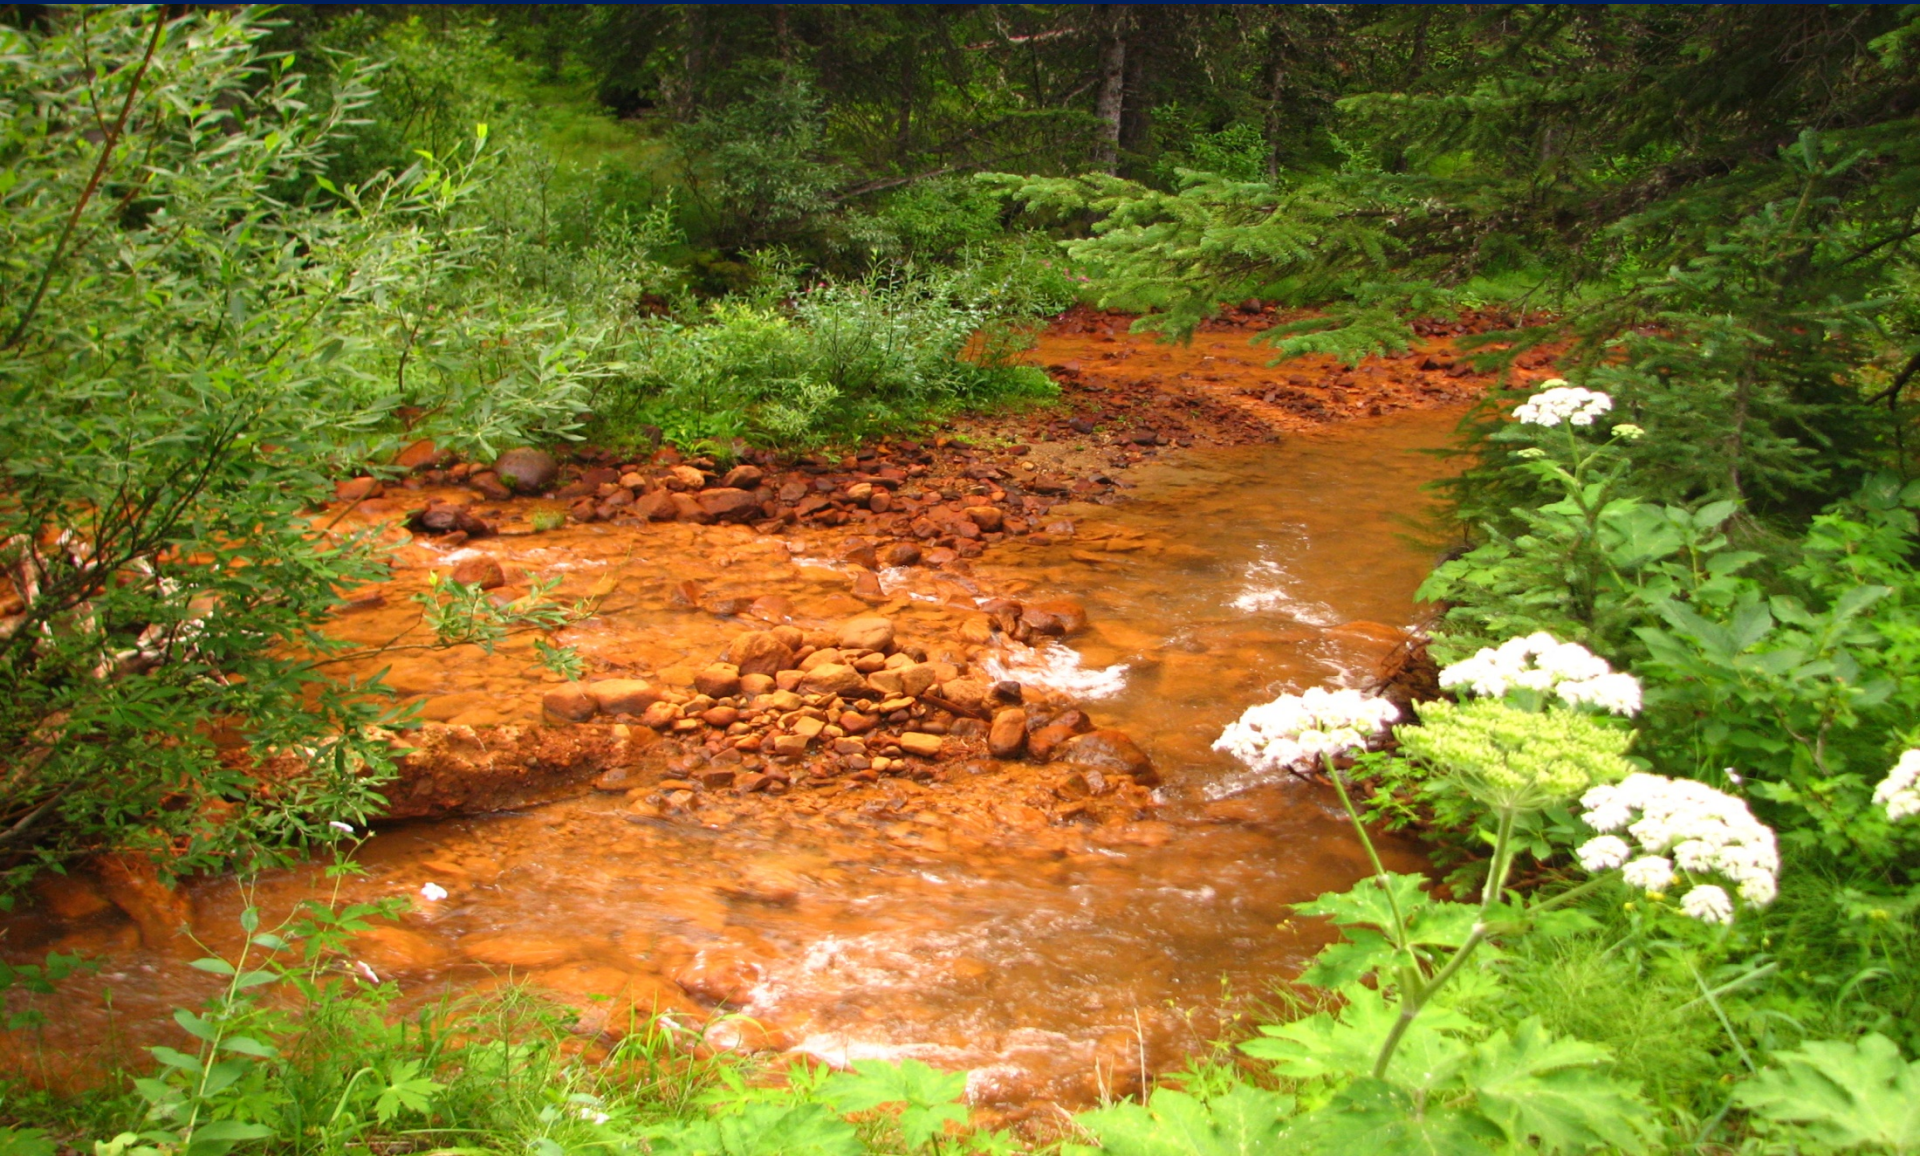
August 2009

# Soda Butte Creek - Downstream

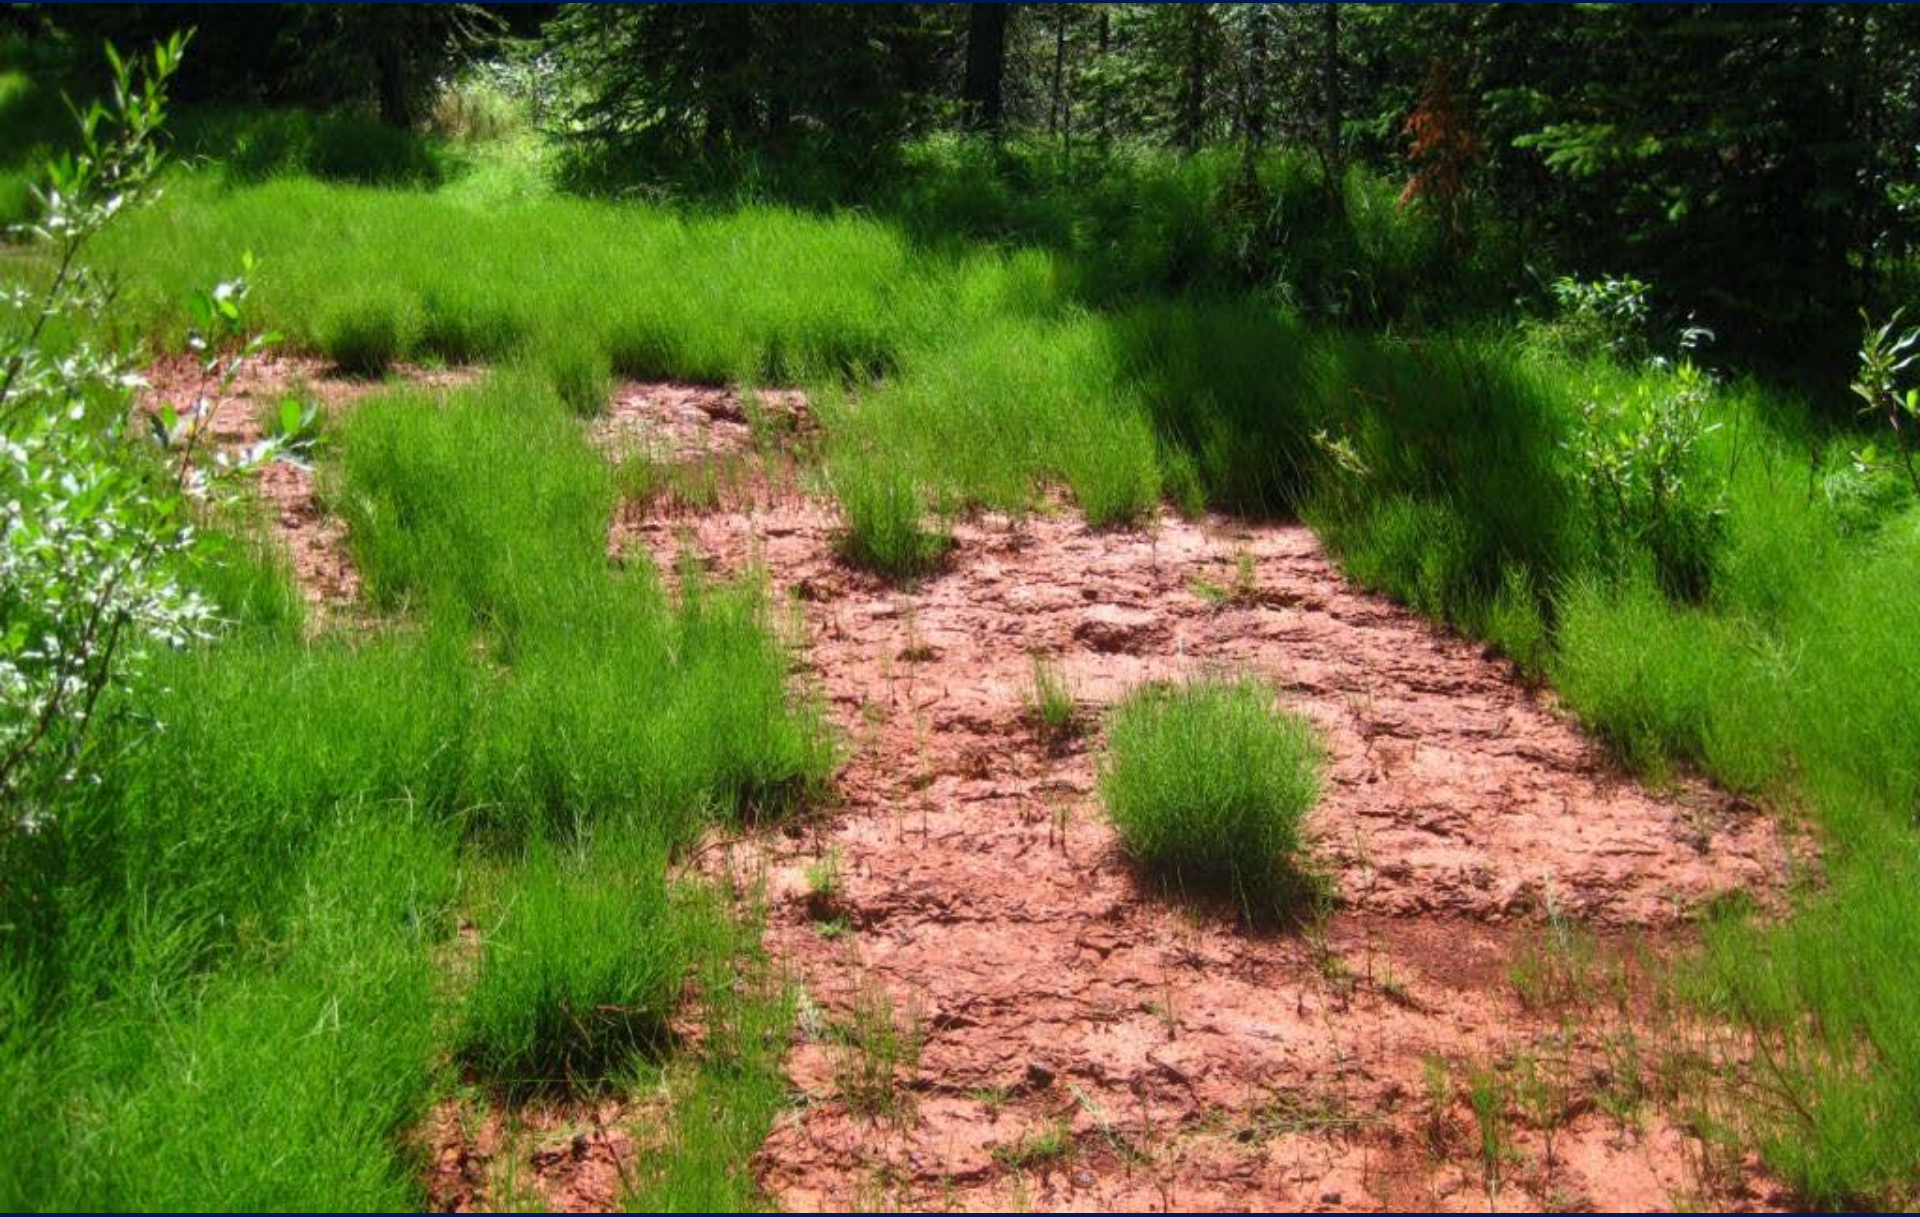
# 2012 Dewatered Acidic Seeps

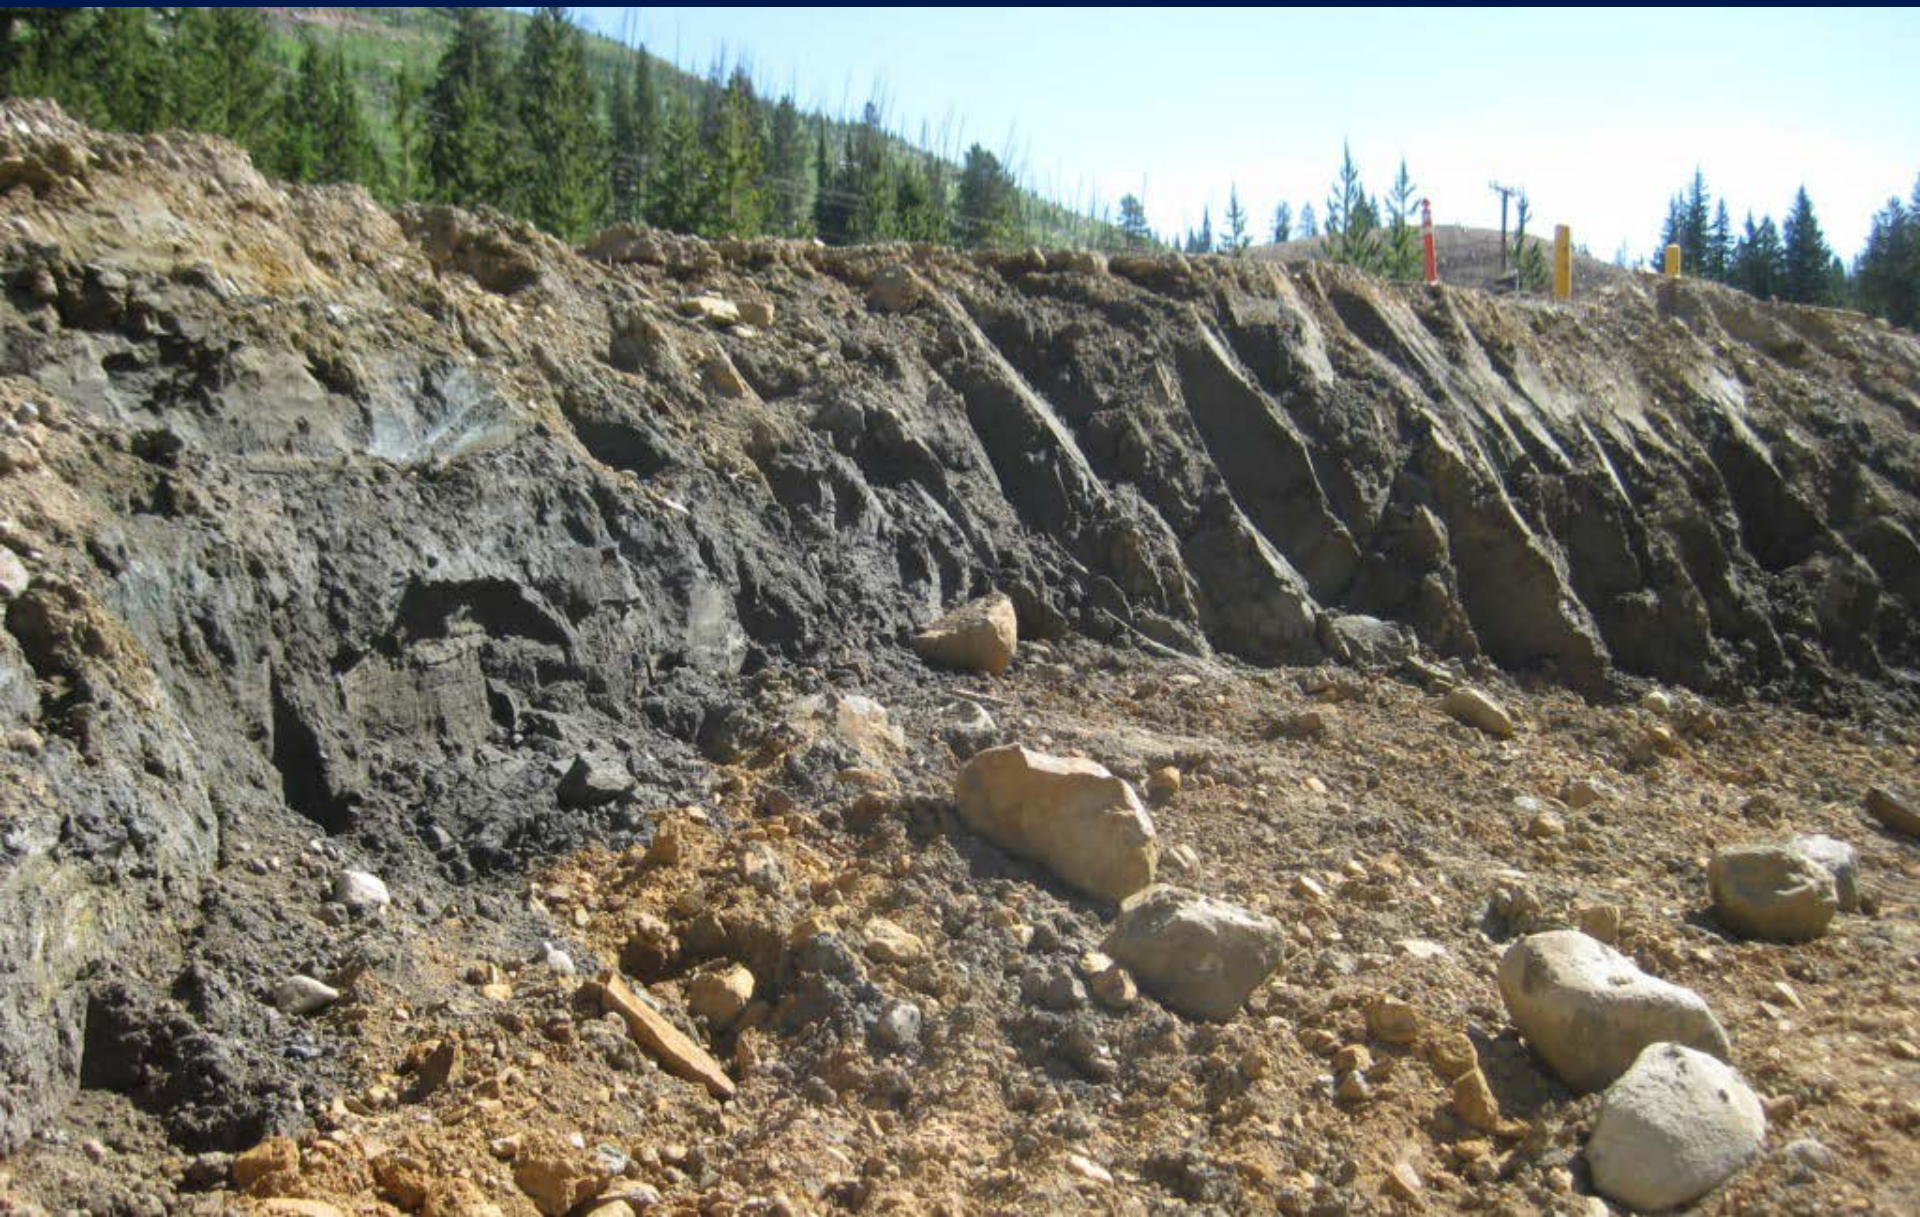
# 2013 Remaining Tailings

- Approximately 245,000 cubic yards of waste rock and tailings have been stabilized with lime and compacted in the repository.
- Compacted volume is approximately 230,000 cubic yards
- Approximately 4,000 cubic yards remain to be excavated along existing Soda Butte Creek.
- Soda Butte Creek will be relocated to new channel before remaining tailings are excavated.
