APPENDIX B - LOWER CLARK FORK TRIBUTARIES TMDL PLANNING AREA SEDIMENT MONITORING REPORT

River Design Group, Inc.
5098 Highway 93 S
Whitefish, Montana 59937

Montana Department of Environmental Quality
Watershed Management Section, Water Quality Planning Bureau
1520 East 6th Avenue
Helena, MT 59620-0901

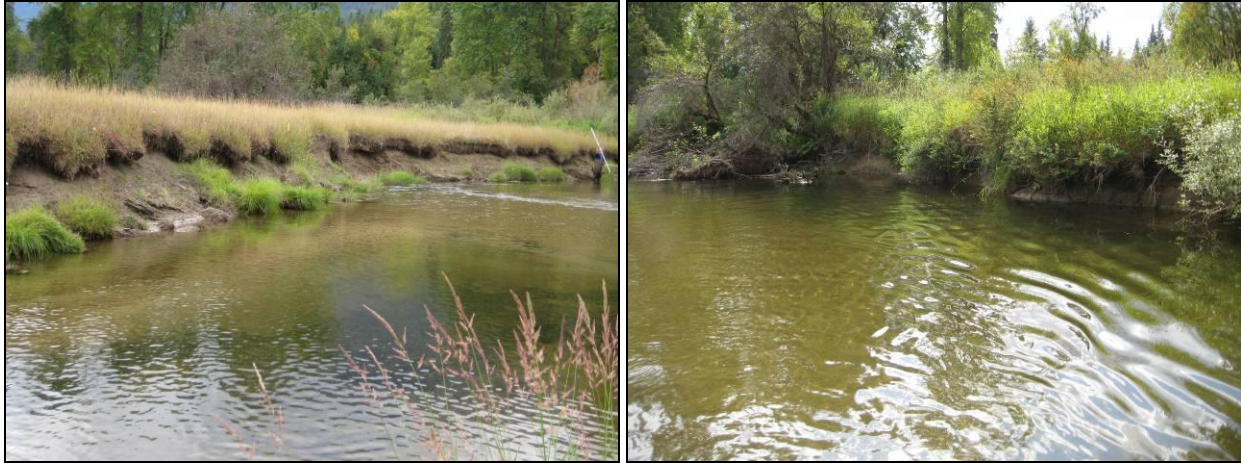
Figure B4-1. Typical streambank conditions in Bull River Reach 3-3.

Streambanks in Bull River Reach 3-3 were stable. The silt-clay bank material is cohesive and resistant to scour. Vegetation conditions range from drier grasses to dense reed canarygrass and shrubs. Vegetated streambanks overhang the stream and provide debris inputs. Typical reach photographs are included in Figure B4-1. BEHI results for Reach 3-3 are included in Table B4-4 and Table B4-5.

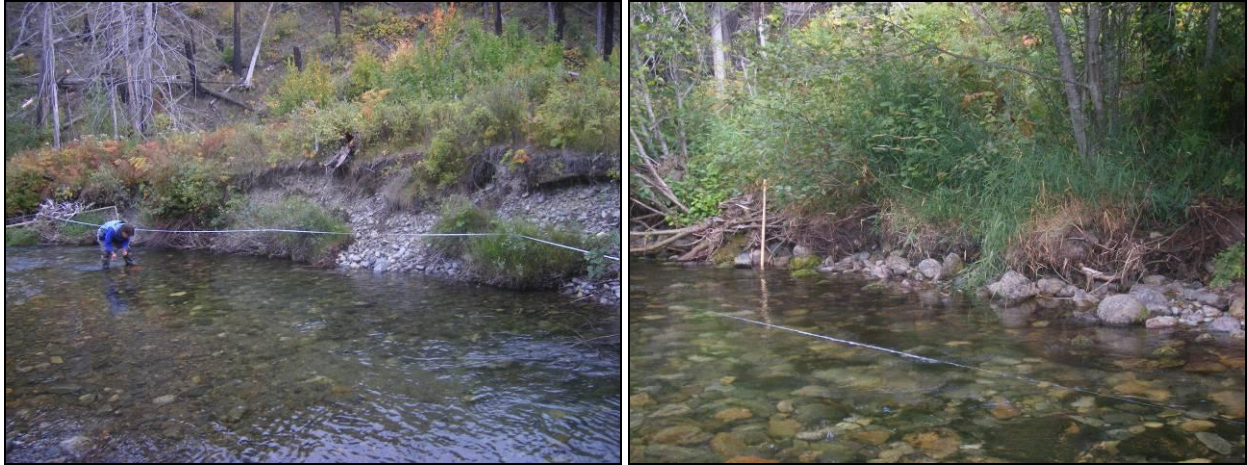
Figure B4-2. Typical eroding bank conditions in Bull River Reach 3-2.

There was moderate bank erosion occurring along areas prone to high NBS. Streambanks on outside meanders with poor vegetation and rooting conditions typically experienced the greatest erosion. Streambanks are comprised of sandy, gravelly unconsolidated materials. Eroded blocks vegetated by reed canarygrass, grass, and shrubs were located throughout the reach. **Figure B4-2** includes typical bank erosion conditions in the reach. Summary data for Bull River Reach 3-2 are presented in **Table B4-6** and **Table B4-7**.

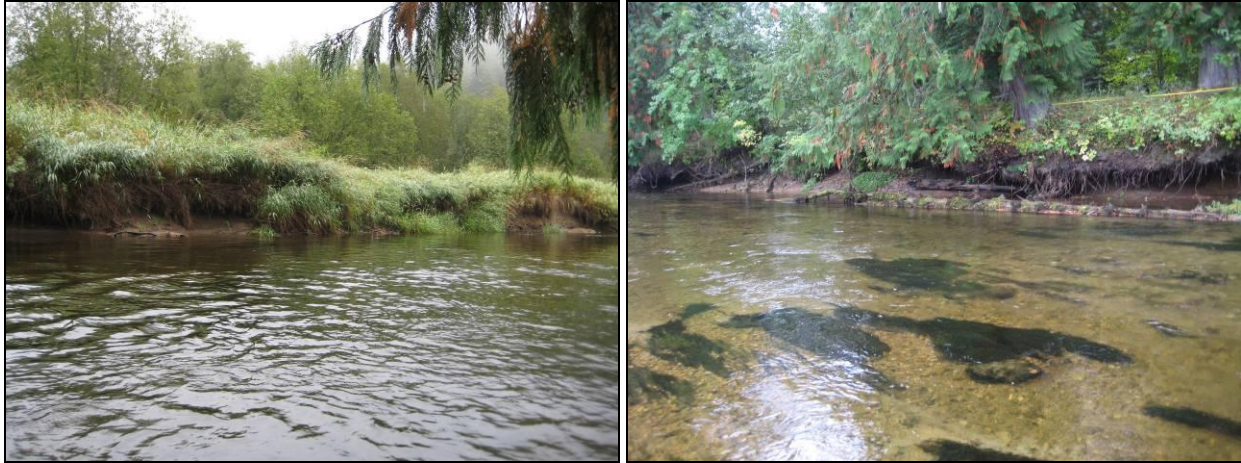
Figure B4-3. Typical eroding bank conditions in Bull River Reach 5-1.

The streambanks are primarily composed of sands and other fine materials, overlain by reed canarygrass, shrubs and scattered cedar roots. Vegetative cover is extensive throughout the reach, but the root mats are undercut and slumping on several banks. Bank structure may have been historically influenced by agriculture, but erosion is currently attributed to natural causes. **Figure B4-3** includes typical bank erosion conditions in the reach. Summary data for Bull River Reach 5-1 are presented in **Table B4-8** and **Table B4-9**.

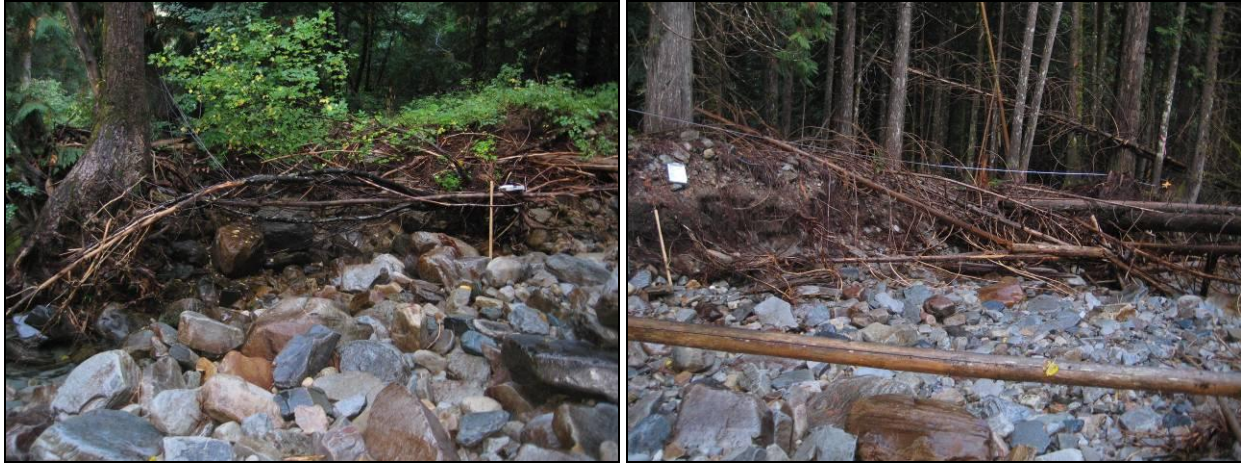
Figure B4-4. Typical eroding bank conditions in Dry Creek Reach 9-2.

Coarse cobbles and boulders form the streambank material in this reach, covered with a mat of forest roots and associated understory shrubs. The high bank height ratios and shallow rooting depths form the basis for erodability, further increased by historical silviculture activity. High near-bank stress ratings on all banks are moderated by the coarse bank material and vegetative cover. **Figure B4-4** includes typical bank erosion conditions in the reach. Summary data for Dry Creek Reach 9-2 are presented in **Table B4-10** and **Table B4-11**.

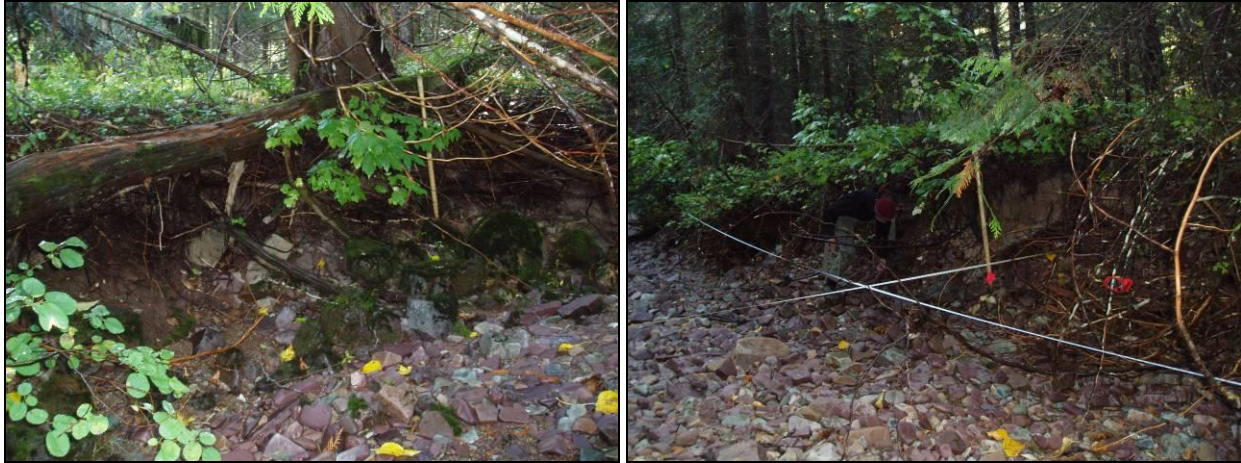
Figure B4-5. Typical eroding bank conditions in West Fork Elk Creek Reach 8-1.

Limited bank erosion in this reach is related to natural influences. Bank erosion occurs primarily near cedar stumps, roots, trunks or large woody debris knick points. Deep, curving bends also result in limited erosion at corners. **Figure B4-5** includes typical bank erosion conditions in the reach. Summary data for West Fork Elk Creek Reach 8-1 are presented in **Table B4-12** and **Table B4-13**.

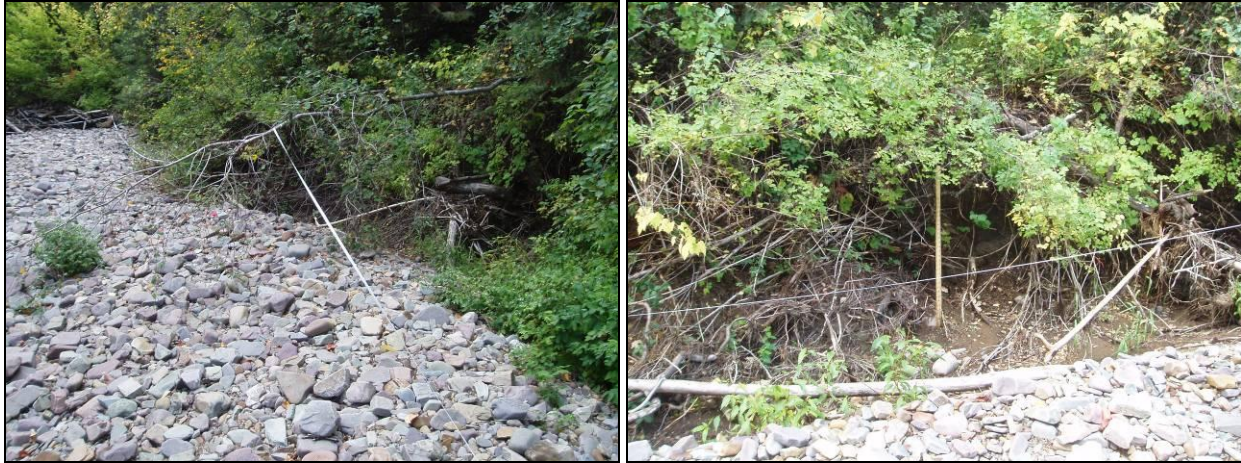
Figure B4-6. Typical eroding bank conditions in East Fork Elk Creek Reach 9-1.

Areas of sand and small fines dominate the substrate; locations where the channel shape shifts due to LWD or bends are responsible for the erosion of these materials. However, not much bank erosion was found outside of these erodible areas. Extensive vegetation cover is successfully mitigating erosion and providing cover. **Figure B4-6** includes typical bank erosion conditions in the reach. Summary data for East Fork Elk Creek Reach 9-1 are presented in **Table B4-14** and **Table B4-15**.

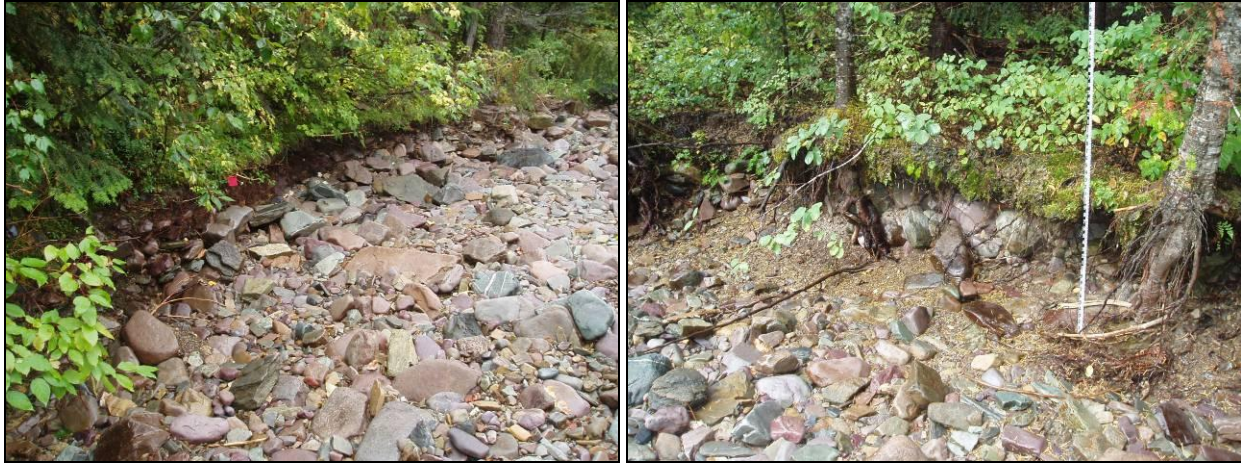
Figure B4-7. Typical eroding bank conditions in East Fork Elk Creek Reach 8-1.

Naturally occurring eroding banks, very limited in size and frequency are usually at outside meanders. The streambanks are armored with large cobble, with a mat of shrub and tree cover on top. One large eroding hillslope with a stable toe is eroding about 8 ft up the bank. The channel intercepts flood lag deposits possibly deposited during the 1964 flood. Mature cottonwoods are buried up to 3 ft by sediment. A homogeneous mixture of sediment size classes is the primary source of material to the channel (natural). **Figure B4-7** includes typical bank erosion conditions in the reach. Summary data for East Fork Elk Creek Reach 8-1 are presented in **Table B4-16** and **Table B4-17**.

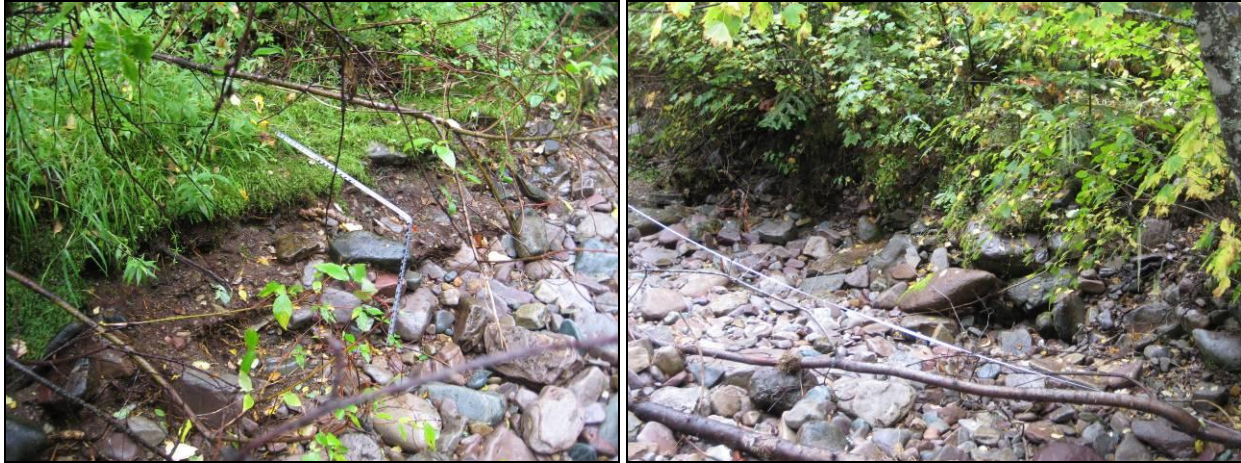
Figure B4-8. Typical eroding bank conditions in East Fork Elk Creek Reach 7-2.

The armored channel exhibits minimal erosion, all of which is attributable to natural causes. Vegetation extends to the channel margin, completely covering the mixed sizes of material that comprise the streambank. **Figure B4-8** includes typical bank erosion conditions in the reach. Summary data for East Fork Elk Creek Reach 7-2 are presented in **Table B4-18** and **Table B4-19**.

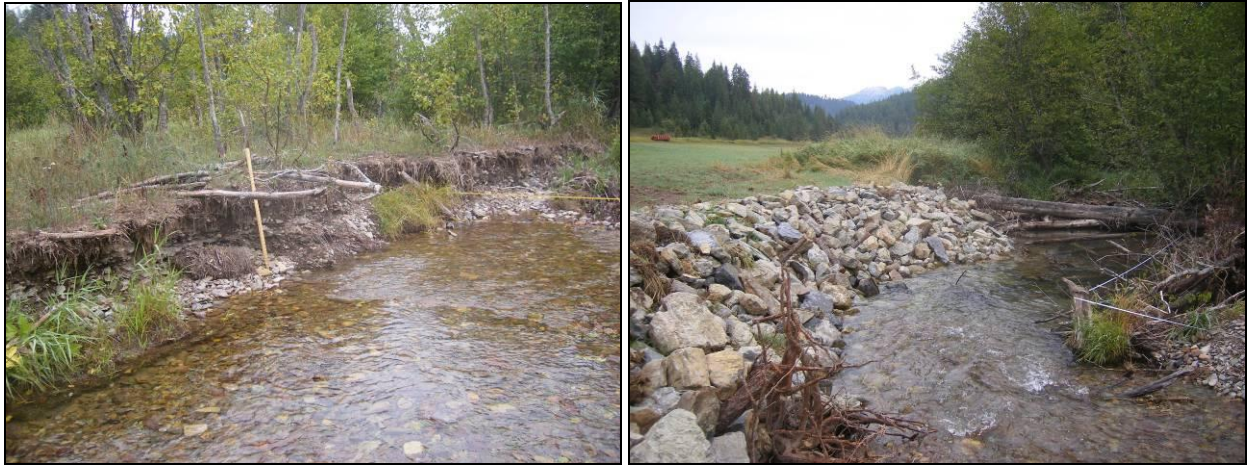
Figure B4-9. Typical eroding bank conditions in East Fork Elk Creek Reach 10-3.

Most streambanks in this reach are actively eroding. Some streambank stabilization projects have been installed including 2 engineered log jams and 1 rip-rap bank. High stream energy and bedload deposits occur at meanders, influencing channel morphology. The riparian vegetation is dominated by reed canarygrass and alder rather than historically dense species such as willow and dogwood, resulting in streambank instability. Large wood redirects flow into streambanks which is also affecting stability. Limited root density and sandy soils in some places also affect bank stability. **Figure B4-9** includes typical bank erosion conditions in the reach. Summary data for East Fork Elk Creek Reach 10-3 are presented in **Table B4-20** and **Table B4-21**.

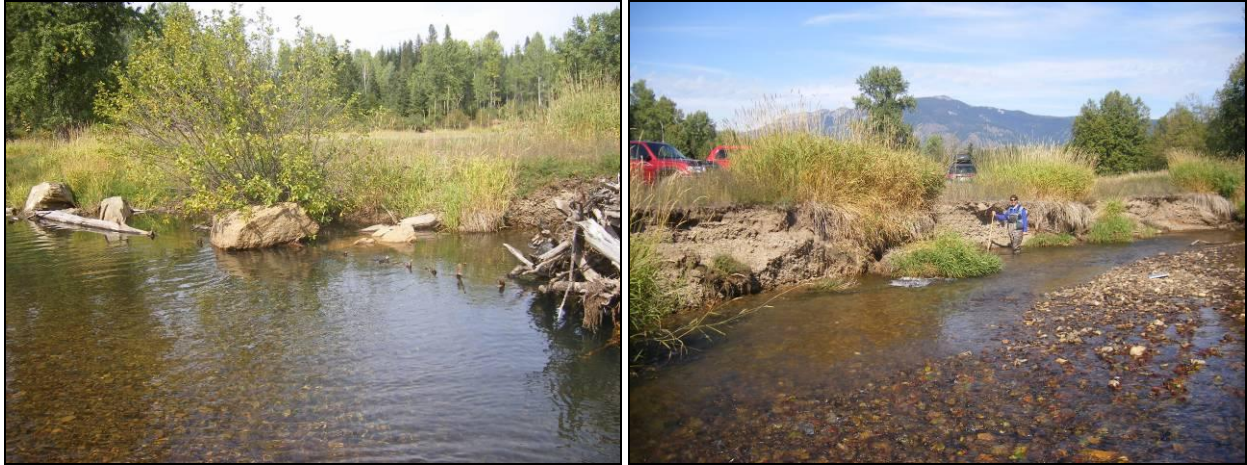
Figure B4-10. Typical eroding bank conditions in Elk Creek Reach 11-3.

Large, long sandy streambanks are unstable due to lack of good riparian vegetation. Local haying occurs in this reach but does not seem to be affecting the streambanks themselves. Minimal riparian vegetation remains on eroding banks aside from reed canarygrass and small patches of alder. **Figure B4-10** includes typical bank erosion conditions in the reach. Summary data for Elk Creek Reach 11-3 are presented in **Table B4-22** and **Table B4-23**.

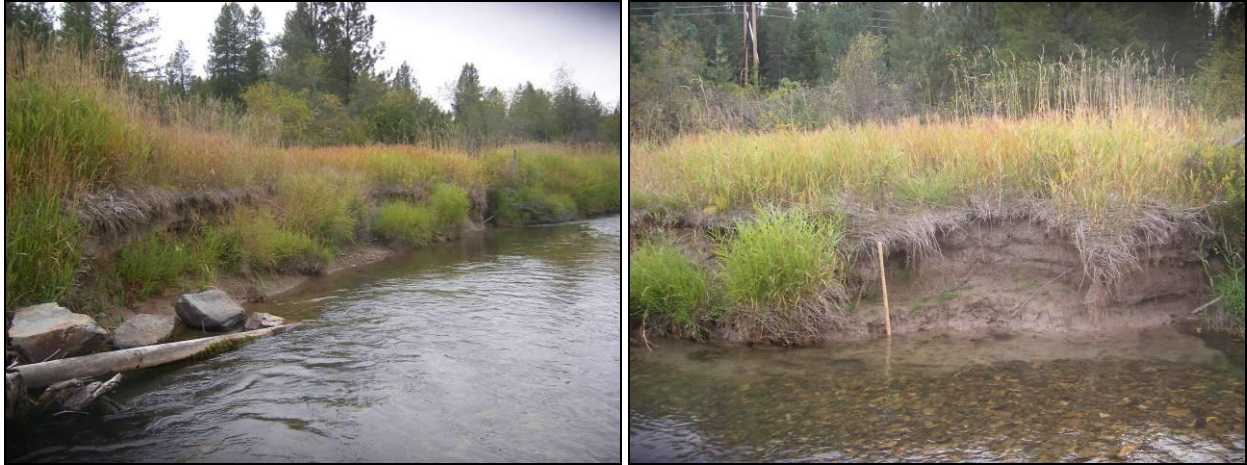
Figure B4-11. Typical eroding bank conditions in Elk Creek Reach 11-6.

Streambanks are generally comprised of fine gravel and lacustrine silt and clays. The rooting depth is relatively shallow and knapweed dominates several droughty terraces. Streambanks have high erosion potential. **Figure B4-11** includes typical bank erosion conditions in the reach. Summary data for Elk Creek Reach 11-6 are presented in **Table B4-24** and **Table B4-25**.

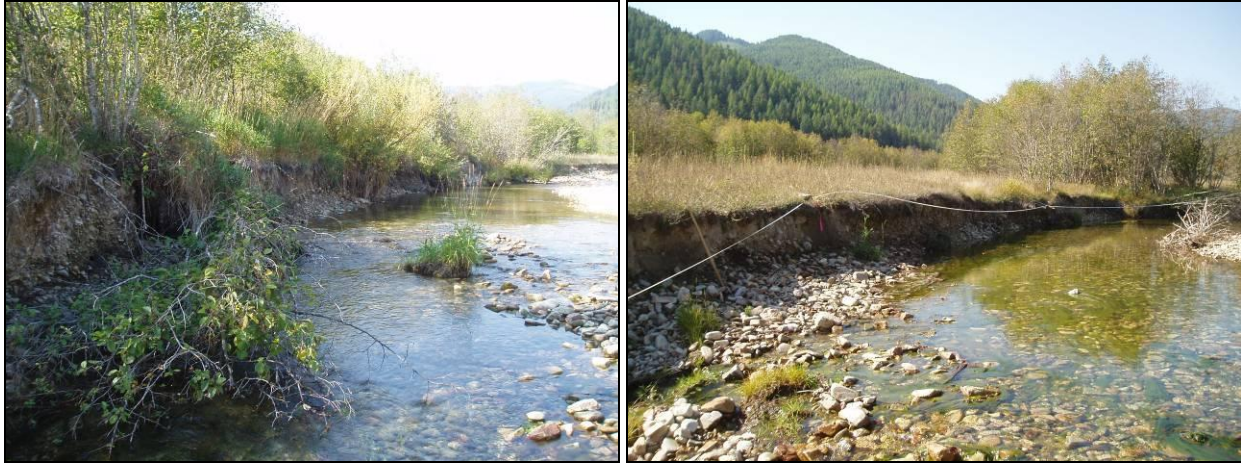
Figure B4-12. Typical eroding bank conditions in White Pine Creek Reach 9-2.

Considerable streambank erosion contributes sediment ranging from silts to medium cobble. Most erosion is occurring on outside streambanks with extreme bank heights. Alders provide some streambank stability but most eroding banks are dominated by grasses and knapweed. Inside banks are characterized by point bar deposits and sparse vegetative cover. Reaches upstream and downstream are influenced by a forest road, active evulsions and shifting channel braids. **Figure B4-12** includes typical bank erosion conditions in the reach. Summary data for White Pine Creek Reach 9-2 are presented in **Table B4-26** and **Table B4-27**.

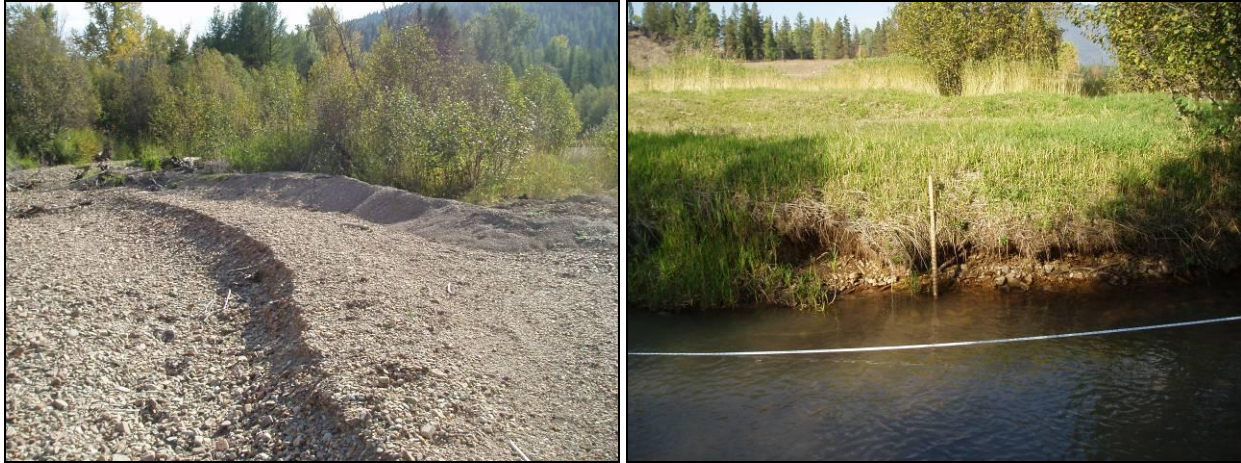
Figure B4-13. Typical eroding bank conditions in White Pine Creek Reach 9-5.

Bank erosion is relatively common at outside streambanks due to excessive bank heights. Reed canary grass colonizes failed streambank blocks. Point bars are largely colonized by reed canarygrass. Alders are located on the floodplain as well as on the streambanks of the entrenched bankfull channel. A few other shrubs are present in the reach, including spirea. The streambank has been anthropogenically altered (bulldozed and graded) on river-left near the downstream end of the reach. Haying is a dominant influence on river-left, which extends from the floodplain to the channel margin. **Figure B4-13** includes typical bank erosion conditions in the reach. Summary data for White Pine Creek Reach 9-5 are presented in **Table B4-28** and **Table B4-29**.

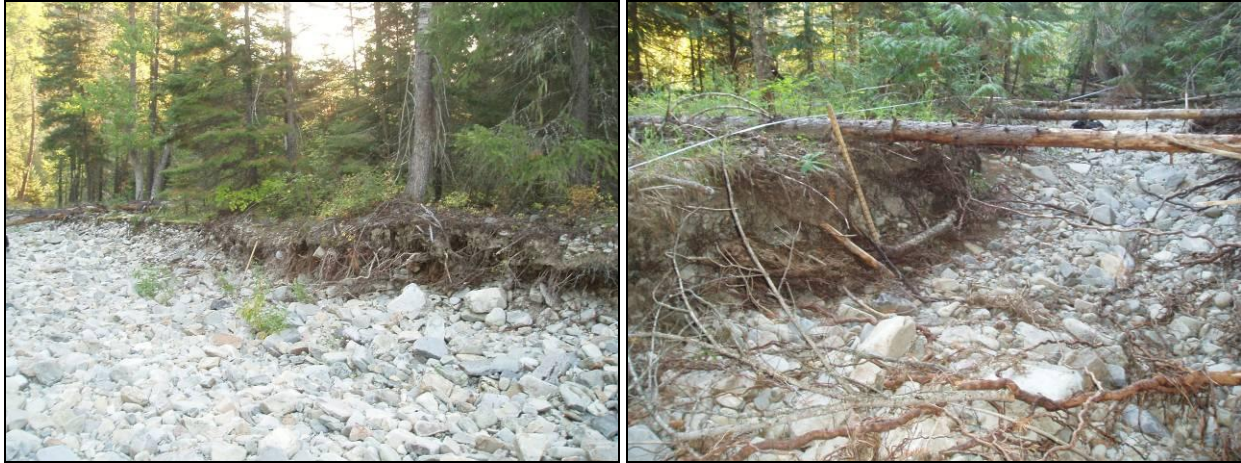
Figure B4-14. Typical eroding bank conditions in White Pine Creek Reach 8-3.

Most streambanks in the reach exhibit erosion. There is considerable sediment, generally coarser substrate, generated within the reach from streambank and floodplain erosion. Large material is mobilized by larger flood events. Lag deposits are vegetated by multi-age vegetation depending on age and disturbance regime of deposit. Multiple braided channels show evidence of scouring during floods then subsequent abandonment. **Figure B4-14** includes typical bank erosion conditions in the reach. Summary data for White Pine Creek Reach 8-3 are presented in **Table B4-30** and **Table B4-31**.

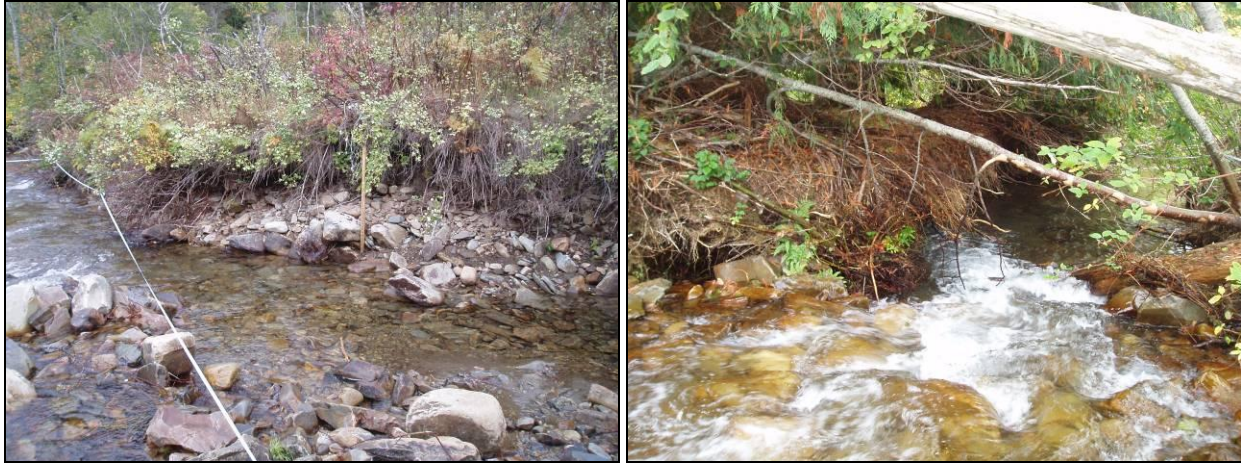
Figure B4-15. Typical eroding bank conditions in Swamp Creek Reach 18-1.

Minimal streambank erosion is present due to coarse bed and streambank material. Some erosion of floodplain areas has occurred as a result of flood channel scour. Dense shrub cover including willow communities and forest understory anchors most of the streambanks while scattered cedar groves provide additional root cover. **Figure B4-15** includes typical bank erosion conditions in the reach. Summary data for Swamp Creek Reach 18-1 are presented in **Table B4-32** and **Table B4-33**.

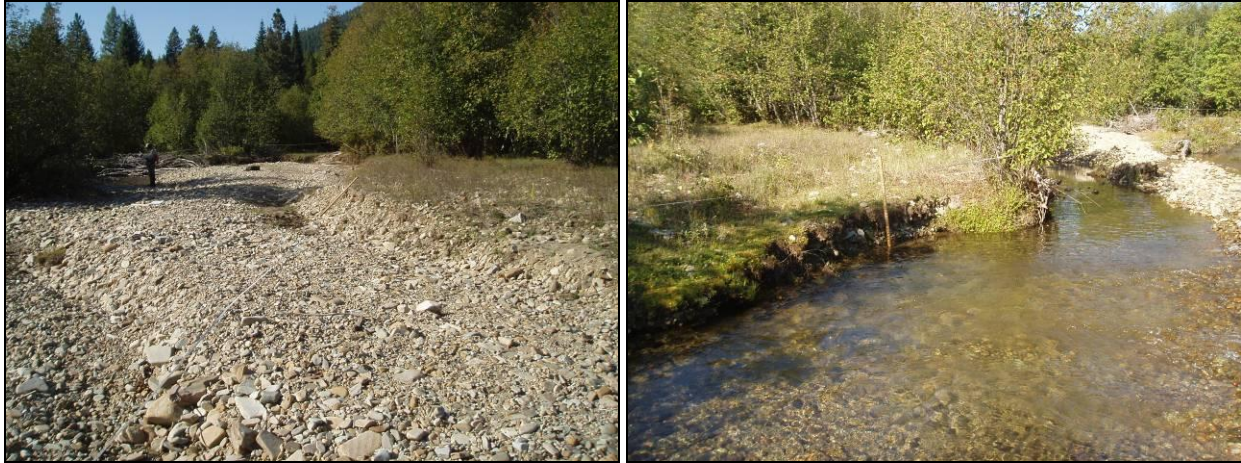
Figure B4-16. Typical eroding bank conditions in Swamp Creek Reach 20-1.

Considerable bank erosion in this reach is contributing sediment to the channel. Most eroding banks are less than 3 ft high. Glacial Lake Missoula deposits are contributing fine silts to the stream. Most of the fine sediment is in the lower portion of the reach, especially downstream of a floodplain channel that joins the creek in Cell 1. Grazing has significantly contributed to stream erosion throughout the reach, as shown by cropped grass and hoof shear. The channel appears to be actively shifting in the upstream cells, with relict point-bars, lack of vegetative cover and abandoned channels. **Figure B4-16** includes typical bank erosion conditions in the reach. Summary data for Swamp Creek Reach 20-1 are presented in **Table B4-34** and **Table B4-35**.

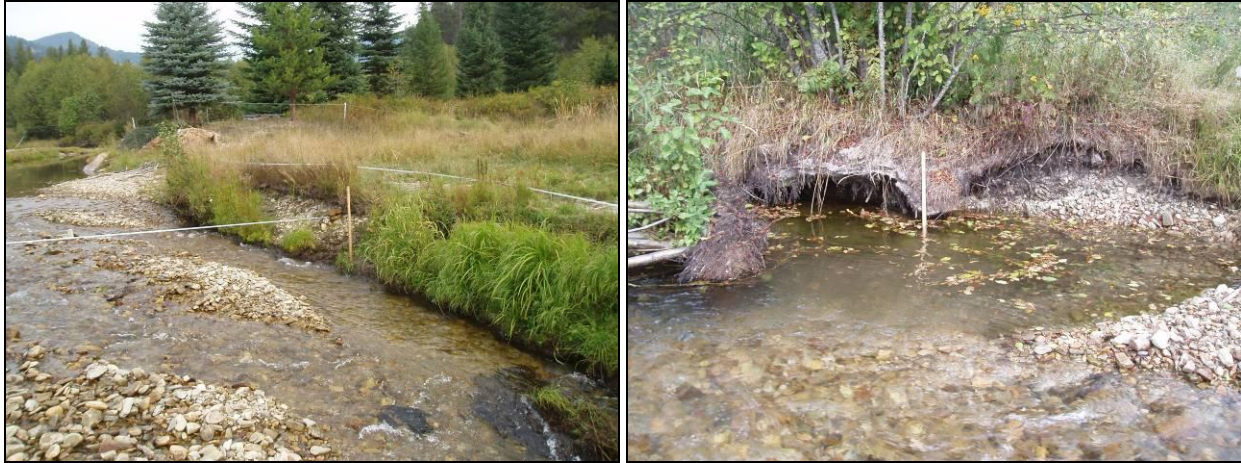
Figure B4-17. Typical eroding bank conditions in Swamp Creek Reach 21-1.

Bank erosion is common in the reach. Accelerated erosion is related to livestock grazing, hoof shear, and vegetation removal. The most severe erosion was due to bank toe failure and bank slumping. **Figure B4-17** includes typical bank erosion conditions in the reach. Summary data for Swamp Creek Reach 21-1 are presented in **Table B4-36** and **Table B4-37**.

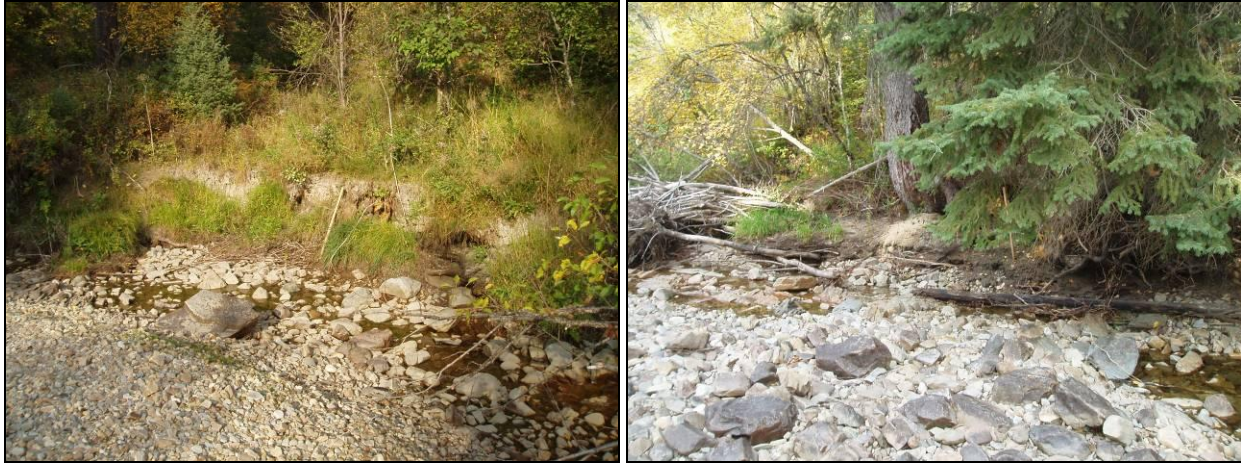
Figure B4-18. Typical eroding bank conditions in Swamp Creek Reach 22-3.

Erosion is moderate in the reach. Bedrock limits erosion in the upper portion of the reach. Failing reed canarygrass-dominated banks are fairly common. However, a good riparian shrub community limits the extent of lateral bank retreat. **Figure B4-18** includes typical bank erosion conditions in the reach. Summary data for Swamp Creek Reach 22-3 are presented in **Table B4-38** and **Table B4-39**.

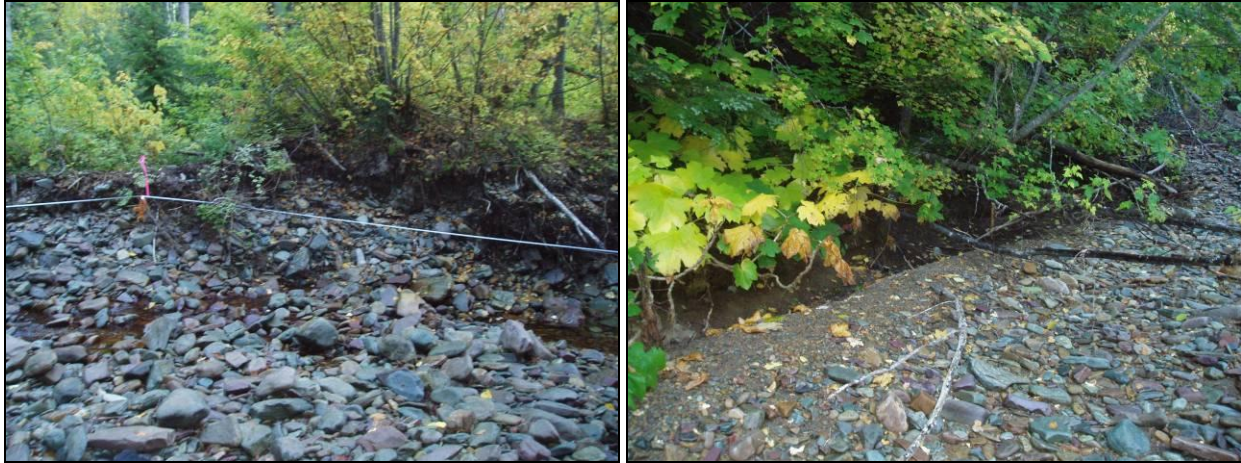
Figure B4-19. Typical eroding bank conditions in Marten Creek Reach 6-2.

In the lower reach, there is a bedrock outcrop on the southern bank. There is minimal bank erosion on the north bank. Bank erosion occurs on most streambanks lacking bedrock. Eroding banks are commonly 3 ft to 4 ft high. **Figure B4-19** includes typical bank erosion conditions in the reach. Summary data for Marten Creek Reach 6-2 are presented in **Table B4-40** and **Table B4-41**.

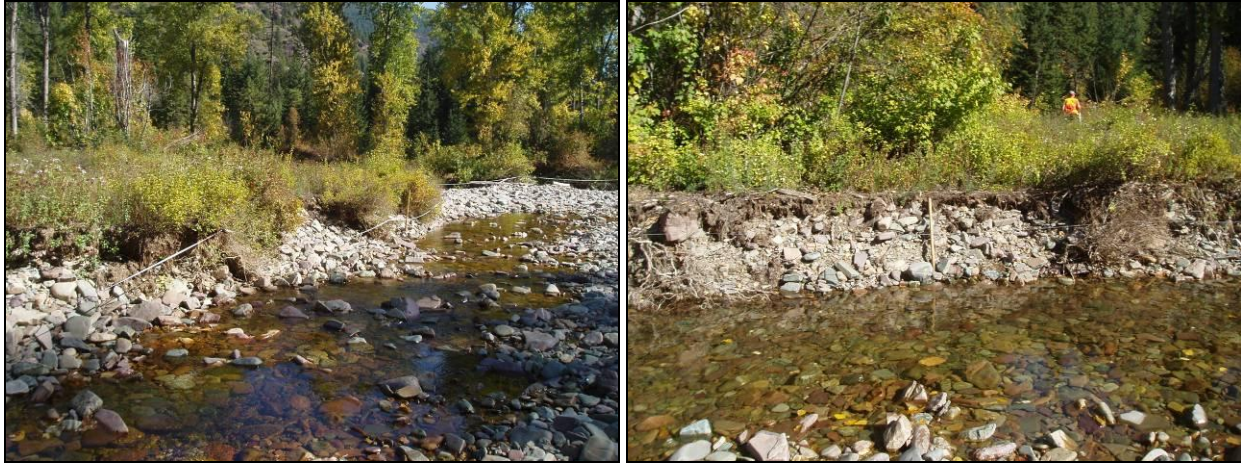
Figure B4-20. Typical eroding bank conditions in Marten Creek Reach 9-1.

Bank erosion is pervasive with most outside banks affected by scour. Flood-deposited coarse material is colonized by shrubs and weeds. Most of these surfaces are not stable enough to resist erosion. Eroding banks range from 2 ft to 4 ft in height. **Figure B4-20** includes typical bank erosion conditions in the reach. Summary data for Marten Creek Reach 9-1 are presented in **Table B4-42** and **Table B4-43**.

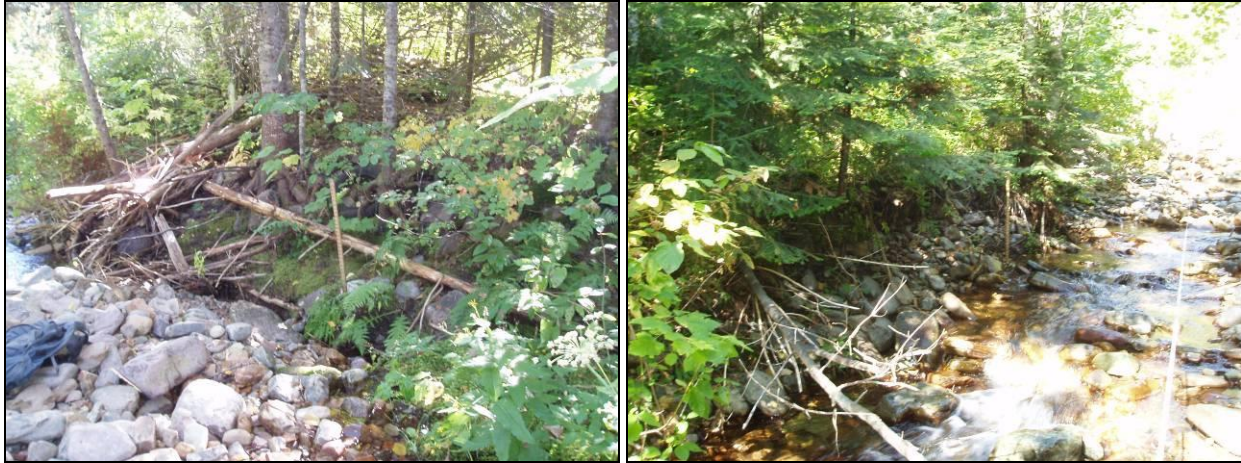
Figure B4-21. Typical eroding bank conditions in North Branch Marten Creek 8-1.

Streambanks are generally stable with some discrete point sources located along meander outcurves and constrictions. Source areas are armored with large cobble-boulder sediment (low-mod BEHI ratings). Overall, there is low supply from eroding streambanks, and high vegetative cover prevents erosion of the thin forest topsoil. **Figure B4-21** includes typical bank erosion conditions in the reach. Summary data for North Branch Marten Creek Reach 8-1 are presented in **Table B4-44** and **Table B4-45**.

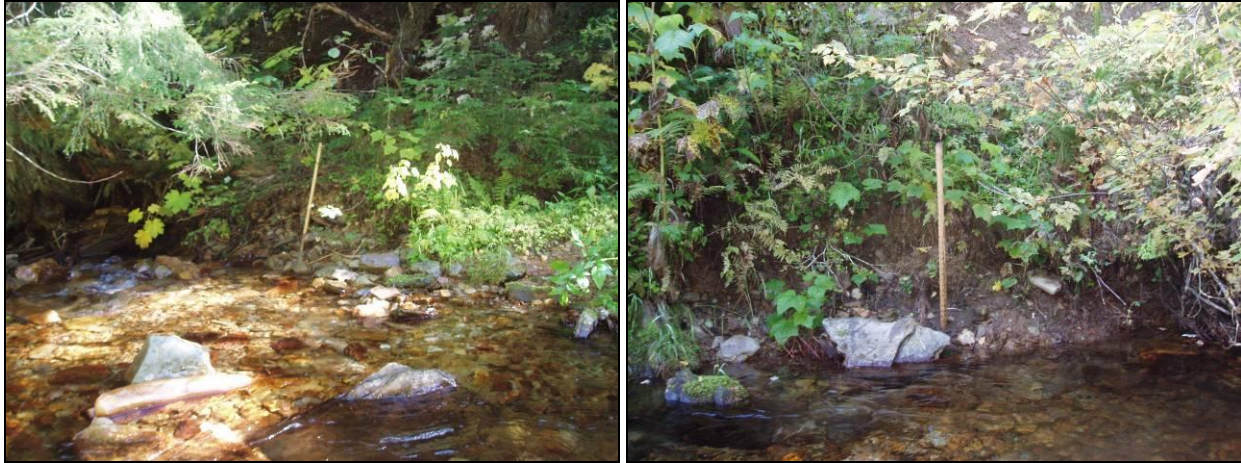
Figure B4-22. Typical eroding bank conditions in South Branch Marten Creek 3-1.

Dense vegetation, a rocky hillslope and coarse bank materials result in minimal to moderate bank erosion. Numerous LWD and boulder deposits dissipate energy and prevent further scouring. **Figure B4-21** includes typical bank erosion conditions in the reach. Summary data for South Branch Marten Creek Reach 3-1 are presented in **Table B4-46** and **Table B4-47**.
