# MADISON WATERSHED

**STREAM SUMMARIES  
2020**

Montana Department of Environmental Quality, Water Quality Planning Bureau, Watershed Protection Section

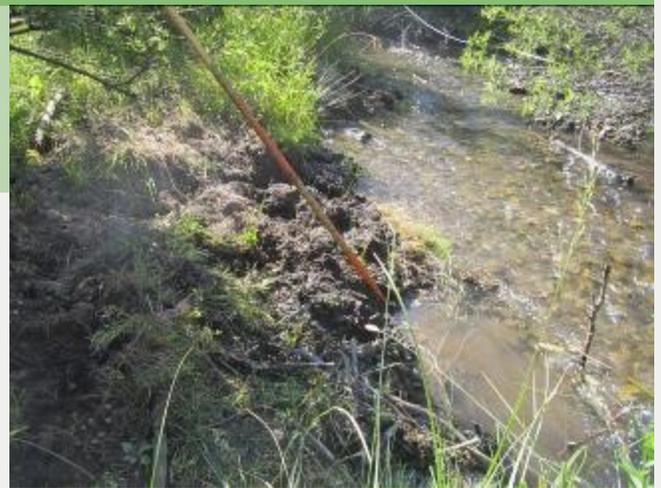
The excess fine sediment loading at the upper DEQ - monitored site (ATLP 04-02) is linked to riparian grazing in the form of trampled streambanks and over-widened areas of the stream from cattle crossings.

**A lack of healthy streamside vegetation and a trampled streambank due to cattle access at monitoring site ATLP 04-02**

Riparian area improvements in the form of grazing best management practices could eventually result in reducing sediment loading enough to meet the water quality standard. The DEQ-monitored site on lower Antelope Creek (ATLP 10-01) demonstrated stable streambanks and a recovering riparian area due to a more recent fencing project and hardened stream crossing that has reduced livestock access to the stream.

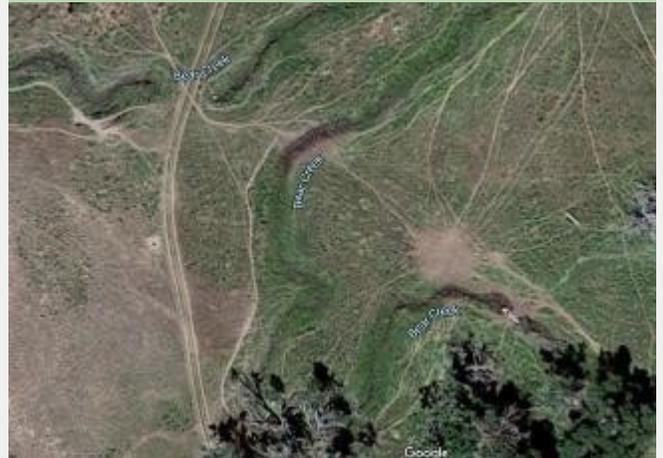
Excess fine sediment in Bear Creek is primarily linked to livestock grazing within the riparian area. Extensive pugging and hummocking, bank trampling, over-widened sections of stream where cattle crossings are located, and loss of riparian vegetation have been observed throughout the watershed.

**Aerial of extensive livestock access causing poor riparian conditions and over-widened sections of Bear Creek**

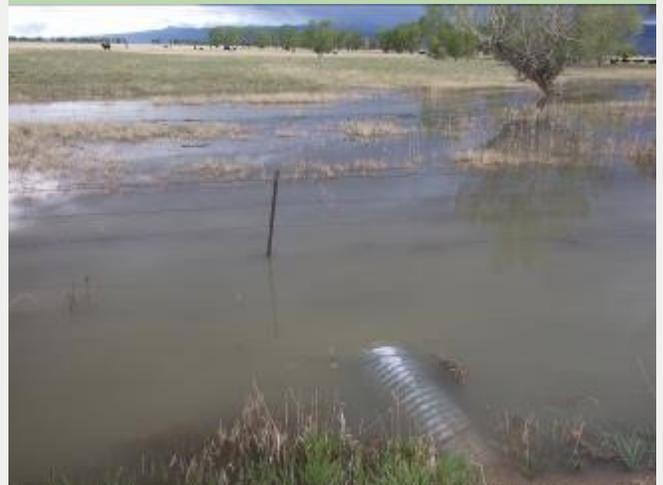
**An undersized culvert at a road crossing along Bear Creek**

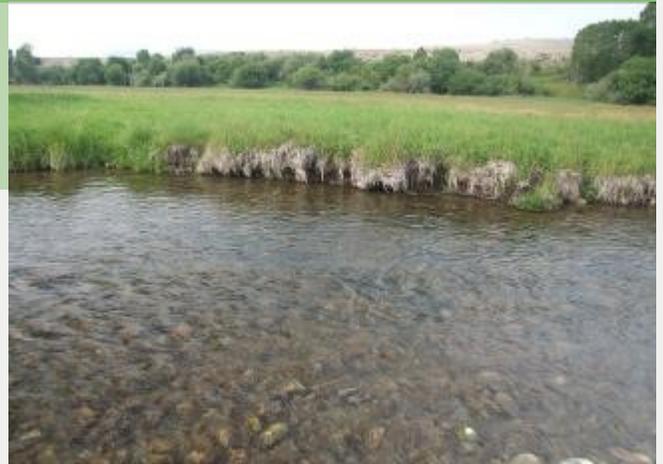
**An eroding streambank with lack of stabilizing streamside vegetation at monitoring site BLNS 06-01**

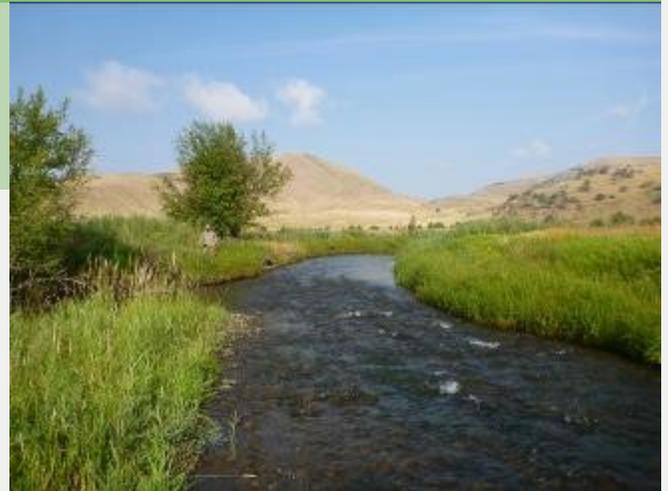
**Lack of native, shading streamside vegetation at monitoring site CHRR 20-01**

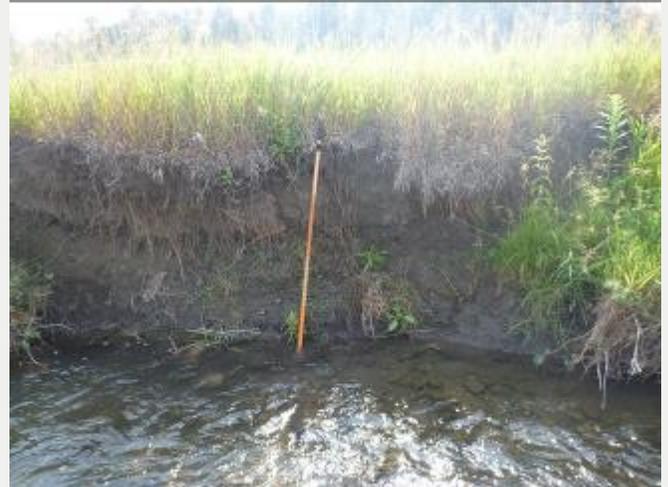
**An eroding streambank and poor streamside vegetation conditions on Cherry Creek**

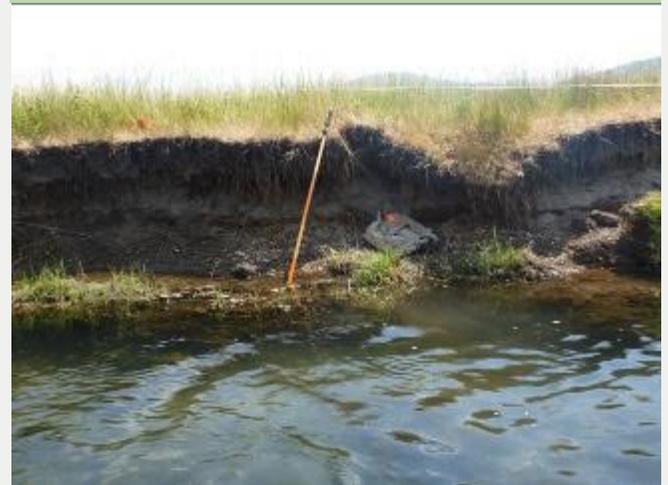
**An eroding streambank and poor streamside vegetation at monitoring location CHRR 18-02**

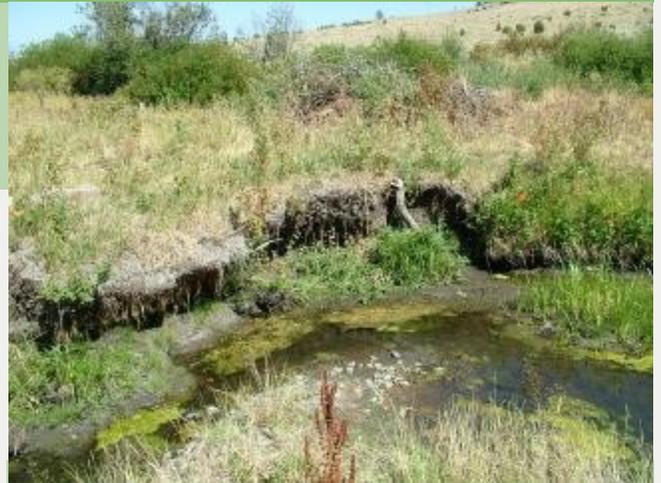
**A failing streambank and poor riparian conditions due to livestock grazing. Lack of shading vegetation has resulted in excessive algal growth.**

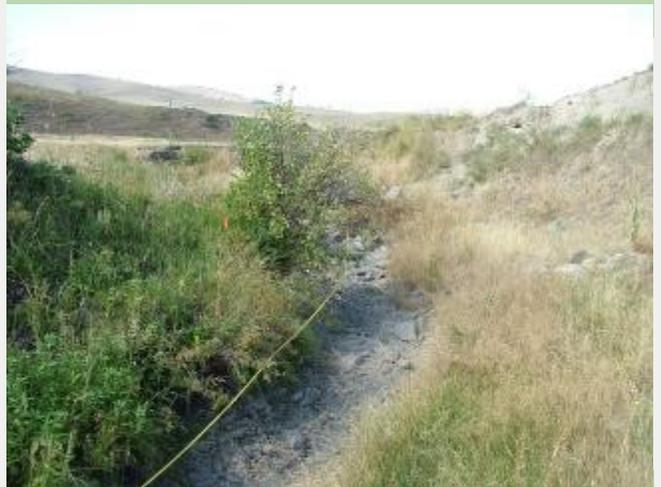
**Elk Creek without flow, resulting from irrigation diversions**

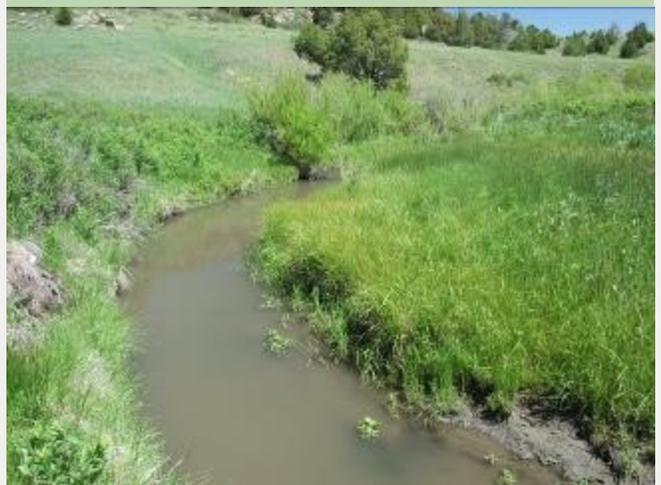
**Turbid water in Elk Creek and lack of native, shading streamside vegetation**

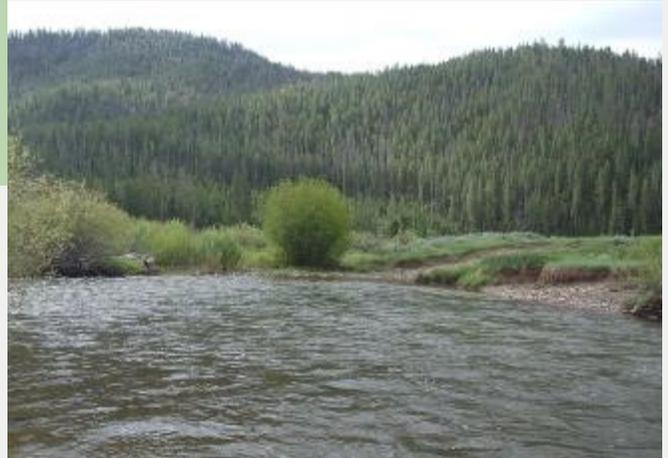
**An eroding streambank and ATV crossing/stream ford on the Elk River**

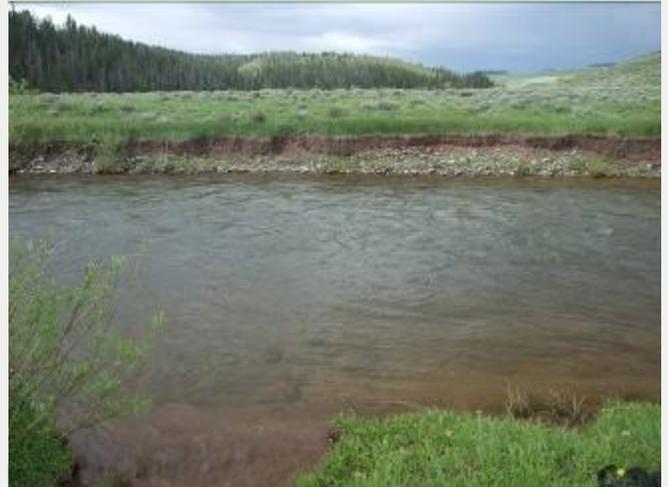
**An eroding streambank along the lower reaches of the Elk River**

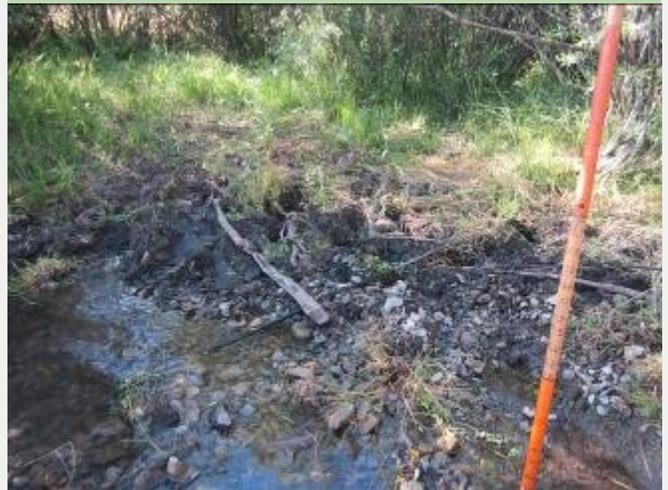
**Streambank erosion resulting from livestock access at Gazelle Creek monitoring site GAZL 16-01**

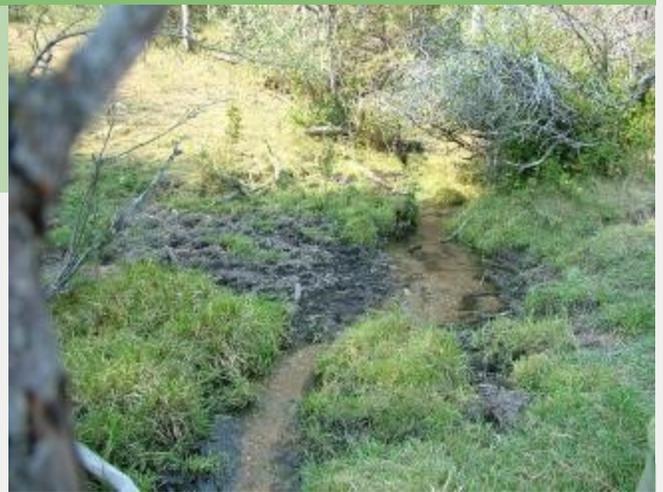
Unpaved roads and riparian grazing are the biggest contributors of excess fine sediment reaching Hot Springs Creek. Overgrazed riparian areas have led to unhealthy riparian vegetation and compromised streambanks. A wildfire burned the lower reach of the stream in 2012 (at DEQ monitoring site HOTS 16-01), which has undoubtedly contributed to excess fine sediment in this portion of the stream. However, riparian vegetation is quickly rebounding to create a buffer against unstable soils in the burned uplands.

**Hummocking, loss of streamside vegetation, and streambank erosion resulting from livestock access to Hot Springs Creek**

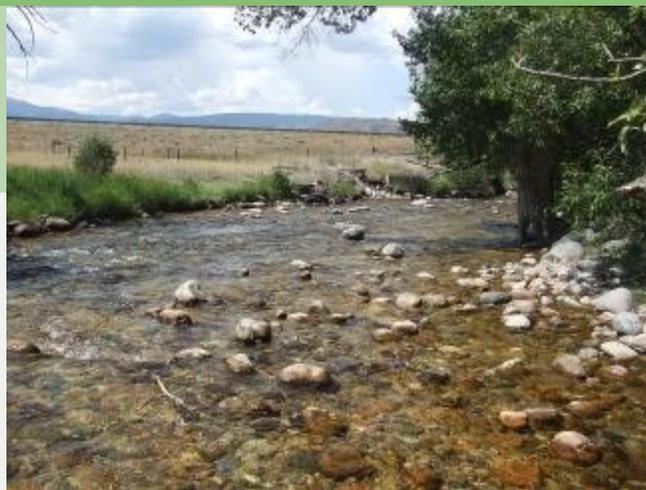
**Lack of healthy streamside vegetation at Indian Creek monitoring site INDN 25-01**

Improved grazing management practices will lead to a healthier riparian area and address the “alteration in stream-side or littoral vegetative covers” impairment. Where possible, efforts should be made to increase instream flow when Indian Creek faces severe low flow conditions or runs dry during summer months.

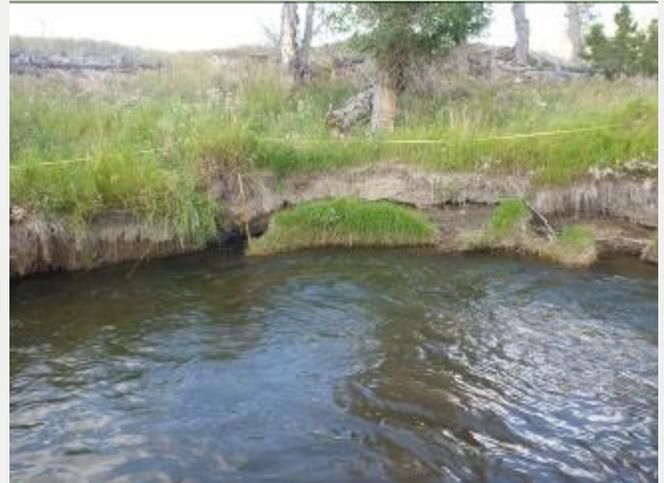
**Lack of stabilizing streamside vegetation resulting in an eroding streambank at site JACK 14-03**

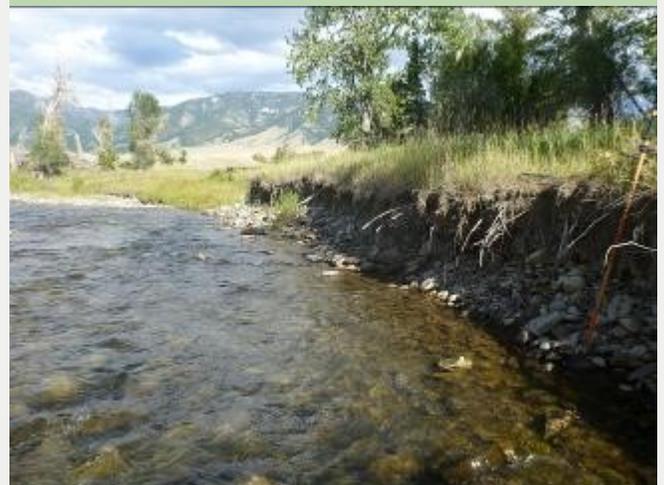
**Unhealthy streamside vegetation and an eroding streambank at monitoring site JACK 14-03**

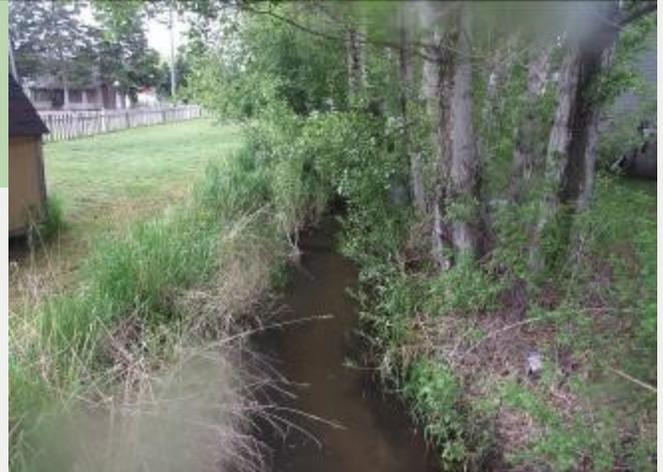
**An Inadequate streamside buffer between a lawn and Moore Creek**

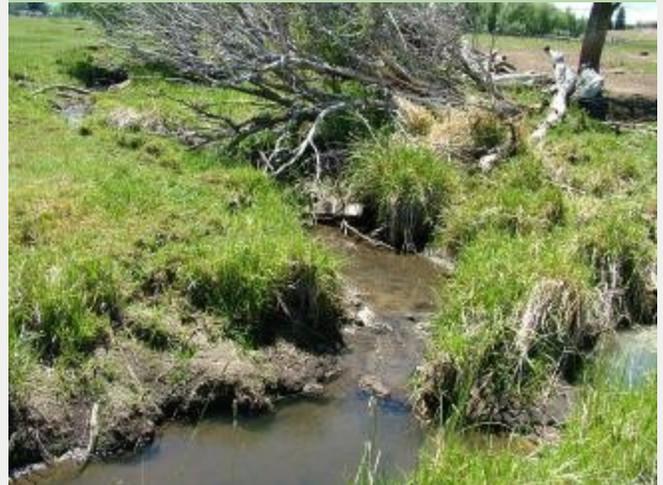
**Unhealthy streamside vegetation and trampled streambanks resulting from livestock access to Moore Creek**

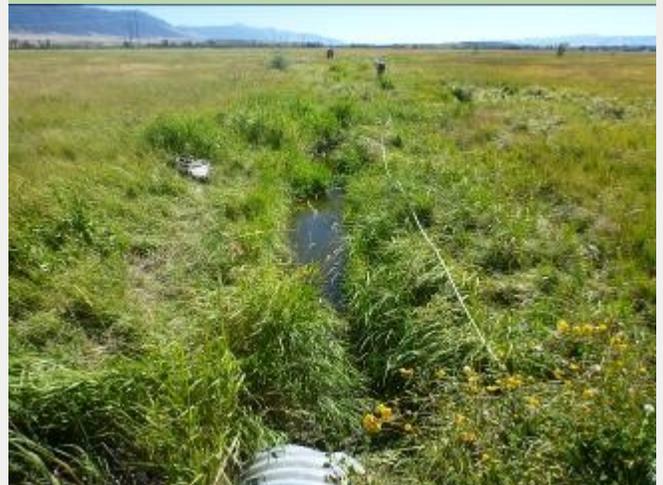
**Lack of shading streamside vegetation resulting from livestock grazing along Moore Creek**

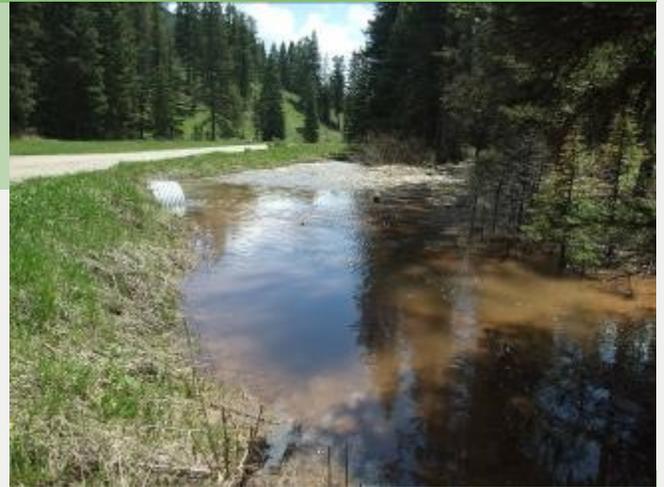
**An undersized culvert at a road crossing along Red Canyon Creek**

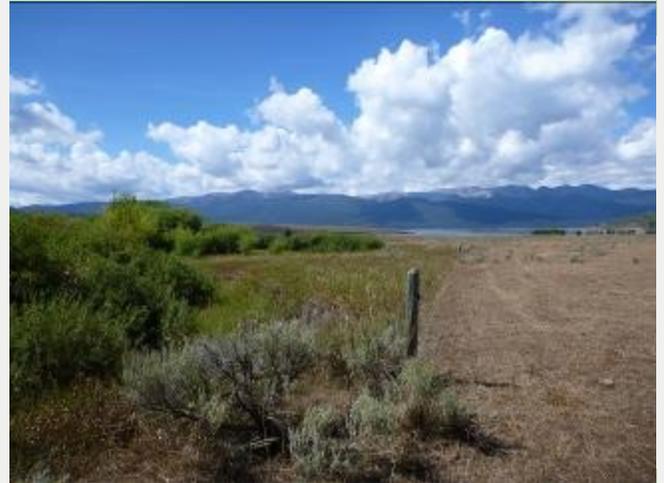
**A heavily grazed parcel compared to protected streamside vegetation along Red Canyon Creek**

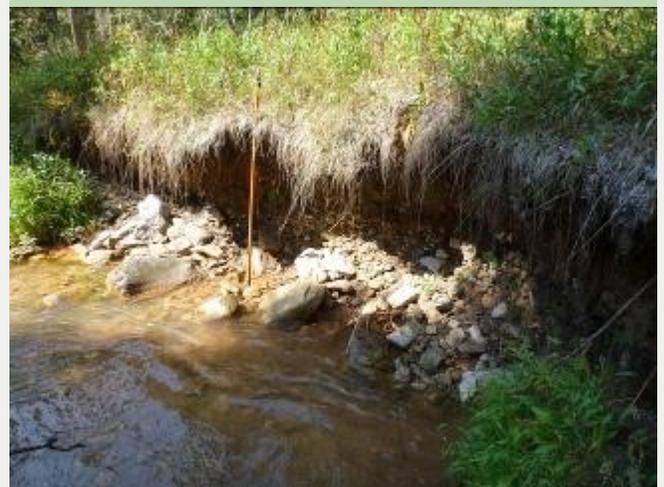
**An eroding streambank along Red Canyon Creek**

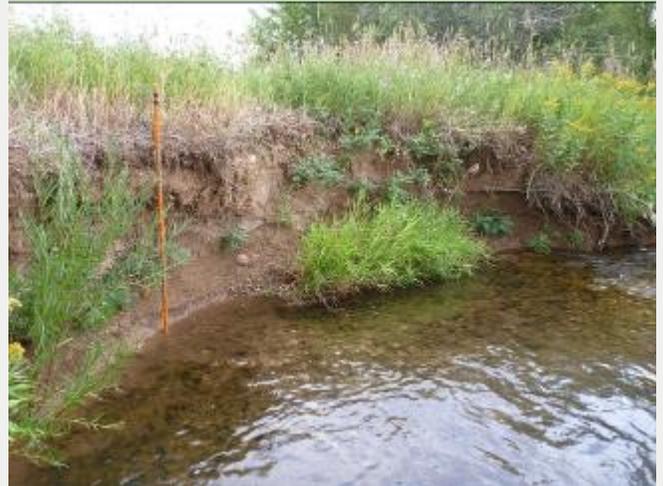
**Unhealthy streamside vegetation resulting in an eroding streambank along Ruby Creek**

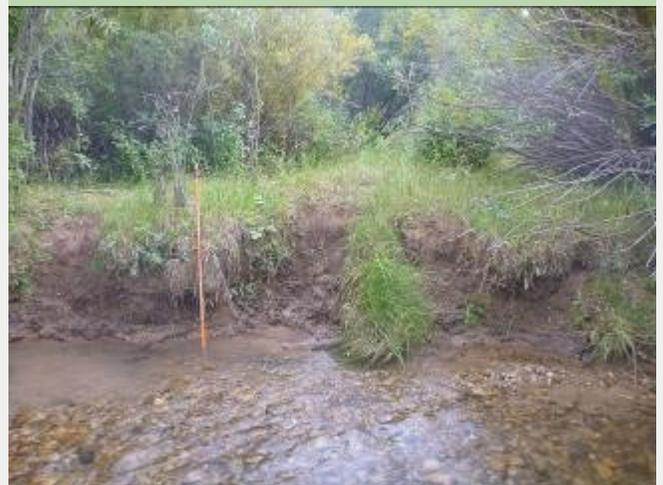
**Unhealthy streamside vegetation and an eroding streambank due to livestock grazing along Ruby Creek**

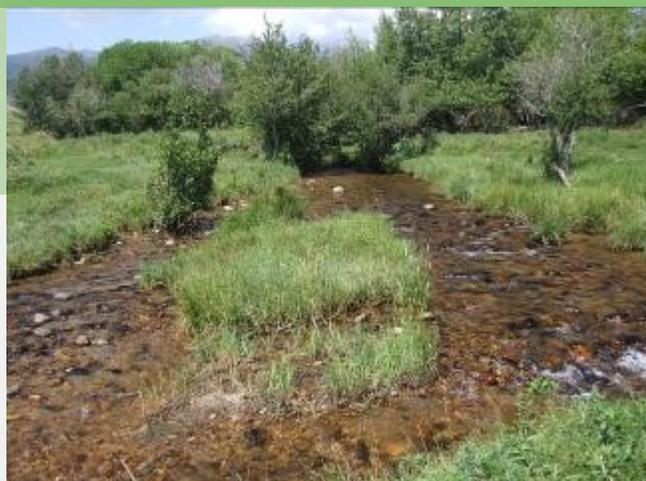
**Over-widened channel conditions due to livestock grazing along South Meadow Creek**

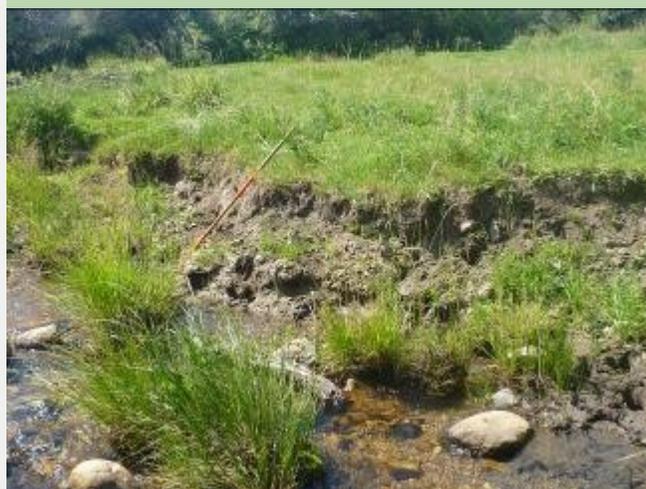
**An eroding streambank and unhealthy streamside vegetation resulting from livestock grazing on South Meadow Creek (site SMDW 18-01)**

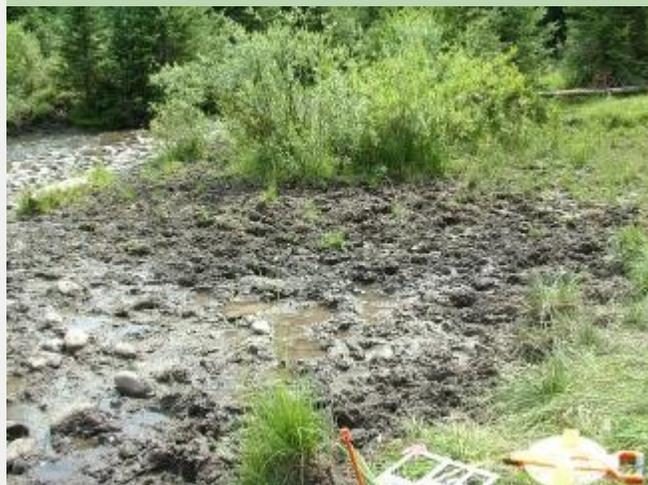
**A trampled streambank due to livestock grazing along Watkins Creek**

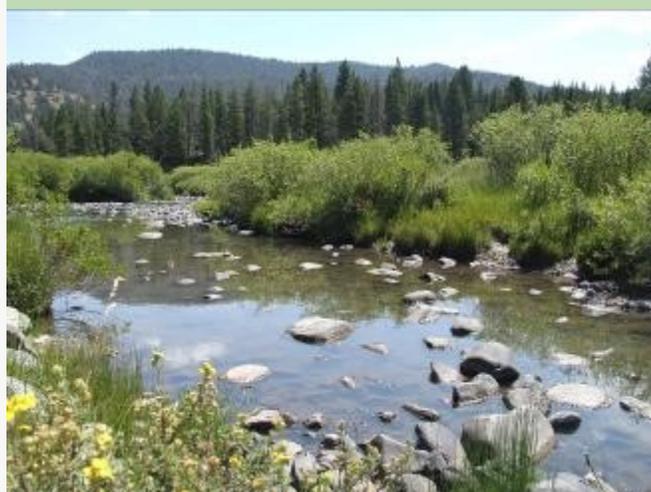
Mix of healthy streamside vegetation and invasive weeds along the lower West Fork Madison River

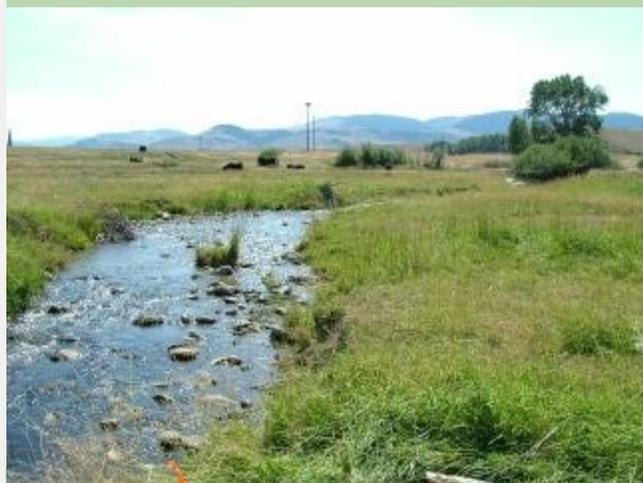
**Unhealthy streamside vegetation and over-widened channel conditions from livestock grazing along Wigwam Creek (site WGWM 18-01)**

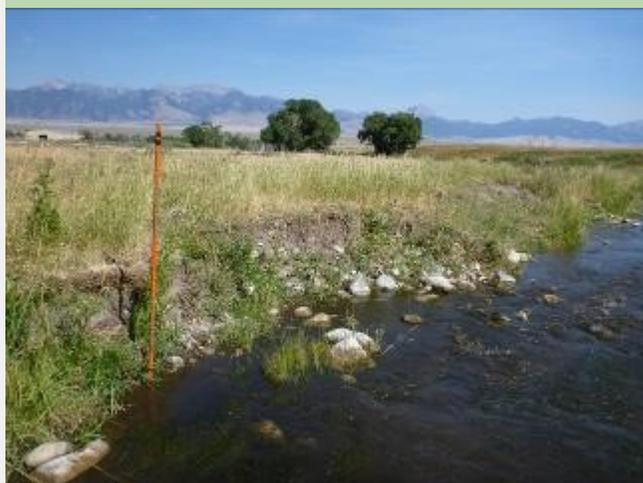
**Unhealthy streamside vegetation and an eroding streambank due to livestock access to Wigwam Creek**
