FINAL ENVIRONMENTAL ASSESSMENT AMENDMENT

JEFFRIES NO. 18 MINE TIPPLE RECLAMATION AND MUSSELSHELL RIVER RESTORATION PROJECT MUSSELSHELL COUNTY, MONTANA

MONTANA DEPARTMENT OF ENVIRONMENTAL QUALITY

November 2018

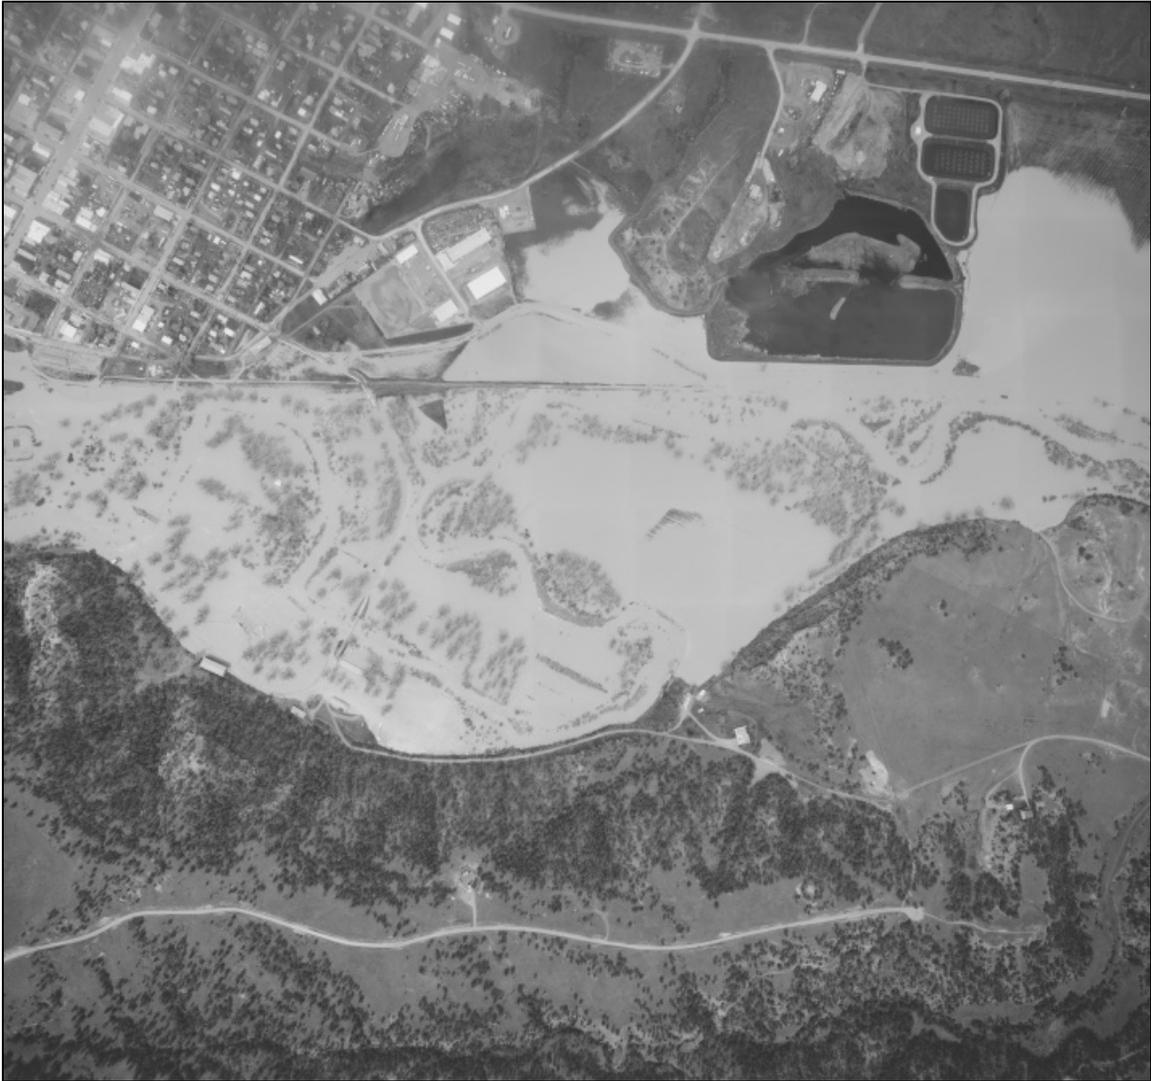
Figure 4 Aerial photo of City of Roundup during 2011 flood (Montana Department of Transportation 2011).

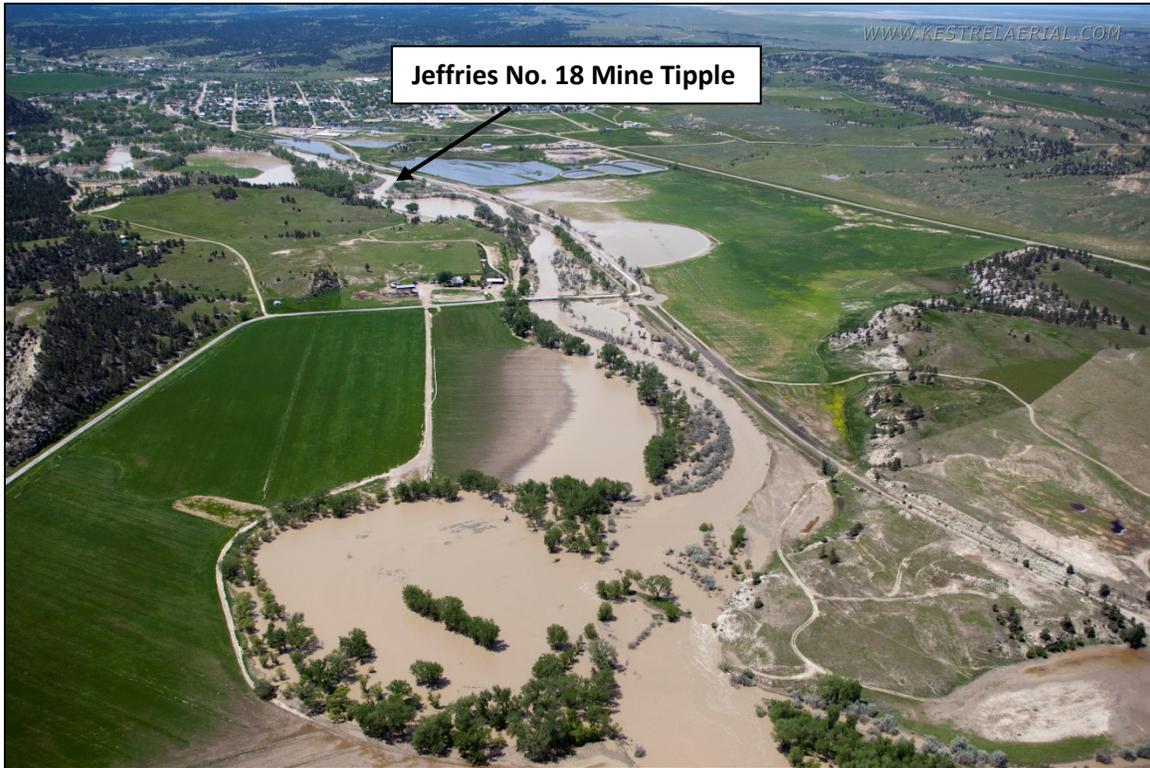
Figure 6 Aerial photo of City of Roundup during 2014 flood (Kestrel Aerial, 2014).

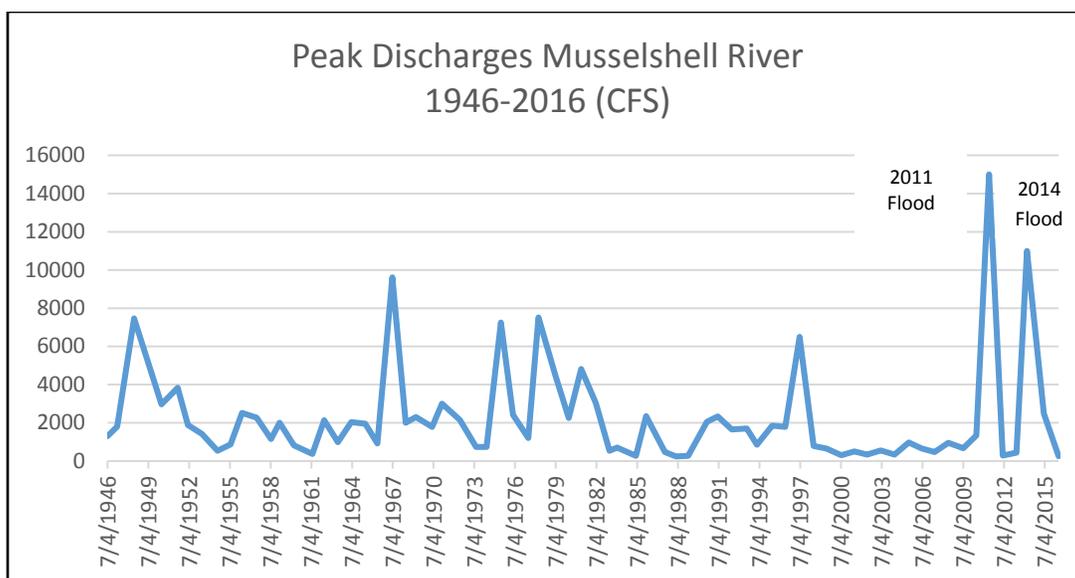
Figure 7 Peak discharges in Musselshell River near Roundup, Montana, 1946-2016 (USGS, 2018).

A summary of peak discharges of the Musselshell River is provided in Figure 7 from 1946 to 2016. Figure 8 illustrates the peak flows from the 2011 and 2014 floods.

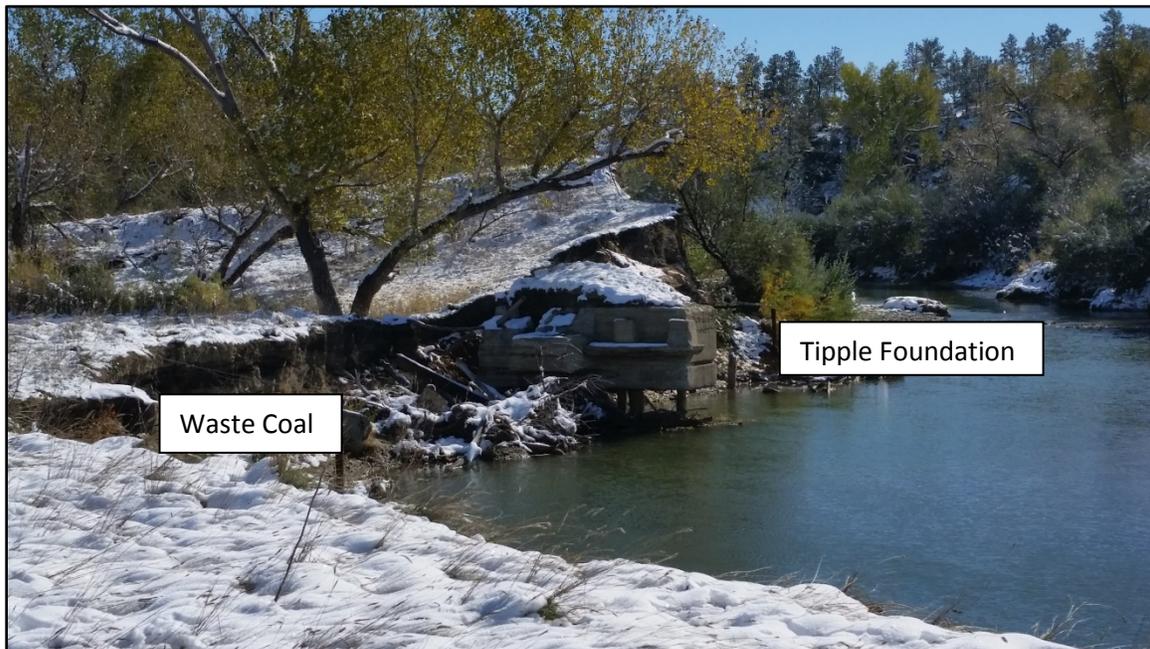
Figure 10 Site conditions following the floods of 2011 and 2014. Flooding exposed the tipple foundation and eroded waste coal waste from the bank (DEQ, SL Graham 2016).

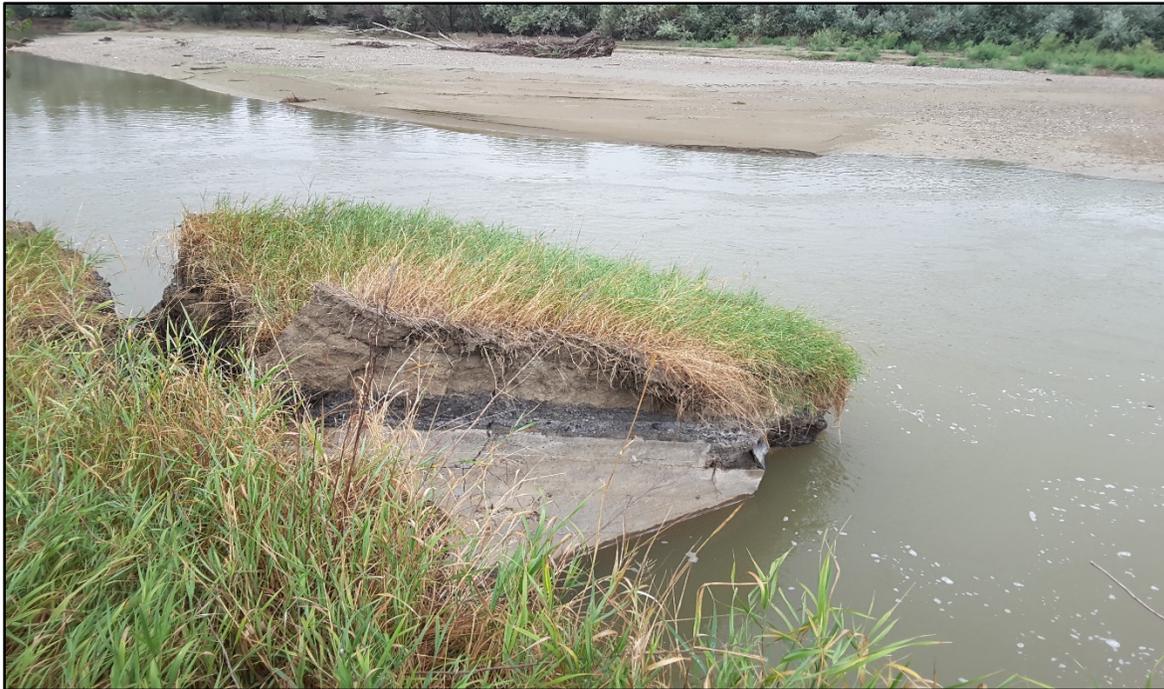
Figure 11 Foundation exposed during 2018 flood. The tipple foundation illustrated in Figure 10 is beneath the point bar located in the background of this photograph.

Jeffries No. 18 Mine consists of the remnants of a coal mine located on both the north and south banks of the Musselshell River. The mine entrance was located on the south bank at the base of a steep hill. The tipple and scales for the mine were located on the north side of the river. GCM Services, Inc. noted that little remained from the mining operation (1984). GCM Services, Inc. also noted that coal slack was visible adjacent to the tipple foundation (1984). The flooding in 2011 and 2014 eroded a large portion of the material adjacent to the tipple depositing waste coal into the river (Figure 10). Prior to 2018, only portions of the tipple structure remain including the concrete footing, a concrete slab, and lumber debris. After the 2018 flooding, the tipple foundation collapsed to the river bottom as the river migrated through its floodplain. The flood exposed an additional foundation (Figure 11).

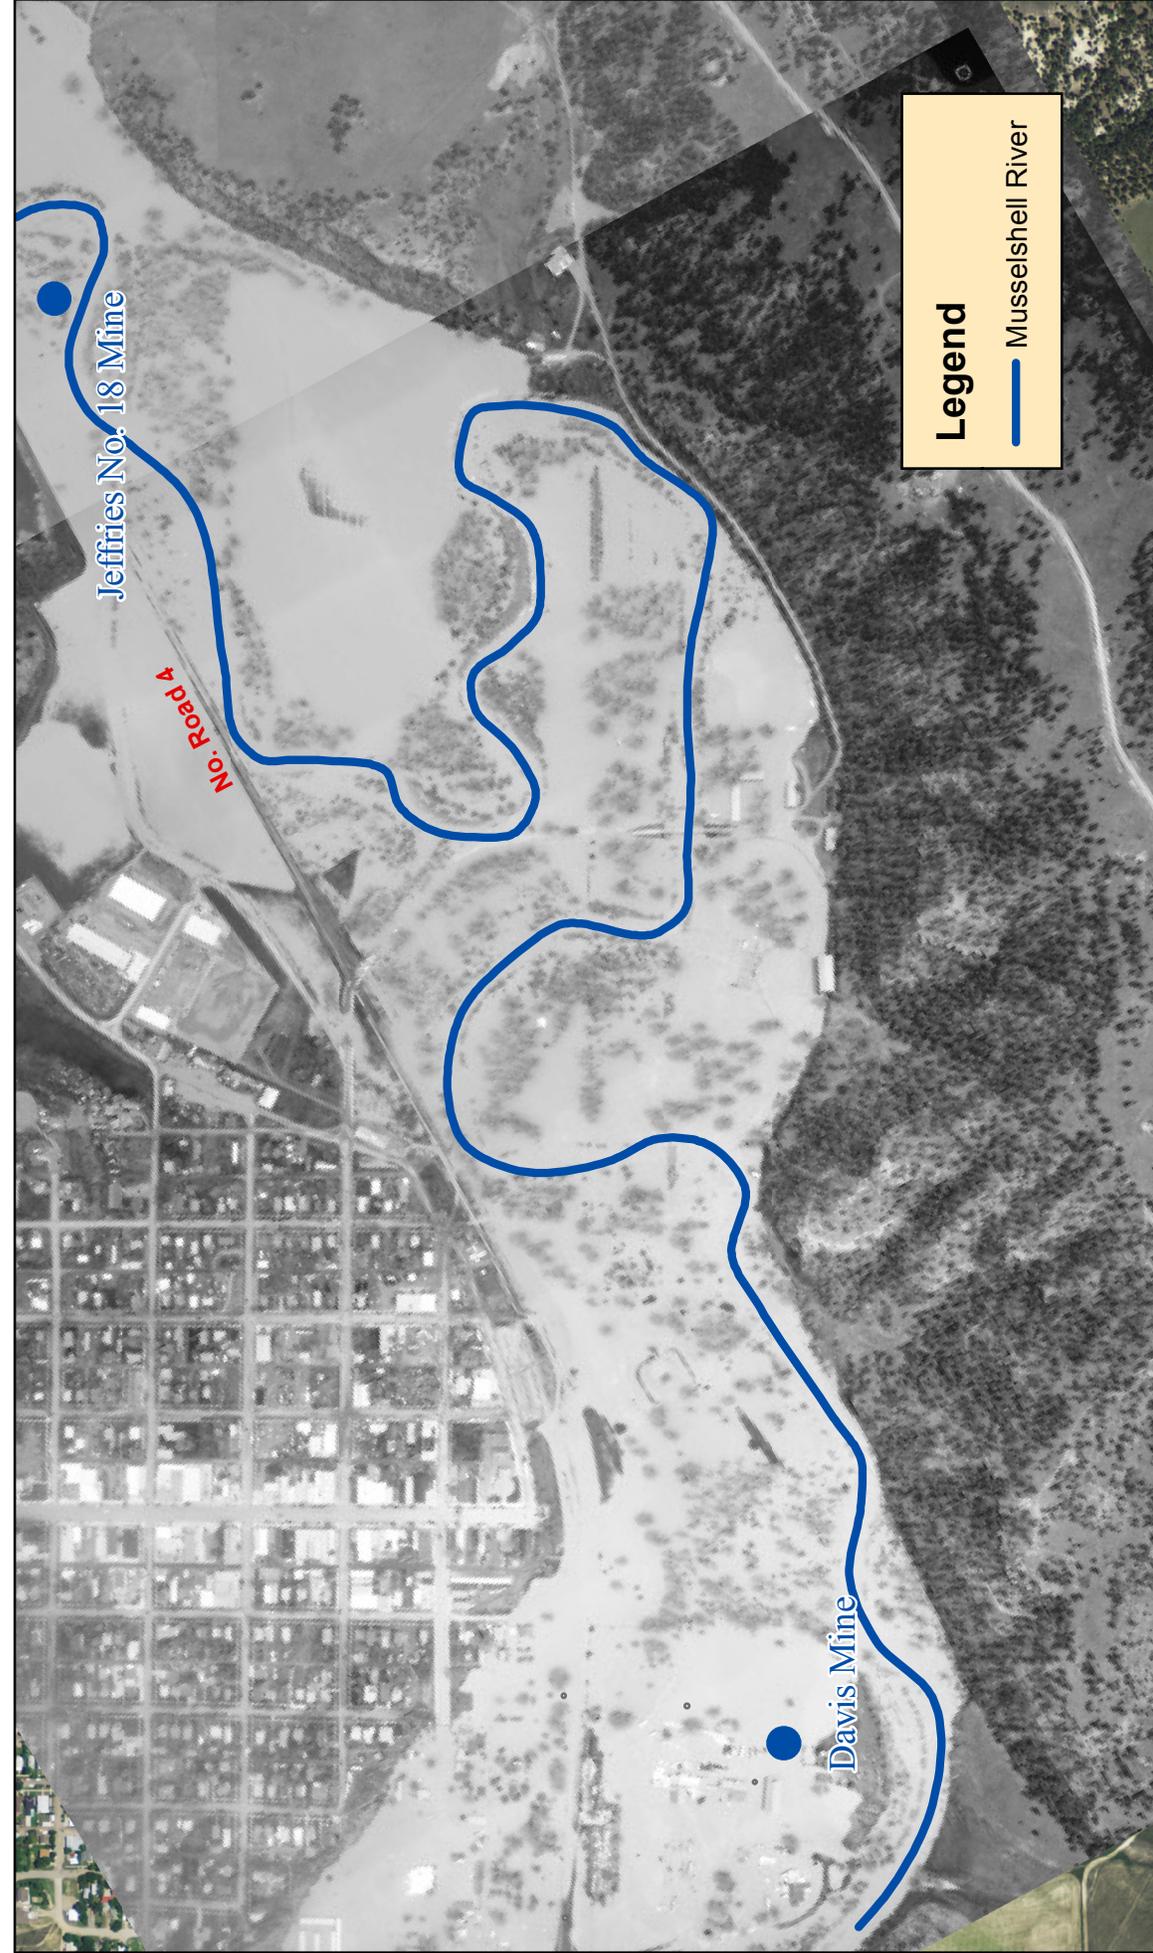
Figure 5
Extent of 2011 Flooding
Jeffries No. 18 Mine Tipple
Roundup, Montana

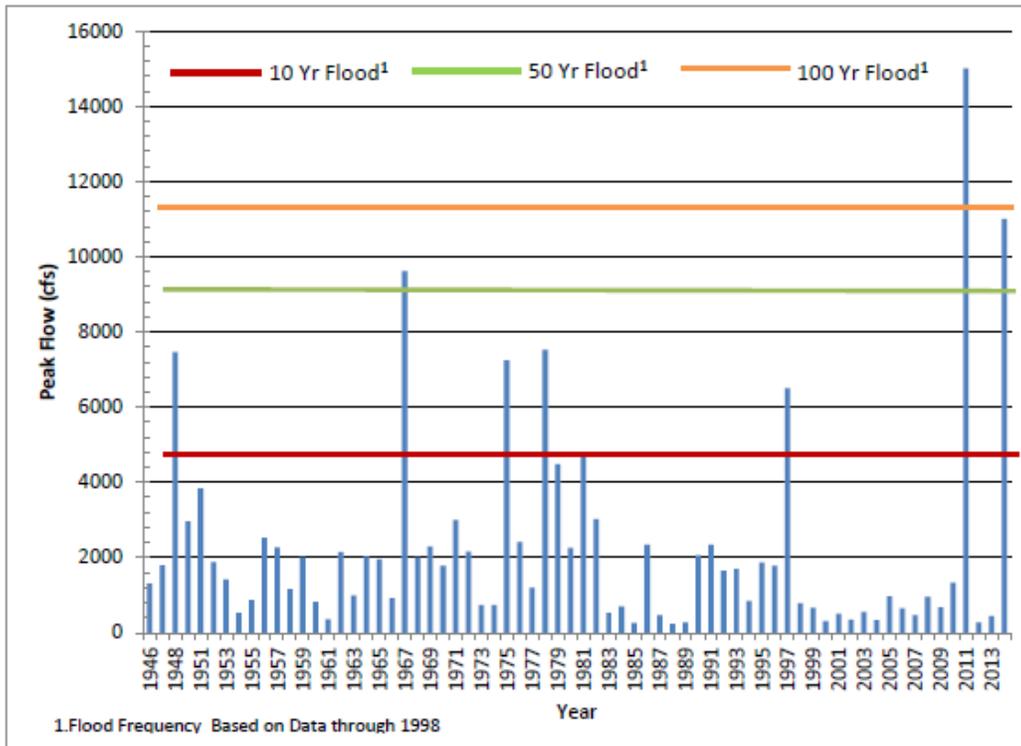
Figure 2. Flood history for Musselshell River near Roundup (Pioneer Technical Services, 2015); flood frequencies do not include post-1988 data.

Figure 2 shows that the 2011 event exceeded a 100-year flood. Although that was widely considered the case when the flood occurred, those flood frequencies were all based on pre-1988 data and thus did not integrate more recent events into the statistics. In 2015, Pioneer Technical Services (PTS) revised the flood frequency discharge values as part of a Musselshell River floodplain study using a more complete dataset that includes the 2011 and 2014 flood events (PTS, 2015). Their results indicated significantly higher peak discharge values for a given flood return interval than had been previously established at the Roundup gage. Whereas earlier studies indicated a 100-year flow event of about 11,500 cfs at Roundup, (Figure 2) the revised calculations increased that value to 15,750 cfs (Table 1, Pioneer, 2015). The PTS results indicate that, at Roundup, the 2011 event was just under a 100-year event, and the 2014 event was about a 50-year flood.

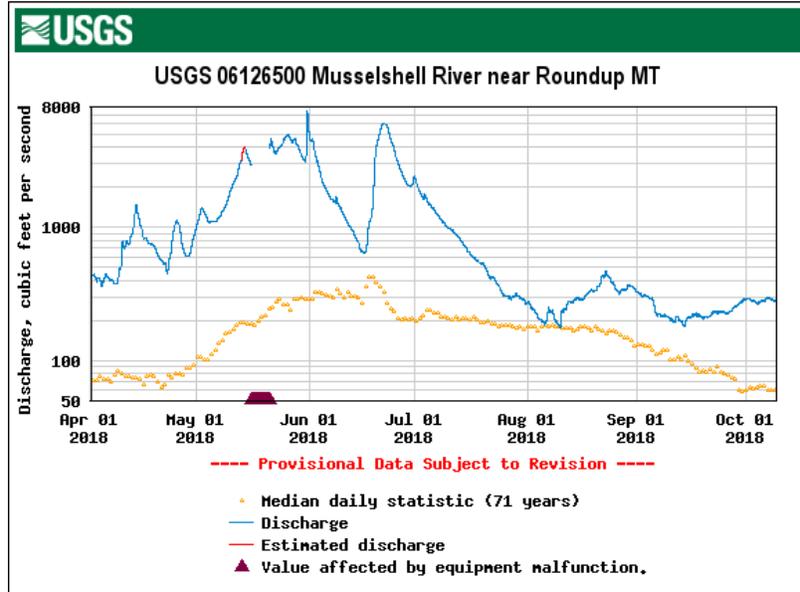
Figure 3. USGS hydrograph for spring and summer 2018 for Musselshell River at Roundup (USGS 06126500).

In early June of 2018 another major flood occurred, the third in eight years (Figure 3 and Figure 4). Although this event recorded about half of the discharge measured at Roundup in 2011, it was still a 25-year flood event that had a long recessional limb throughout July, which provided a capacity to perform major geomorphic work in the river corridor. The relevance of flood history to the project is that, prior to the 2018 flood, the river was still in a state of post-2011 geomorphic adjustment. As such, subsequent 2018 flooding caused additional major geomorphic response which has affected site conditions and the appropriateness of previously developed remediation strategies.

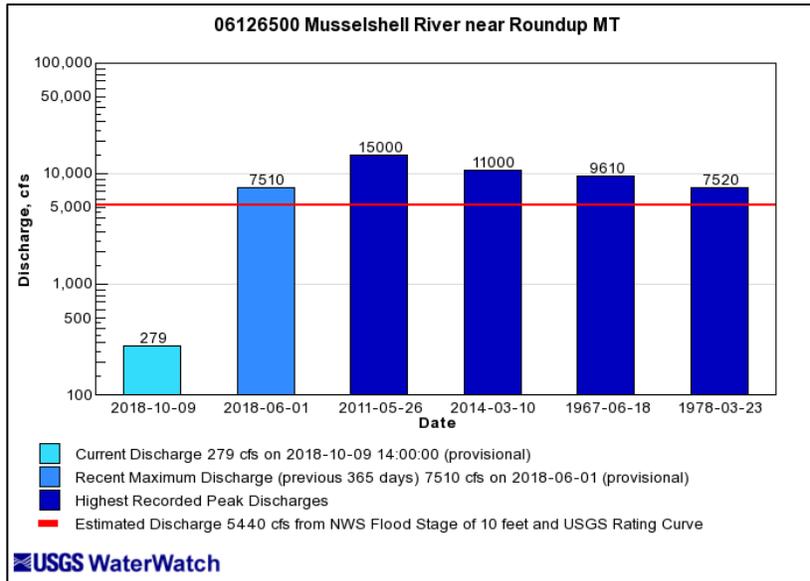
Figure 4. Major flood history for Musselshell River at Roundup (USGS 06126500).

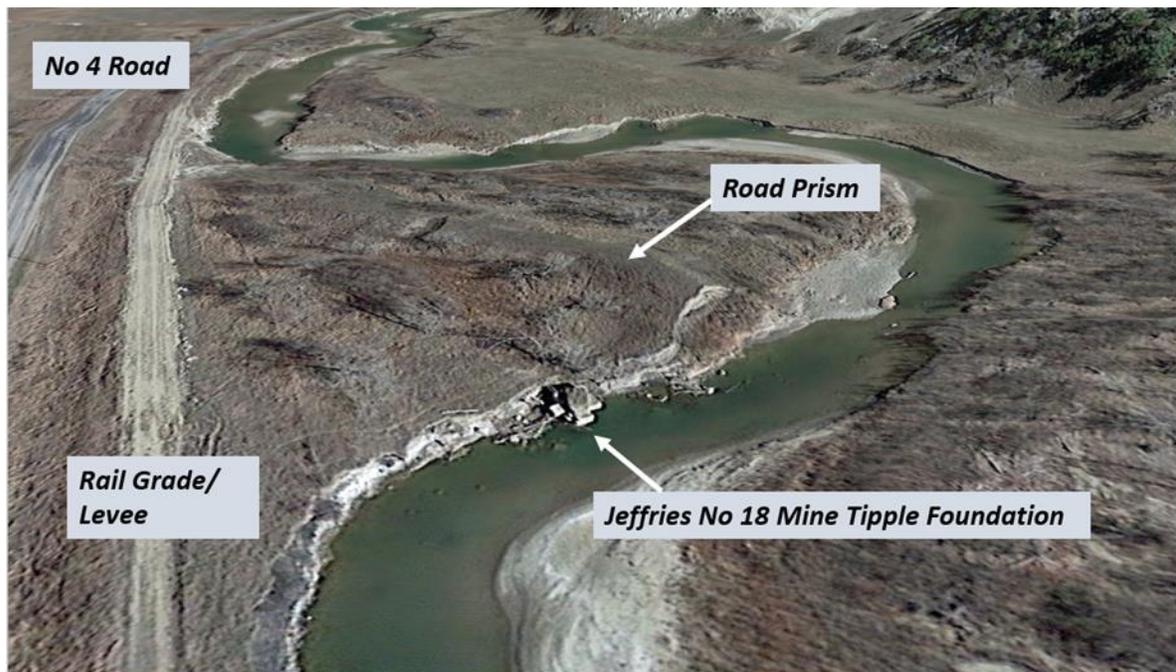
Figure 5. Oblique Google Earth image showing Mine Tipple Foundation and road prism downstream of Roundup; view is downstream (eastward).

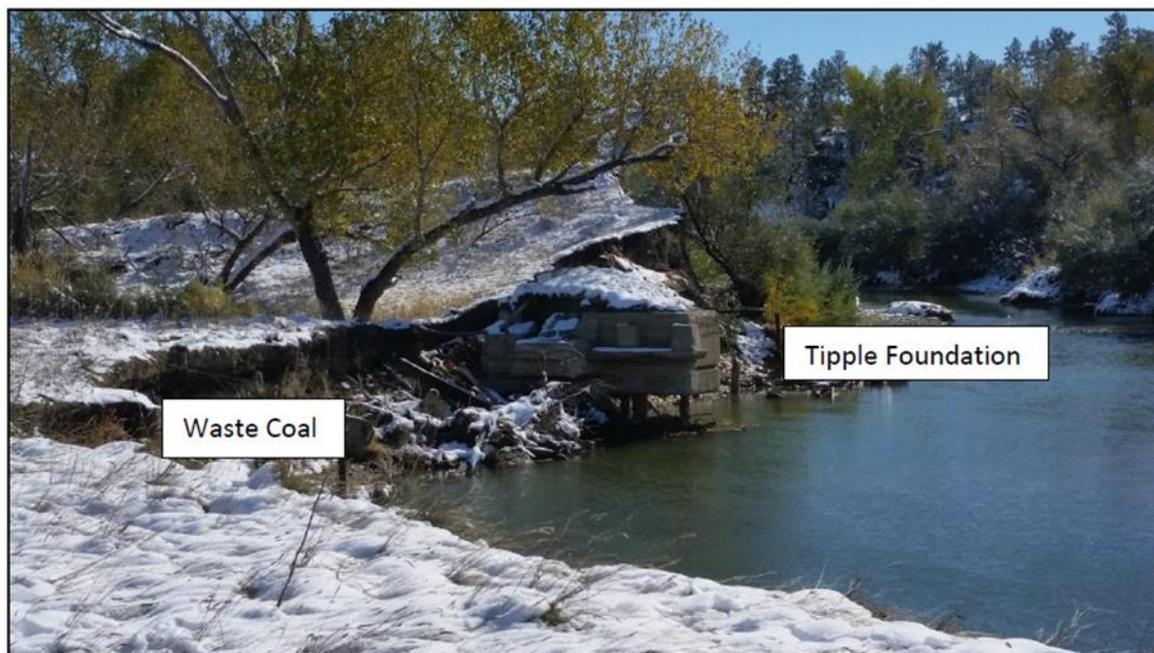
Figure 6. View downstream of mine tipple and loading berm behind prior to 2018 flood; note how road prism behind tipple slopes to left (MTDEQ, 2018).

Figure 6 shows the Tipple Foundation prior to the flood (MTDEQ, 2018). Also note the high road prism behind the Tipple Foundation and the identified waste coal in the foreground. Each of these areas were slated for remediation as described in a Draft Environmental Assessment of the site (MTDEQ, 2018).

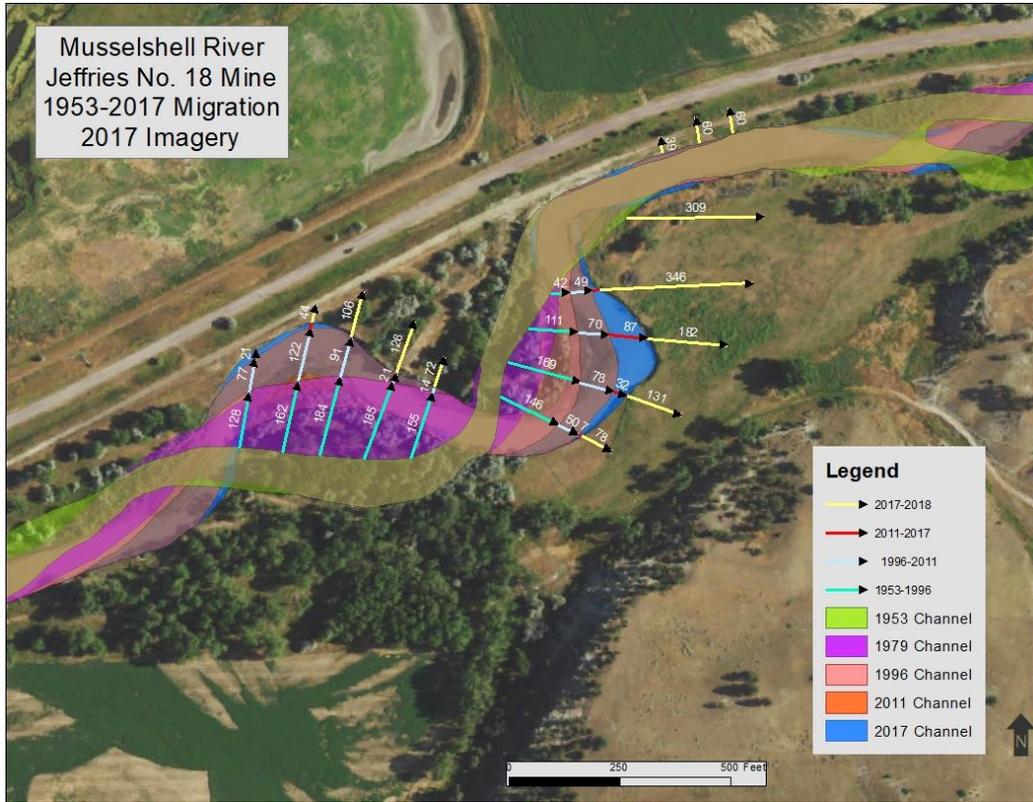
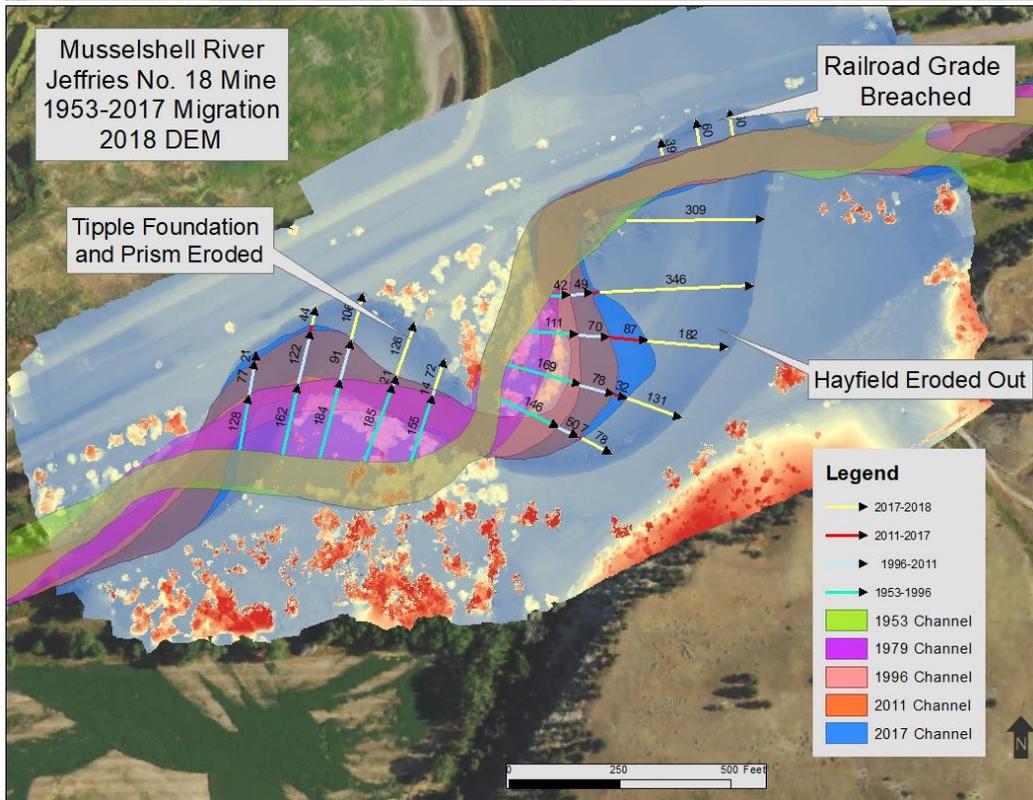
Figure 7. Bankline comparison showing pre-2018 conditions and post-flood erosion sites and extents.

The 2018 flood drove dramatic planform changes at the site, which consisted primarily of unprecedented rates of lateral movement and associated bank migration. As the Tipple Foundation and high road prism were both located on the downstream limb of a meander, these areas were especially prone to bankline movement. Figure 7 shows the amount and patterns of bank movement since 1953 at the meander bend that hosts the Tipple Foundation and Road Prism. The meander shown by the 1953 banklines has essentially compressed and translated down valley (east) to its current configuration. Whereas the top image in Figure 7 shows the digitized banklines on a 2017 air photo, the lower image shows banklines overlain on a 2018 post-flood DEM provided by Pioneer Technical. Darker blue colors on the DEM that are dissected by yellow migration vectors show areas eroded during the 2018 flood that are now channel. This included erosion of the Tipple Foundation and Road Prism on the upstream end of meander, as well as extensive erosion of a previously productive hayfield downstream. Northward channel migration about a thousand feet downstream of the Tipple site breached the abandoned Milwaukee Rail grade which had been performing as a levee, allowing water to spill north of the Number 4 Road which runs parallel to the rail grade.

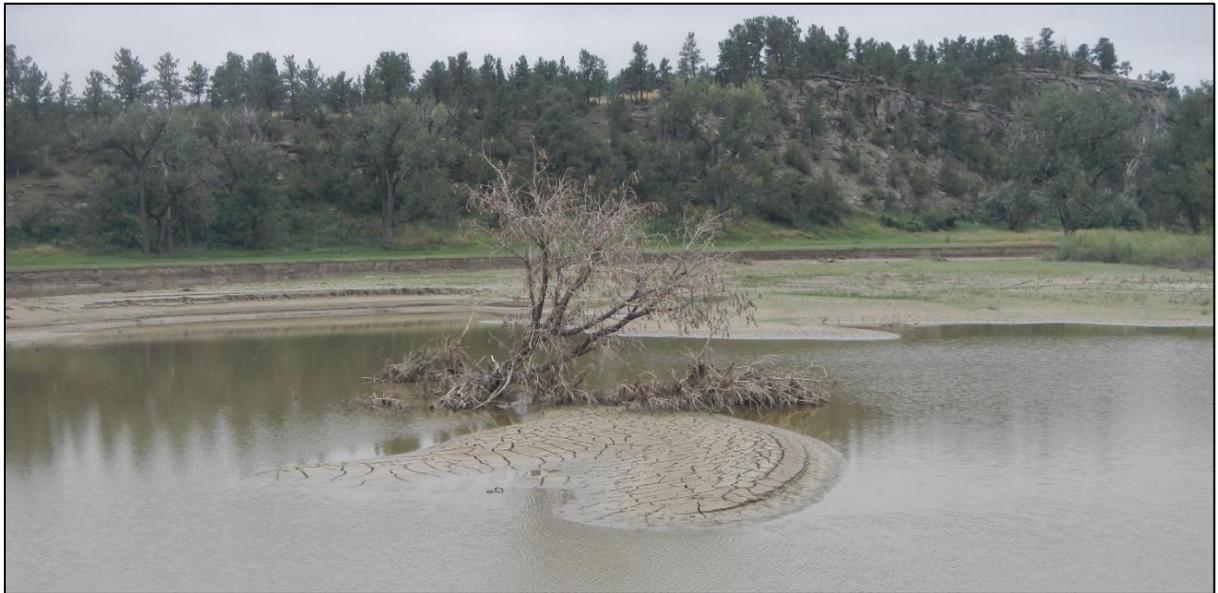
Figure 8. View southward showing hayfield erosion on lower limb of tipple site bendway; colonizing vegetation on sand bars is primarily salt cedar.

Figure 8 shows the area where a hayfield eroded out on the lower limb of the meander, creating an overwidened channel/wetland complex that is actively being colonized by salt cedar. Figure 9 shows the rail grade breach located about 1,000 feet downstream of the project site.

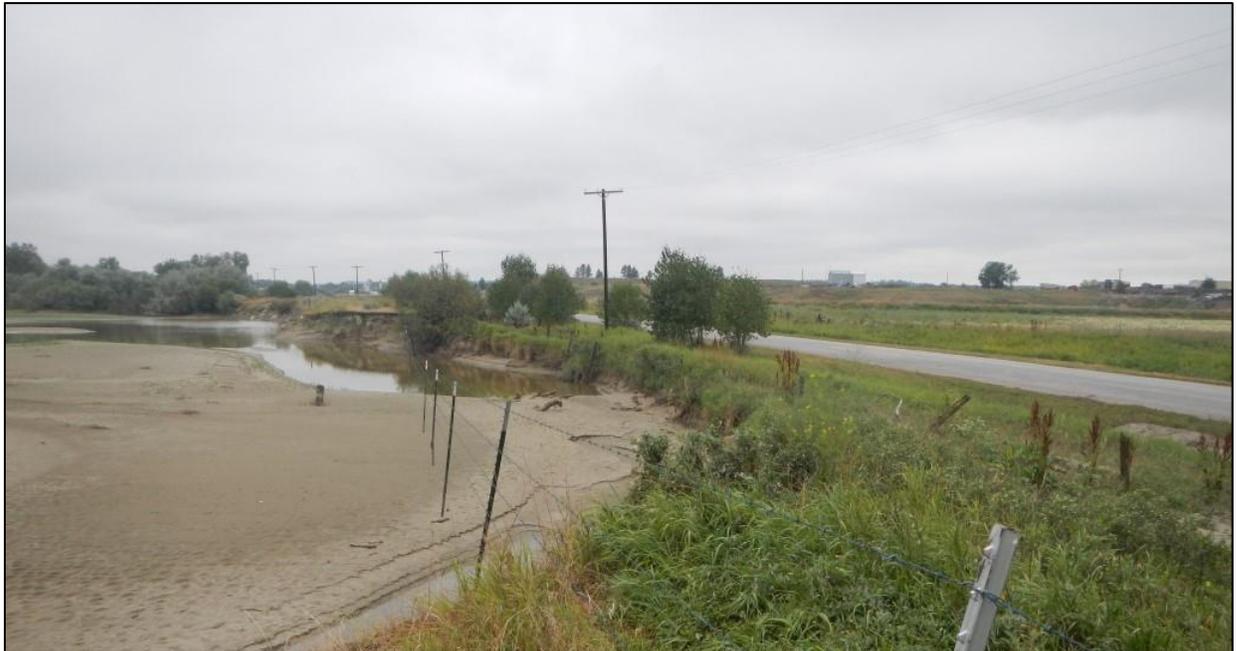
Figure 9. View upstream showing railroad grade breach east of tipple site (site is located beyond Russian olive stand on left side of photo).

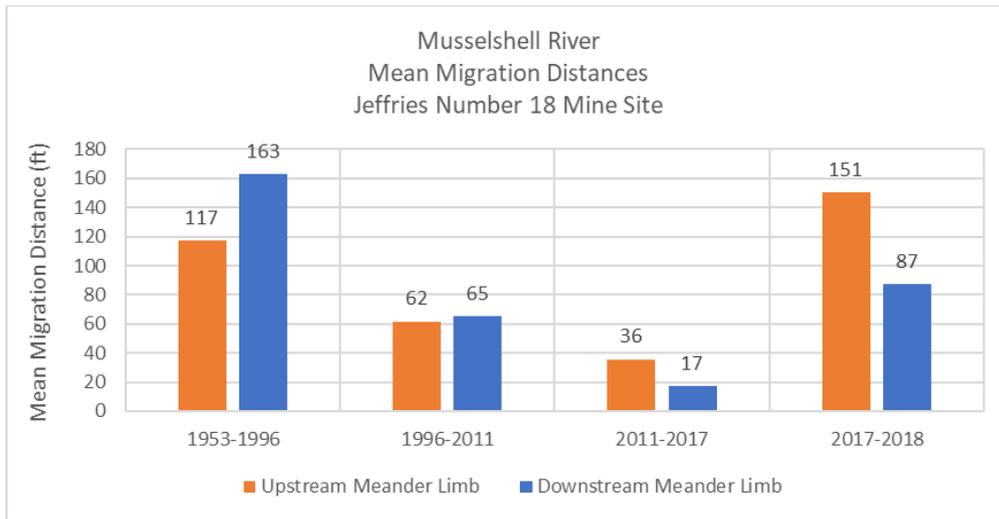
Figure 10. Mean migration distances at site for a range of timeframes.

Although the 2011 flood was larger than that of 2018 with respect to discharge at Roundup, the geomorphic impact of the 2018 flood was far more substantial at the project site. Figure 10 and Figure 11 show the mean migration distances and mean migration rates at the site, respectively. Figure 10 shows that channel migration has been ongoing at the site as the 1953 bendway has been continuously compressing and translating in the downstream direction, which is a typical geomorphic trajectory for river meanders. When considered in terms of rates, however, Figure 11 shows the very high short-term rates of movement at the site. As the timeframes shown in these figures are not equivalent, the mean values are somewhat skewed, so the results are intended simply to show the general extent and high rate of movement during 2018 relative to the previous 65 years.

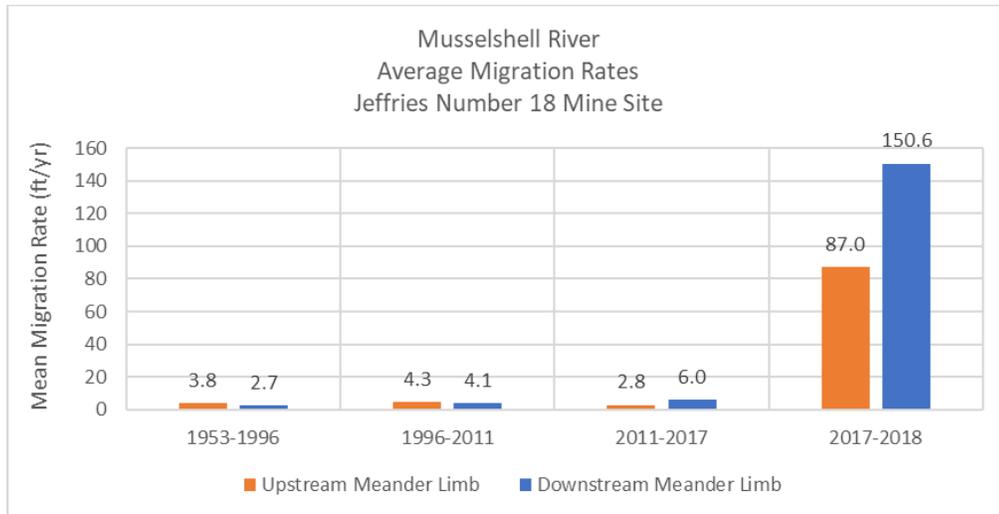
Figure 11. Mean migration rates at site for a range of timeframes.

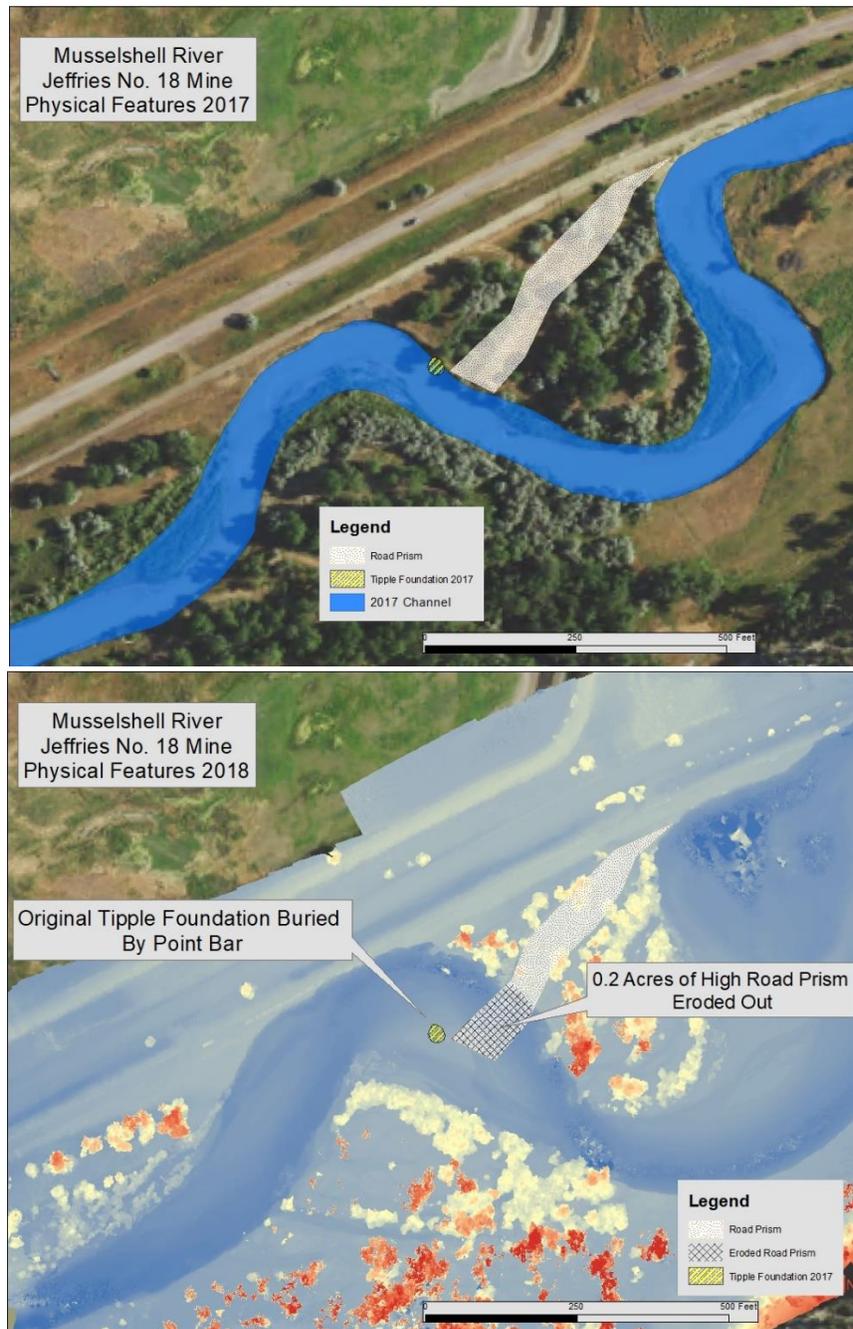
Figure 12. Physical features relative to channel location in 2017 (top) and 2018 (bottom).

The 2018 changes at the project site warrant a wholesale reconsideration of previously developed remediation strategies. Most importantly, the river channel has migrated through and beyond the Tipple Foundation, leaving it presumably buried under a newly developed point bar on the opposite bank (Figure 12). Additionally, about 0.2 acres of the road prism as well as floodplain areas identified as having waste coal were also eroded out (Figure 13).

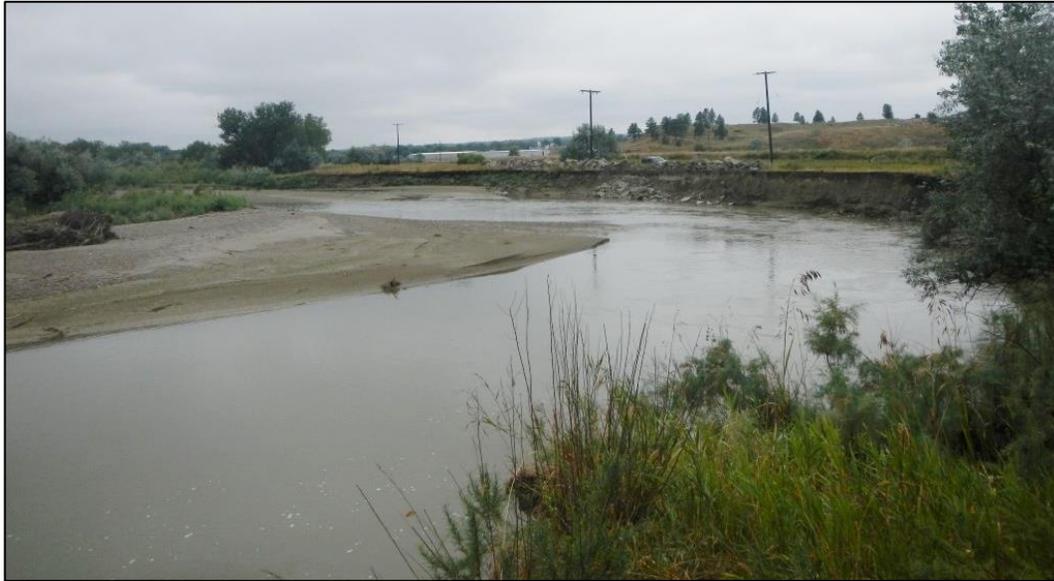
Figure 13. View upstream from road prism remnant showing point bar accretion over old tipple foundation and bank erosion that removed mapped waste coal.

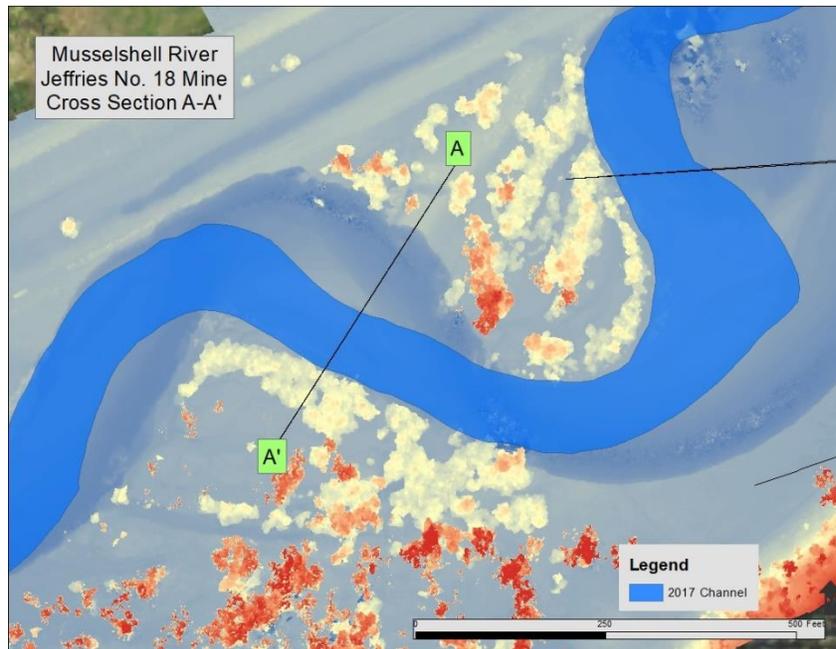
Figure 14. Digitized 2017 banklines overlain on 2018 DEM showing Cross Section A-A'.

Figure 14 shows a cross section drawn through the road prism to compare condition from a 2012 LiDAR dataset and the 2018 DEM. The comparison of cross sections was possible using an ARCVIEW 3-D analyst tool, although the vertical results are considered somewhat approximate due to inconsistent vertical datums (Figure 15). The cross sections show that, with about 40 feet of lateral migration, the high projection of the road prism shown in Figure 6 was eroded out, reducing the maximum prism height by about 10 feet. Presuming no downstream transport, the Tipple Foundation shown in Figure 6 is buried by several feet of recent sedimentation on the opposite bank. It is also interesting to note that the lateral migration shown in Figure 15 has exposed another concrete foundation that now sits at the bank toe (Figure 16).

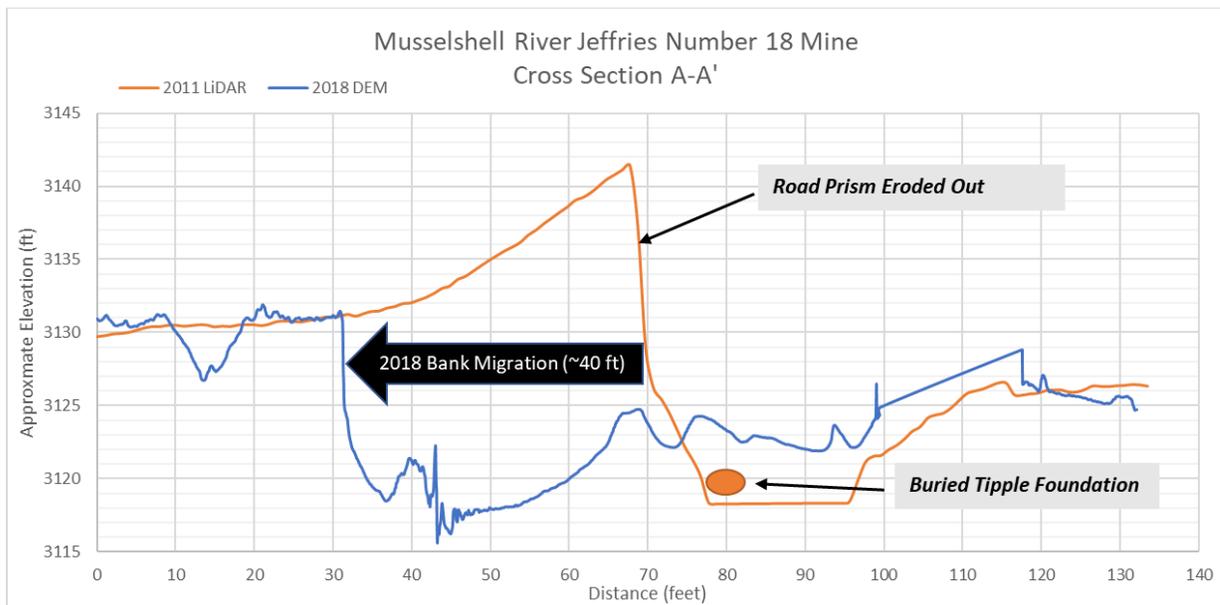
Figure 15. Comparison of 2011 LiDAR data (orange) with 2018 DEM showing bank migration at Cross Section A-A'; view is downstream.

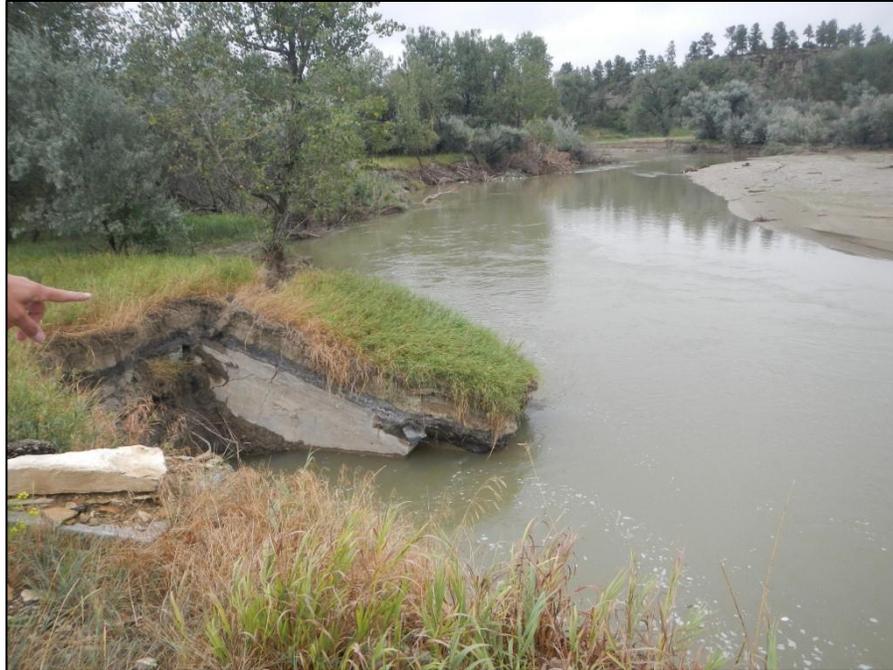
Figure 16. Post-2018 view downstream of eroding bankline at project site showing exposure of concrete slab
