RPT-5006
Rev. 0

**Repository Investigation Report
for the Broken Hill Mine Site,
Sanders County, Montana**

**REPOSITORY INVESTIGATION REPORT
FOR THE BROKEN HILL MINE SITE,
SANDERS COUNTY, MONTANA**

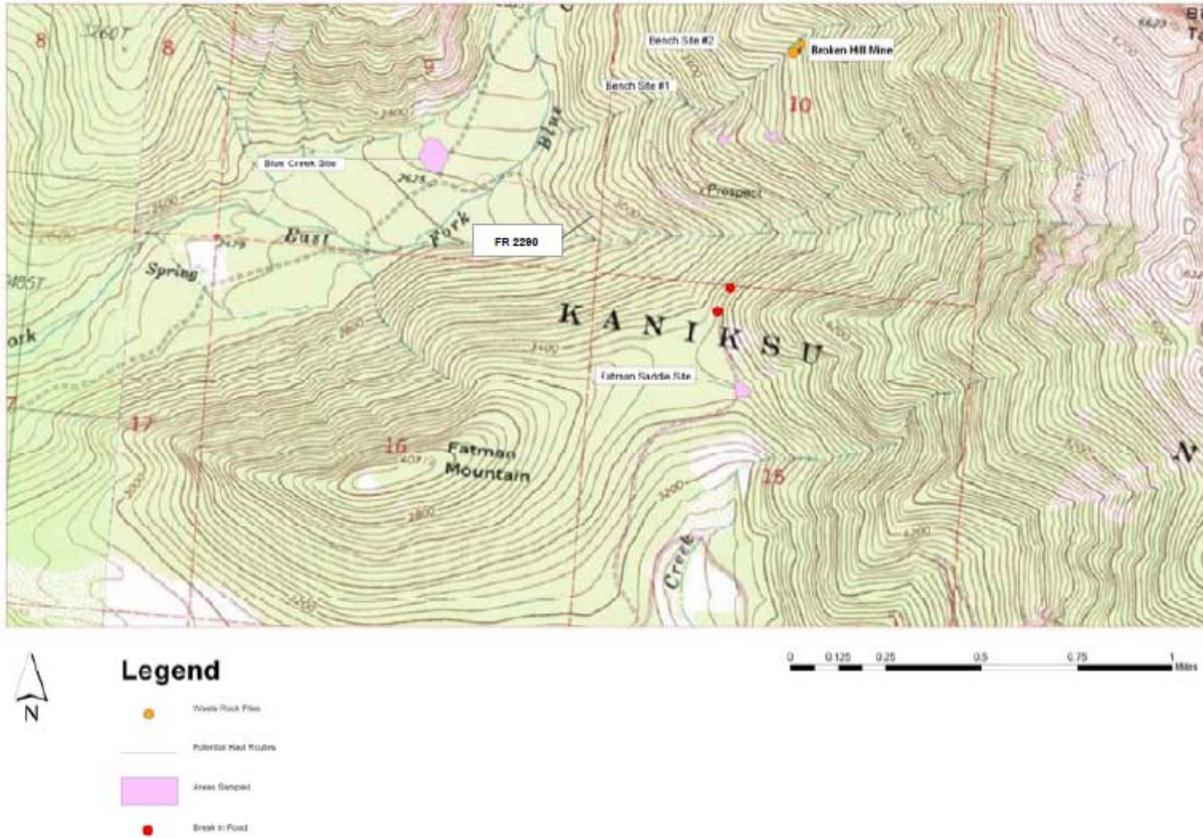
Figure 2. Potential repository site locations.
(Base Map: 1:24,000 Scale Digital Format Map, Heron, Montana, United States Geological Survey 1983)

Figure 1 shows the location of the BHMS within Montana, and Figure 2 shows potential repository site locations in relation to the BHMS.

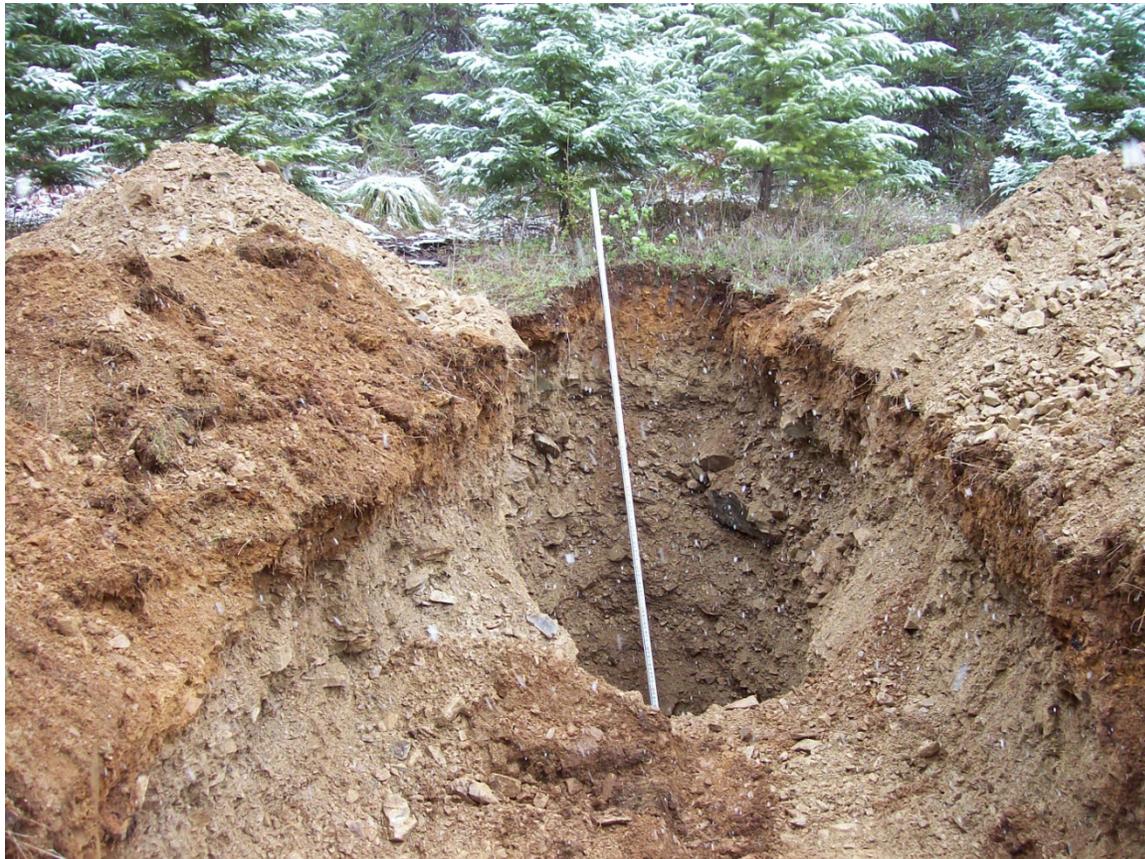
Depth (ft)	Materials/Observations	Comments
Surface	Very sparse vegetation	Next to roadway
0.0 – 1.0	Silty topsoil; medium-dark brown; moist	Topsoil layer varies from 6 to 18 in. thick.
1.0 – 19.0 T.D. = 19.0	Angular rock and coarse sand with a trace of fines; tan to reddish brown; moist to very moist. Some layers with greater amounts of clayey fines. Relatively easy digging.	No groundwater or seeps present in the test pit.

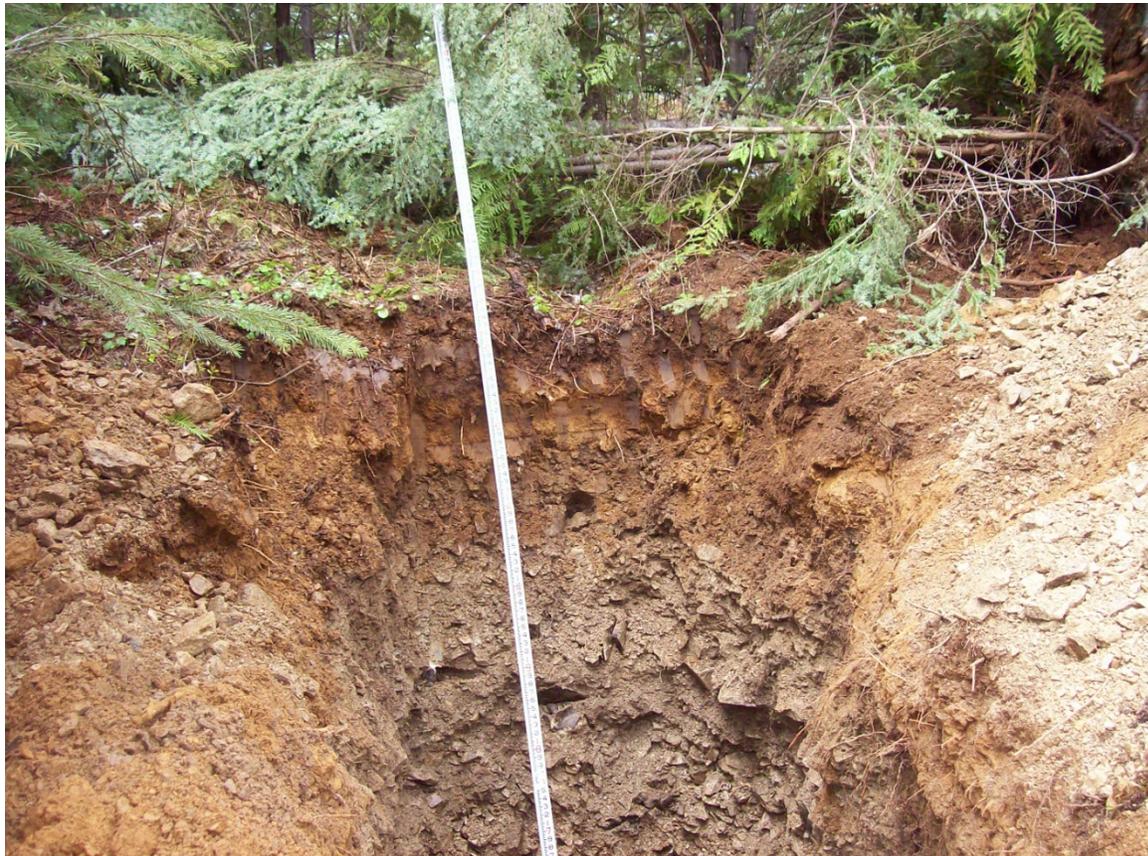
Depth (ft)	Materials/Observations	Comments
Surface	Forested land	Next to roadway
0.0 – 1.0	Silty topsoil; medium-dark brown; moist	Topsoil layers vary from 6 to 18 in. thick.
1.0-1.5	Silt with few coarse rocks; light brown to reddish brown; moist	Topsoil layers vary from 6 to 18 in. thick.
1.5 – 12.0 T.D. = 12.0 (possible bedrock)	Angular rock and very coarse sand with a trace of fines; tan to reddish brown; moist to very moist. Some layers with greater amounts of clayey fines. Relatively easy digging.	No groundwater or seeps present in the test pit.

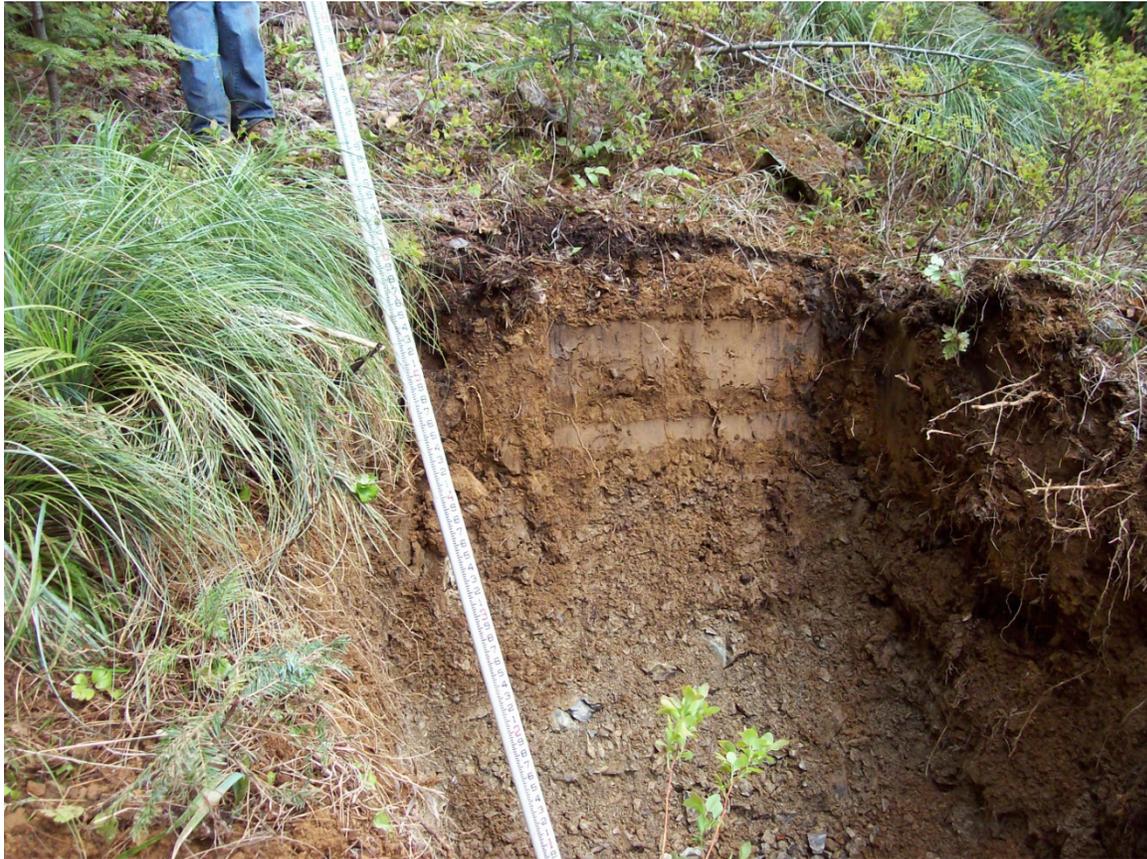
Depth (ft)	Materials/Observations	Comments
Surface	Forested land/Thin layer of black topsoil	On bedrock side-slope
0.0 – 1.5	Silty topsoil; medium-reddish brown; moist	Topsoil layers vary from 6 to 18 in. thick.
1.5 – 5.0 T.D. = 5.0 (bedrock)	Angular rock and coarse sand with a trace of fines; tan to reddish brown; moist to very moist. Some layers with greater amounts of clayey fines. Relatively easy digging.	No groundwater or seeps present in the test pit.

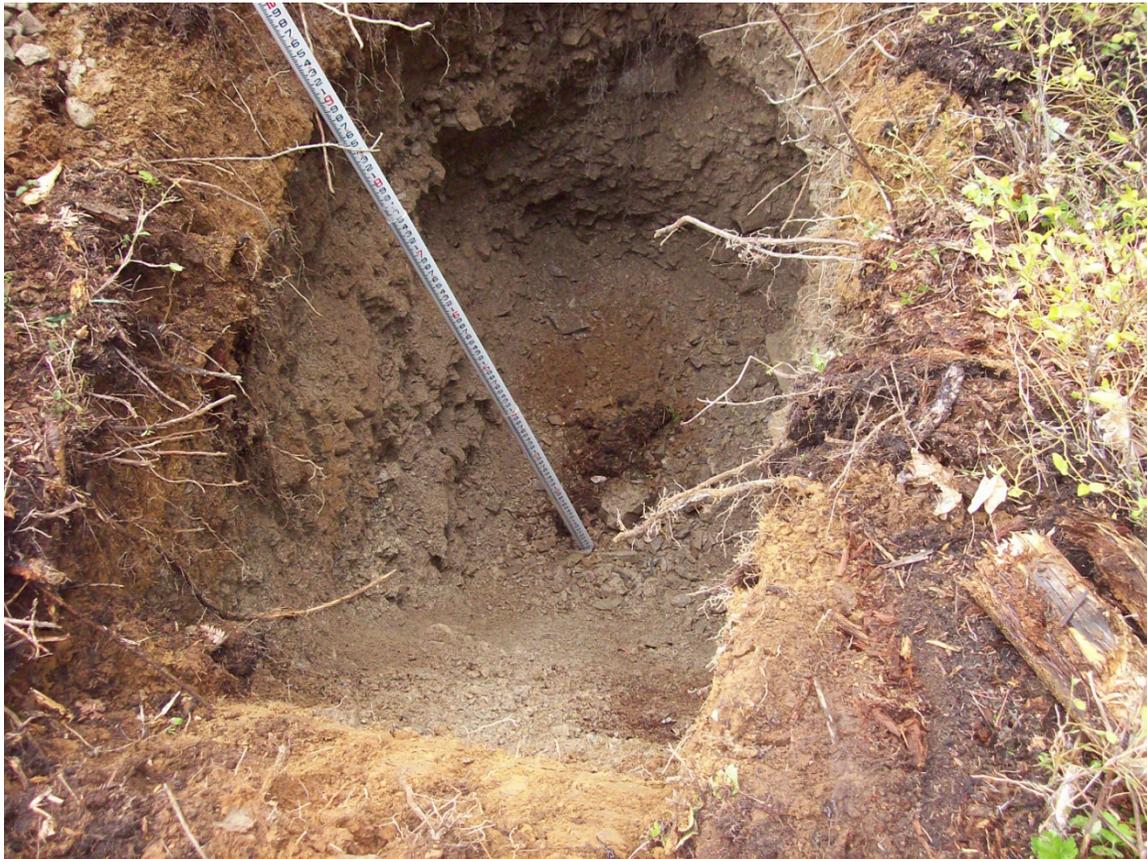
Depth (ft)	Materials/Observations	Comments
Surface	Forested land	Next to bedrock side-slope
0.0 – 3.5	Silty topsoil; medium-reddish brown; moist	
1.5 – 8.0 T.D. = 8.0 (bedrock)	Angular rock and coarse sand with a trace of fines; tan to reddish brown; moist to very moist. Some layers with greater amounts of clayey fines. Relatively easy digging.	No groundwater or seeps present in the test pit.

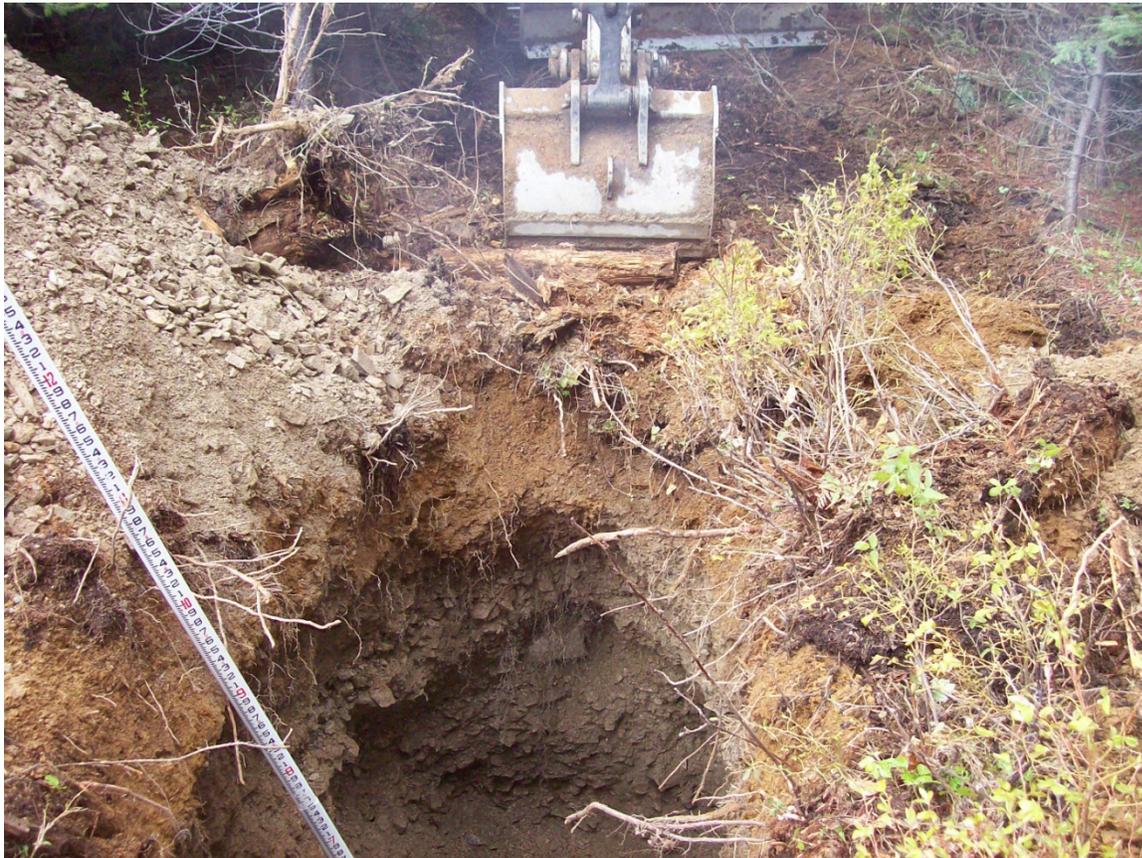
Depth (ft)	Materials/Observations	Comments
Surface	Forested land/Thin layer of black topsoil	Next to bedrock side-slope
0.0 – 2.0	Silty topsoil; reddish brown; moist	
2.0 – 9.5 T.D. = 9.5 (bedrock)	Angular rock and very coarse sand; tan to reddish brown; moist; some layers with traces of clayey fines. Relatively easy digging.	No groundwater or seeps present in the test pit.

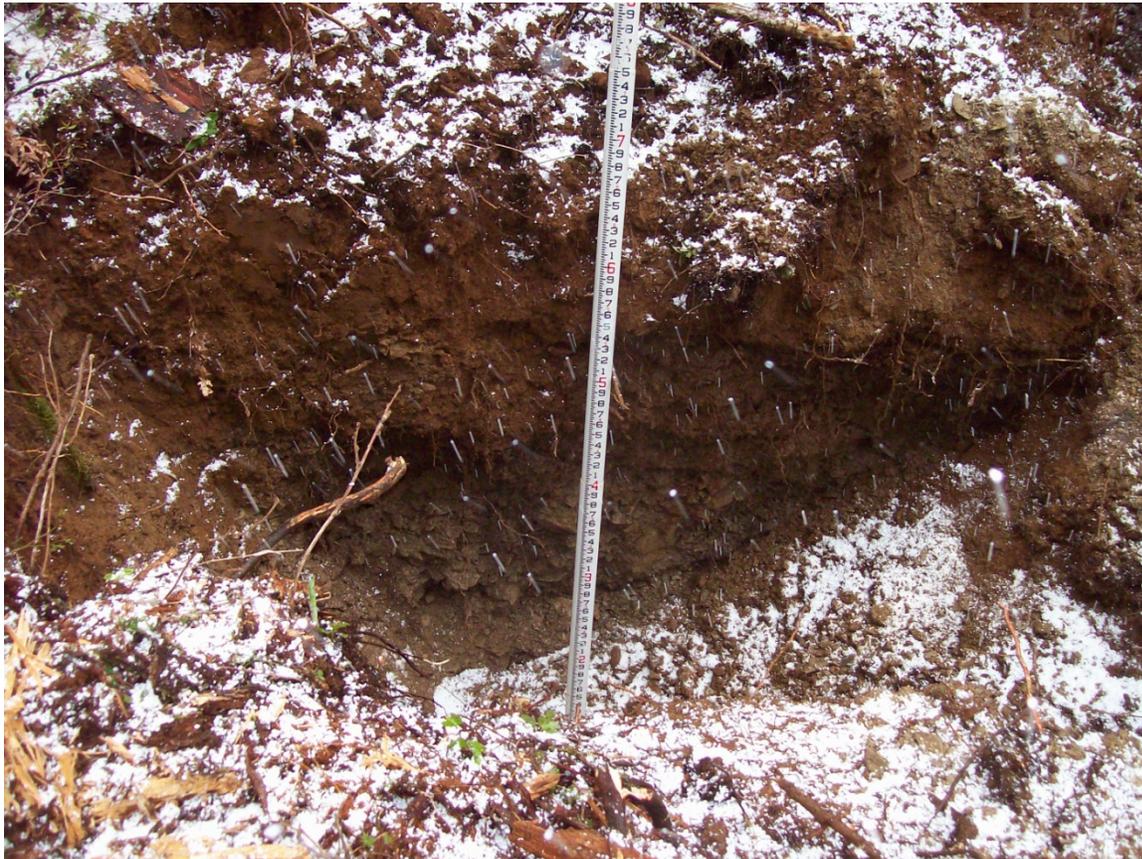
Depth (ft)	Materials/Observations	Comments
Surface	Forested land/Thin layer of black topsoil	Next to bedrock side-slope
0.0 – 2.0	Silty topsoil; reddish brown; moist	
2.0 – 7.0 T.D. = 7.0 (bedrock)	Angular rock and very coarse sand; tan to reddish brown; moist; some layers with traces of clayey fines. Relatively easy digging.	No groundwater or seeps present in the test pit.

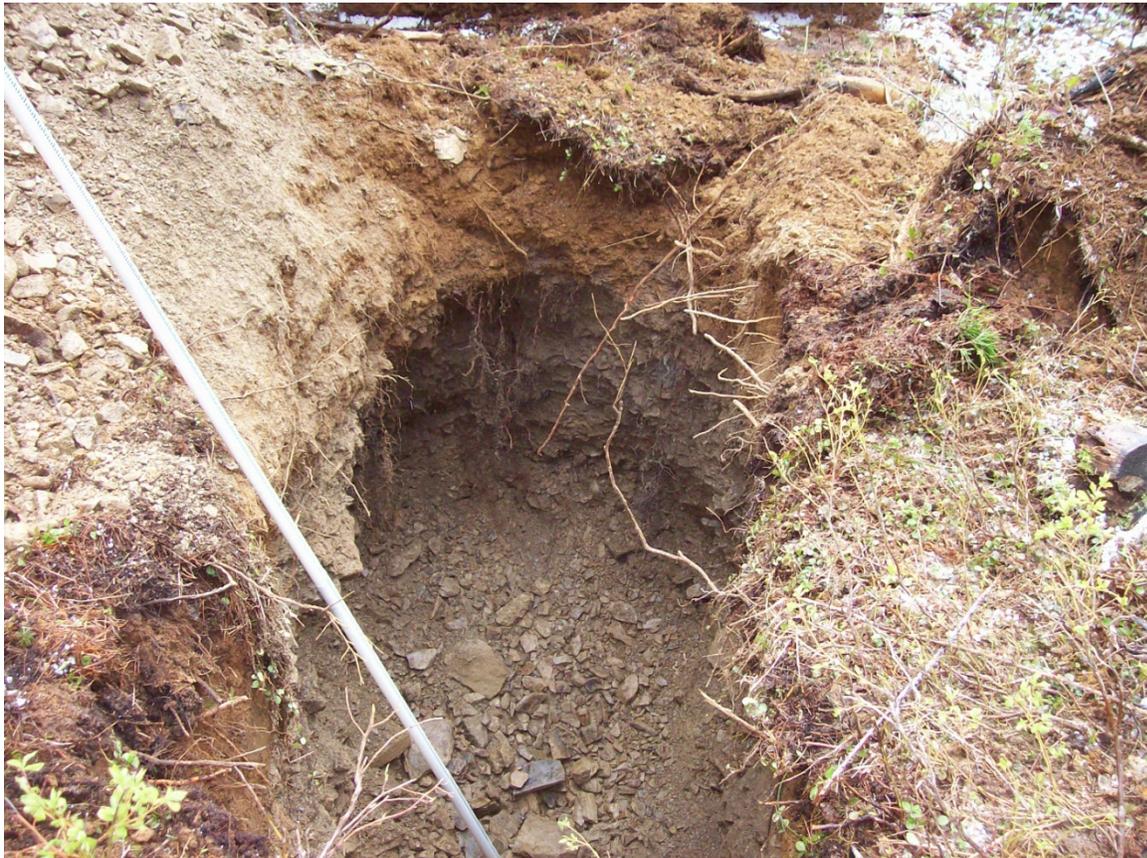
Depth (ft)	Materials/Observations	Comments
Surface	Forested land/Thin layer of black topsoil	Next to bedrock side-slope
0.0 – 2.0	Silty topsoil; reddish brown; moist	
2.0 –9.0 T.D. = 9.0 (bedrock)	Angular rock and very coarse sand; tan to reddish brown; moist; some layers with traces of clayey fines. Relatively easy digging.	No groundwater or seeps present in the test pit.

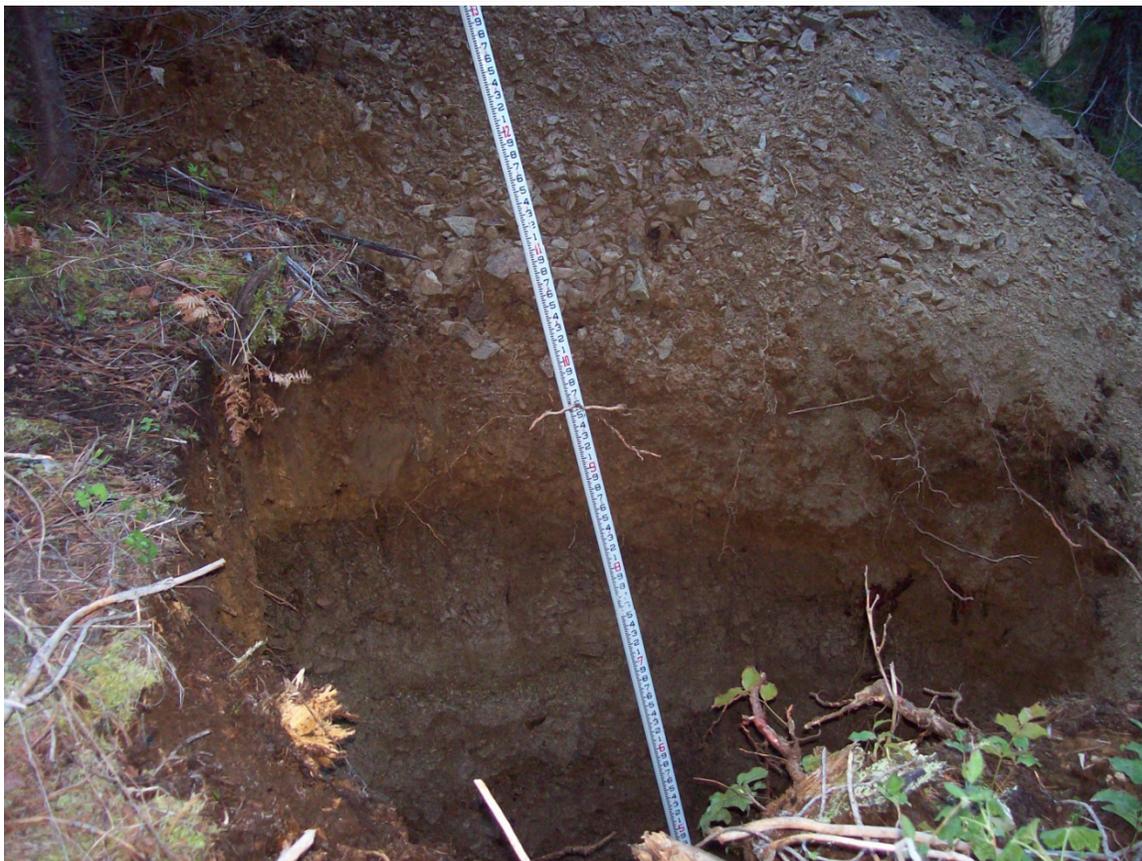
Depth (ft)	Materials/Observations	Comments
Surface	Forested land/Thin layer of black topsoil	Center of site, just off main road
0.0 – 2.0	Silty topsoil; reddish brown; moist	
2.0 – 11.0 T.D. = 11.0 (bedrock)	Angular rock and very coarse sand; tan to reddish brown; moist; some layers with traces of clayey fines. Relatively easy digging.	No groundwater or seeps present in the test pit.

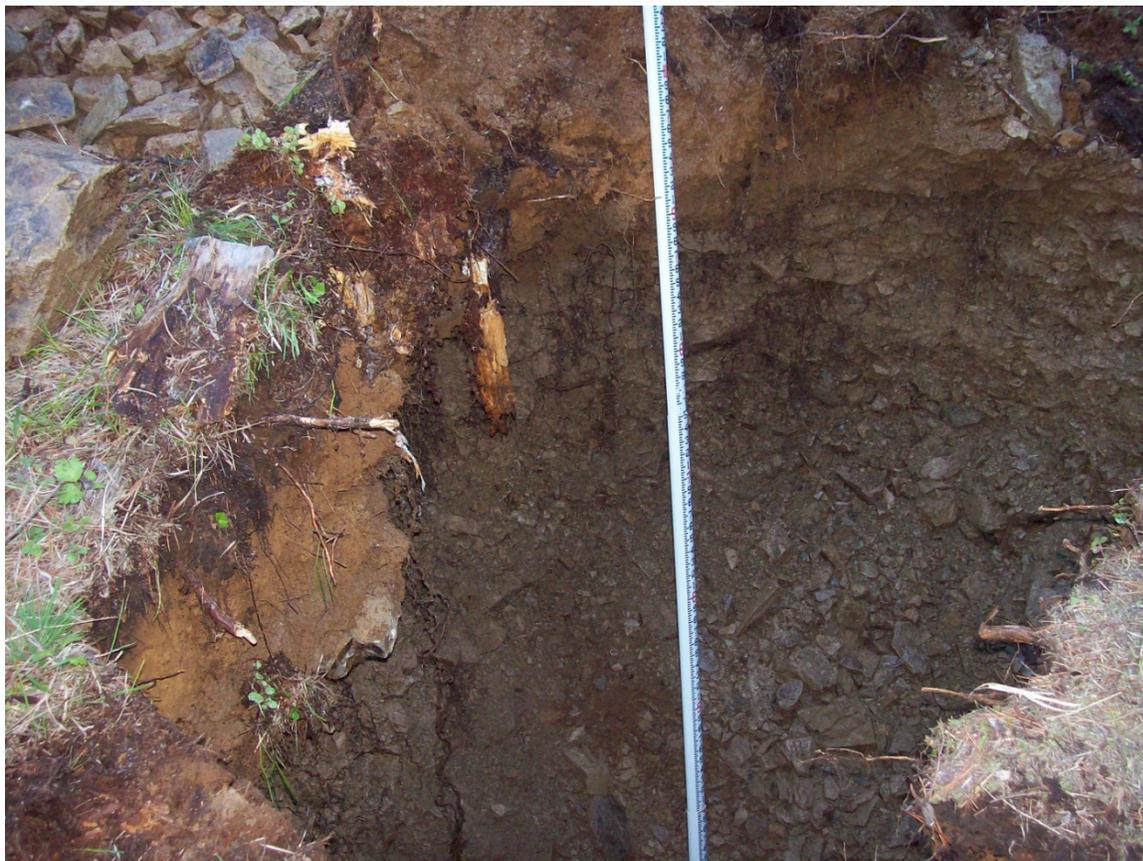
Depth (ft)	Materials/Observations	Comments
Surface	Forested land/Thin layer of black topsoil	On bedrock side-slope
0.0 – 2.0	Silty topsoil; reddish brown; moist	
2.0 –10.0 T.D. = 10.0 (bedrock)	Angular rock and very coarse sand; tan to reddish brown; moist; some layers with traces of clayey fines. Relatively easy digging.	No groundwater or seeps present in the test pit.

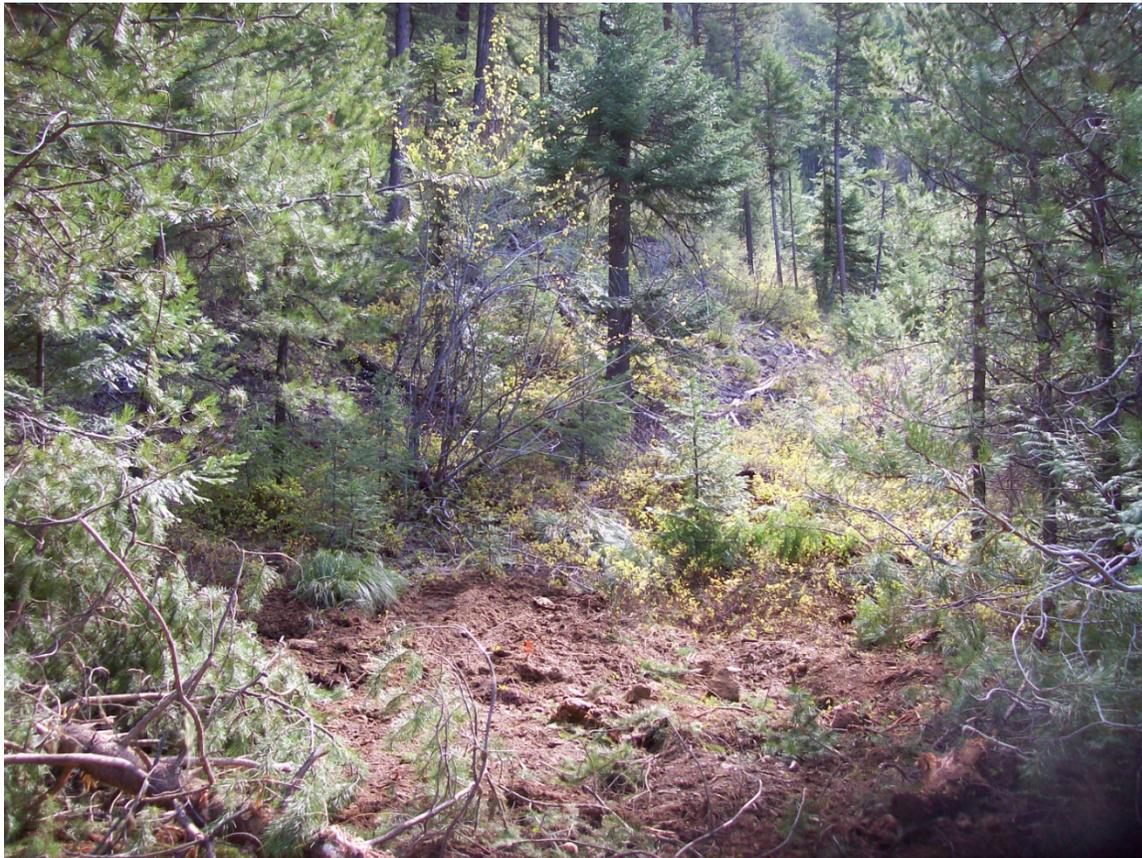
Depth (ft)	Materials/Observations	Comments
Surface	Forested land/Thin layer of black topsoil	Near bedrock side-slope
0.0 – 1.5	Silty topsoil; reddish brown; moist	
1.5 –12.0 T.D. = 12.0	Angular rock and coarse sand; tan to reddish brown; moist to very moist; Some layers with traces of clayey fines. Relatively easy digging.	No groundwater or seeps present in the test pit.

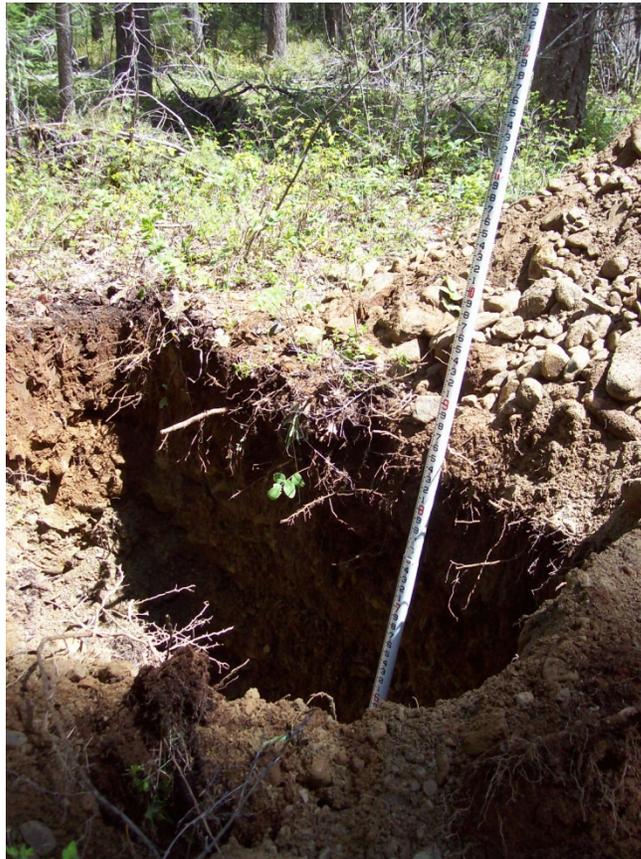
Depth (ft)	Materials/Observations	Comments
Surface	Forested land/Thin layer of black topsoil	Area has received 3+ in. of rain within the last week.
0.0 – 1.5	Silty topsoil; dark brown; very moist	
1.5 – 8.5 T.D. = 8.5 (possible bedrock)	Sub-angular/Sub-rounded rock and coarse sand; dark- medium reddish brown; moist to very moist. Relatively easy digging.	No groundwater or seeps present in the test pit.

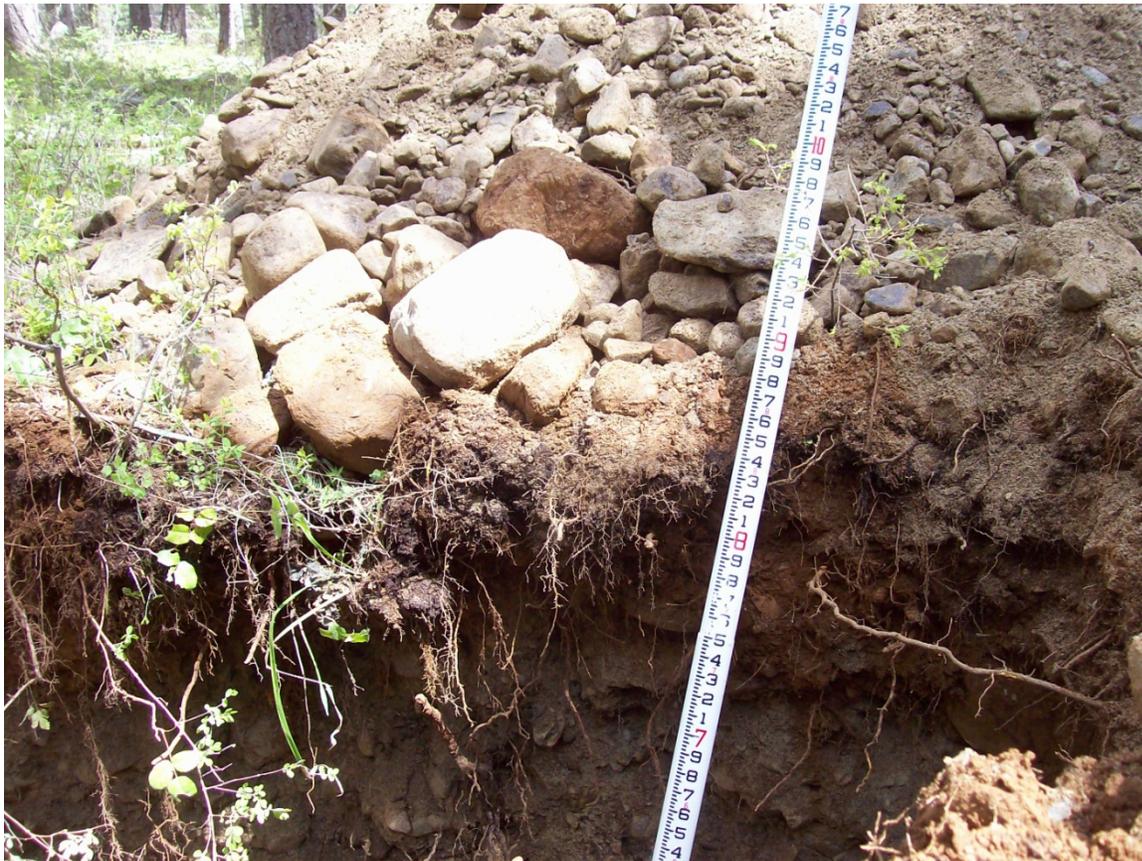
Depth (ft)	Materials/Observations	Comments
Surface	Forested land/Thin layer of black topsoil	Area has received 3+ in. of rain within the last week.
0.0 – 2.0	Silty topsoil; dark brown; very moist.	
2.0 – 8.0 T.D. = 8.0 (possible bedrock)	Sub-angular/Sub-rounded rock and coarse sand; trace of silty fines; dark-medium reddish brown; moist to very moist. Relatively easy digging.	No groundwater or seeps present in the test pit.

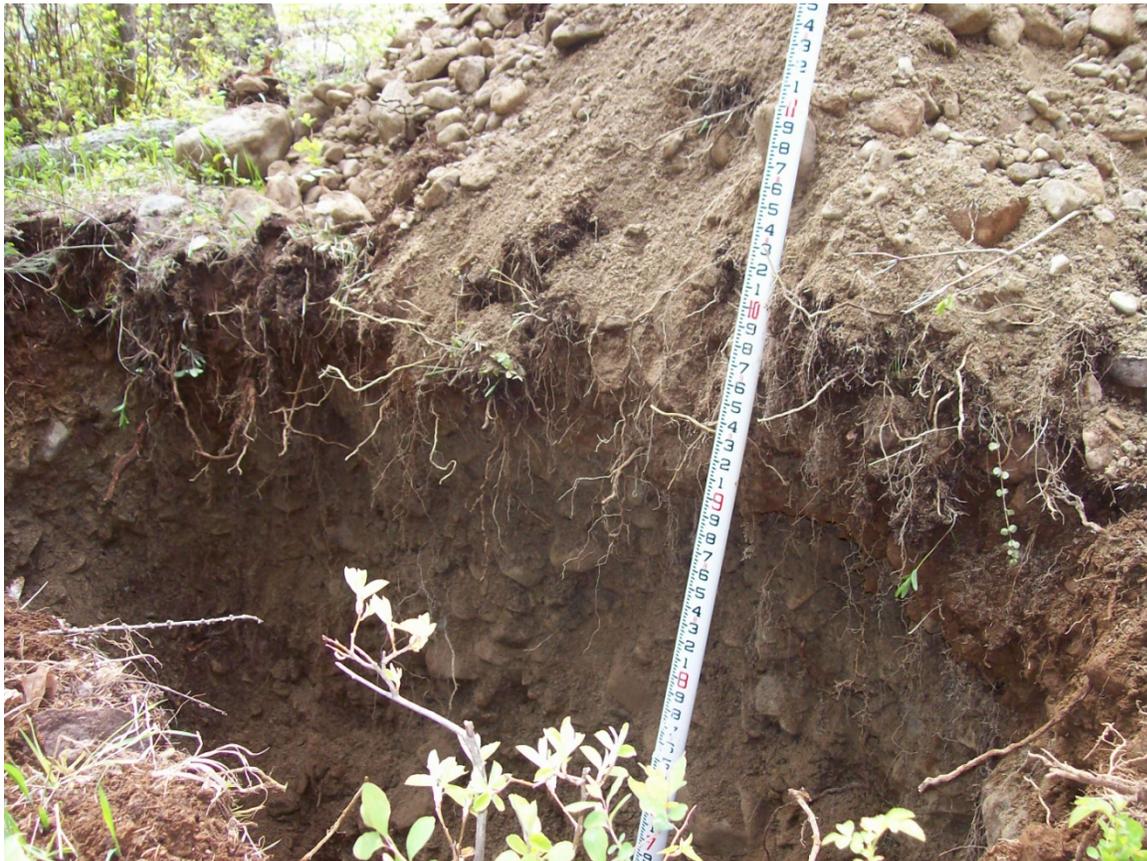
Depth (ft)	Materials/Observations	Comments
Surface	Forested land/Thin layer of black topsoil	Area has received 3+ in. of rain within the last week.
0.0 – 1.5	Very rocky topsoil; dark brown silt-sand; very moist	
1.5 –9.5 T.D. = 9.5	Sub-angular/Sub-rounded rock and coarse sand; trace of silty fines; dark-medium reddish brown; moist to very moist. Relatively easy digging.	No groundwater or seeps present in the test pit.

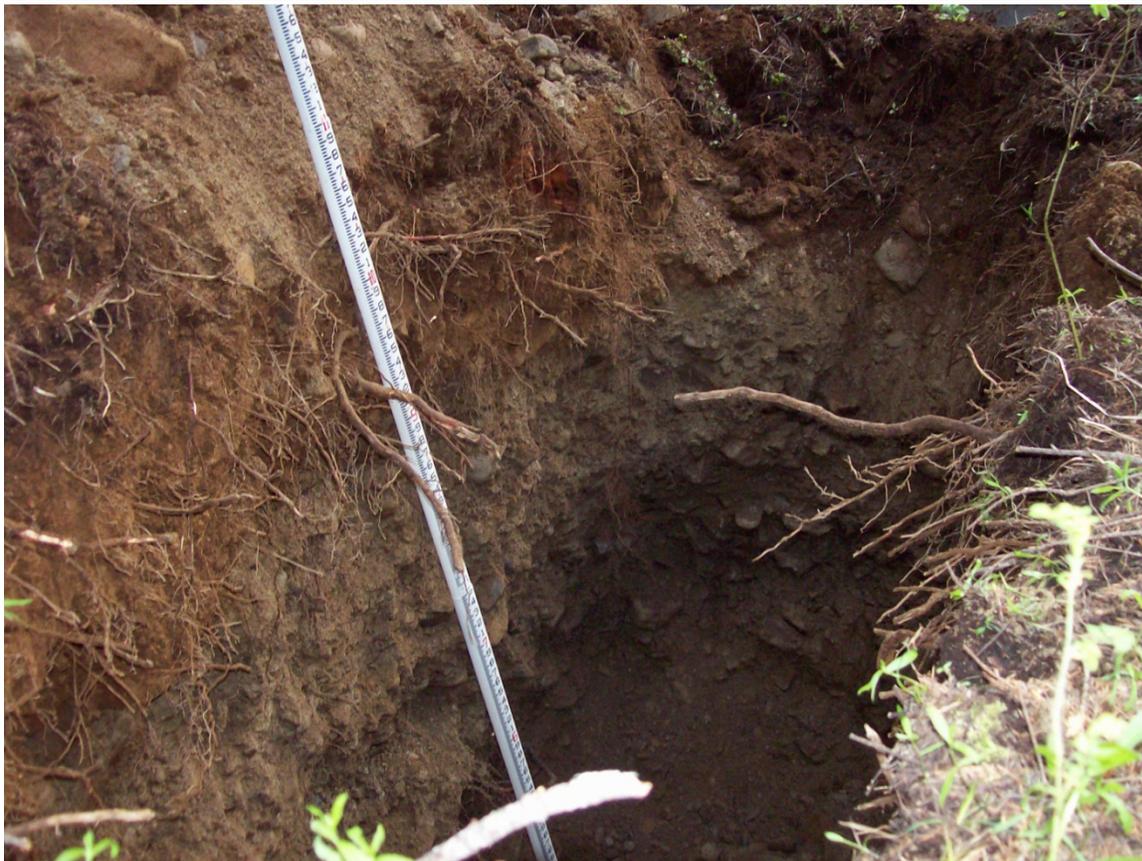
Depth (ft)	Materials/Observations	Comments
Surface	Forested land/Thin layer of black topsoil	Area has received 3+ in. of rain within the last week.
0.0 – 2.0	Very rocky topsoil; dark brown silt-sand; very moist	
2.0 –10.5 T.D. = 10.5 (large rocks)	Sub-angular/Sub-rounded rock and coarse sand; trace of silty fines; dark-medium reddish brown; moist to very moist. Relatively easy digging.	No groundwater or seeps present in the test pit.

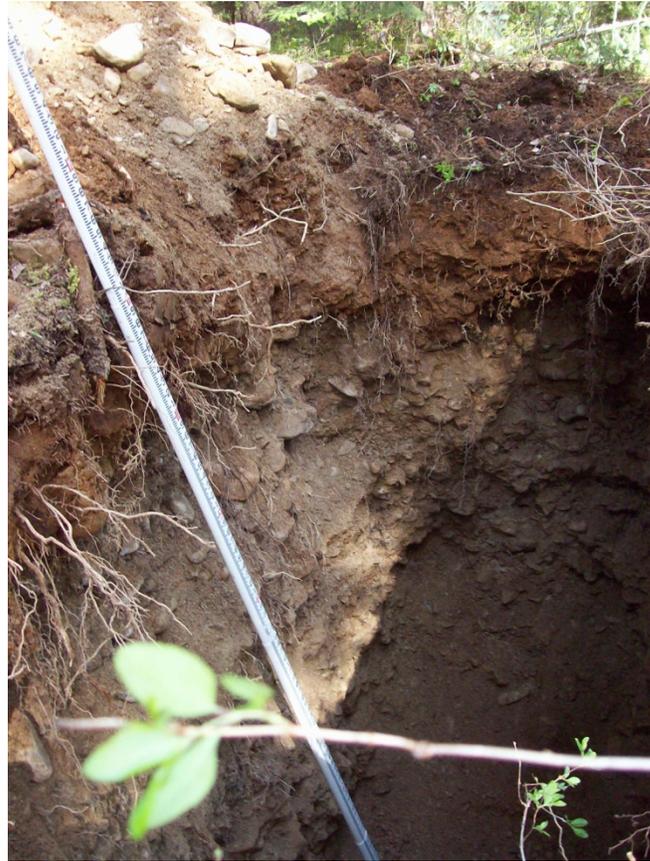
Depth (ft)	Materials/Observations	Comments
Surface	Forested land/Thin layer of black topsoil	Area has received 3+ in. of rain within the last week; just off the main road.
0.0 – 1.5	Very rocky topsoil; dark brown silt-sand; very moist	
1.5 –11.0 T.D. = 11.0 (large rocks)	Sub-angular/Sub-rounded rock and coarse sand; trace of silty fines; dark-medium reddish brown; moist to very moist. Relatively easy digging.	No groundwater or seeps present in the test pit.

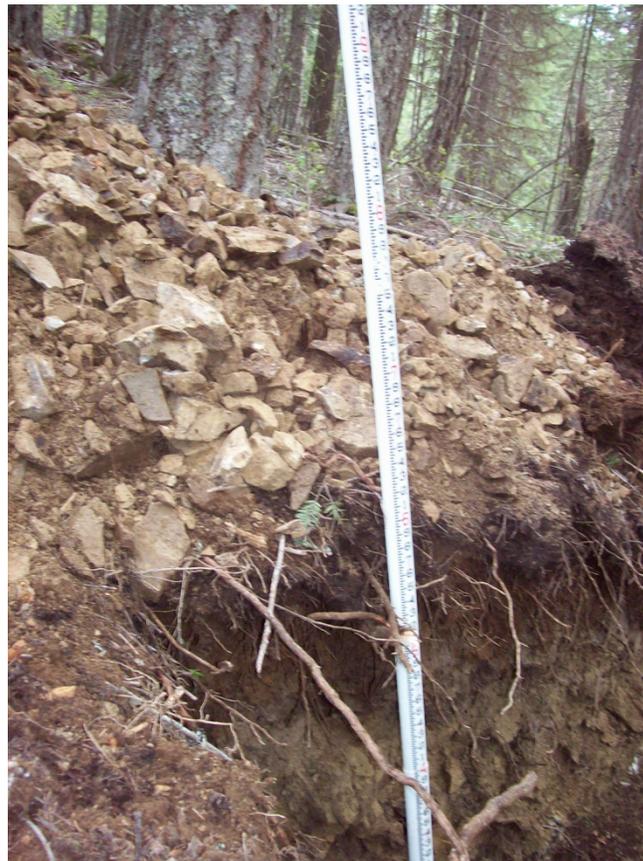
Depth (ft)	Materials/Observations	Comments
Surface	Forested land	
0.0 – 1.0	Black silty topsoil overlying reddish-brown silty topsoil; very moist	
1.0 – 5.5 T.D. = 5.5 (hard bedrock)	Angular fractured rock (in place); weathered residual bedrock with silty medium-reddish brown soil in fill; moist to very moist. Relatively easy digging.	No groundwater or seeps present in the test pit.

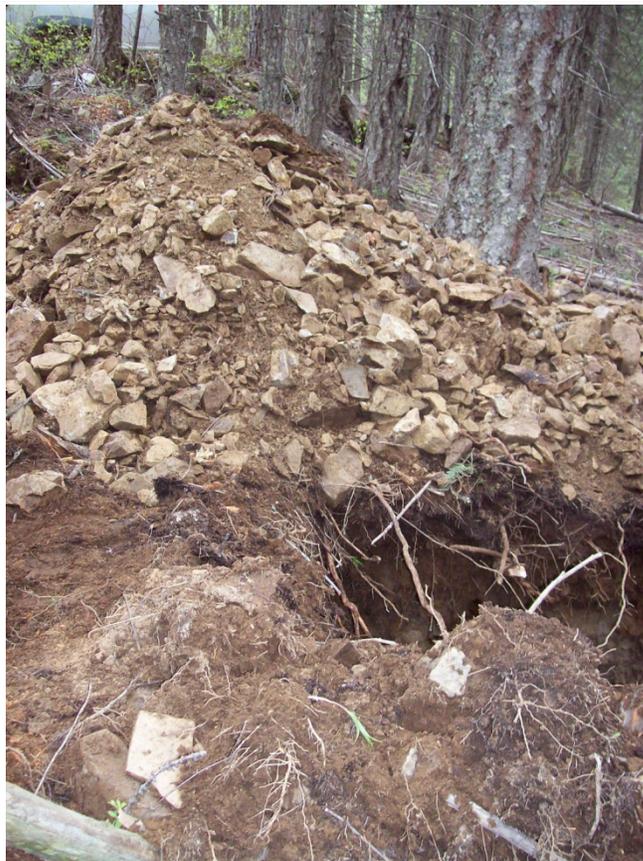
Depth (ft)	Materials/Observations	Comments
Surface	Forested land	
0.0 – 1.0	Dark brown topsoil and roots	
1.0-5.0	Angular rock and silt	
5.0 –9.0 T.D. = 9.0 (bedrock)	Friable shale; light greenish-brown; moist to very moist. Relatively easy digging.	No groundwater or seeps present in the test pit.

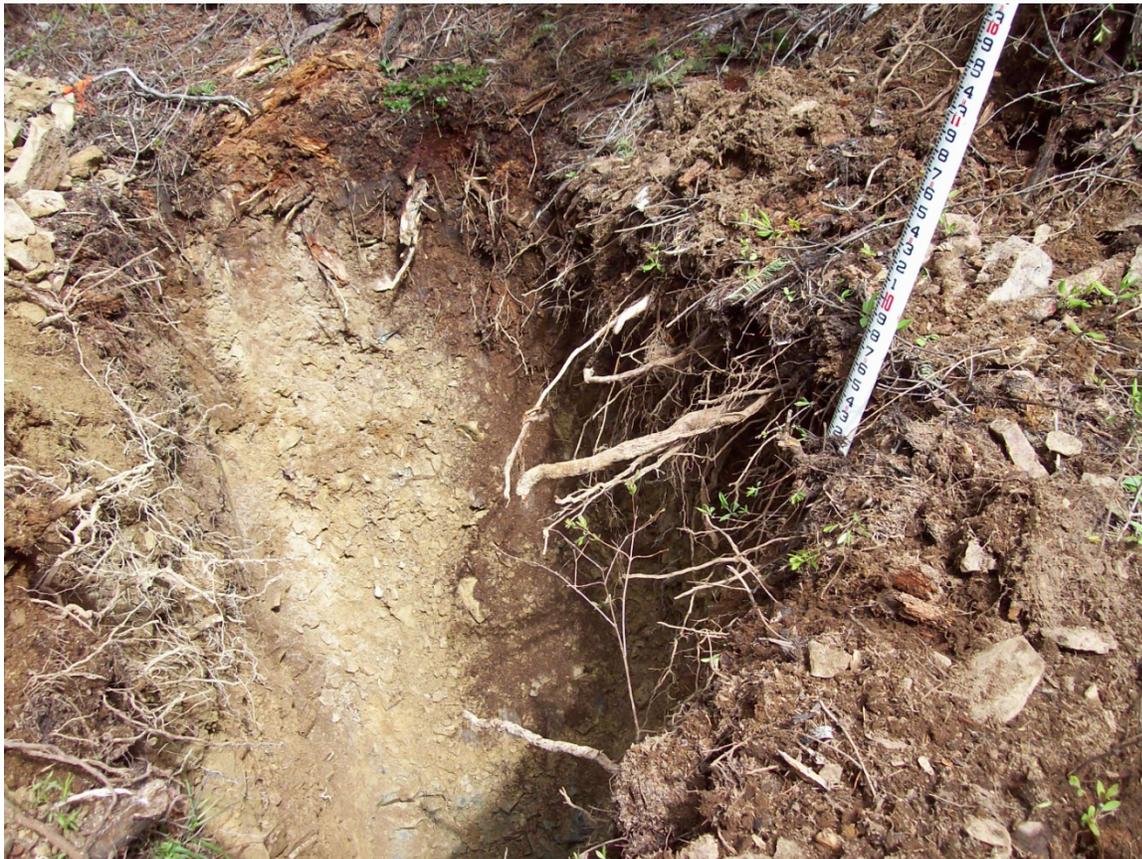
Depth (ft)	Materials/Observations	Comments
Surface	Forested land/ Thin layer of black topsoil	
0.0 – 1.5	Reddish-brown silty topsoil	
1.5-5.5	Angular rock and silt; moist	
5.5 –8.0 T.D. = 8.0	Grayish light brown silty clay; low plasticity; moist to very moist. Relatively easy digging.	No groundwater or seeps present in the test pit.

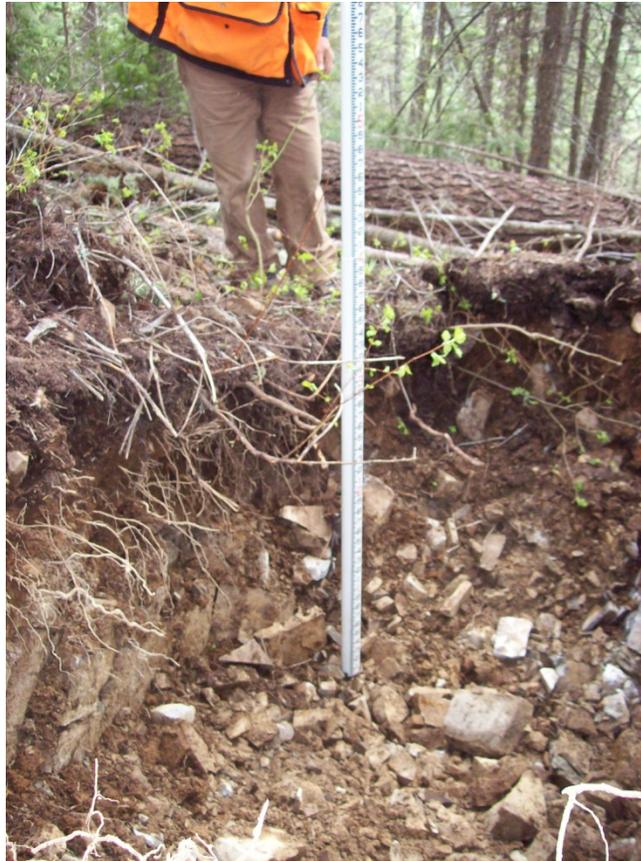
Depth (ft)	Materials/Observations	Comments
Surface	Forested land/ Thin layer of black topsoil	
0.0 – 0.5	Black and reddish-brown silty topsoil	
0.5-3.5 T.D. = 3.5 (bedrock)	Fractured bedrock with silt infiltration	No groundwater or seeps present in the test pit.

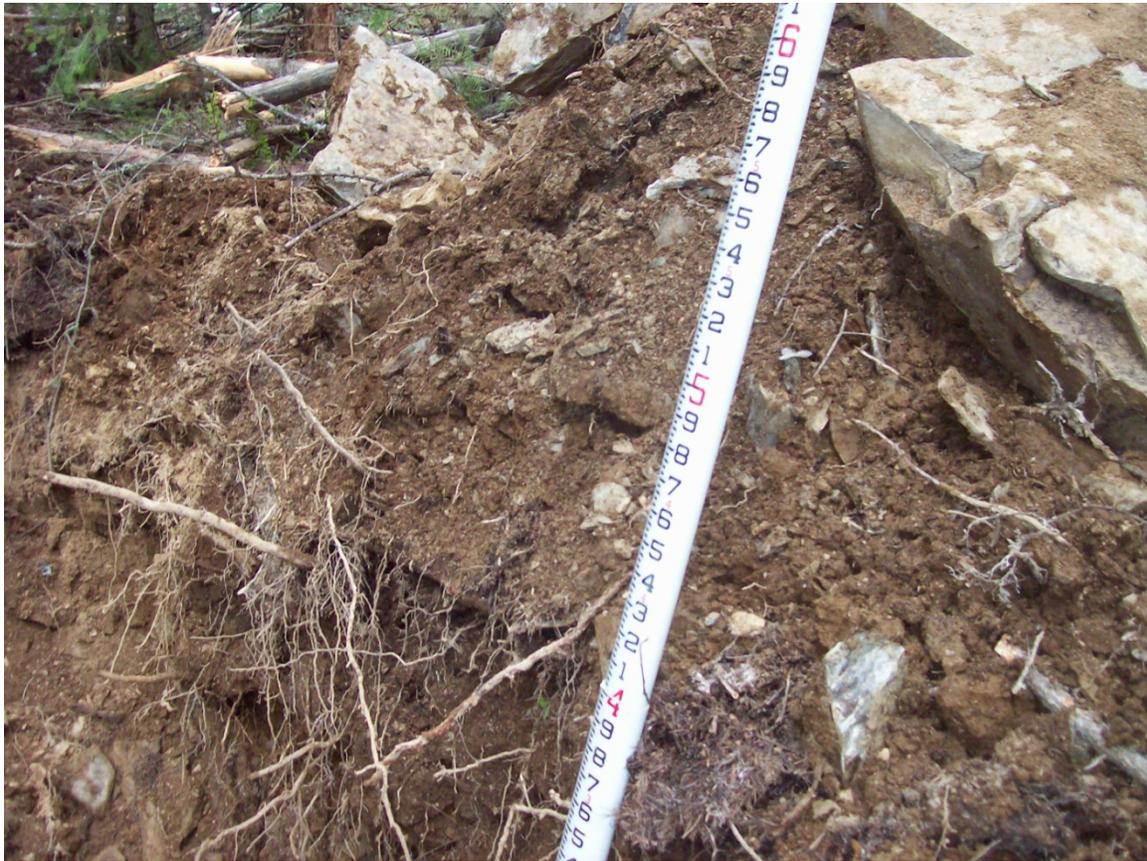
Depth (ft)	Materials/Observations	Comments
Surface	Forested land/ Thin layer of black topsoil	
0.0 – 1.0	Black and reddish-brown silty topsoil	
1.0 – 4.0 T.D. = 4.0 (bedrock)	Fractured bedrock with silt infiltration	No groundwater or seeps present in the test pit.

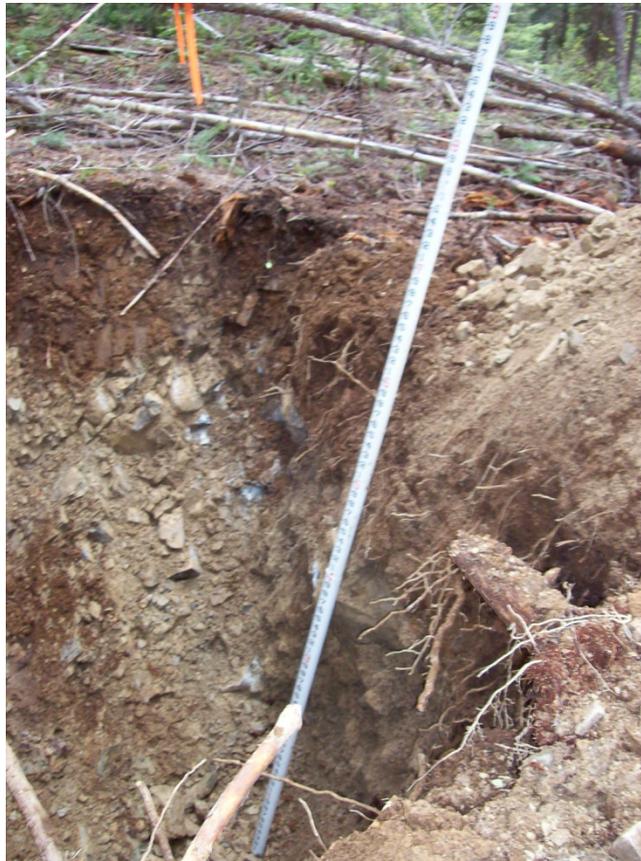
Depth (ft)	Materials/Observations	Comments
Surface	Forested land/ Thin layer of black topsoil	
0.0 – 1.0	Black and reddish-brown silty topsoil	
1.0 – 7.0 T.D. = 7.0 (bedrock)	Fractured bedrock with silt infiltration	No groundwater or seeps present in the test pit.

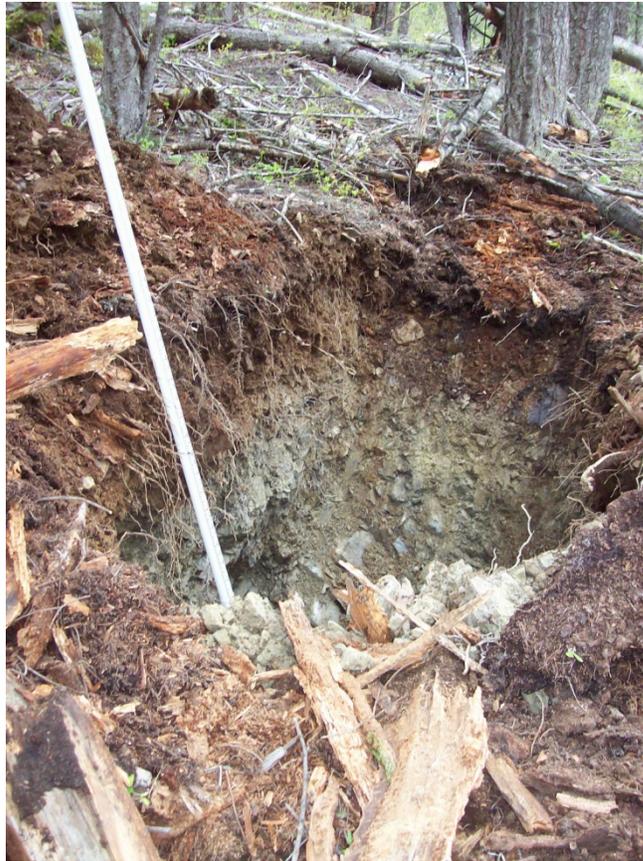
Depth (ft)	Materials/Observations	Comments
Surface	Forested land/ Thin layer of black topsoil	
0.0 – 1.0	Black and reddish-brown silty topsoil	
1.0 – 7.0 T.D. = 7.0 (bedrock)	Fractured bedrock with silt infiltration	No groundwater or seeps present in the test pit.

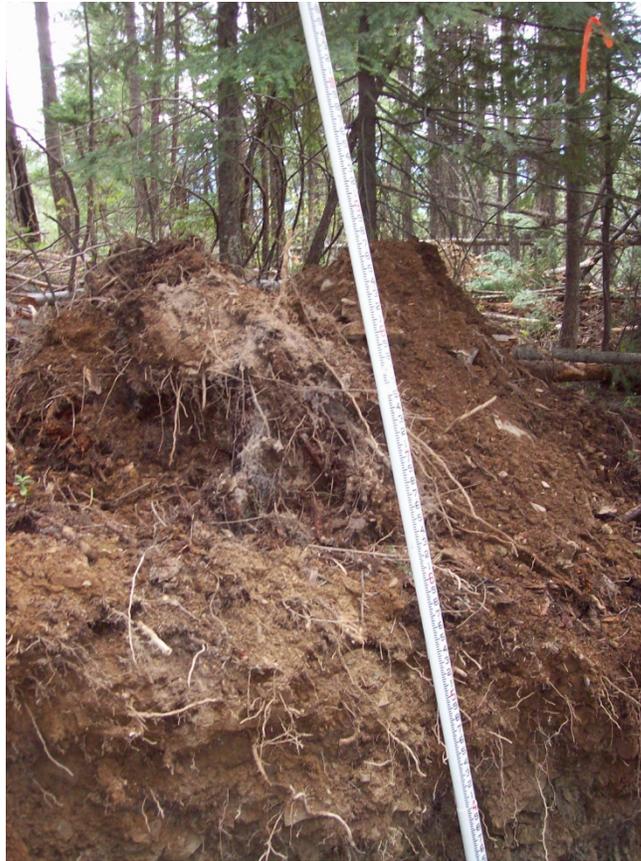
Depth (ft)	Materials/Observations	Comments
Surface	Forested land/ Thin layer of black topsoil	
0.0 – 1.0	Black and reddish-brown silty topsoil	
1.0 – 5.5 T.D. = 5.5 (bedrock)	Fractured bedrock with silt infiltration	No groundwater or seeps present in the test pit.
