RPT-5006
Rev. 0

**Repository Investigation Report
for the Broken Hill Mine Site,
Sanders County, Montana**

**REPOSITORY INVESTIGATION REPORT
FOR THE BROKEN HILL MINE SITE,
SANDERS COUNTY, MONTANA**

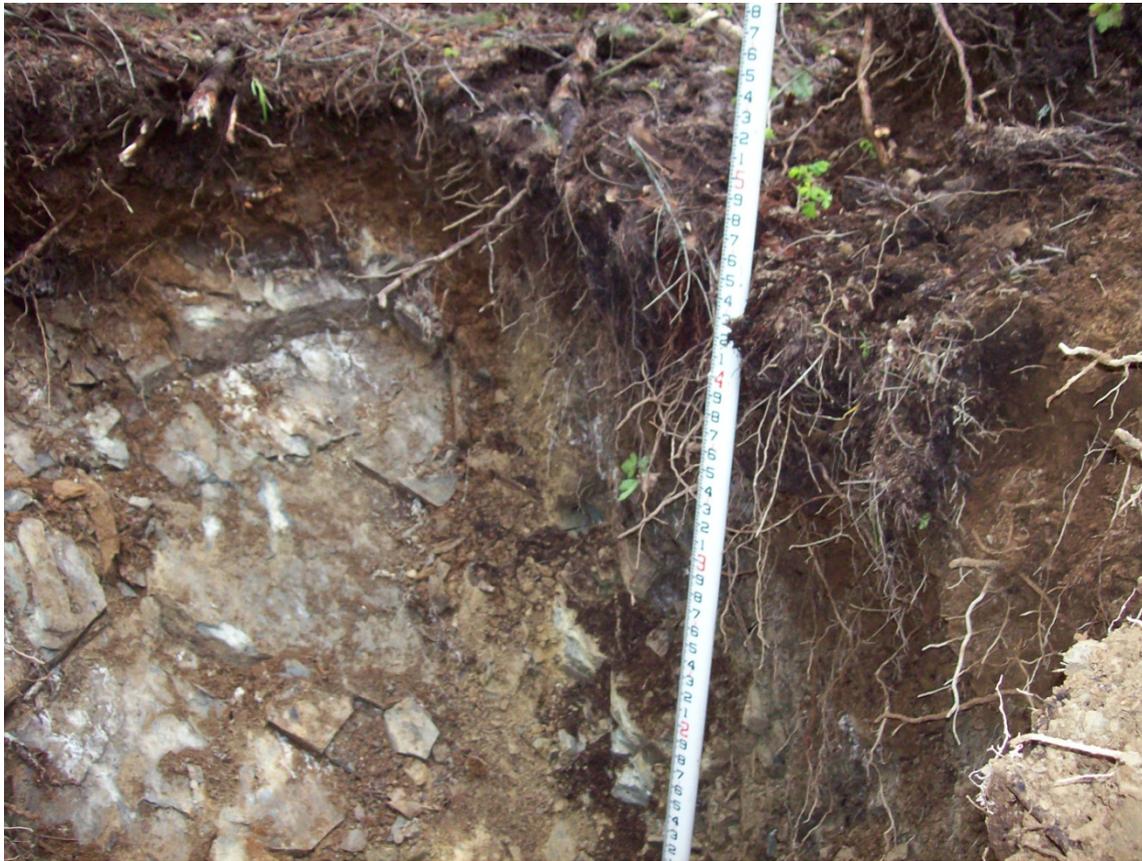
Depth (ft)	Materials/Observations	Comments
Surface	Forested land/ Thin layer of black topsoil	
0.0 – 1.0	Black and reddish-brown silty topsoil	
1.0 – 4.5 T.D. = 4.5 (bedrock)	Fractured bedrock with silt infiltration	No groundwater or seeps present in the test pit.

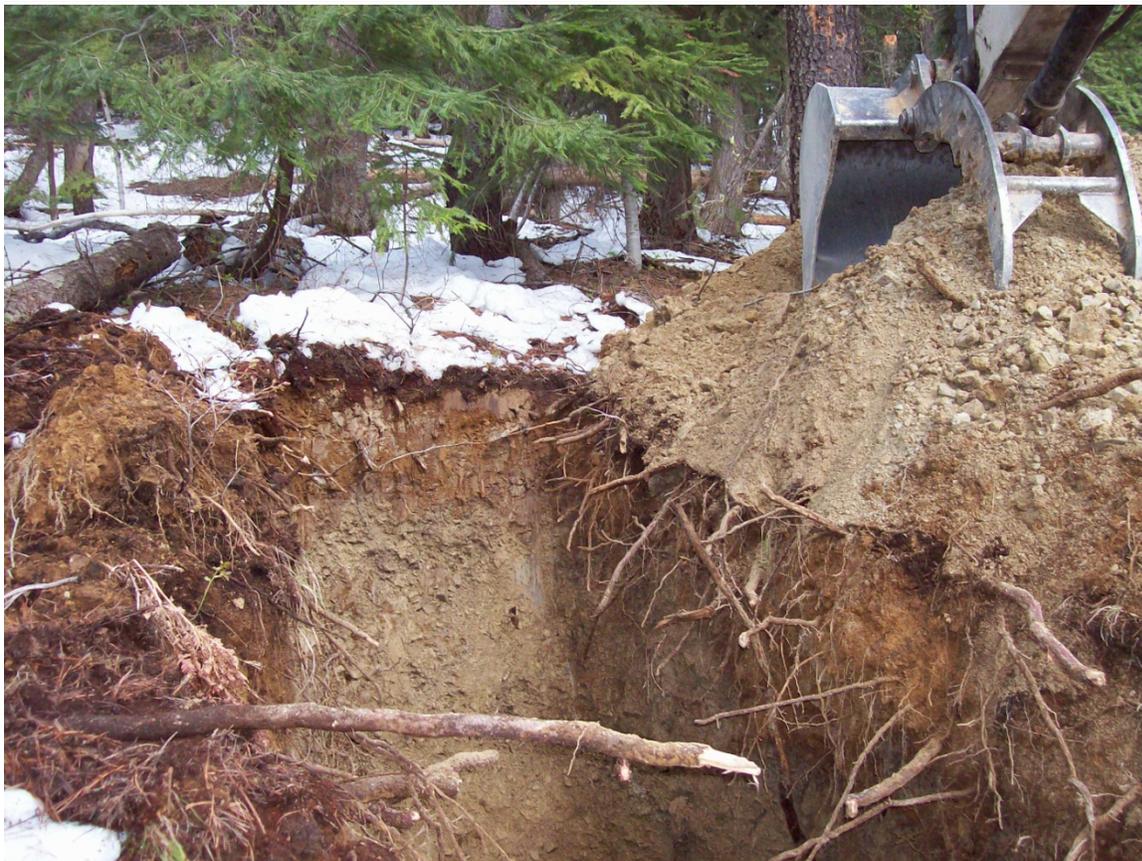
Depth (ft)	Materials/Observations	Comments
Surface	Forested land/ Thin layer of black topsoil	
0.0 – 1.0	Black and reddish-brown silty topsoil	
1.0 – 12.0 T.D. = 12.0	Colluvium; angular rocks and silty sand; light brown rocks; slightly moist	No groundwater or seeps present in the test pit.

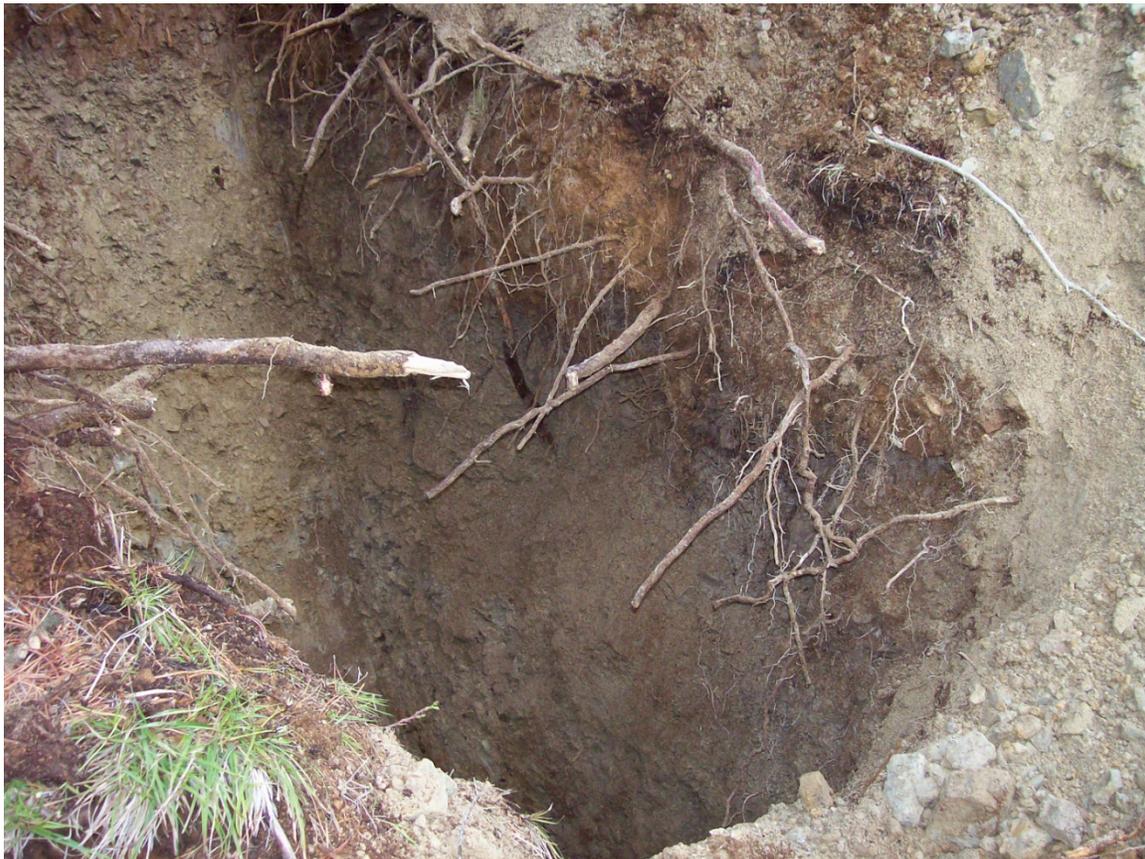
Depth (ft)	Materials/Observations	Comments
Surface	Forested land/ Thin layer of black topsoil	
0.0 – 2.0	Black topsoil overlying medium brown silty topsoil	
2.0 – 9.0 T.D. = 9.0	Angular rock and silt – light brown; moist to very moist. Relatively easy excavating.	No groundwater or seeps present in the test pit.

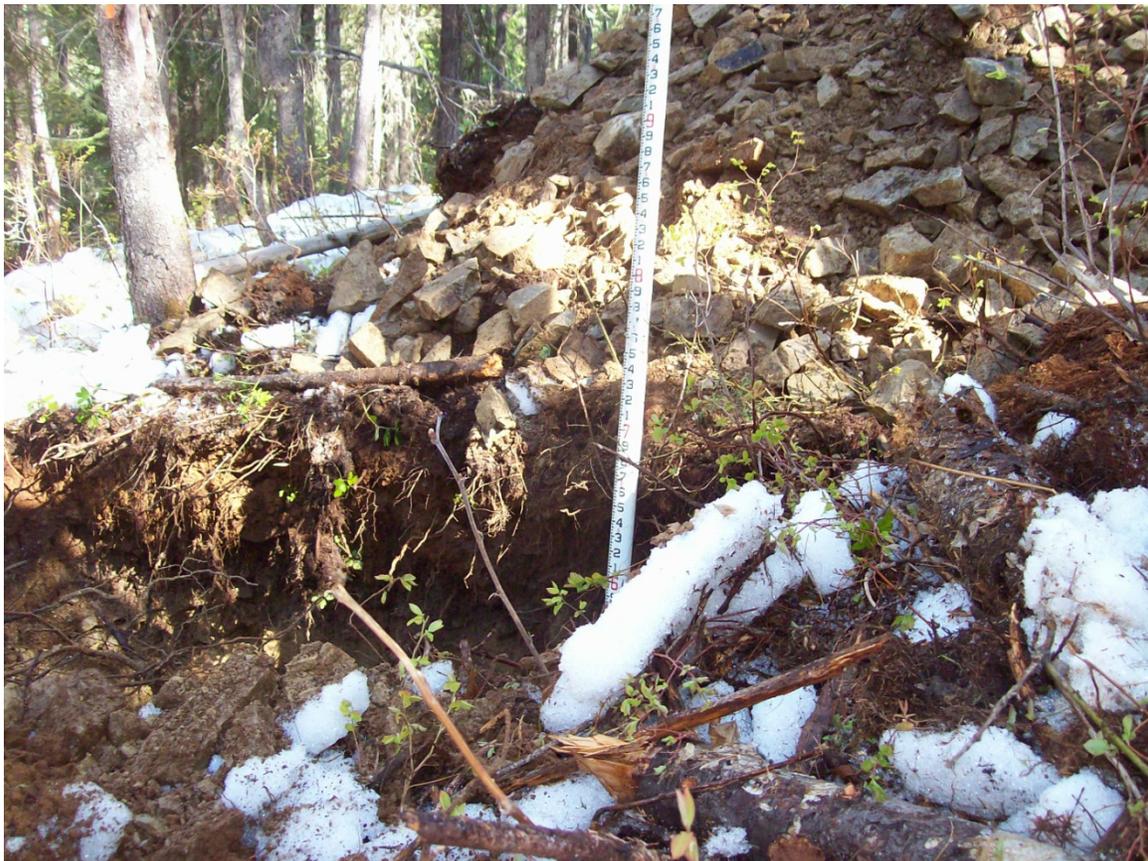
Test Pit Excavation Date: May 7, 2010
Logged By: Ray Schwaller, P.E.
Equipment: Bobcat 442 tracked excavator w/36-in.-wide bucket
Test Pit Number: TP-28
General Location: Approximate center of Road Bench #2 site

Depth (ft)	Materials/Observations	Comments
Surface	Forested land/ Thin layer of black topsoil	
0.0 – 1.0	Black topsoil overlying medium reddish-brown silty topsoil	
1.0 – 7.0 T.D. = 7.0 (hard rock)	Fractured rock with silty soil in fill; moist to very moist. Difficult excavating with depth.	No groundwater or seeps present in the test pit.

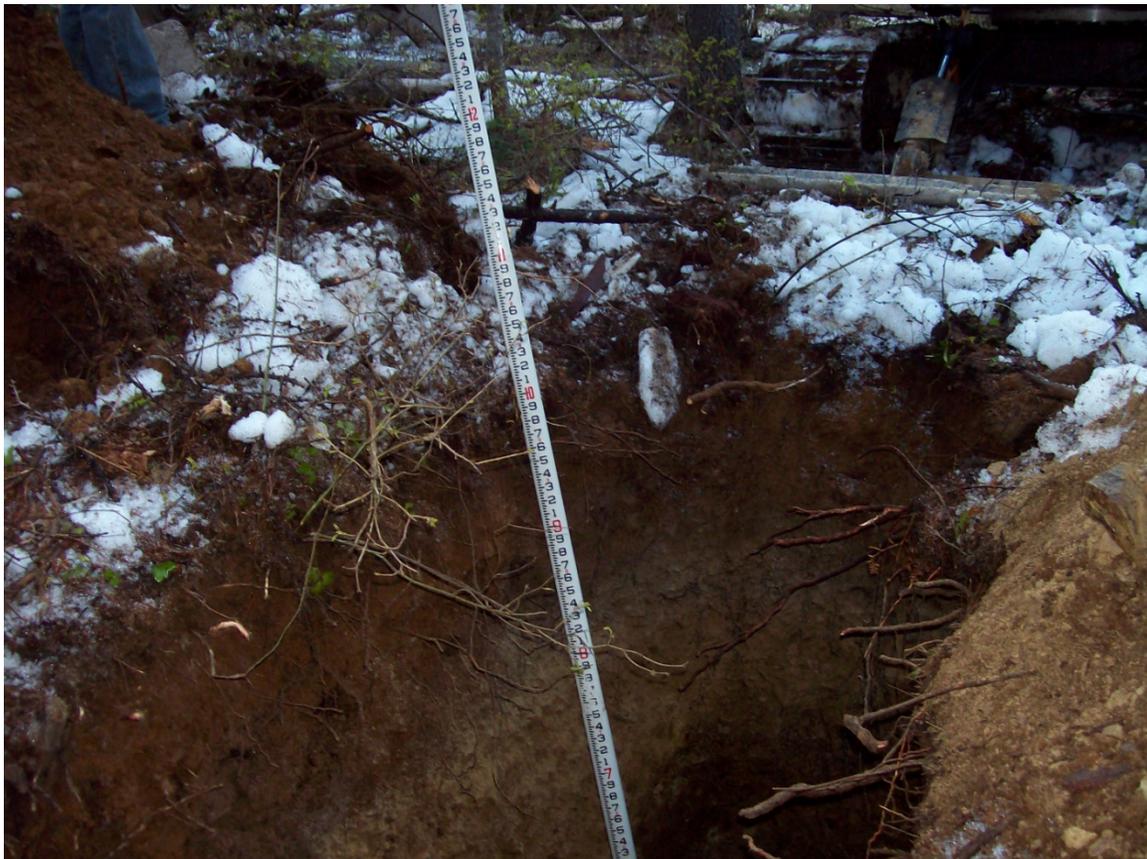
Test Pit Excavation Date: May 7, 2010
Logged By: Ray Schwaller, P.E.
Equipment: Bobcat 442 tracked excavator w/36-in.-wide bucket
Test Pit Number: TP-29
General Location: West corner of Road Bench #2 site

Depth (ft)	Materials/Observations	Comments
Surface	Forested land/ Thin layer of black topsoil	
0.0 – 2.0	Black topsoil overlying medium reddish-brown silty topsoil; moist	
2.0 – 10.0 T.D. = 10.0	Fractured angular rock with medium brown silty sand (colluvium); rock and clayey soil in fill at greater depth; moist to very moist. Relatively easy excavating.	No groundwater or seeps present in the test pit.

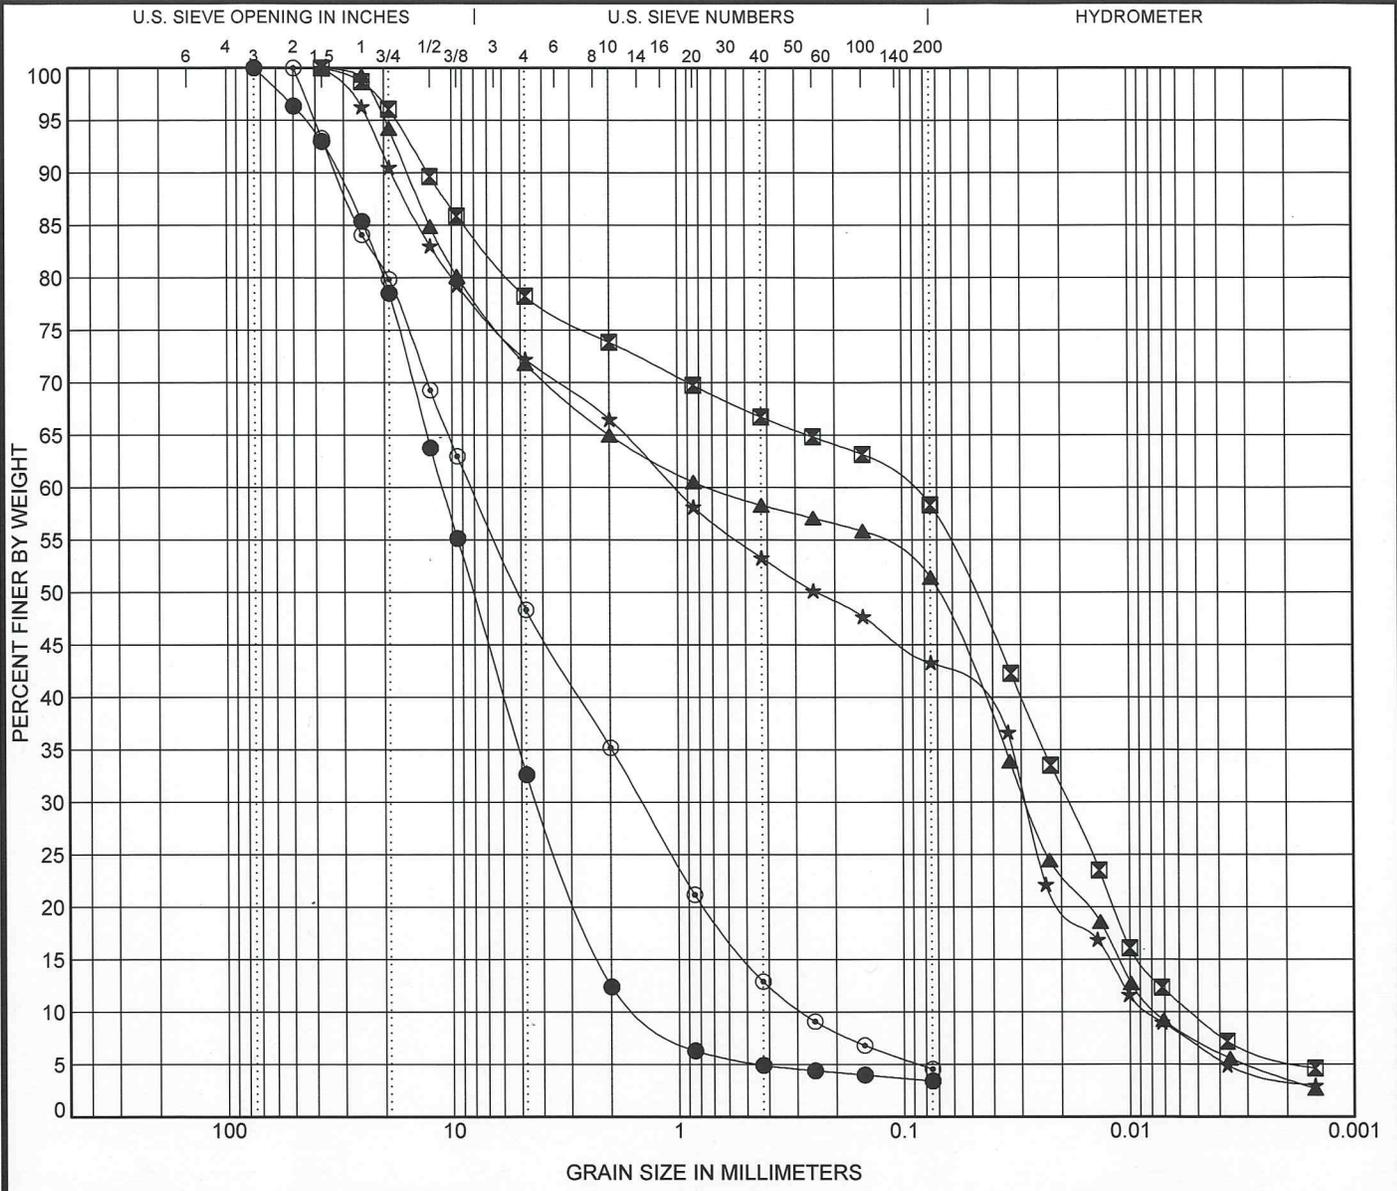
GRAIN SIZE DISTRIBUTION

COBBLES	GRAVEL		SAND			SILT OR CLAY
	coarse	fine	coarse	medium	fine

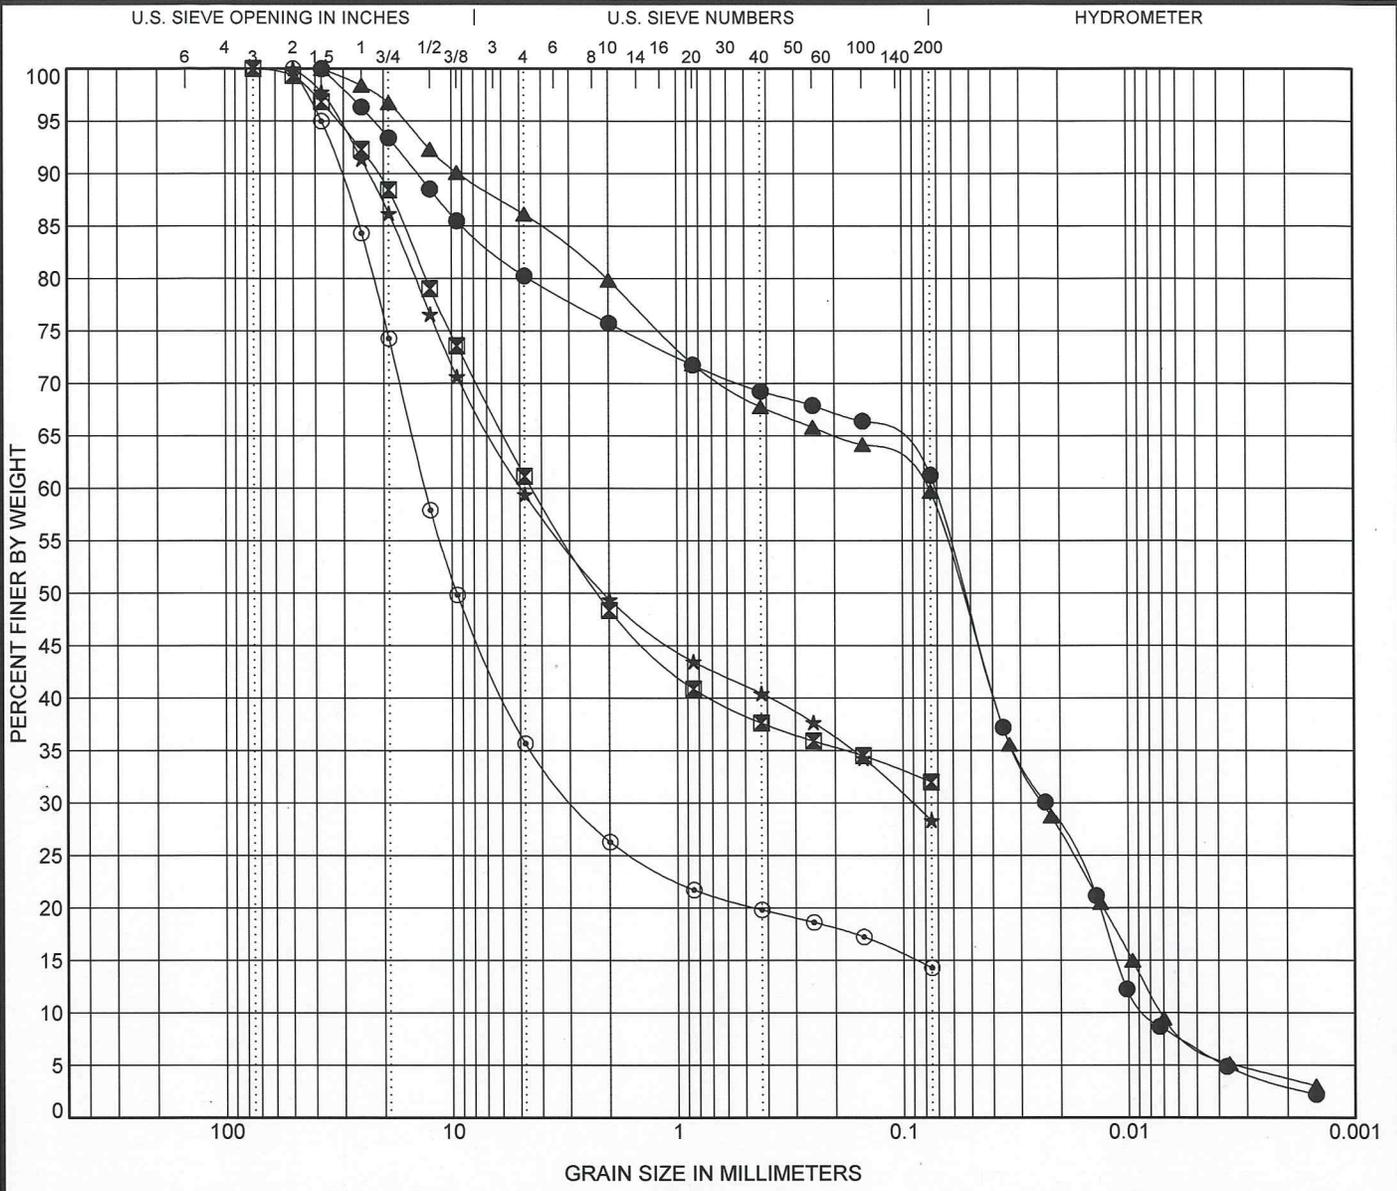
GRAIN SIZE DISTRIBUTION

COBBLES	GRAVEL		SAND			SILT OR CLAY
	coarse	fine	coarse	medium	fine

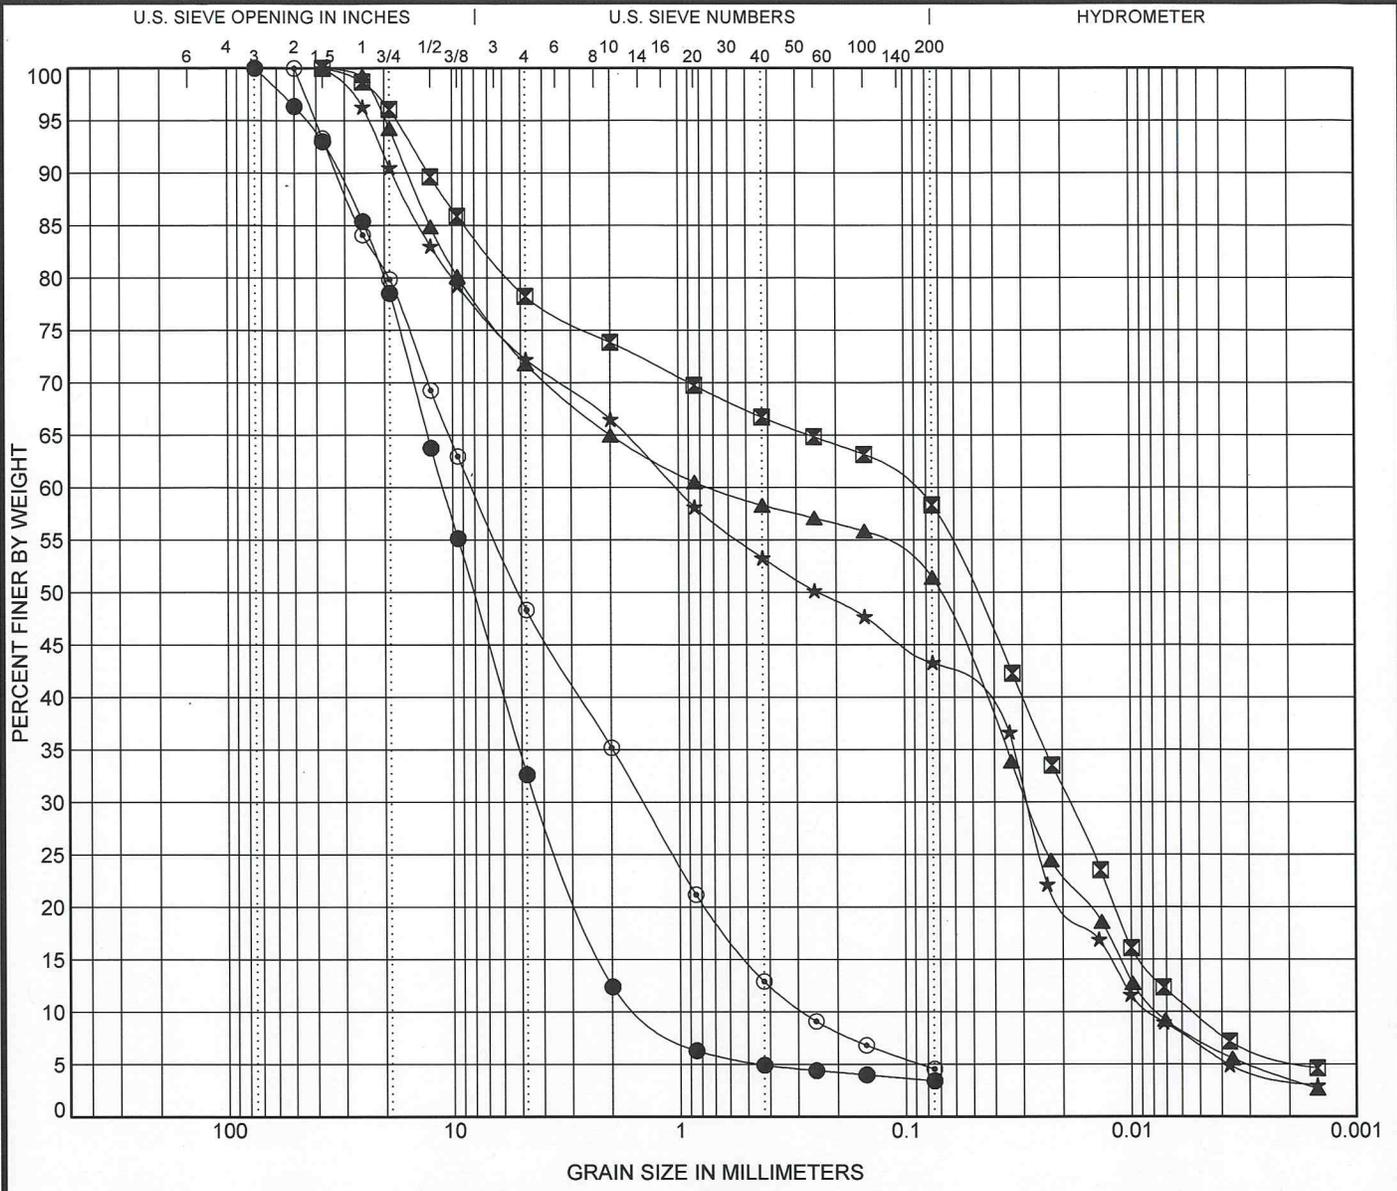
GRAIN SIZE DISTRIBUTION

COBBLES	GRAVEL		SAND			SILT OR CLAY
	coarse	fine	coarse	medium	fine

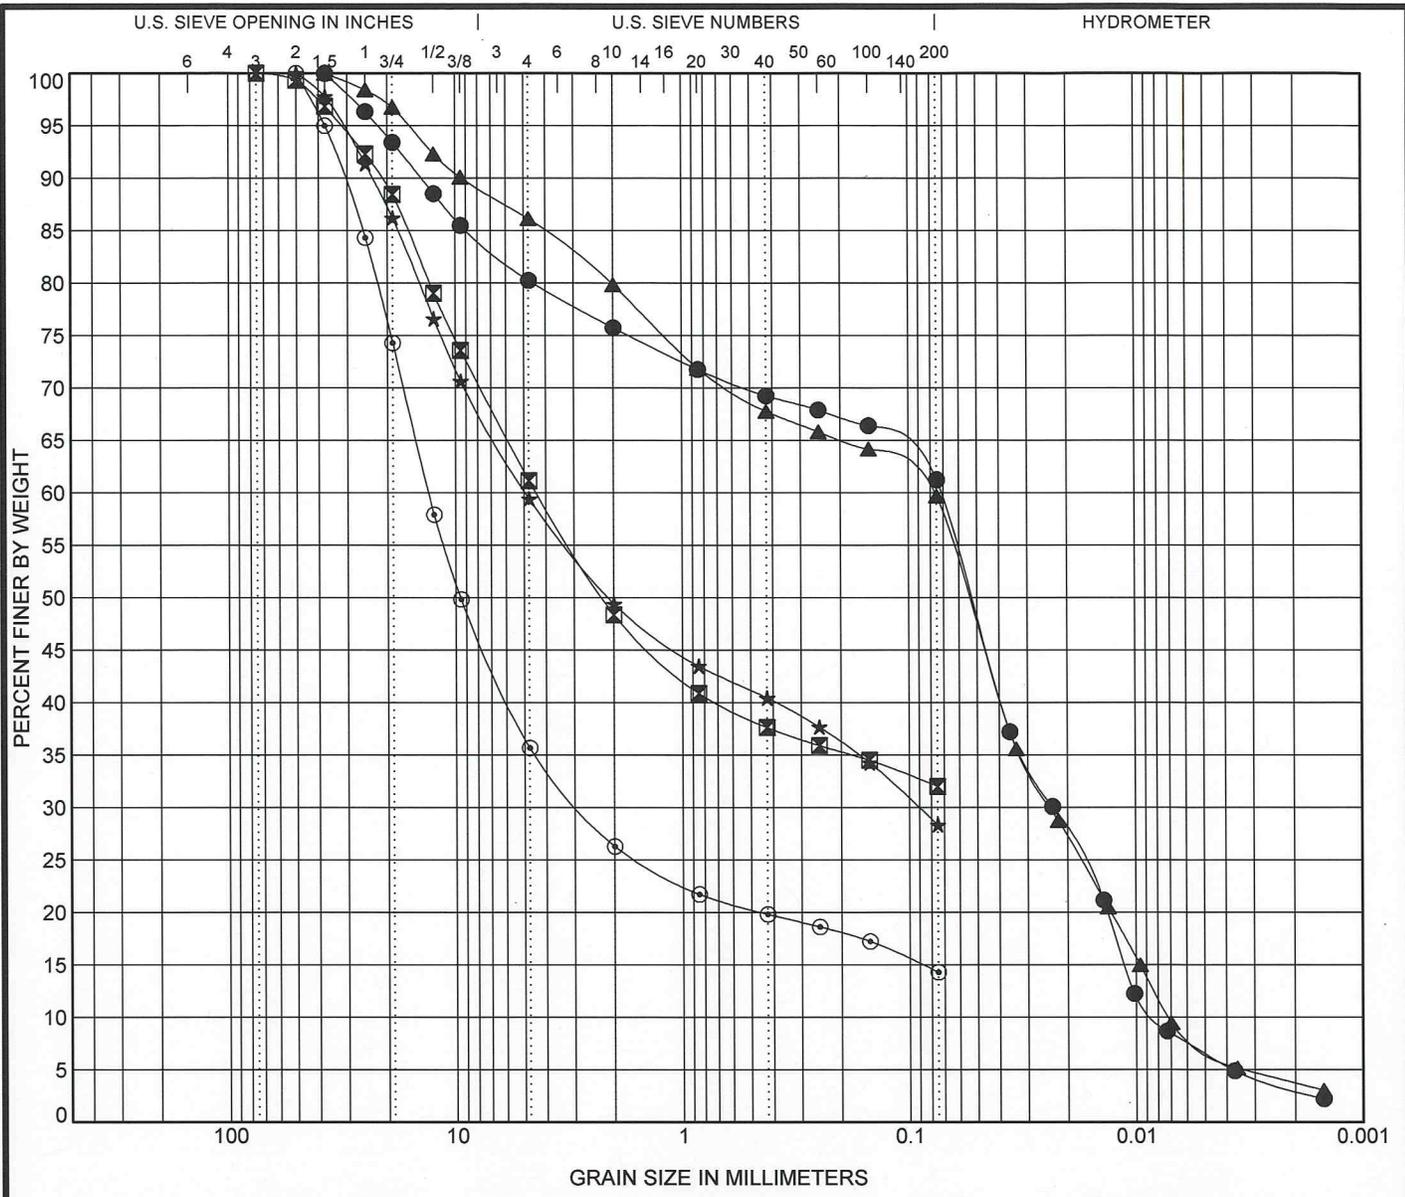
GRAIN SIZE DISTRIBUTION

COBBLES	GRAVEL		SAND			SILT OR CLAY
	coarse	fine	coarse	medium	fine
