**FOREST ROSE MINE AND MILL COMPLEX
Beaverhead-Deerlodge National Forest**

DRAFT SITE INVESTIGATION

**Contract No. 53-0343-0-0009
Task Order No. HNF-MCS-03-04**

Prepared by
MCS Environmental, Inc.
*5562 Alloy South
Missoula, MT 59808*

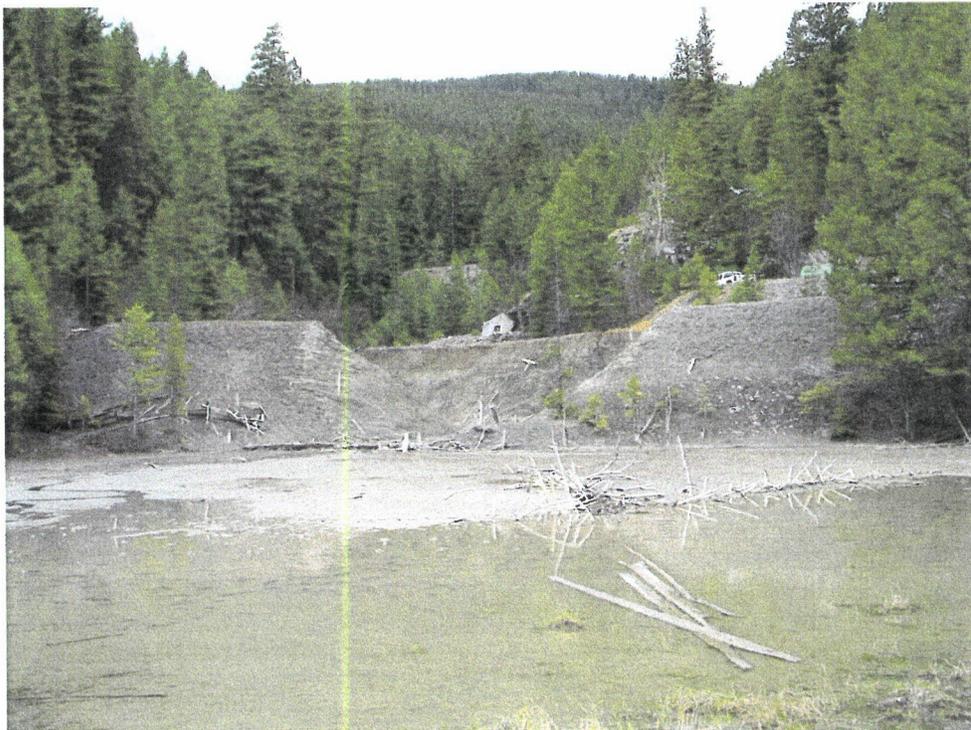
Photo 8 T3 impoundment dam face and breach and T2 Area pond. Looking south, May 2003.

The exposed surface area of the impoundment is approximately 0.75 acres. The impoundment surface and impoundment dam face is vegetated with only a few pine trees (Photo 8). The surface tailings consist of dense to slightly dense, moist, gray, sandy silt. The surface of the slope adjacent to the western edge of the impoundment and below FDR 707 contains waste rock.

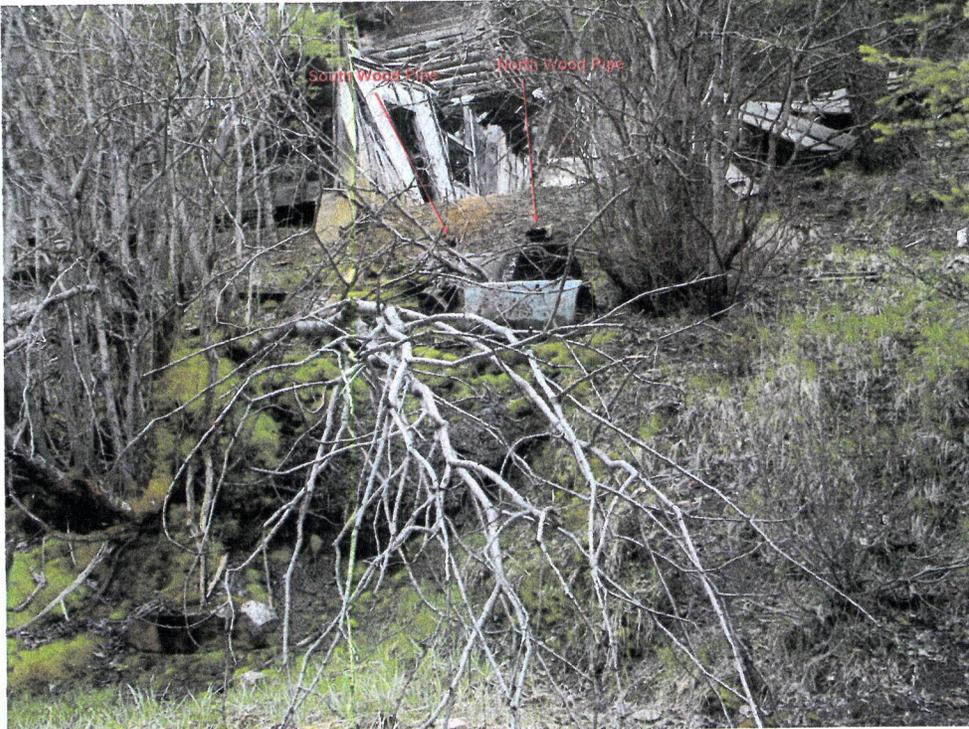
Photo 11 Wooden pipe discharge locations and associated wetted area. Looking west, May 2003.

Surface water sample AD-12-0-SW was collected from the wooden pipe discharge below the NE corner of the mill works building area (Figure 3.2). There are two discharge pipes at this location (Photo 11). The origin of these square wooden discharge pipes is unknown. Water sample AD-12-0-SW was collected from the southern discharge pipe. The southern pipe flowed at a rate of approximately 2 to 4 gpm at the time of sample collection. The pipes discharge water onto waste rock and tailings. This water then flows onto the T3 Area where it collects and infiltrates into the sub-surface (Figure 3.2). The water sample was collected from a pool MCS excavated below the southern pipe. The area directly adjacent to the discharge pipes is not vegetated. The slope and impoundment surface that is wetted by this discharge is vegetated with shrubs, grasses and mosses. Analytical results indicate the sample contained 0.0049 mg/L total copper, 0.0087 mg/L total lead, and 0.0808 mg/L total zinc (Table 4.4). Total and dissolved arsenic, total cadmium, and total mercury concentrations were below laboratory PQLs. This sample contained the following general water quality parameters: 90.2 mg/L total calcium, 8.94 mg/L total magnesium, 102 mg/L sulfate, 0.70 mg/L chloride, 262 mg/L hardness, and a pH of 7.91.

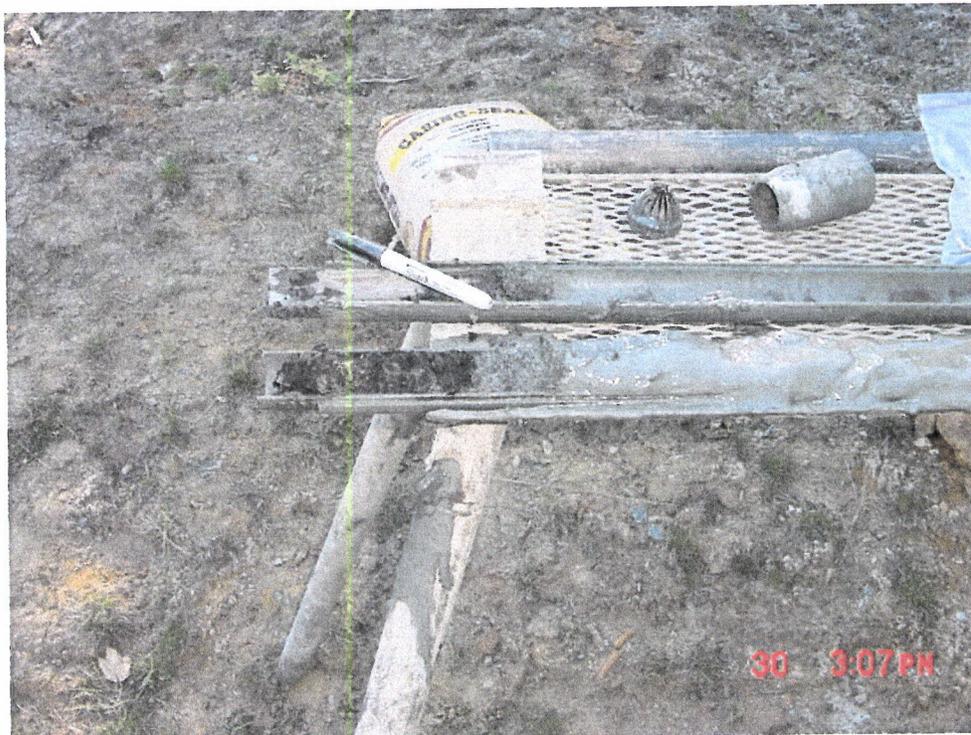
Photo 16 Split spoon showing tailings and native soil contact in boring B2.

Standard penetration tests conducted during the geotechnical investigation showed that the tailings had little to no cohesion. One to three blow counts were generally required to drive the split spoon 6 inches. At some places in the tailings, one blow by the hammer would drive the split spoon 18 inches. These results indicate that the tailings are highly erodible if water were to top either of the dams. The condition of the decant system in the T2 Area is questionable and a failure of the system could cause surface water to top the dam. In addition, the outlet of the T2 Area decant tower onto the T1 Area surface is not visible and water is likely discharging through the base of the T2 Area dam from a collapsed portion of the effluent pipe buried inside the T2 Area dam. It is likely that the effluent water discharging through the base of the Dam is causing the active slumping and erosion observed at this location (Figure 3.1). Continued slumping at the base of the T2 Area dam may decrease the stability of this impoundment.
