# Construction Completion Report

## 2010 Highland Mine Reclamation Project

### Silverbow County, Montana

Prepared by:  
TerraGraphics Environmental Engineering, Inc.  
15 West 6th Avenue, Power Block West - 3rd Floor  
Helena, MT 59601

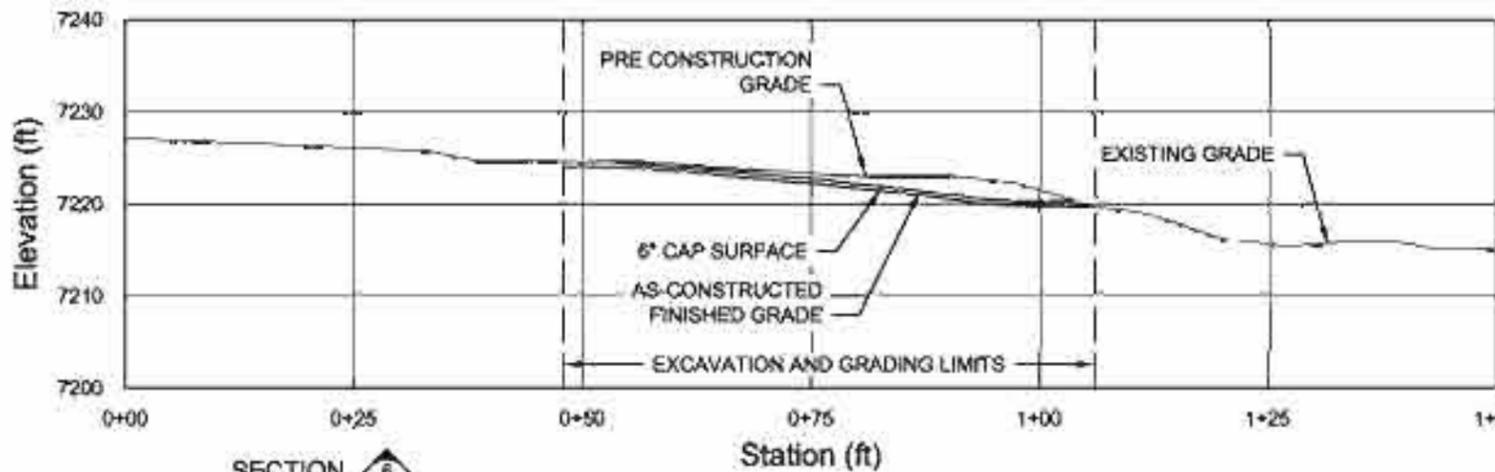
SECTION 6  
1" = 20'

NOTE:  
 TP1 EXCAVATED AND PLACED IN WR1.  
 EXCAVATION COVERED WITH 6" CAP SURFACE CONSISTING OF COVER SOIL, SEED, AND MULCH.  
 DEPTH OF EXCAVATION IS APPROXIMATE, ACTUAL DEPTH MAY VARY BASED ON ENGINEER'S INSPECTION.

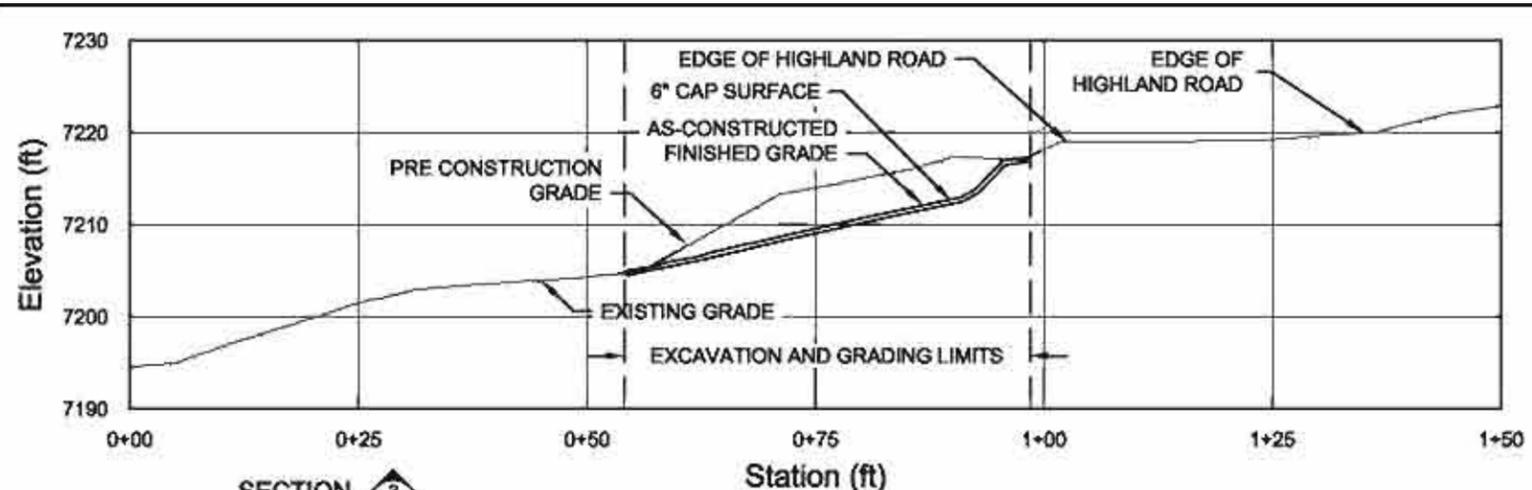
SECTION 3  
1" = 20'

NOTE:  
TP1 EXCAVATED AND PLACED IN WR1.  
EXCAVATION COVERED WITH 6" CAP SURFACE CONSISTING OF COVER SOIL, SEED, AND MULCH.  
DEPTH OF EXCAVATION IS APPROXIMATE, ACTUAL DEPTH MAY VARY BASED ON ENGINEER'S INSPECTION.

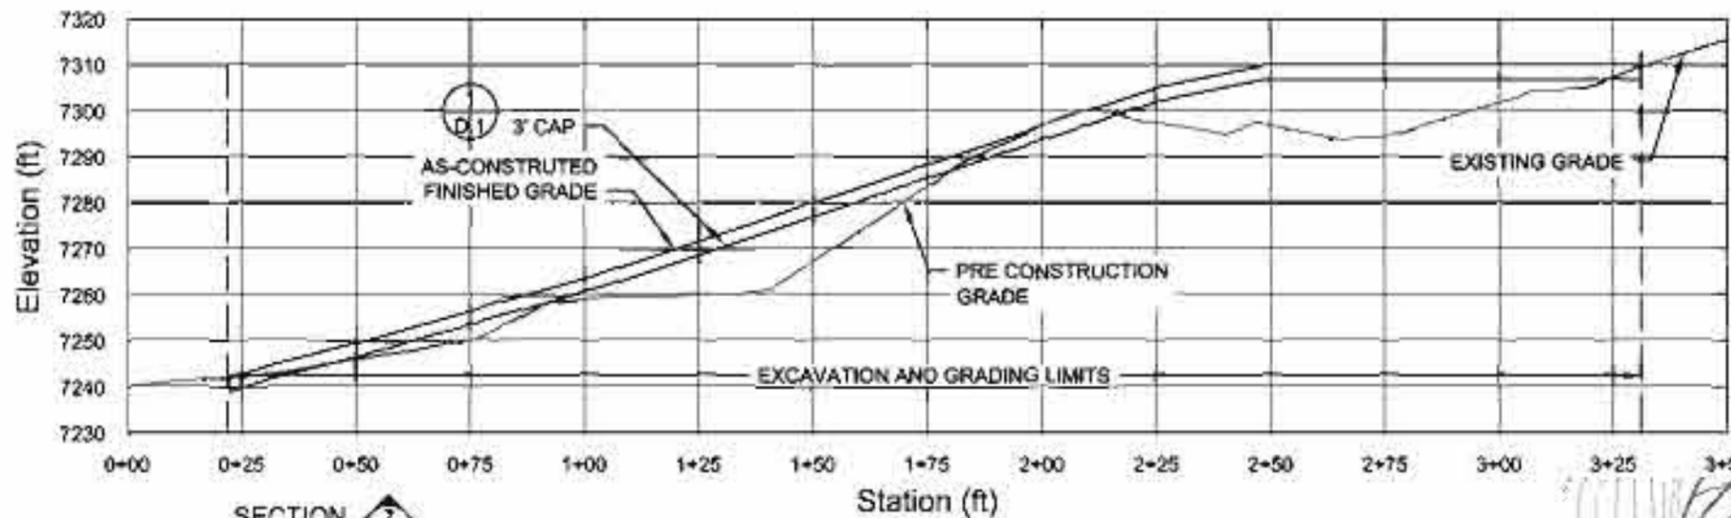
SECTION 7  
1" = 40'

NOTE:  
EXCAVATED TAILINGS PILES PLACED IN WR1.  
WR1 GRADED AND COVER SOIL APPLIED PER DETAILS.  
ENGINEER WILL STAKE CONSTRUCTION LIMITS.

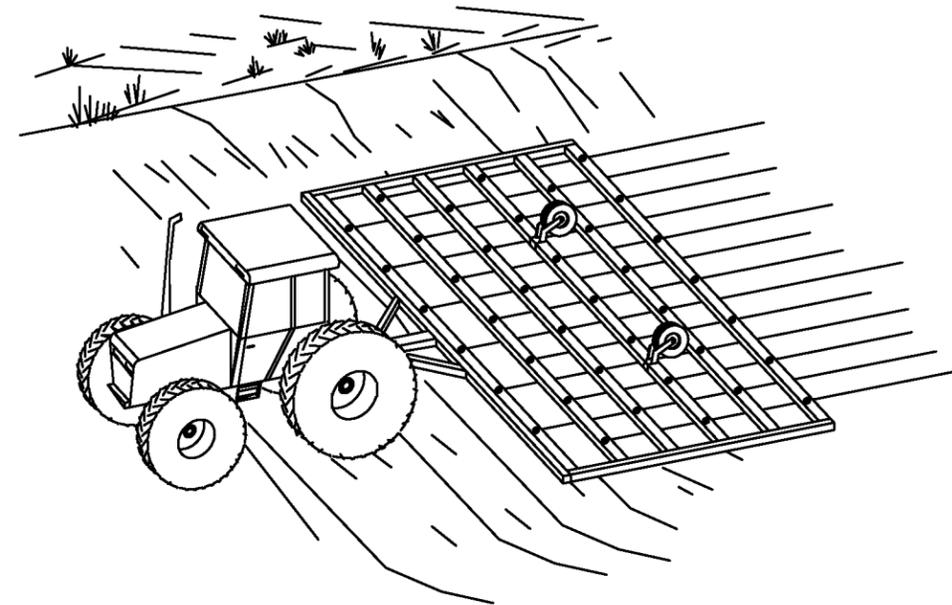
ALL SLOPES STEEPER THAN 3:1 AND GREATER THAN 5 VERTICAL FEET REQUIRE SLOPE ROUGHENING, EXCLUDING ROCK SLOPES THAT CANNOT BE EXCAVATED BY RIPPING. ROUGHEN DISTURBED SLOPES OR LEAVE IN A ROUGHENED CONDITION.

ROUGHEN SLOPES WITH HEAVY EQUIPMENT OR LEAVE IN ROUGHENED CONDITION

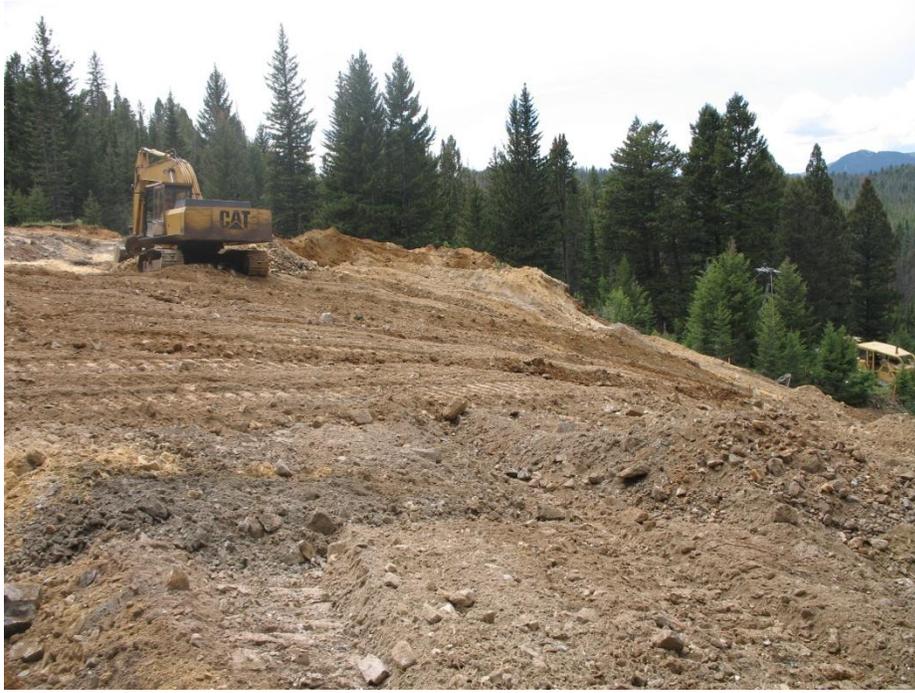
Photo Date: 8-9-10  
No. 1

Description: Looking  
South toward the main  
tailings pile.

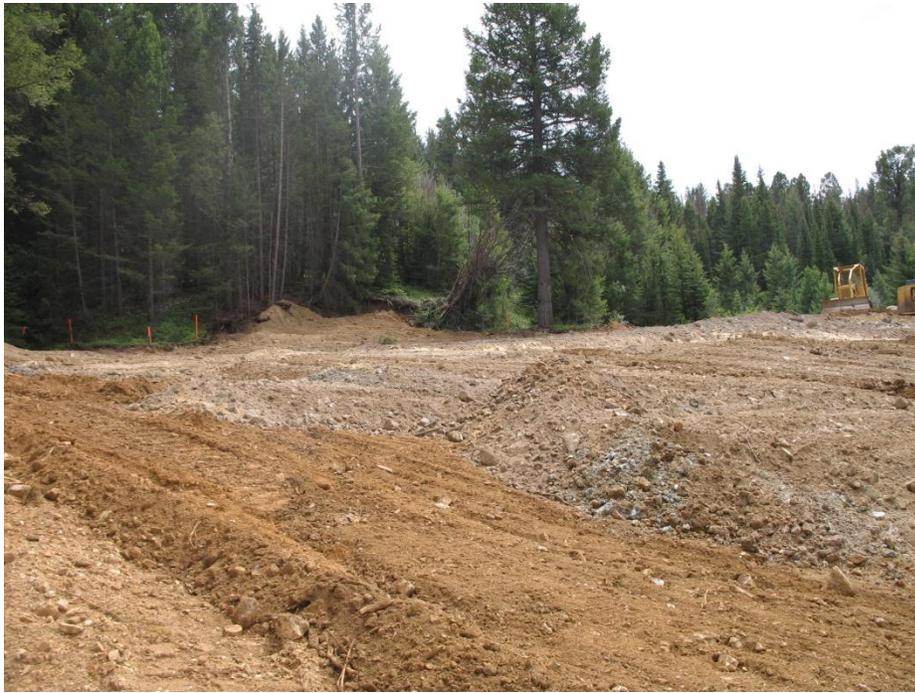
Photo Date: 8-9-10  
No. 2

Description: Top of  
mine site. Working on  
sub-grade.

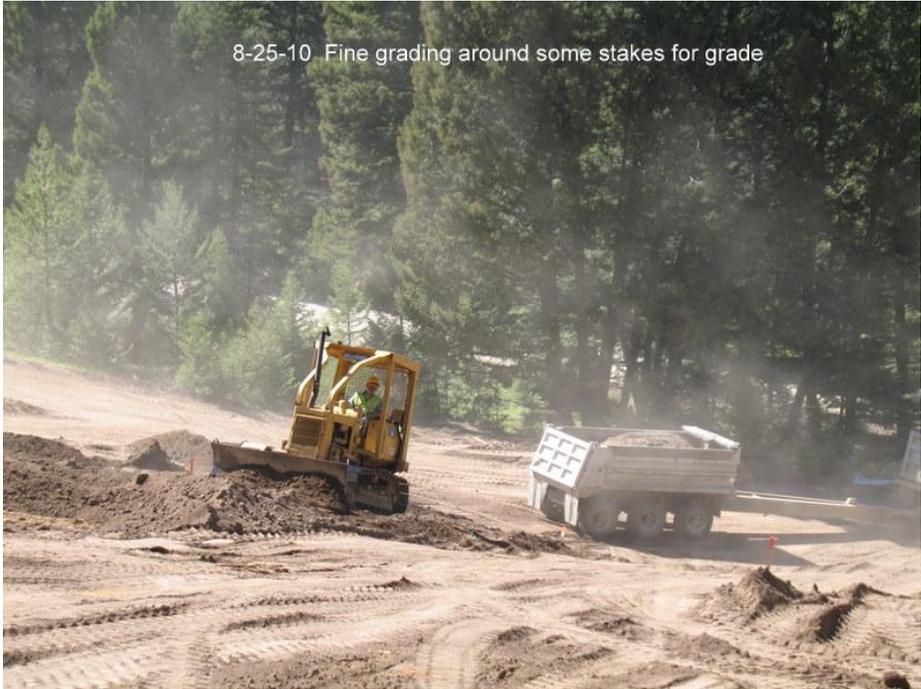
8-25-10 Fine grading around some stakes for grade

Description: Fine  
grading cover soil on  
WR 1.

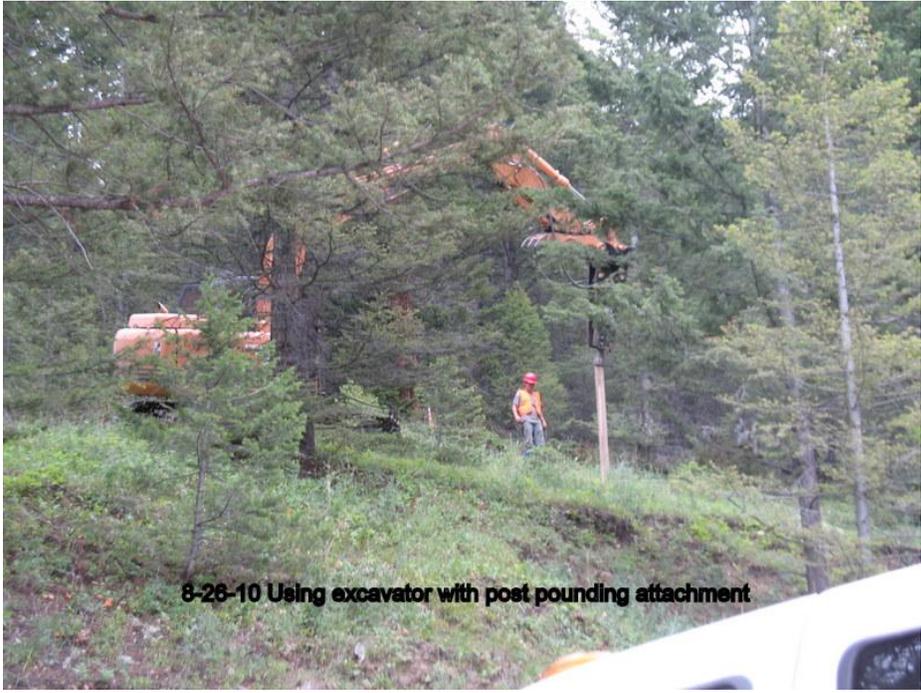
**8-26-10 Using excavator with post pounding attachment**

Description: Installing corner posts with excavator.

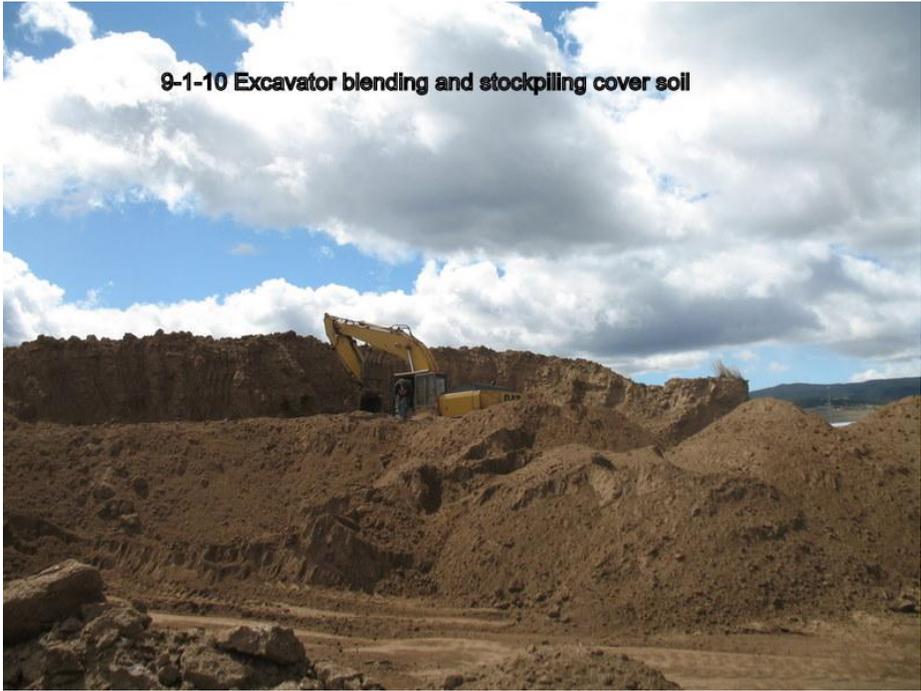
**9-1-10 Excavator blending and stockpiling cover soil**

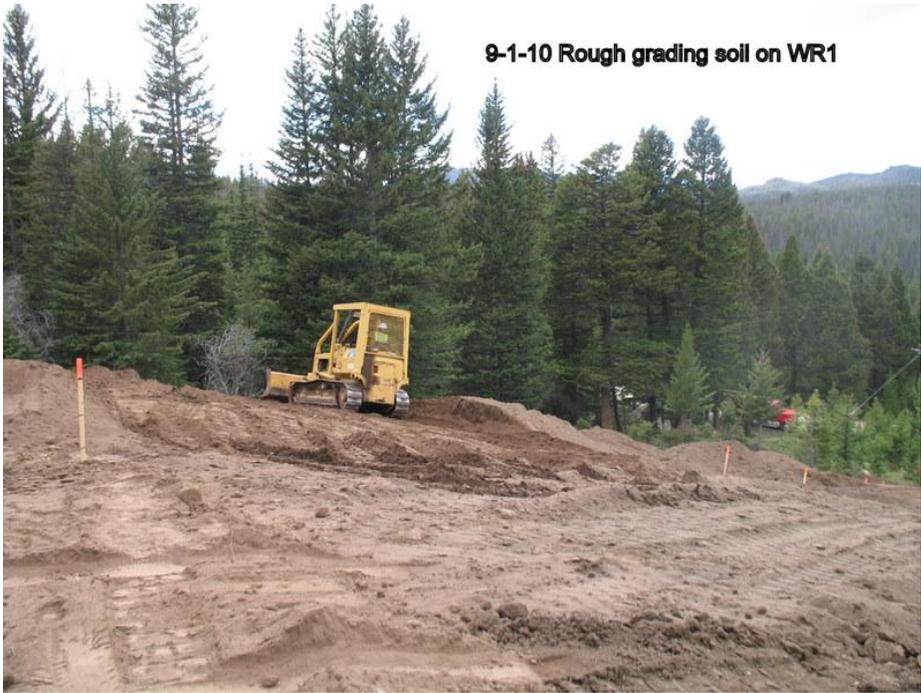
**9-1-10 Rough grading soil on WR1**

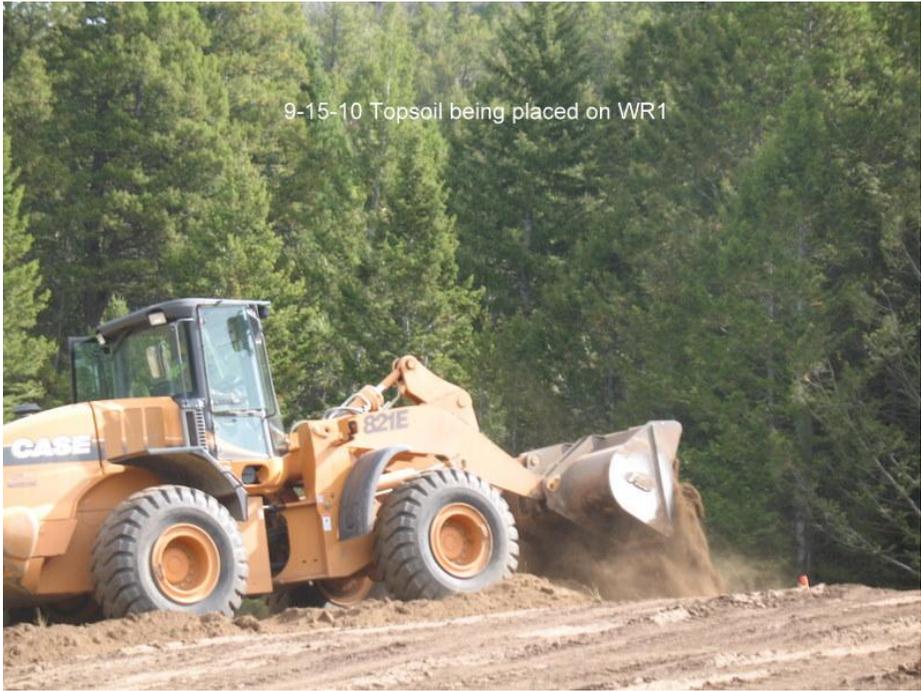
9-15-10 Topsoil being placed on WR1

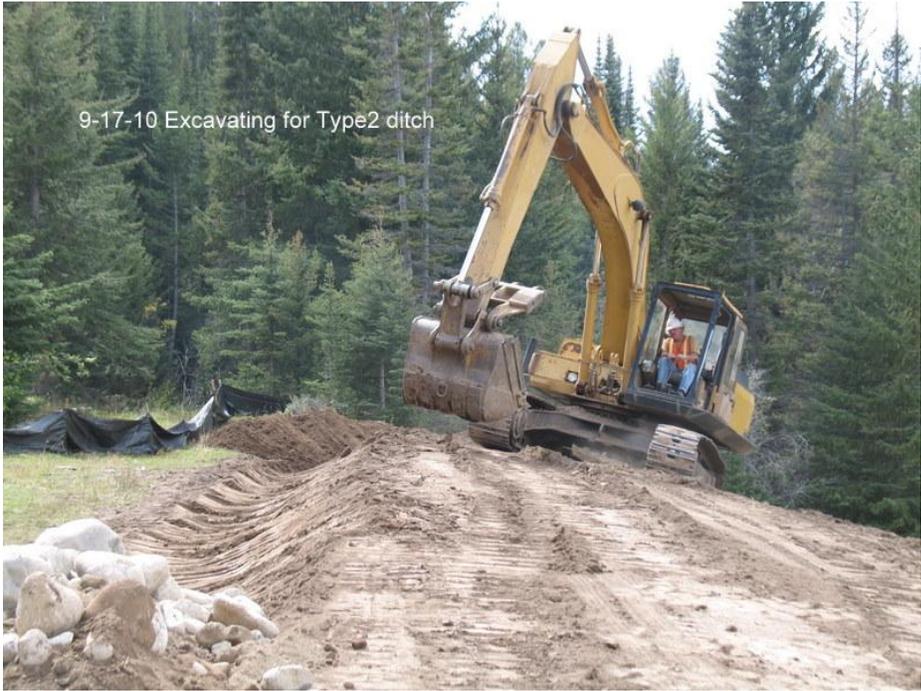
9-17-10 Excavating for Type2 ditch

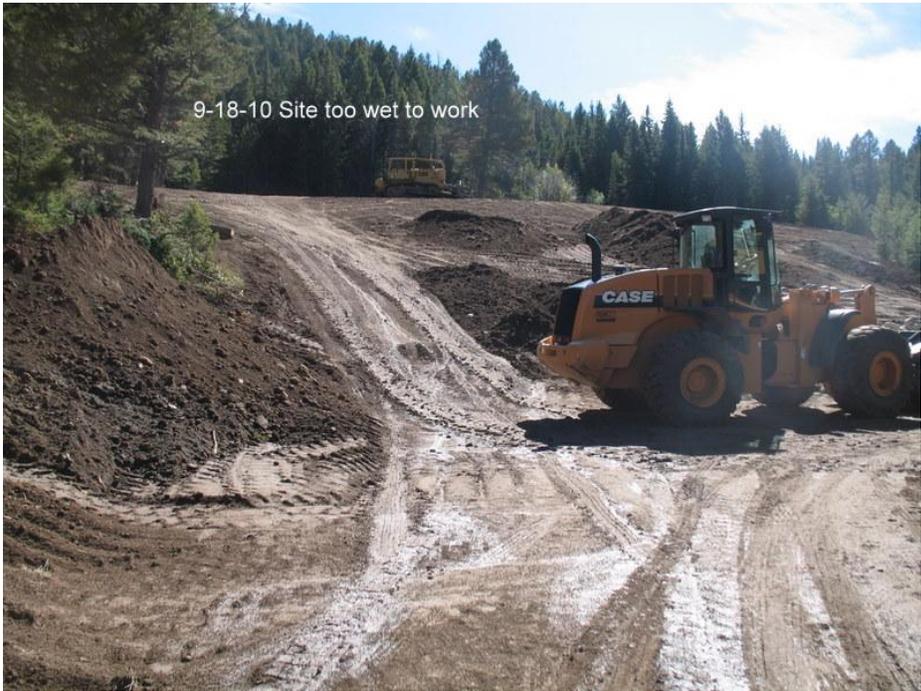
Photo Date: 9-18-10  
No. 1

Description: Site is wet from rain the night before.

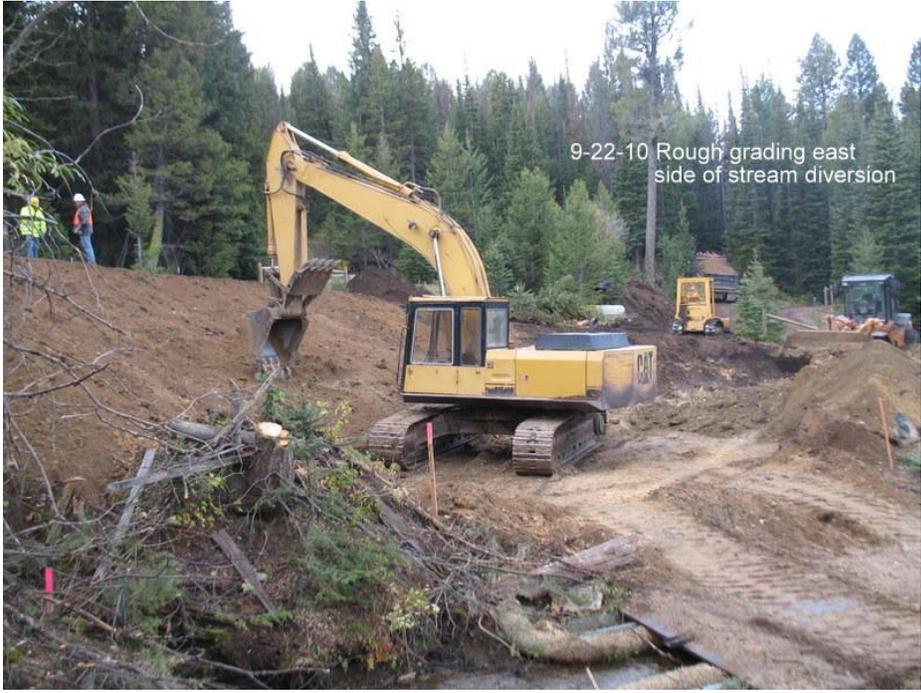
9-22-10 Rough grading east side of stream diversion

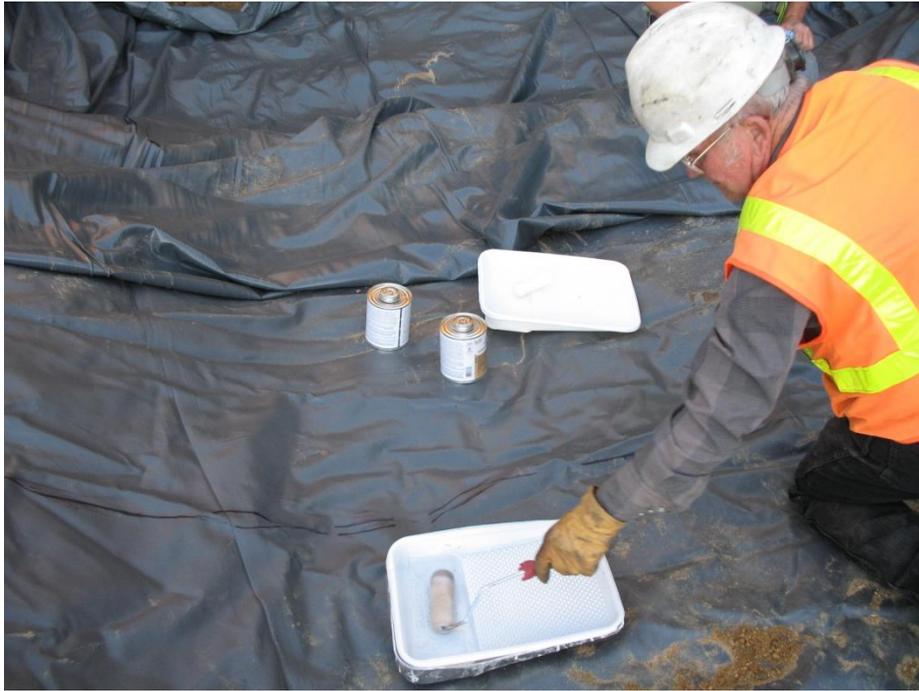
Photo Date: 9-27-10  
No. 9

Description: Gluing the  
seam of the two pieces  
of the liner together  
with PVC cleaner and  
cement.
