**RE: Final 2012 Annual Construction Completion Report for the McLaren Tailings
Abandoned Mine Site Reclamation Project**

Final 2012 Construction Completion Report for the McLaren Tailings Abandoned Mine Site

April 2013

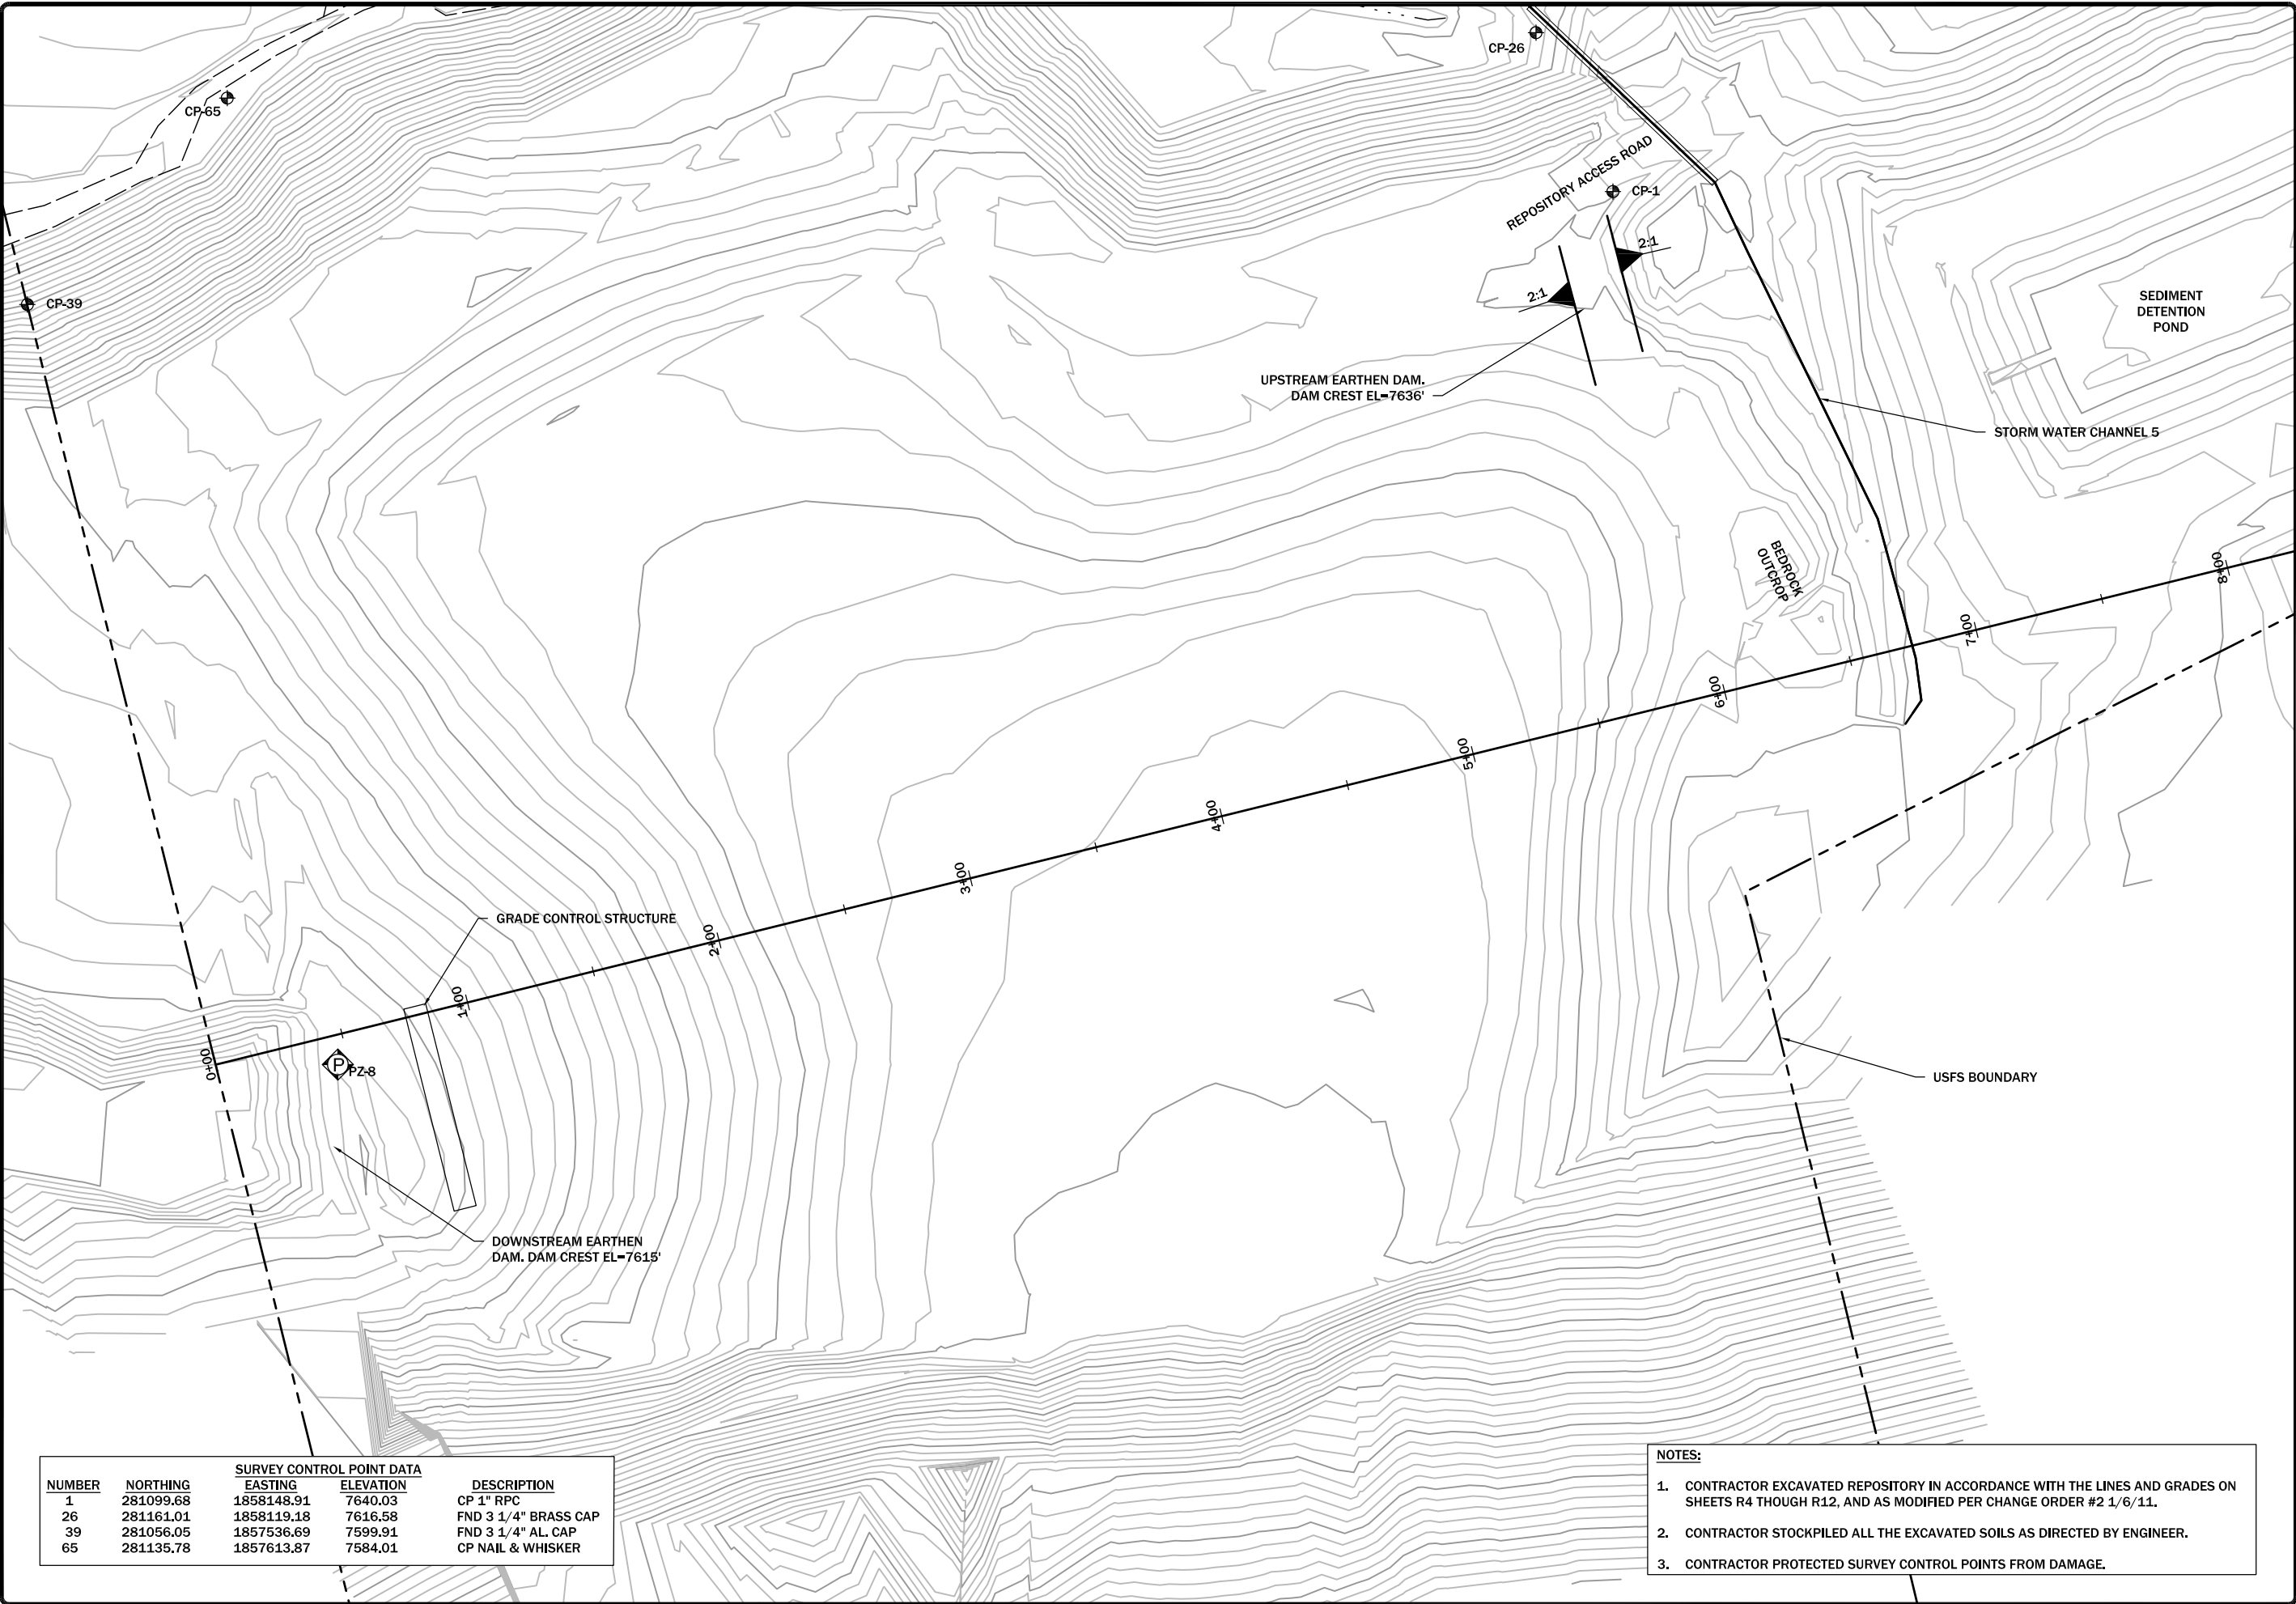
SHEET
TE-5AB

SURVEY CONTROL POINT DATA				
NUMBER	NORTHING	EASTING	ELEVATION	DESCRIPTION
1	281099.68	1858148.91	7640.03	CP 1" RPC
26	281161.01	1858119.18	7616.58	FND 3 1/4" BRASS CAP
39	281056.05	1857536.69	7599.91	FND 3 1/4" AL. CAP
65	281135.78	1857613.87	7584.01	CP NAIL & WHISKER

- NOTES:
- CONTRACTOR EXCAVATED REPOSITORY IN ACCORDANCE WITH THE LINES AND GRADES ON SHEETS R4 THROUGH R12, AND AS MODIFIED PER CHANGE ORDER #2 1/6/11.
 - CONTRACTOR STOCKPILED ALL THE EXCAVATED SOILS AS DIRECTED BY ENGINEER.
 - CONTRACTOR PROTECTED SURVEY CONTROL POINTS FROM DAMAGE.

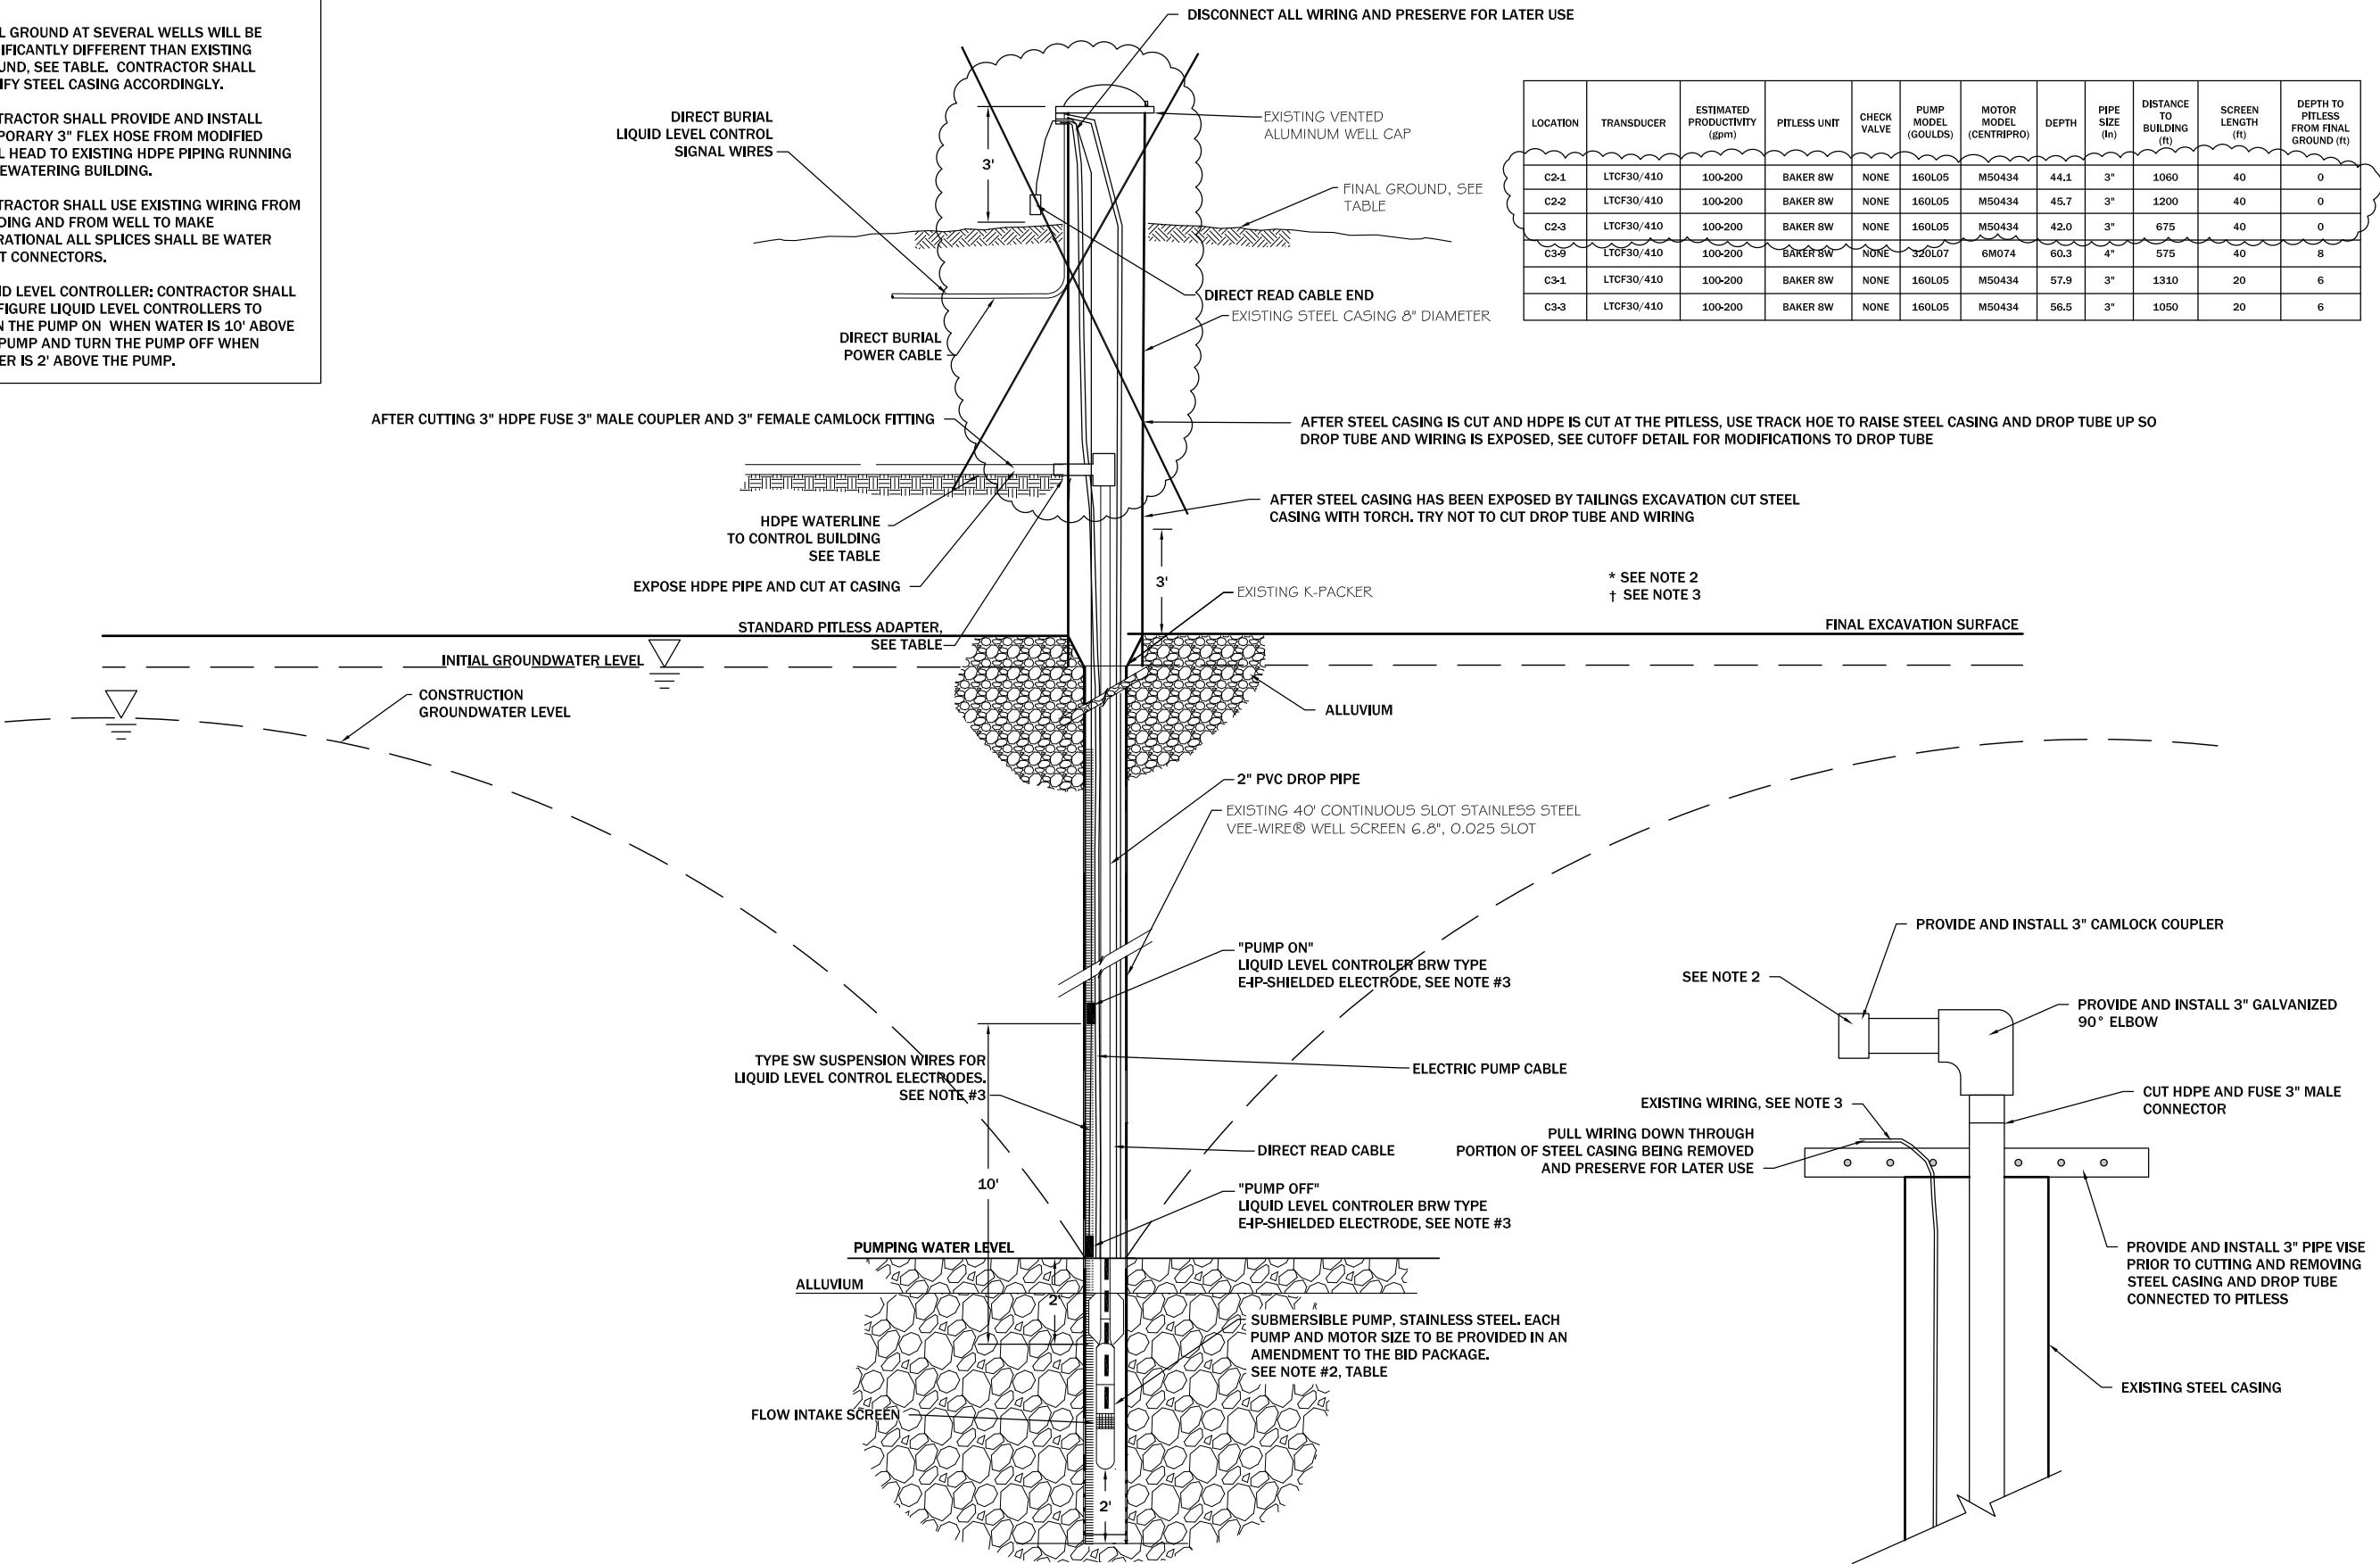
SHEET
GWD-2AB

1. FINAL GROUND AT SEVERAL WELLS WILL BE SIGNIFICANTLY DIFFERENT THAN EXISTING GROUND, SEE TABLE. CONTRACTOR SHALL MODIFY STEEL CASING ACCORDINGLY.
2. CONTRACTOR SHALL PROVIDE AND INSTALL TEMPORARY 3" FLEX HOSE FROM MODIFIED WELL HEAD TO EXISTING HDPE PIPING RUNNING TO DEWATERING BUILDING.
3. CONTRACTOR SHALL USE EXISTING WIRING FROM BUILDING AND FROM WELL TO MAKE OPERATIONAL ALL SPLICES SHALL BE WATER TIGHT CONNECTORS.
4. LIQUID LEVEL CONTROLLER: CONTRACTOR SHALL CONFIGURE LIQUID LEVEL CONTROLLERS TO TURN THE PUMP ON WHEN WATER IS 10' ABOVE THE PUMP AND TURN THE PUMP OFF WHEN WATER IS 2' ABOVE THE PUMP.

LOCATION	TRANSDUCER	ESTIMATED PRODUCTIVITY (gpm)	PITLESS UNIT	CHECK VALVE	PUMP MODEL (GOULDS)	MOTOR MODEL (CENTRIPRO)	DEPTH	PIPE SIZE (in)	DISTANCE TO BUILDING (ft)	SCREEN LENGTH (ft)	DEPTH TO PITLESS FROM FINAL GROUND (ft)
C2-1	LTCF30/410	100-200	BAKER 8W	NONE	160L05	M50434	44.1	3"	1060	40	0
C2-2	LTCF30/410	100-200	BAKER 8W	NONE	160L05	M50434	45.7	3"	1200	40	0
C2-3	LTCF30/410	100-200	BAKER 8W	NONE	160L05	M50434	42.0	3"	675	40	0
C3-9	LTCF30/410	100-200	BAKER 8W	NONE	320L07	6M074	60.3	4"	575	40	8
C3-1	LTCF30/410	100-200	BAKER 8W	NONE	160L05	M50434	57.9	3"	1310	20	6
C3-3	LTCF30/410	100-200	BAKER 8W	NONE	160L05	M50434	56.5	3"	1050	20	6

To maintain dry conditions in the excavation, the C2 series dewatering wells were not abandoned as the tailings excavation proceeded past them. These wells were kept operational and the steel casings were lowered as described in Change Order No. 8.
