MONTANA DEPARTMENT OF ENVIRONMENTAL QUALITY

McLaren Tailings  
Project Update  
September 3, 2014

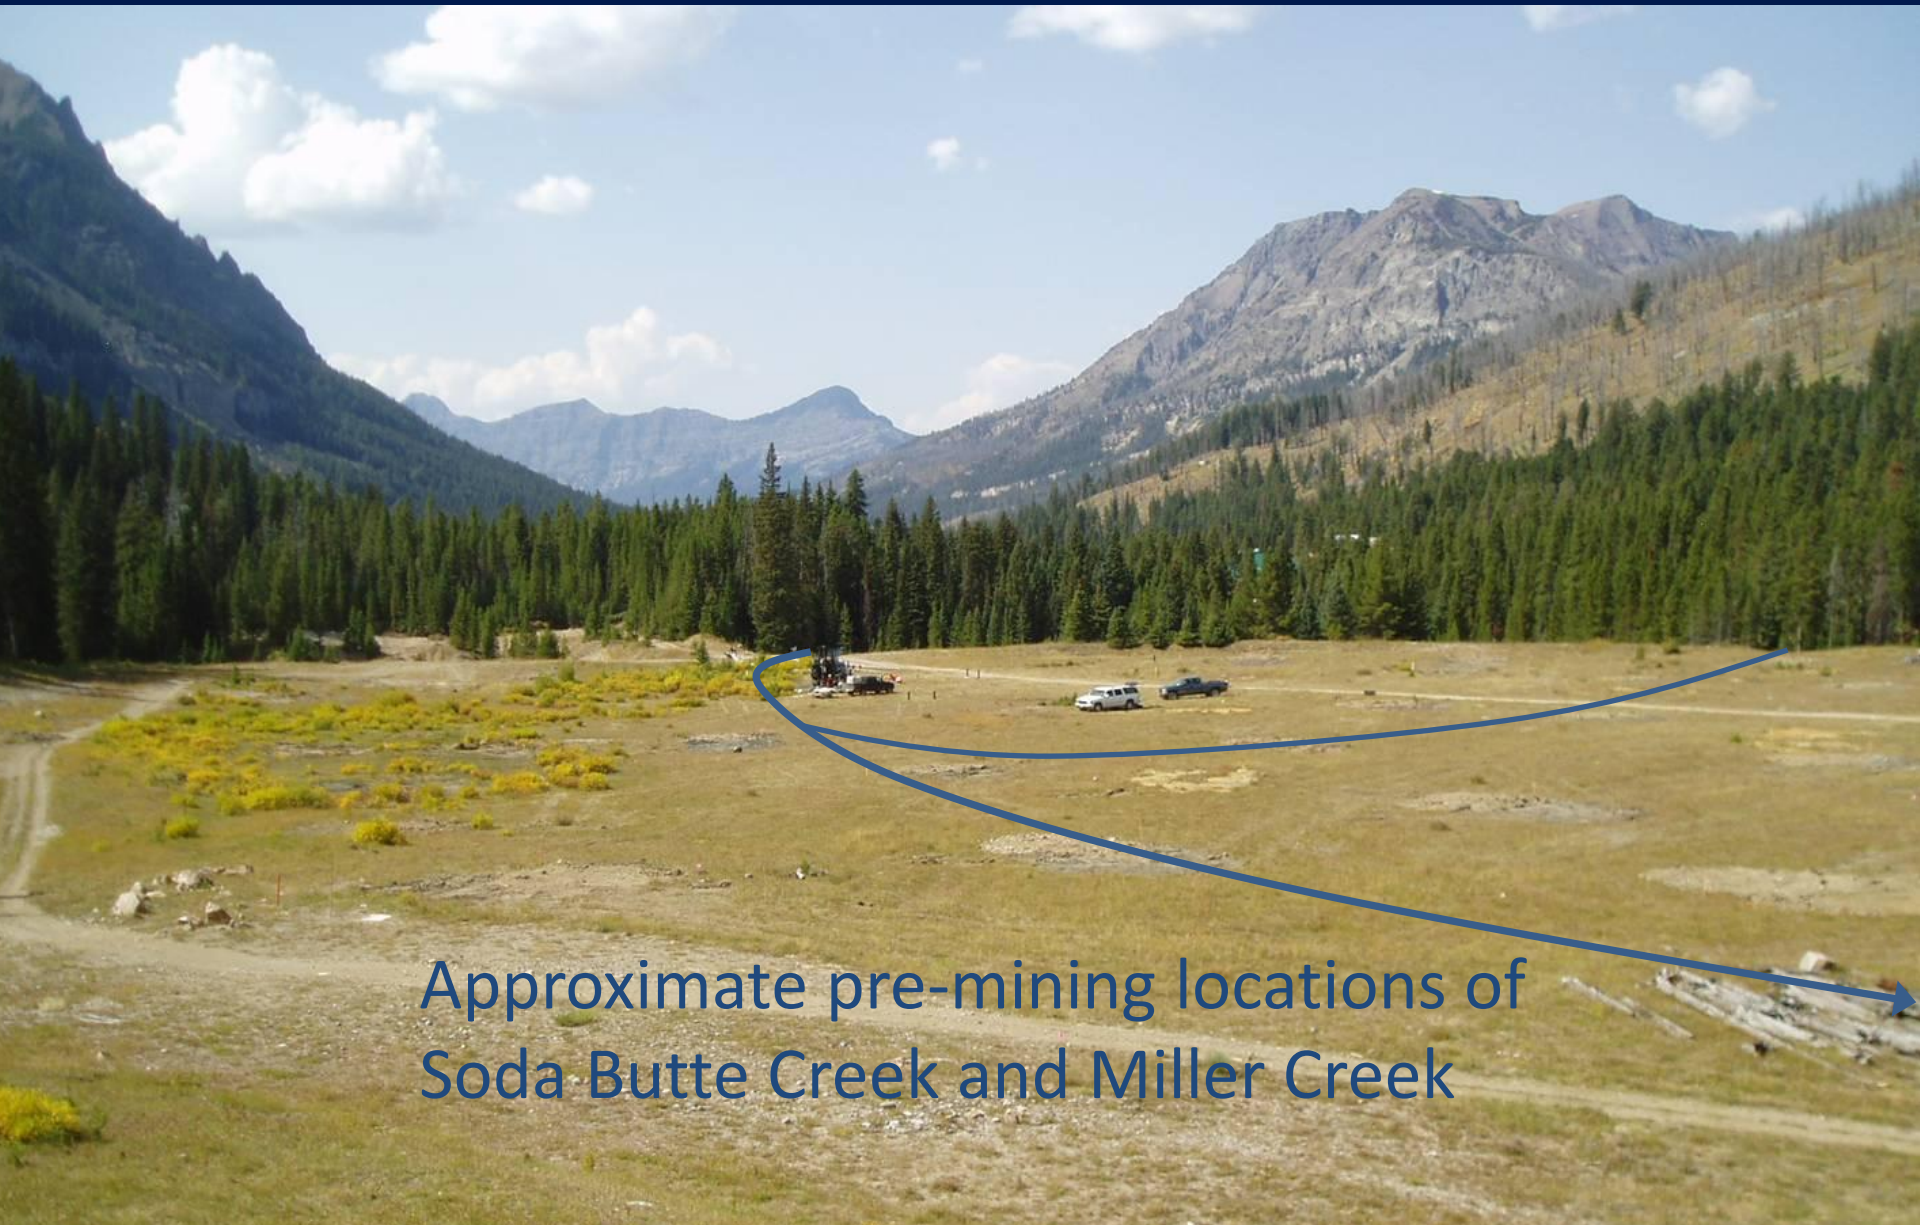
# Tailings Impoundment - 2008

Approximate pre-mining locations of  
Soda Butte Creek and Miller Creek

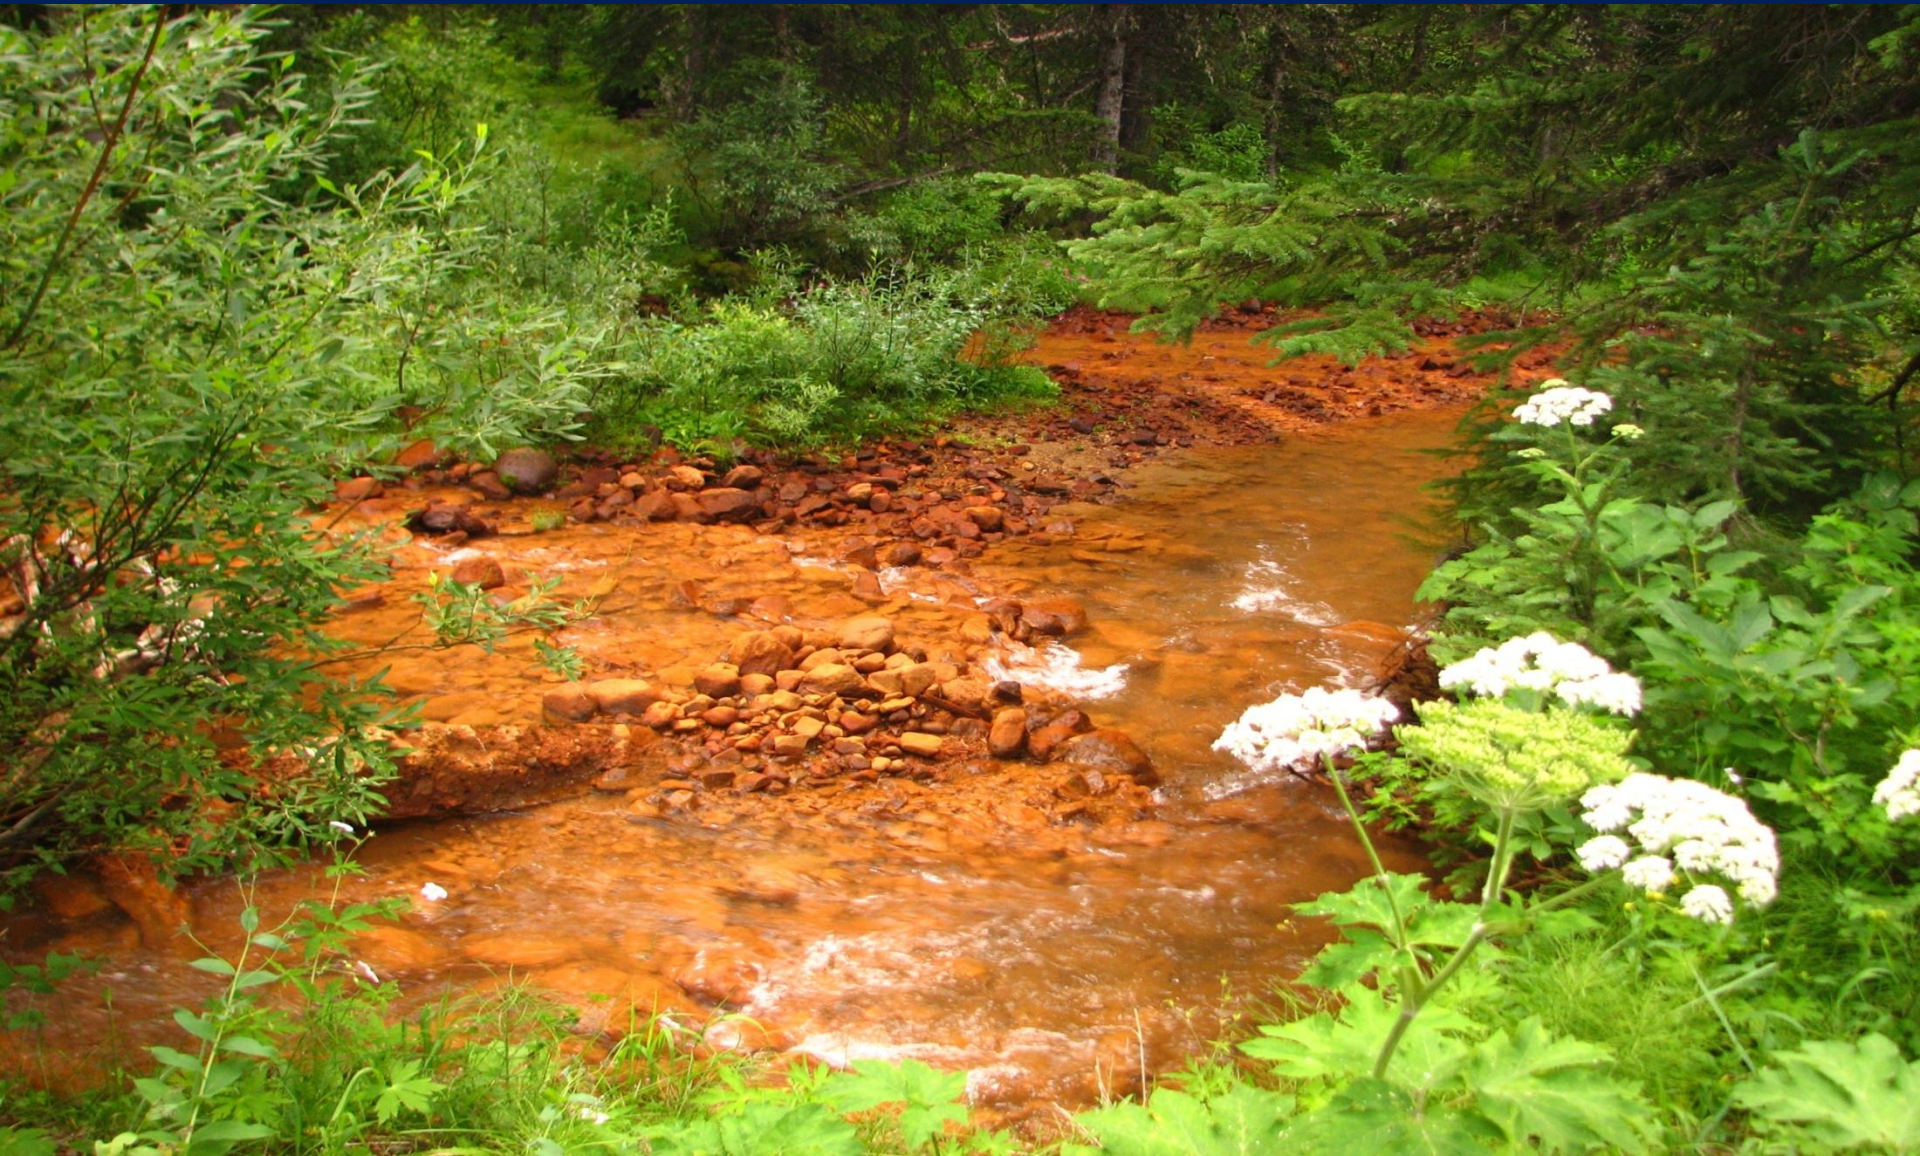
# Soda Butte Creek – August 2009

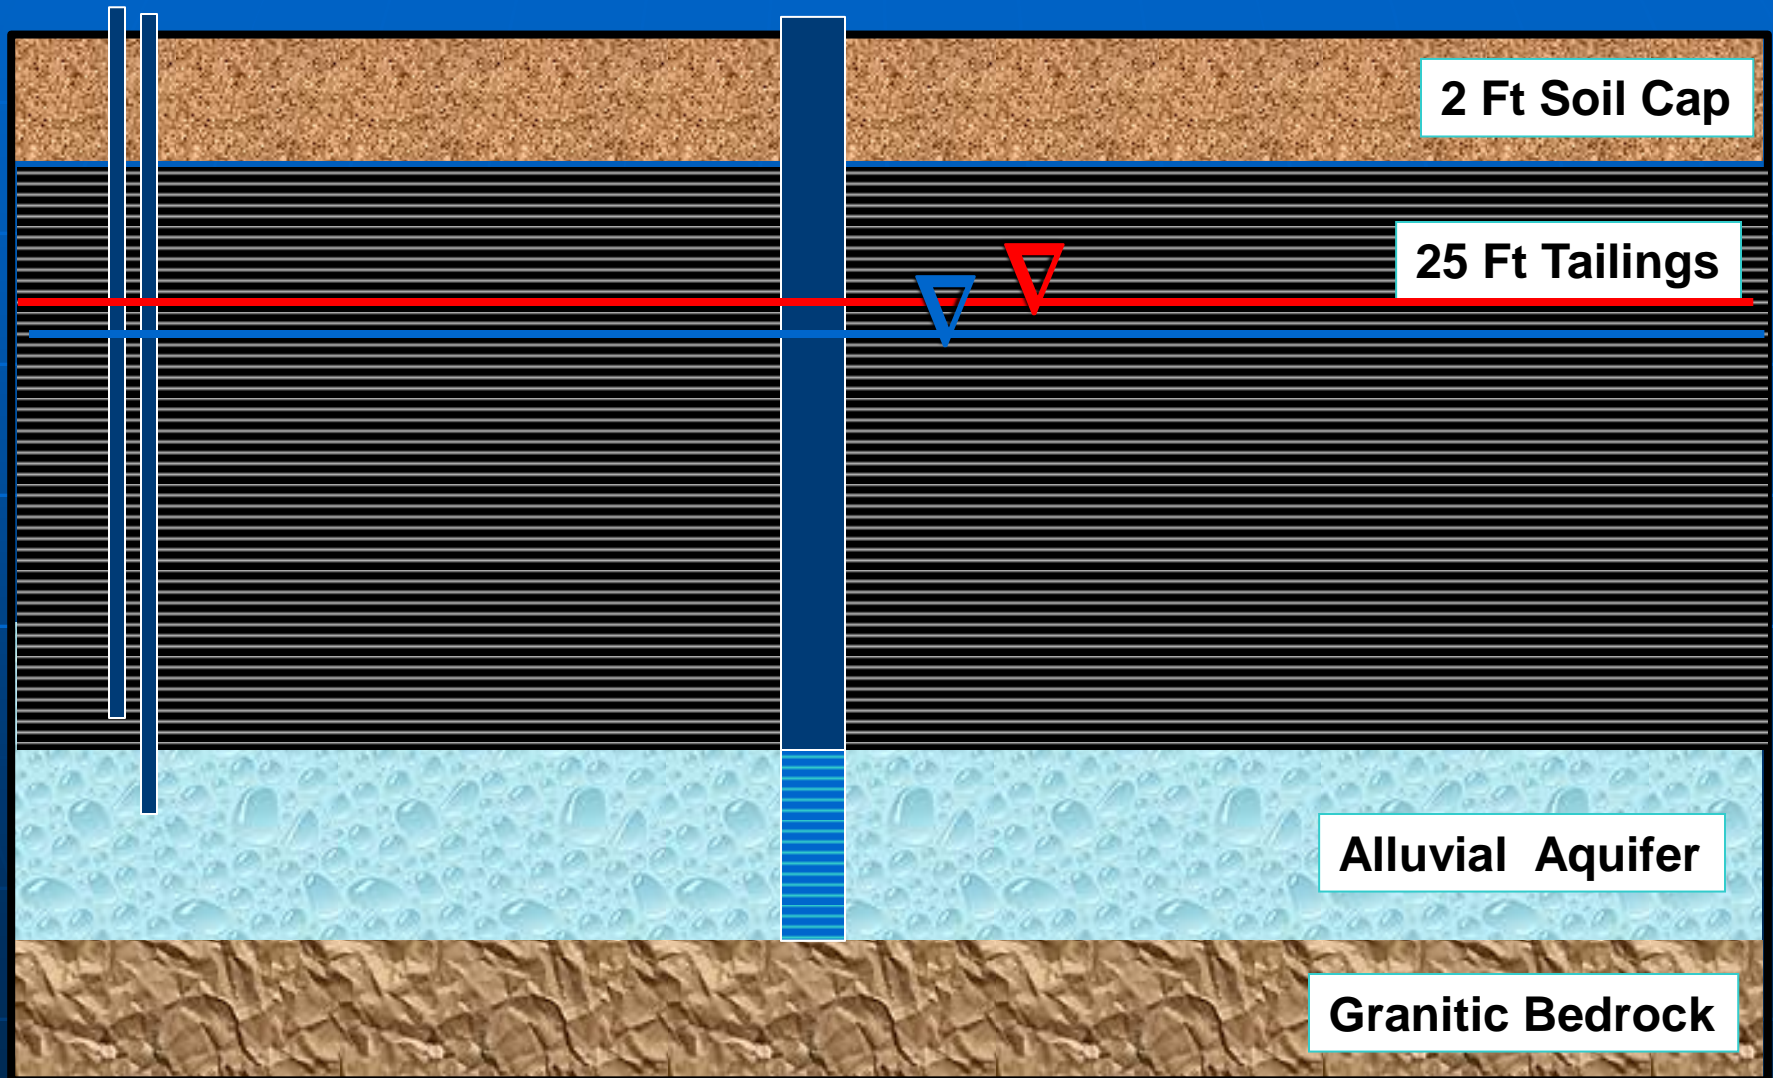
# Construction Dewatering

- Dewater the tailings by pumping the underlying aquifer
  - Intercept clean water
  - Treat contaminated water to DEQ water quality standards
- Stabilize tailings using lime
  - Reduce moisture and strengthen tailings
  - Reduce metal mobility
- Implement seasonal shut down BMPs
  - Interim repository liner
  - Water and sediment control
- Complete site reclamation
  - Soil amendment and revegetation
  - Stream reconstruction

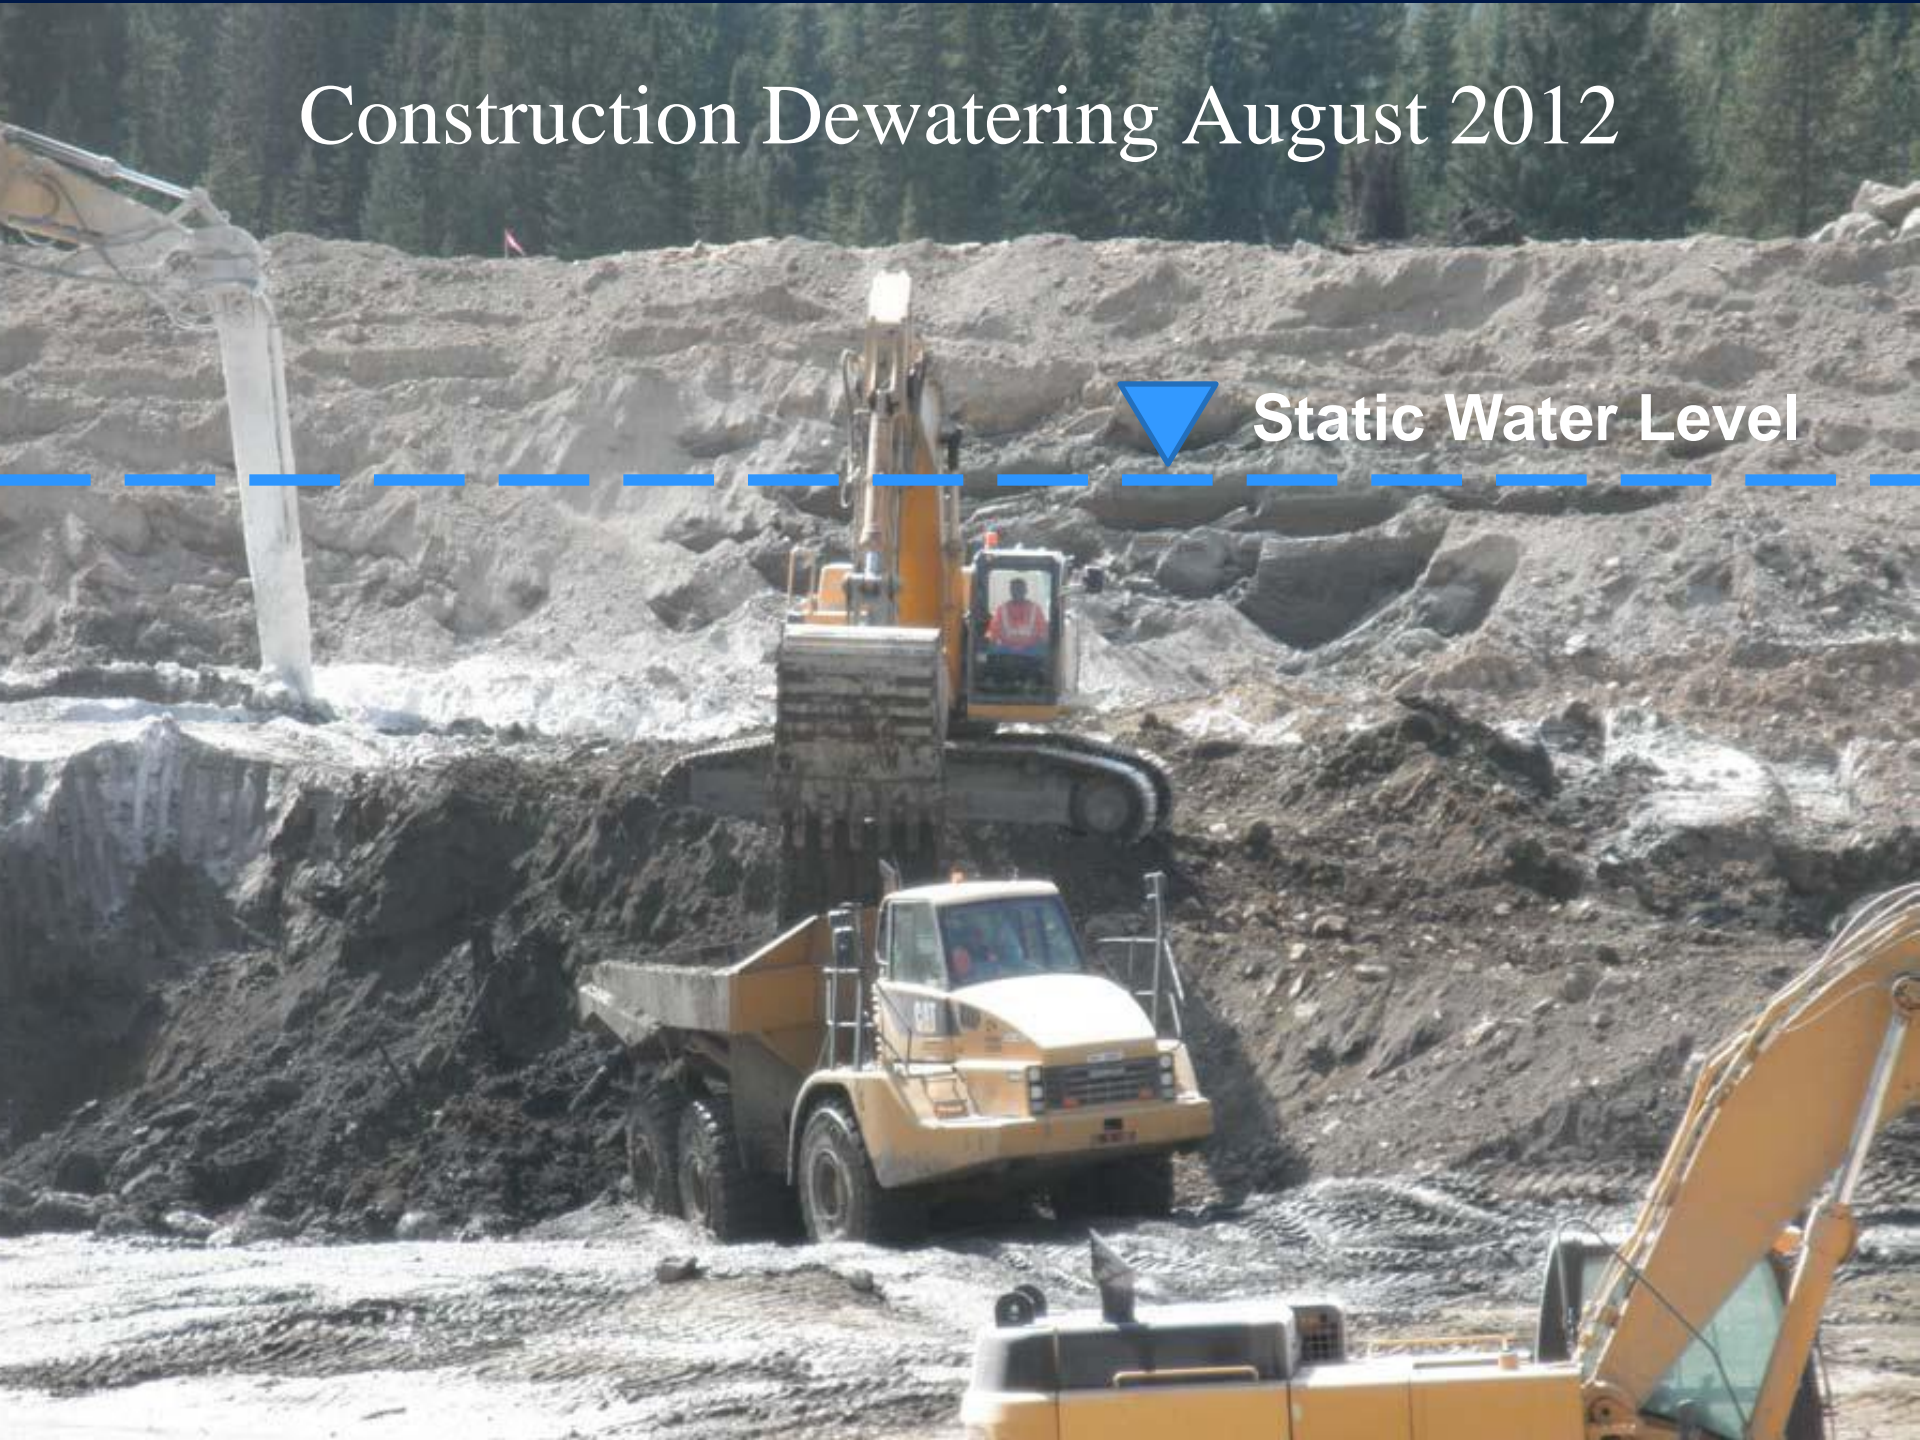
# Construction Dewatering August 2012

Static Water Level

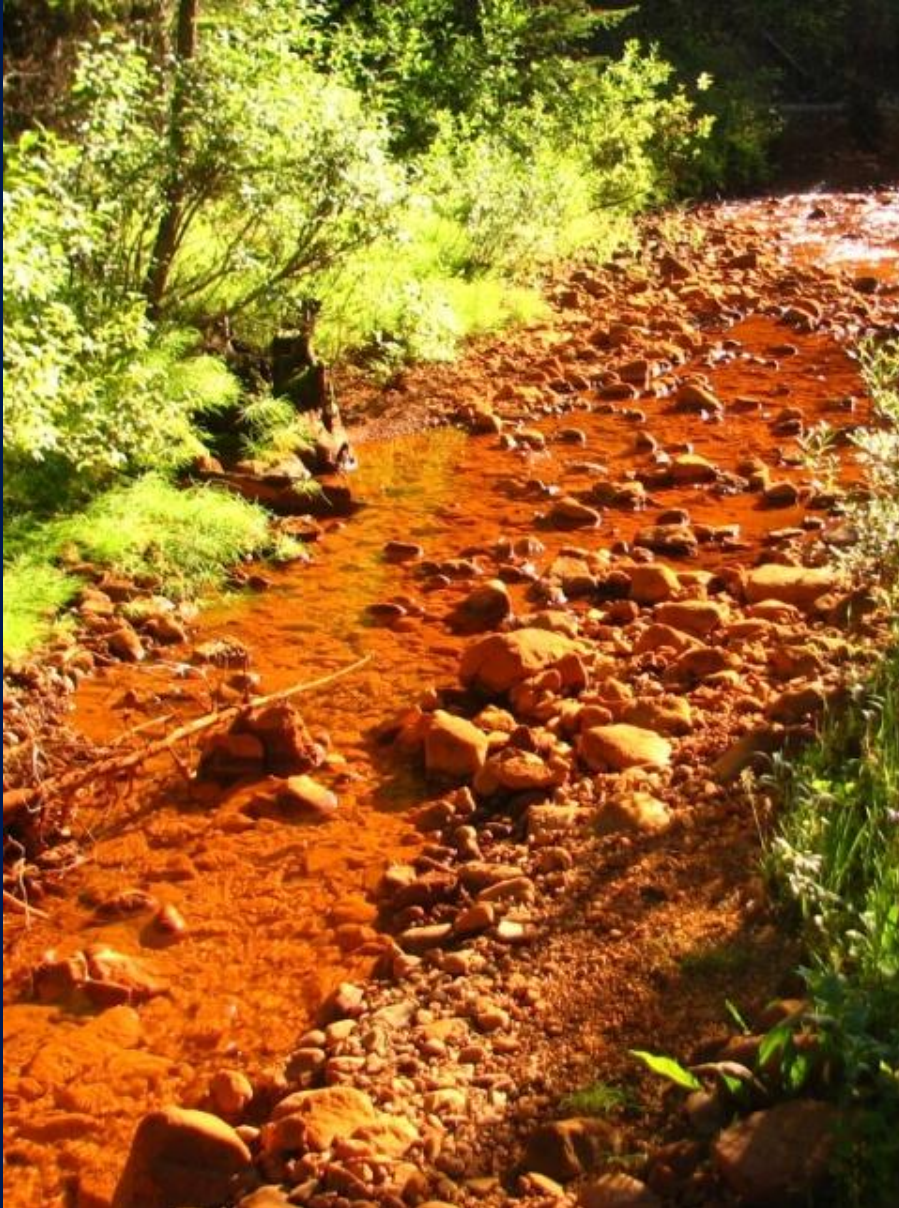
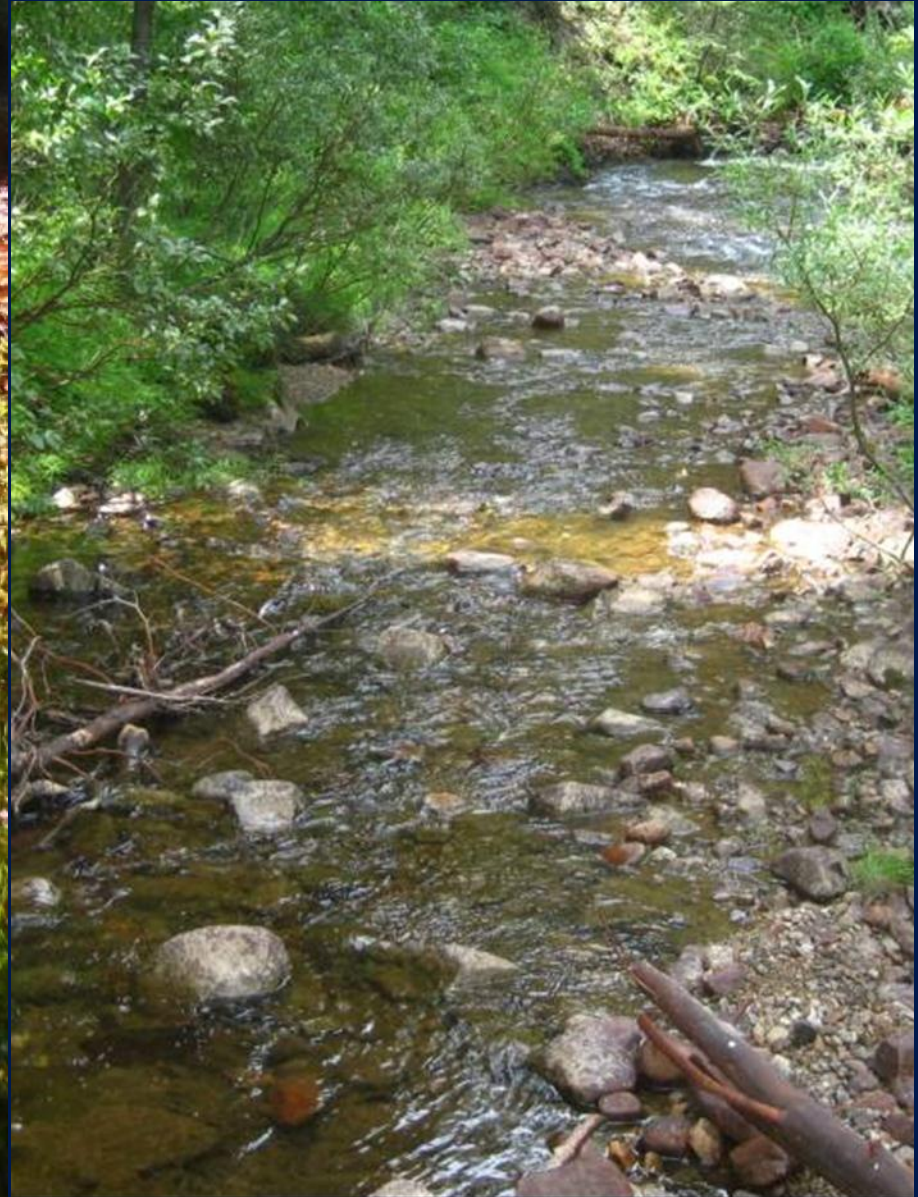
# Soda Butte Creek

2008

2013

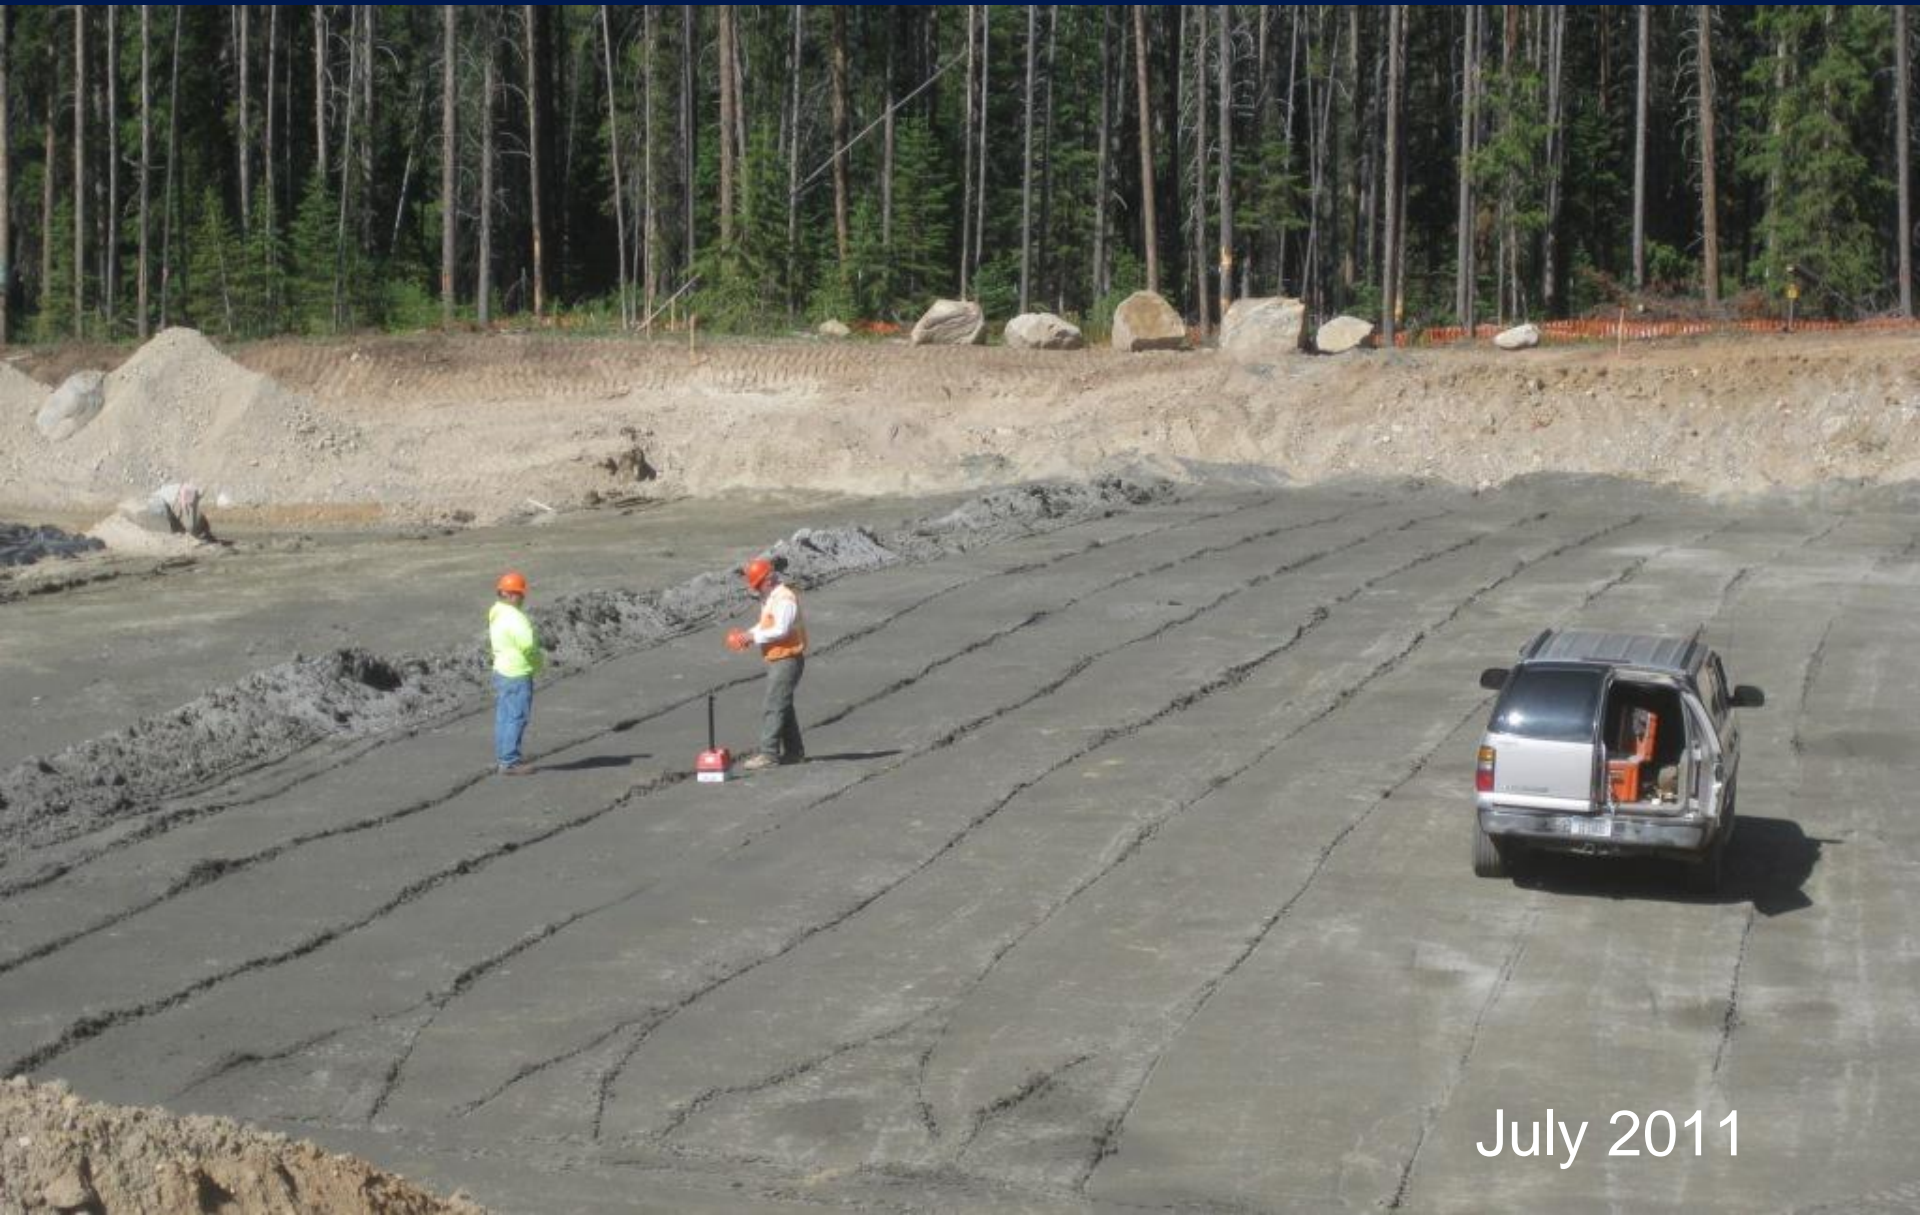
# Repository Compaction

- Contains approximately 240,000 cubic yards of compacted lime-stabilized tailings and ore rock
- Capped with a geochusion, 60-mil HDPE liner, drainage geocomposite, and 3 feet of cover soil.
- Side slopes are 5:1 horizontal to vertical based on seismic stability analysis for the area

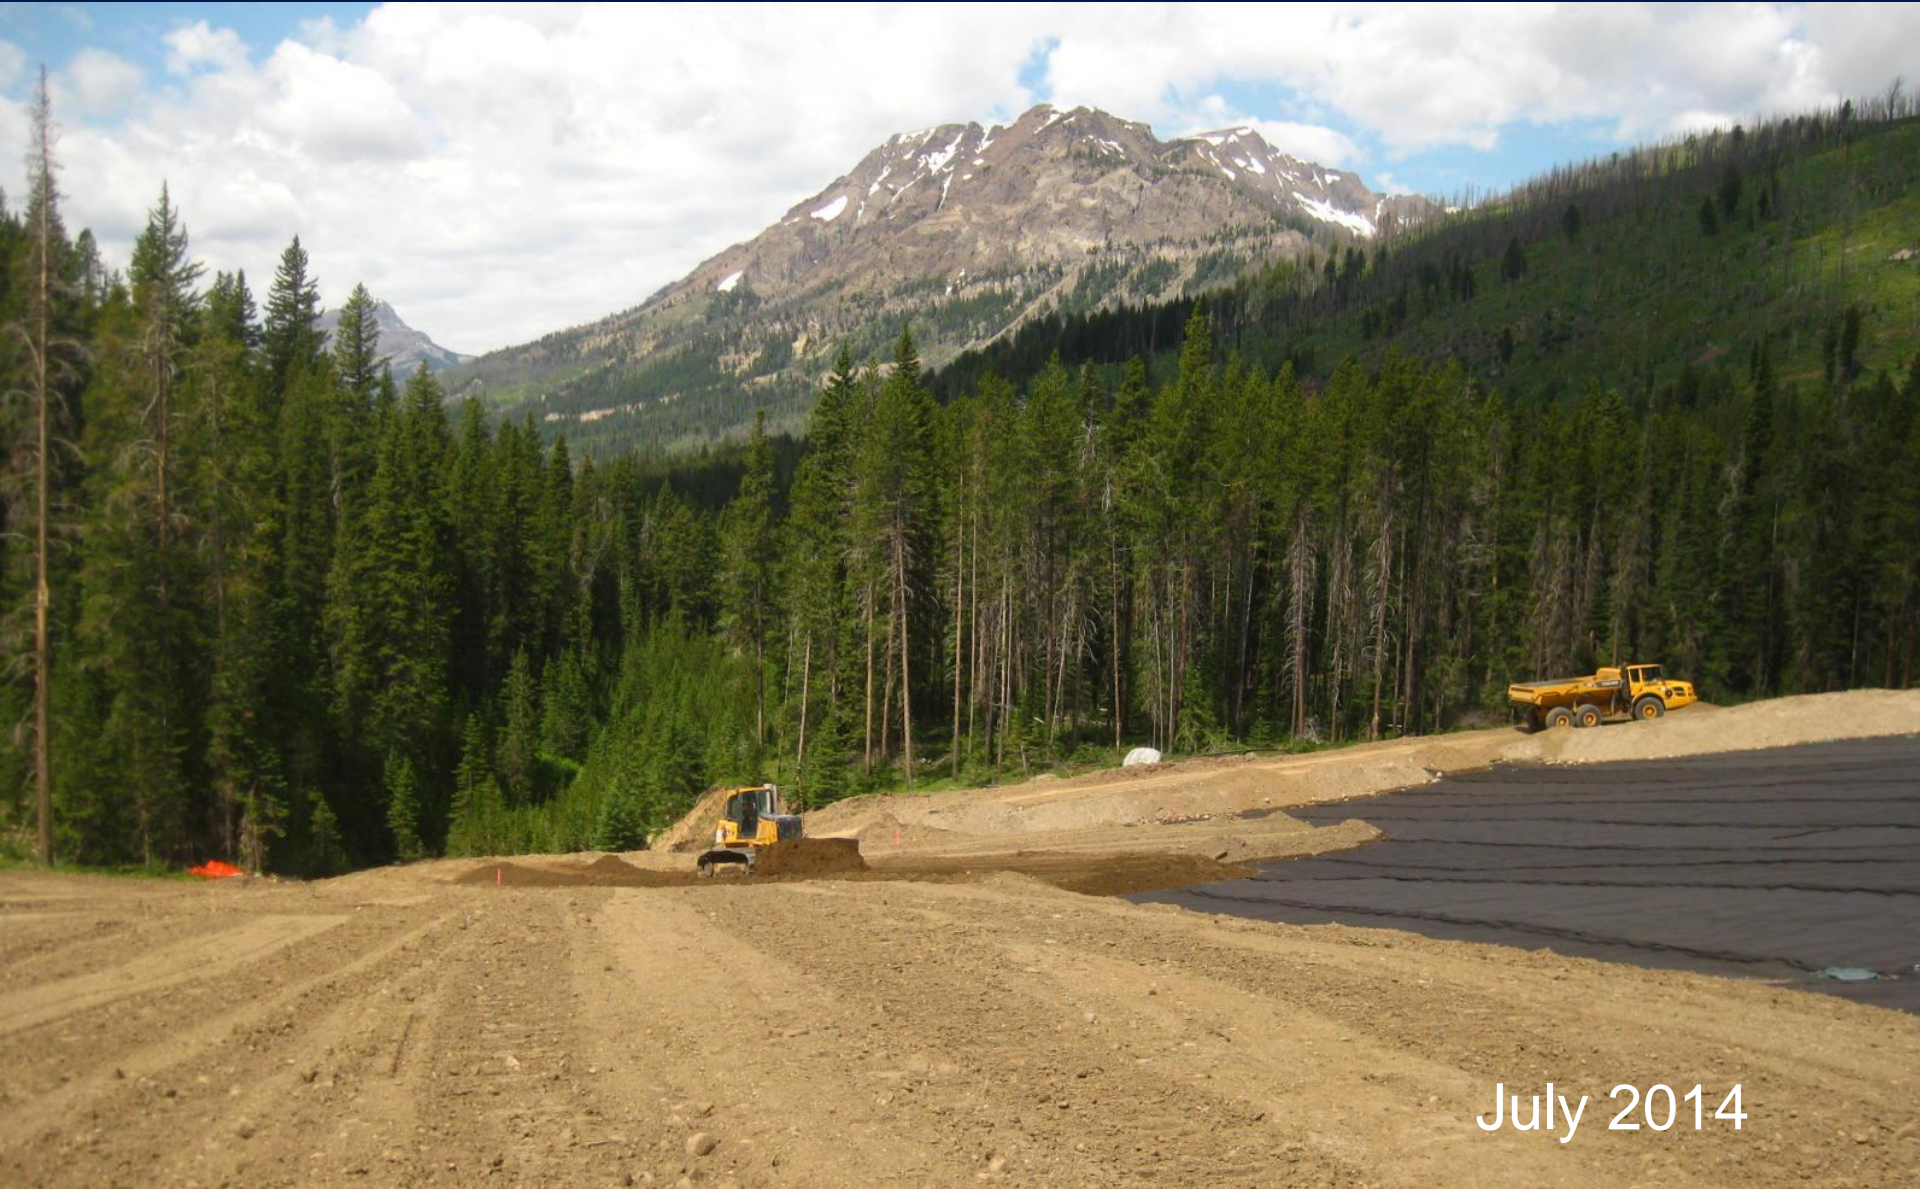
# Repository – Soil Cap

- Install repository cap – 3 feet of soil
- Improve soil productivity using compost
- Cover project with one foot of compost-amended soil
- Monitor performance of reconstructed stream channels
- Construct water collection features
- Seed in September
